# Final Reclamation Inspection

Operator: Forestar Group inc

Location ID: 395653

Morgan County, CO

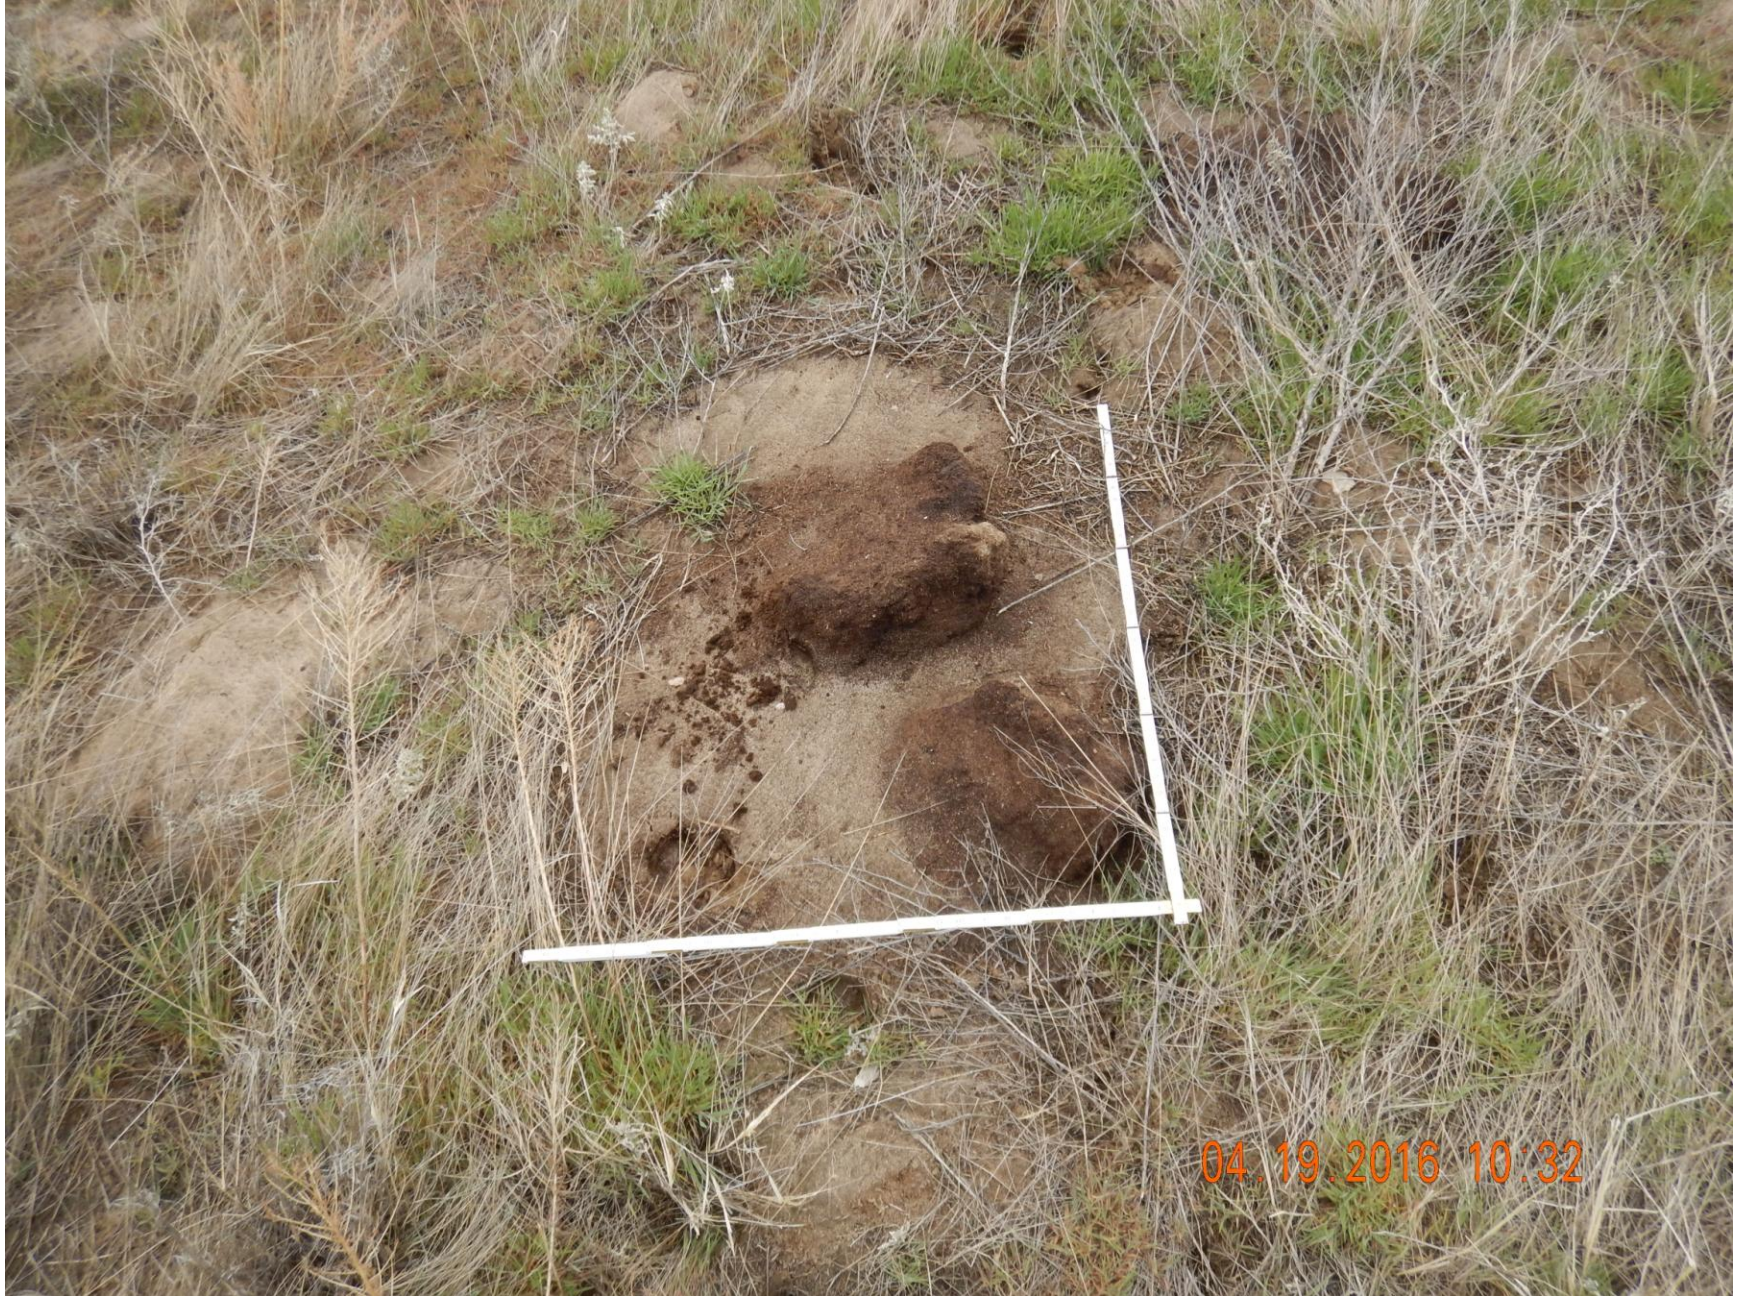
**Figure 11:** Photo taken from the southern end of the location (east end of the former pit location), photo shows stained soil. 3.5'x2.5' measuring stick for reference.

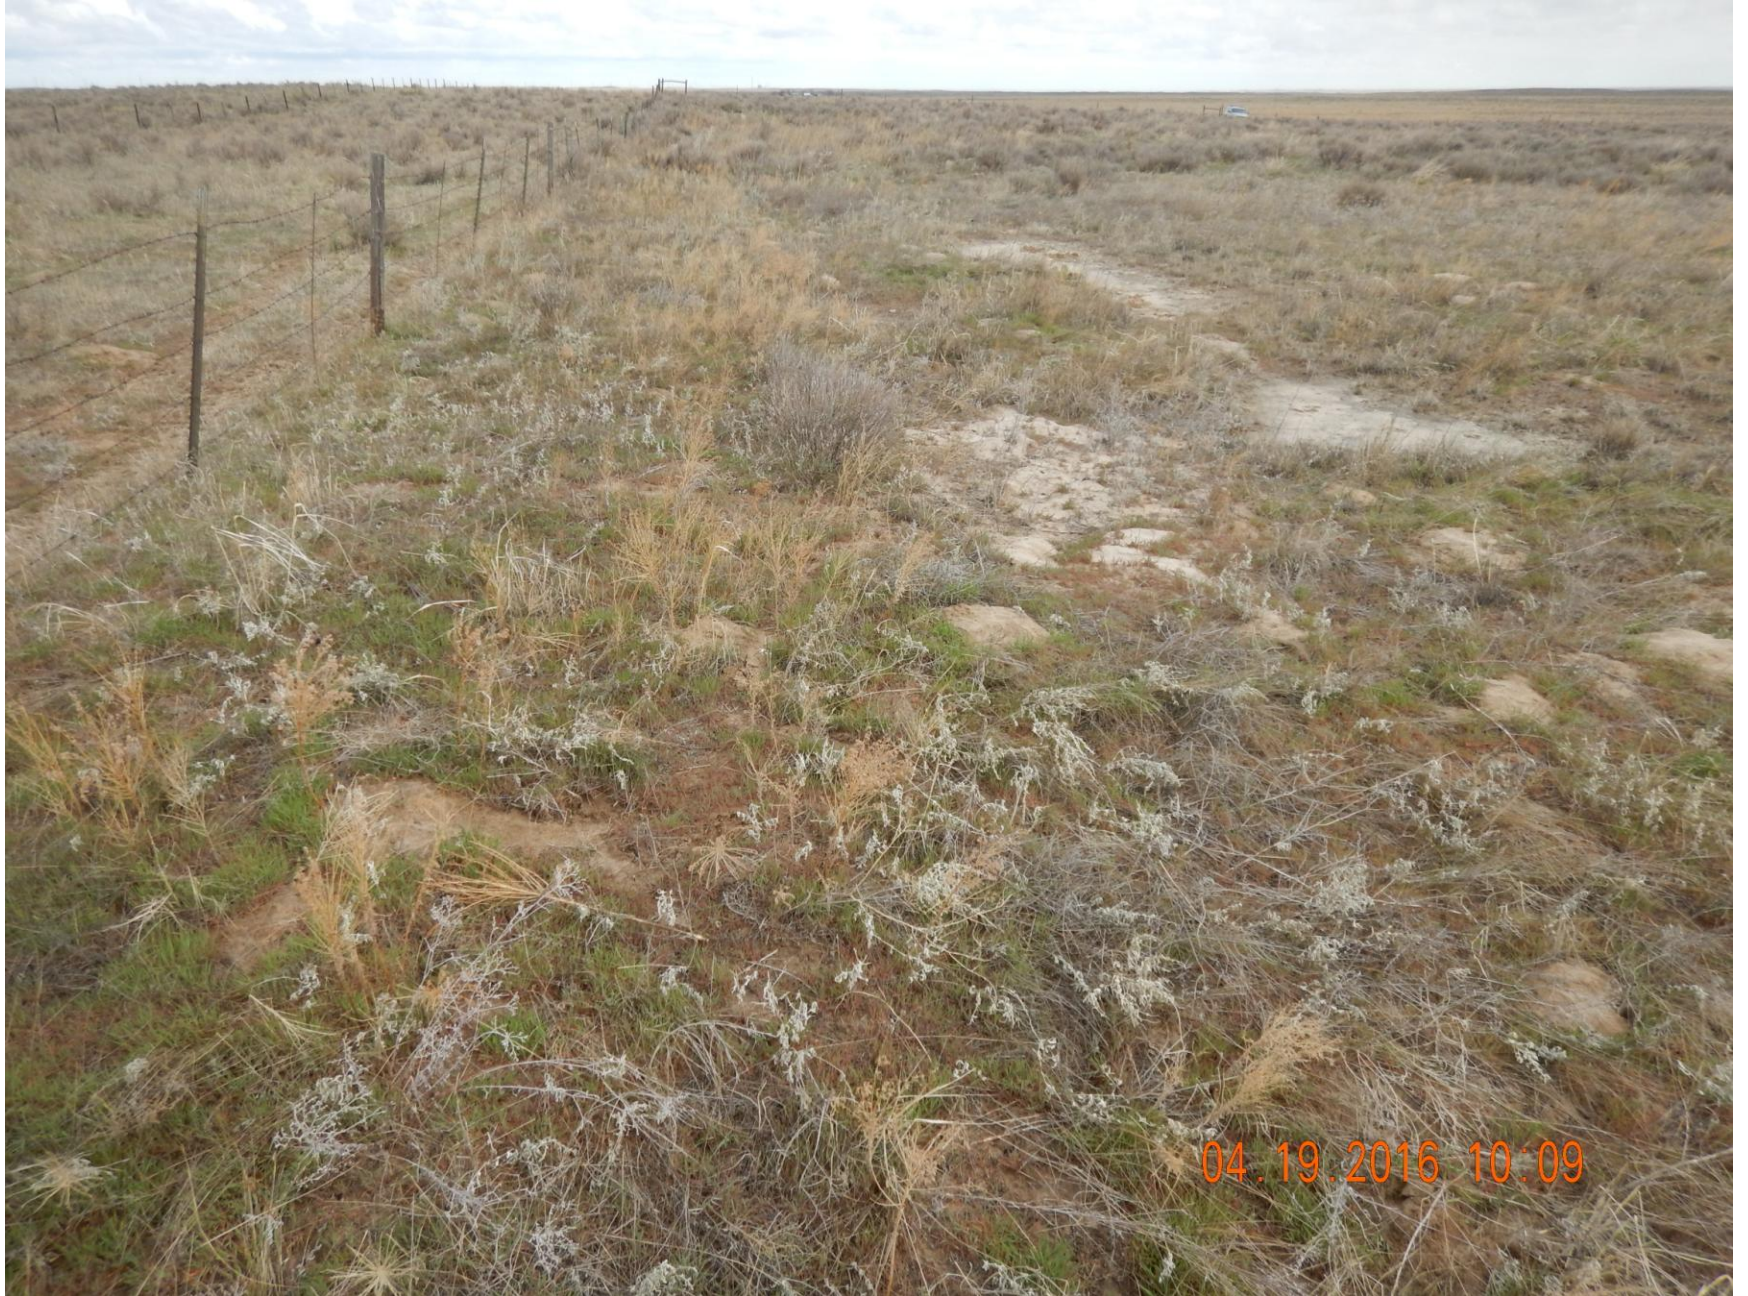
**Figure 12:** Photo taken from the southeast corner of the location, facing west. Photo shows vegetation on the location.

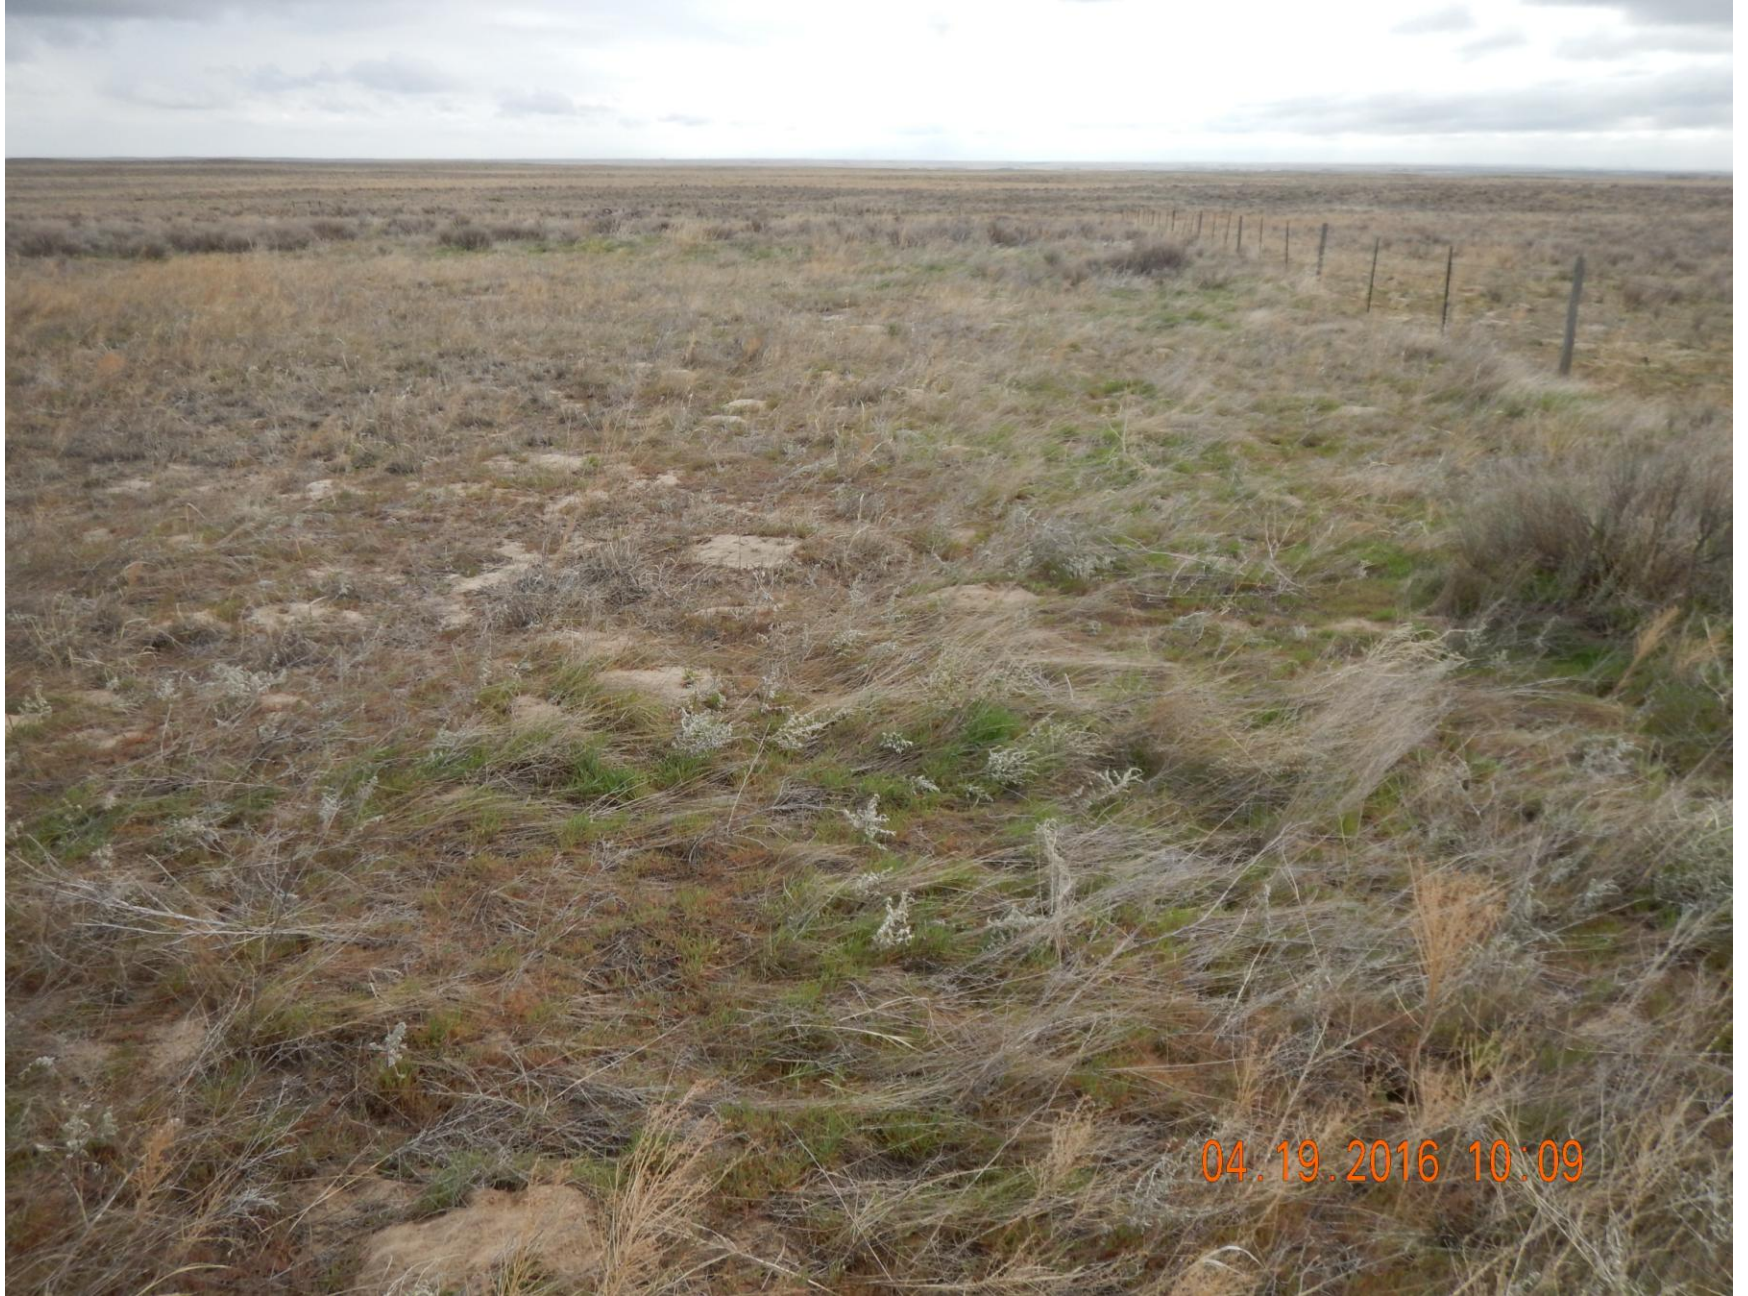
**Figure 13:** Photo taken from the southeast corner of the location, facing north. Photo shows vegetation on the location.

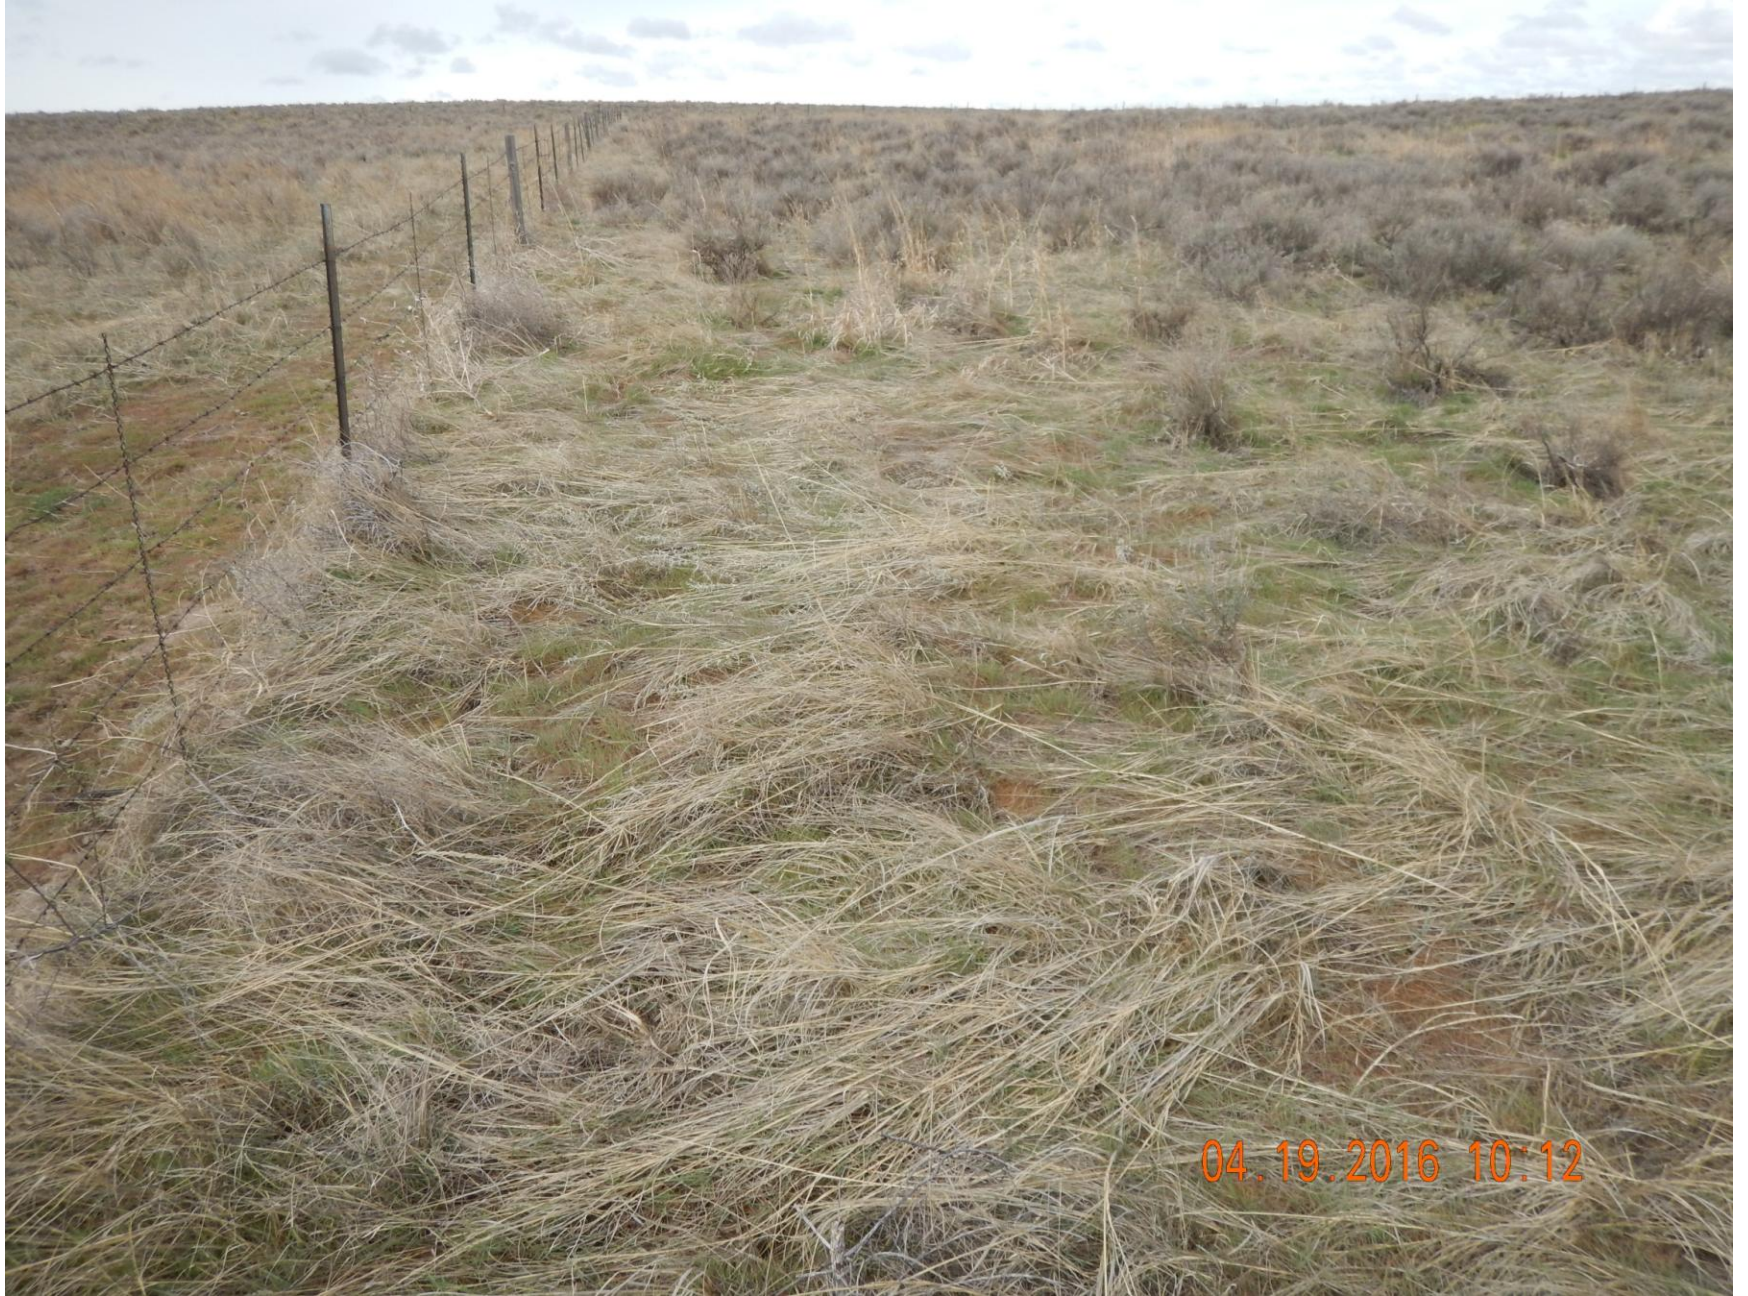
**Figure 14:** Photo taken from the northeast corner of the location, facing south. Photo shows vegetation on the location.

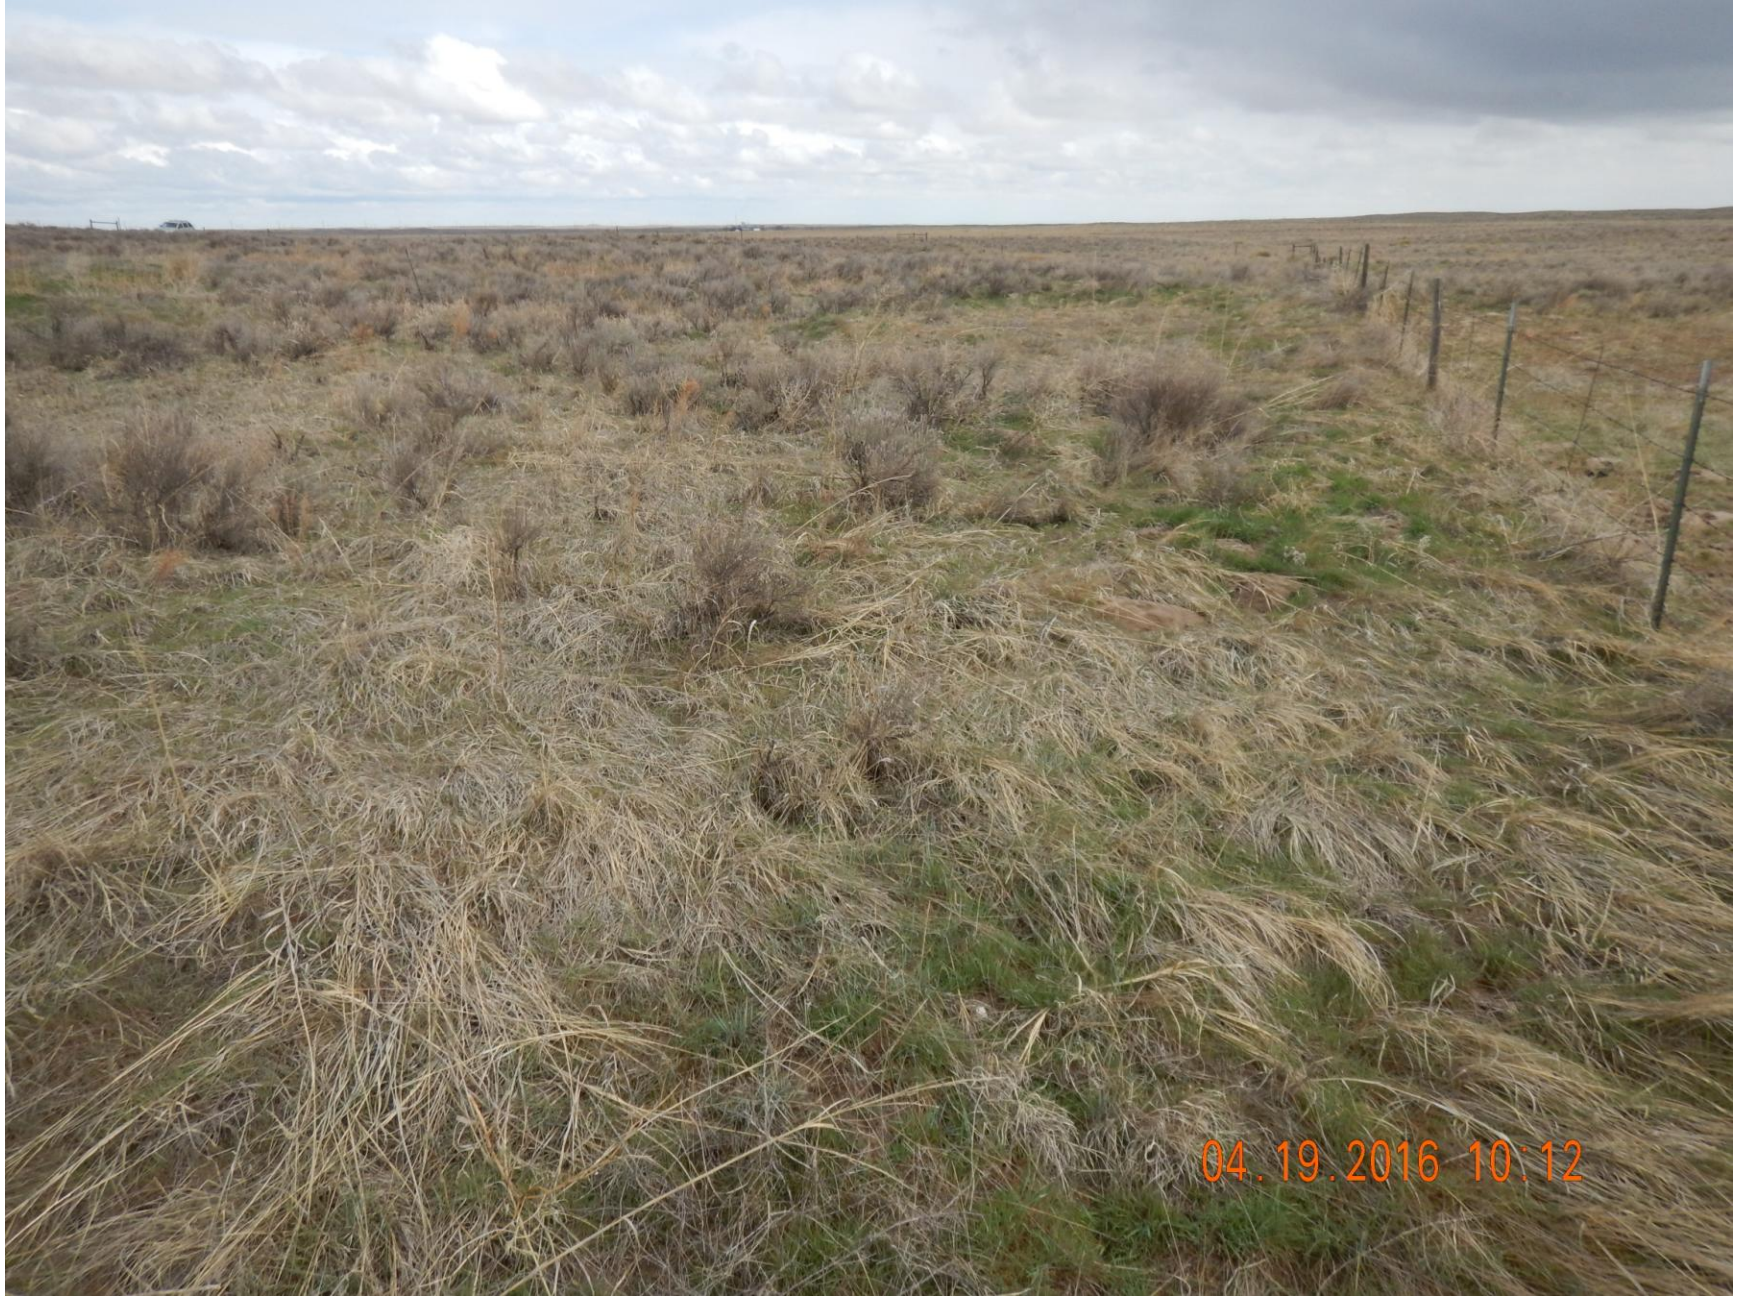
**Figure 15:** Photo taken from the northeast corner of the location, facing northwest. Photo shows vegetation on the location.

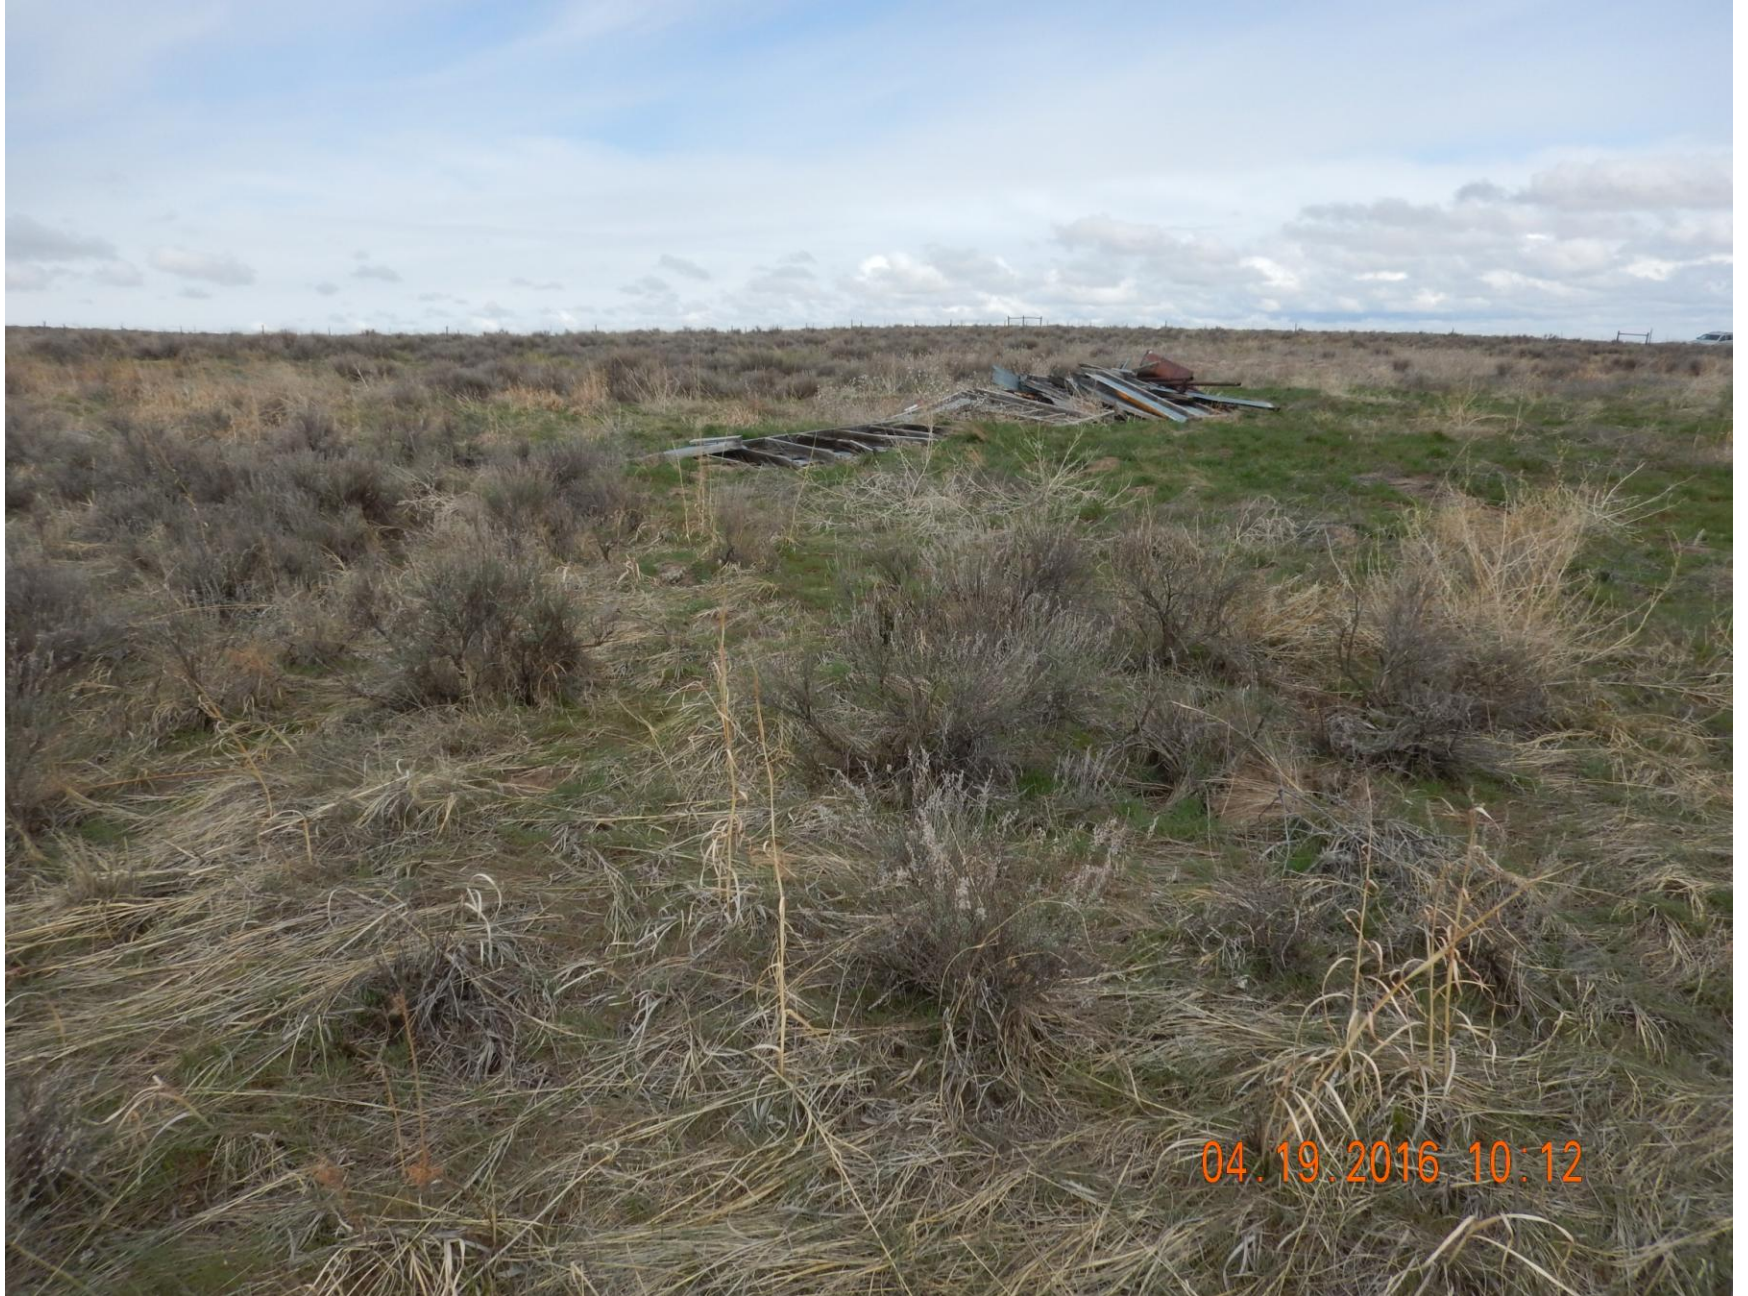
**Figure 16:** Photo taken from the south-central portion of the project area, facing northwest. Photo shows equipment and trash debris piled and left on location.

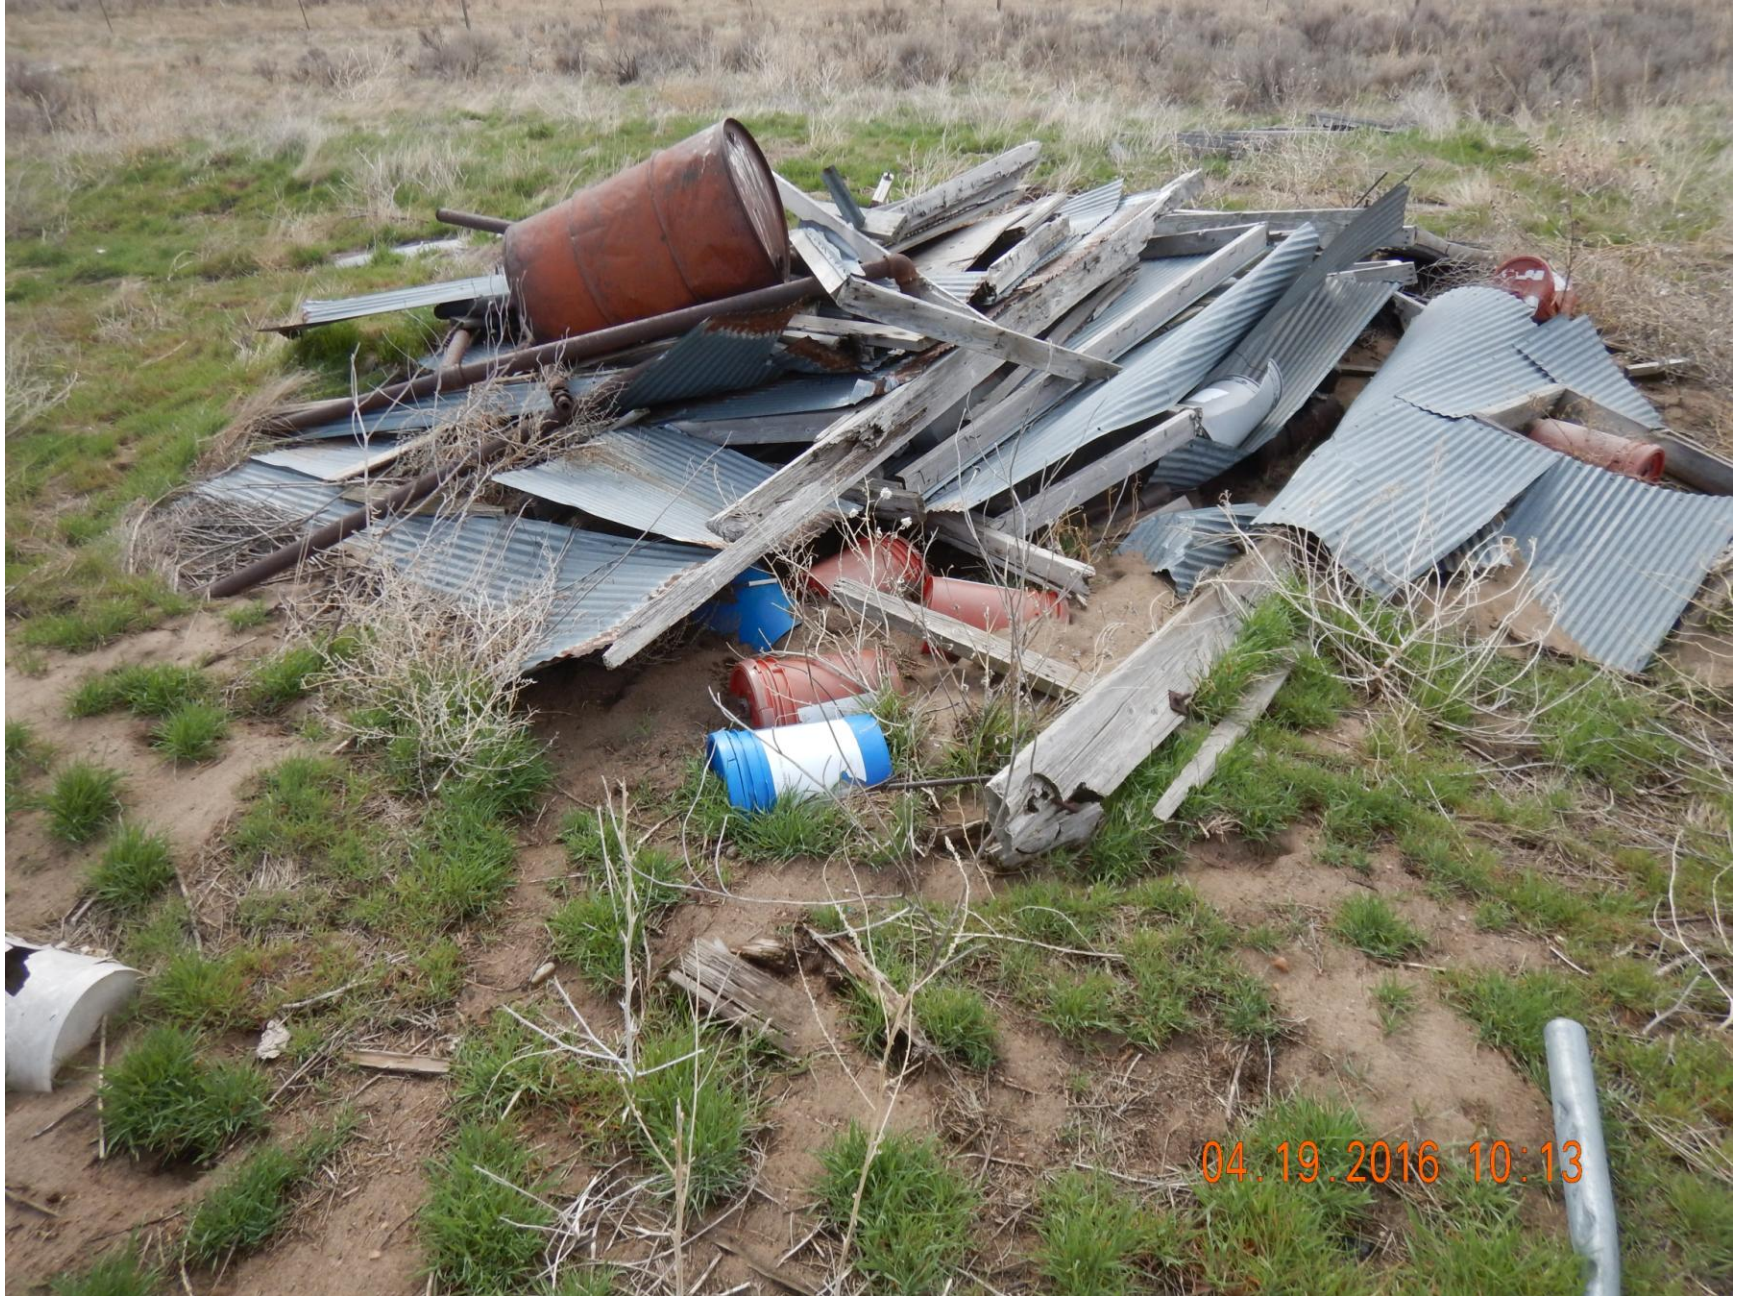
**Figure 17:** Photo taken from the south-central portion of the project area. Photo shows equipment and trash debris piled and left on location.

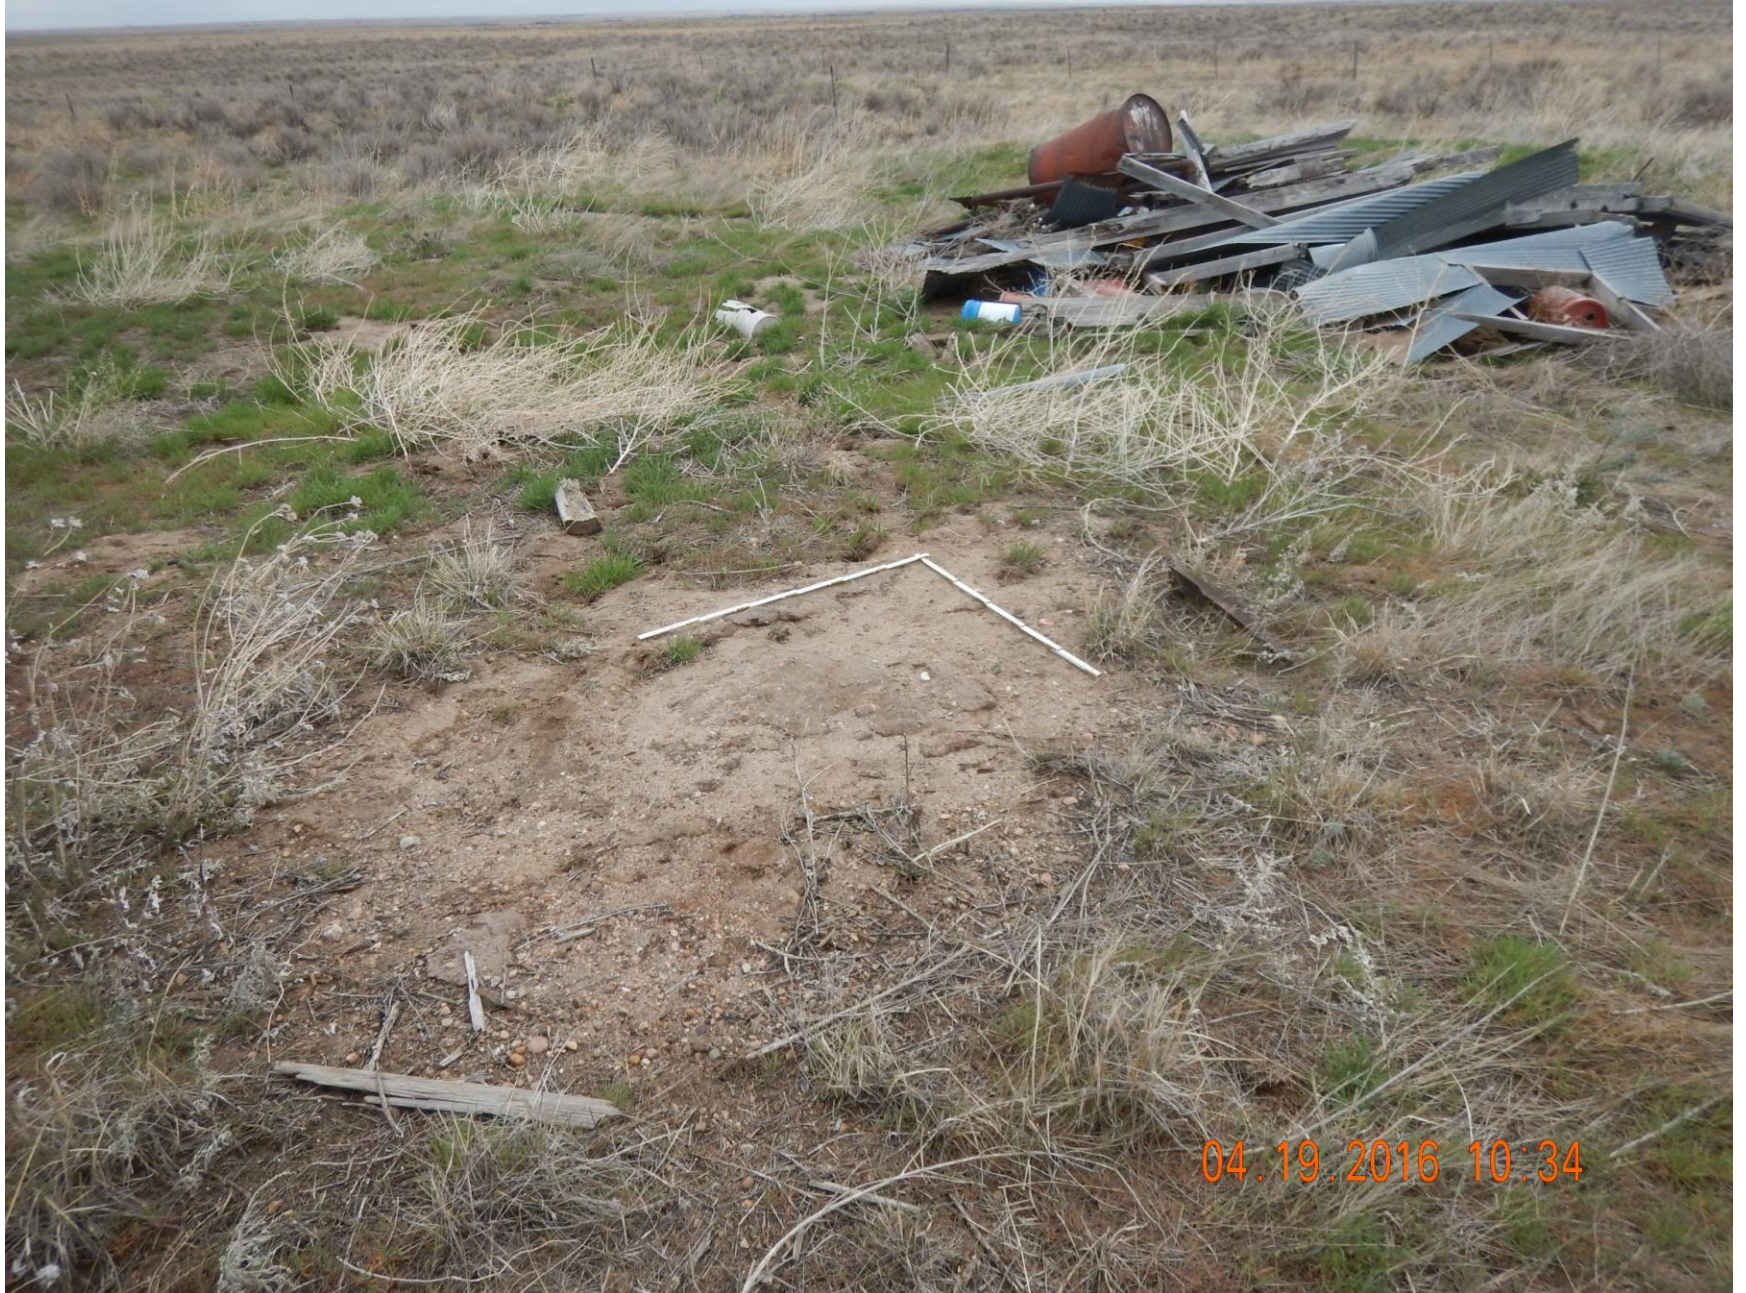
**Figure 18:** Photo taken from the south-central portion of the project area. Photo shows un vegetated area on the location with what appears to be a hard substance (likely concrete) remaining on location. 3.5'x2.5' measuring stick for reference.

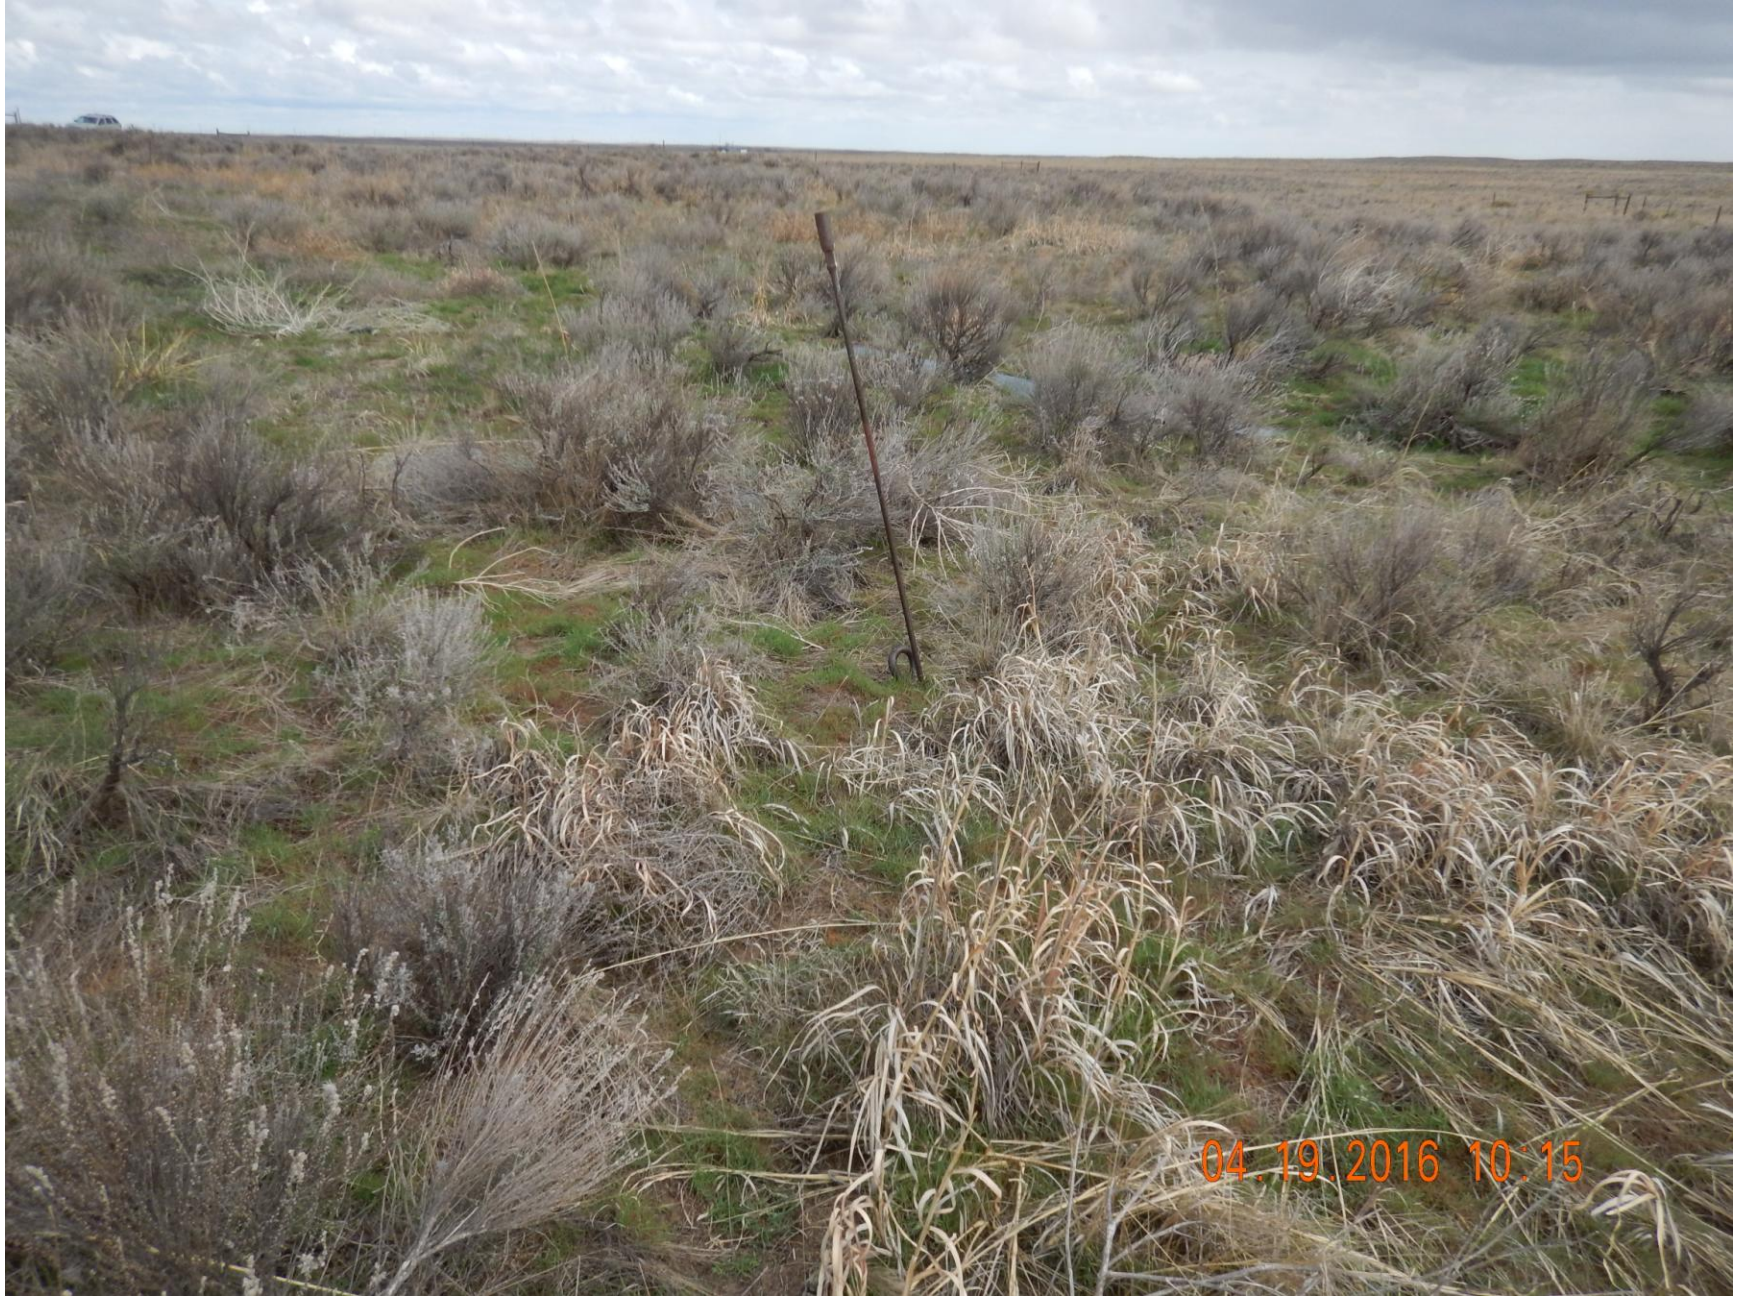
**Figure 19:** Photo taken from the east end of the project area, facing north. Photo shows anchor equipment have not been removed.

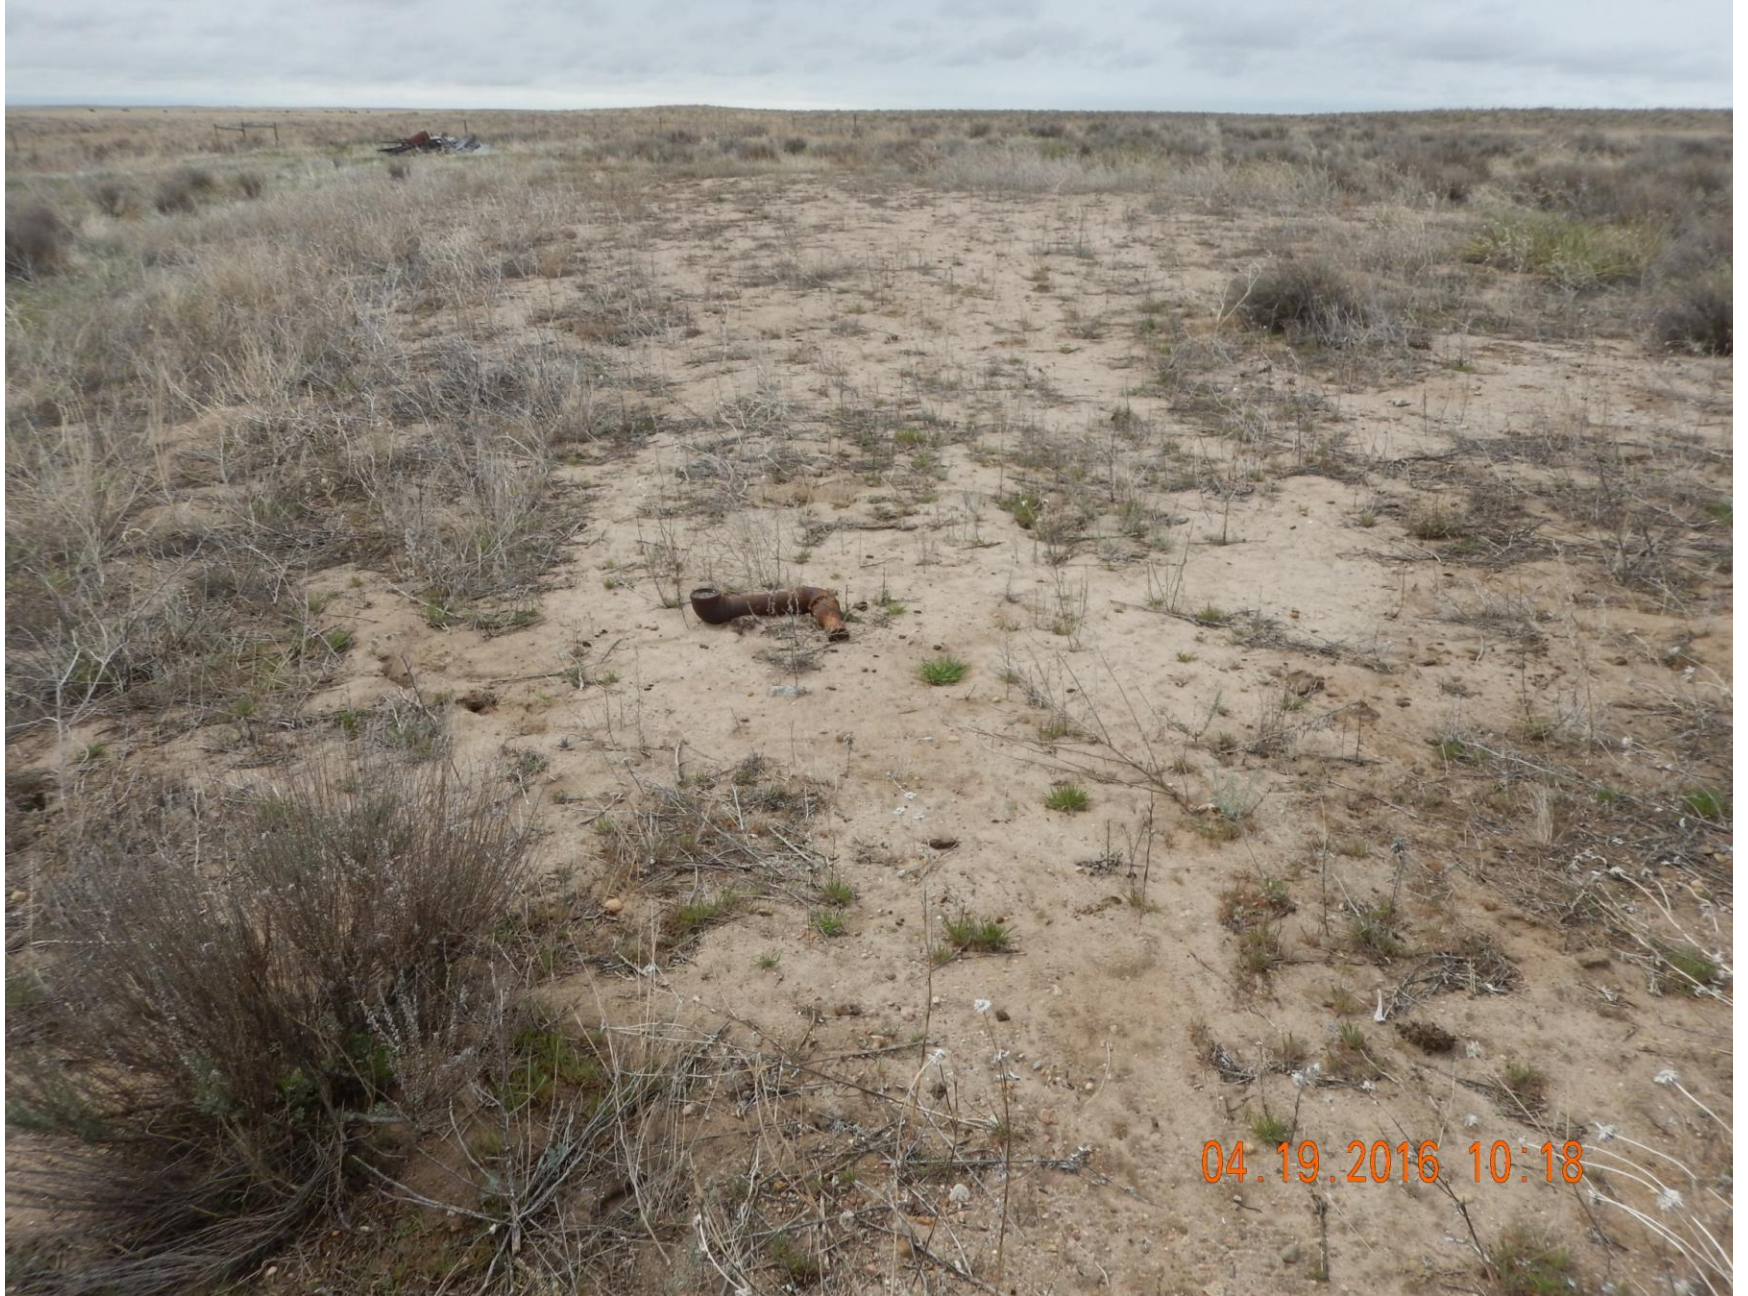
**Figure 20:** Photo taken from the north end of the project area facing south. Photo shows an area approximately 125' x 63' in size of the project location that remains un-reclaimed.
