# Final Reclamation Inspection

Operator: Forestar Group inc

Location ID: 395653

Morgan County, CO

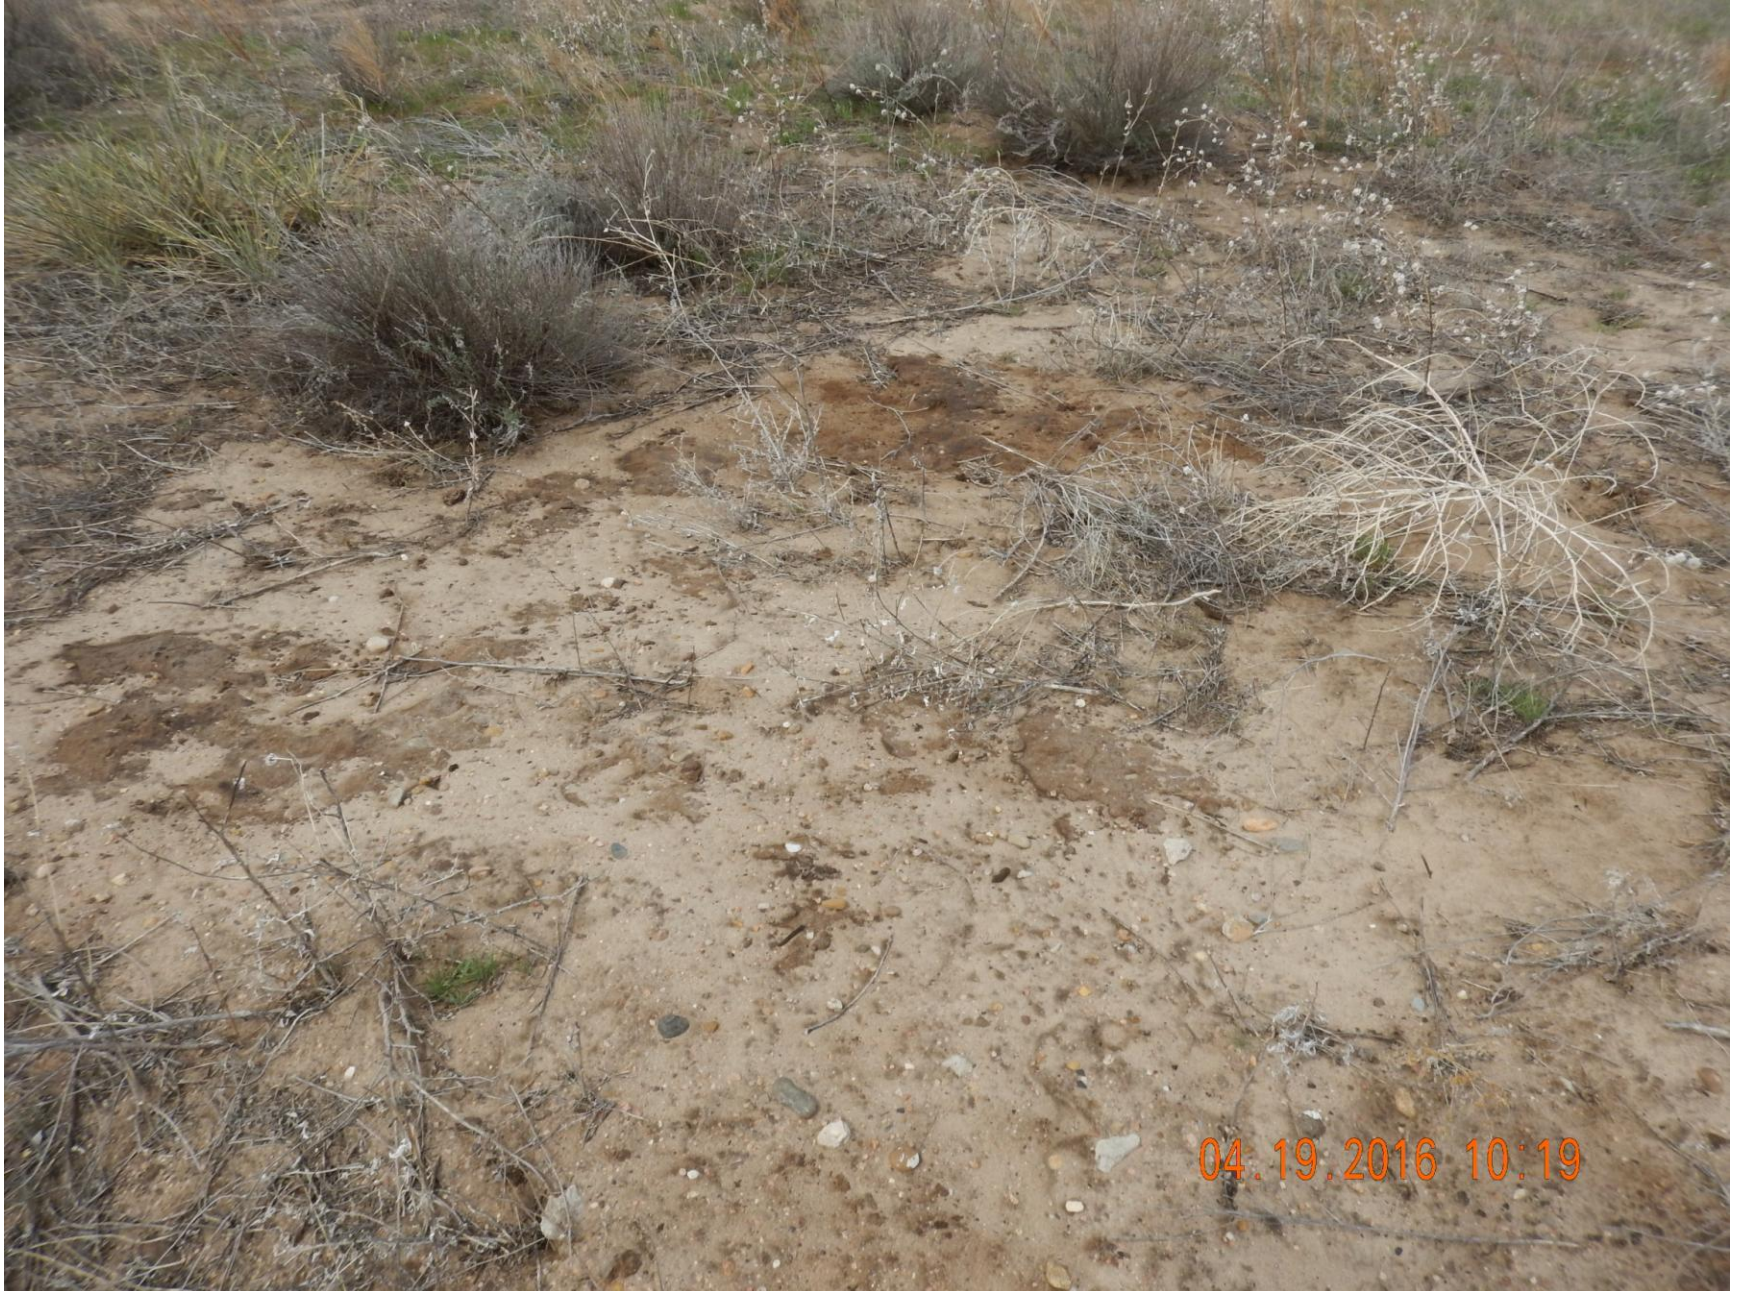
**Figure 21:** Photo taken on the northwest portion of the unvegetated project area (see figure 20), facing west. Photo shows areas with stained soil. Area appears to be near where the tank batteries were once located.

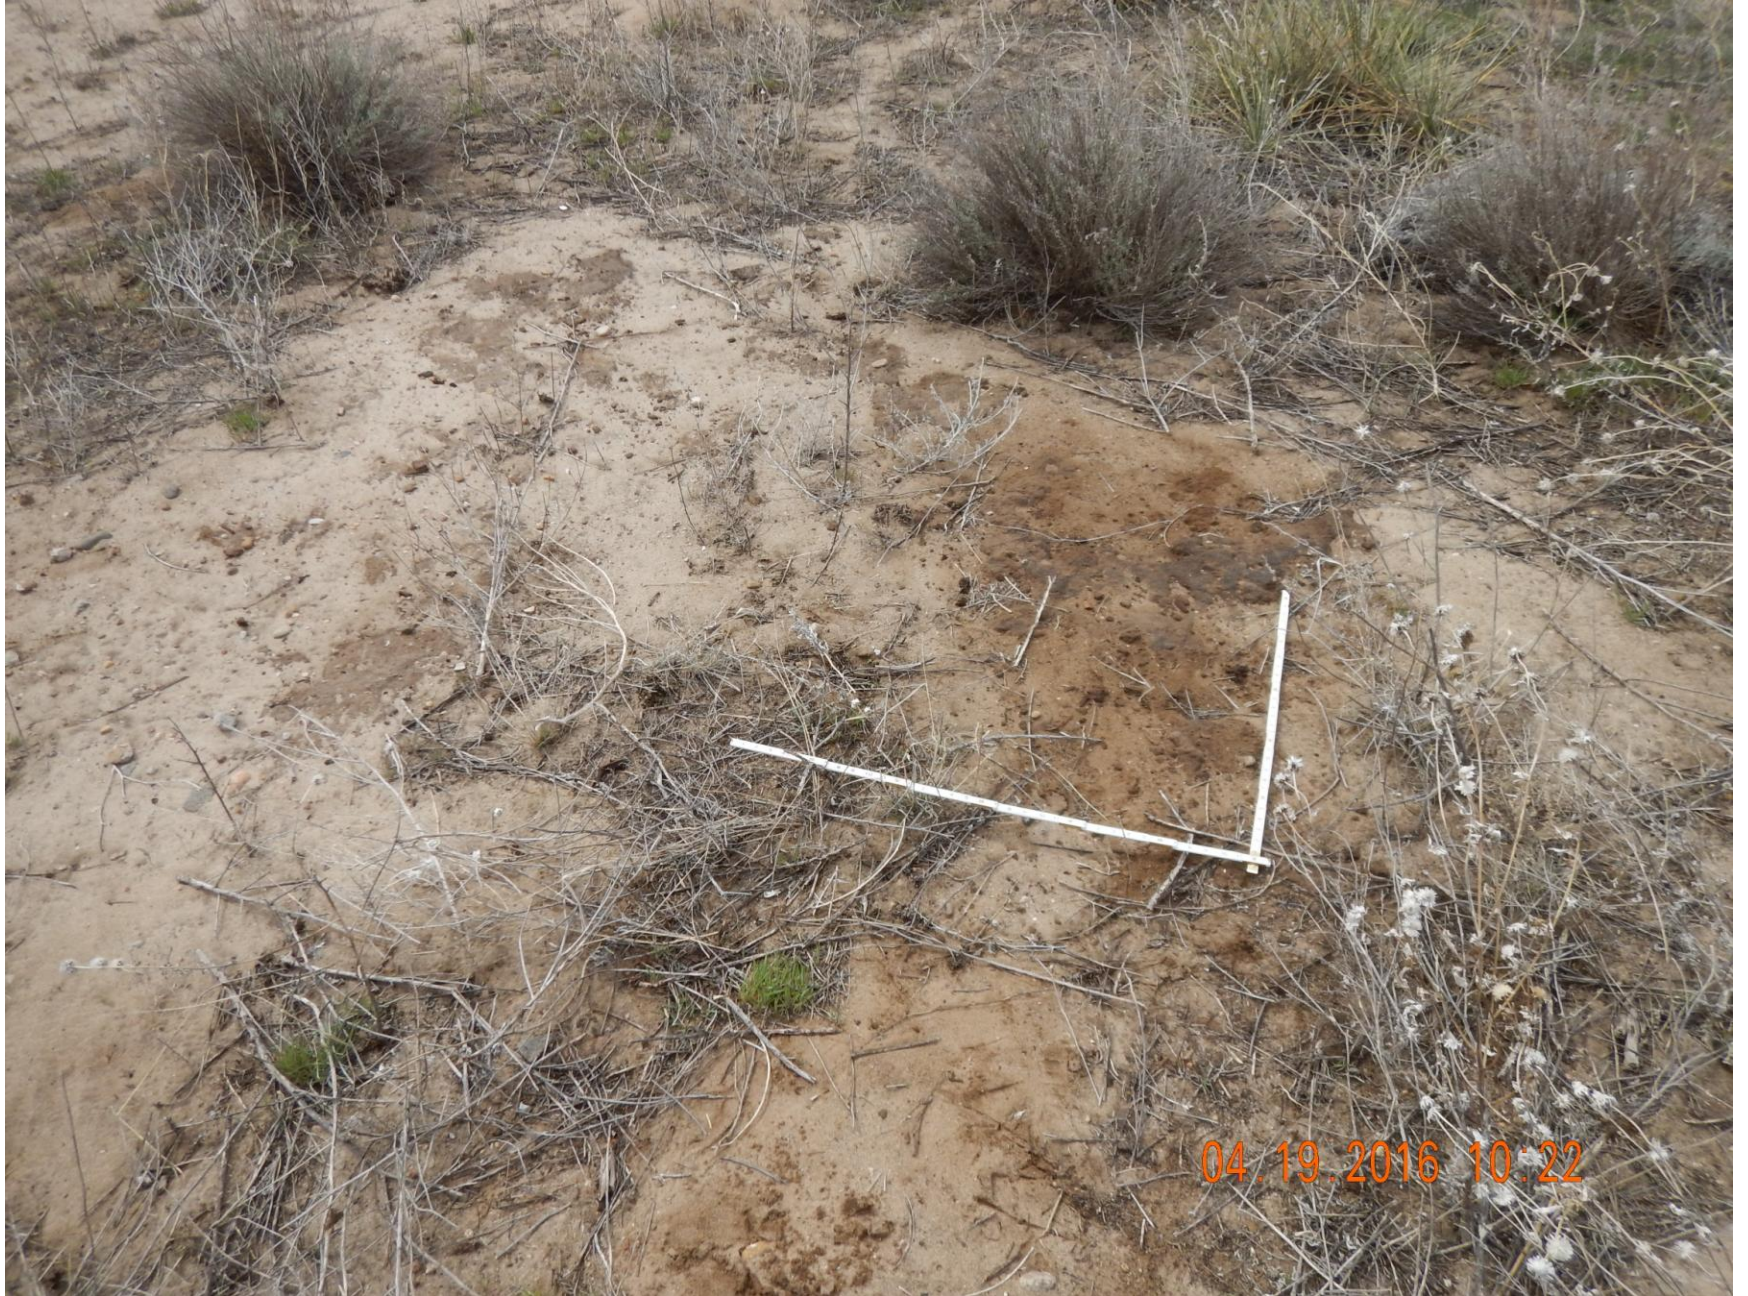
**Figure 22:** Photo taken on the northwest portion of the unvegetated project area (see figure 19). Photo shows areas with stained soil. Area appears to be near where the tank batteries were once located. 3.5'x2.5' measuring stick for reference.
