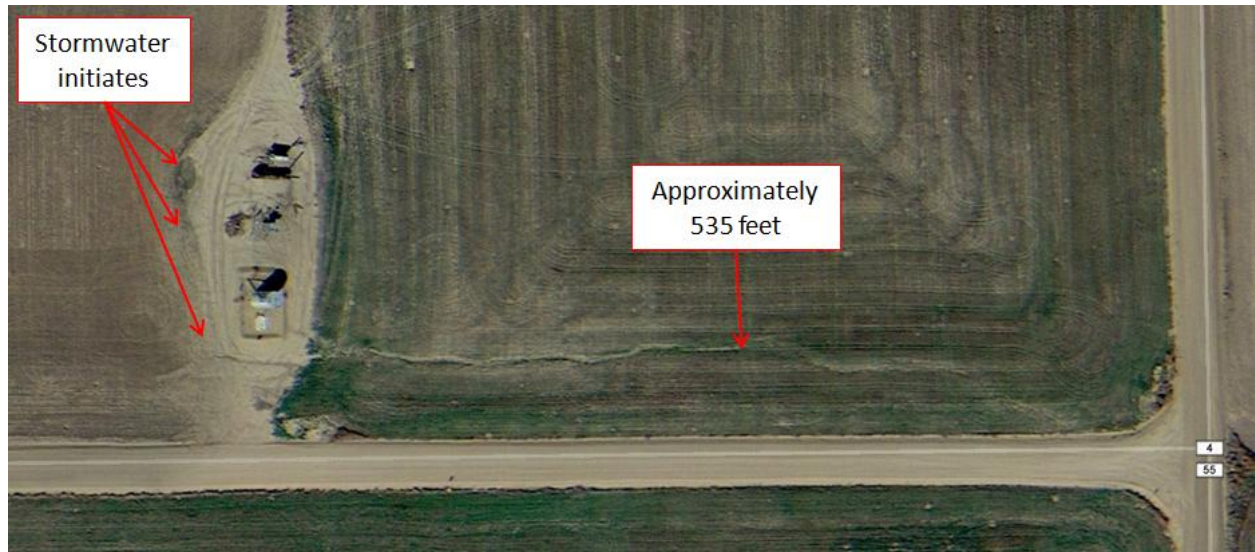
Photo 1: Google Earth aerial photo illustrating that erosion and transport of sediment initiates on the western area of the tank battery, then travels east onto cropland, and then onto the north roadside ditch of CR 4, totaling approximately 535 feet. Refer to Document# 682400489 for complete field photos from the 3/8/16 inspection.

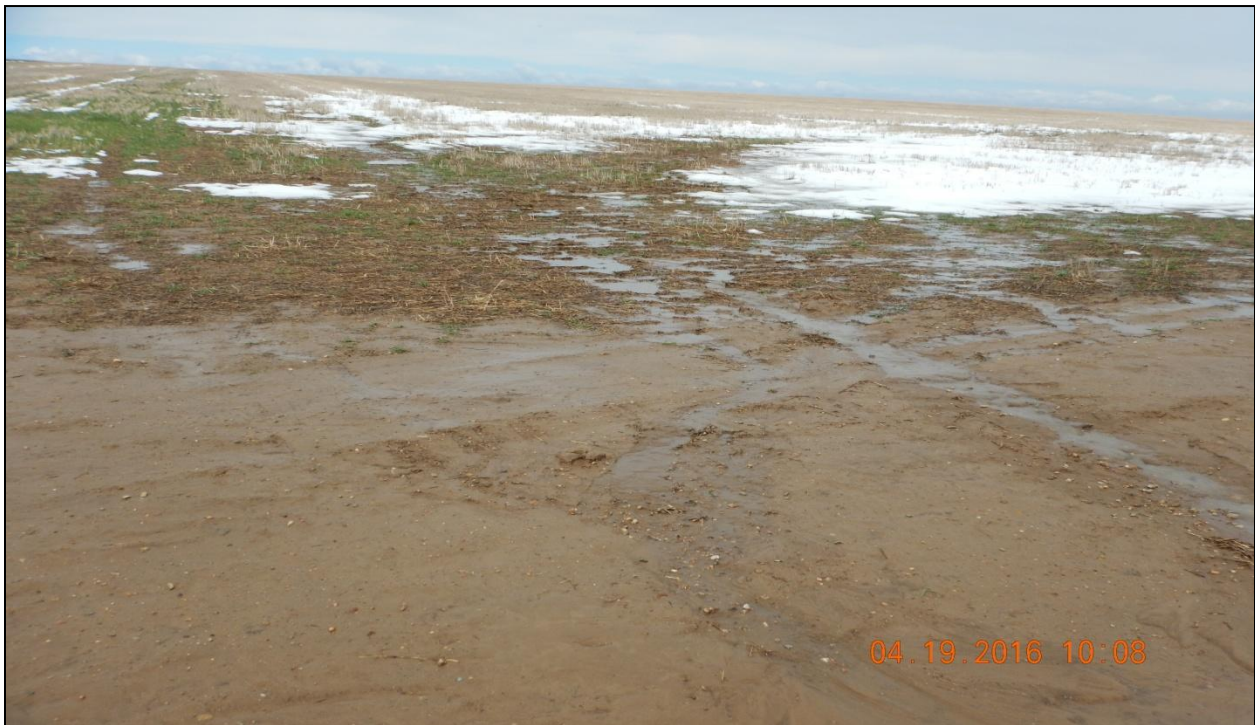
Photo 2: Photo taken 4/19/16 from entrance of location, facing West. Need to control run-on and run-off to prevent transport of sediment offsite and site degradation.

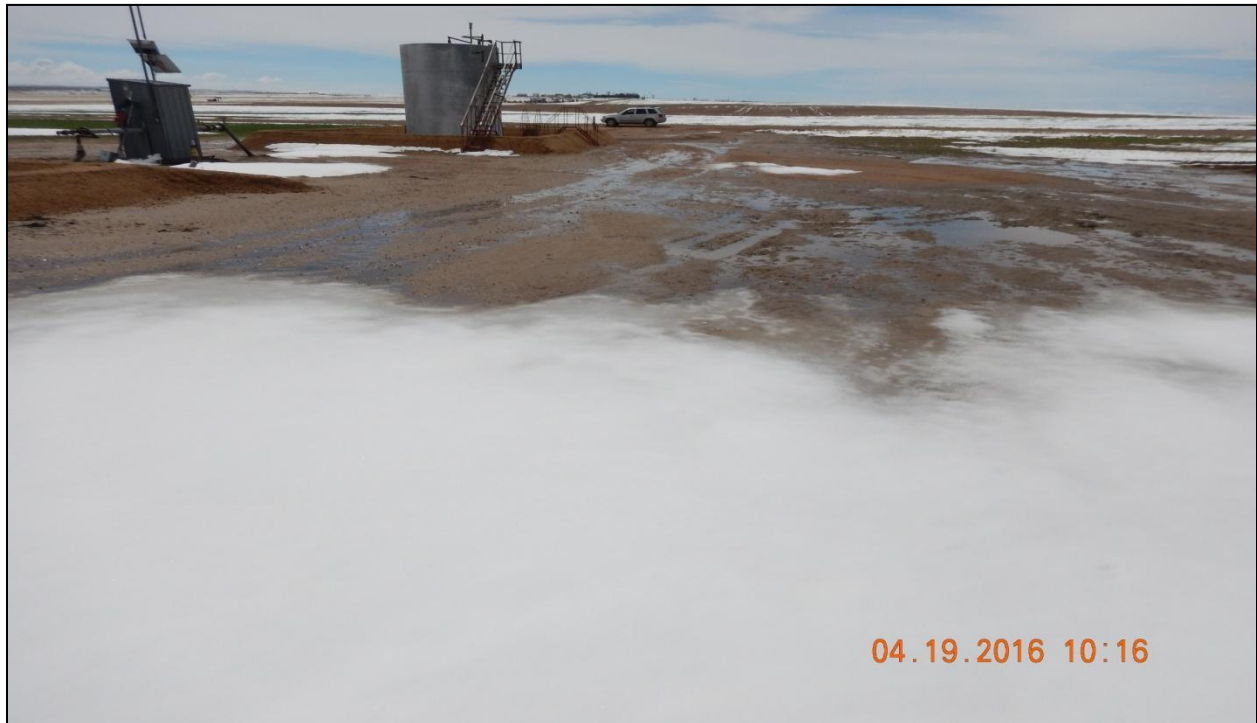
Photo 3: Photo taken 4/19/16 from north of location, facing South. This photo illustrates stormwater traveling south, then onto cropland.

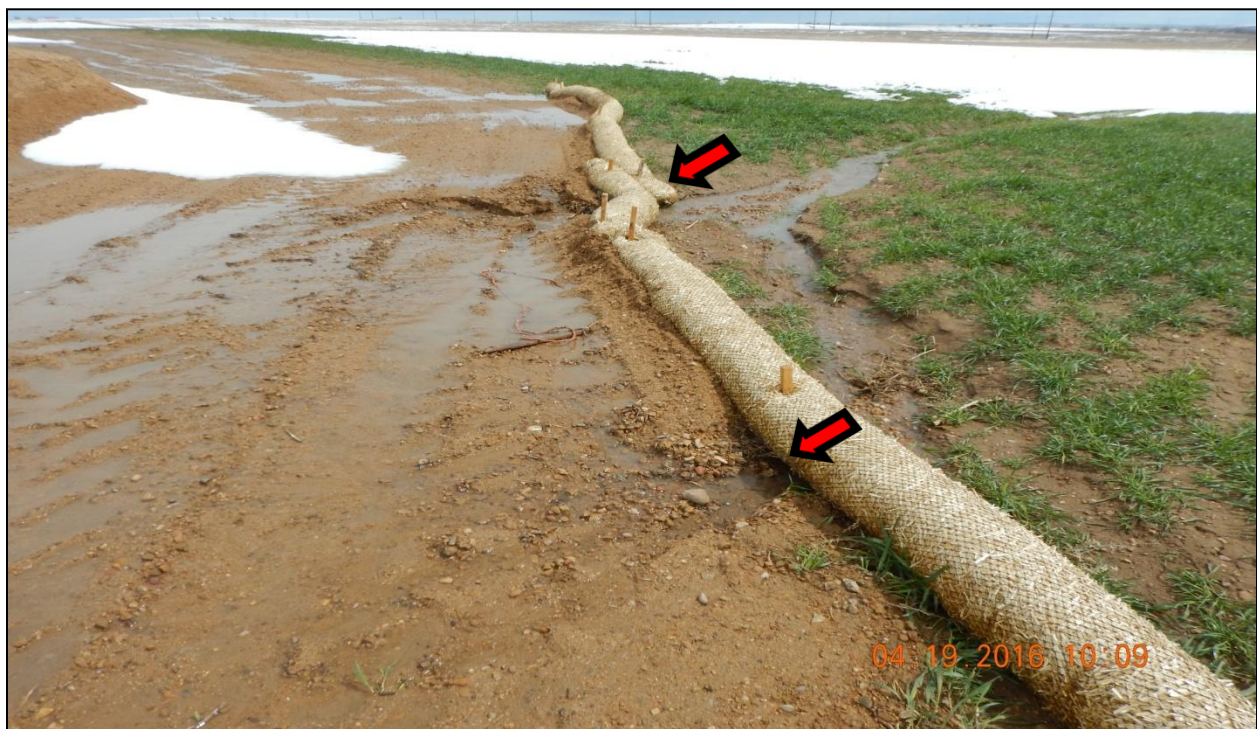
Photo 4: Photo taken 4/19/16 from east of location, facing North. Insufficient stormwater BMP and wattle was not properly installed.

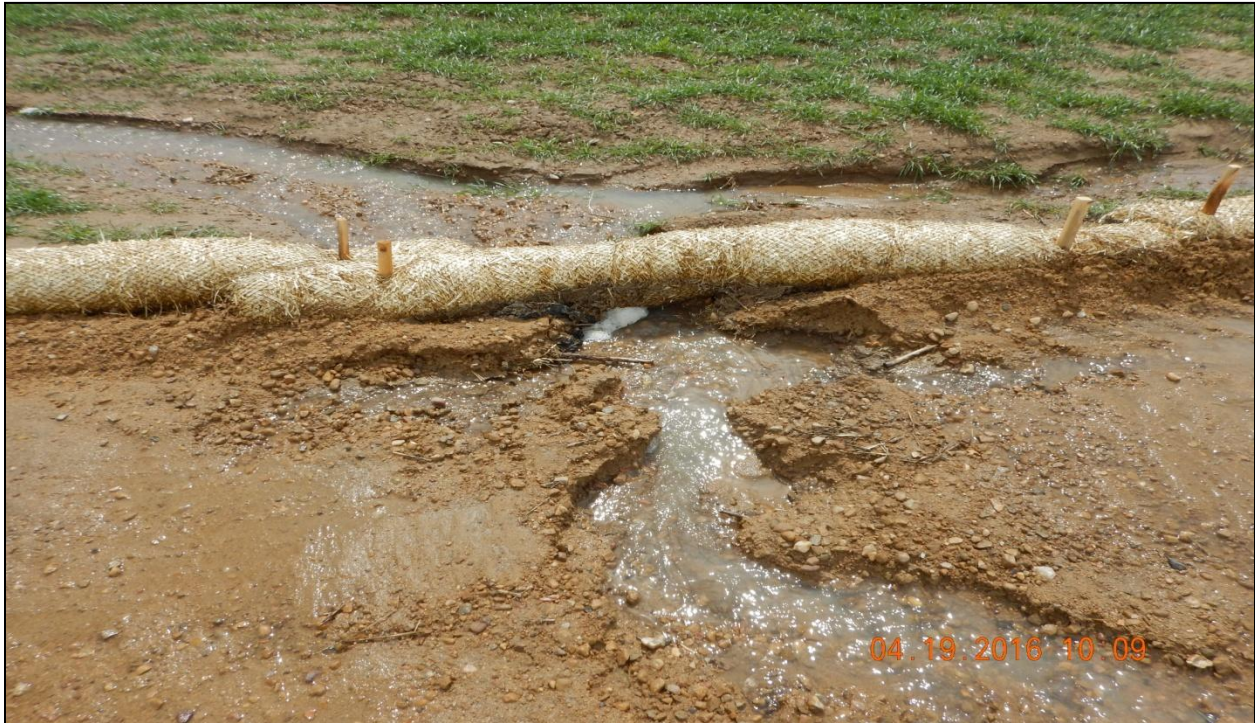
Photo 5: Photo taken 4/19/16 of failed wattle installation.
