Construction Inspection

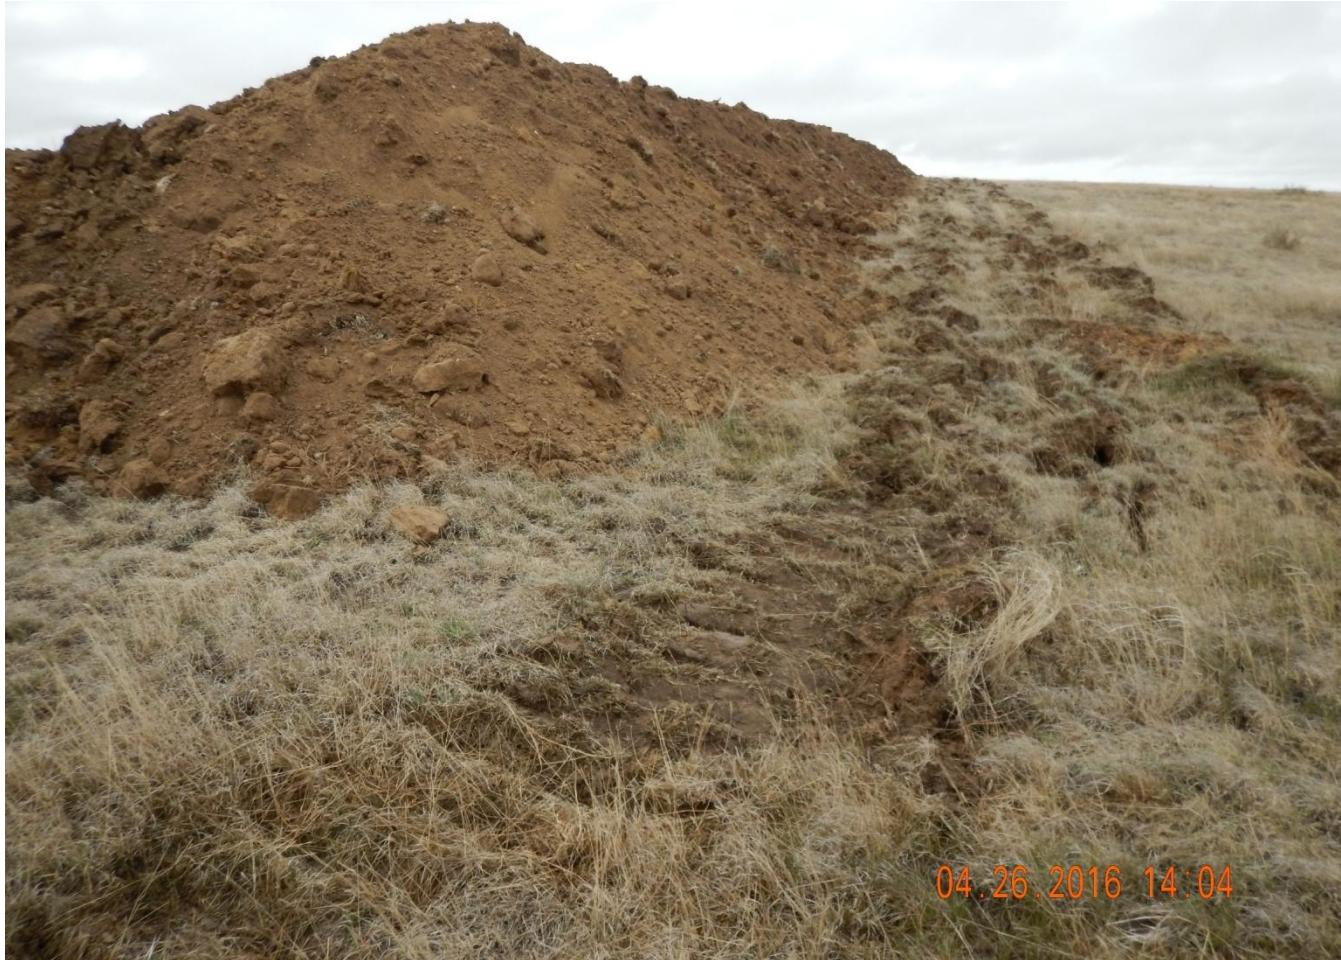
Photo 1. Photo taken from northeast location, facing West. Temporary BMP installed in center of photo while topsoil salvage is in process. Permanent BMPs will be installed upon completion of topsoil salvage per a discussion with a Wells Trucking operator.

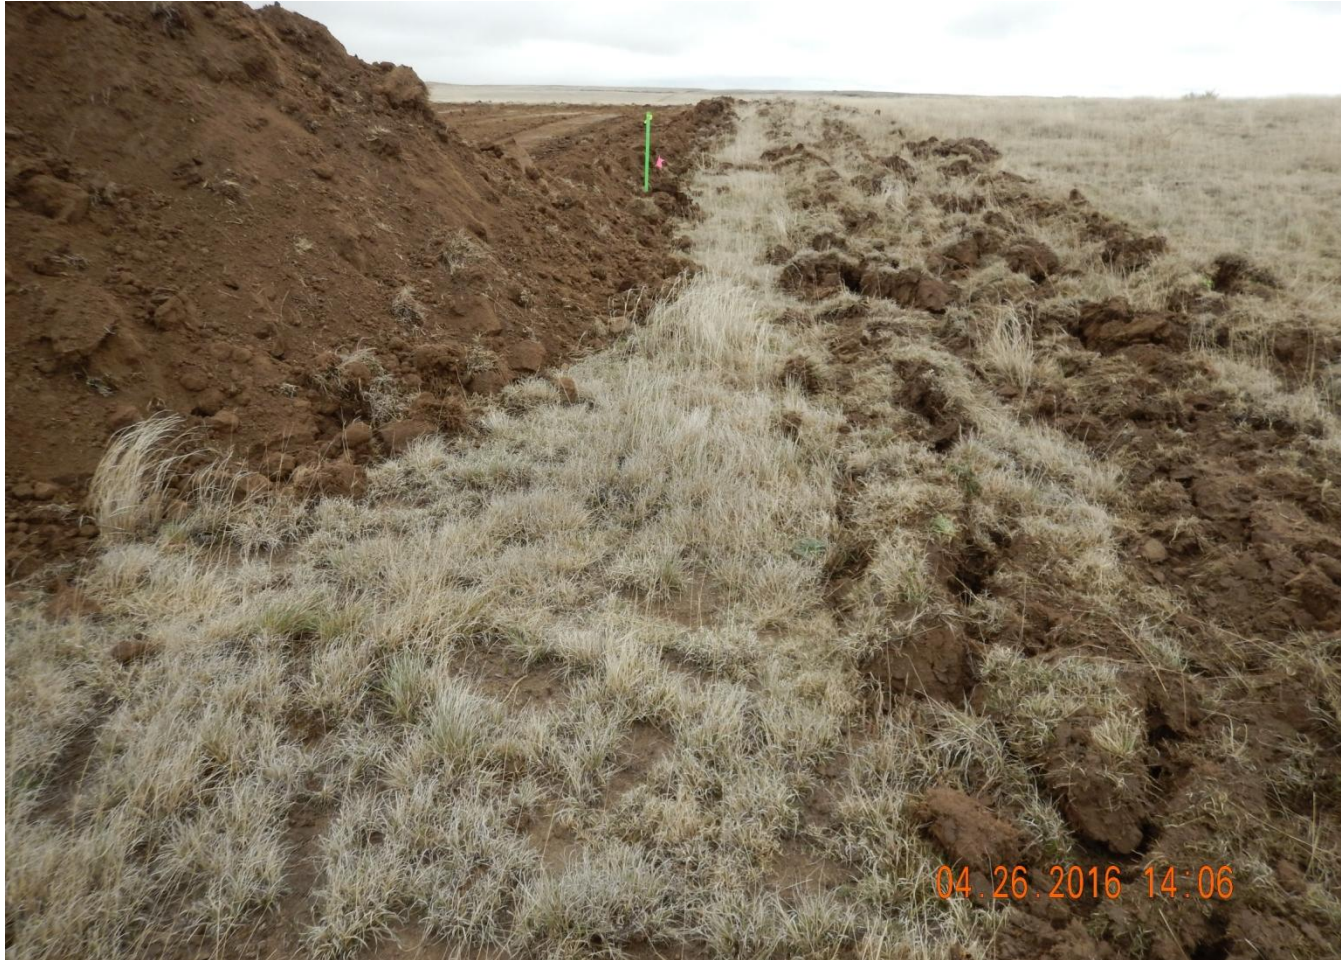
Photo 2. Photo taken from northwest location, facing South. Temporary BMP installed in center of photo while topsoil salvage is in process. Permanent BMPs will be installed upon completion of topsoil salvage per a discussion with a Wells Trucking operator.

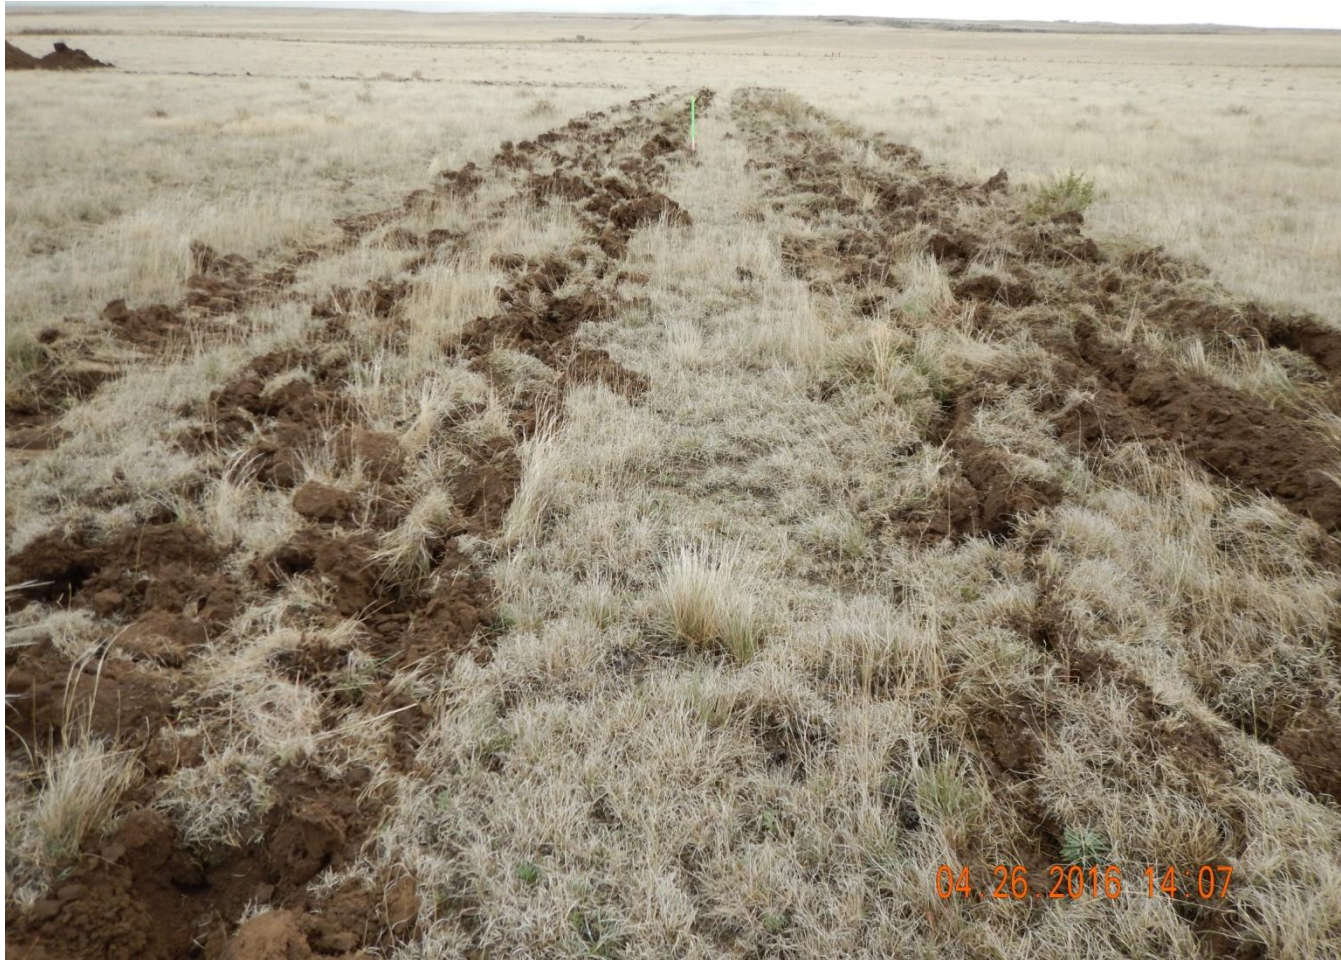
Photo 3. Photo taken from western location, facing South. Temporary BMP installed in center of photo while topsoil salvage is in process. Permanent BMPs will be installed upon completion of topsoil salvage per a discussion with a Wells Trucking operator.

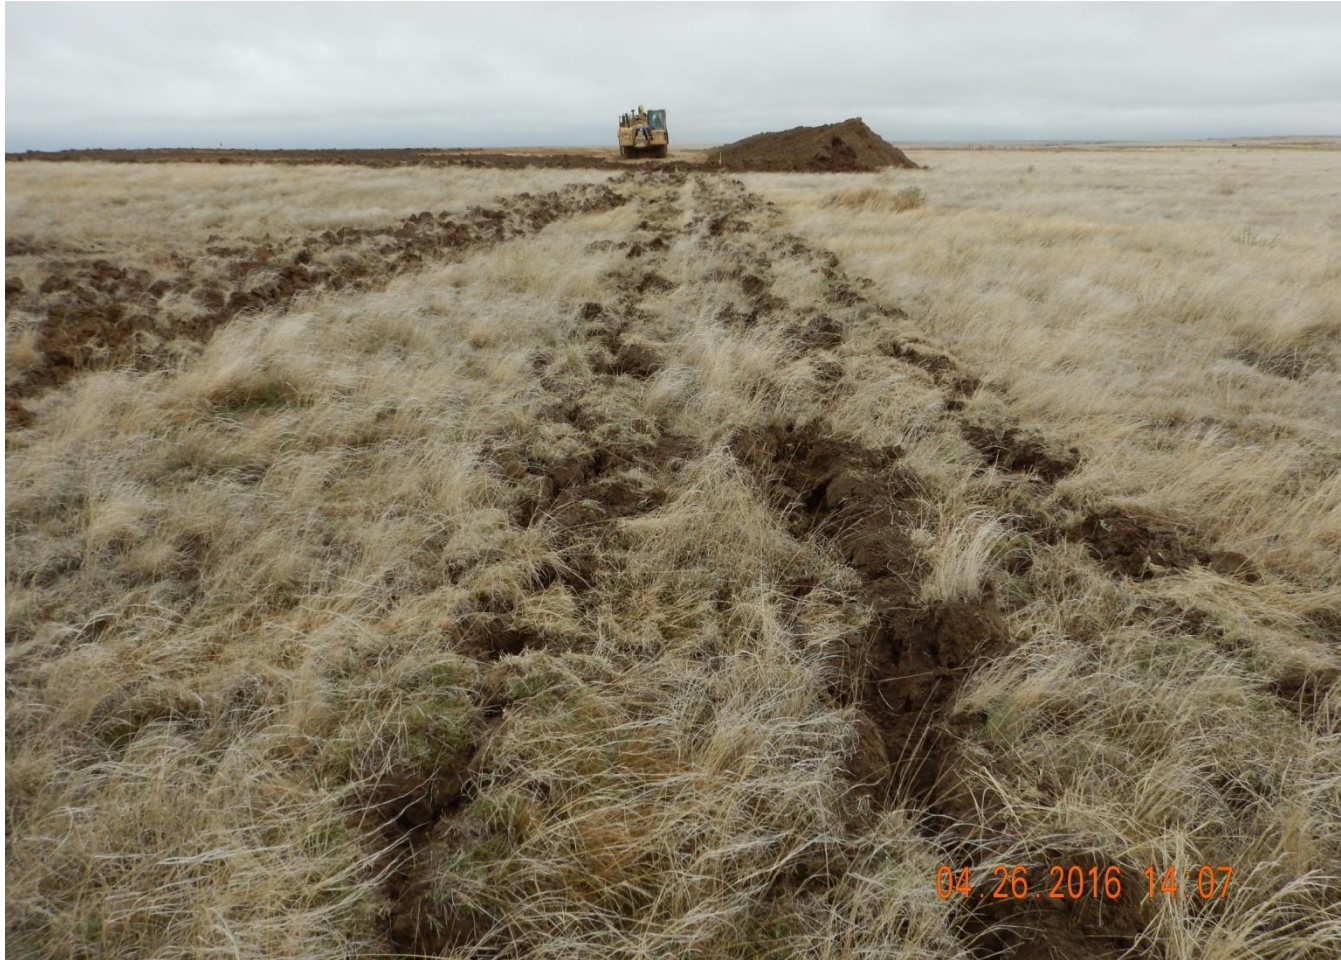
Photo 4. Photo taken from southwest location, facing East. Temporary BMP installed in center of photo while topsoil salvage is in process. Permanent BMPs will be installed upon completion of topsoil salvage per a discussion with a Wells Trucking operator.

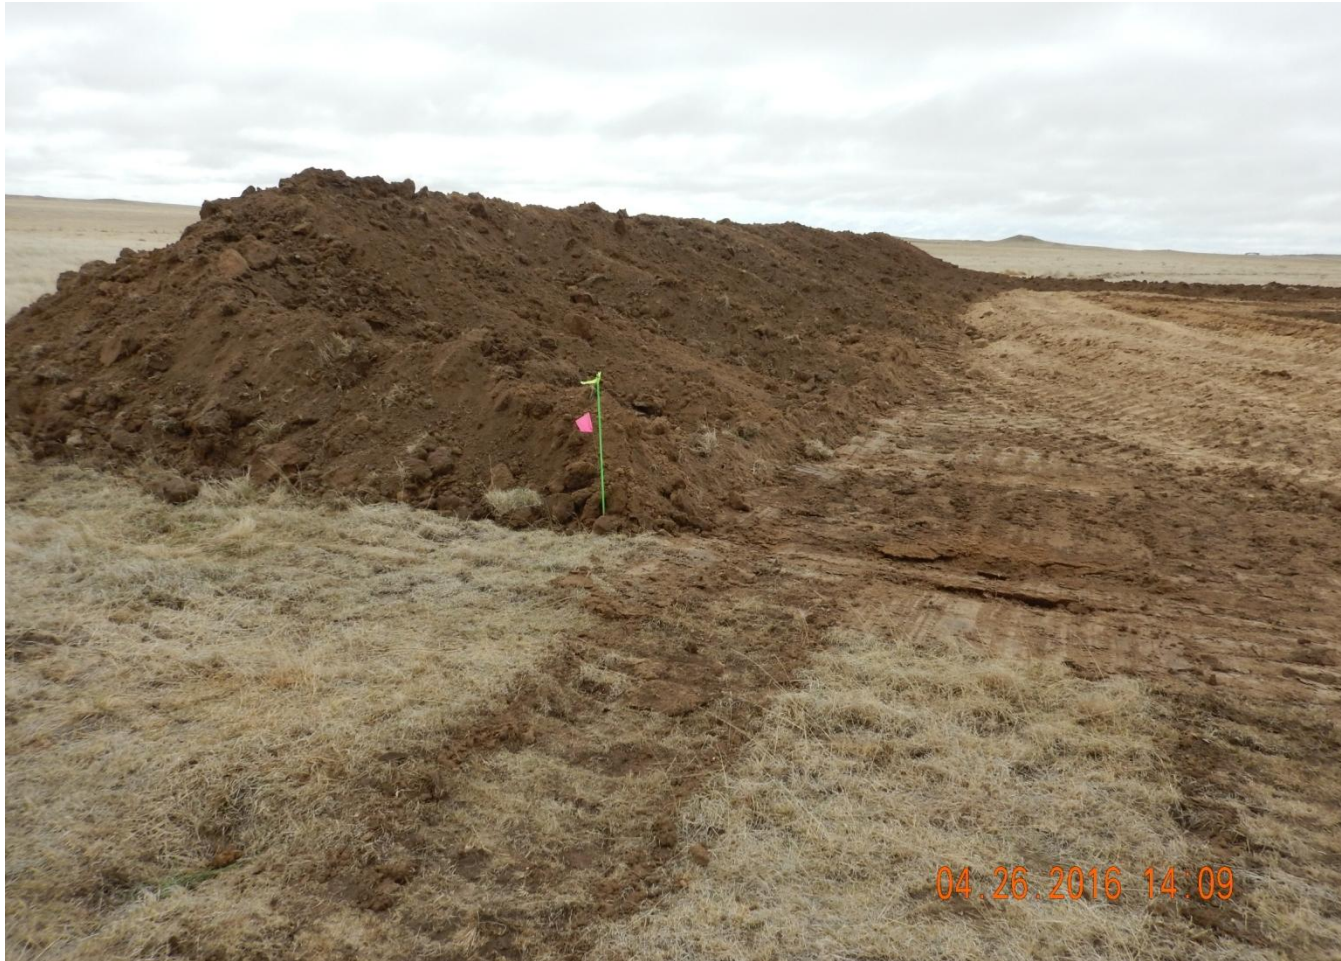
Photo 5. Photo taken from southeast location, facing West. Topsoil stockpile in center of photo. Need to stabilize upon completion of topsoil salvage process.

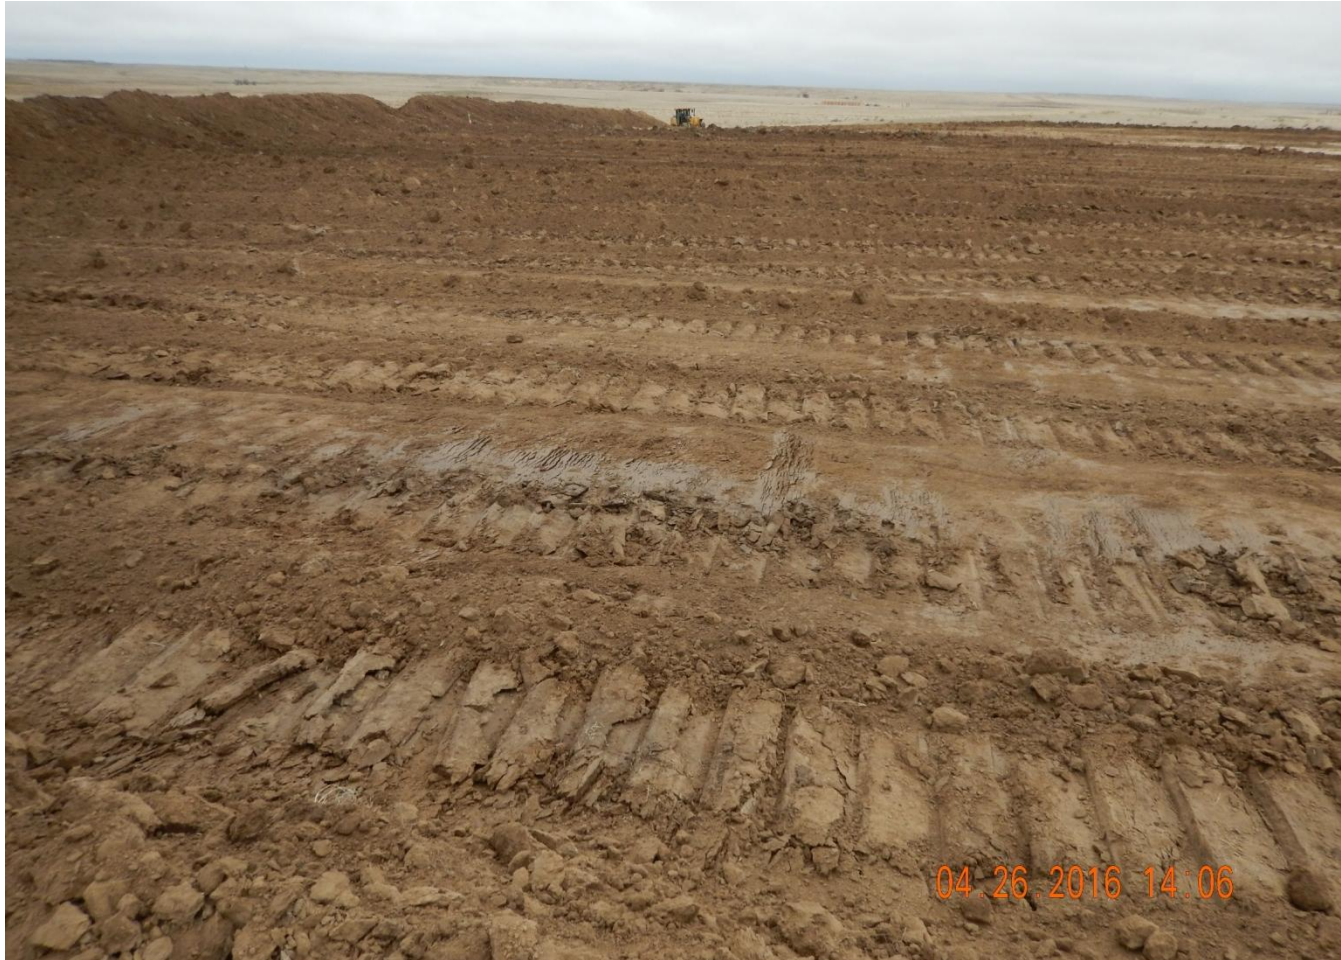
Photo 6. Photo taken from western location, facing East. Topsoil salvage in process.
