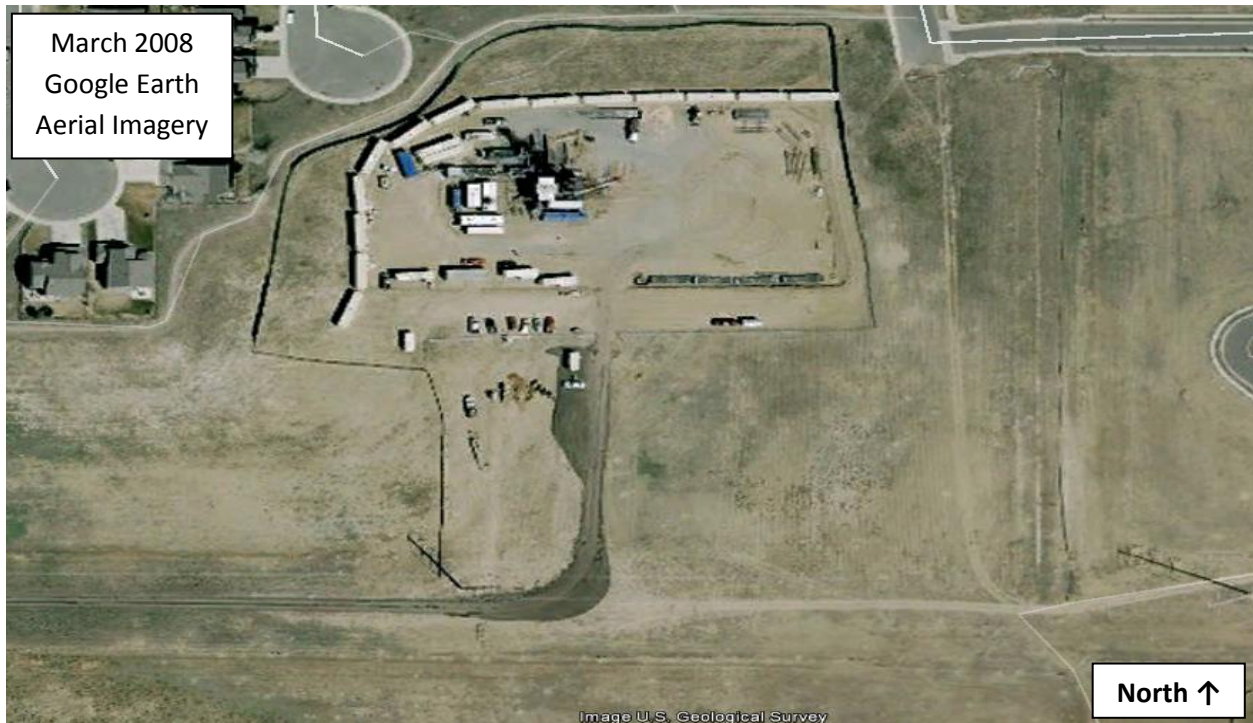
Photo 1: Photo taken from Google Earth documenting approximate initial total disturbance.

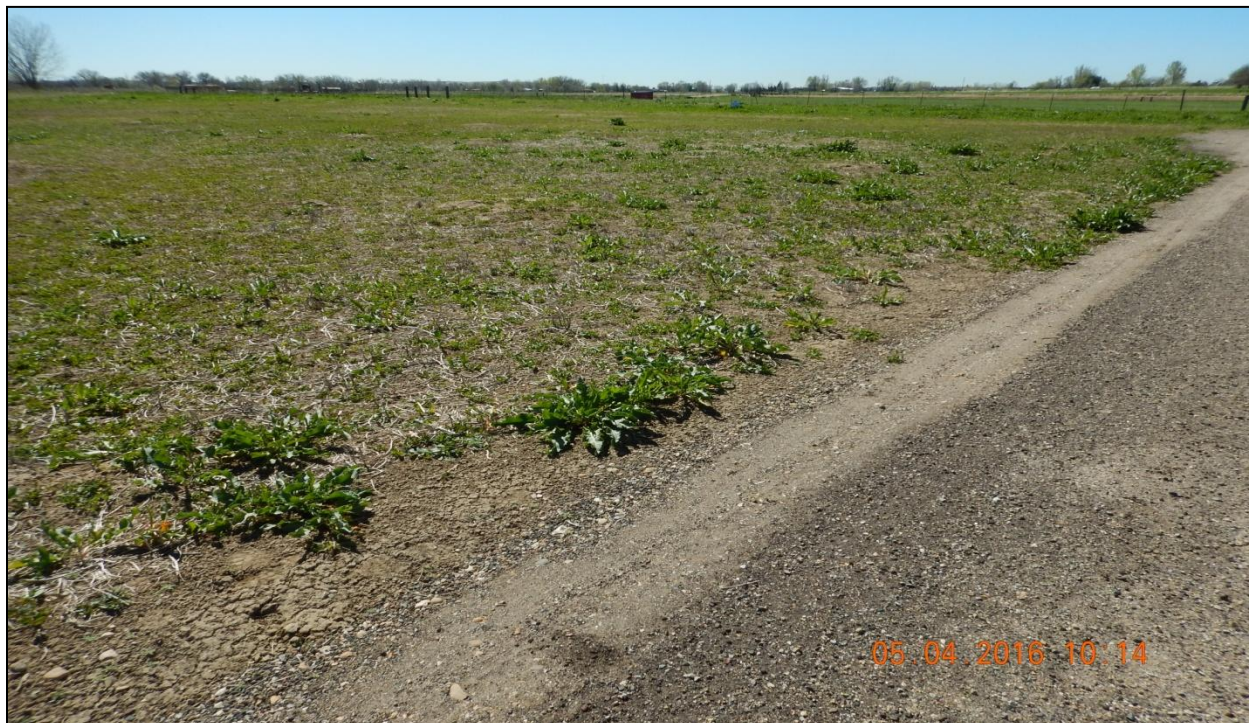
Photo 3: Photo taken 5/4/16 from south entrance of location, facing Southeast. Location dominated by curly dock (*Rumex crispus*) and bindweed (*Convolvulus sp.*).

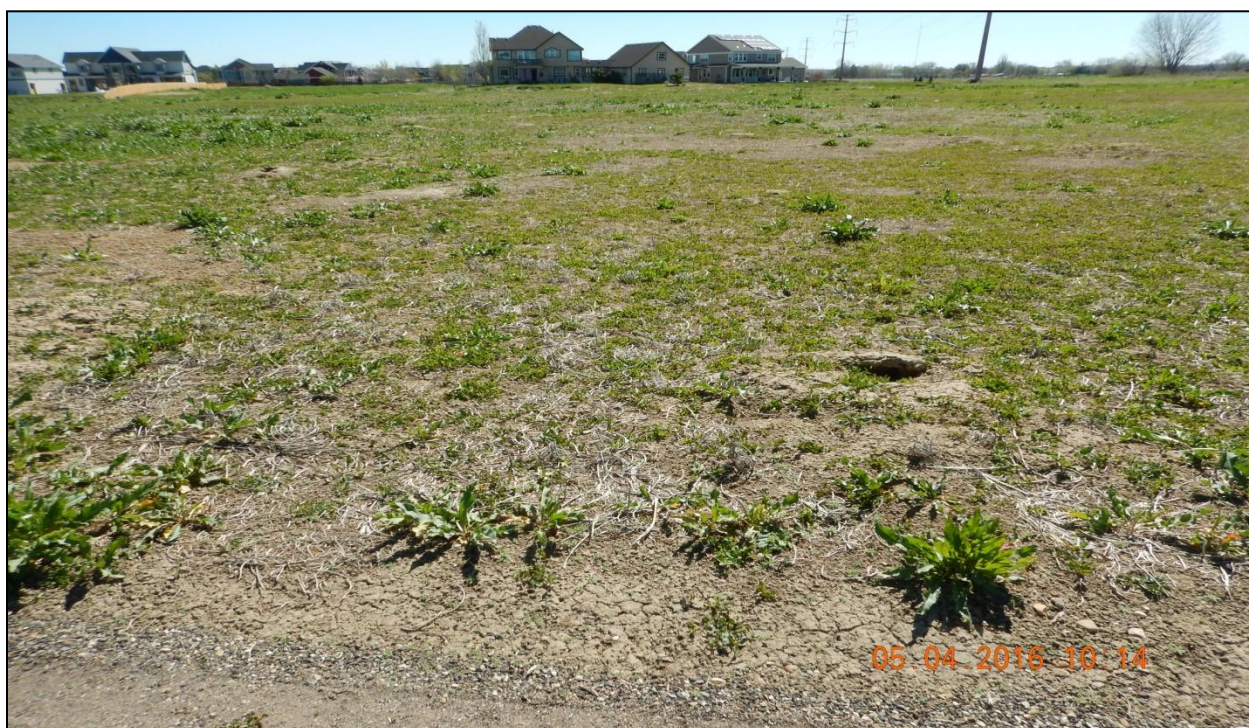
Photo 4: Photo taken 5/4/16 from south entrance of location, facing East. Location dominated by curly dock (*Rumex crispus*) and bindweed (*Convolvulus sp.*).

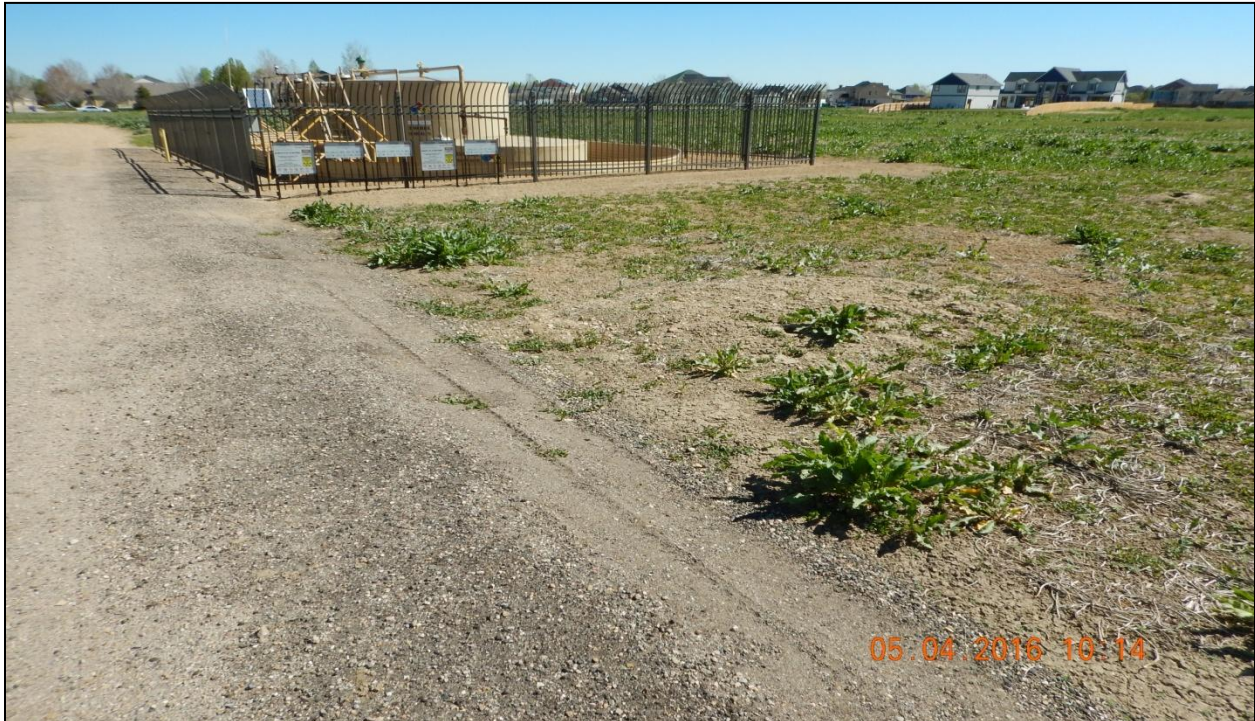
Photo 5: Photo taken 5/4/16 from south entrance of location, facing Northeast. Location dominated by curly dock (*Rumex crispus*) and bindweed (*Convolvulus sp.*).

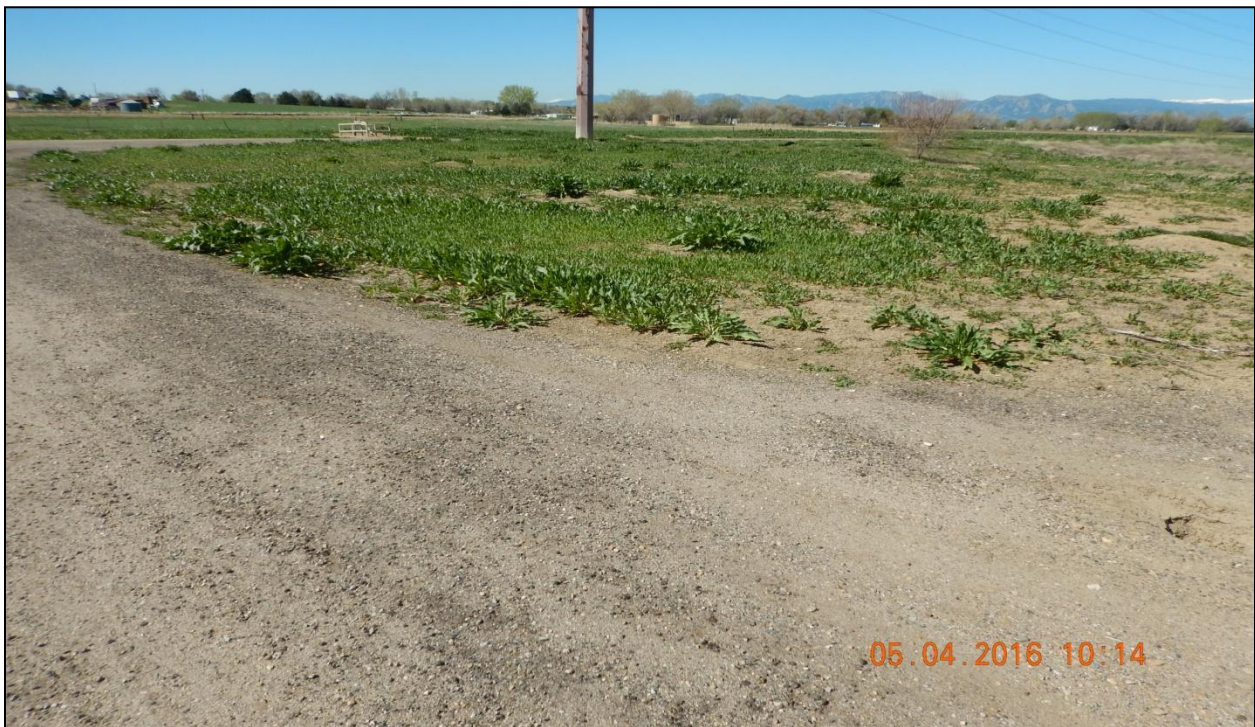
Photo 6: Photo taken 5/4/16 from south entrance of location, facing Southwest. Location dominated by curly dock (*Rumex crispus*) and bindweed (*Convolvulus sp.*).

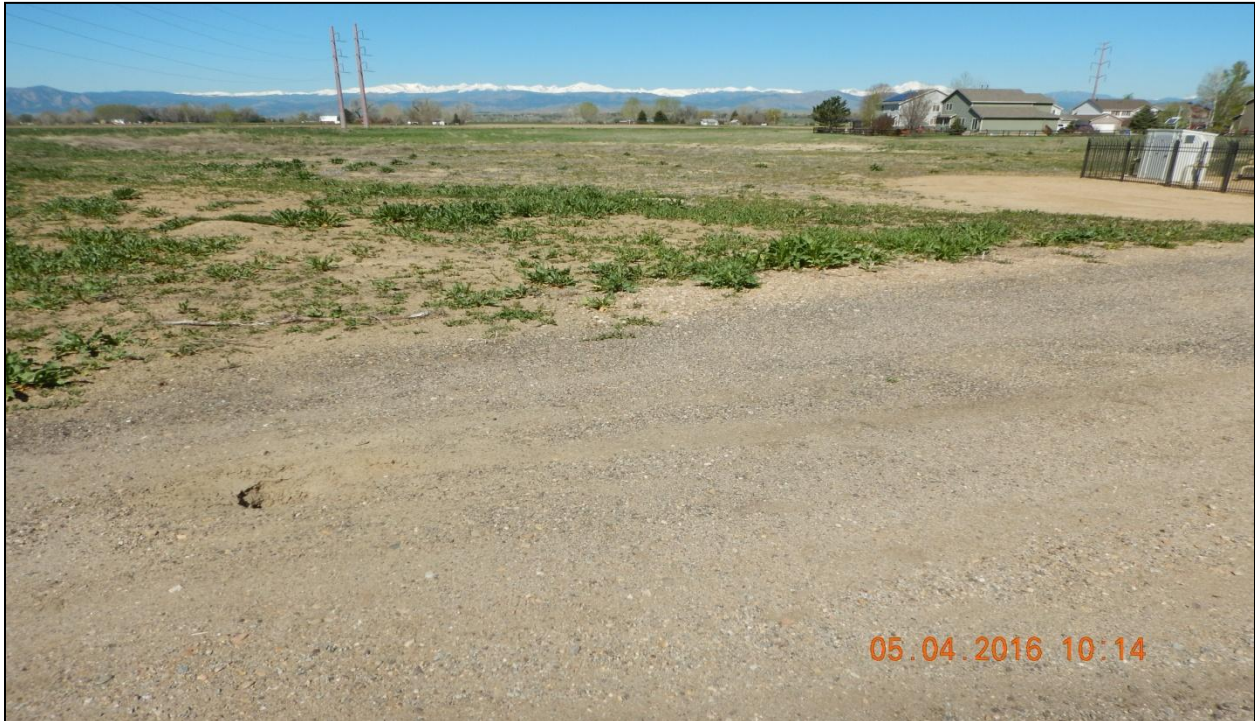
Photo 7: Photo taken 5/4/16 from south entrance of location, facing West. Location dominated by curly dock (*Rumex crispus*) and bindweed (*Convolvulus sp.*).

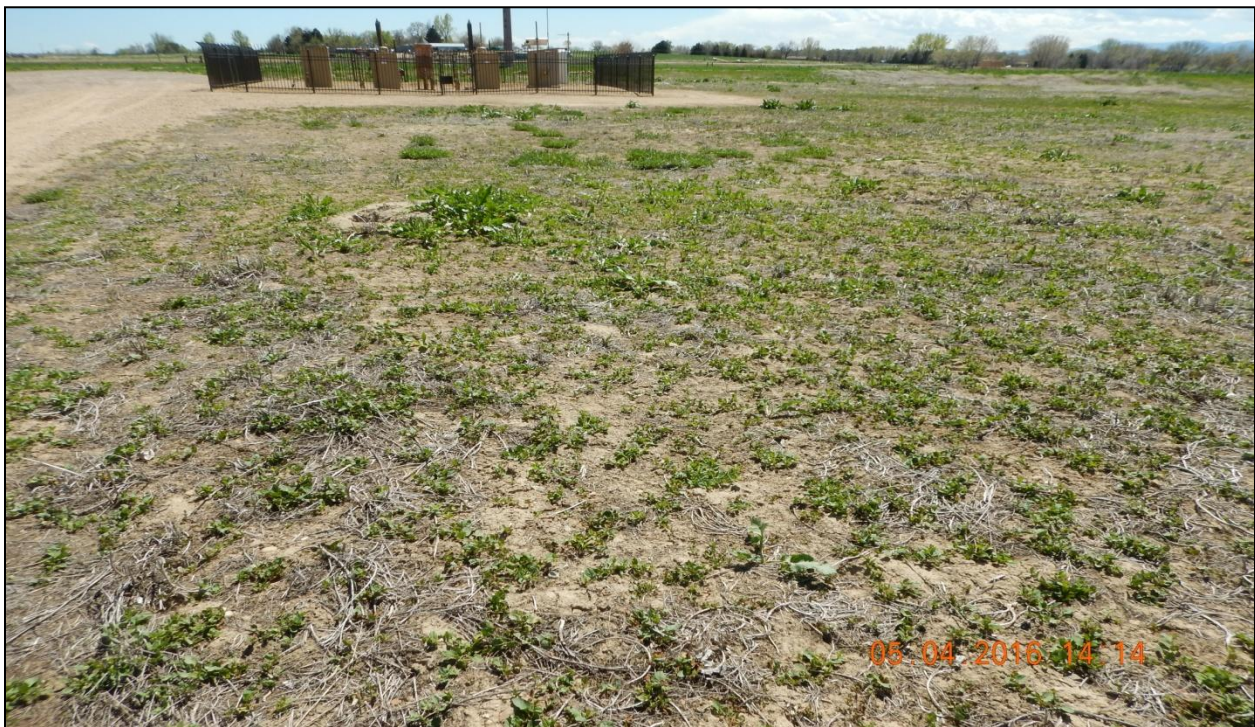
Photo 8: Photo taken 5/4/16 from northern lease road, facing South. Location dominated by curly dock (*Rumex crispus*) and bindweed (*Convolvulus sp.*).

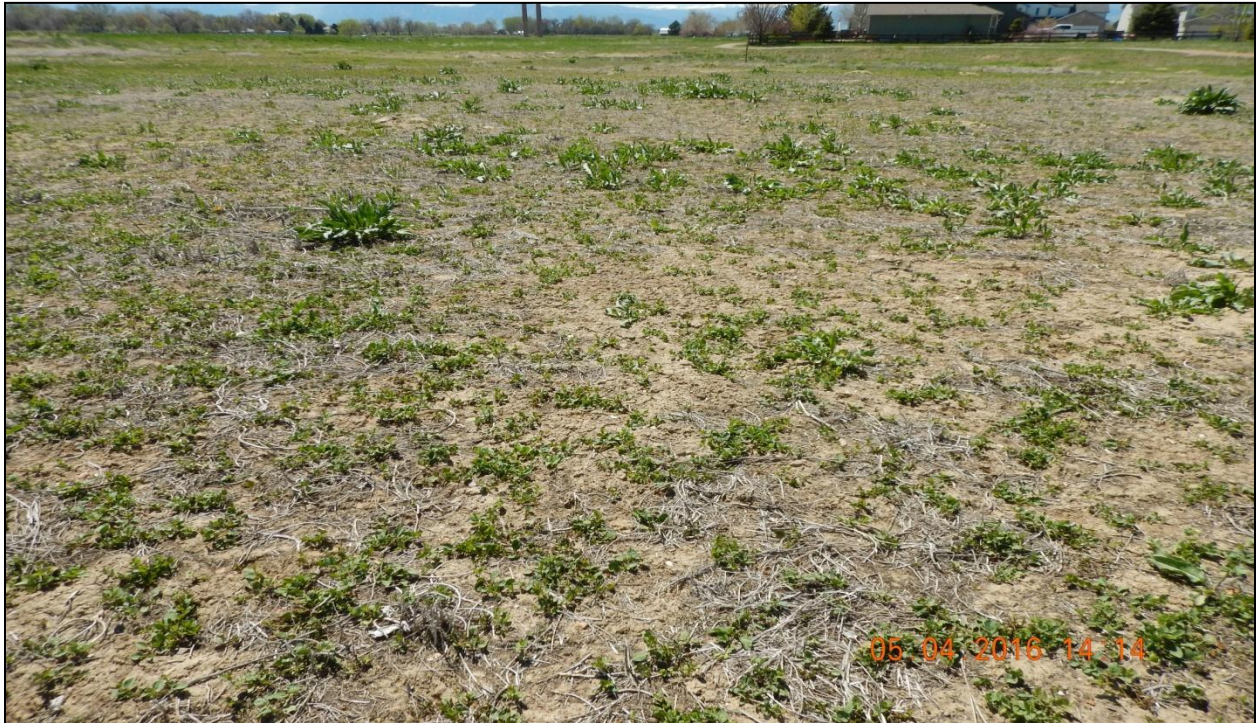
Photo 9: Photo taken 5/4/16 from northern lease road, facing West. Location dominated by curly dock (*Rumex crispus*) and bindweed (*Convolvulus sp.*).

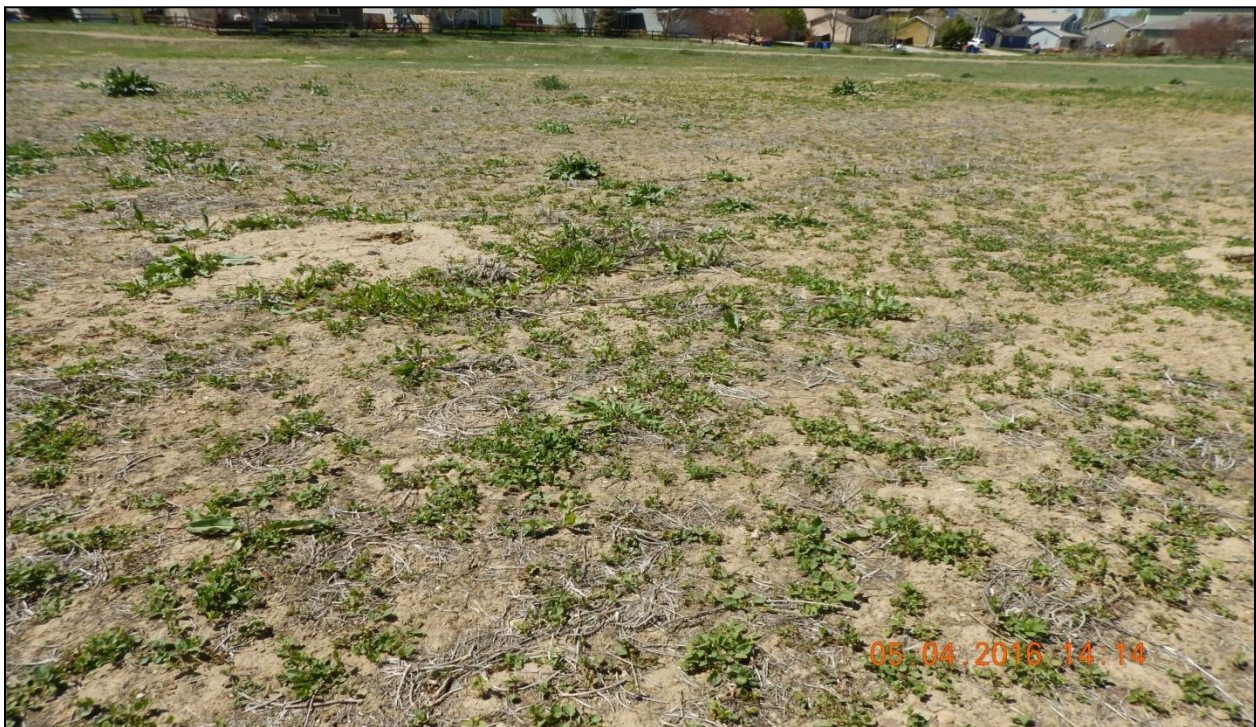
Photo 10: Photo taken 5/4/16 from northern lease road, facing Northwest. Location dominated by curly dock (*Rumex crispus*) and bindweed (*Convolvulus sp.*).

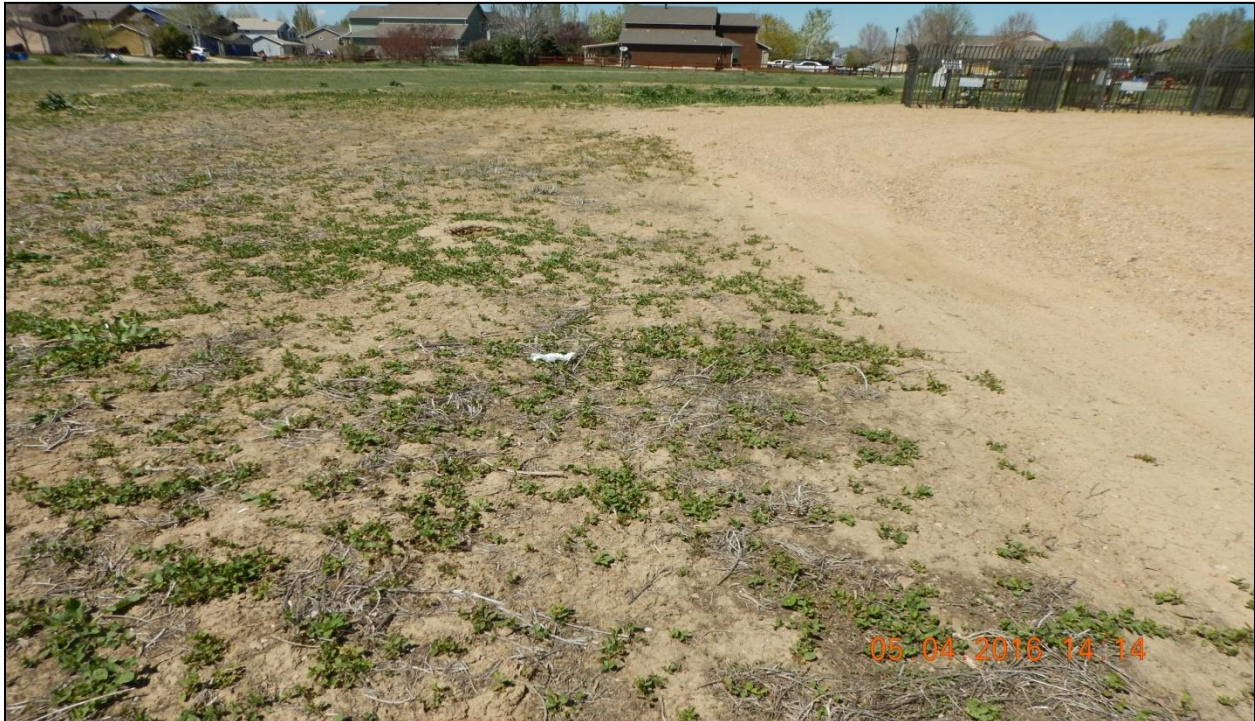
Photo 11: Photo taken 5/4/16 from northern lease road, facing North. Location dominated by curly dock (*Rumex crispus*) and bindweed (*Convolvulus sp.*).

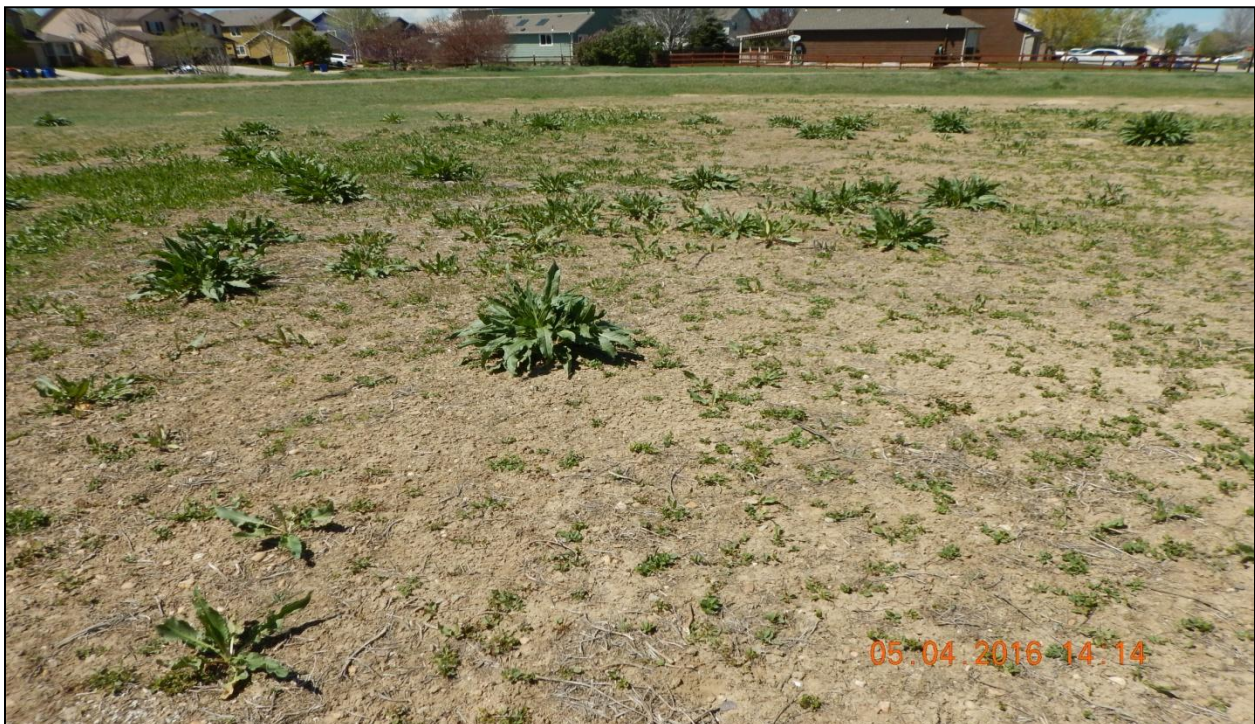
Photo 12: Photo taken 5/4/16 from northwest location, facing Northwest. Location dominated by curly dock (*Rumex crispus*) and bindweed (*Convolvulus sp.*).

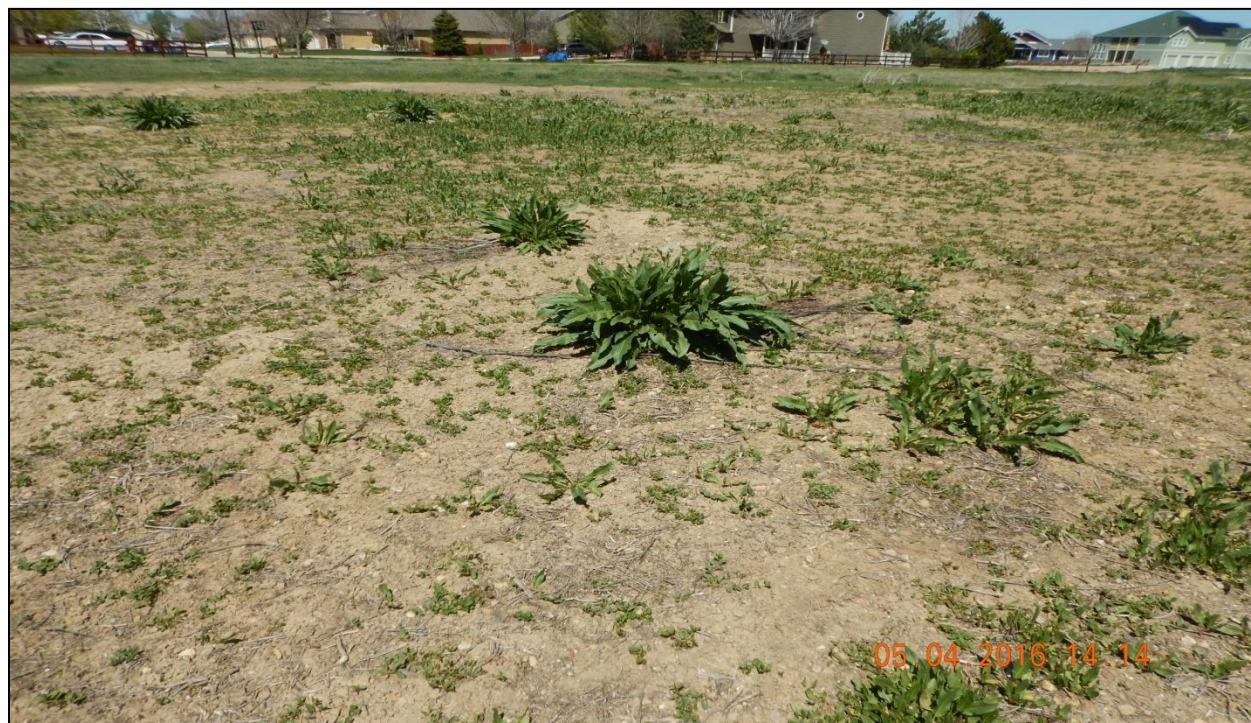
Photo 13: Photo taken 5/4/16 from northwest location, facing North. Location dominated by curly dock (*Rumex crispus*) and bindweed (*Convolvulus sp.*).

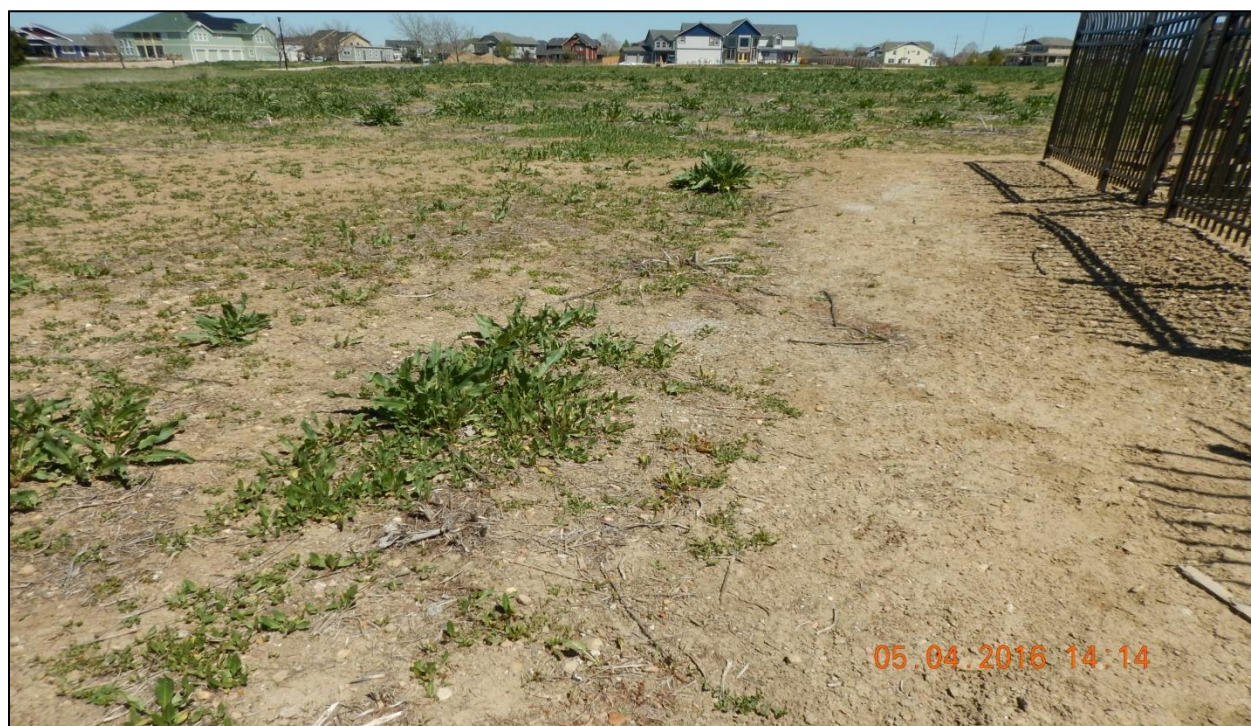
Photo 14: Photo taken 5/4/16 from northwest location, facing East. Location dominated by curly dock (*Rumex crispus*) and bindweed (*Convolvulus sp.*).

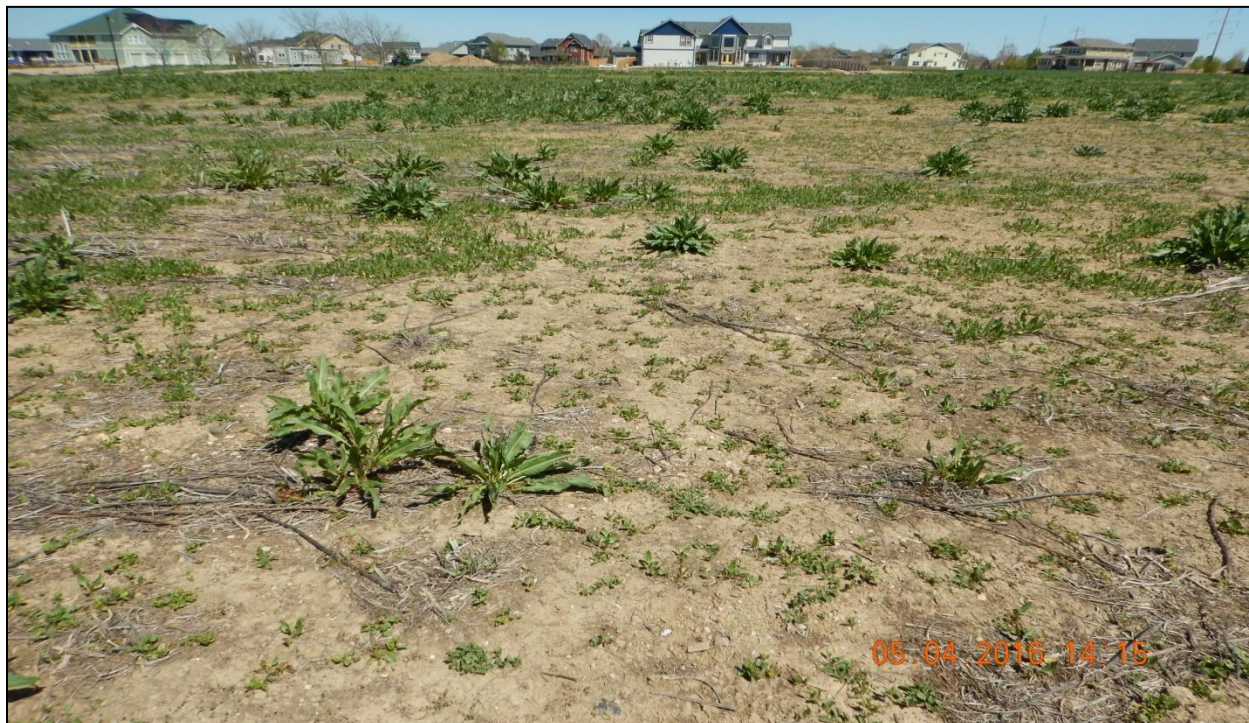
Photo 15: Photo taken 5/4/16 from northeast location, facing East. Location dominated by curly dock (*Rumex crispus*) and bindweed (*Convolvulus sp.*).

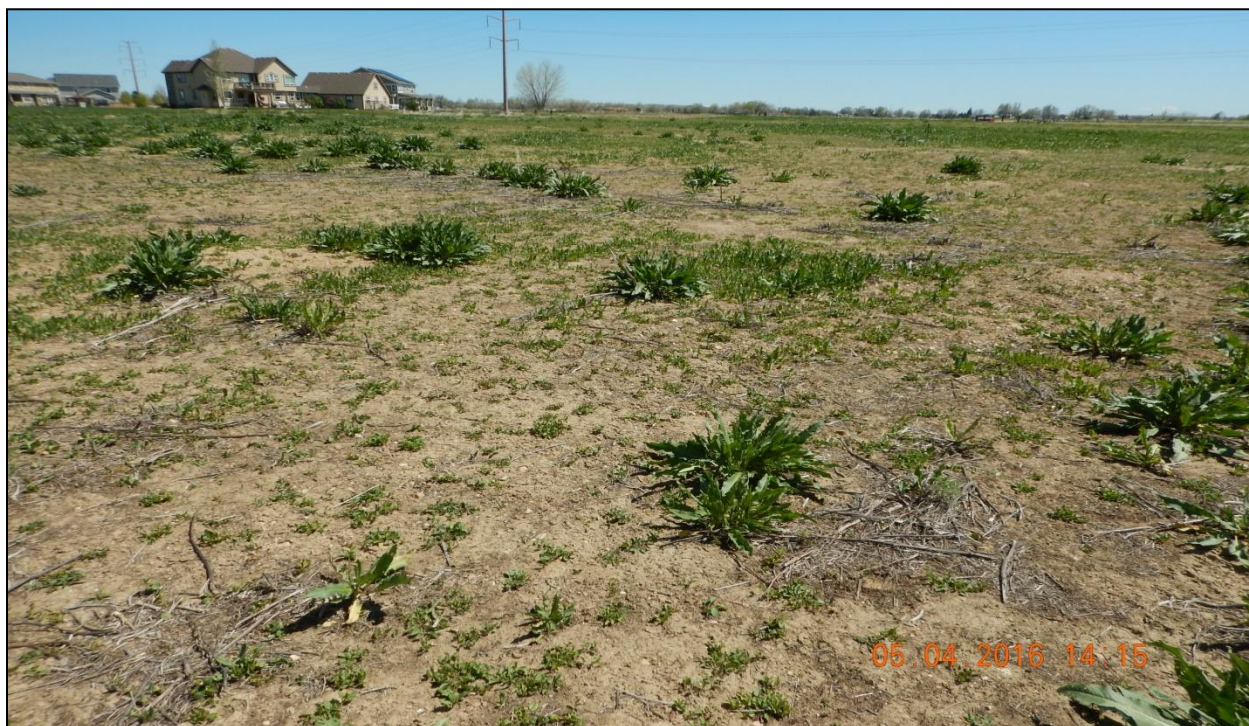
Photo 16: Photo taken 5/4/16 from northeast location, facing Southeast. Location dominated by curly dock (*Rumex crispus*) and bindweed (*Convolvulus sp.*).

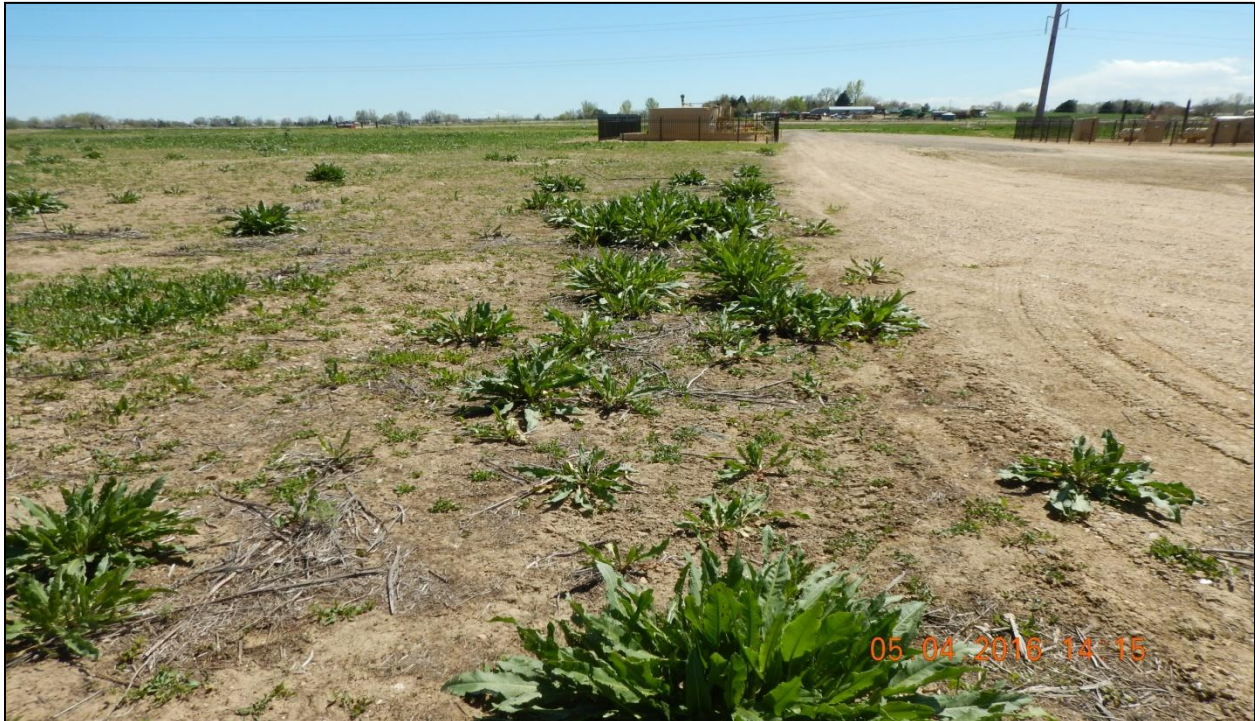
Photo 17: Photo taken 5/4/16 from northeast location, facing South. Location dominated by curly dock (*Rumex crispus*) and bindweed (*Convolvulus sp.*).

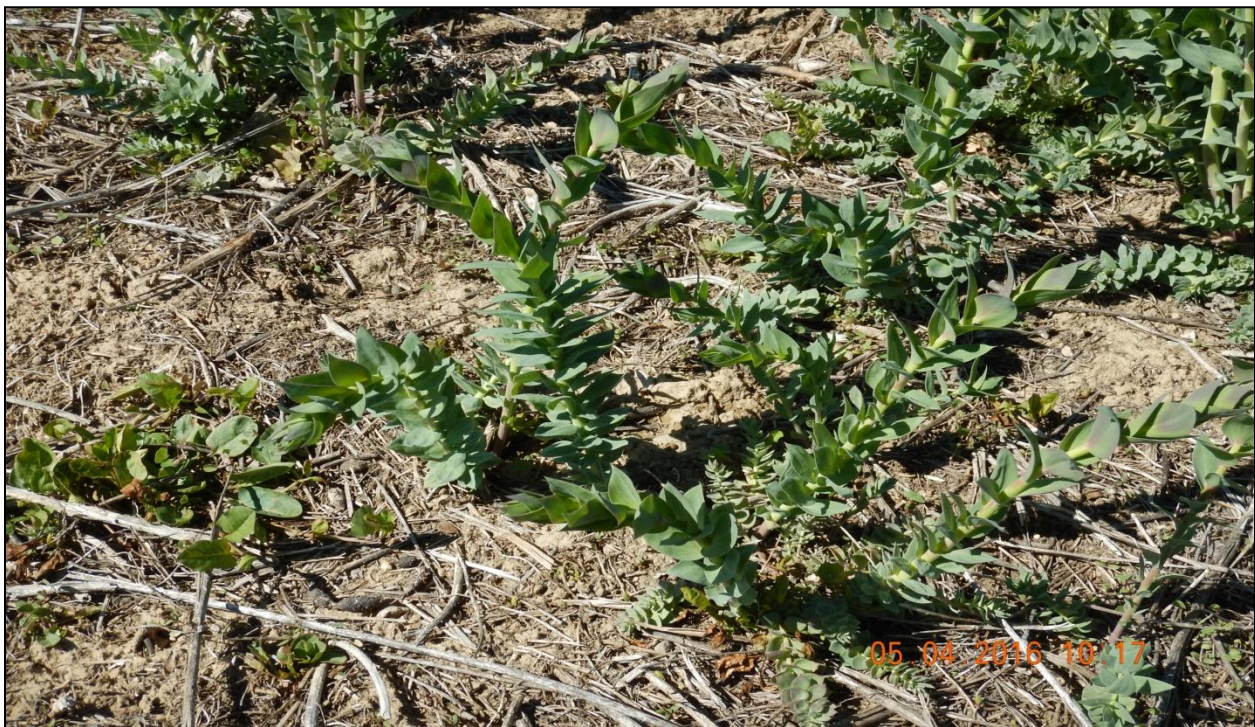
Photo 18: Photo taken 5/4/16 of a Colorado Noxious Weed List B species, Dalmatian toadflax (*Linaria dalmatica*). Perennial forb reproduces both by seed and by extensive, creeping rhizomes. A single plant produces thousands of seeds (e.g. 500,000 seeds) which can remain viable for at least ten years.

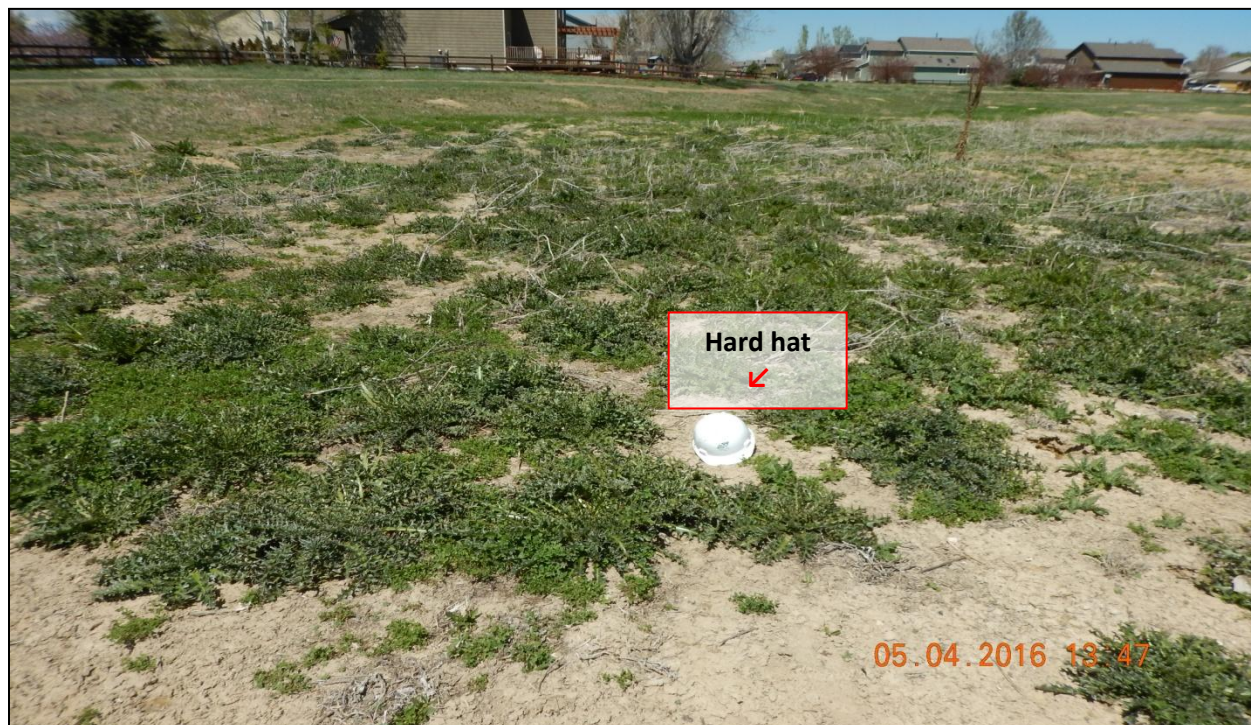
Photo 19: Photo taken 5/4/16 of two Colorado Noxious Weed List B species, Bull thistle (*Cirsium vulgare*) and Canada thistle (*Cirsium arvense*).
