Interim Reclamation Inspection

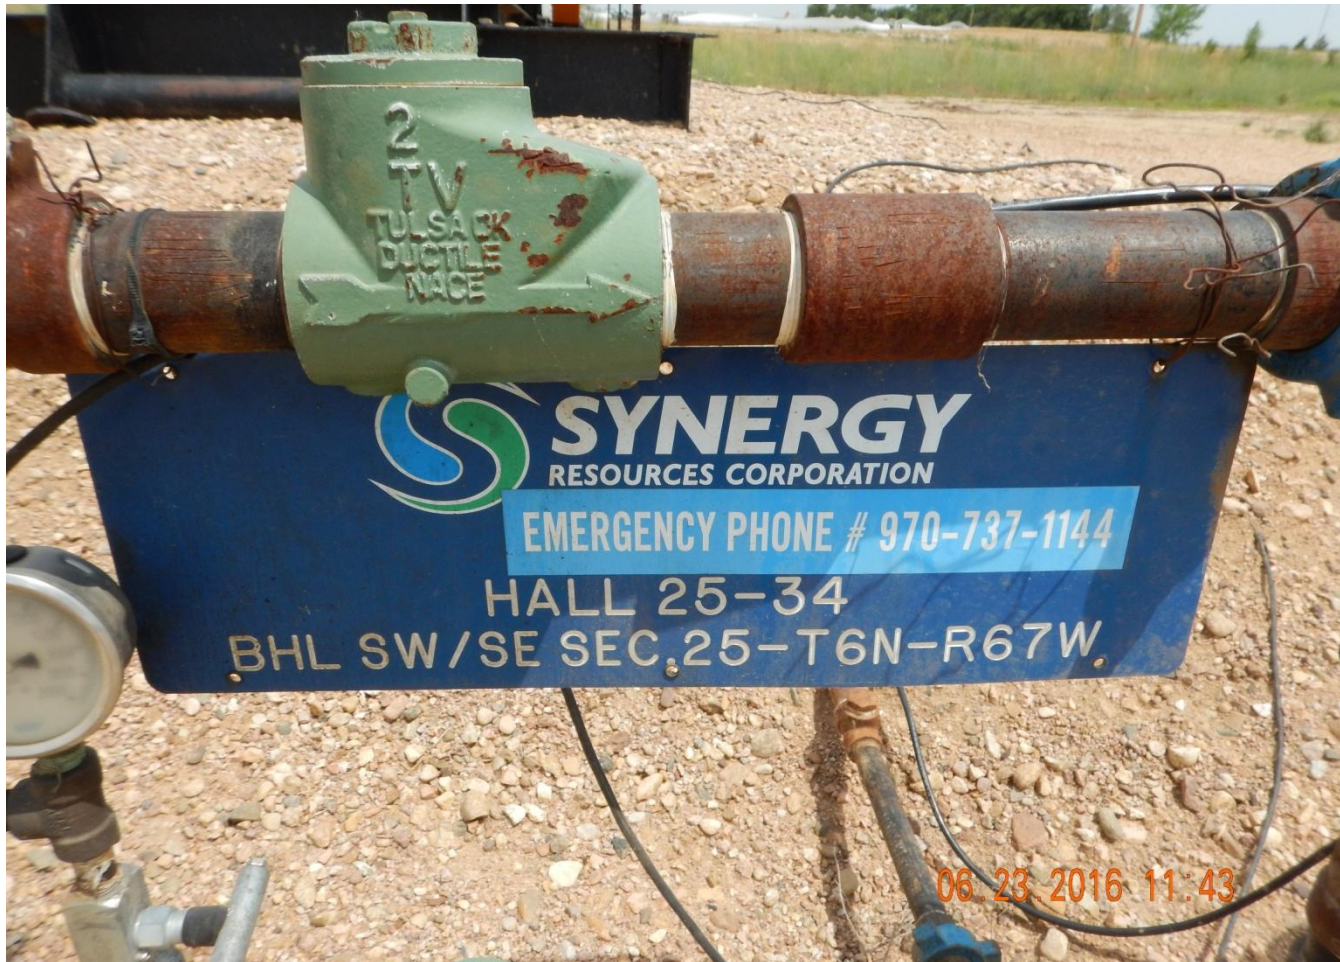
Photo 1. Photo of Producing well sign for API #123-31080.

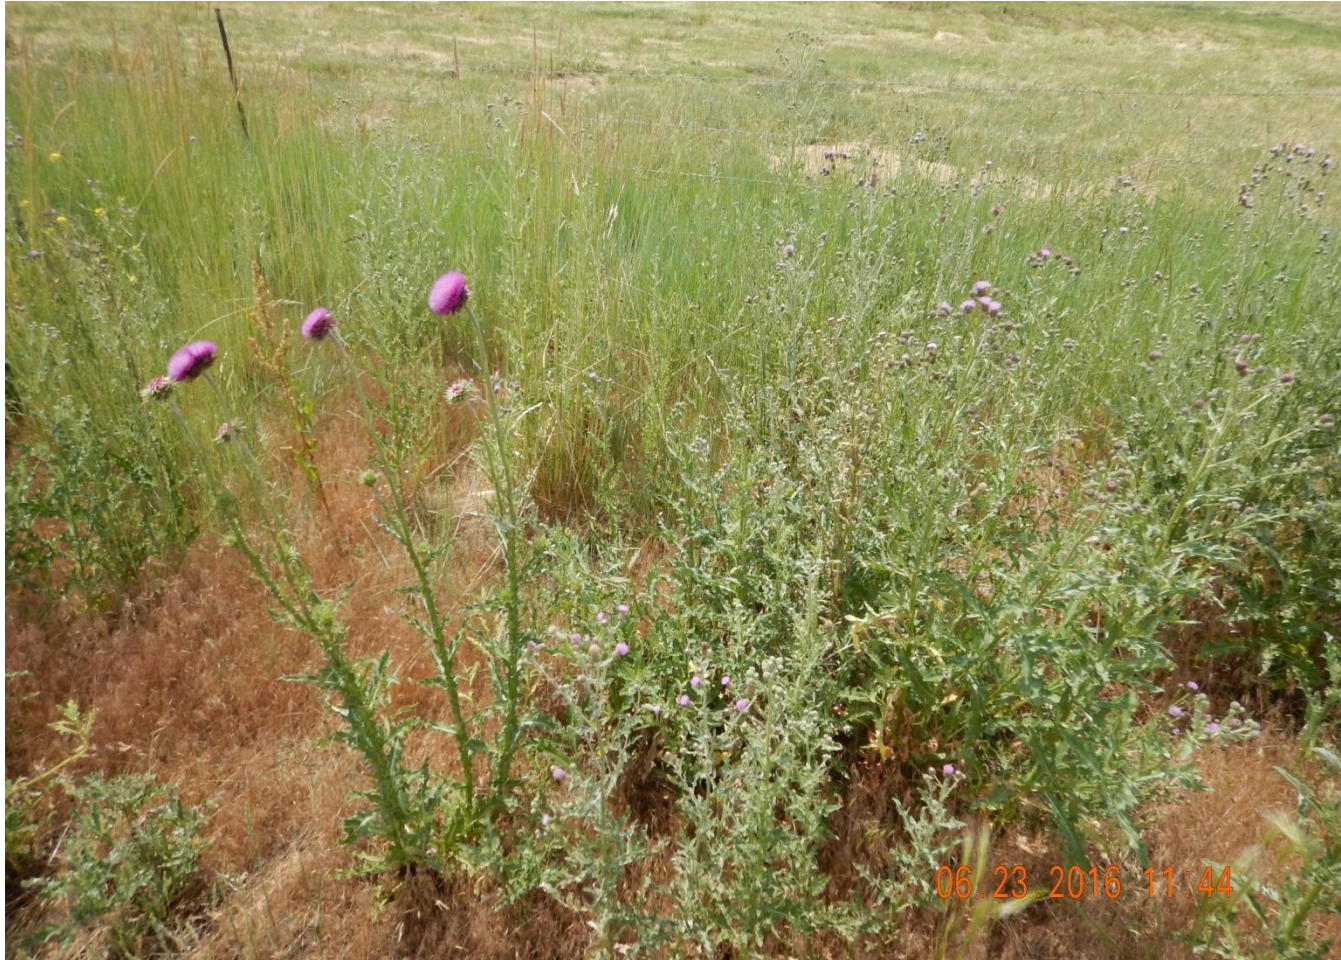
Photo 2. Two List B Colorado Noxious weed species, Canada thistle (*Cirsium arvense*) and Musk thistle (*Carduus nutans*), exist throughout entire interim reclamation area.

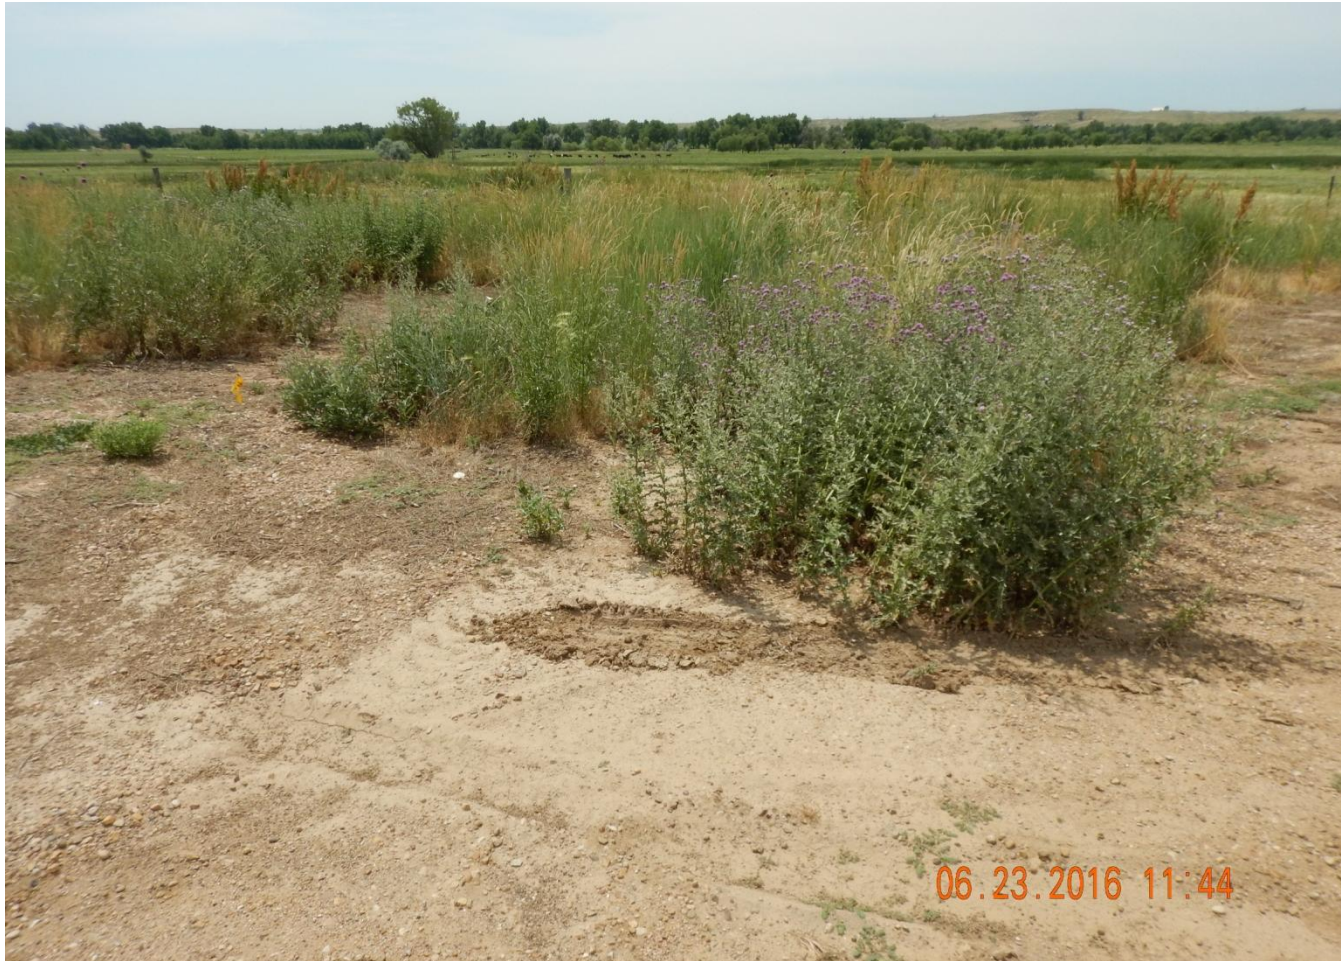
Photo 3. Photo taken from the southern location, facing South. Two List B Colorado Noxious weed species, Canada thistle (*Cirsium arvense*) and Musk thistle (*Carduus nutans*), exist throughout entire interim reclamation area.

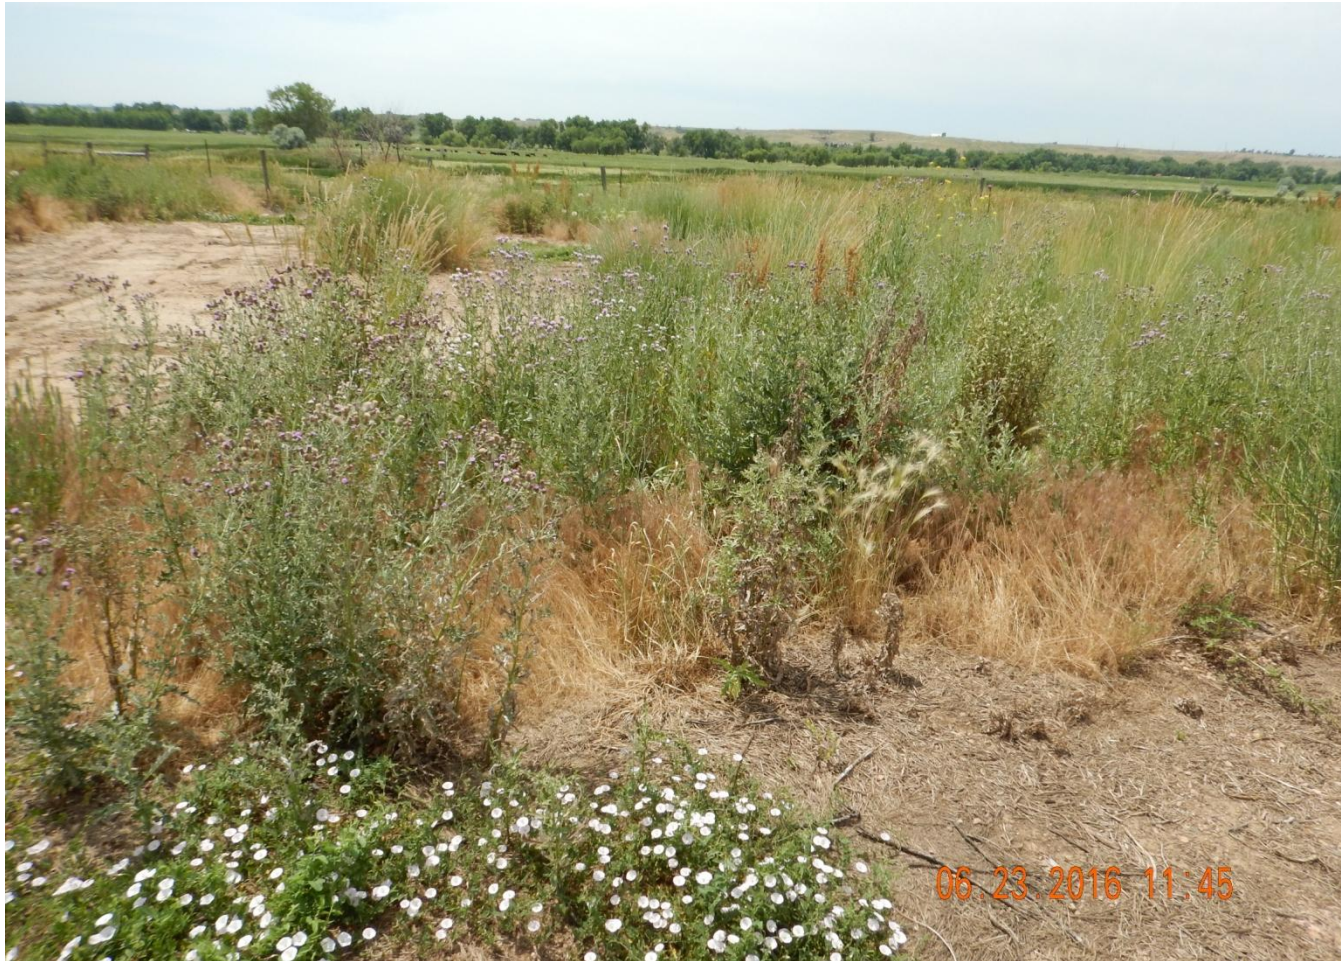
Photo 4. Photo taken from the southeastern location, facing South. Two List B Colorado Noxious weed species, Canada thistle (*Cirsium arvense*) and Musk thistle (*Carduus nutans*), exist throughout entire interim reclamation area.

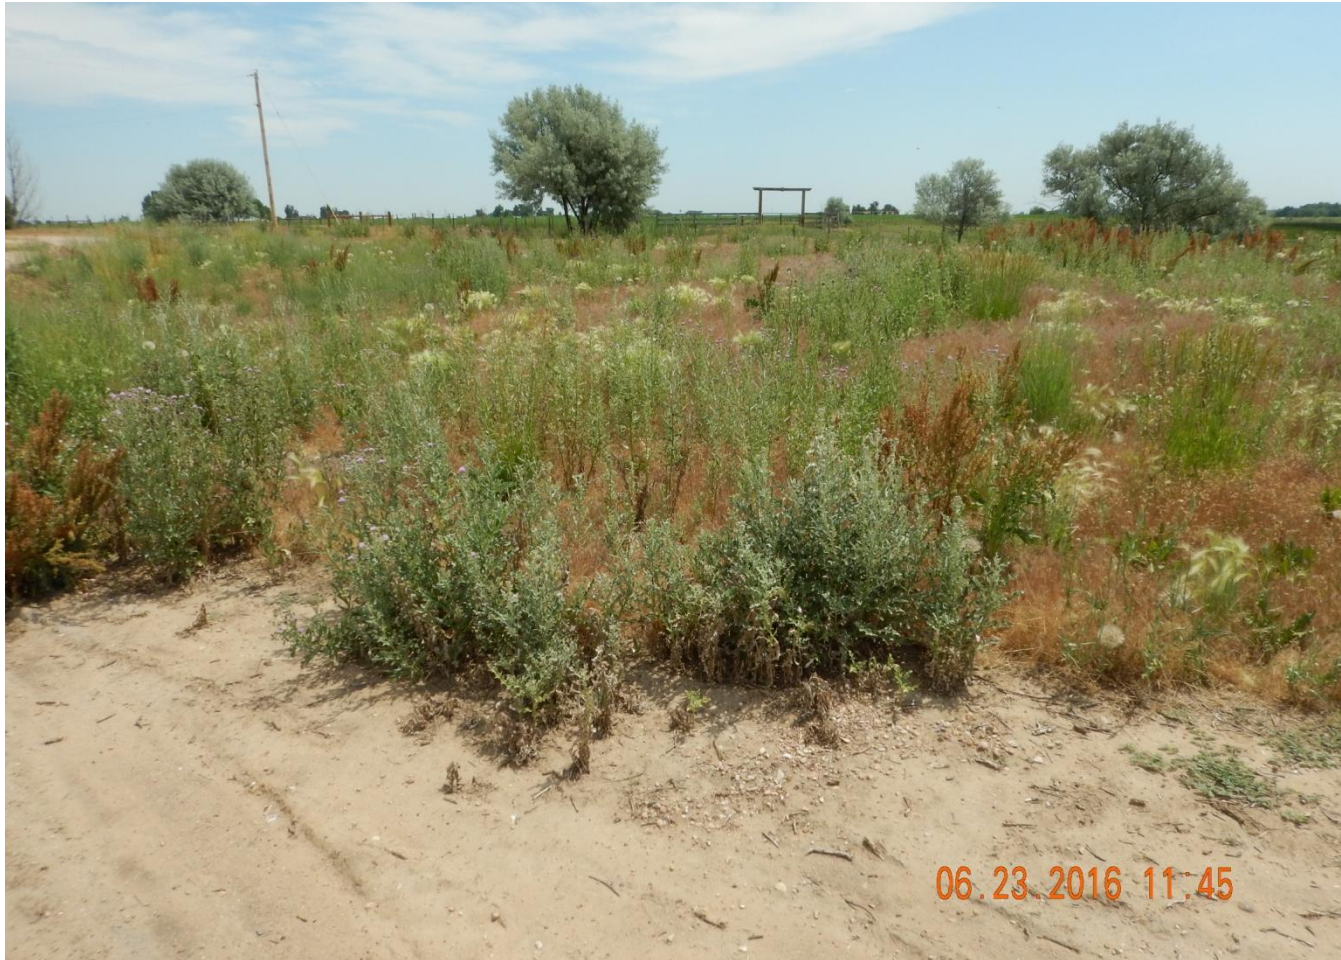
Photo 5. Photo taken from the eastern location, facing East. Two List B Colorado Noxious weed species, Canada thistle (*Cirsium arvense*) and Musk thistle (*Carduus nutans*), exist throughout entire interim reclamation area.

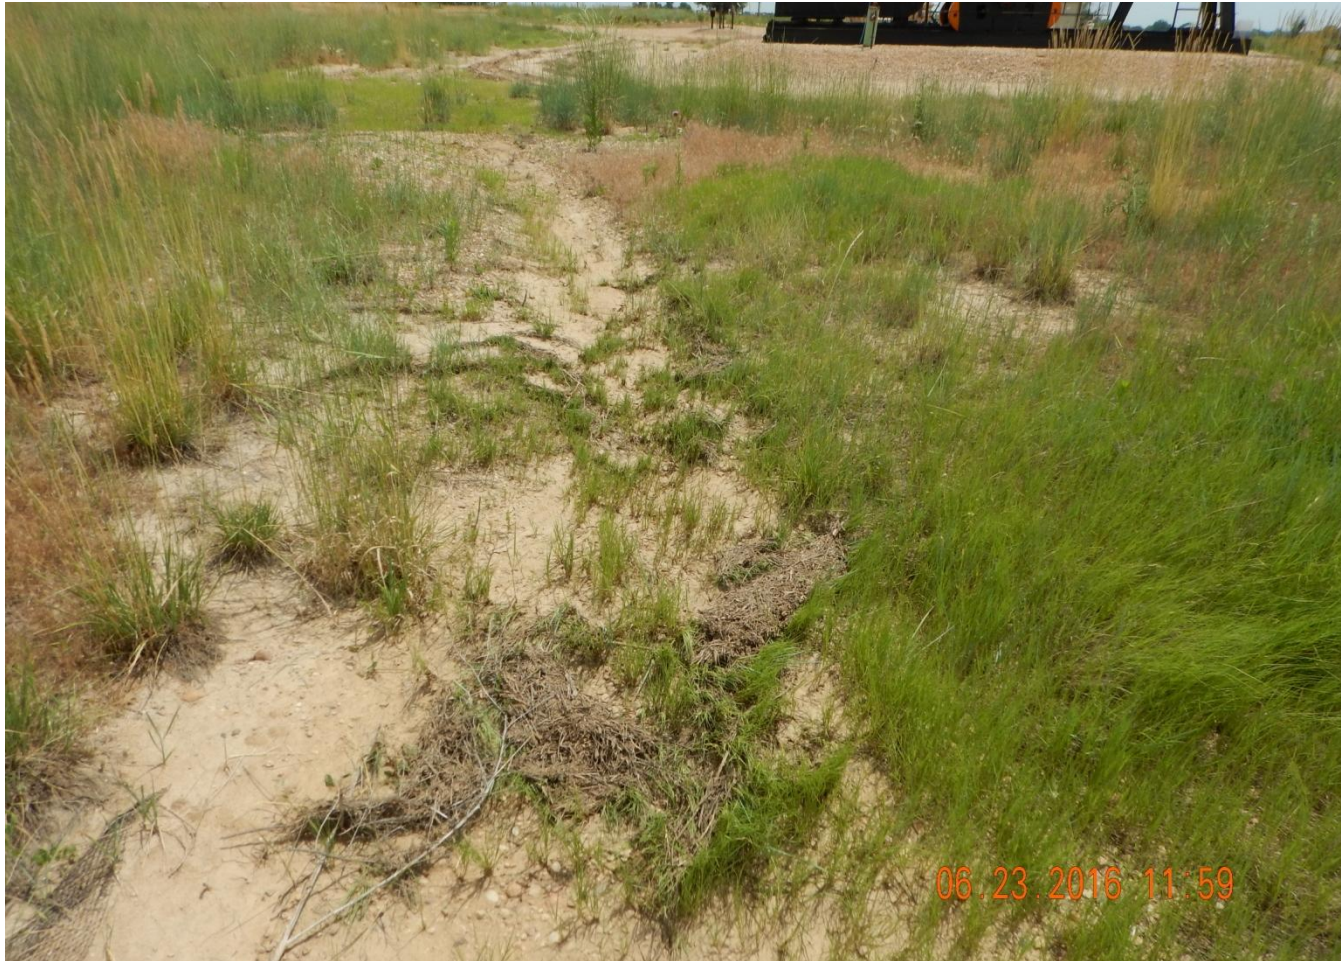
Photo 6. Photo taken from the northwest location, facing East. Need to install sufficient stormwater and sediment control BMPs.

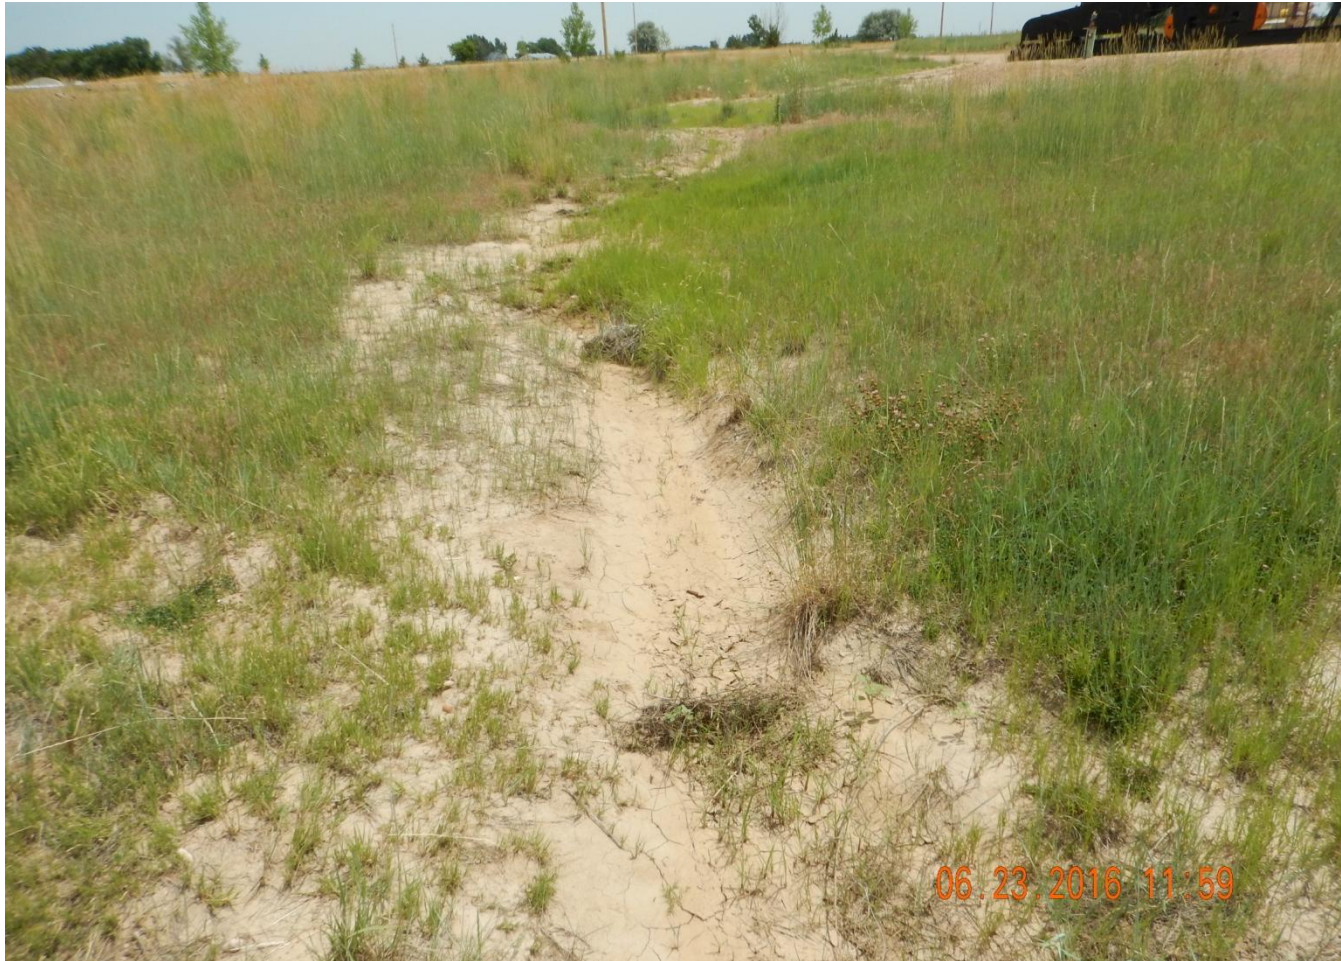
Photo 7. Photo illustrating gulley forming off location and transporting sediment offsite. Need to install sufficient stormwater and sediment control BMPs.

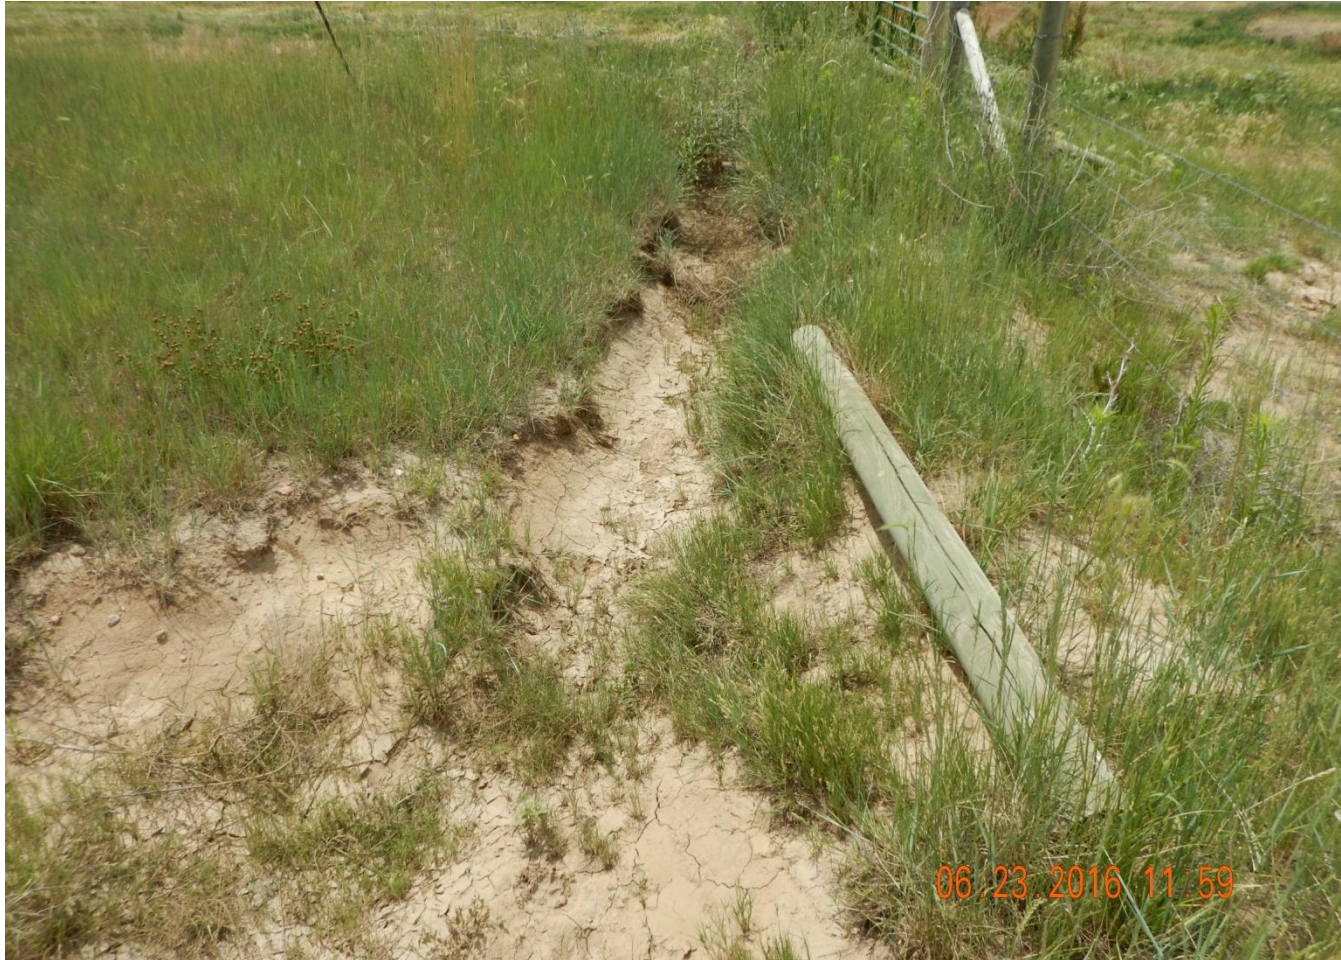
Photo 8. Photo taken from the southwest location, facing South, illustrating gully forming off location and transporting sediment offsite. Need to install sufficient stormwater and sediment control BMPs.
