Final Reclamation Inspection

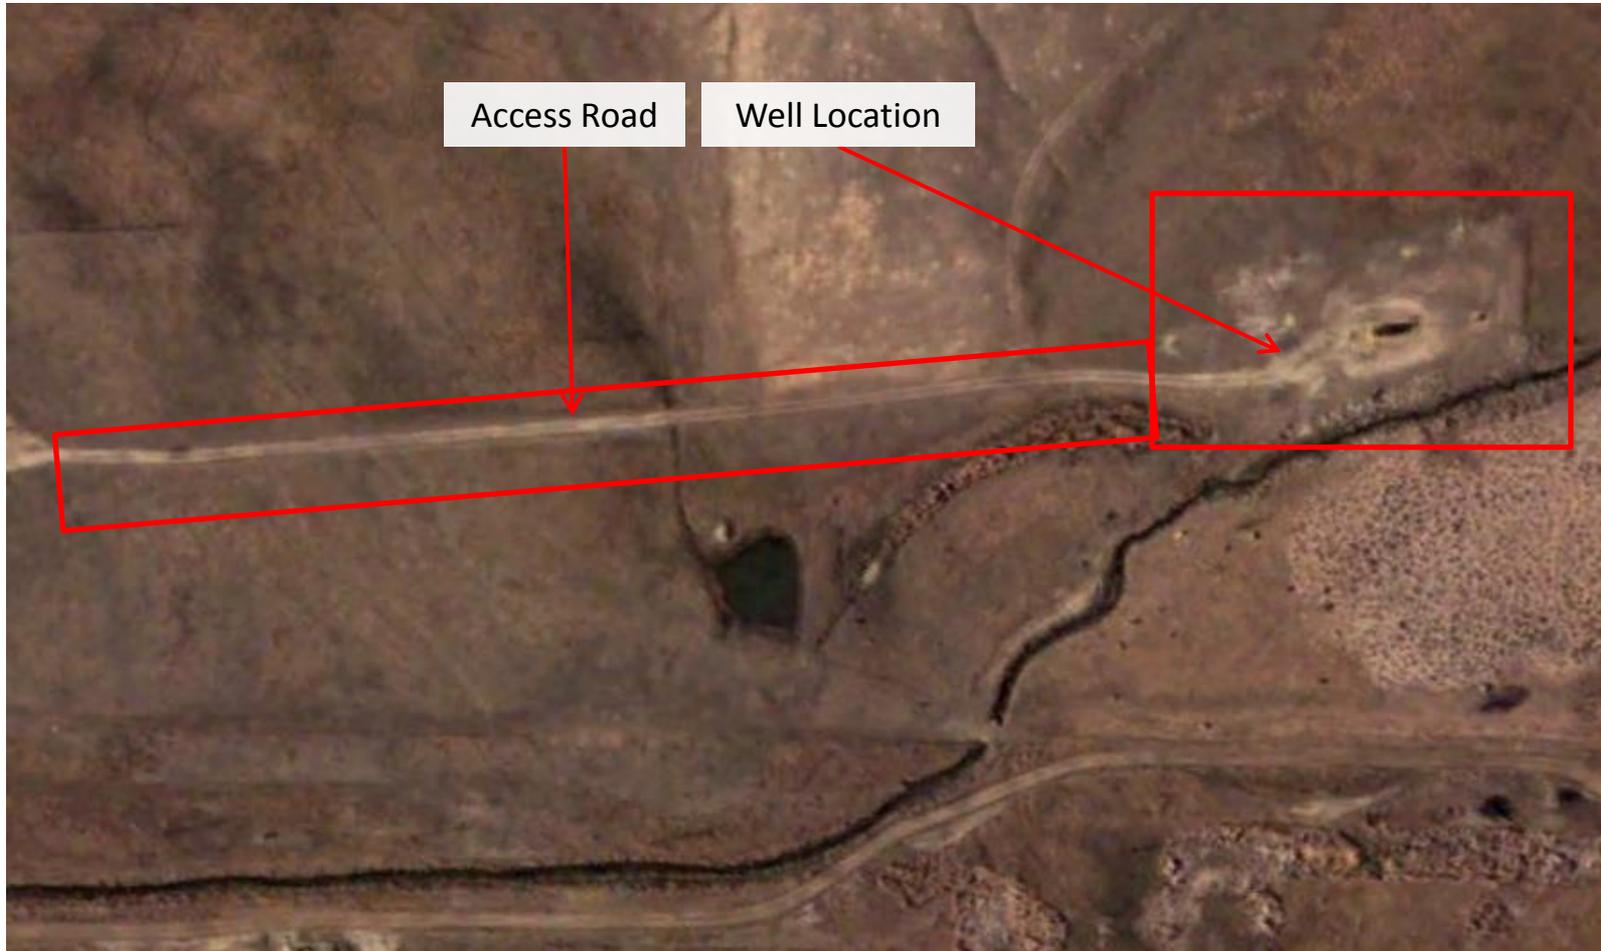
Photo 1. Aerial imagery from 12/2/2002, illustrating total areas that have not been reclaimed per Rule 1004 (highlighted in red). Large portions of the well location are infested with a List B Colorado Noxious weed- see following photos.

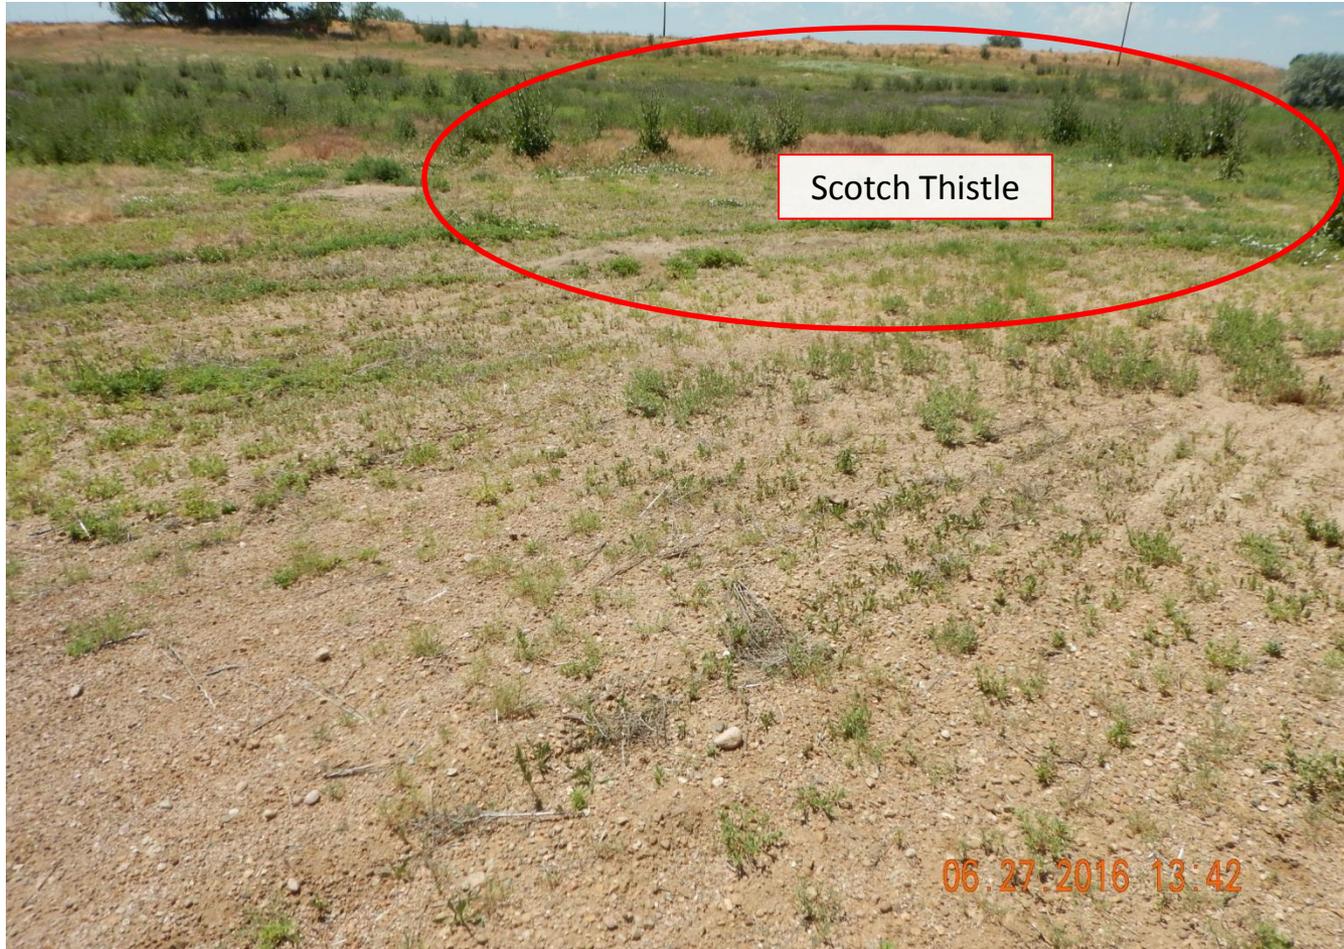
Photo 2. Photo taken from well location, facing West. Need to reclaim location per Rule 1004. A seeding attempt was made but gravel was not removed preventing proper vegetative establishment.

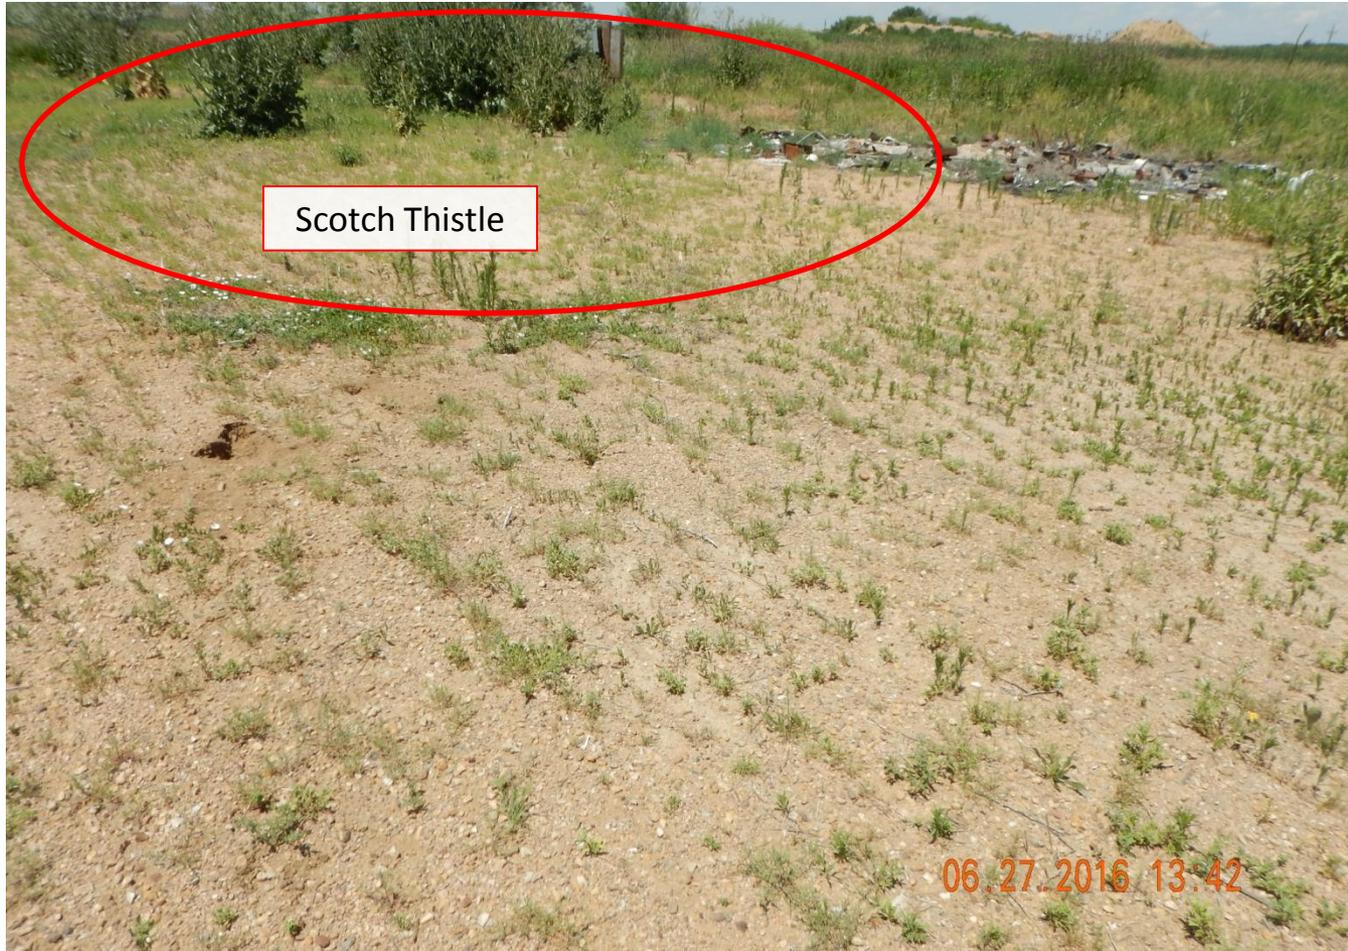
Photo 3. Photo taken from well location, facing North. Need to reclaim location per Rule 1004. A seeding attempt was made but gravel was not removed preventing proper vegetative establishment.

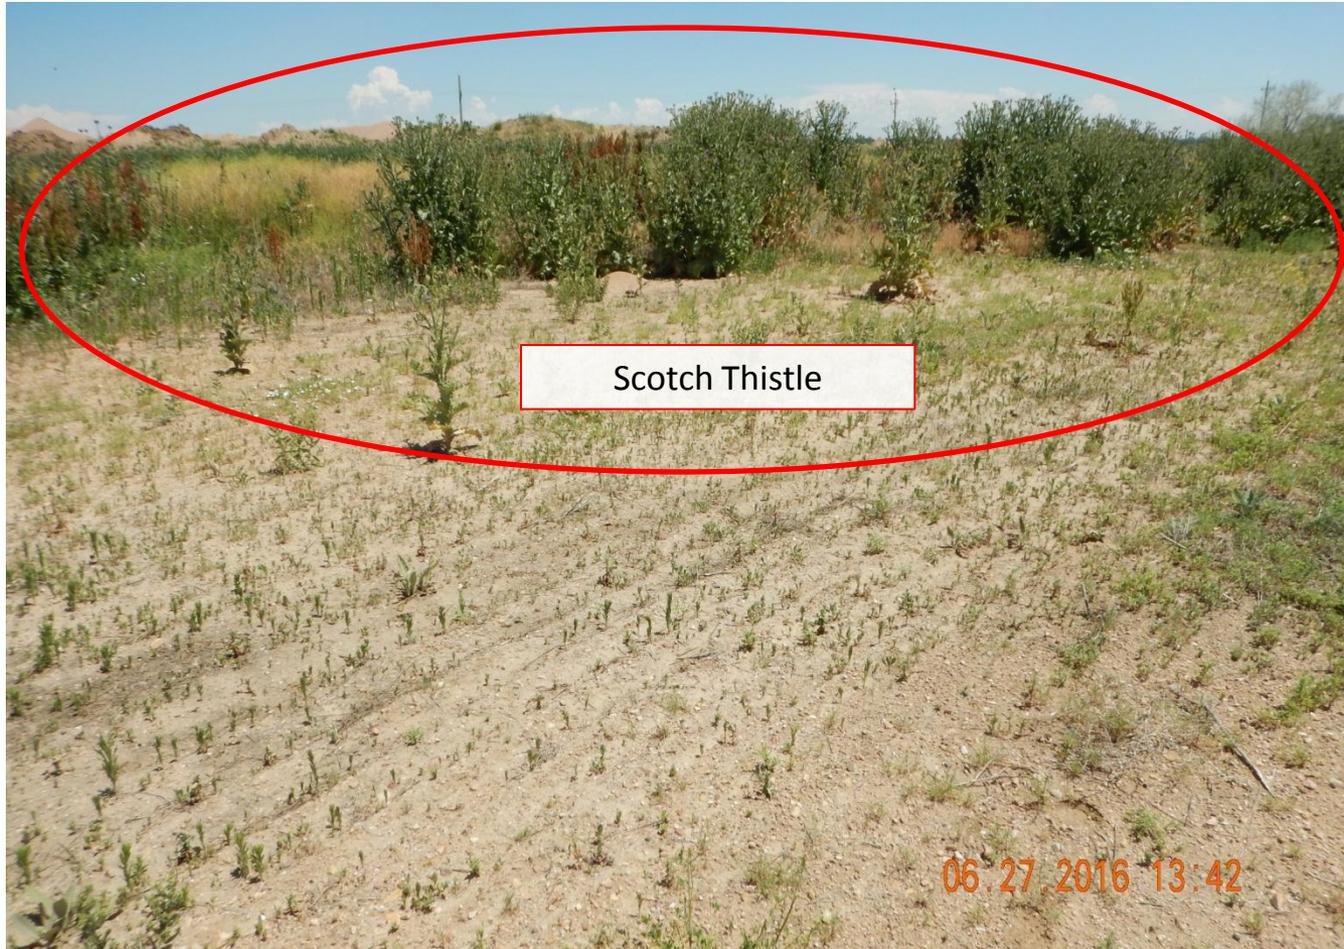
Photo 4. Photo taken from well location, facing East. Need to reclaim location per Rule 1004. A seeding attempt was made but gravel was not removed preventing proper vegetative establishment.

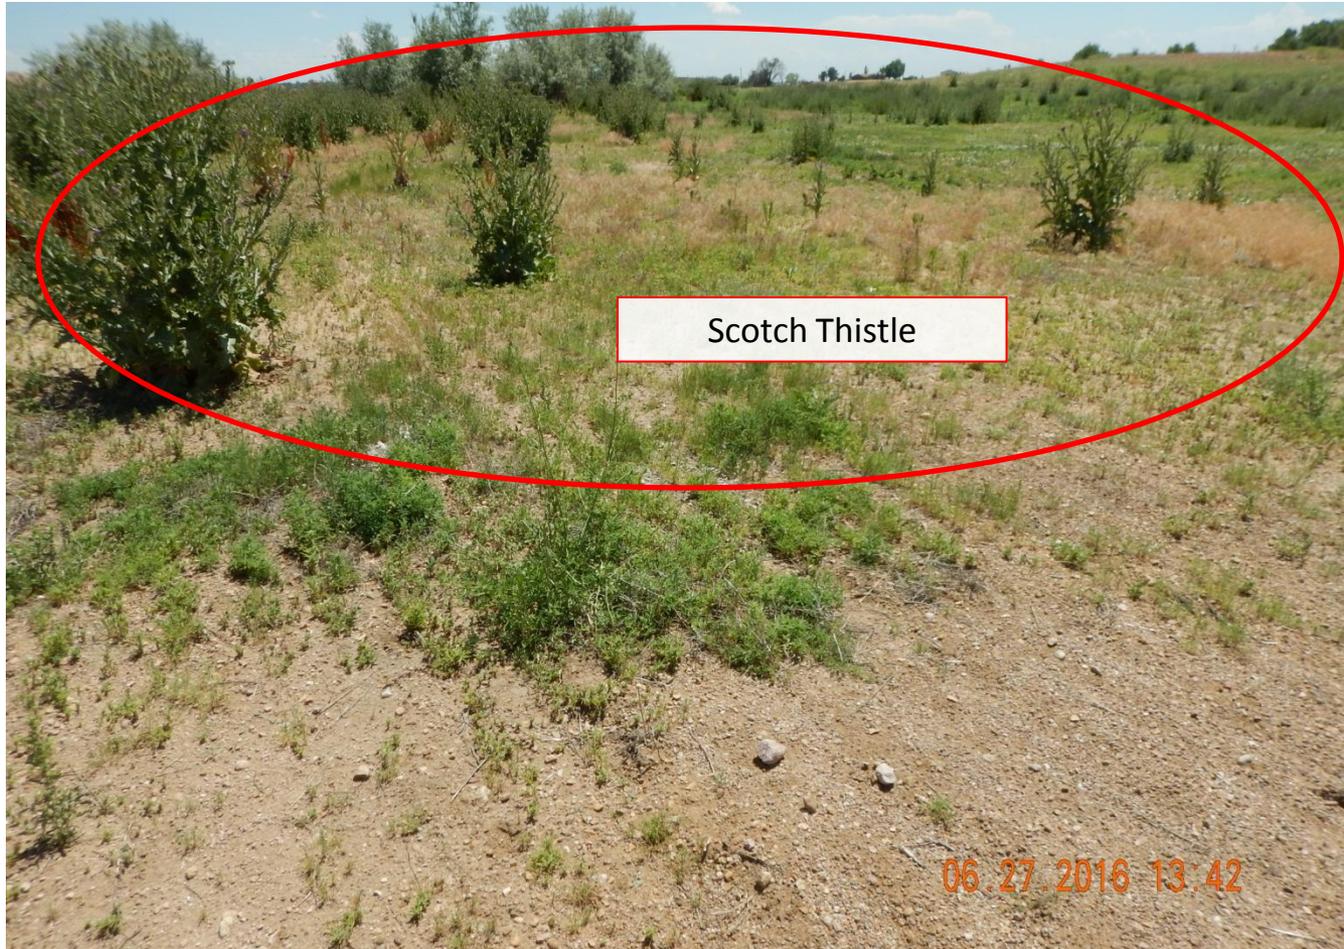
Photo 5. Photo taken from well location, facing South. Need to reclaim location per Rule 1004. A seeding attempt was made but gravel was not removed preventing proper vegetative establishment.

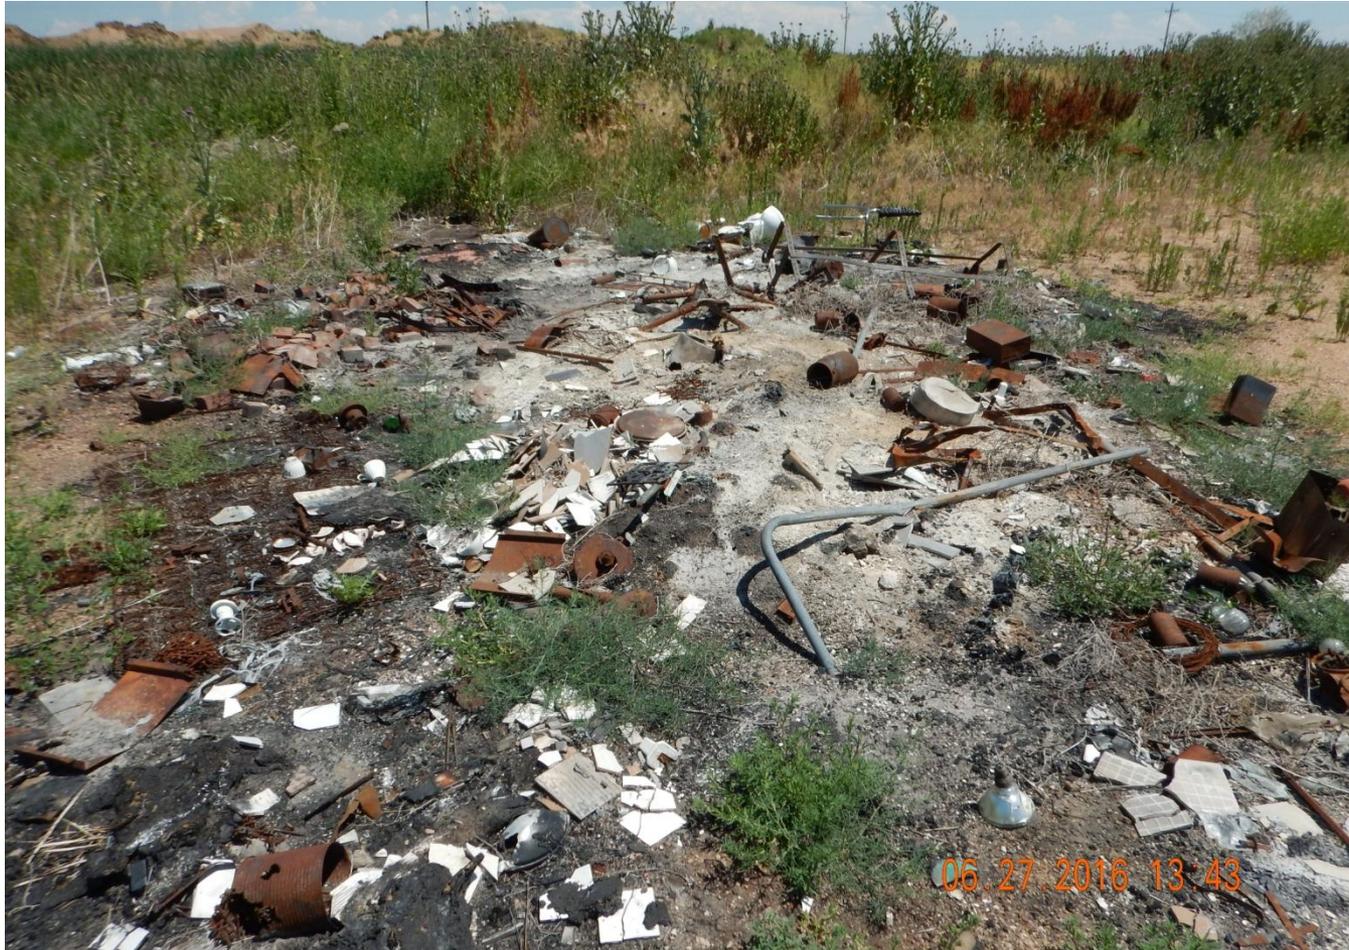
Photo 6. Photo taken from northeast well location. Need to remove trash per Rule 603.f.

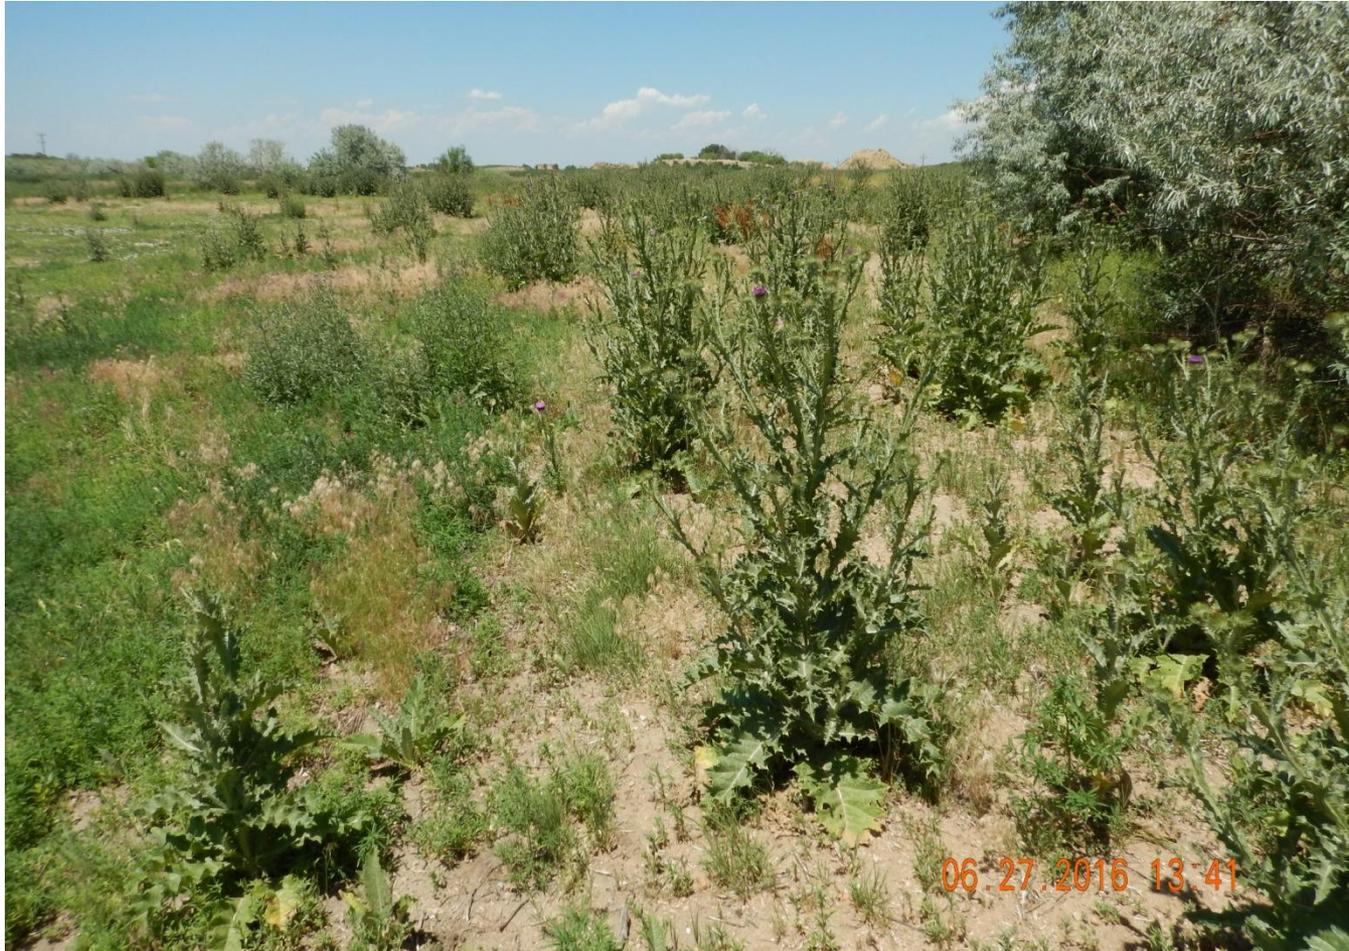
Photo 7. Photo taken from southern well location, facing North. A List B Colorado Noxious weed has infested large portions of the location- Scotch thistle (*Onopordum acanthium*)- and needs to be removed from location by 7/26/2016.

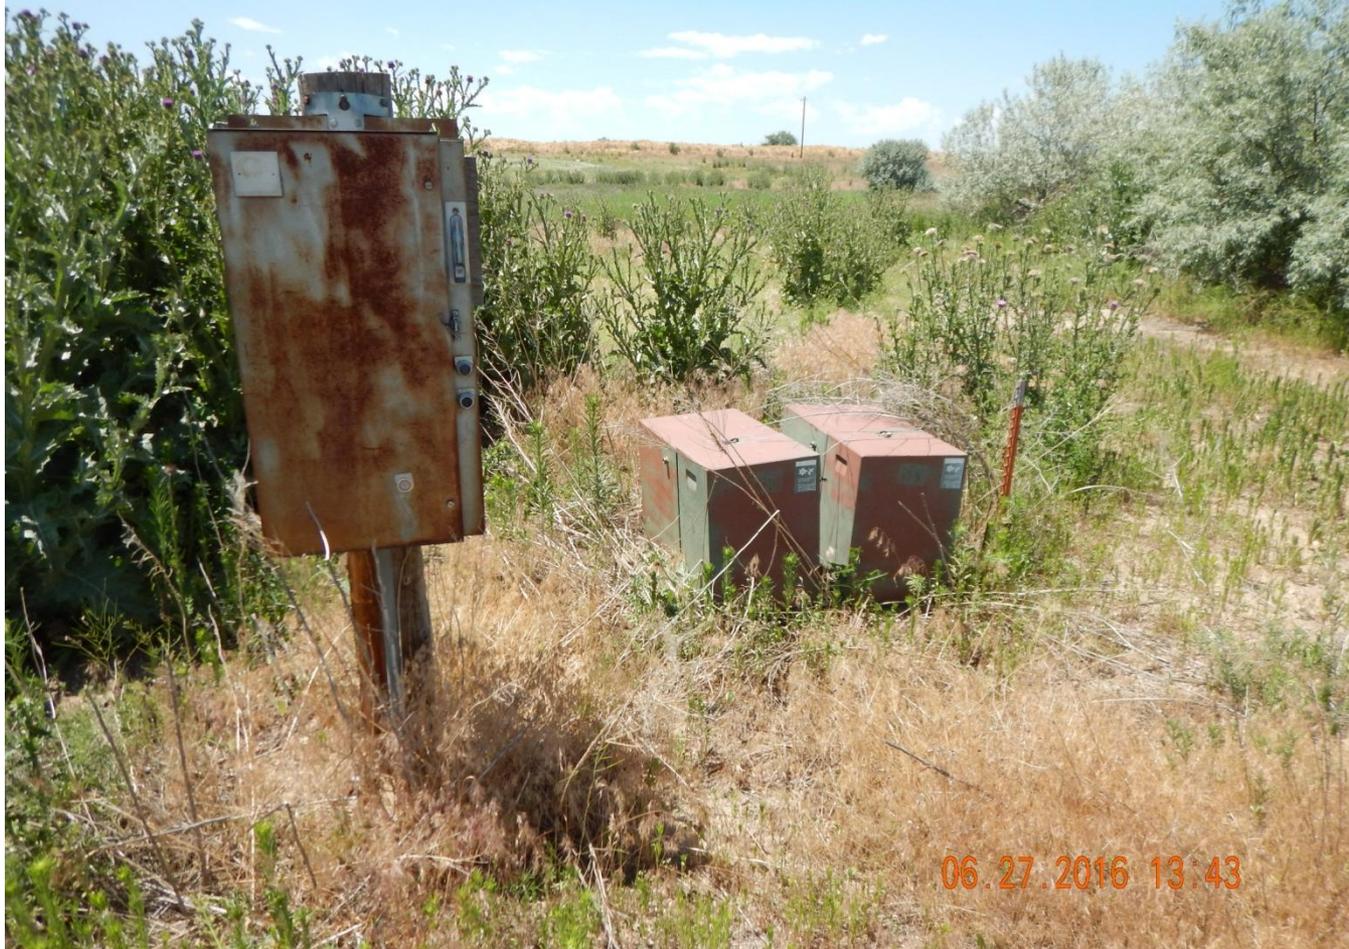
Photo 8. Photo taken from well location illustrating equipment and debris that still remains and needs to be removed per Rule 1004.
