Form 2A - Attachment E

Topographic Map Showing Surface Waters

BMC D

39.44145 -108.04075
Section 18, Township 7 South, Range 95 West

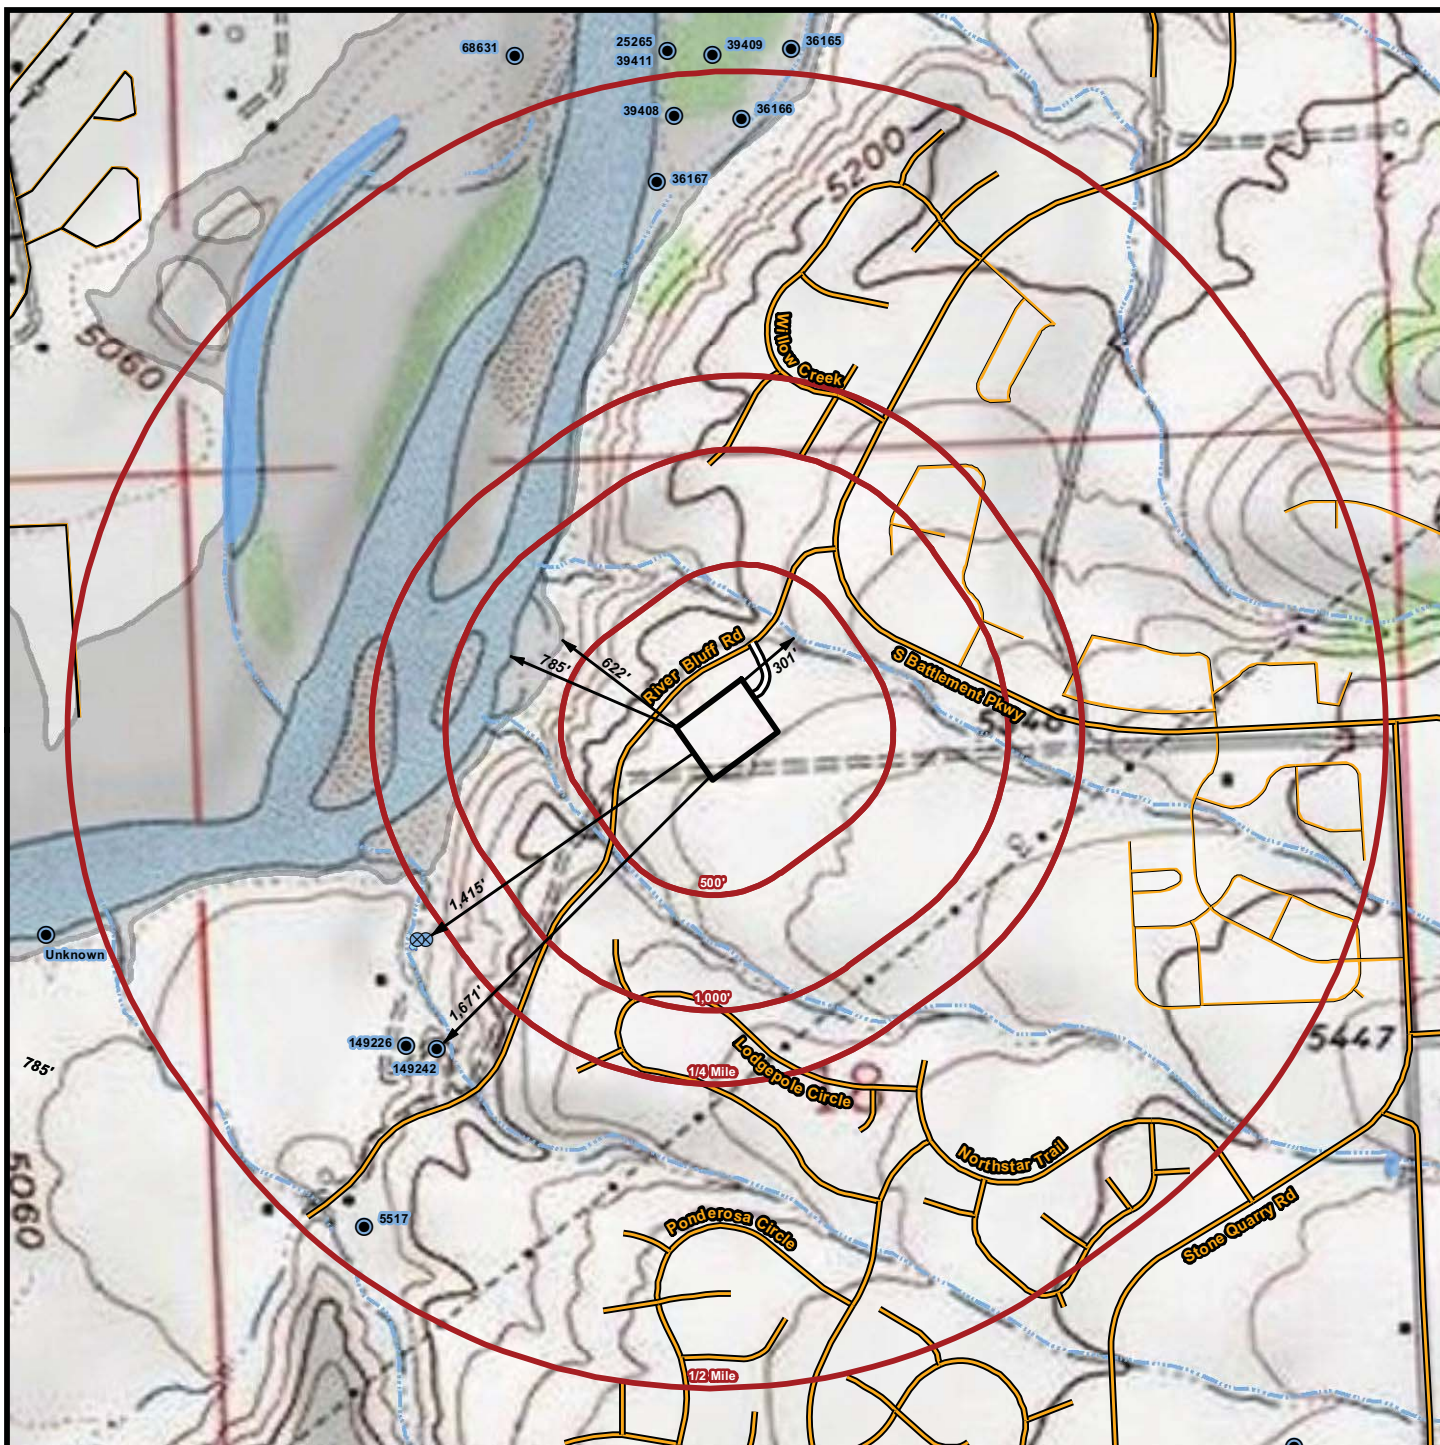
HYDROGRAPHY:

FEATURE	PRESENT WITHIN 1,000 ft
Ditch	No

Floodplain	Yes - 622 ft

Groundwater Depth	Approx. 130 ft
Intermittent Stream	Yes - 301 ft

Perennial Stream	Yes - 785 ft

Riparian Area	No
Spring	No

Water Body	No

Watershed	No
Water Well	No

Wetland	No
