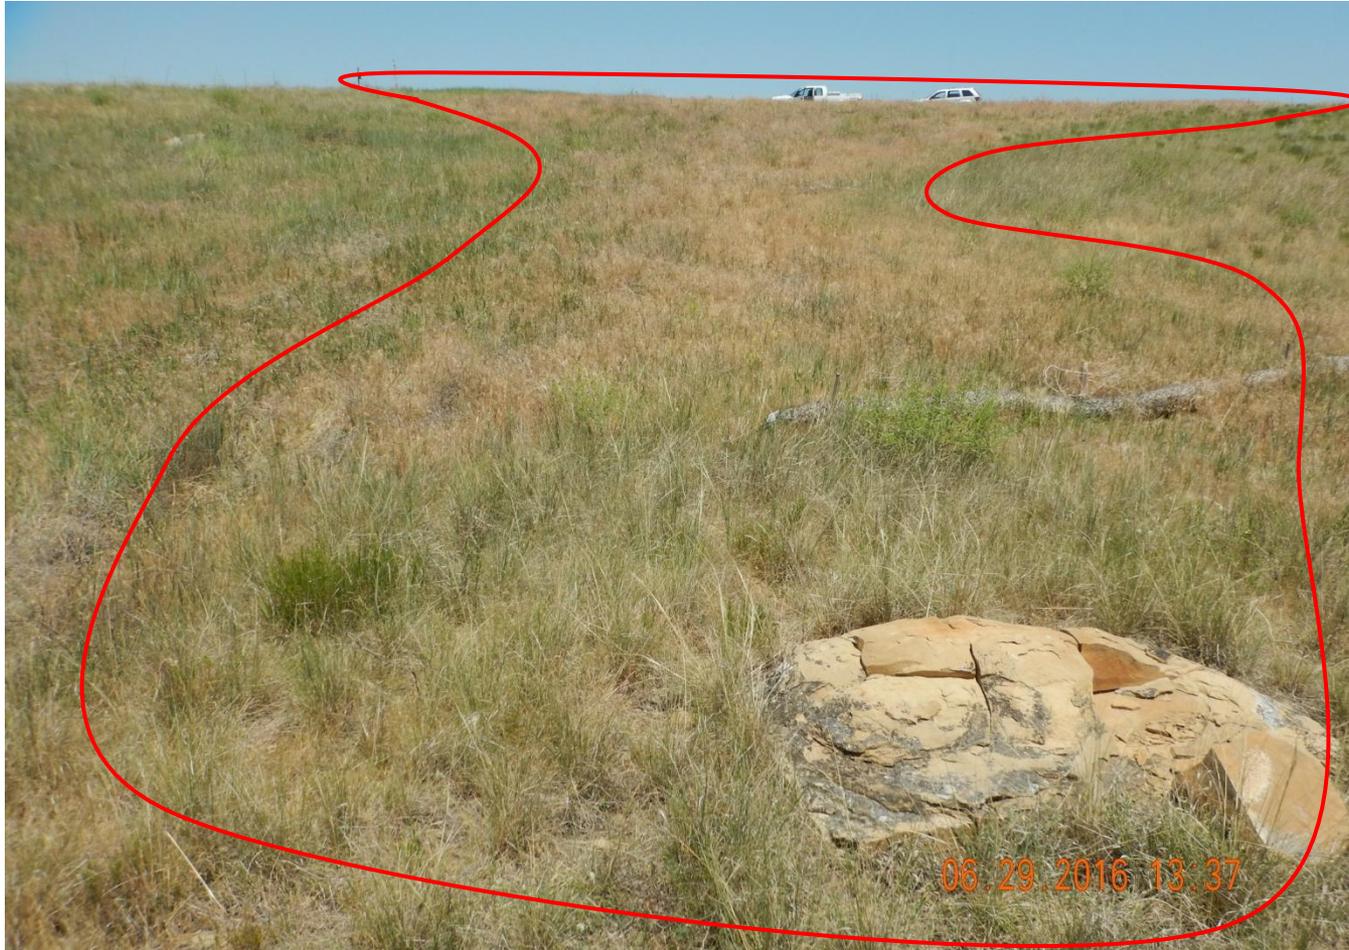
Photo 1. Photo taken from the approximate central release area, facing East. Reclamation is IN PROCESS and vegetation is dominated by Cheatgrass (*Bromus tectorum*) in the release area. Stormwater BMPs have been installed along the down gradient slope. Vegetation, whether it is desirable or not (i.e., cheatgrass), appears to be stabilizing the slope.

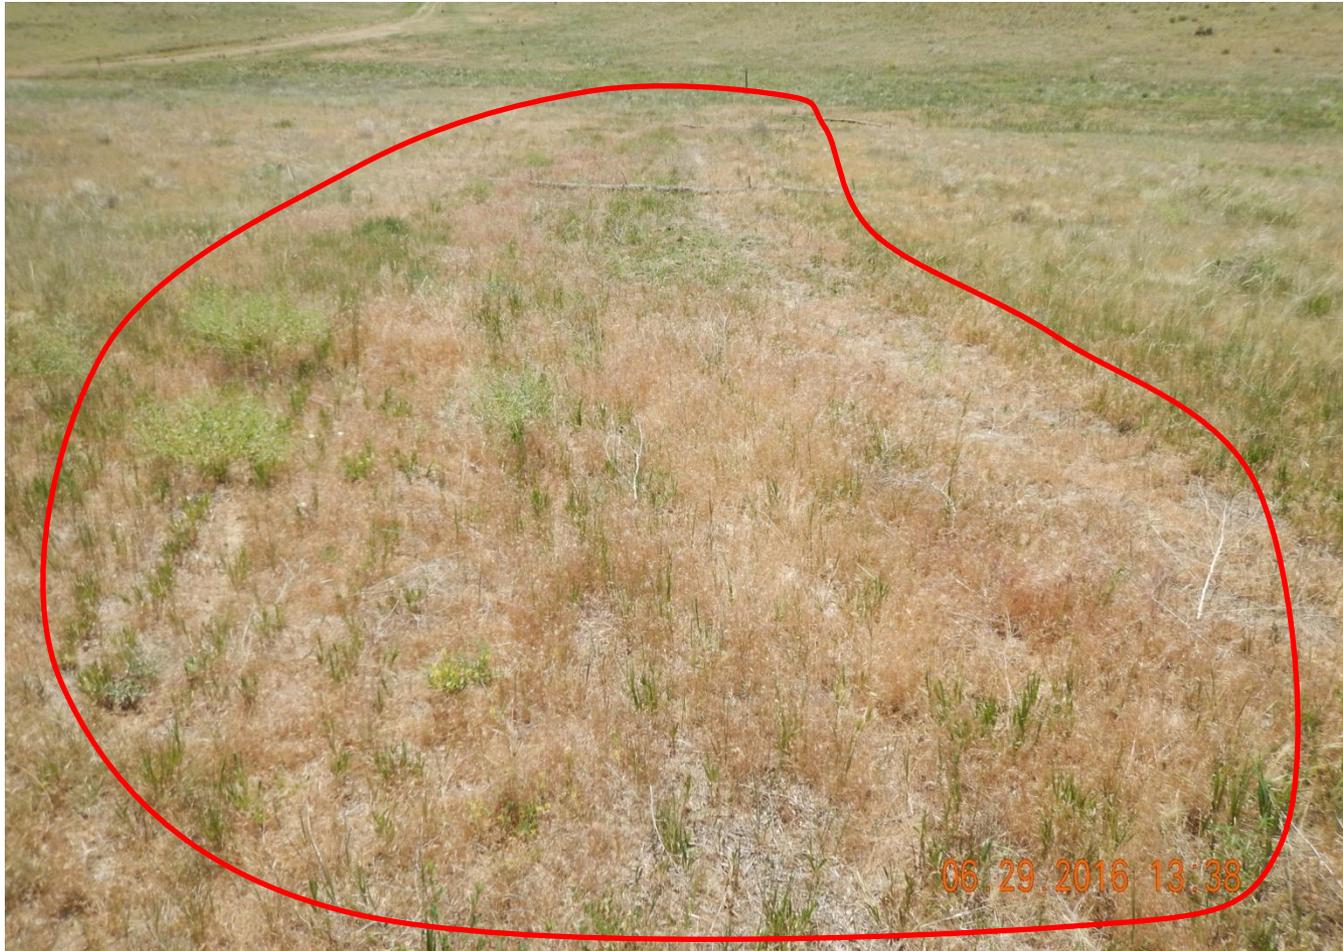
Photo 2. Photo taken from the approximate central release area, facing West. Reclamation is IN PROCESS and vegetation is dominated by Cheatgrass (*Bromus tectorum*) in the release area. Stormwater BMPs have been installed along the down gradient slope. Vegetation, whether it is desirable or not (i.e., cheatgrass), appears to be stabilizing the slope.

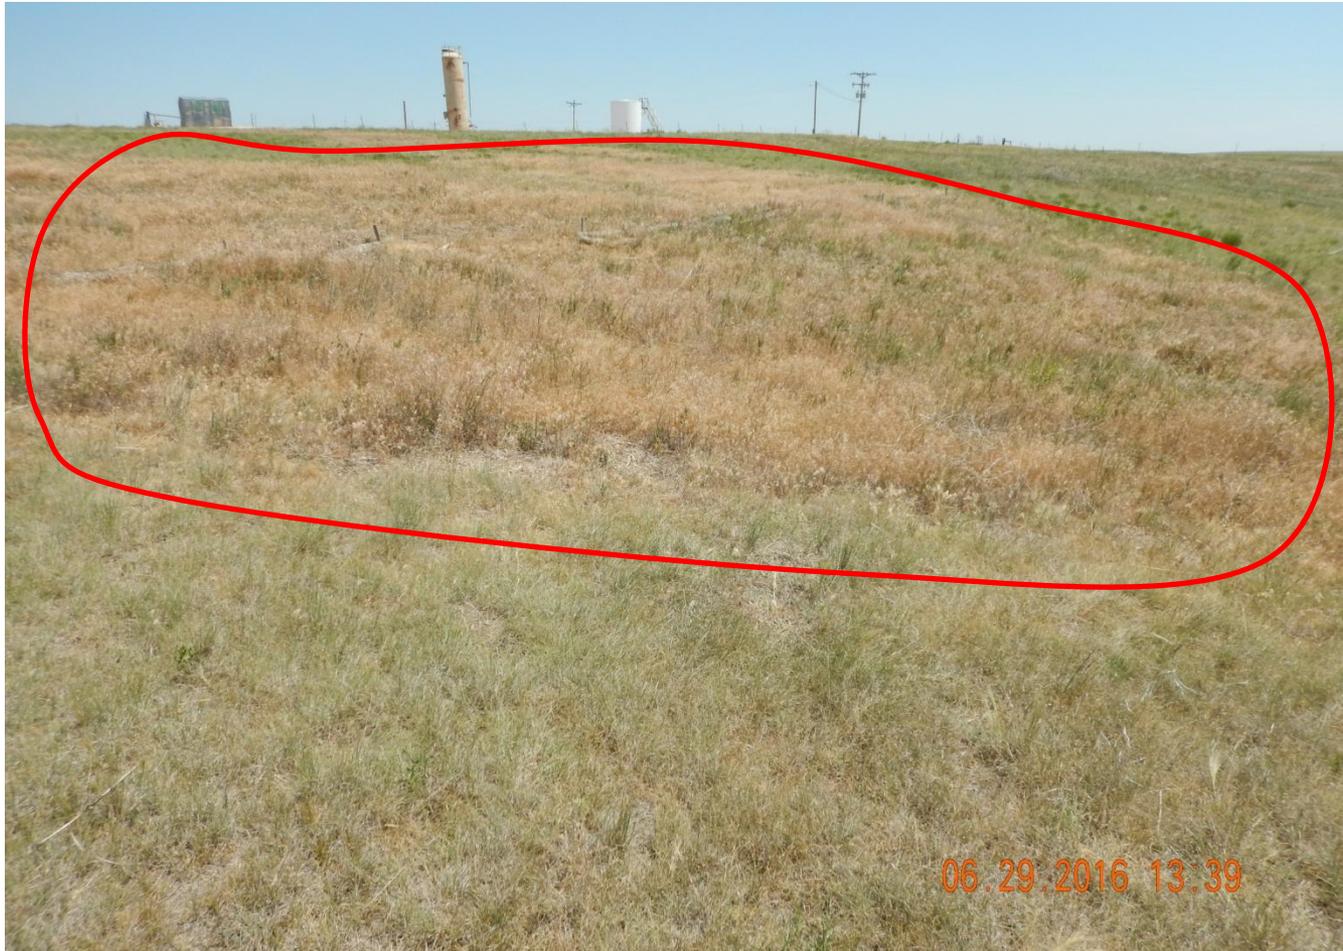
Photo 3. Photo taken from the approximate central release area, facing South. Reclamation is IN PROCESS and vegetation is dominated by Cheatgrass (*Bromus tectorum*) in the release area. Stormwater BMPs have been installed along the down gradient slope. Vegetation, whether it is desirable or not (i.e., cheatgrass), appears to be stabilizing the slope.

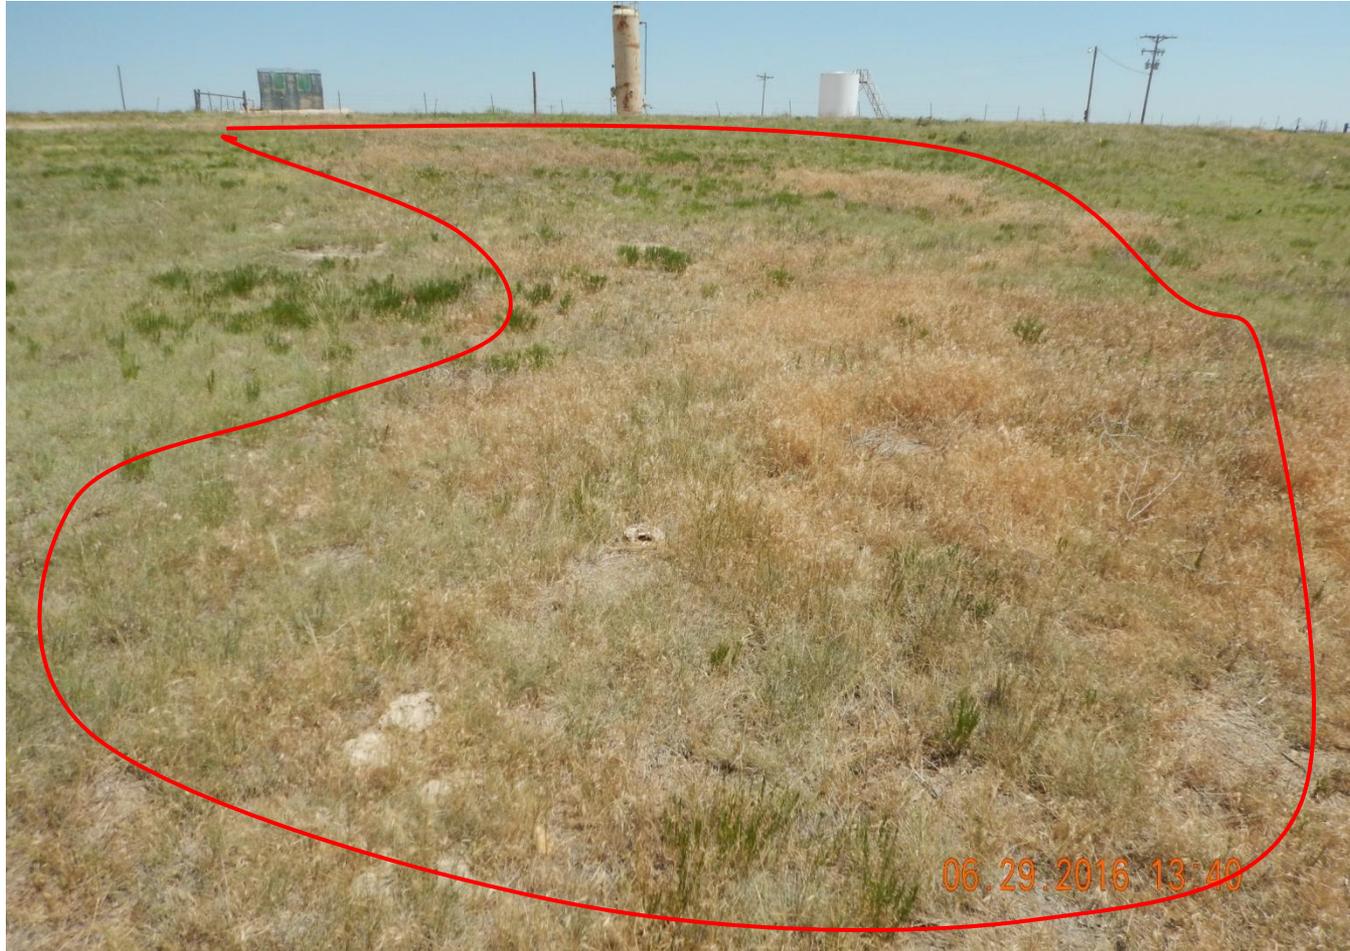
Photo 4. Photo taken from the eastern release area, facing South. Reclamation is IN PROCESS and vegetation is dominated by Cheatgrass (*Bromus tectorum*) in the release area.

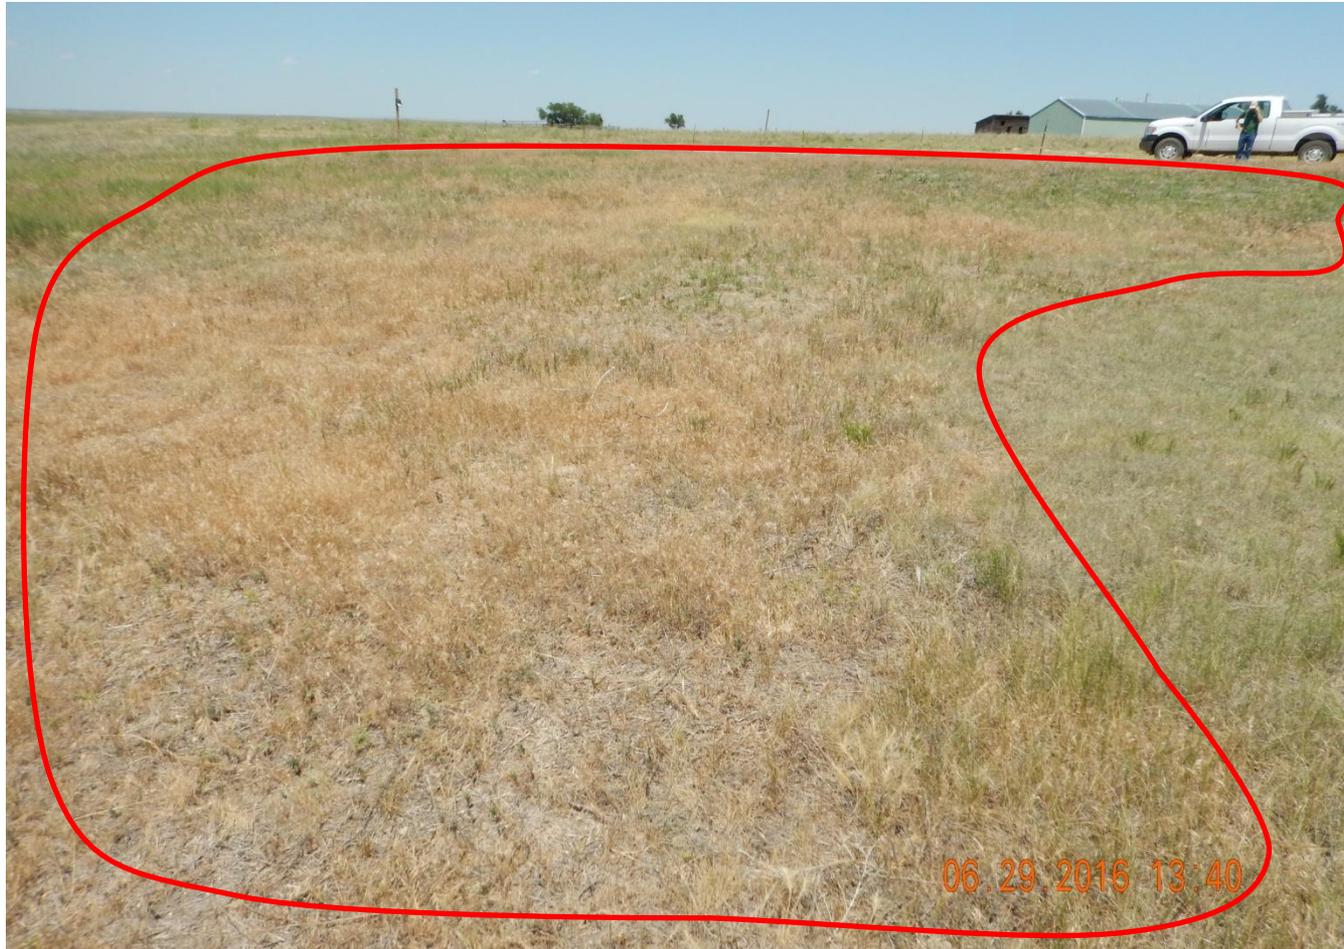
Photo 5. Photo taken from the eastern release area, facing East. Reclamation is IN PROCESS and vegetation is dominated by Cheatgrass (*Bromus tectorum*) in the release area.

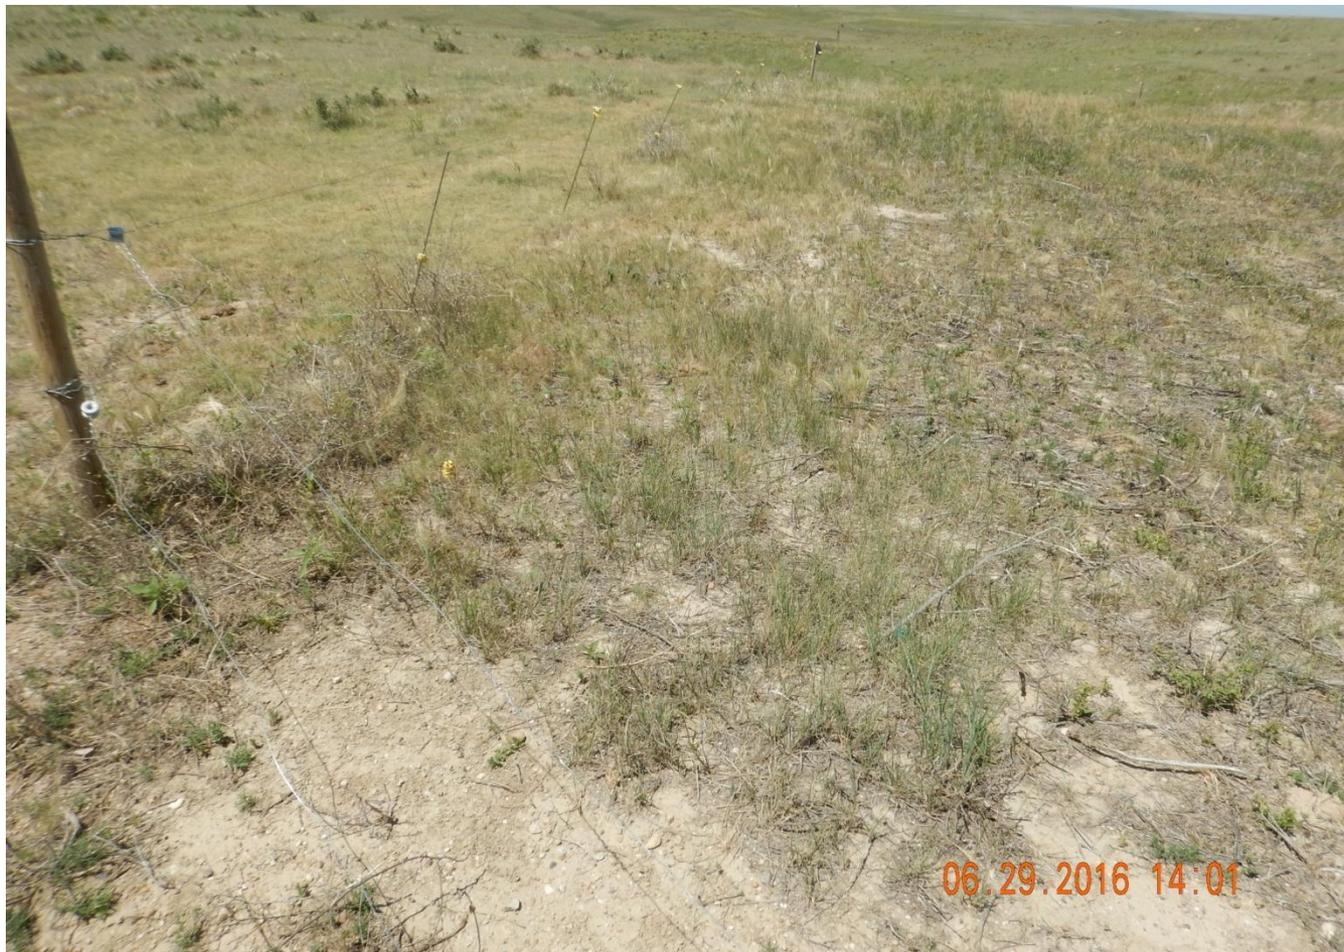
Photo 6. Photo taken from the southwest release area on #8550, facing North. Reclamation is IN PROCESS and need to maintain fence to ensure cattle does not negatively affect the reclamation process.

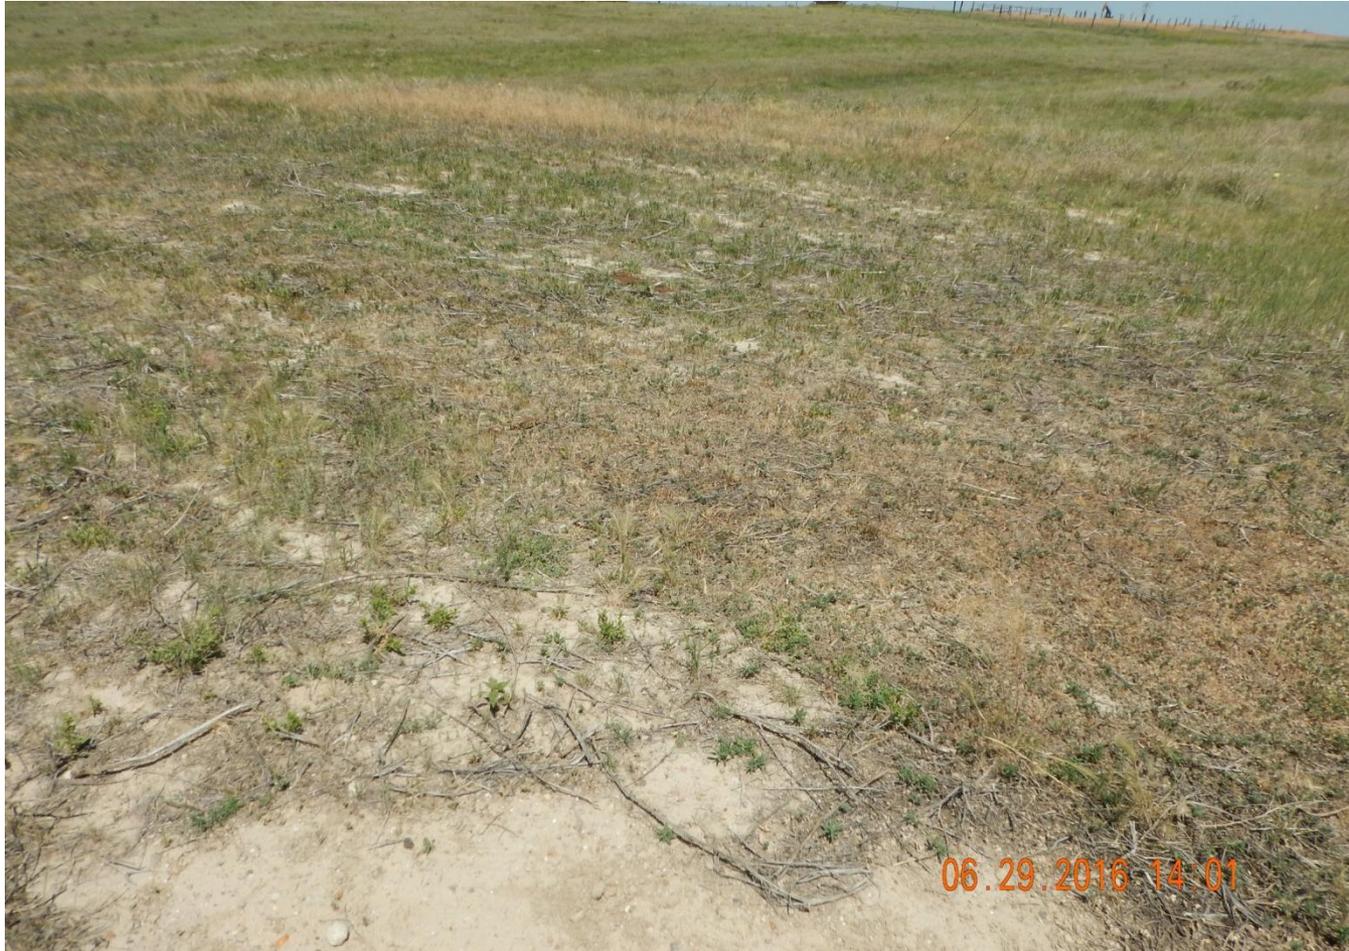
Photo 7. Photo taken from the southwest release area on #8550, facing Northeast. Reclamation is IN PROCESS and need to maintain fence to ensure cattle does not negatively affect the reclamation process.
