Final Reclamation Inspection

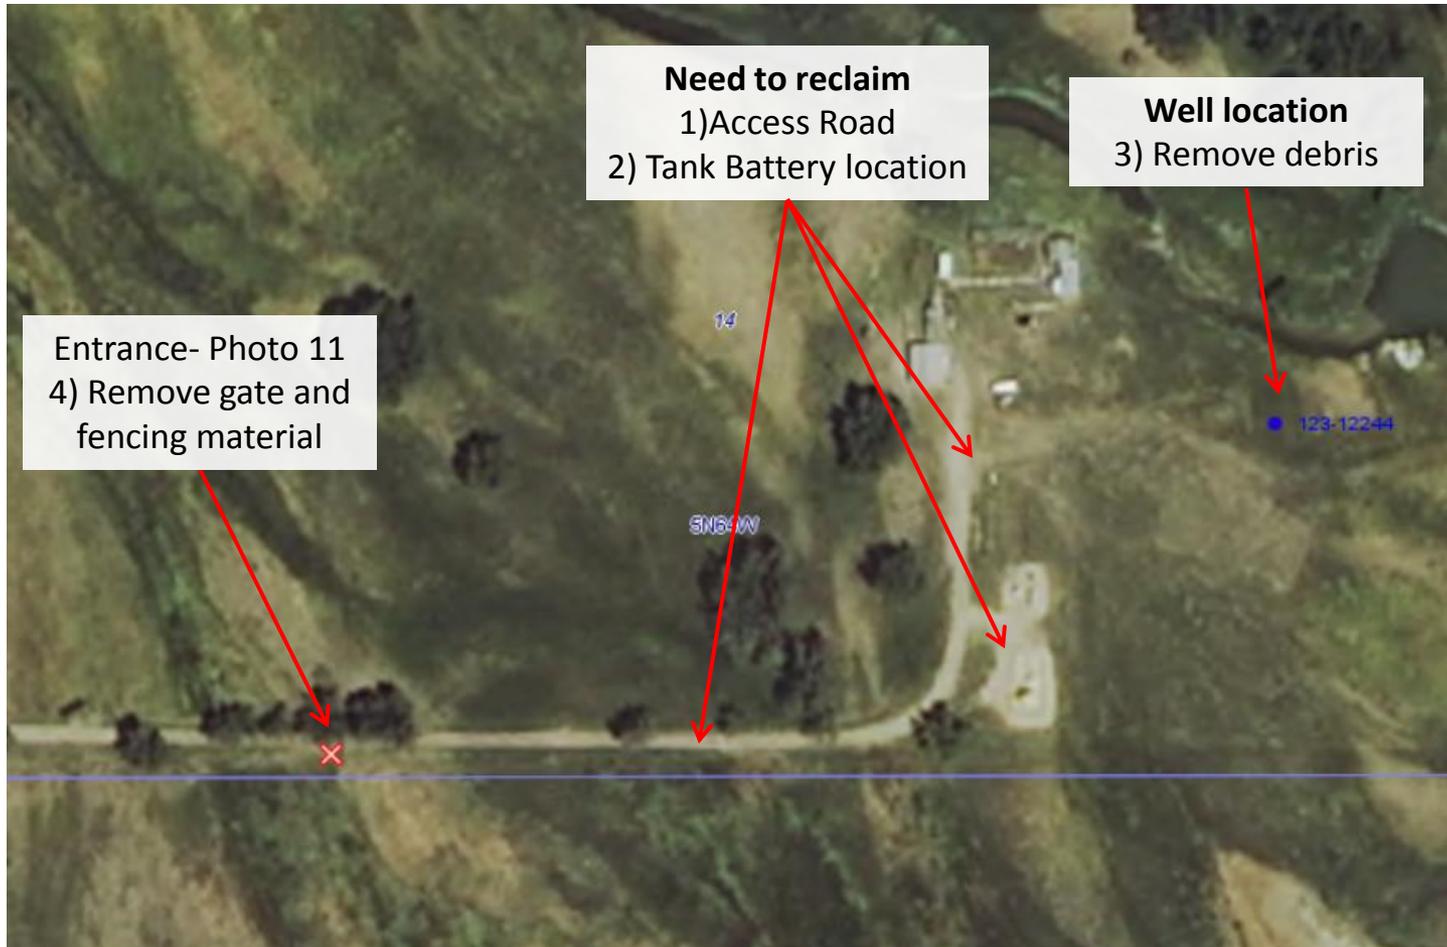
Photo 1. 2013 aerial imagery using COGCC GISOnline, illustrating total areas that have not been reclaimed per Rule 1004 and debris left behind.

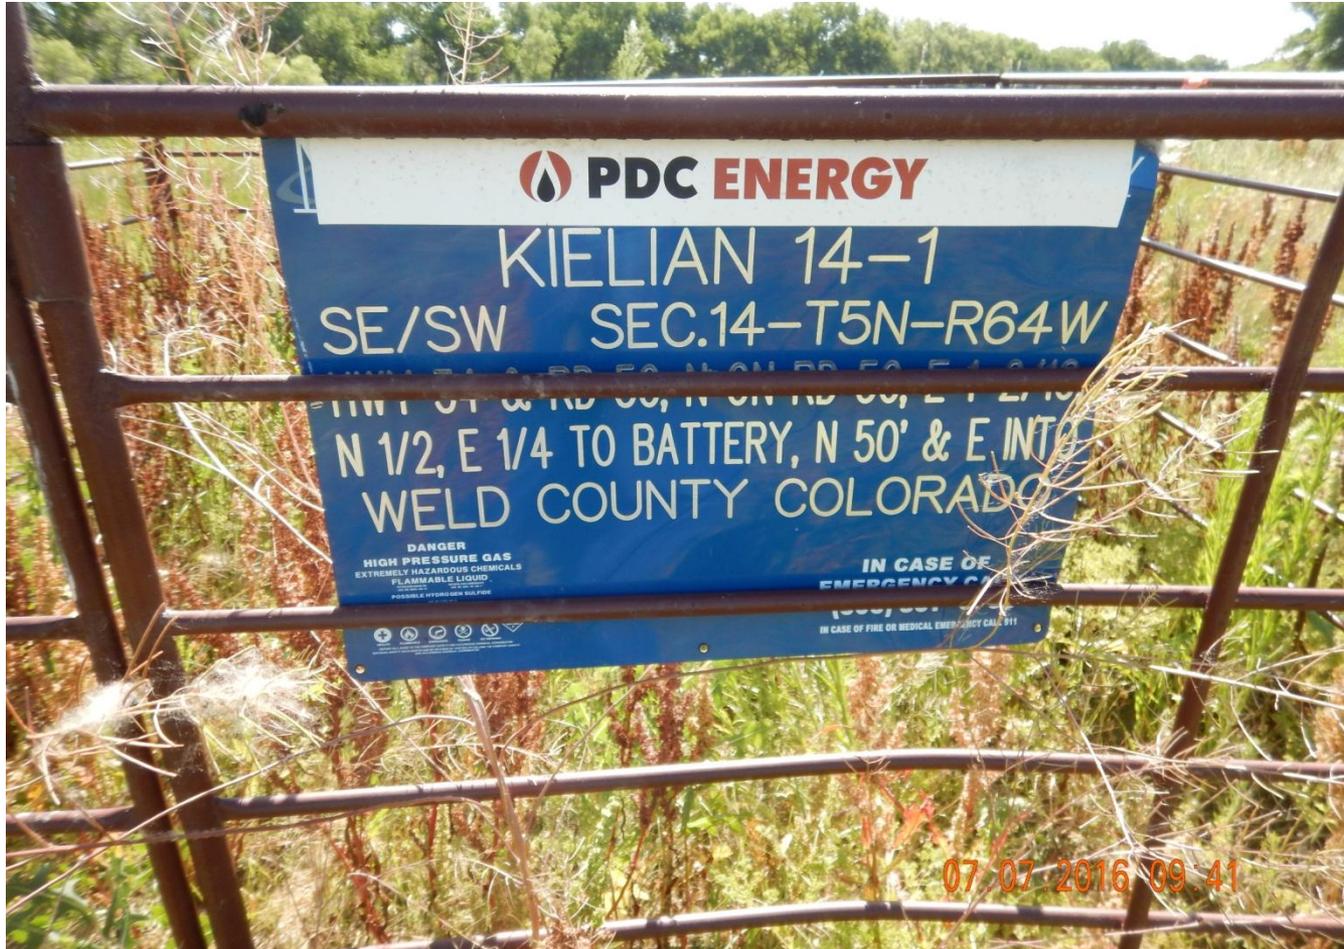
Photo 2. Photo taken of well sign for API# 123-12244 that needs to be removed, along with fencing material and trash around wellhead.

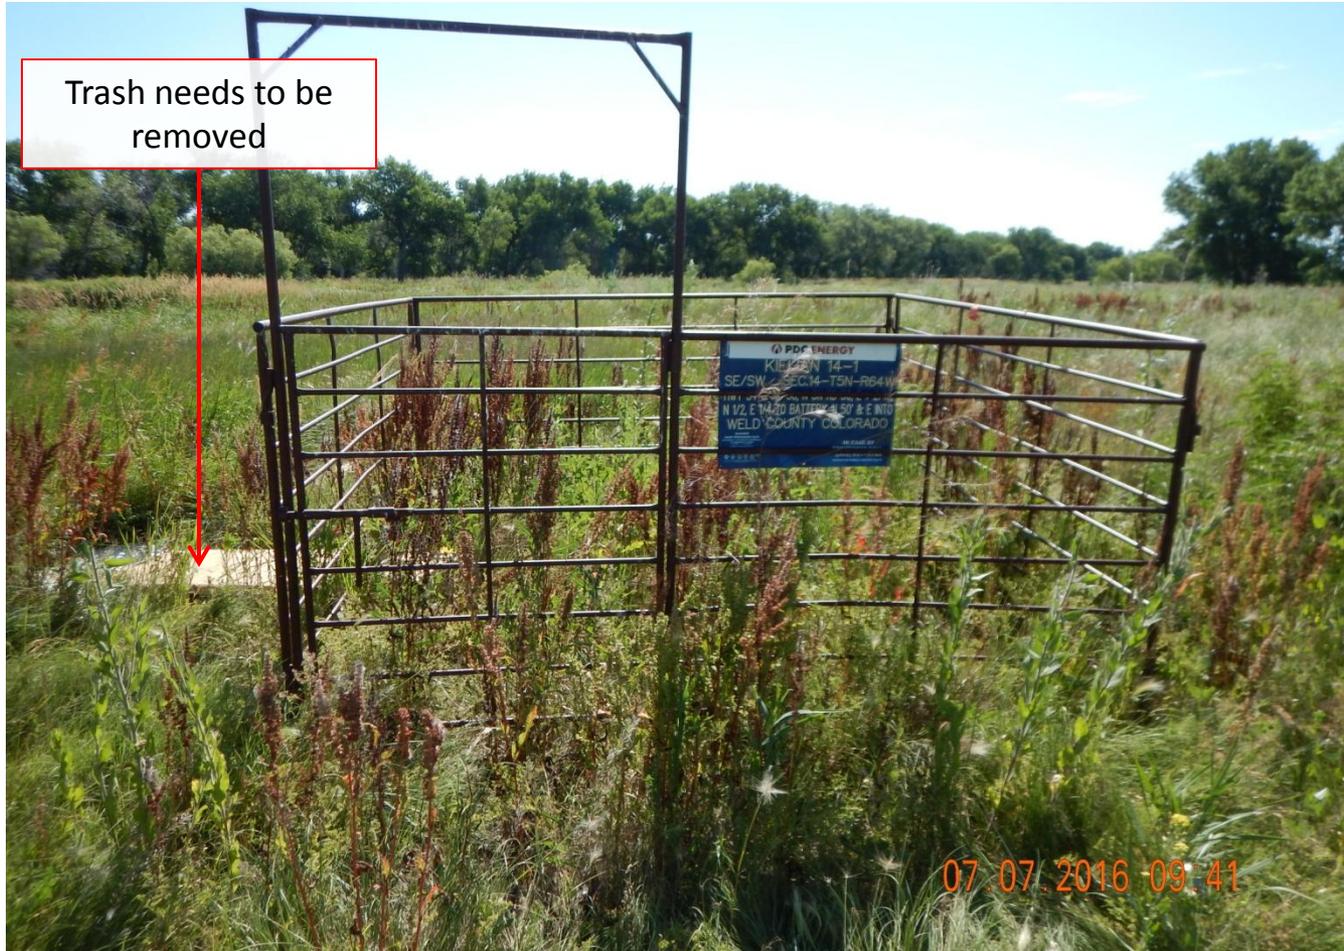
Photo 3. Photo taken west of well sign for API# 123-12244, facing East, that needs to be removed, along with fencing material and trash around wellhead.

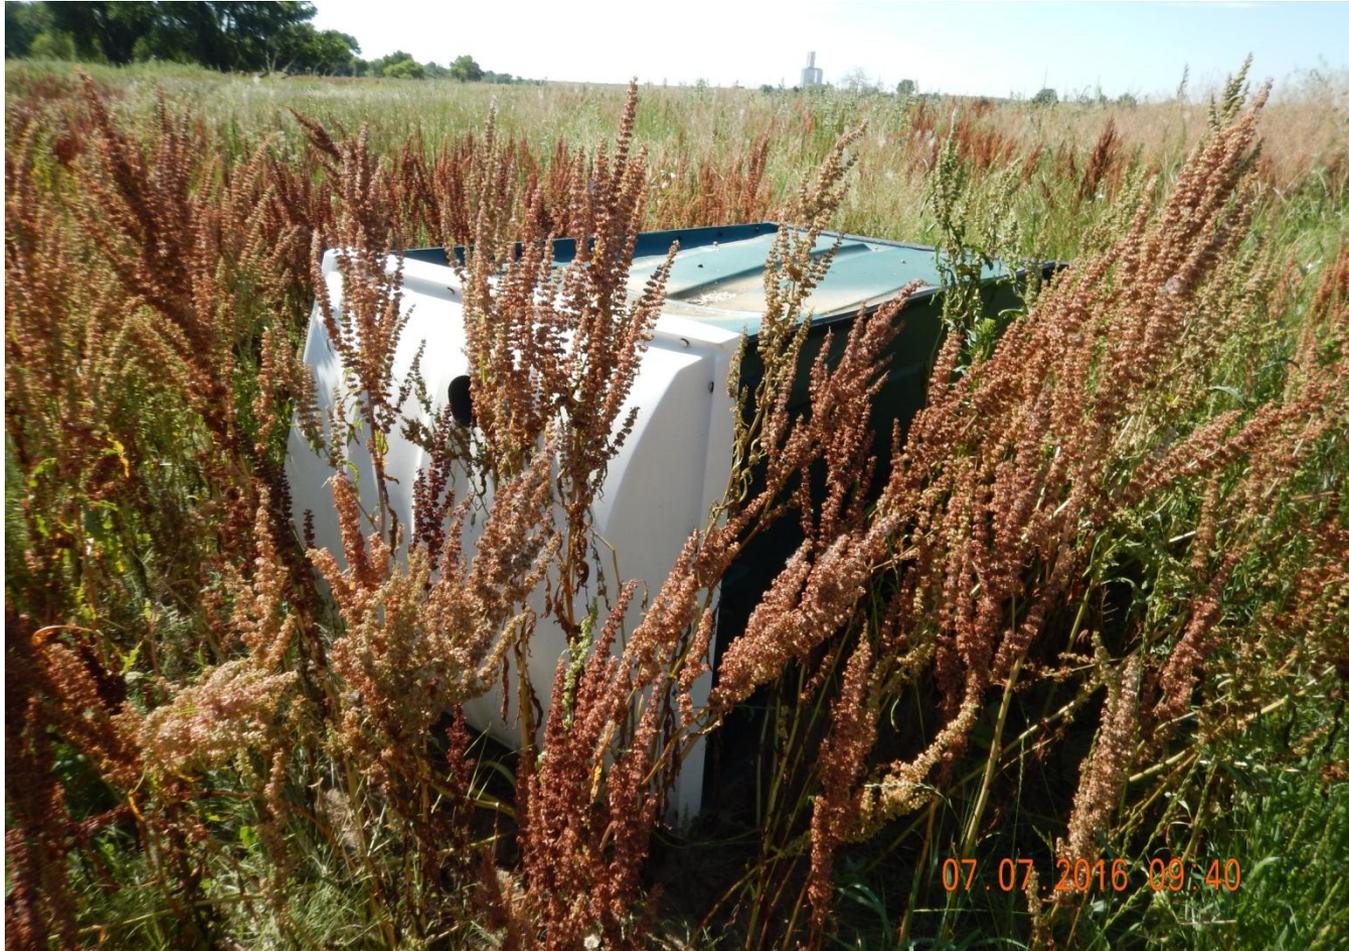
Photo 4. Photo taken from southwest of wellhead, facing South. Need to remove portable waste facility (i.e., trash).

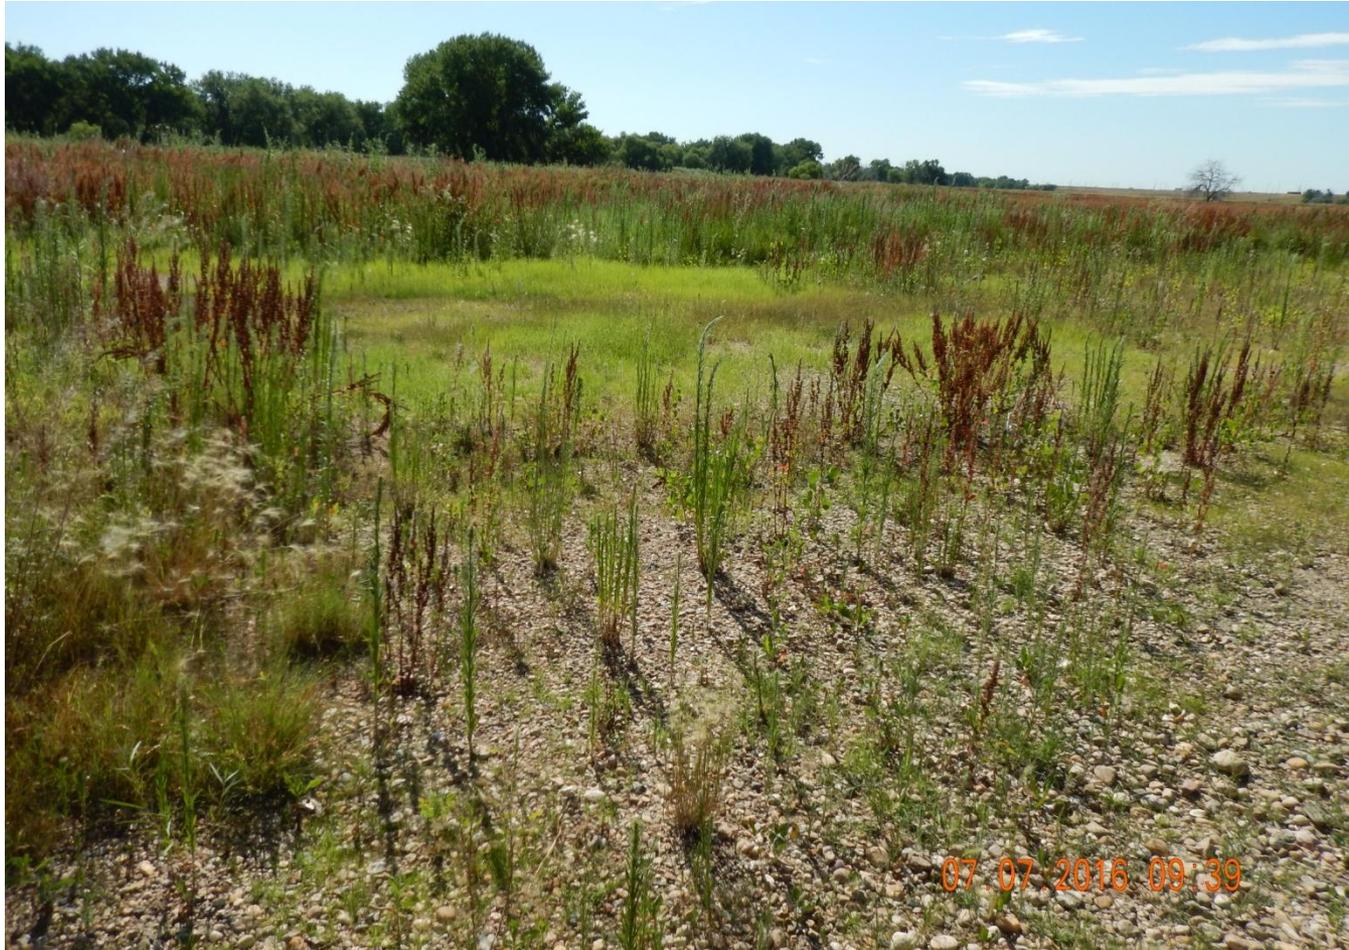
Photo 5. Photo taken from west of tank battery location, facing East. Need to reclaim location per Rule 1004 (i.e., remove gravel first before seeding location).

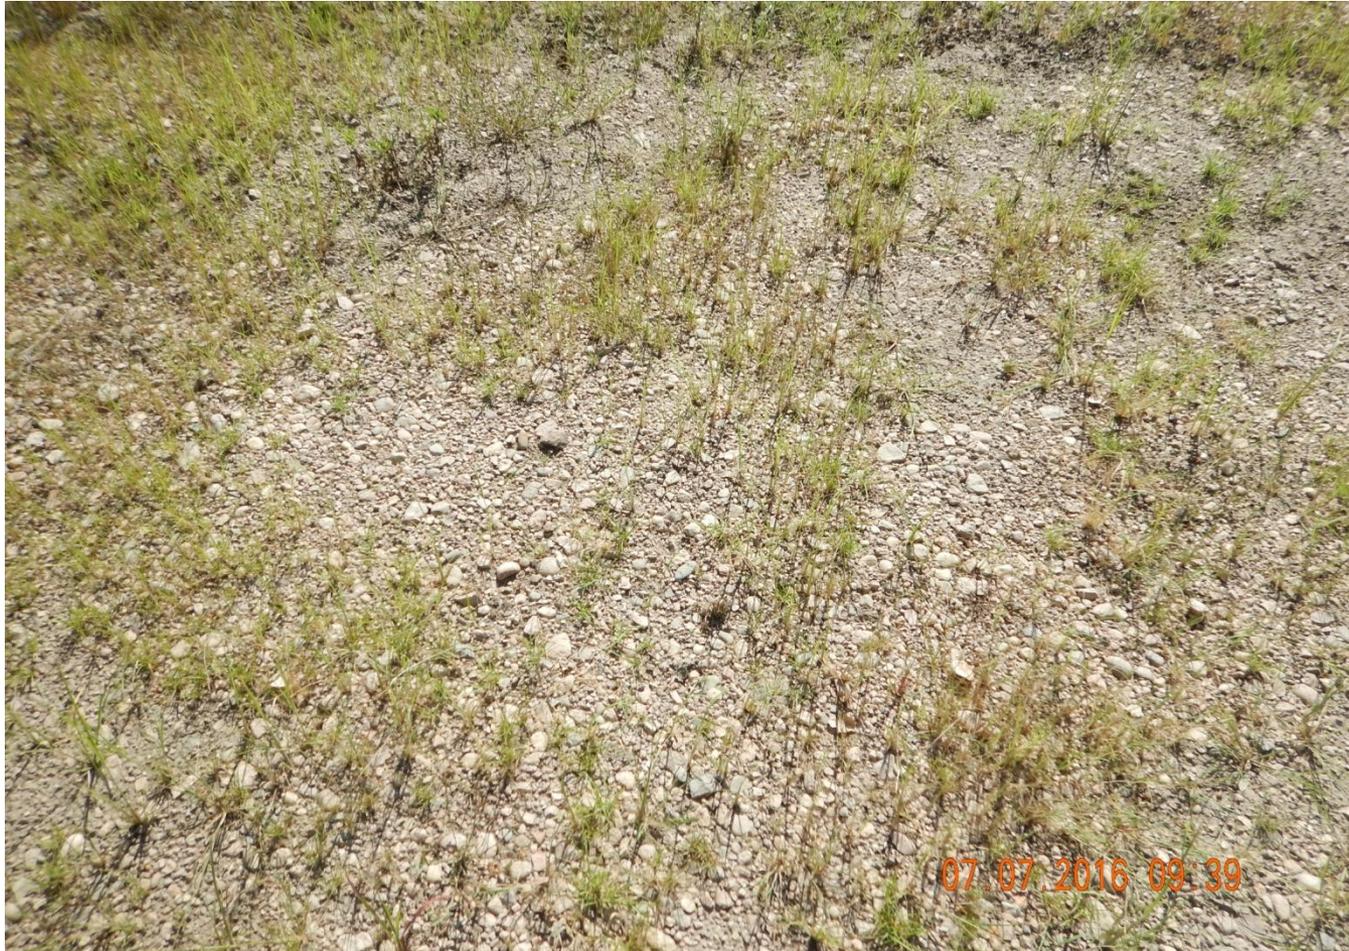
Photo 6. Close up photo taken from the tank battery location, illustrating that gravel has not been removed per Rule 1004.

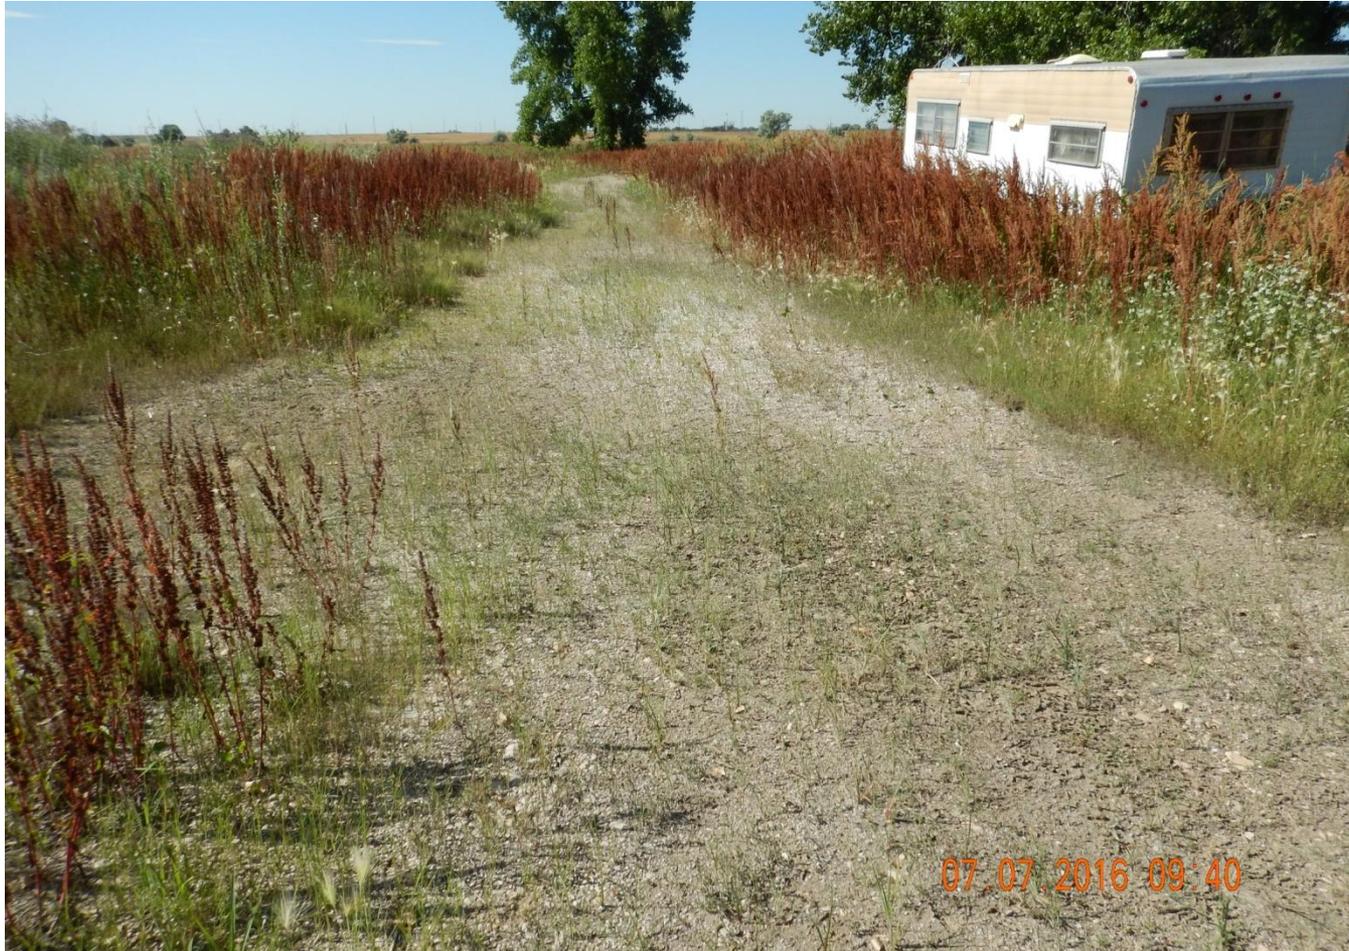
Photo 7. Photo taken from northern access road, north of tank battery location, facing South. Need to reclaim access road per Rule 1004.

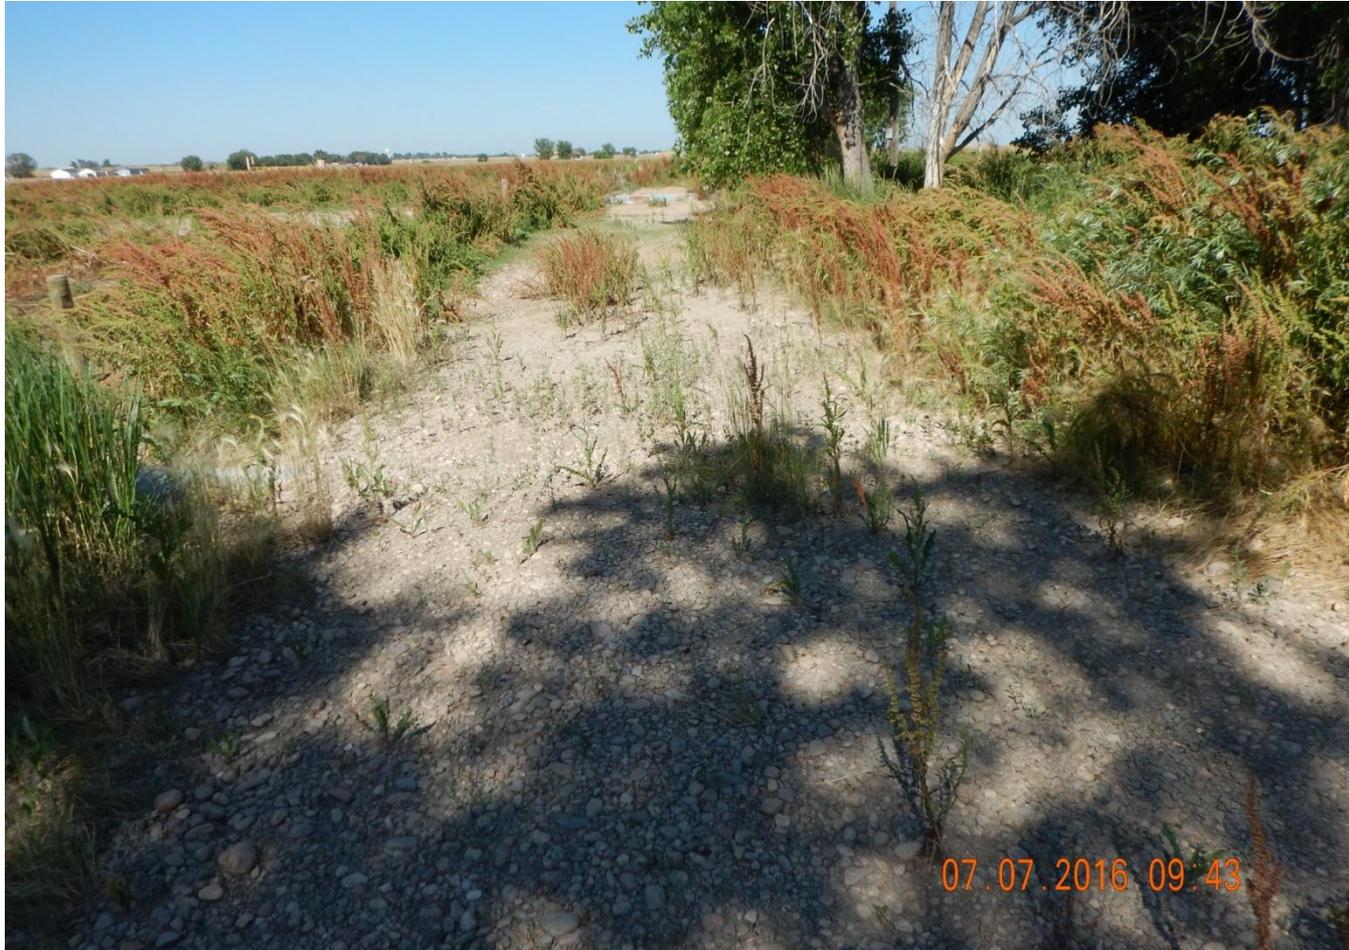
Photo 8. Photo taken from southeast access road, facing West. Need to reclaim access road per Rule 1004.

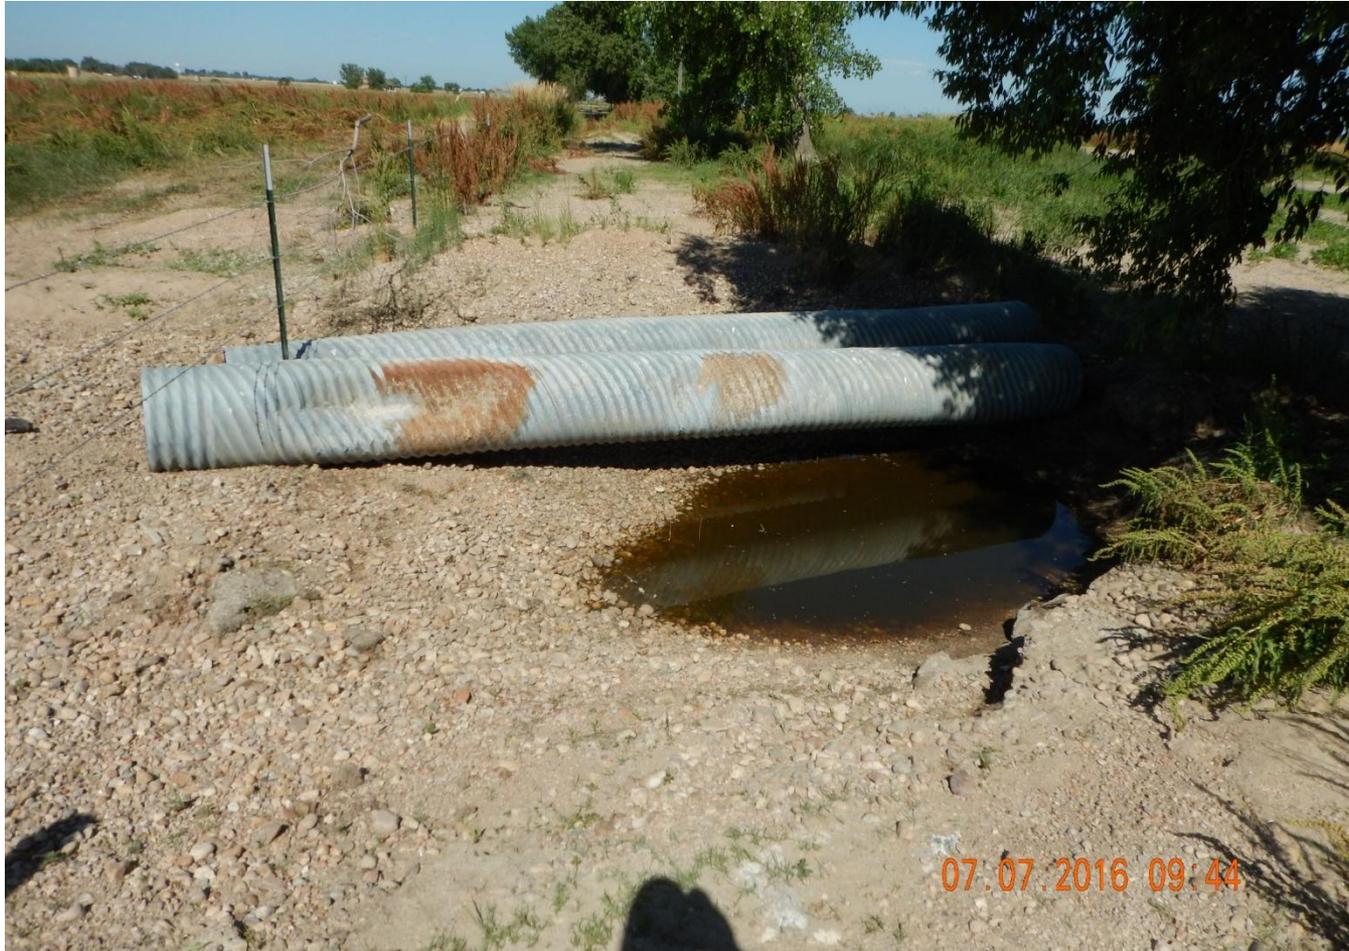
Photo 9. Photo taken along access road, facing West. Need to remove debris (i.e., culverts).

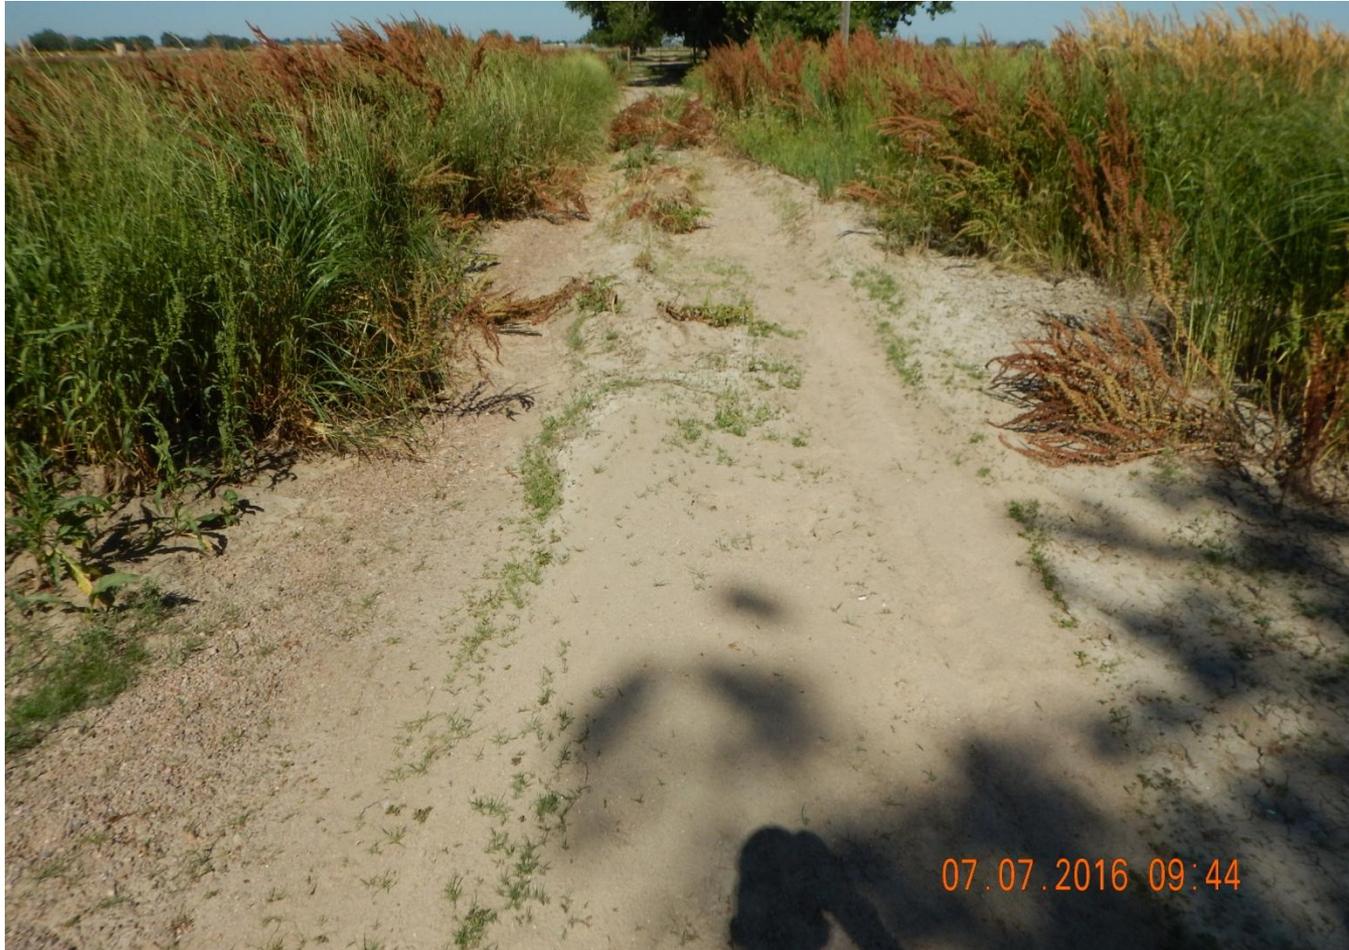
Photo 10. Photo taken from western access road, facing West. Need to reclaim access road per Rule 1004.

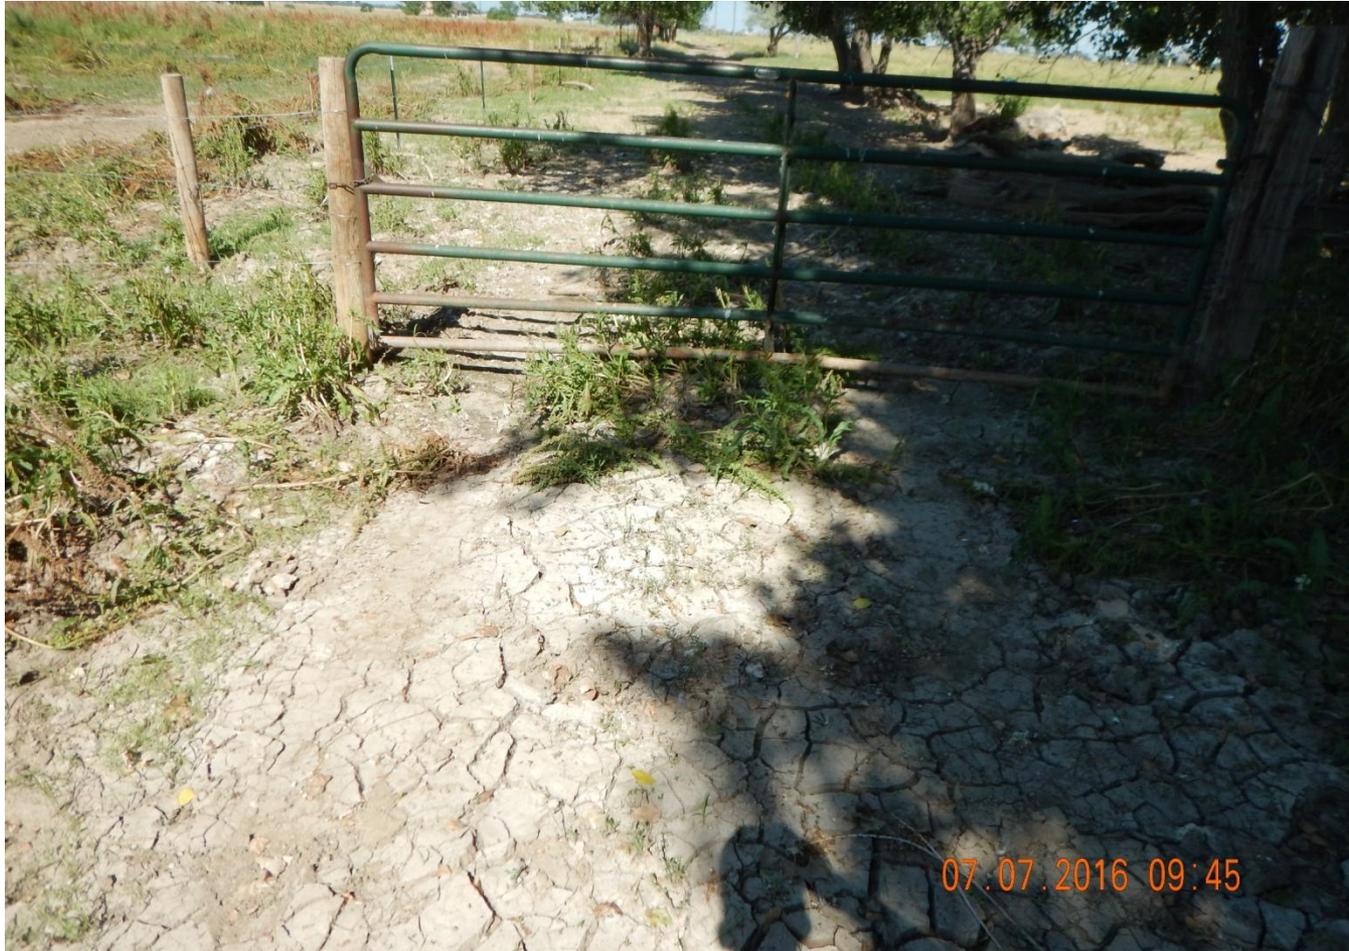
Photo 11. Photo taken from what appears to be location entrance. Need to remove gate and fencing material per Rule 1004.
