Interim Reclamation Inspection

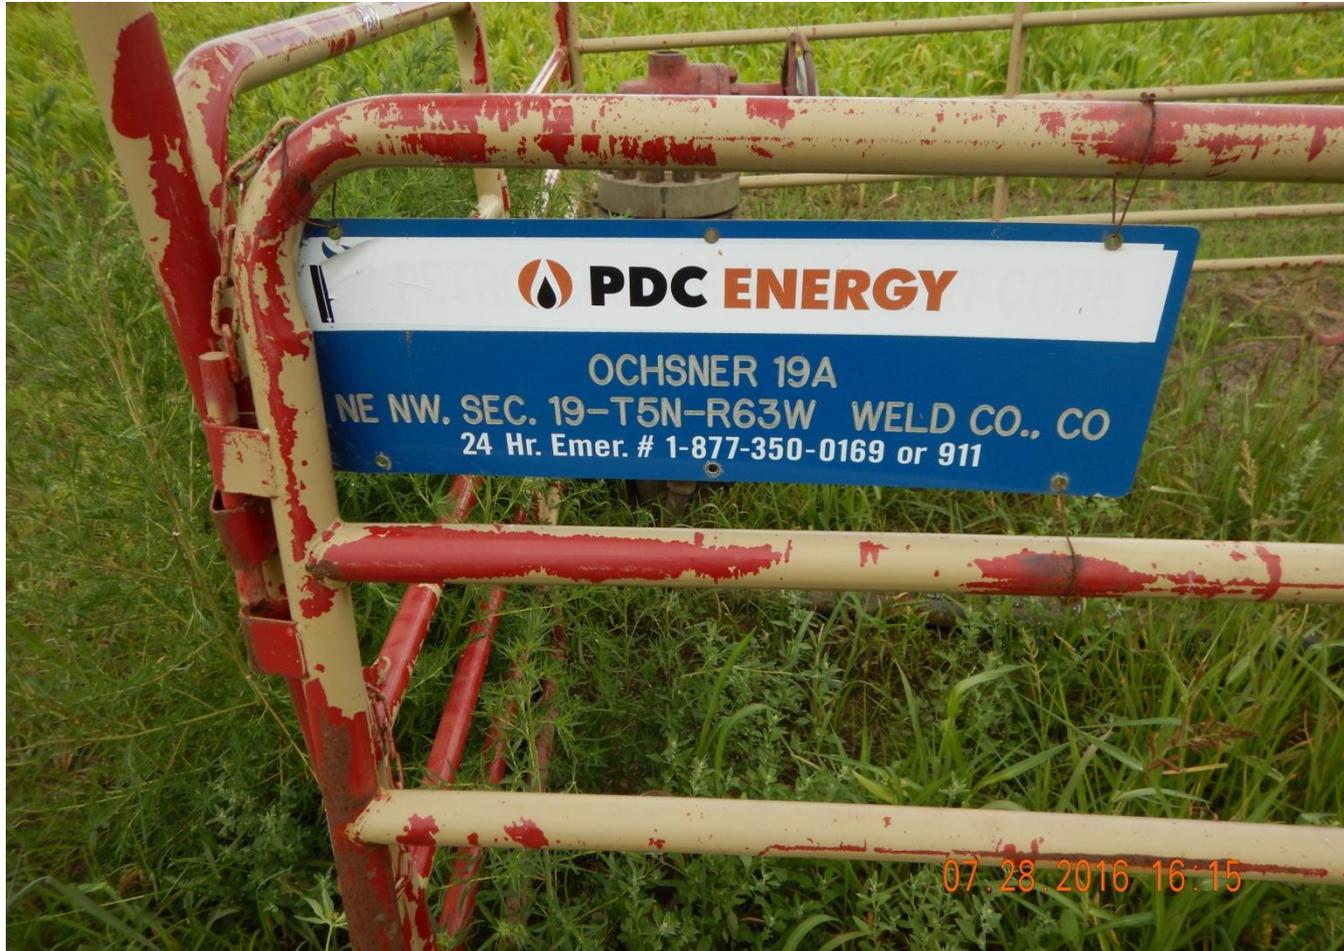
Photo 1. Photo taken of PR well sign for API #123-31153.

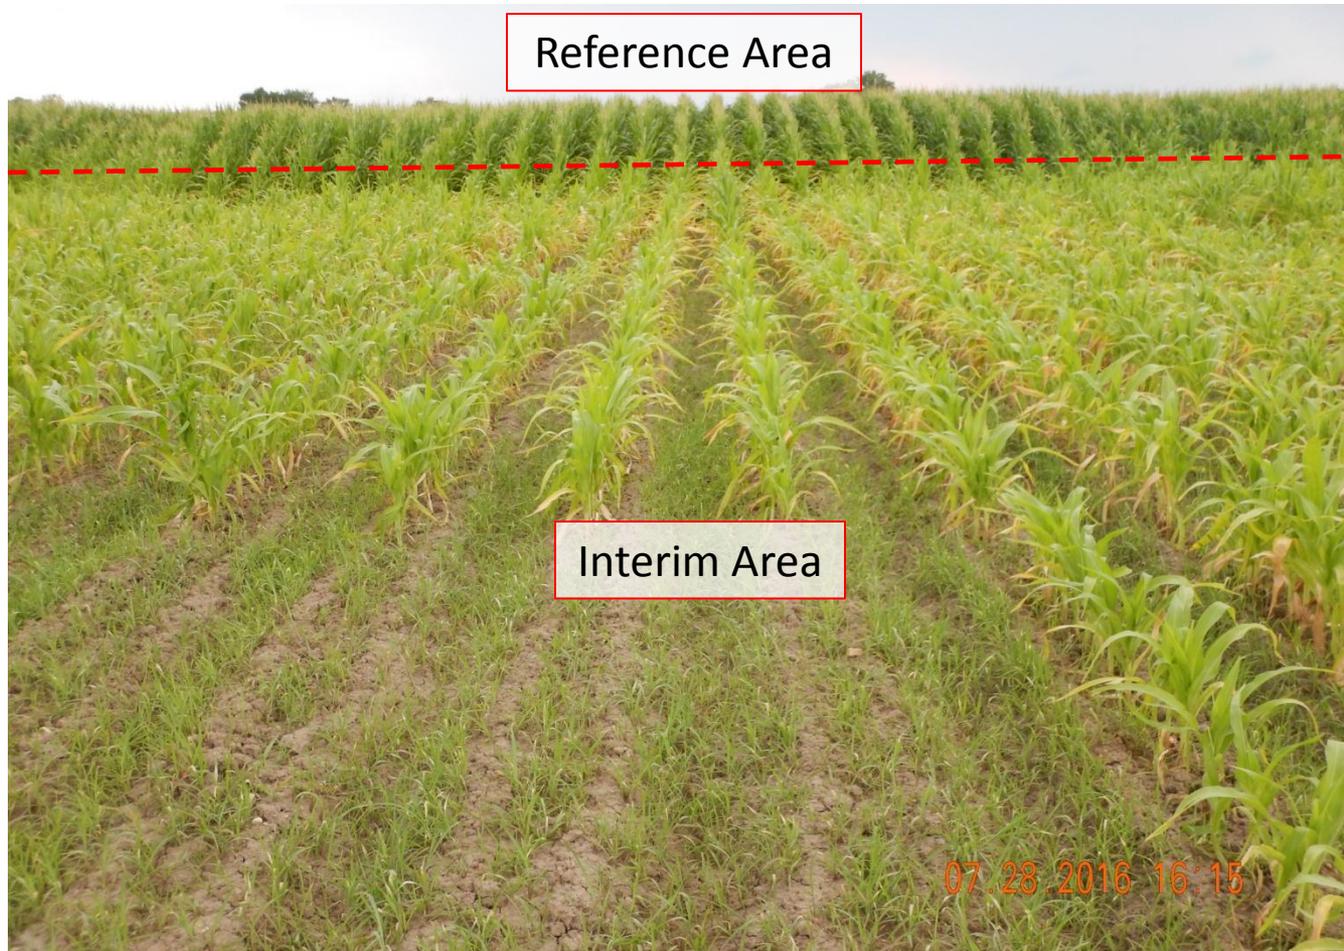
Photo 2. Photo taken from well location, facing West. Crop growth is stunted and crop density is diminished or not growing which is not reflective of reference areas. Crop height in interim areas averaged 24" versus 84" in reference areas.

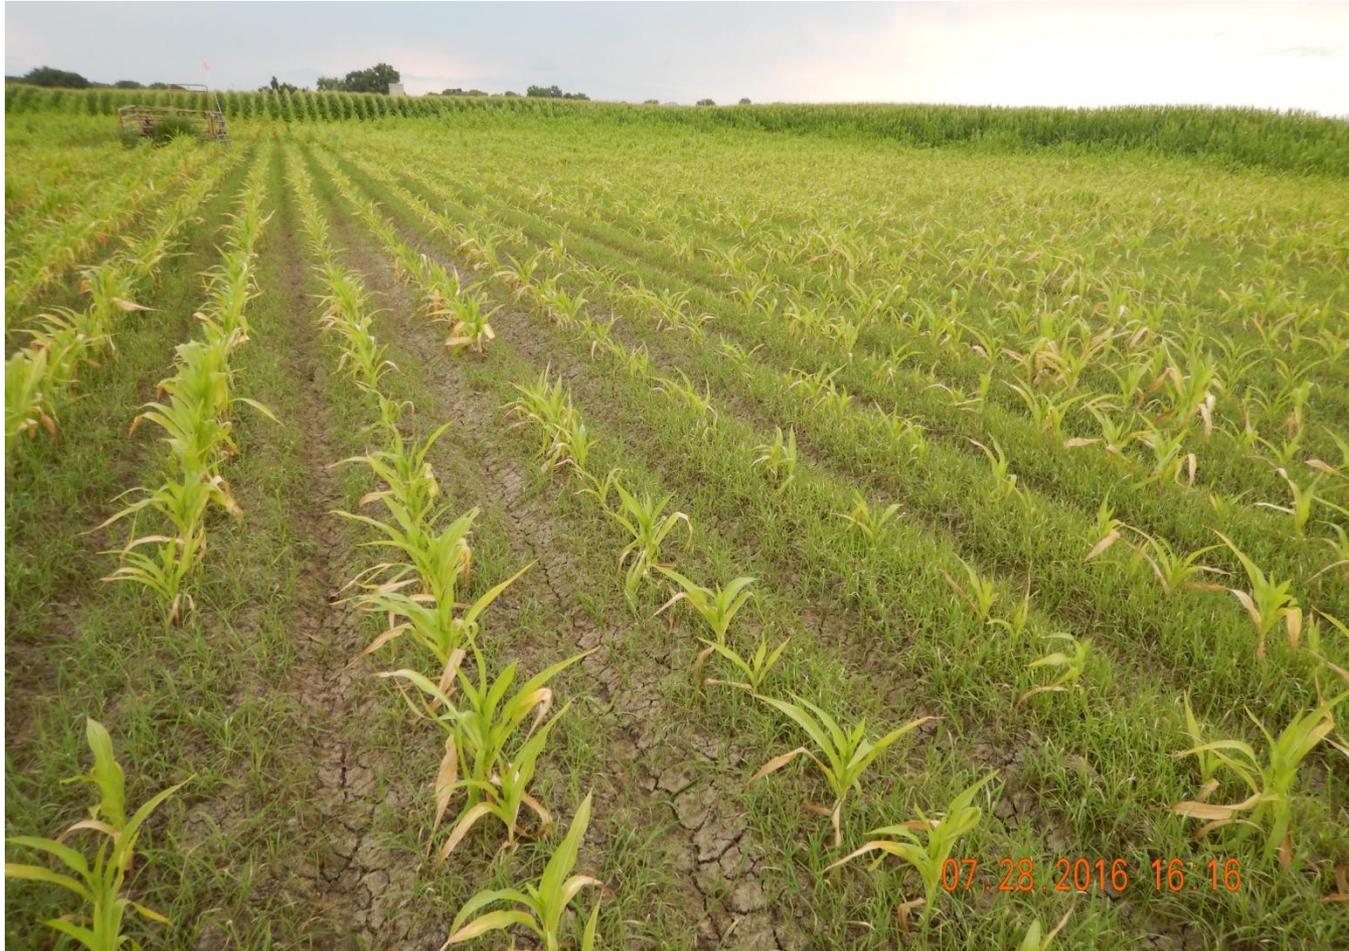
Photo 3. Photo taken from eastern location, facing West, illustrating discrepancy between reference and interim areas. Interim area density and height not representative of reference area.

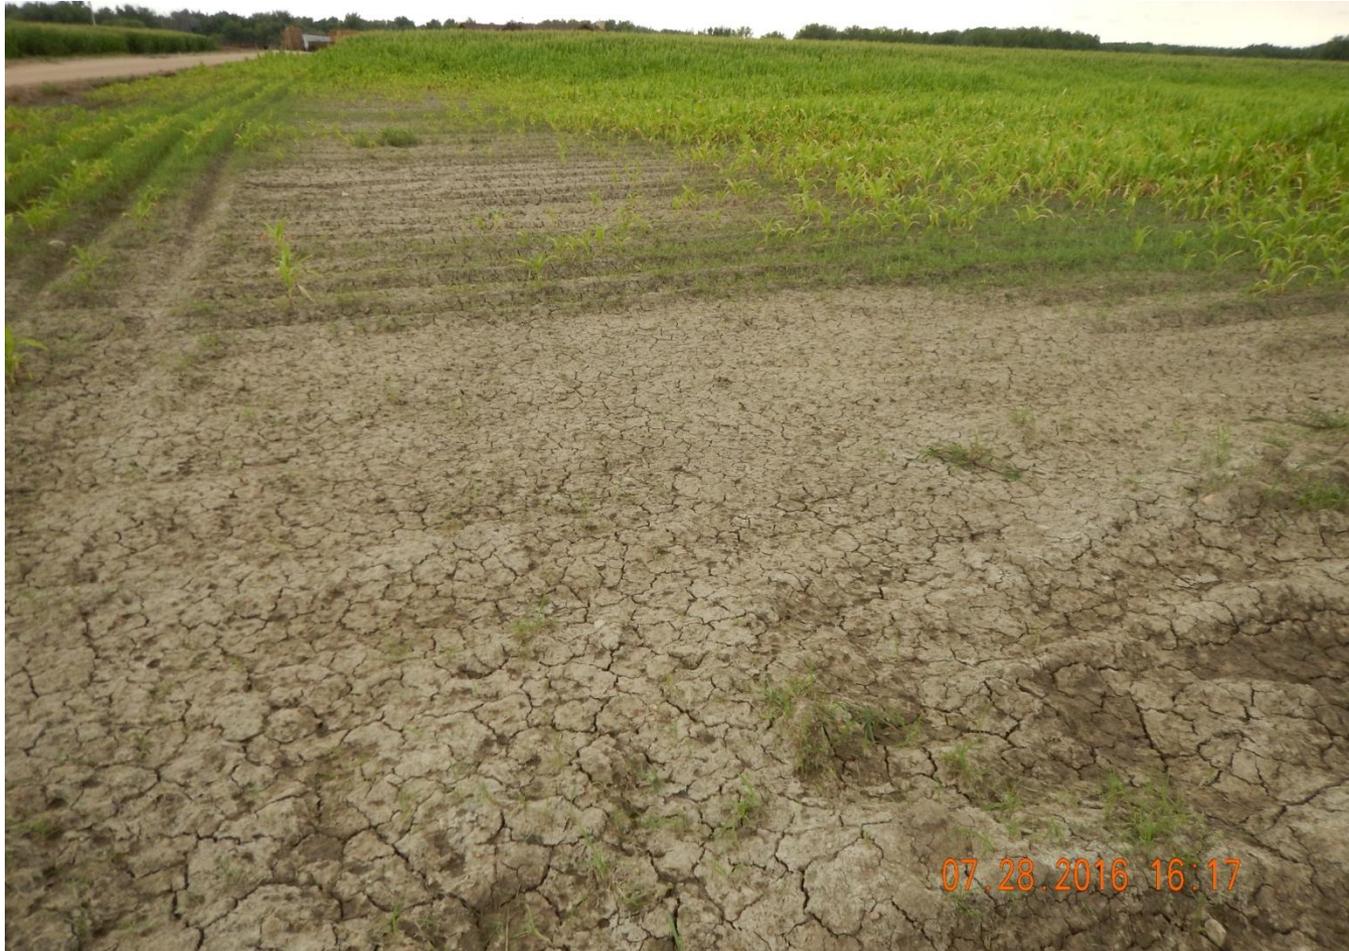
Photo 4. Photo taken from eastern location, facing South, illustrating areas with no crop growth.

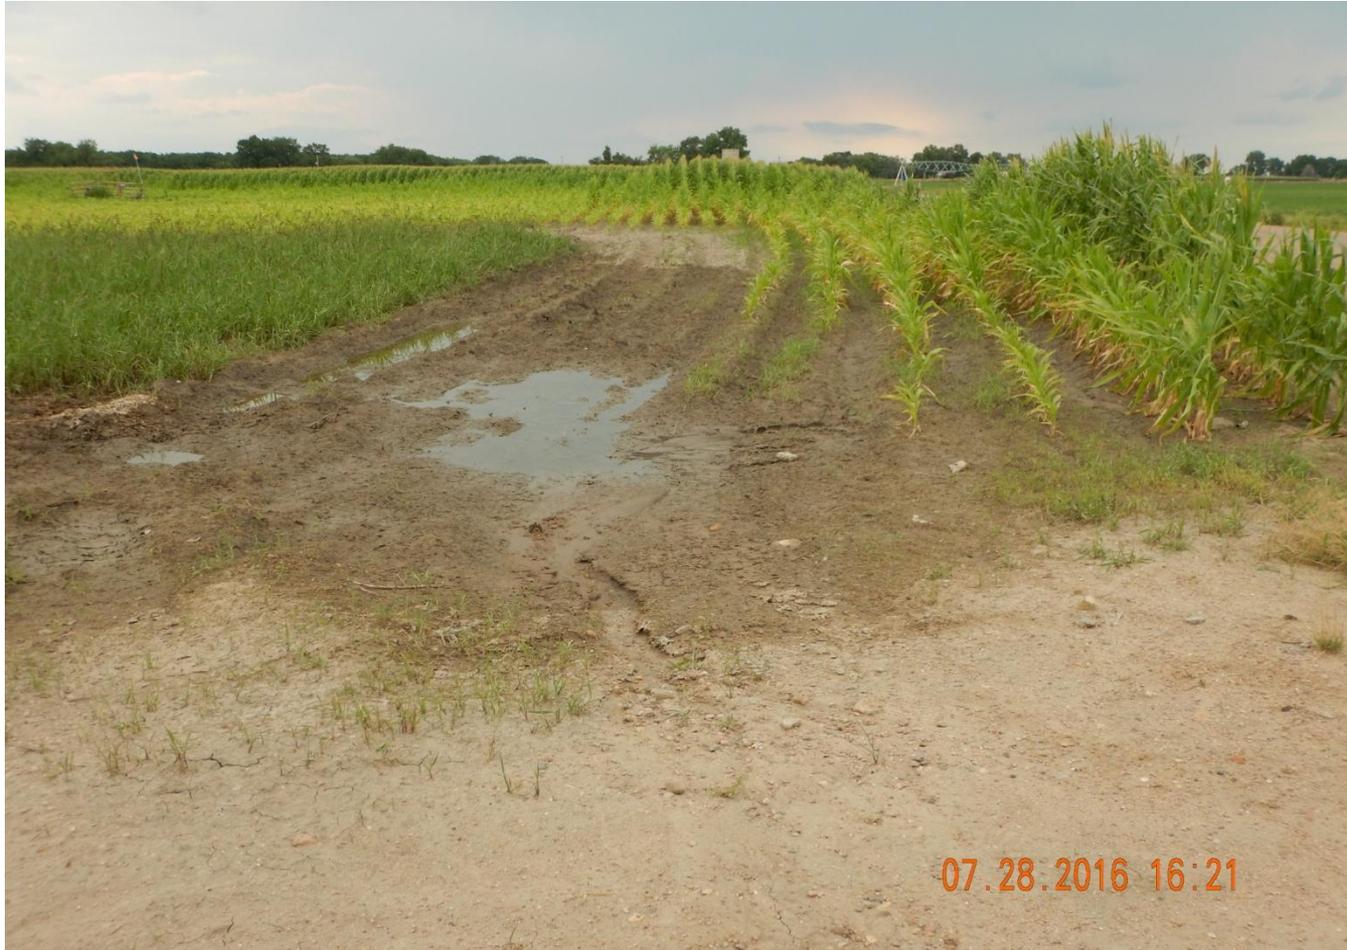
Photo 5. Photo taken from northeast location, facing West, illustrating areas with no crop growth and/or stunted crop growth.
