Final Reclamation Inspection

06/28/2016

Operator: Petro-Canada

Location ID: 376781

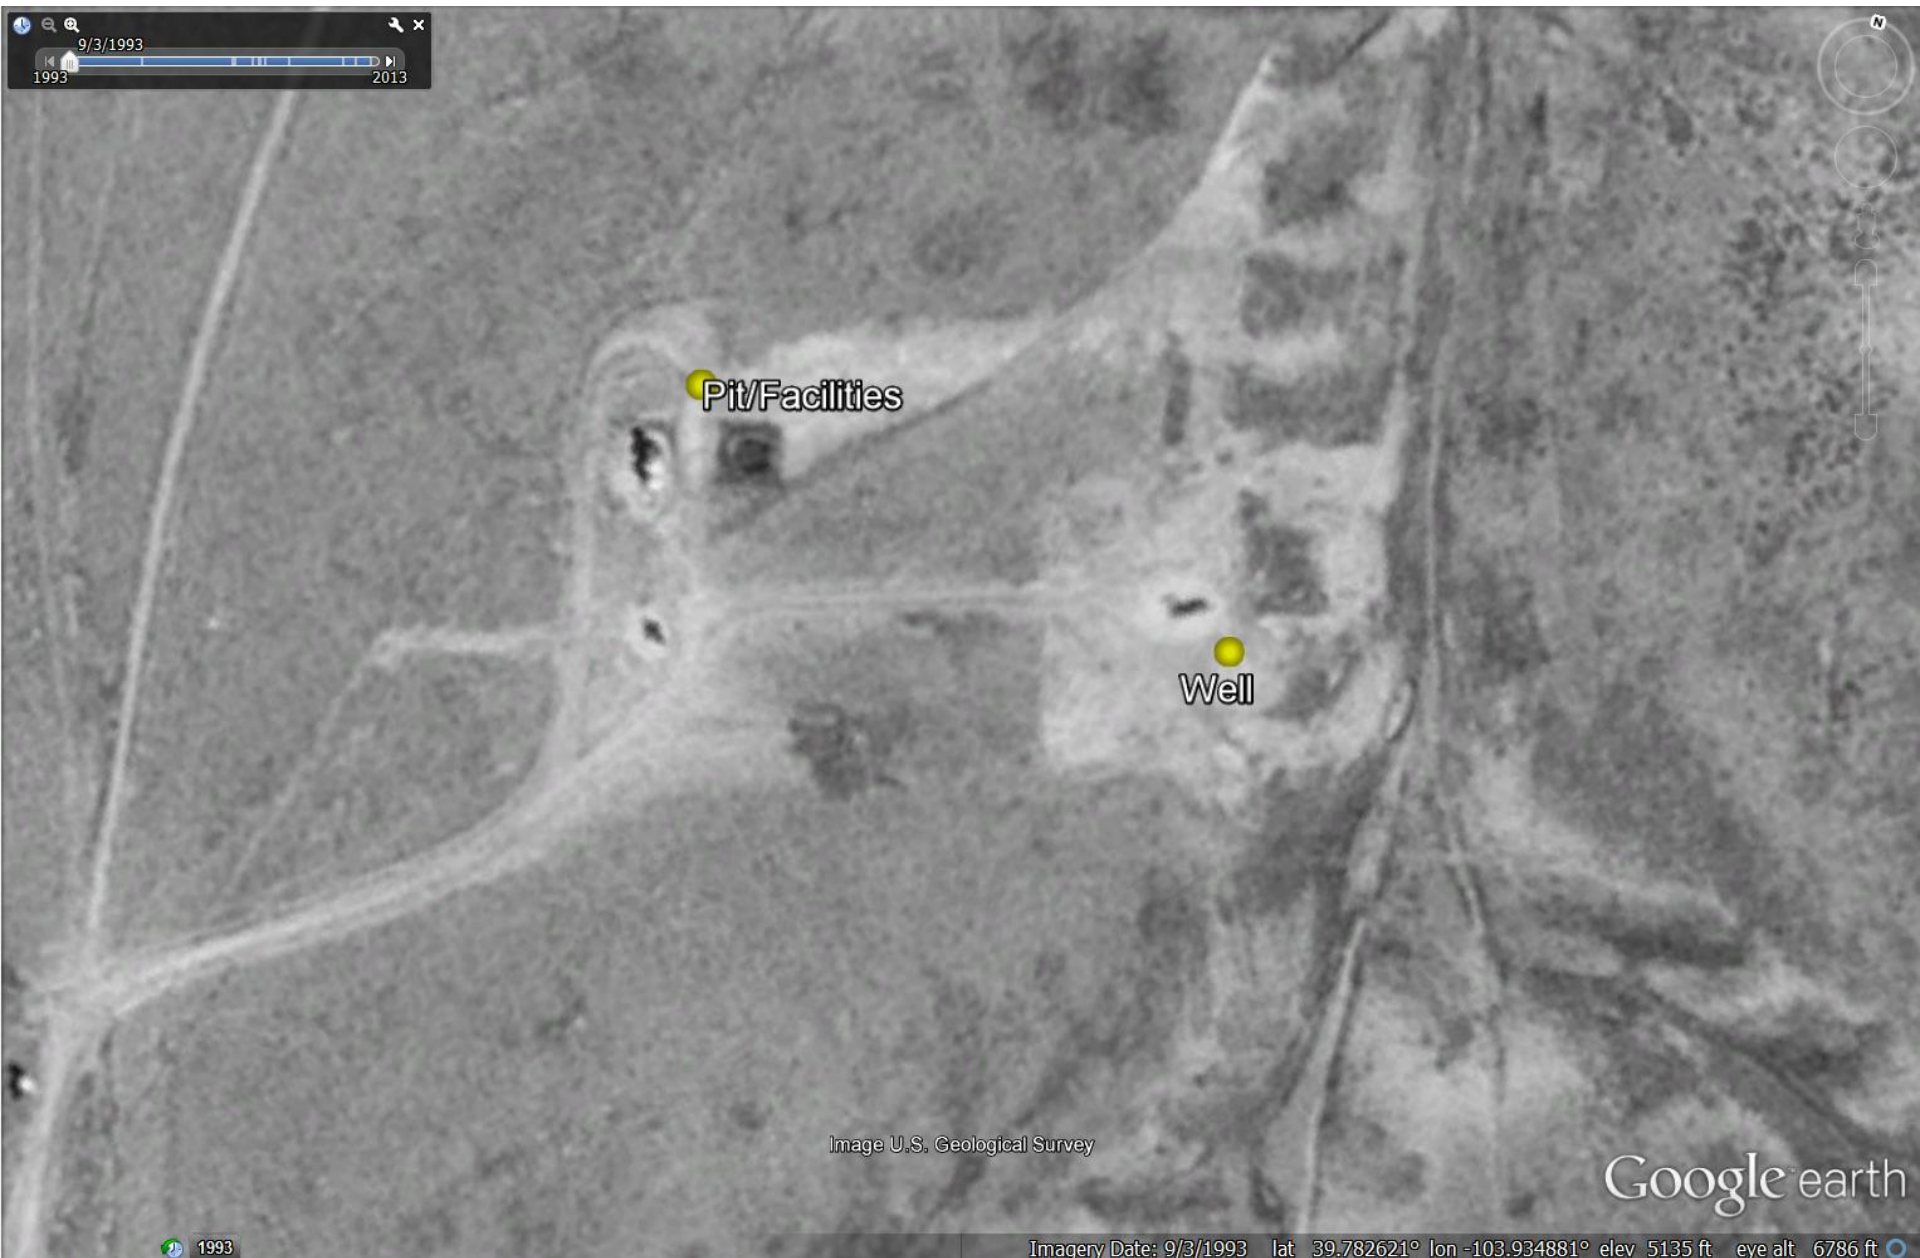
Figure 1: 1933 Aerial imagery showing location of Pit, facilities and well.

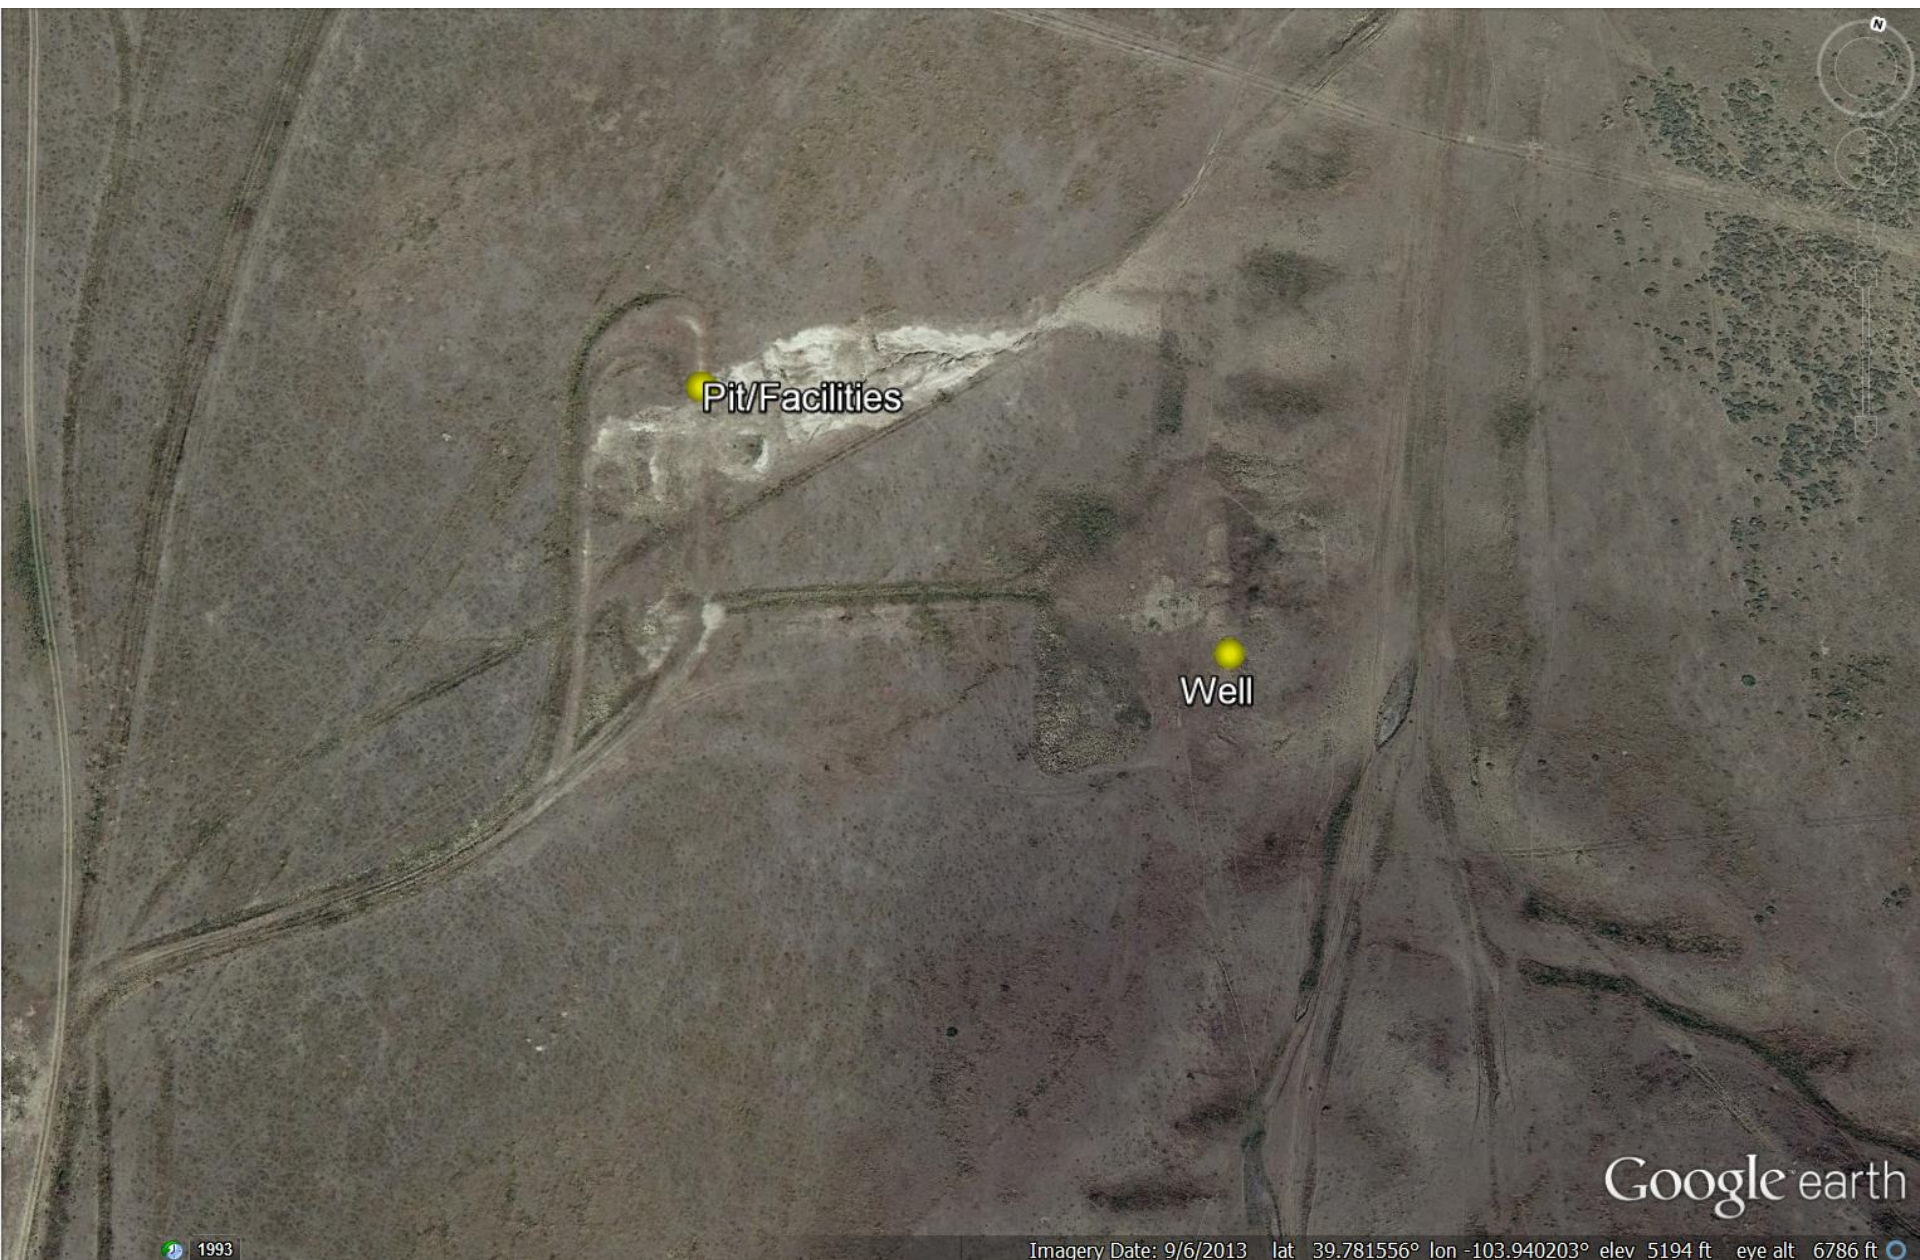
Figure 2: 9/6/2013 aerial imagery of location. Note area of salt kill below (east) area of pit. Sundry doc 2172955 submitted in 2012 stated reclamation complete.

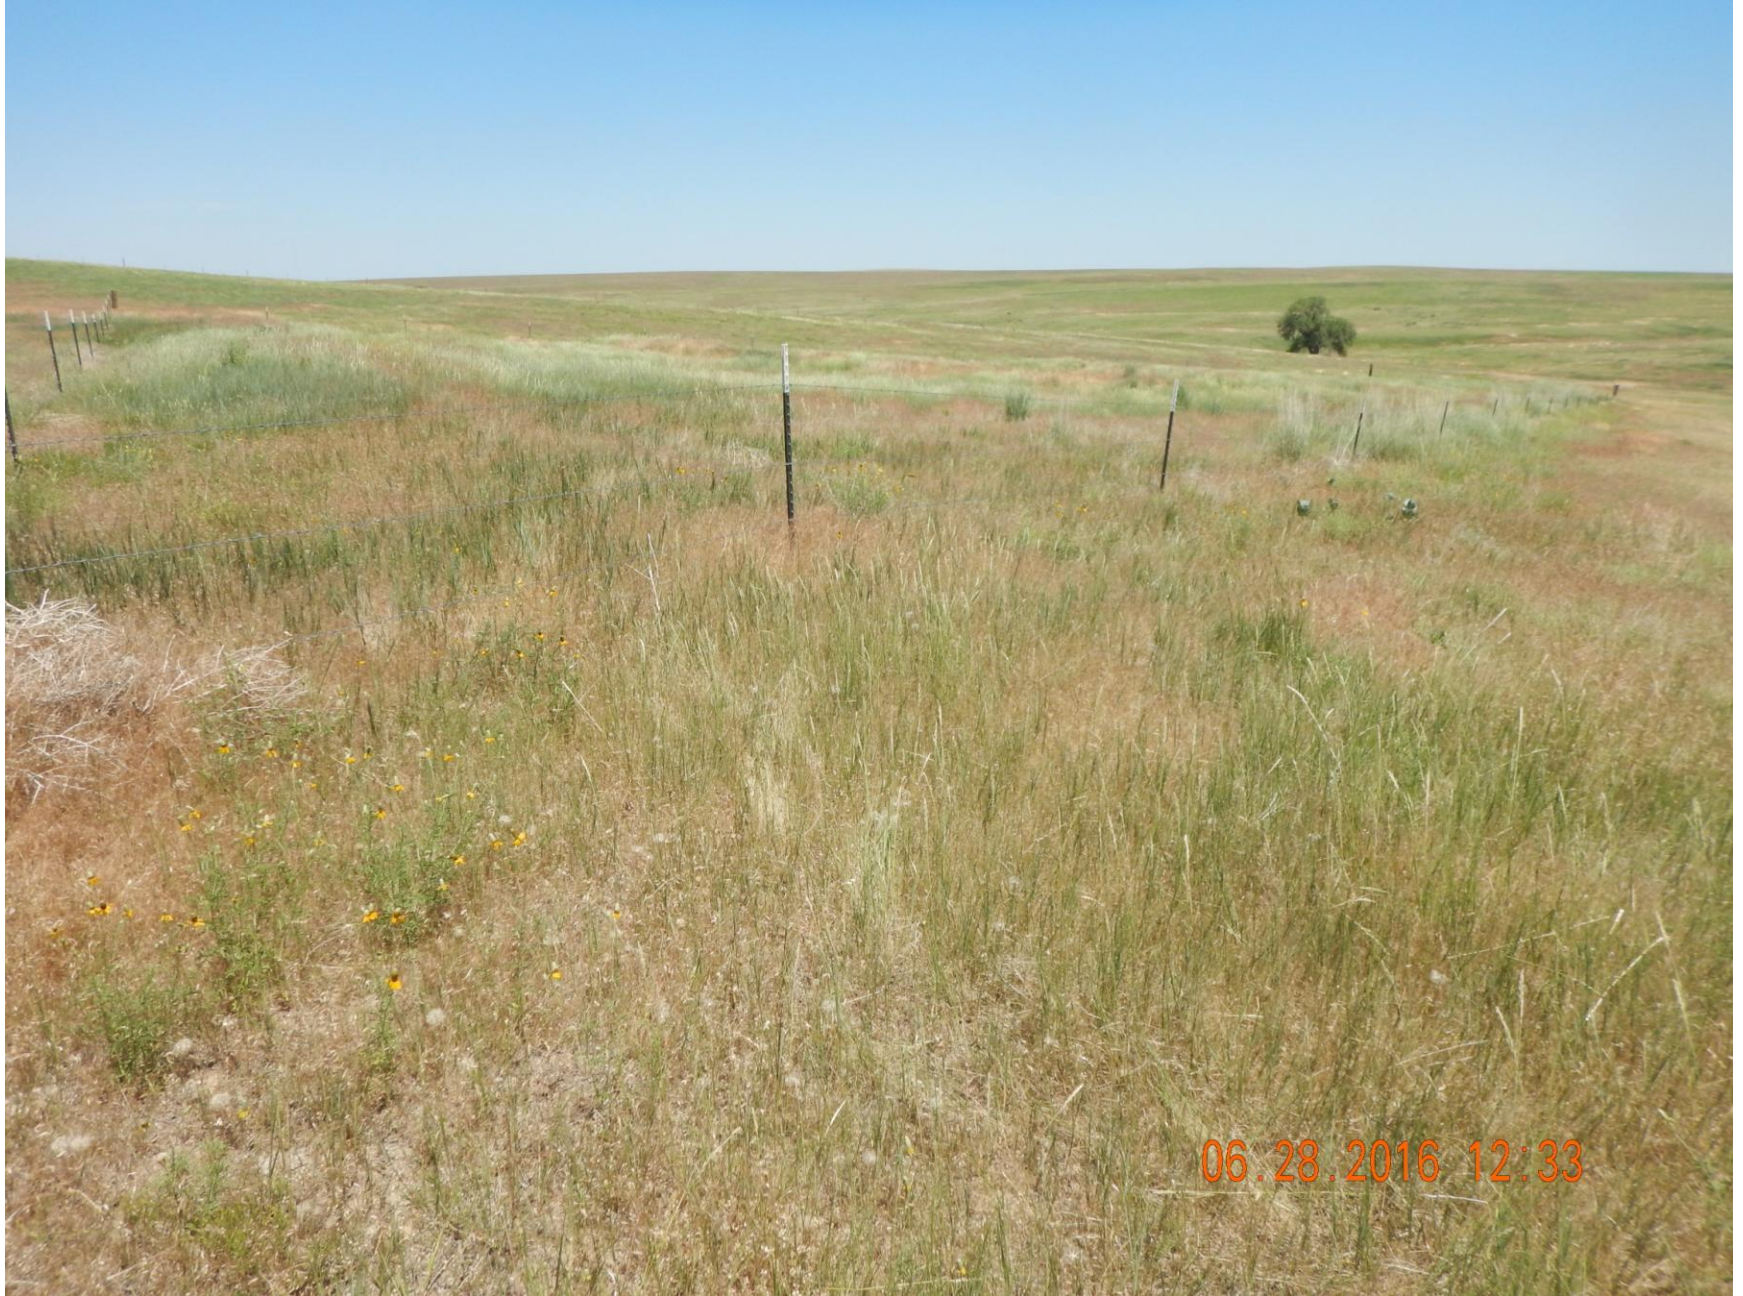
Figure 3: Photo taken from the east end of the pit area, facing northeast. Photo shows fenced off, salt kill area from figure 2.

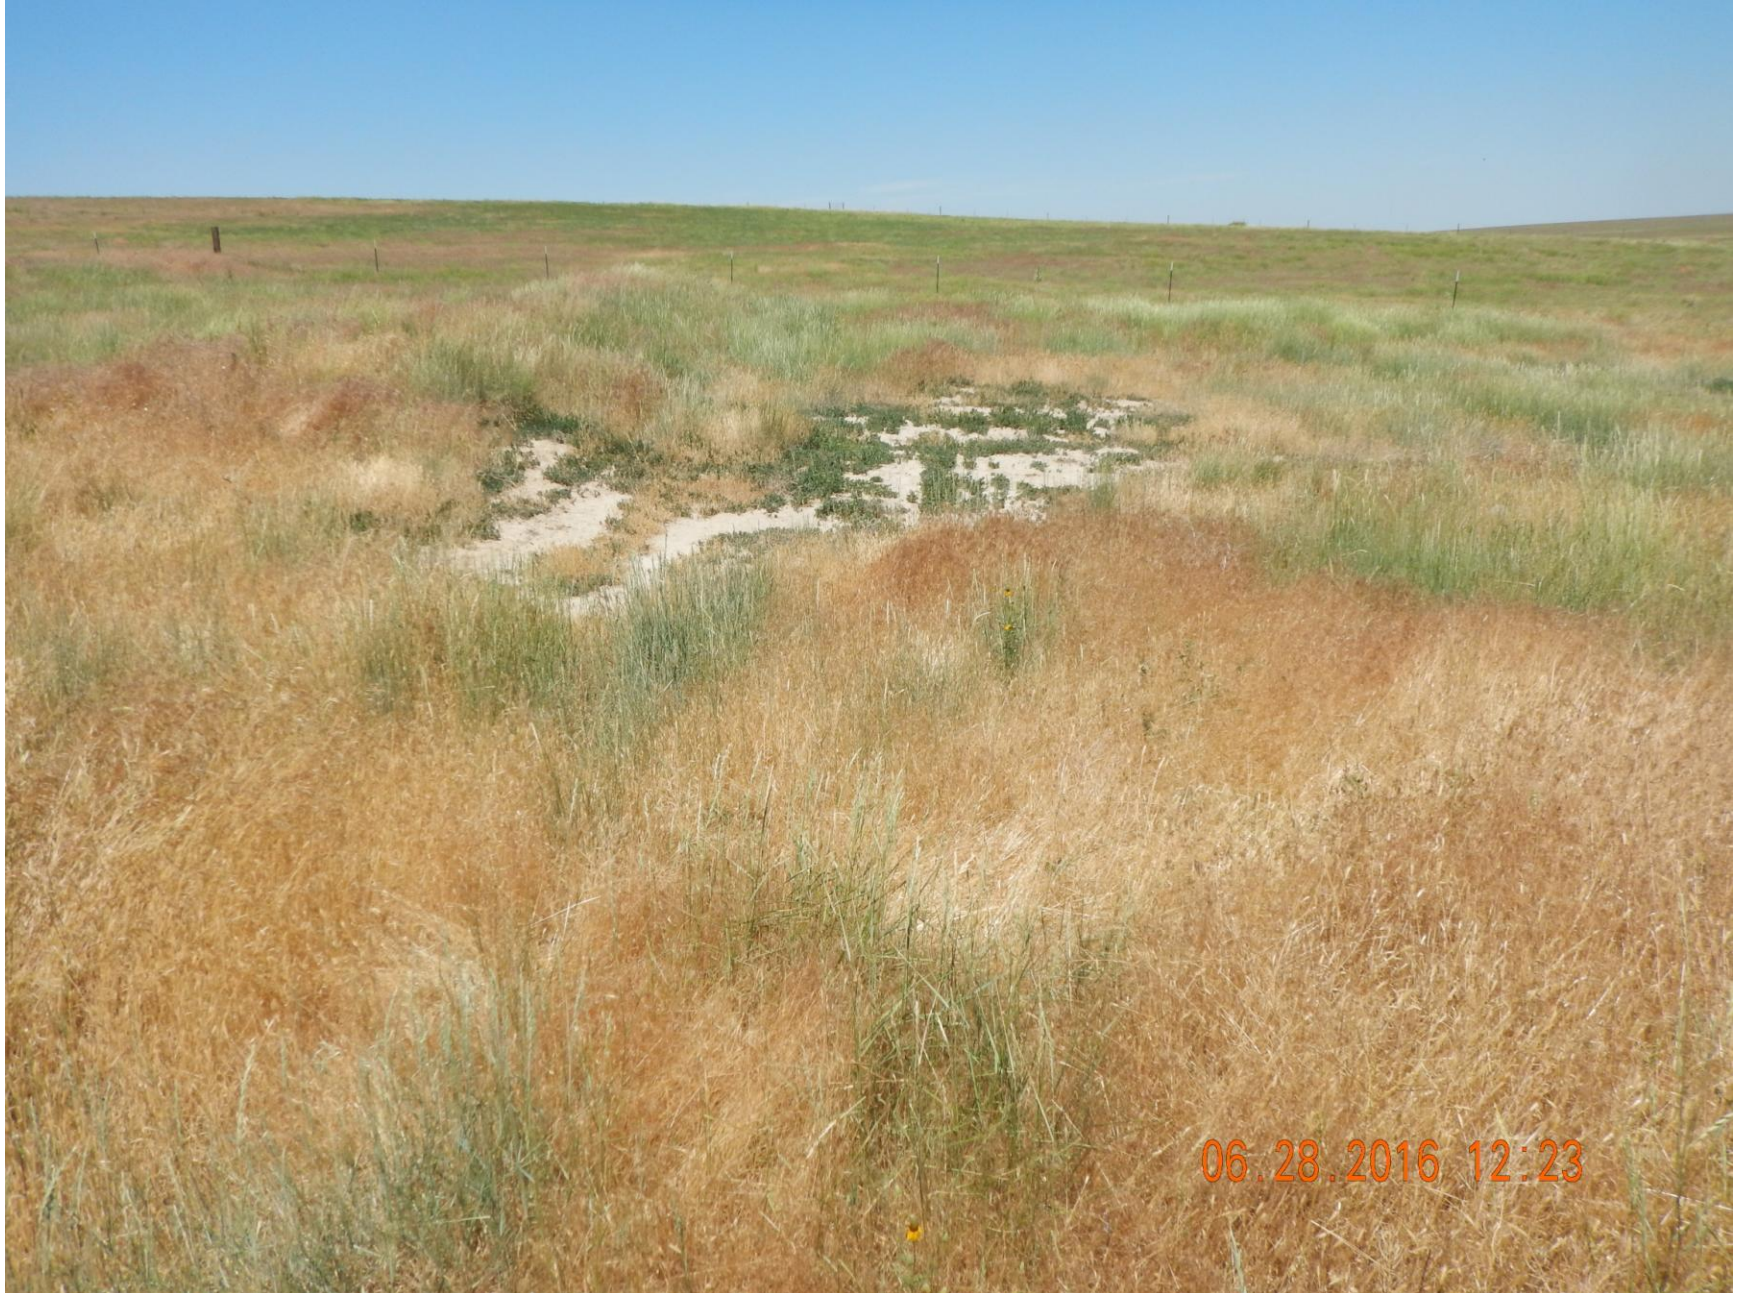
Figure 4: Photo taken from the fenced area on the north end of the location, facing north. Photo shows vegetation on location has not achieved uniform distribution. Possible salt kill remains.

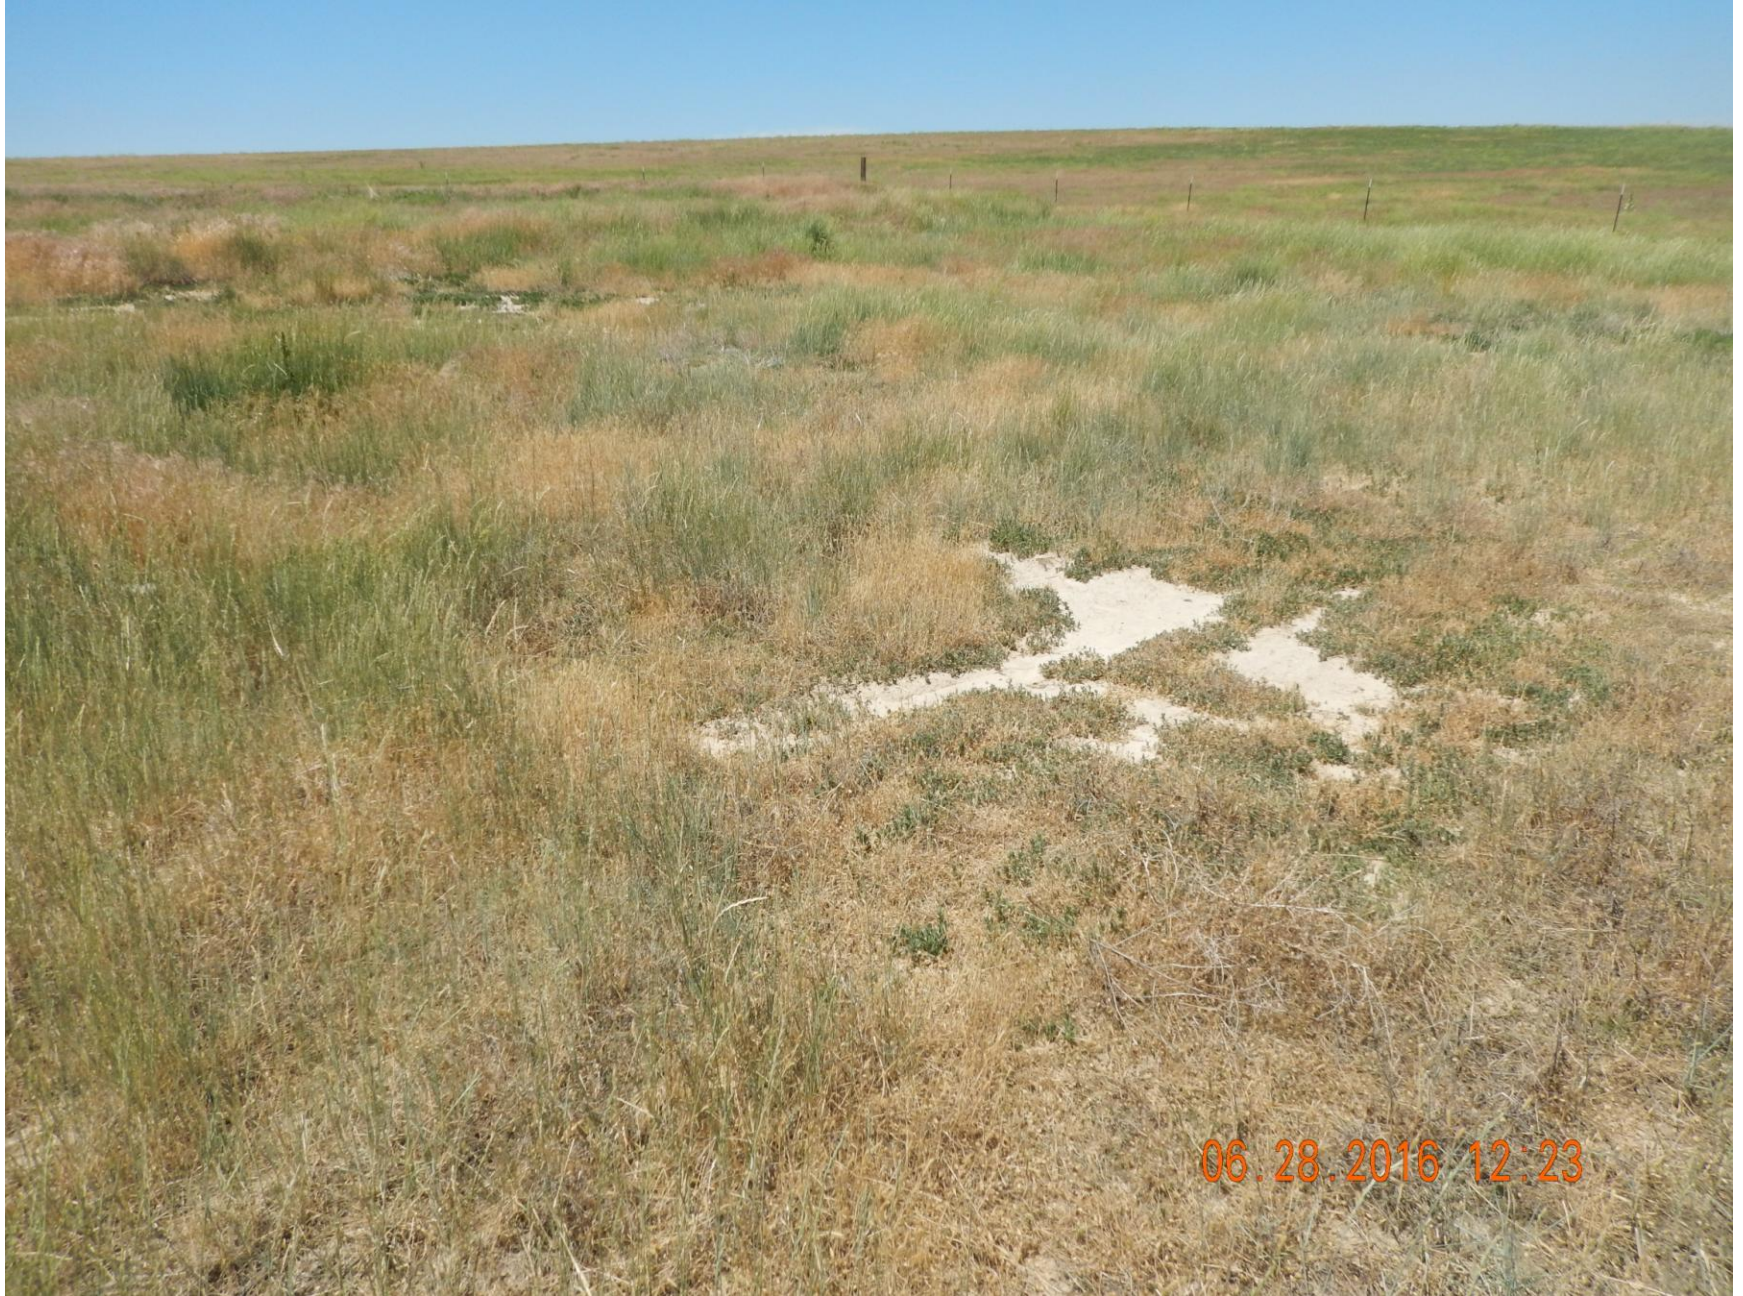
Figure 5: Photo taken from the fenced area on the north end of the location, facing north. Photo shows areas of possible salt kill still remaining within the fenced remediation area.

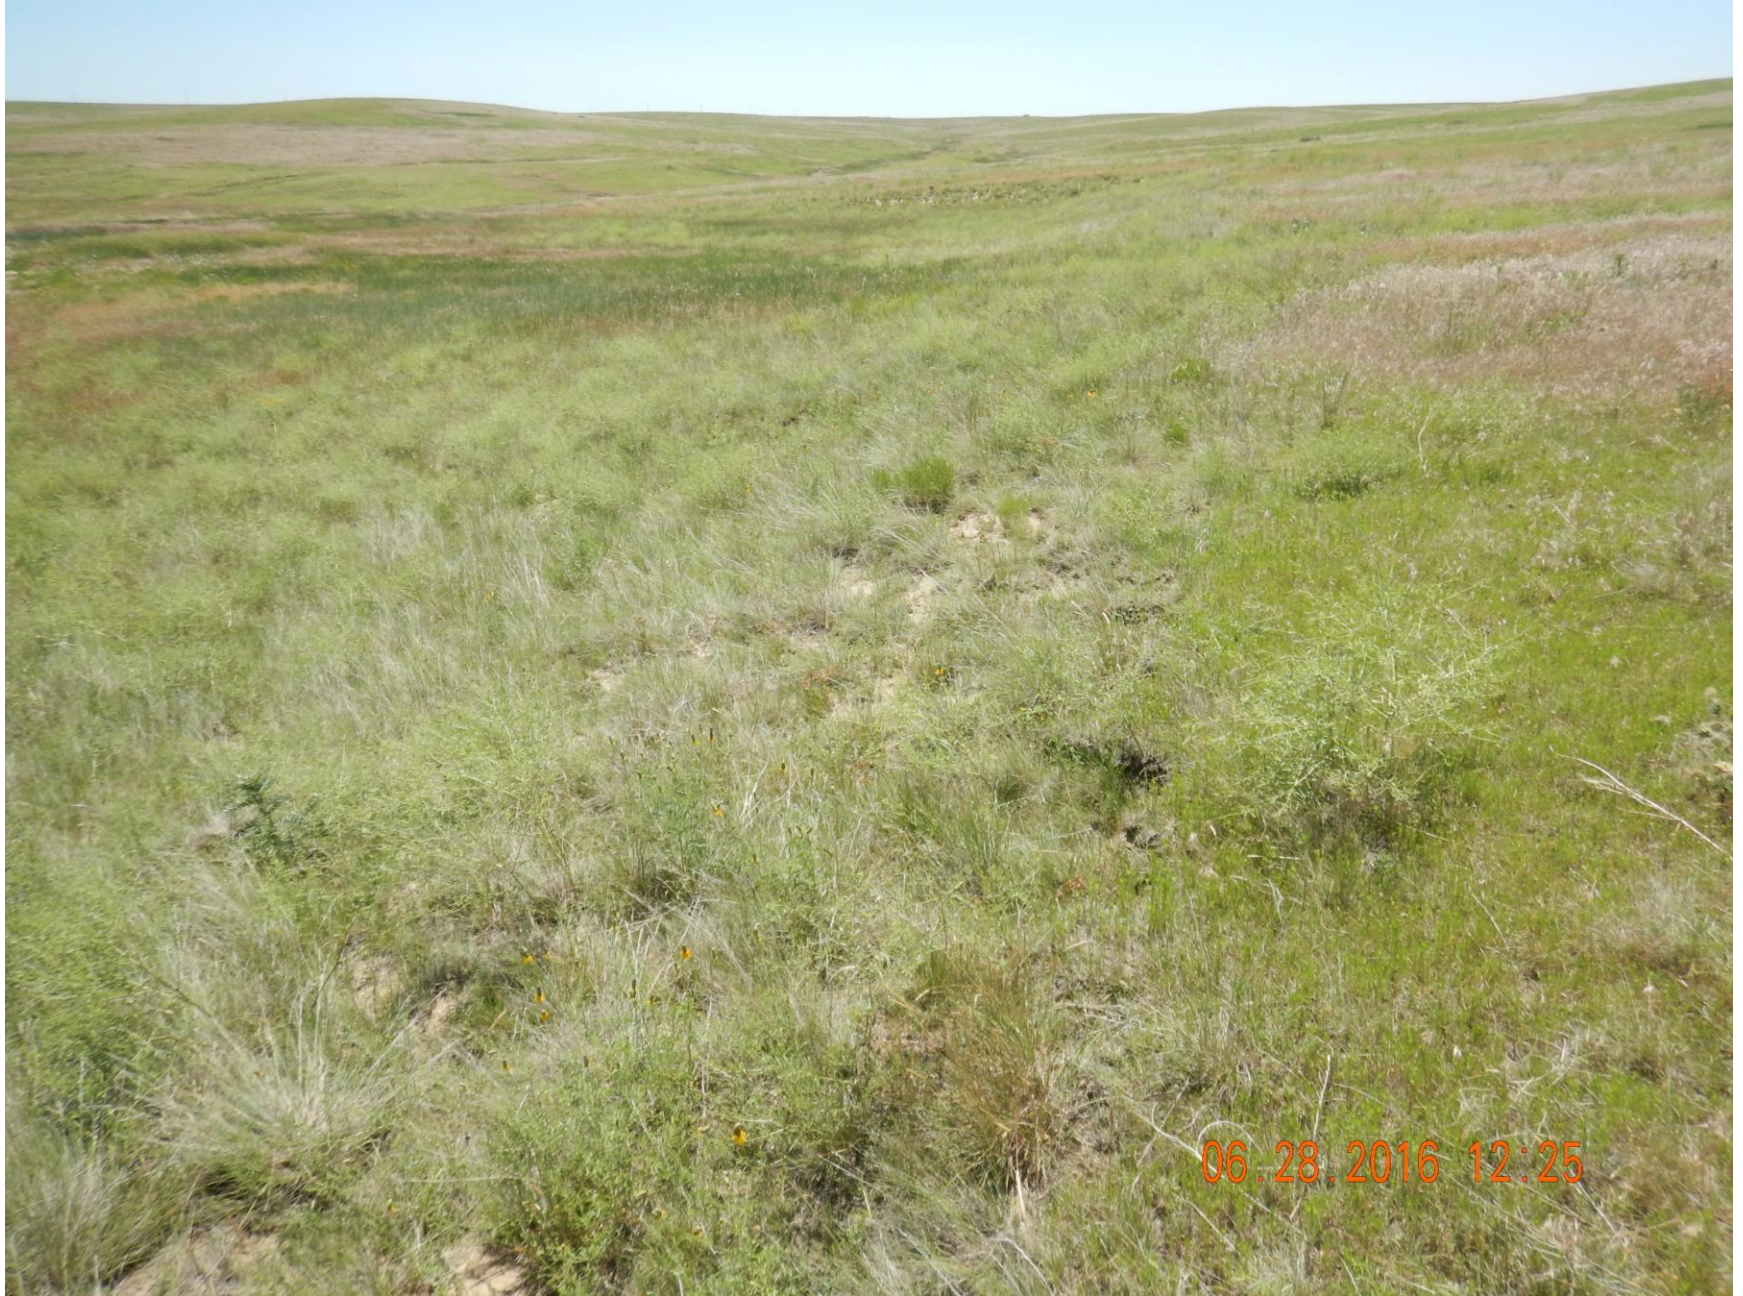
Figure 6: Photo taken from the northwest corner of the well location, facing south. Photo shows interim reclamation areas appear to be adequately vegetated.

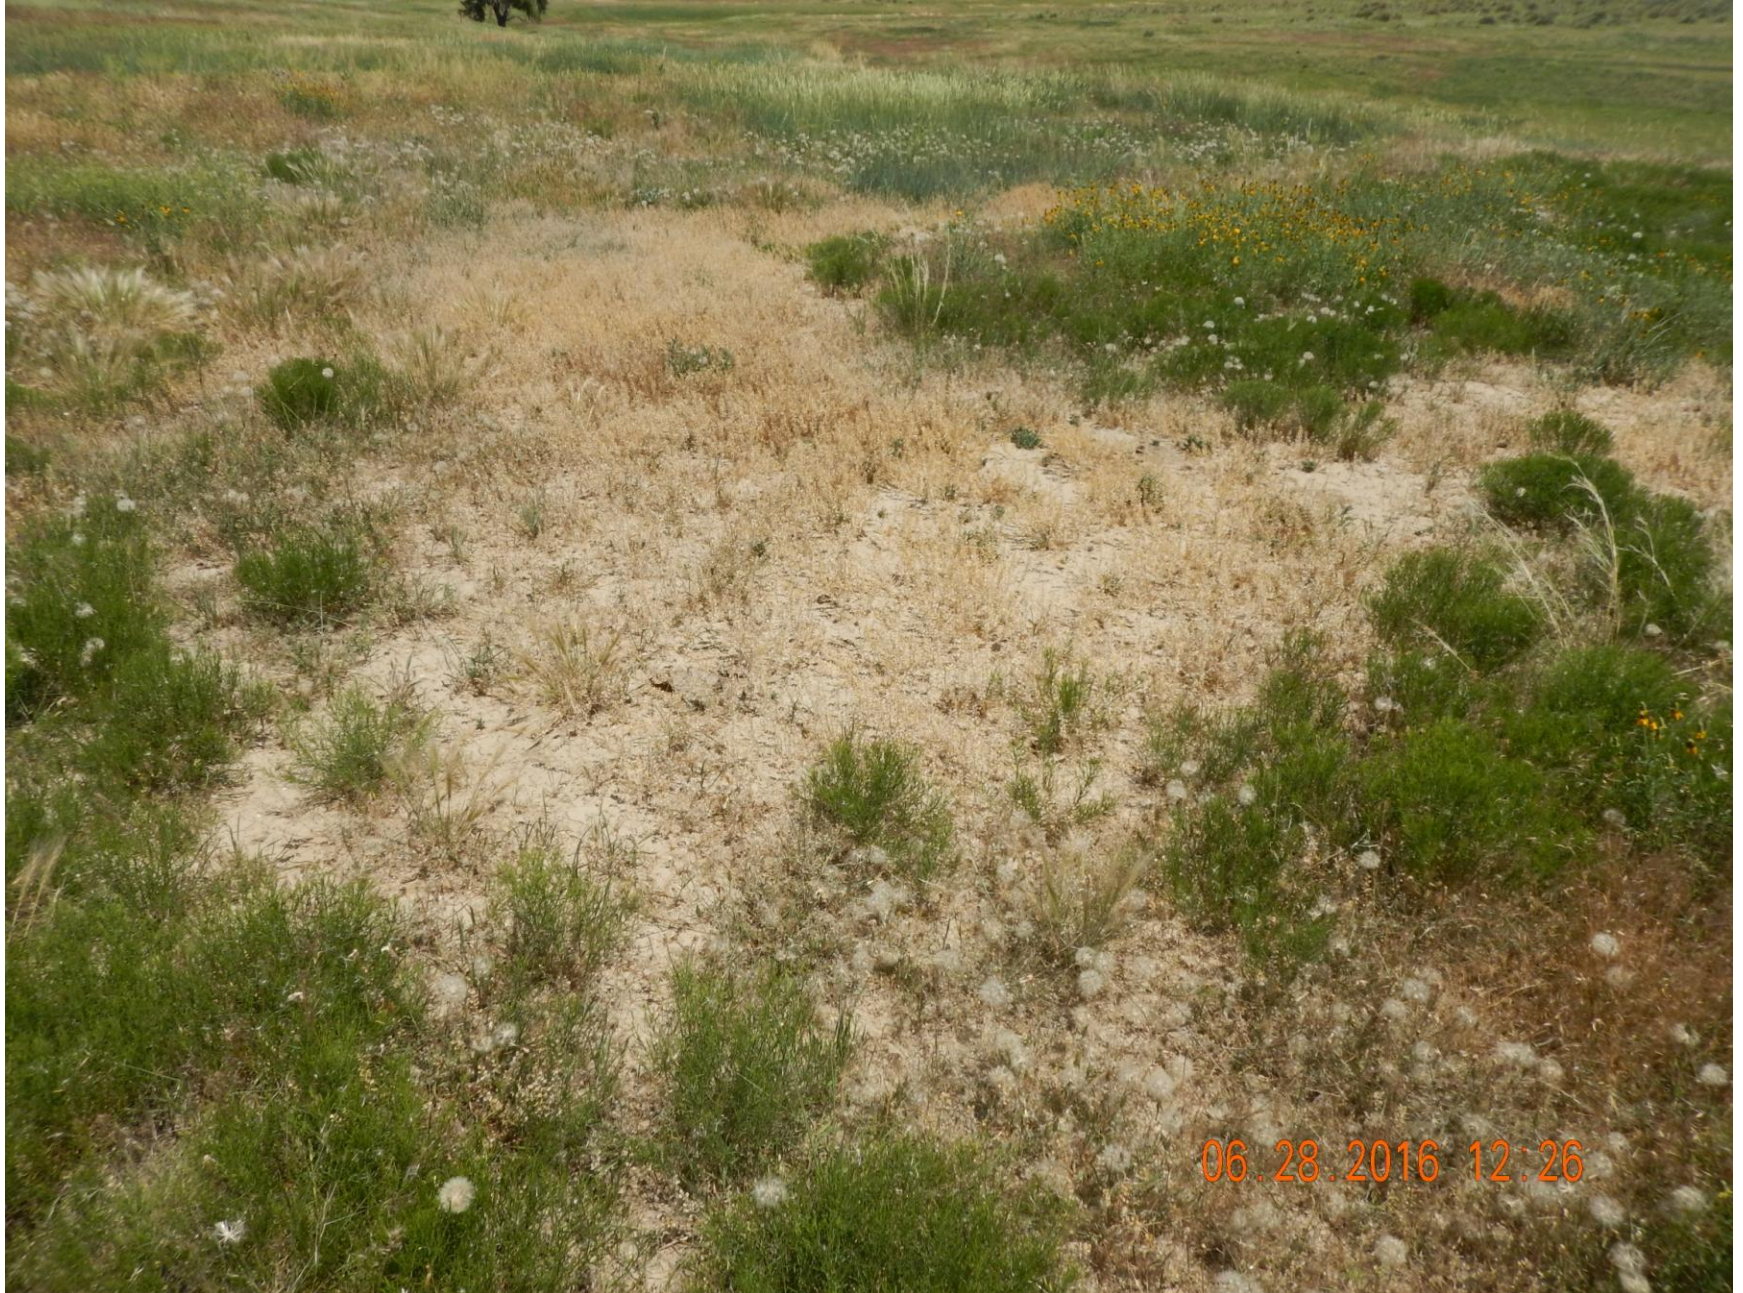
Figure 7: Photo taken from the site of the well, facing north. Photo shows the well location has not achieved uniform perennial vegetative cover. Plants seen are predominantly annual *Thlaspi arvense*

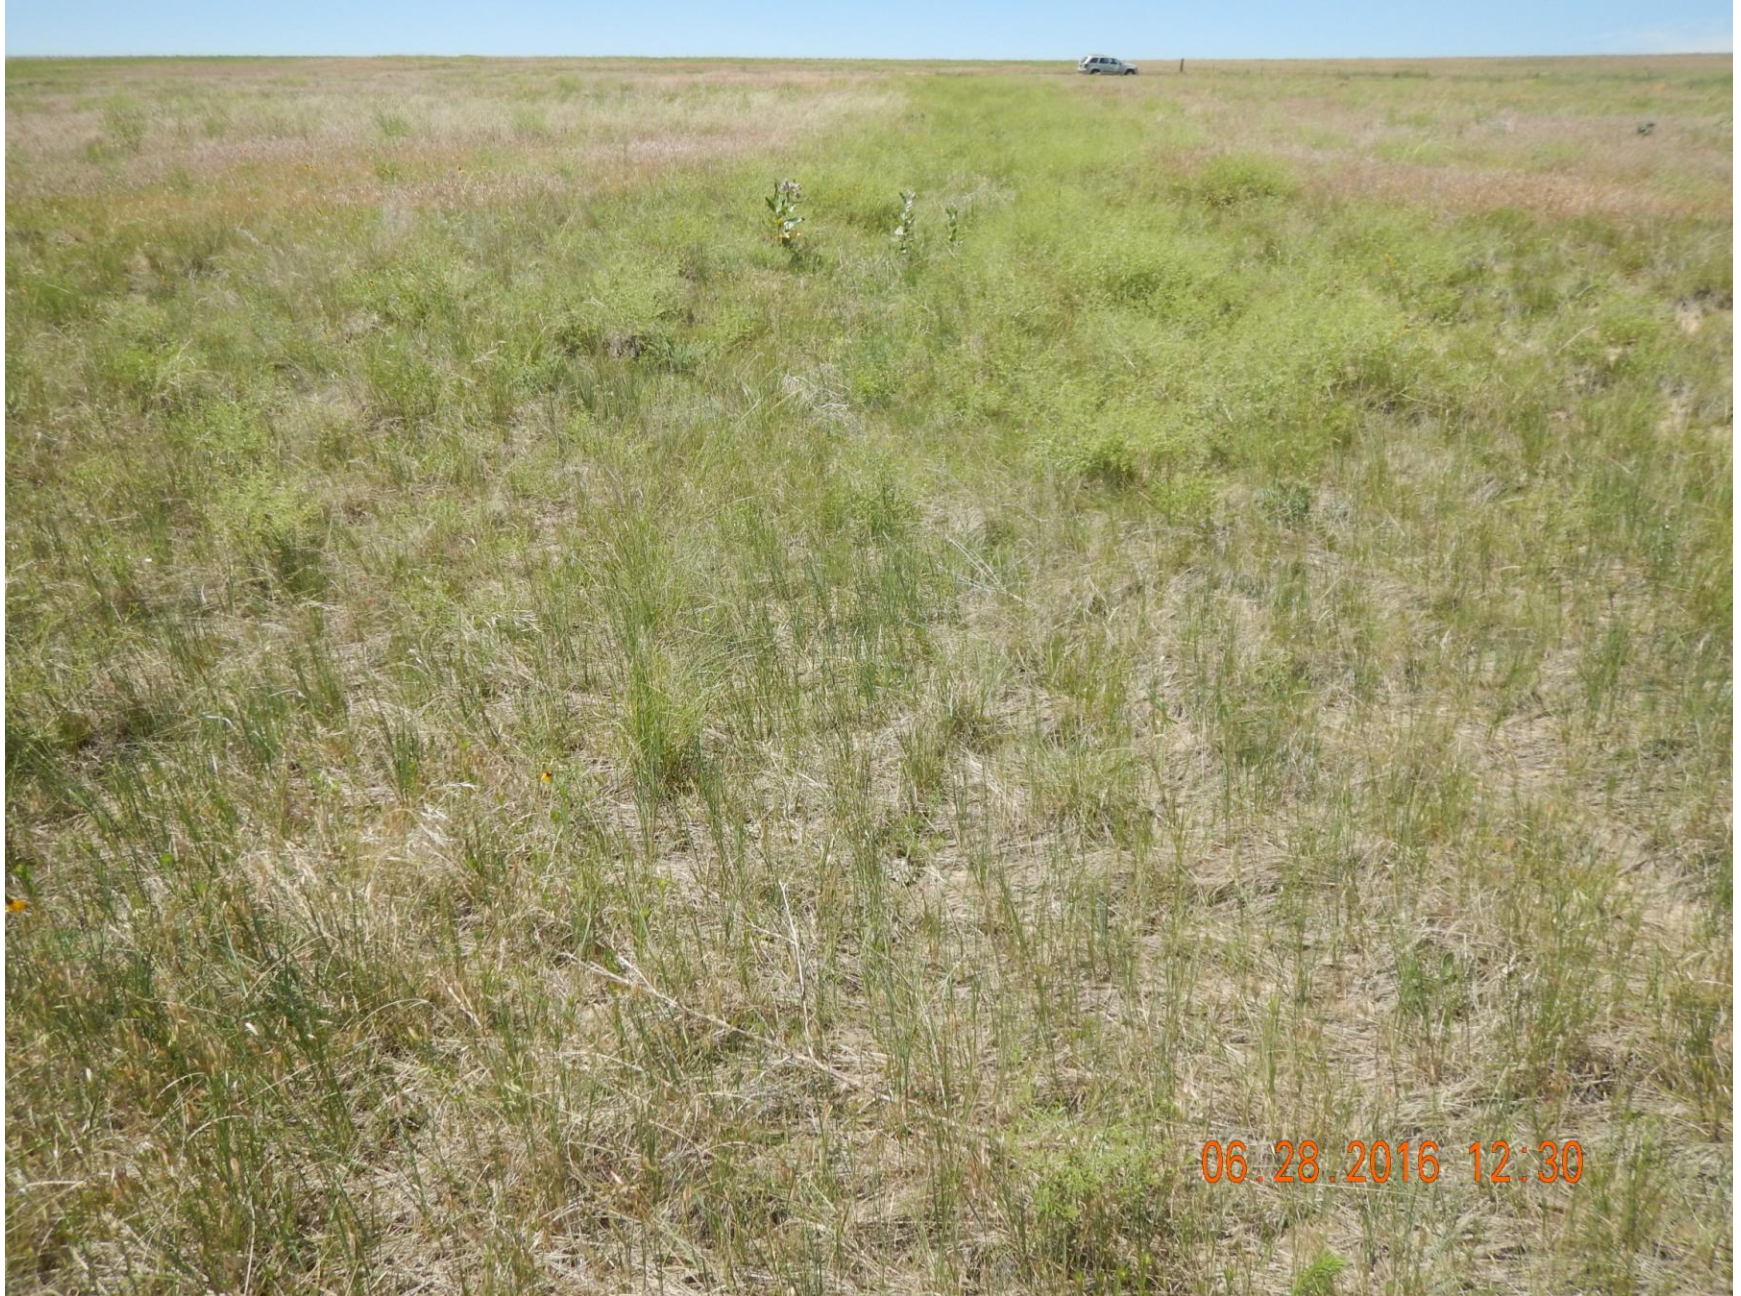
Figure 8: Photo taken from the access road on the west end of the well location, facing west. Photo shows access road has not been recontoured.

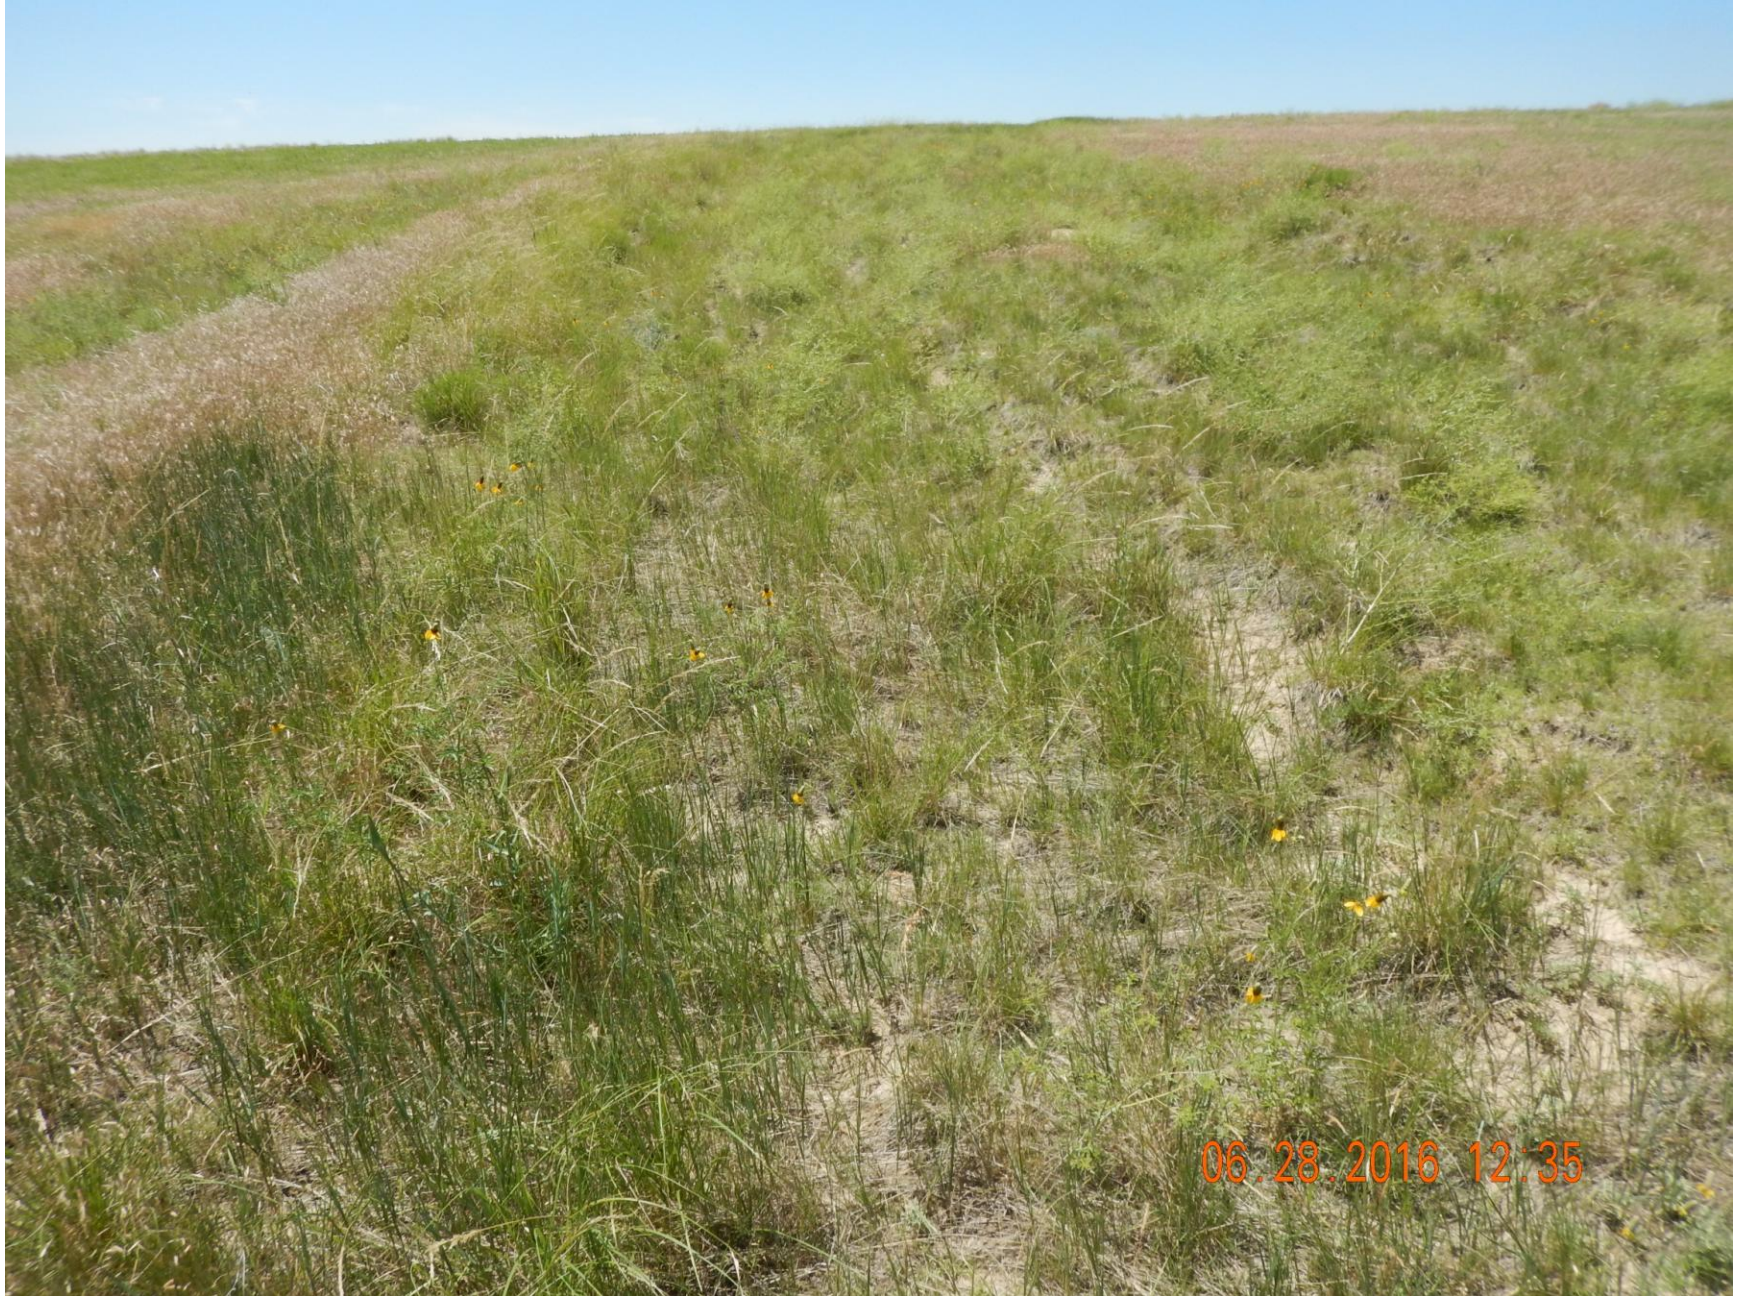
Figure 9: Photo taken from the access road, southwest of the location, facing west. Photo shows access road had not been recontoured.

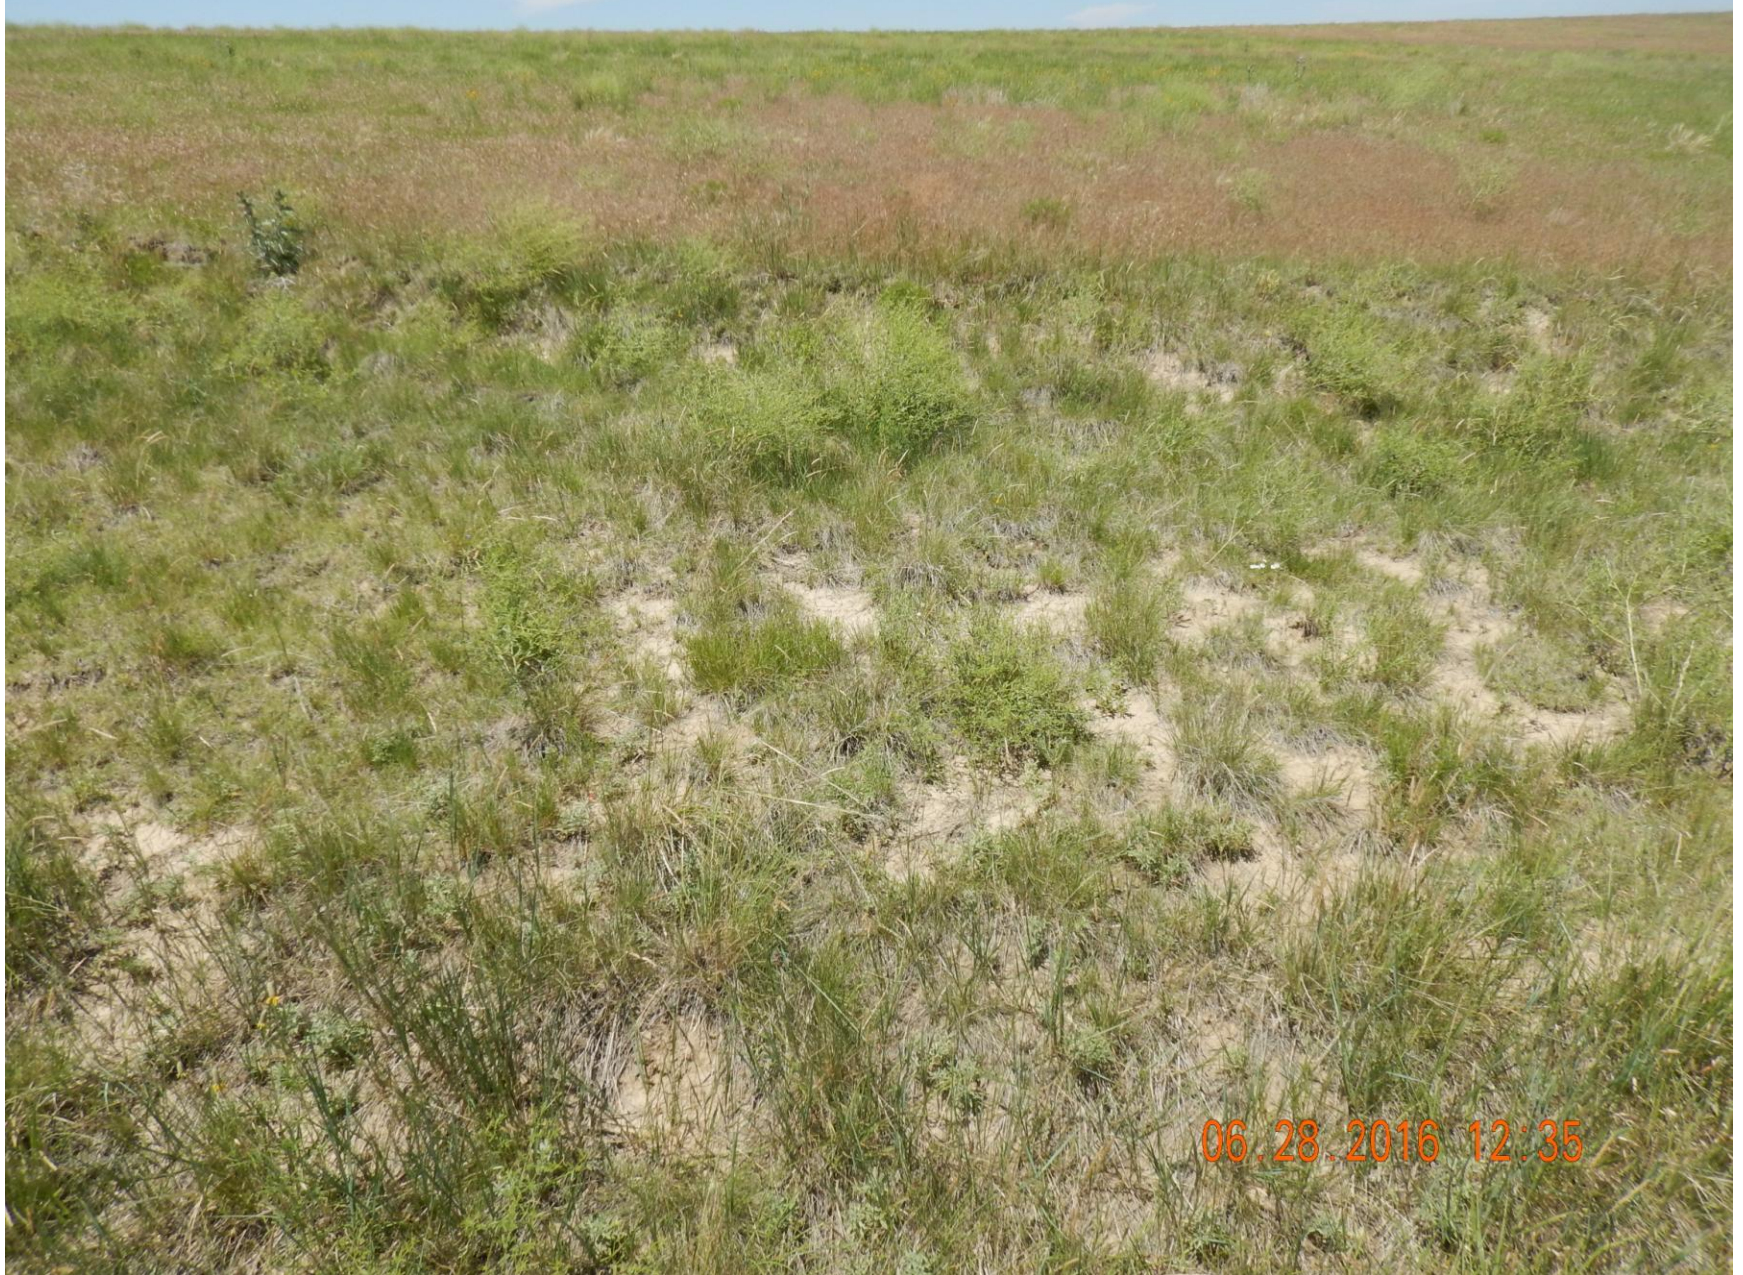
Figure 10: Photo taken from the access road, southwest of the location, facing northwest. Photo shows access road had not been recontoured.
