Final Reclamation Inspection

06/28/2016

Operator: Petro-Canada

Location ID: 376781

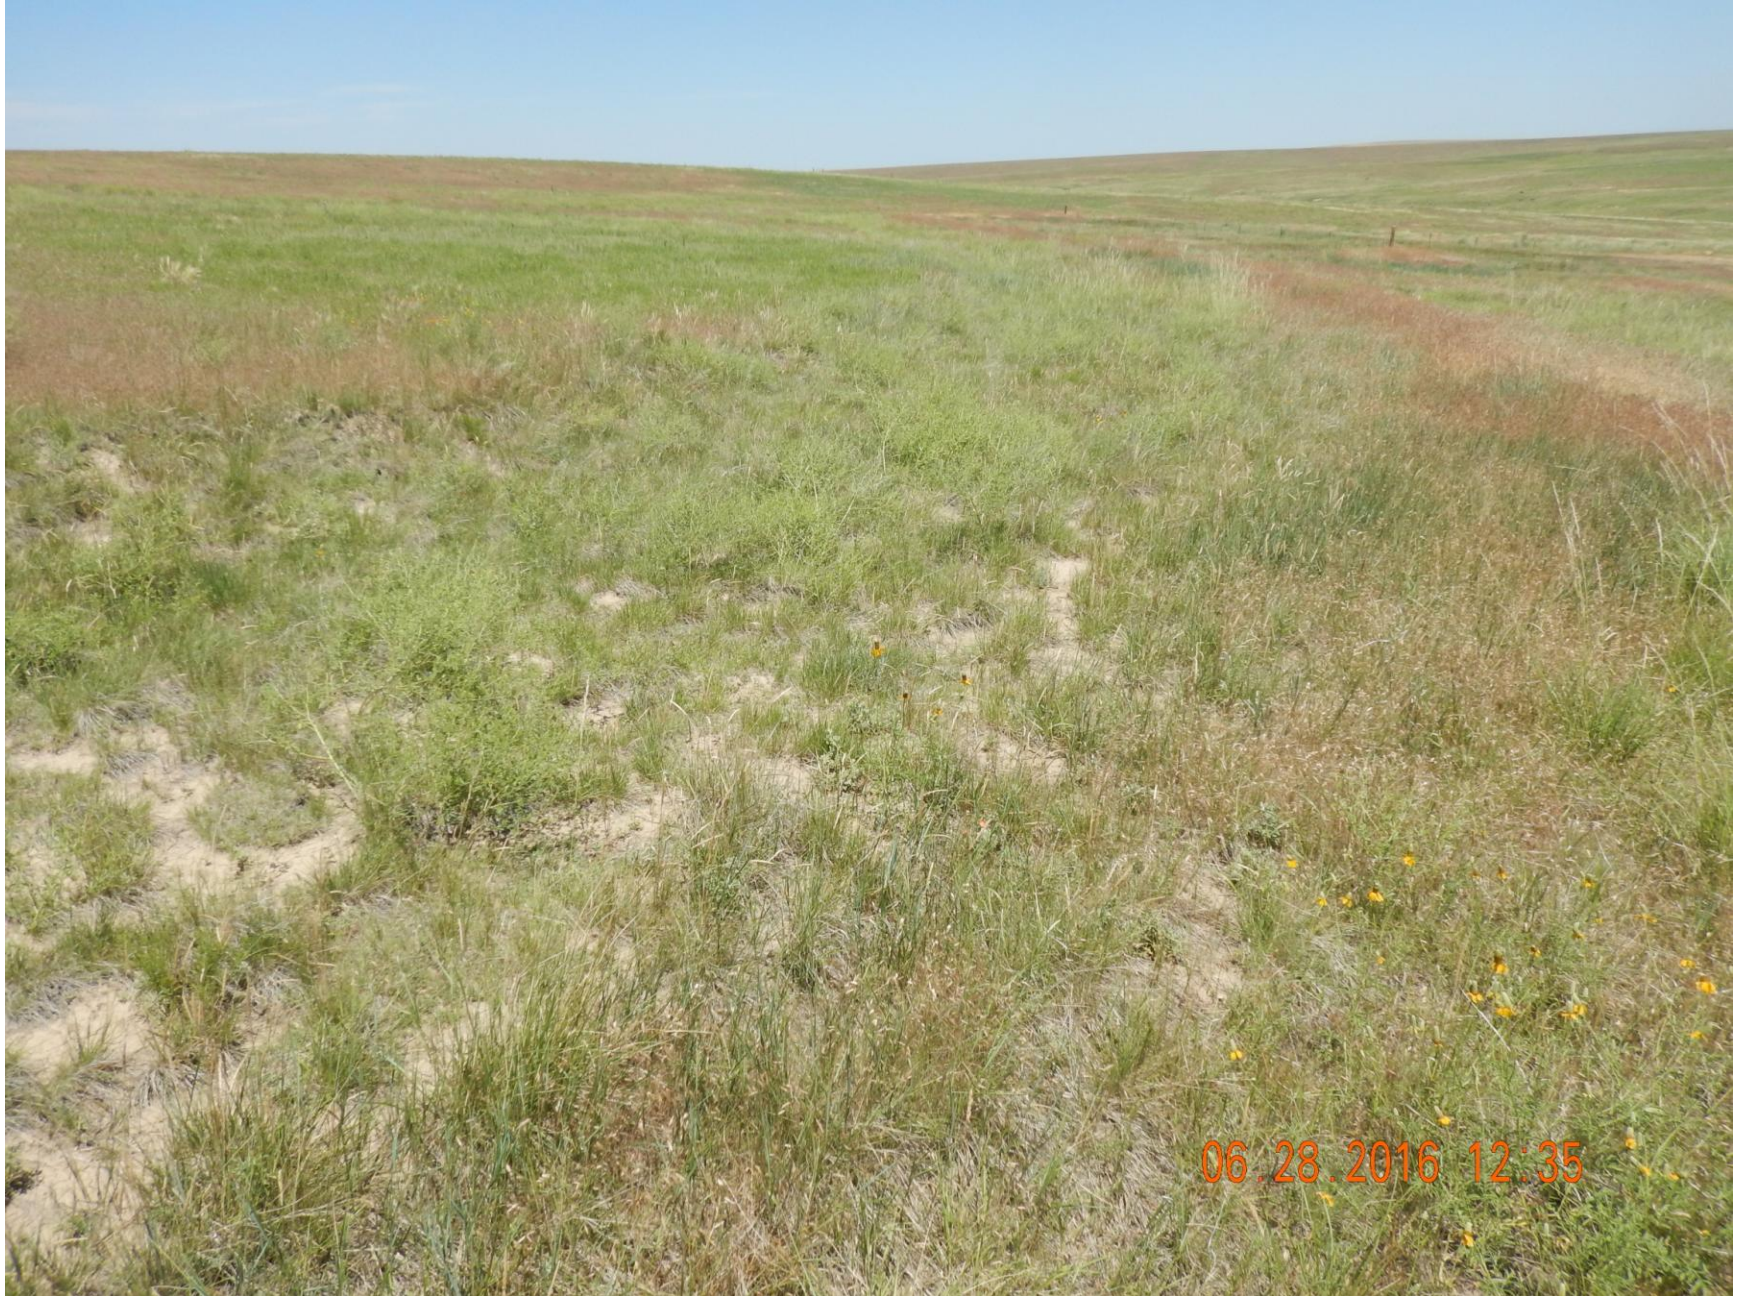
Figure 11: Photo taken from the access road, southwest of the location, facing north. Photo shows access road had not been recontoured.
