# Final Reclamation Inspection

Operator: Petro-Canada

Location ID: 375675

NESE Section 23 T3S R59W

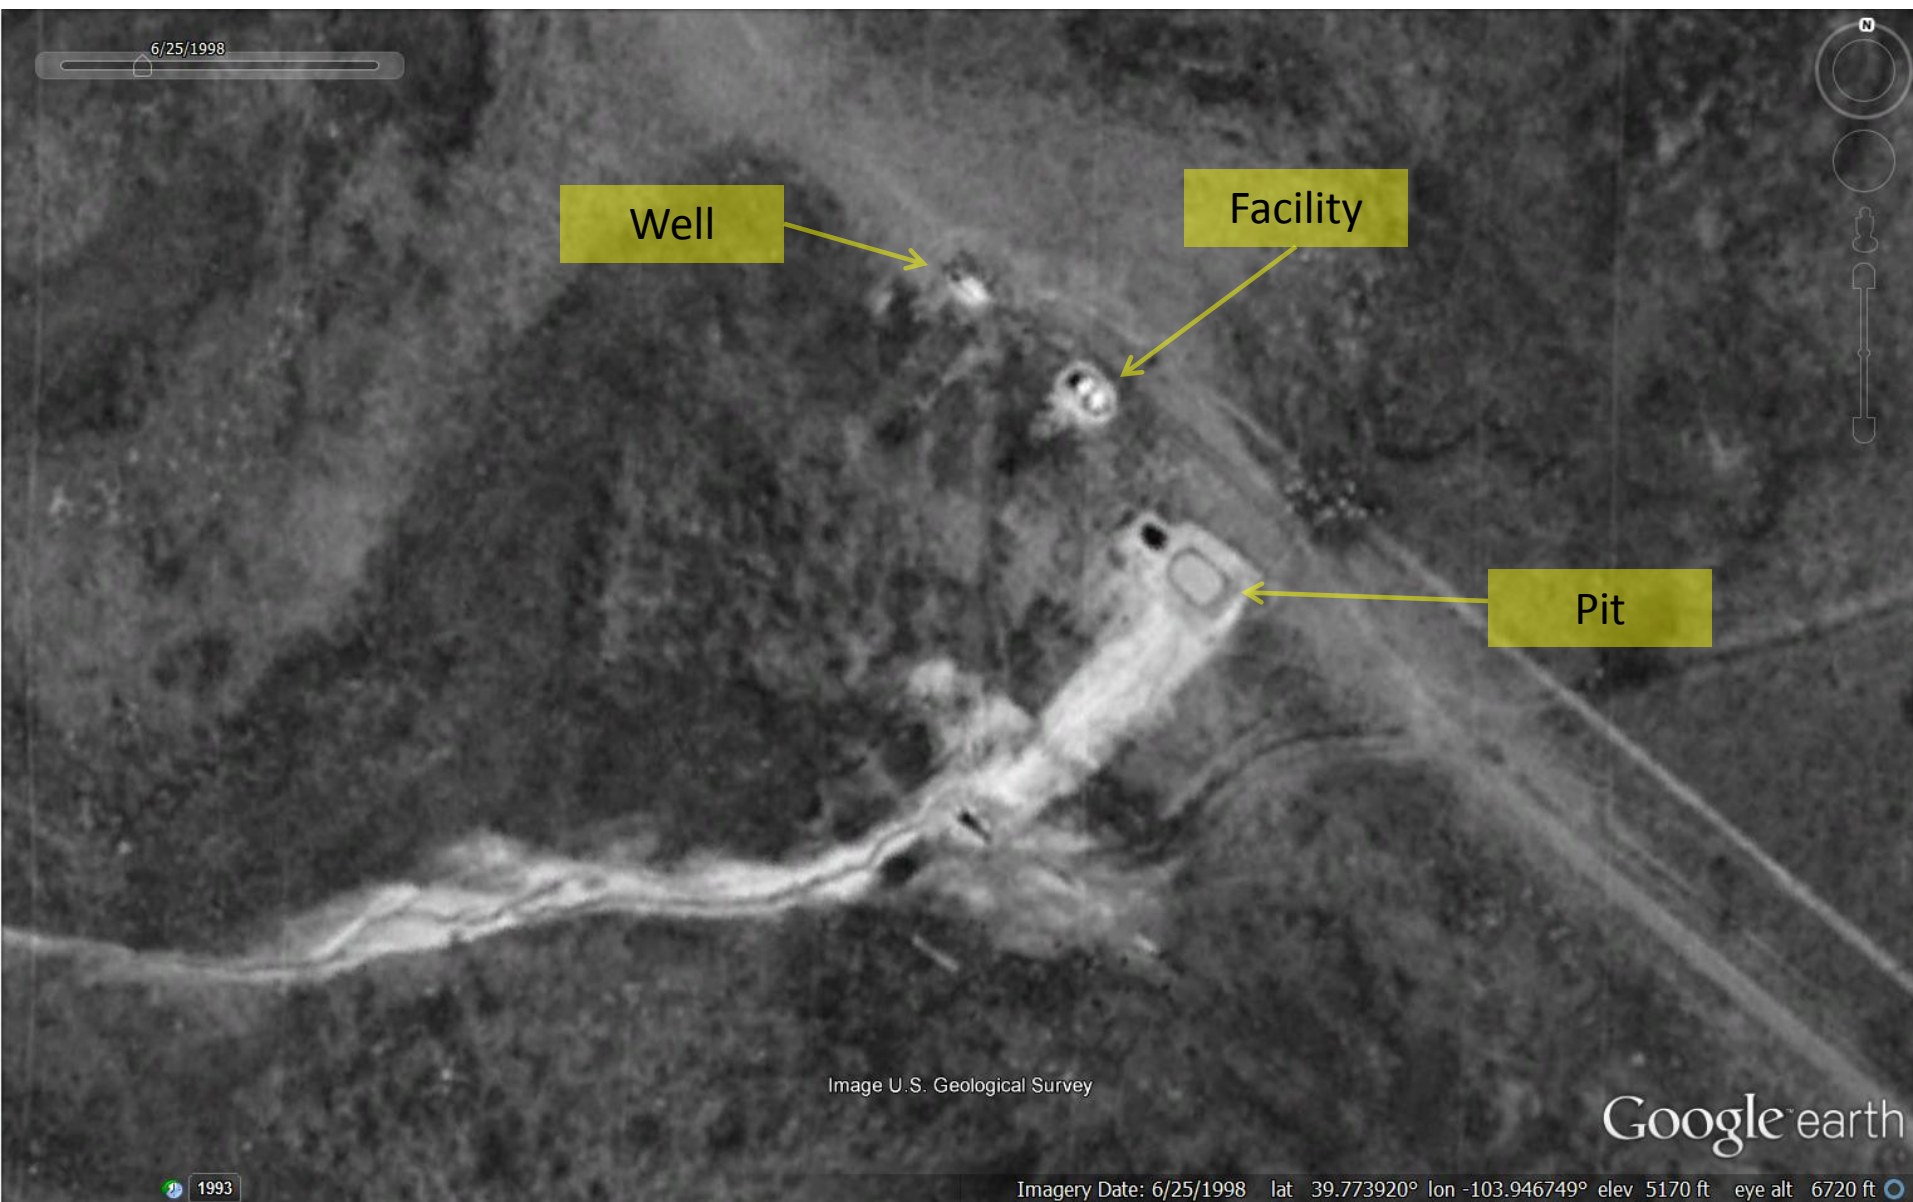
**Figure 1:** 1933 Aerial imagery showing location of Pit, facilities and well. Note the two large areas of degradation

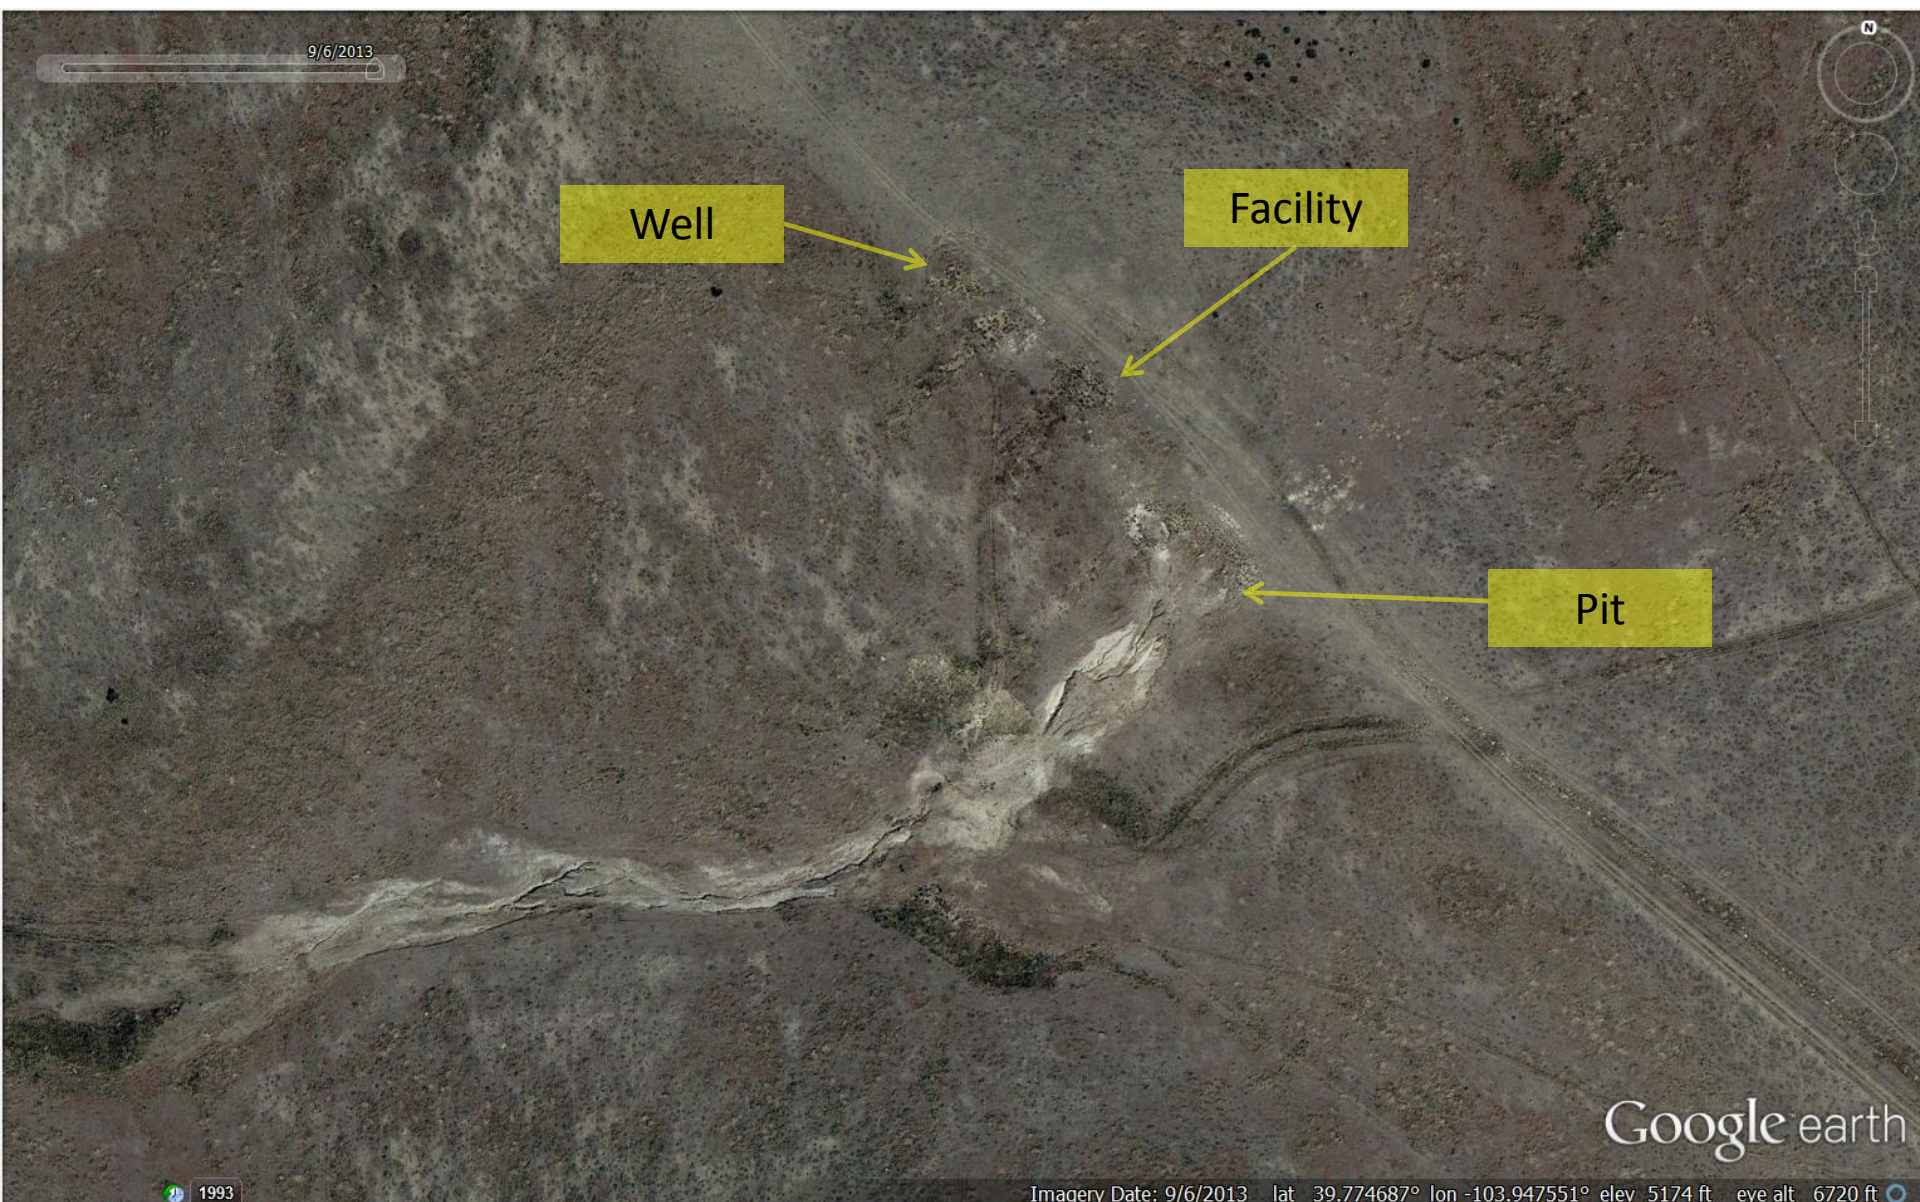
**Figure 2:** 9/6/2013 aerial imagery of location. Note areas of degradation (southern and northern), and an area that has been fenced off

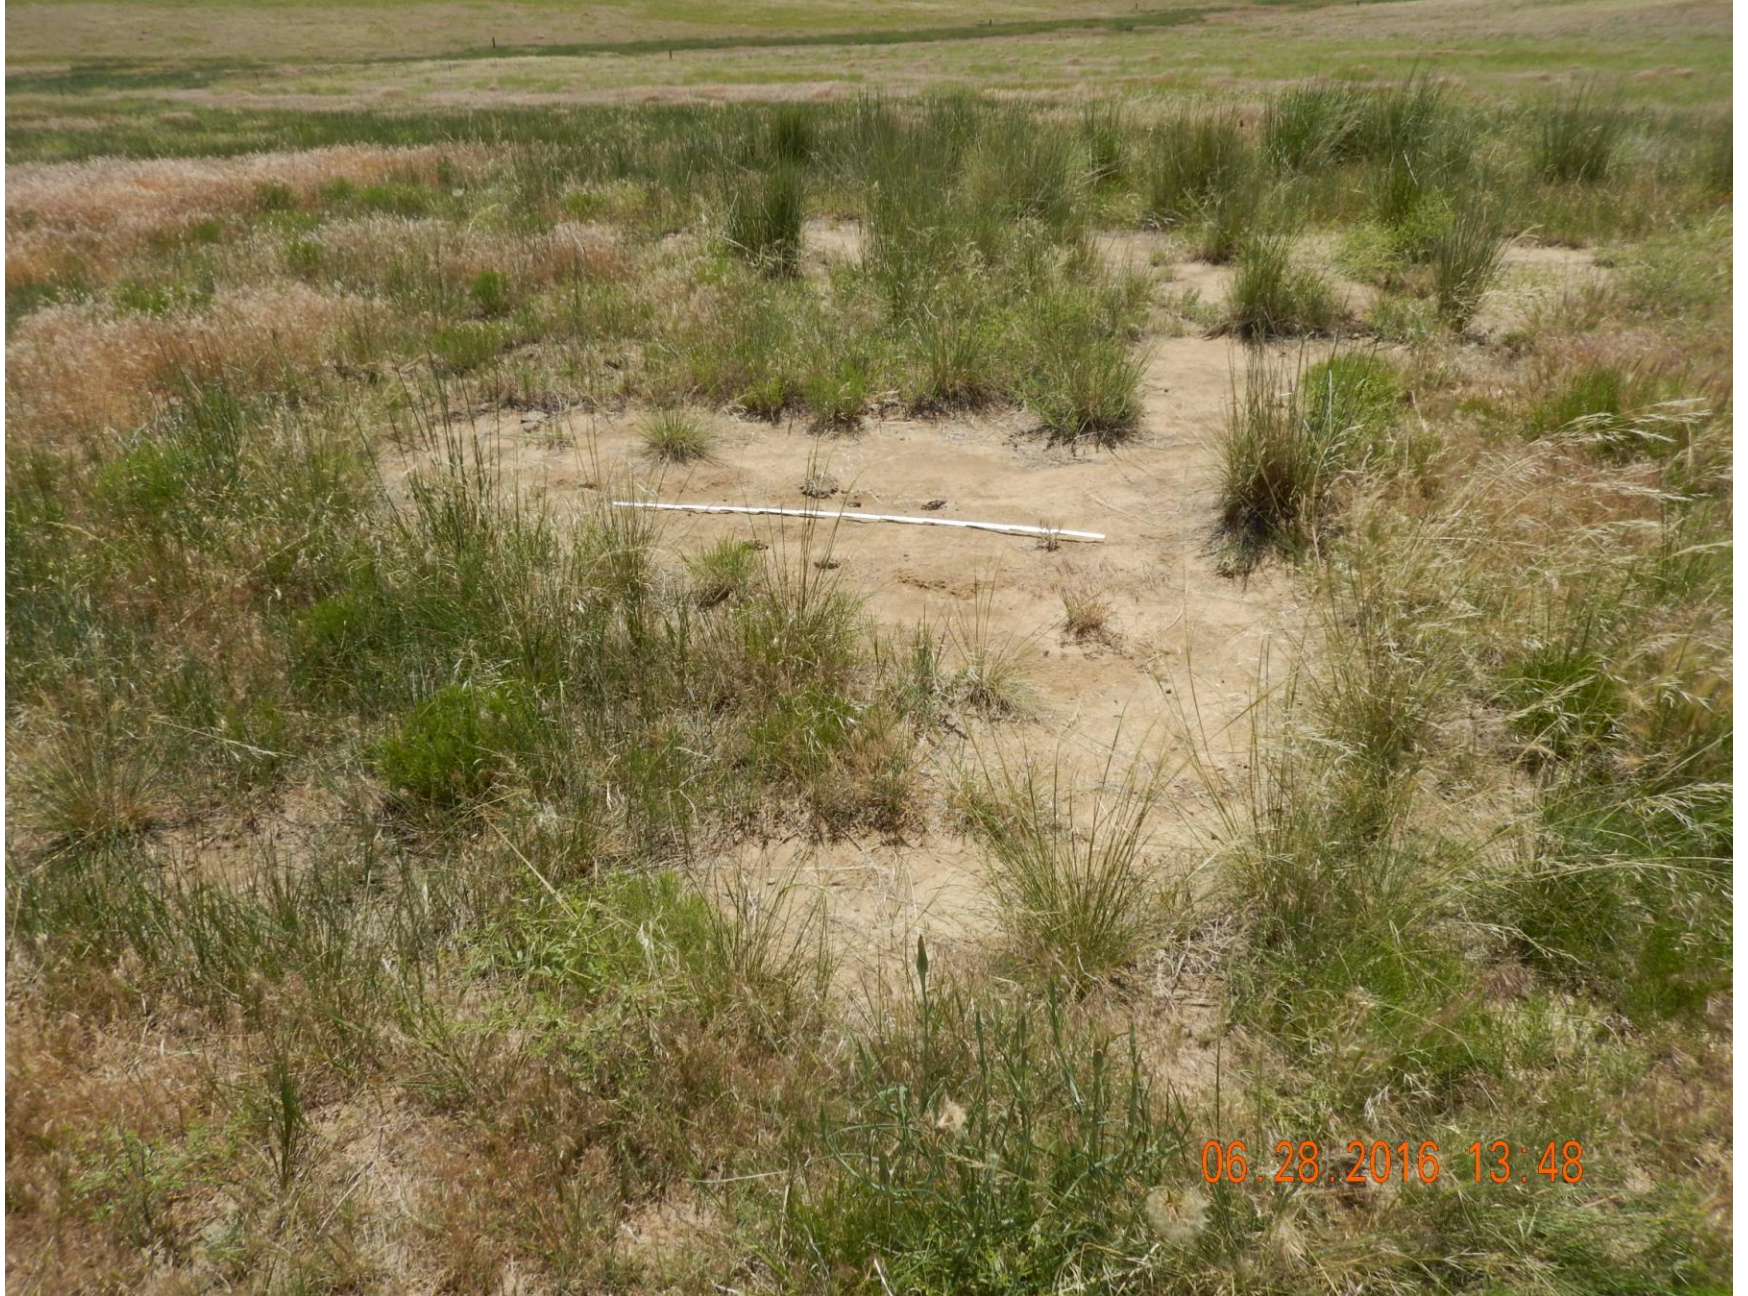
**Figure 3:** Photo taken from the well location, facing south. Photo shows well location has not achieved uniform vegetative cover. 6' measuring stick for reference.

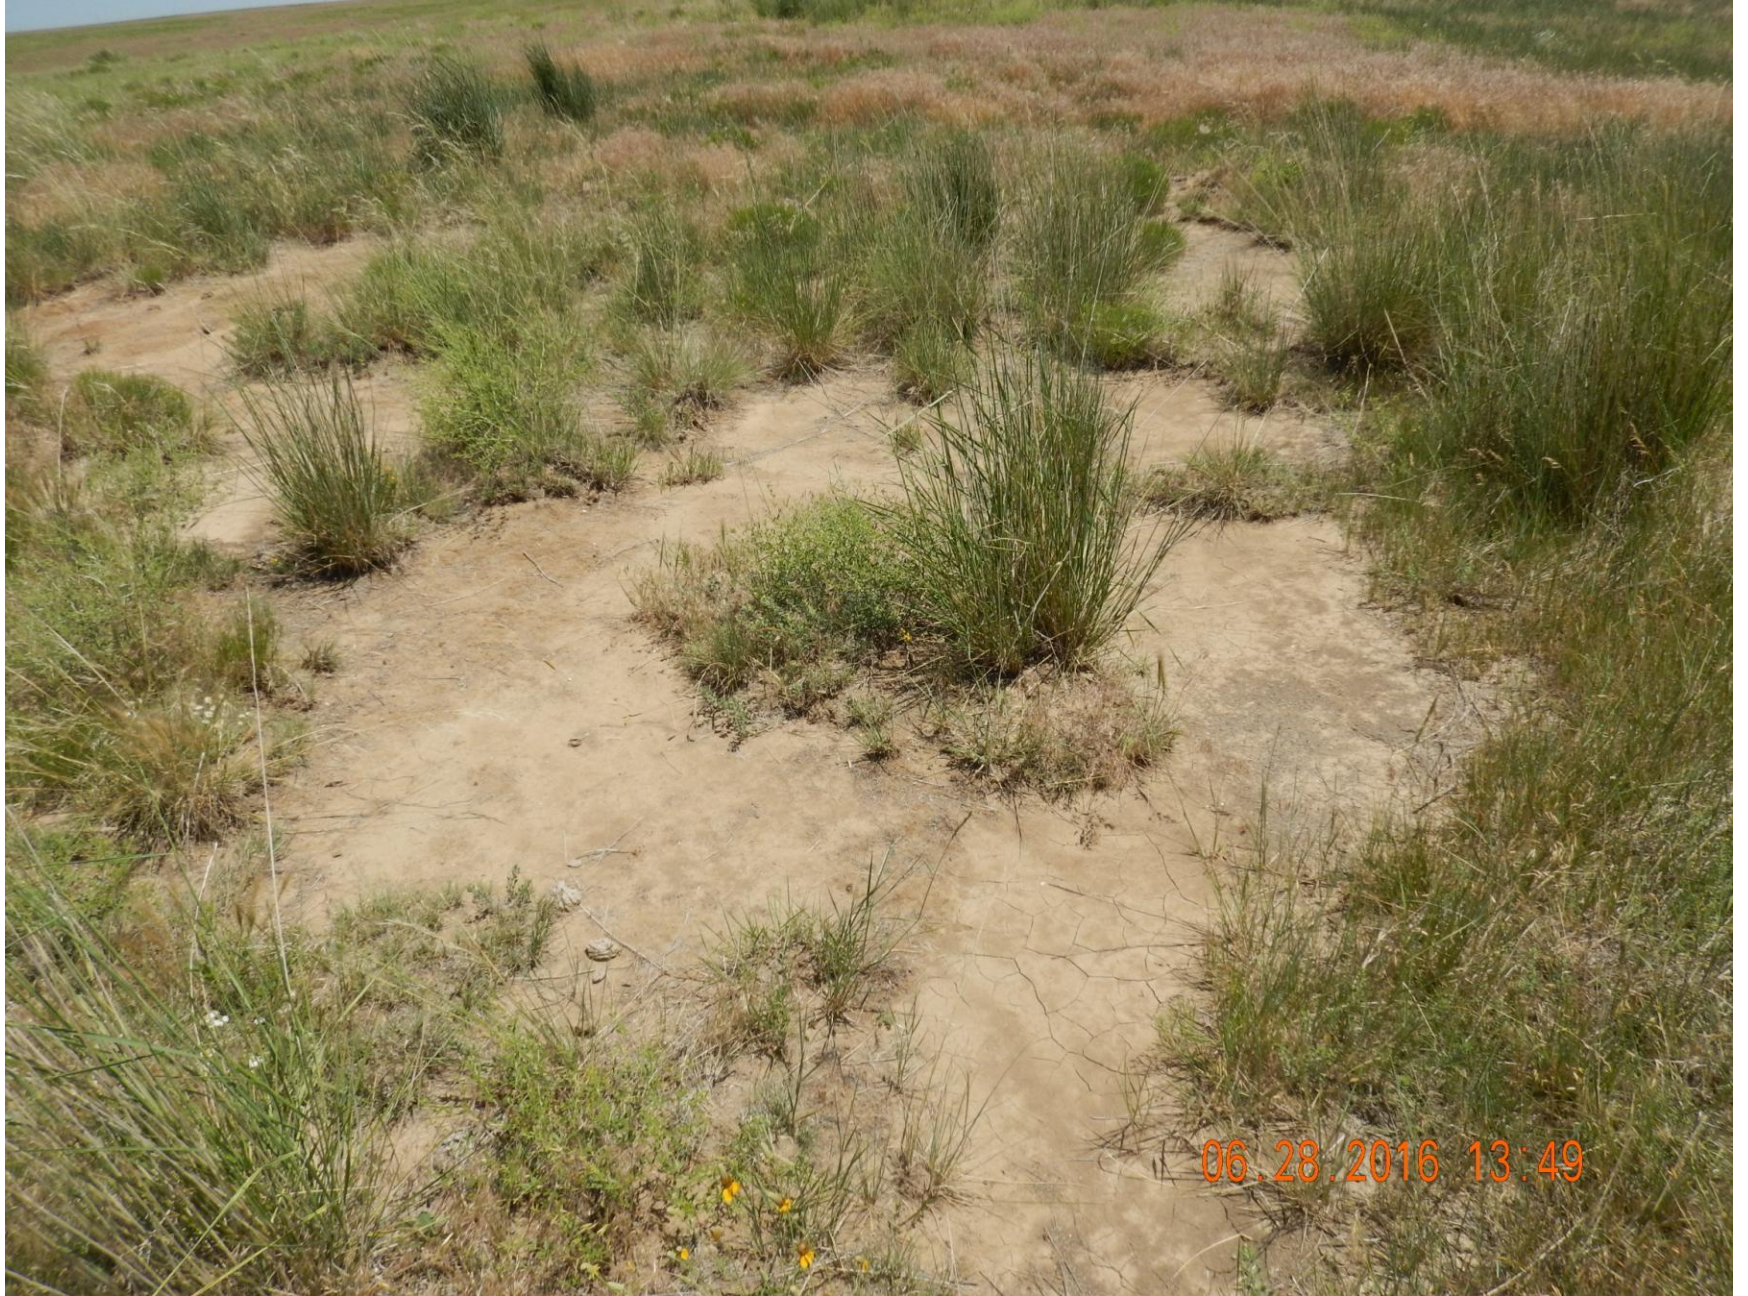
**Figure 4:** Photo taken from the well location, facing east. Photo shows well location has not achieved uniform vegetative cover.

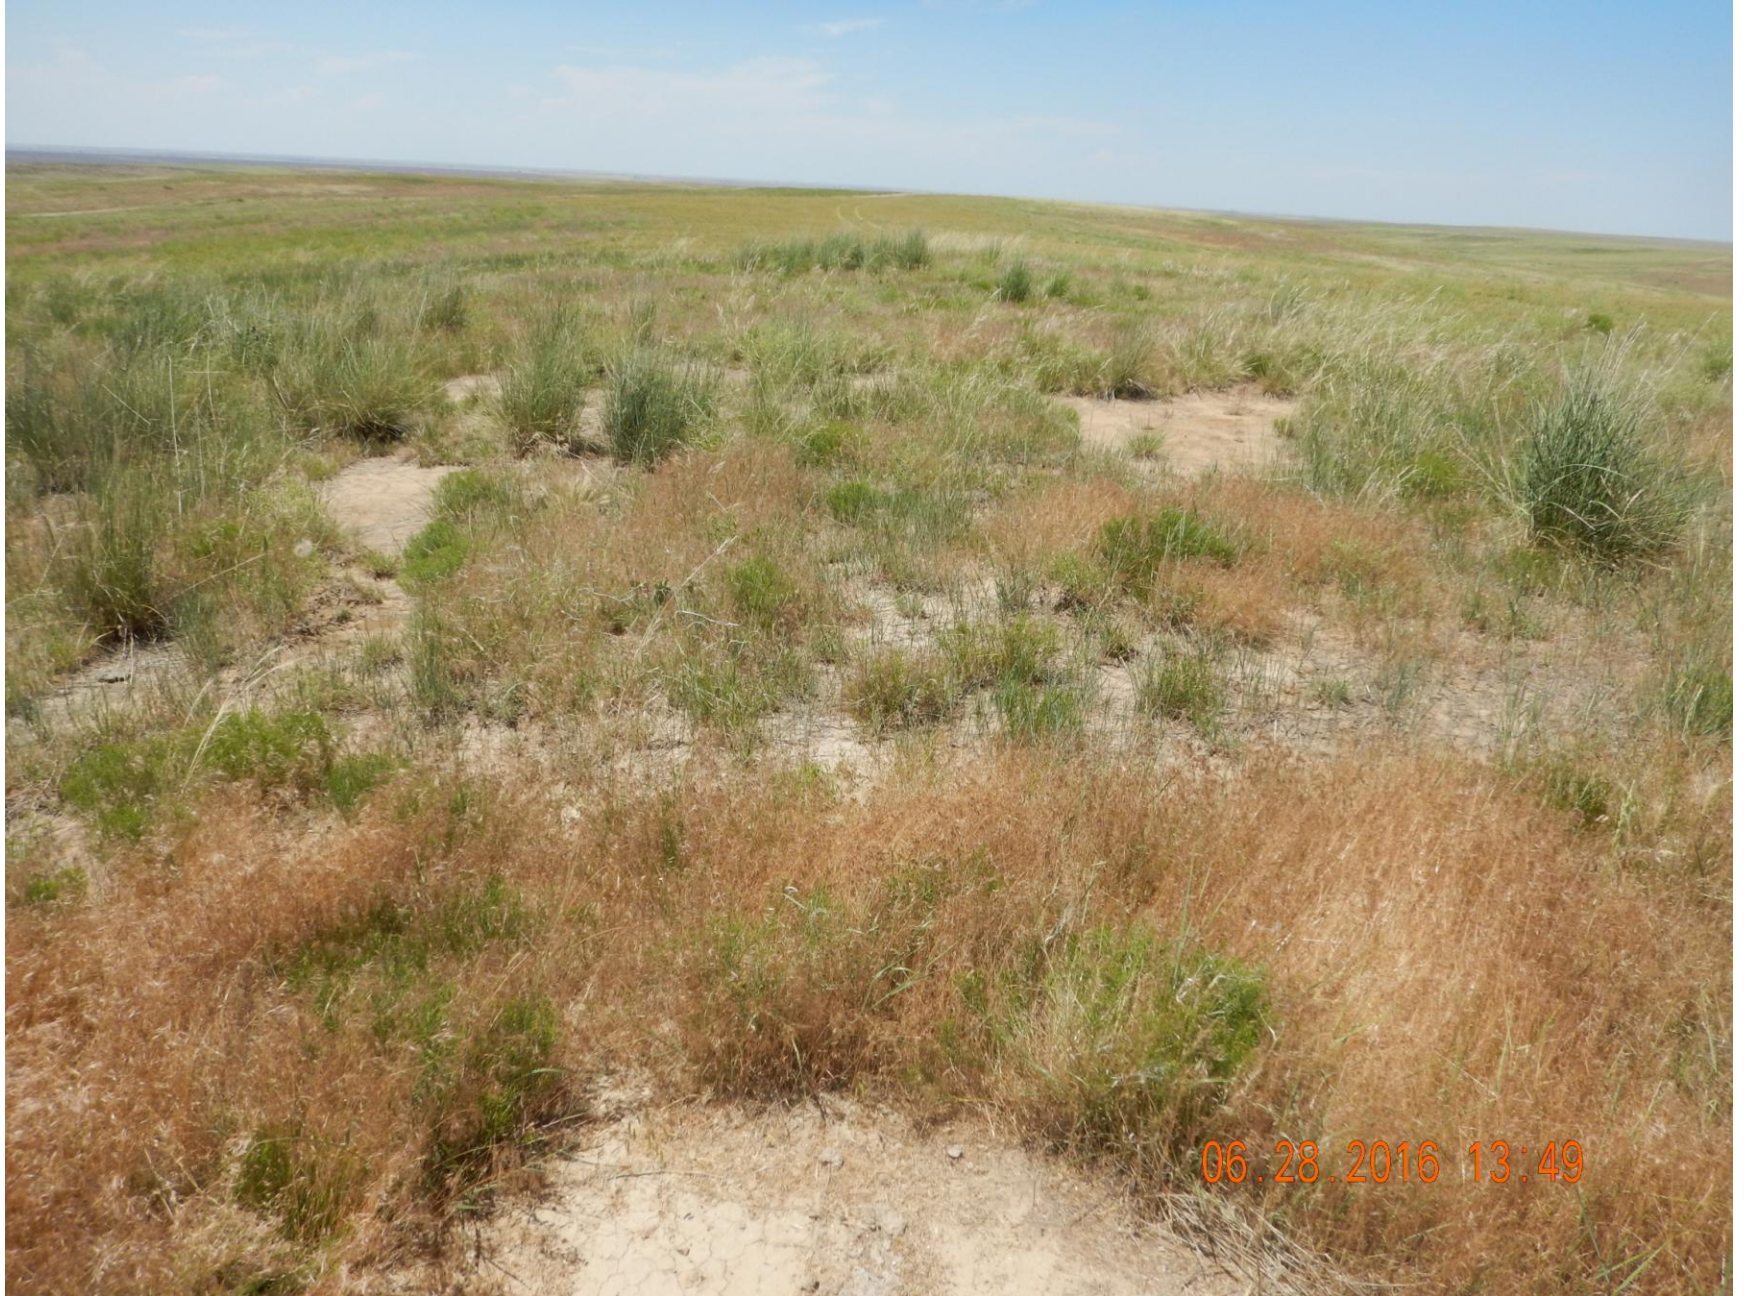
**Figure 5:** Photo taken from the well location, facing west. Photo shows well location has not achieved uniform vegetative cover.

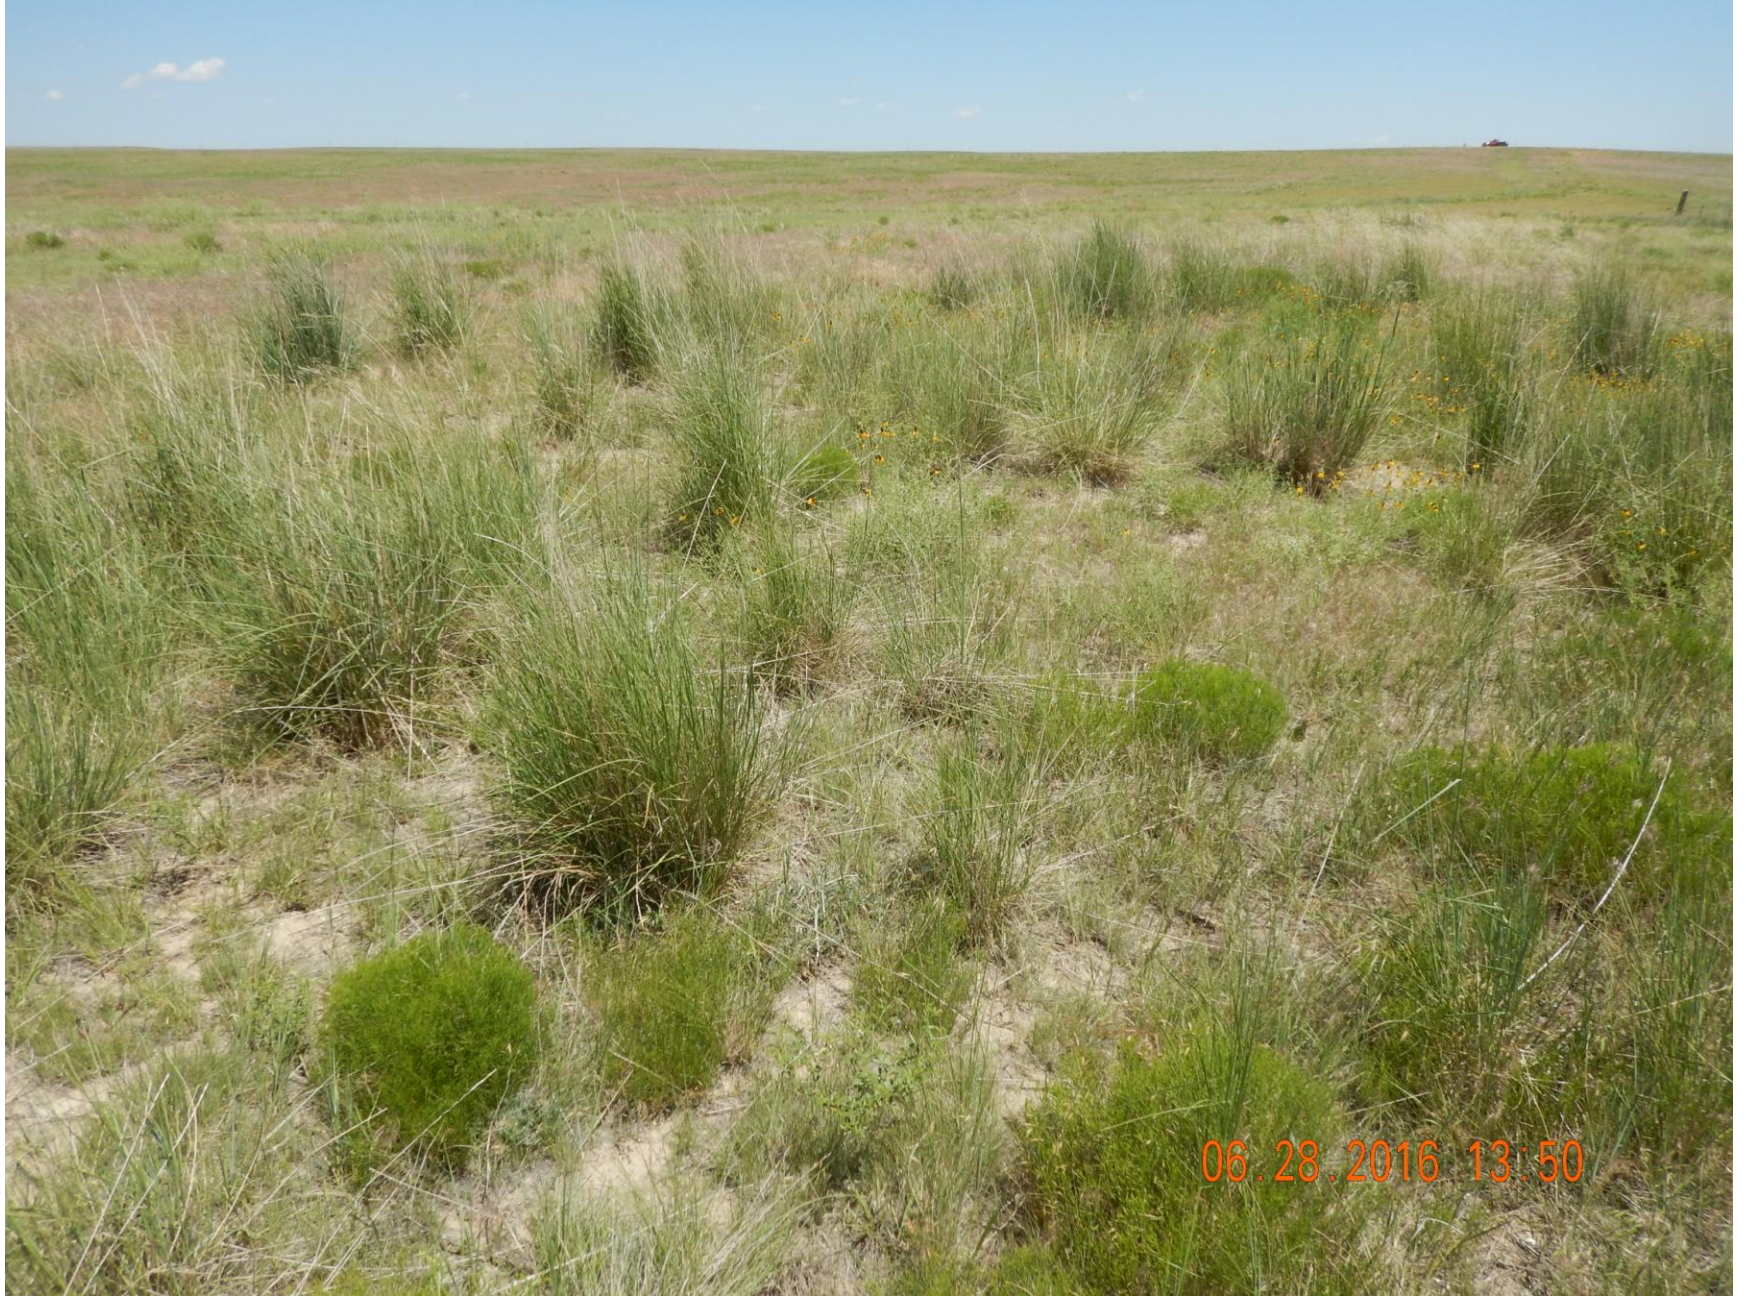
**Figure 6:** Photo taken from the facility/battery area of the location, facing east. Photo shows vegetation appears to be progressing towards reclamation requirements over this portion of the location.

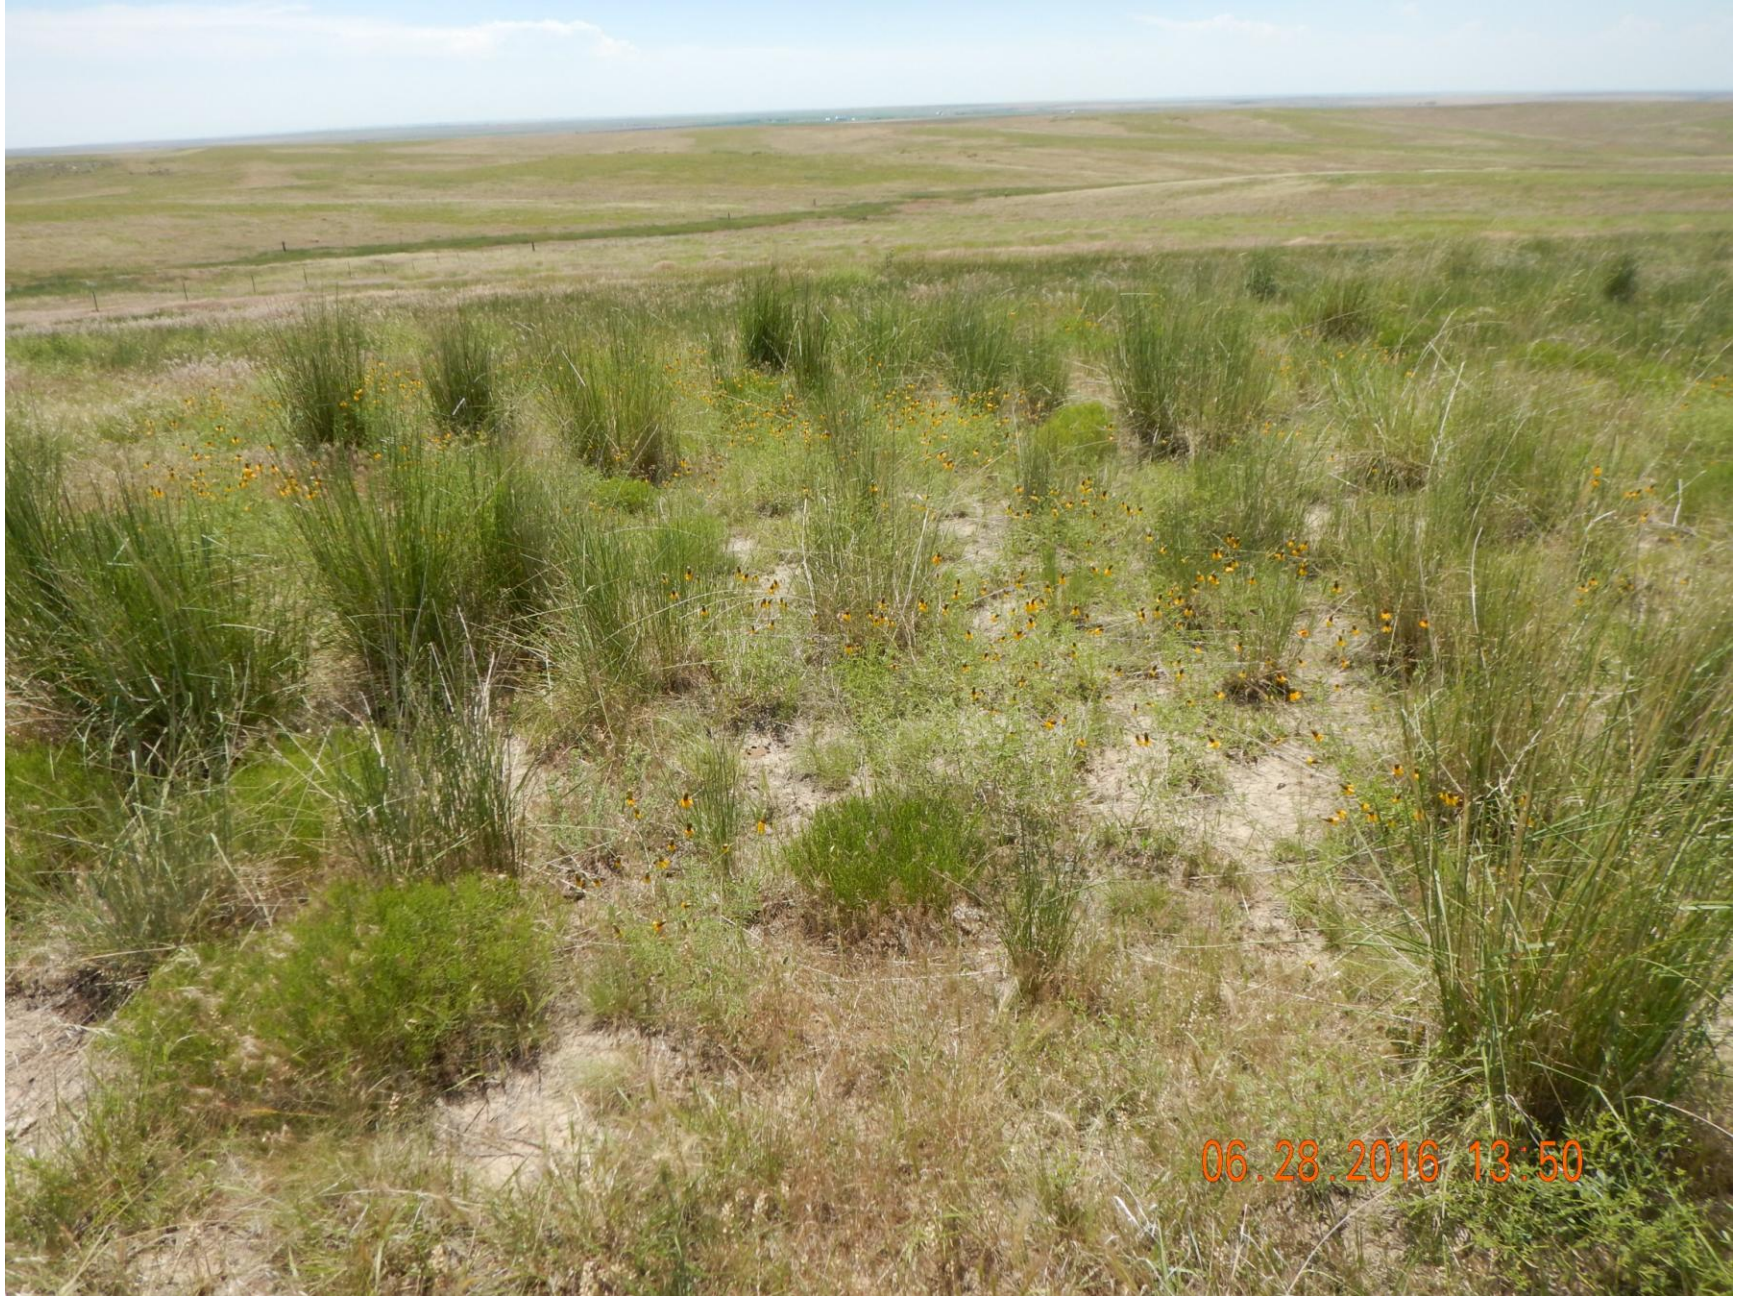
**Figure 7:** Photo taken from the facility/battery area of the location, facing south. Photo shows vegetation appears to be progressing towards reclamation requirements over this portion of the location.

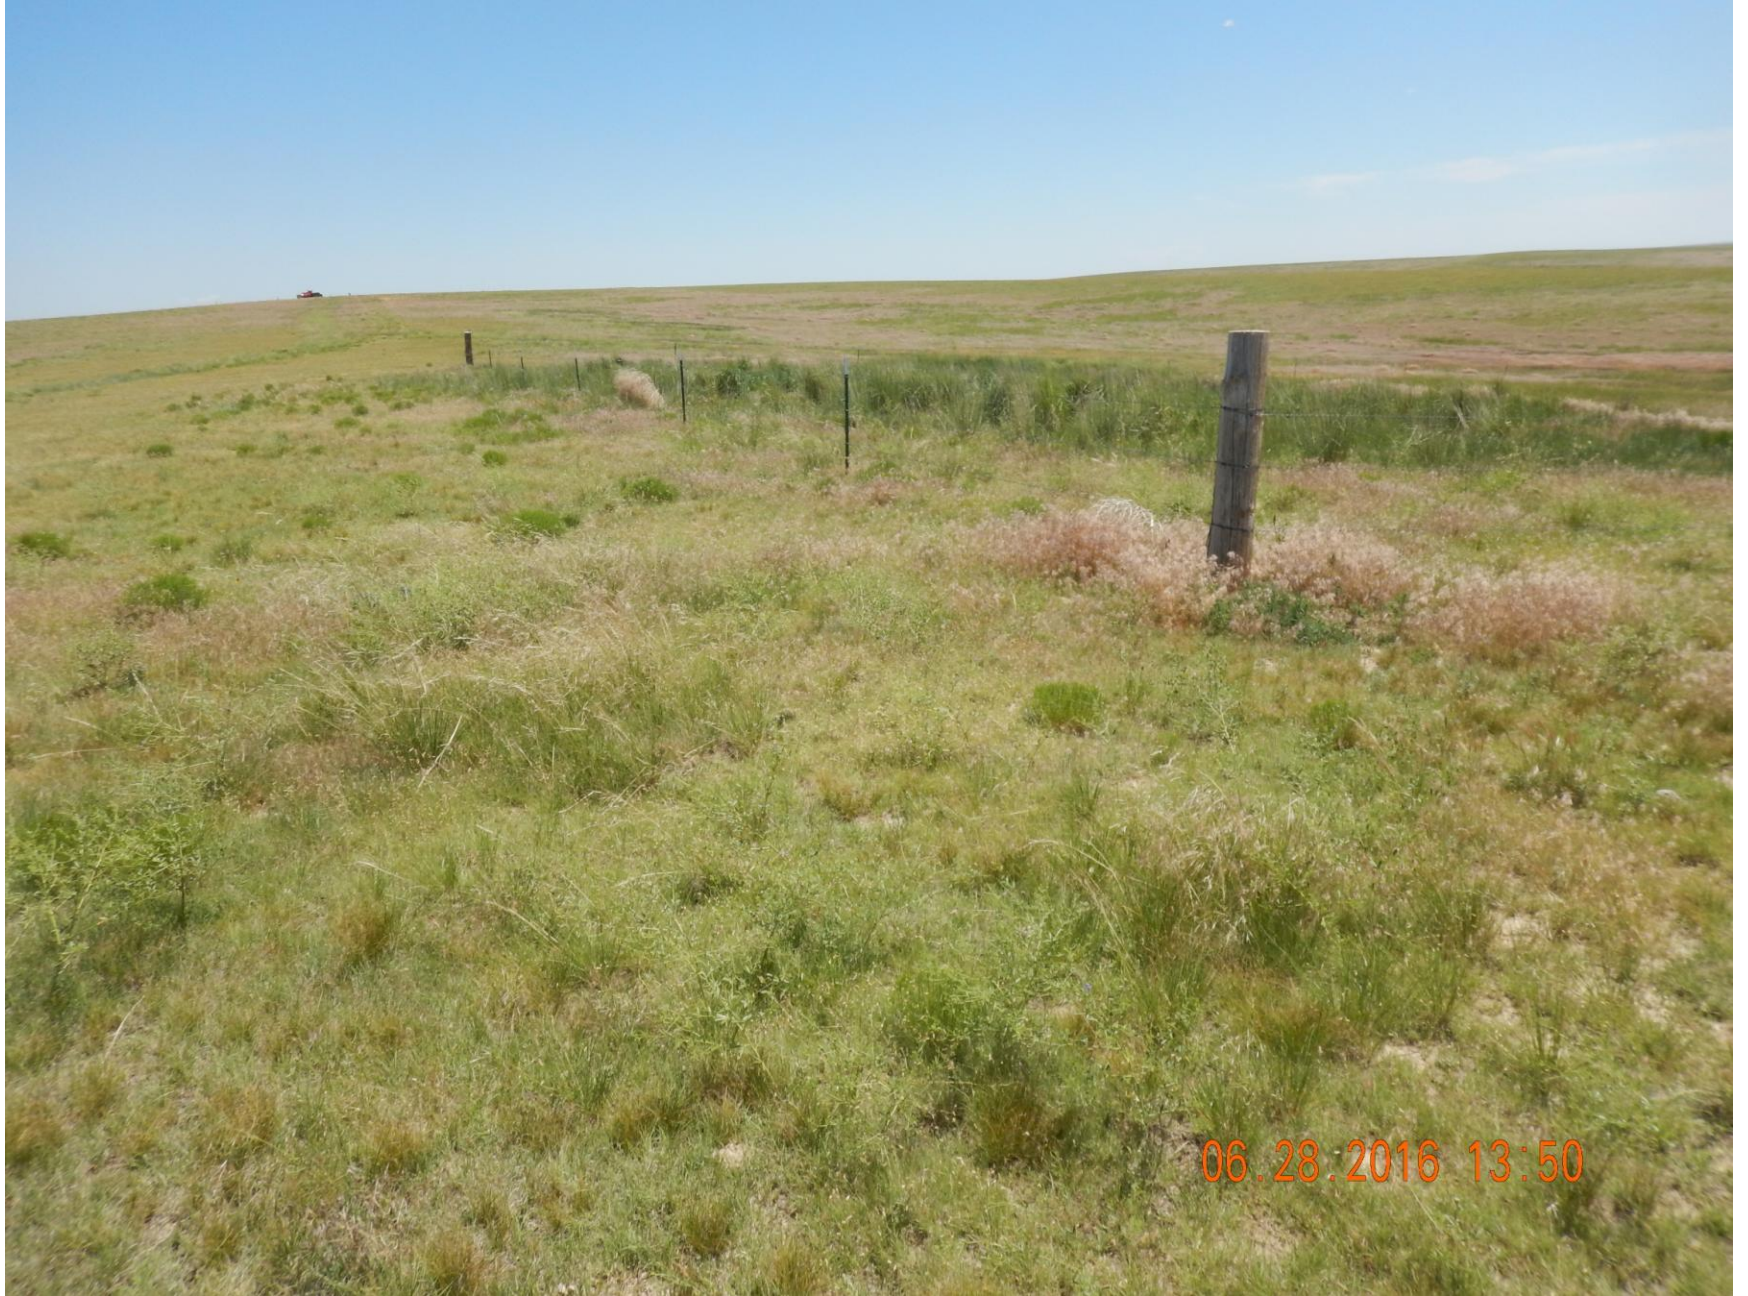
**Figure 8:** Photo taken from the northwest corner of the pit location, facing southwest. Photo shows remediation area has been fenced off and terraced.

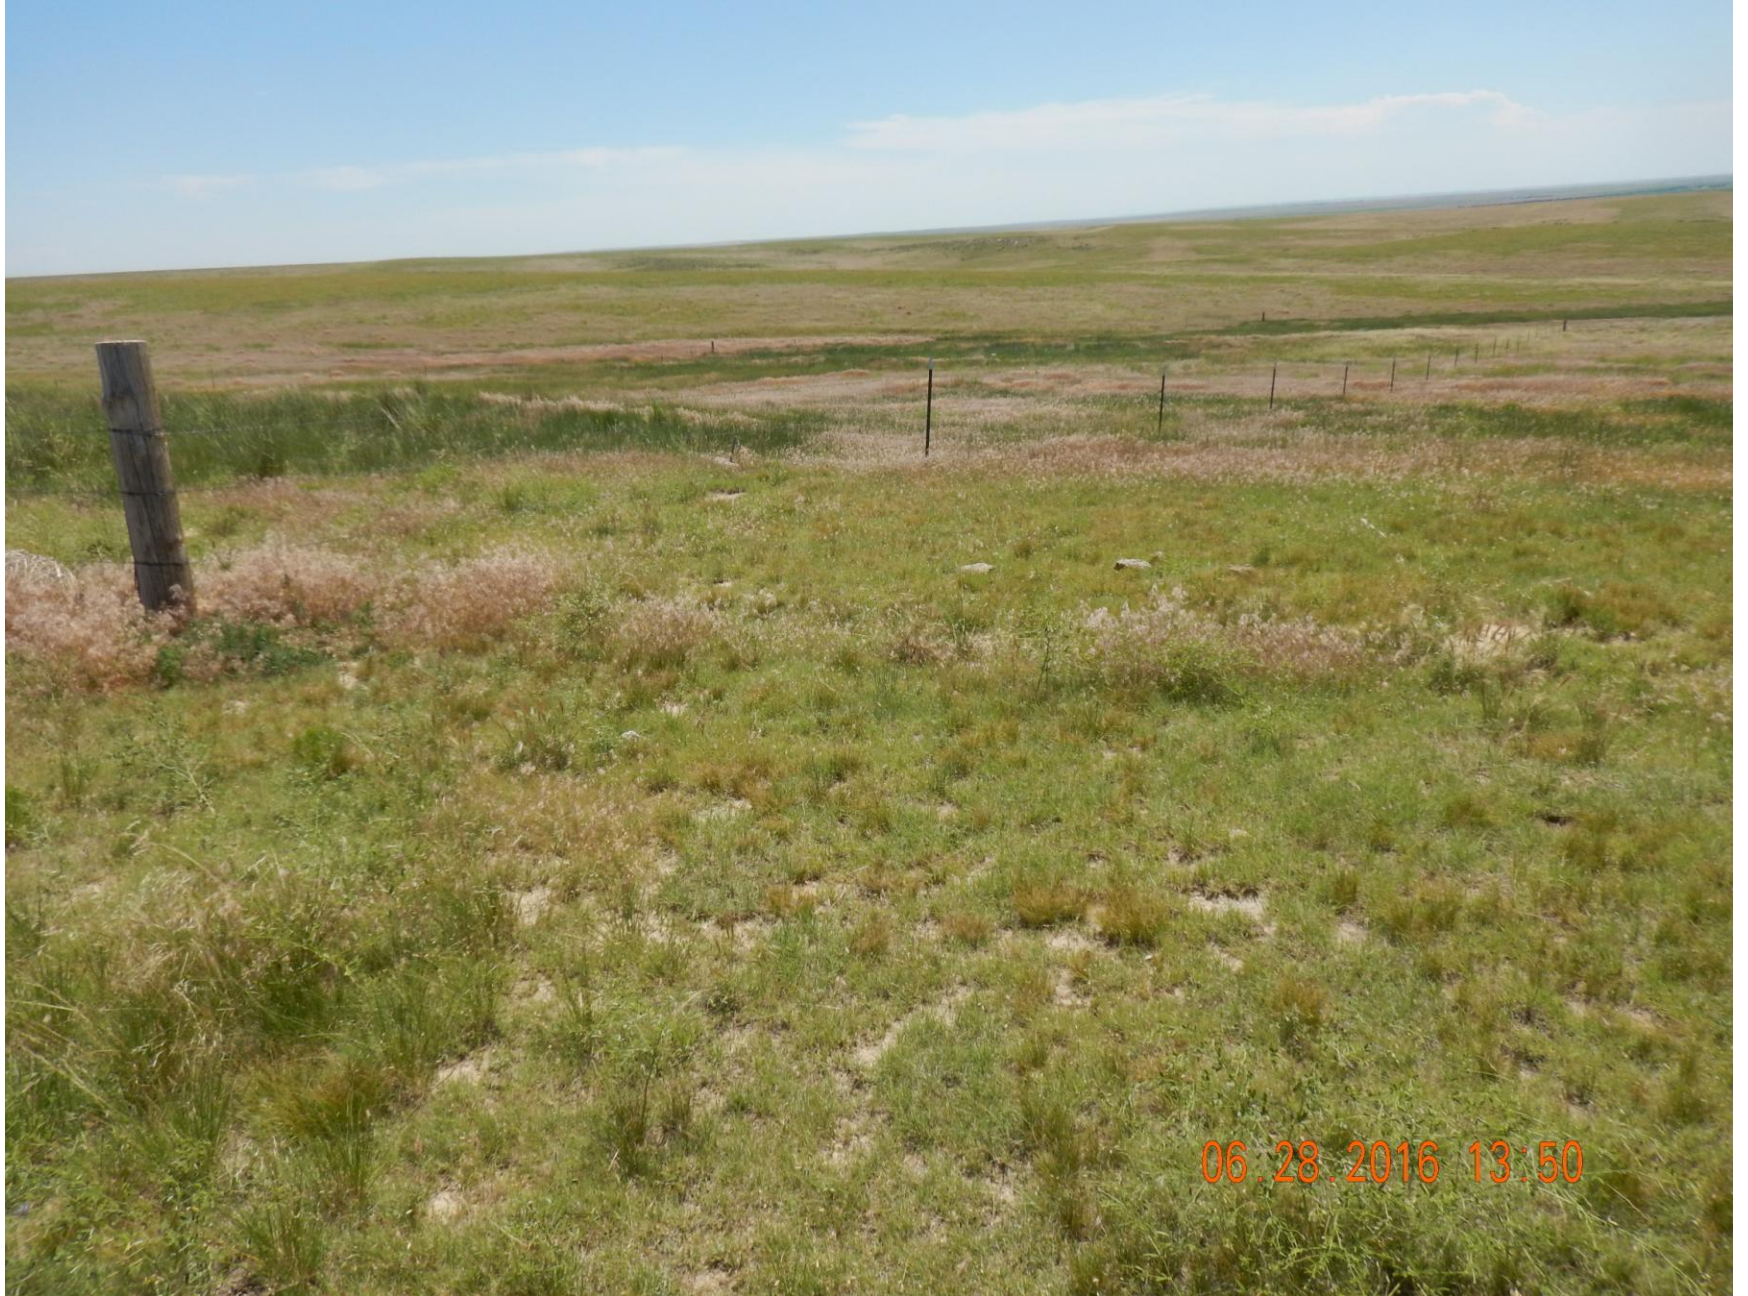
**Figure 9:** Photo taken from the northwest corner of the pit location, facing south. Photo shows remediation area has been fenced off and terraced.

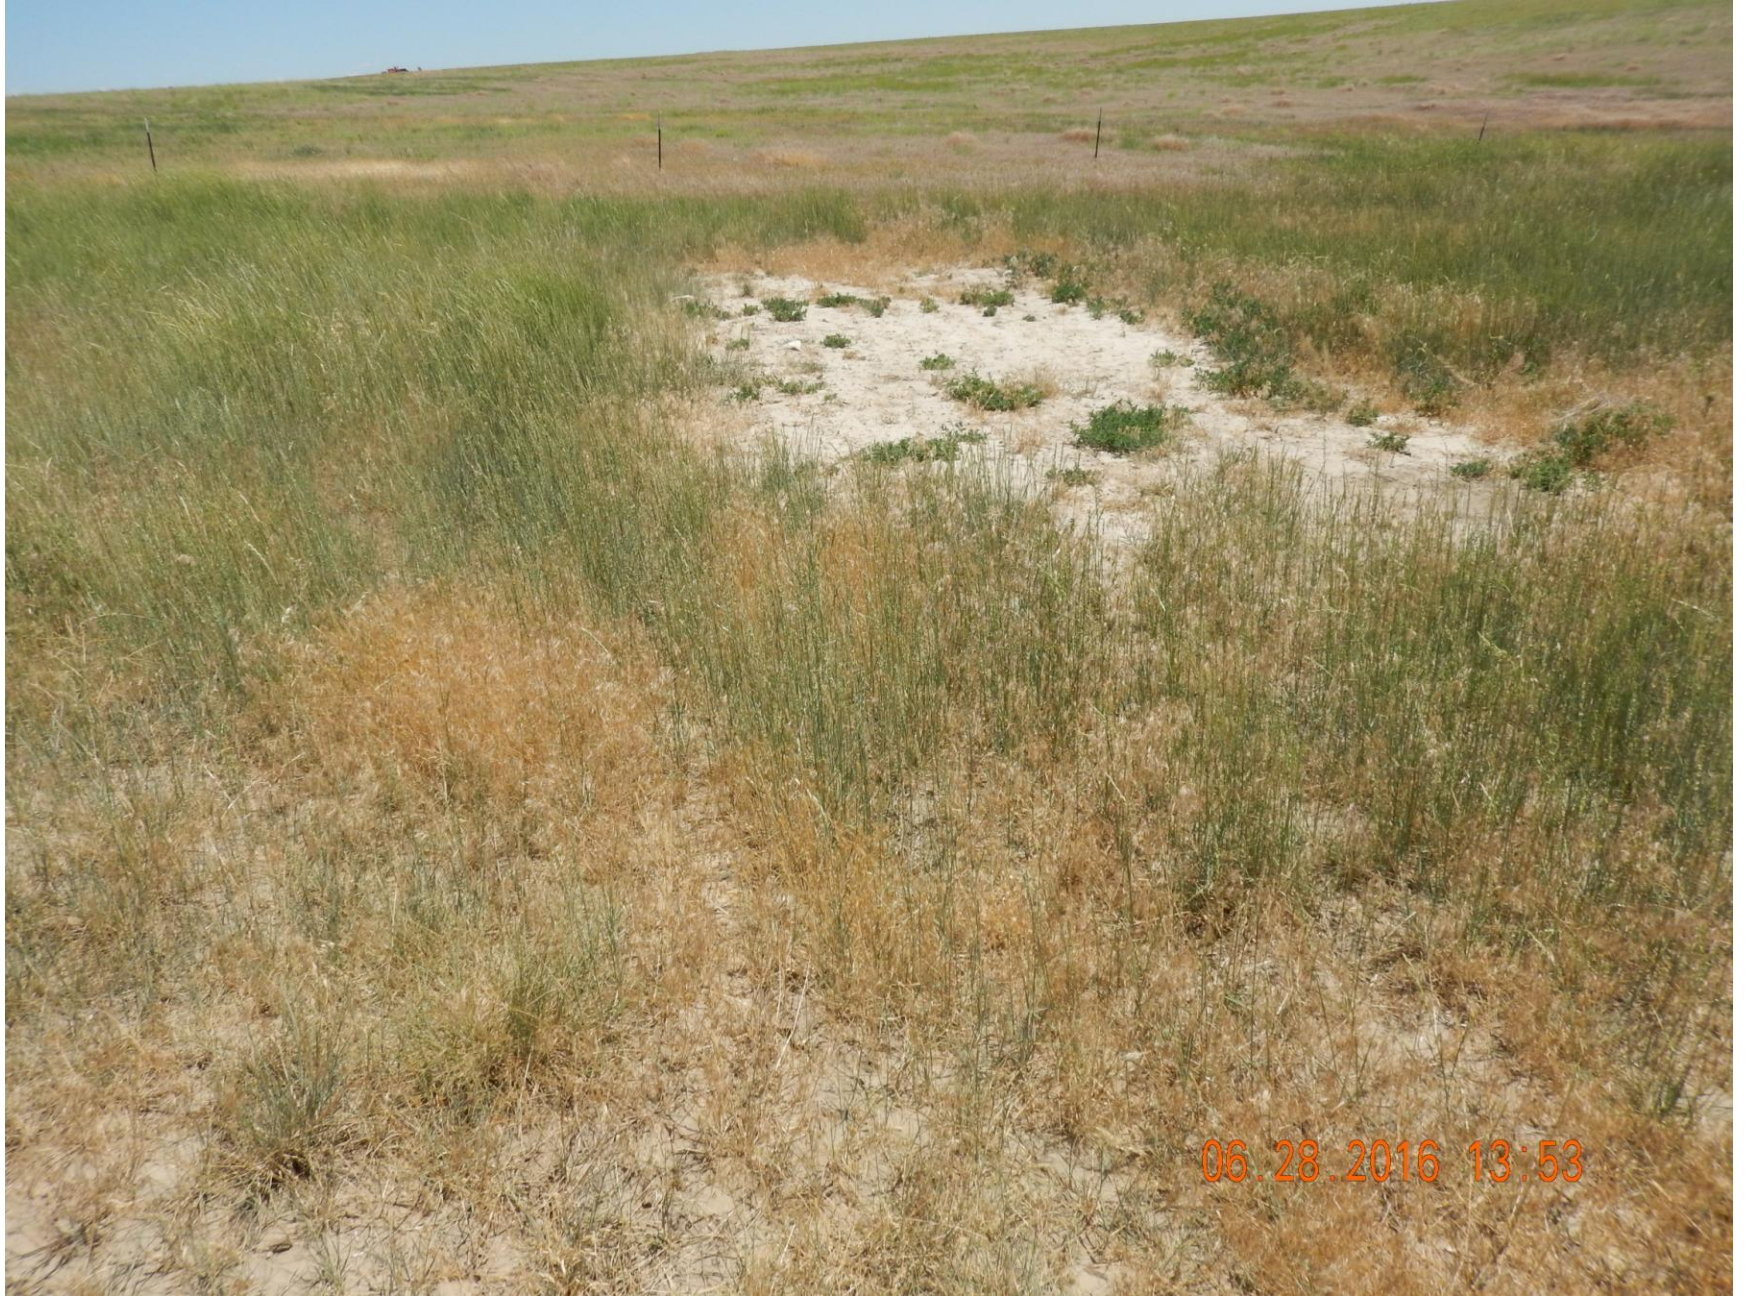
**Figure 10:** Photo taken from within the fenced remediation area. Photo shows remediation has not achieved uniform vegetative cover per reclamation regulations.
