# Final Reclamation Inspection

Operator: Petro-Canada

Location ID: 375675

NESE Section 23 T3S R59W

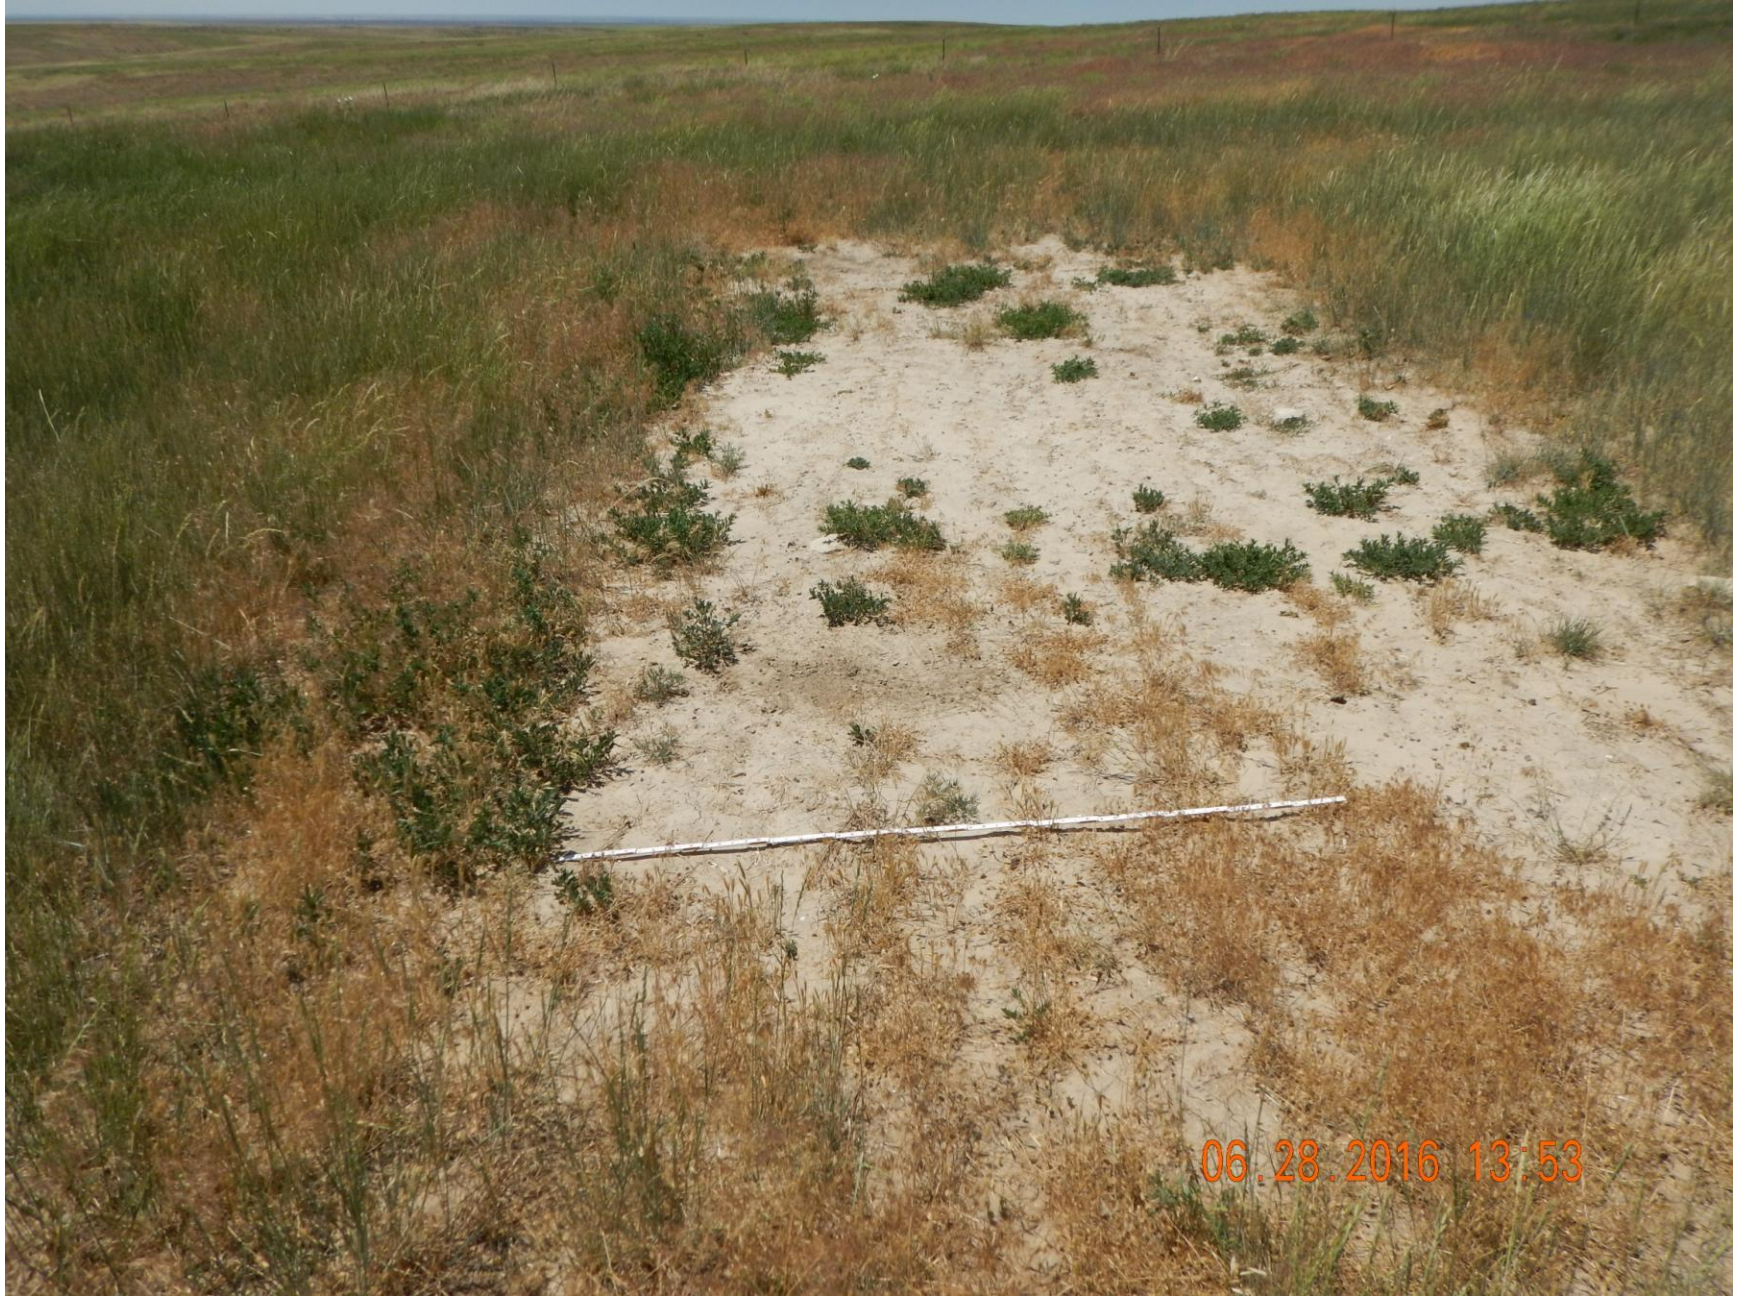
**Figure 11:** Photo taken from within the fenced remediation area. Photo shows remediation has not achieved uniform vegetative cover per reclamation regulations. 6' measuring stick for reference.

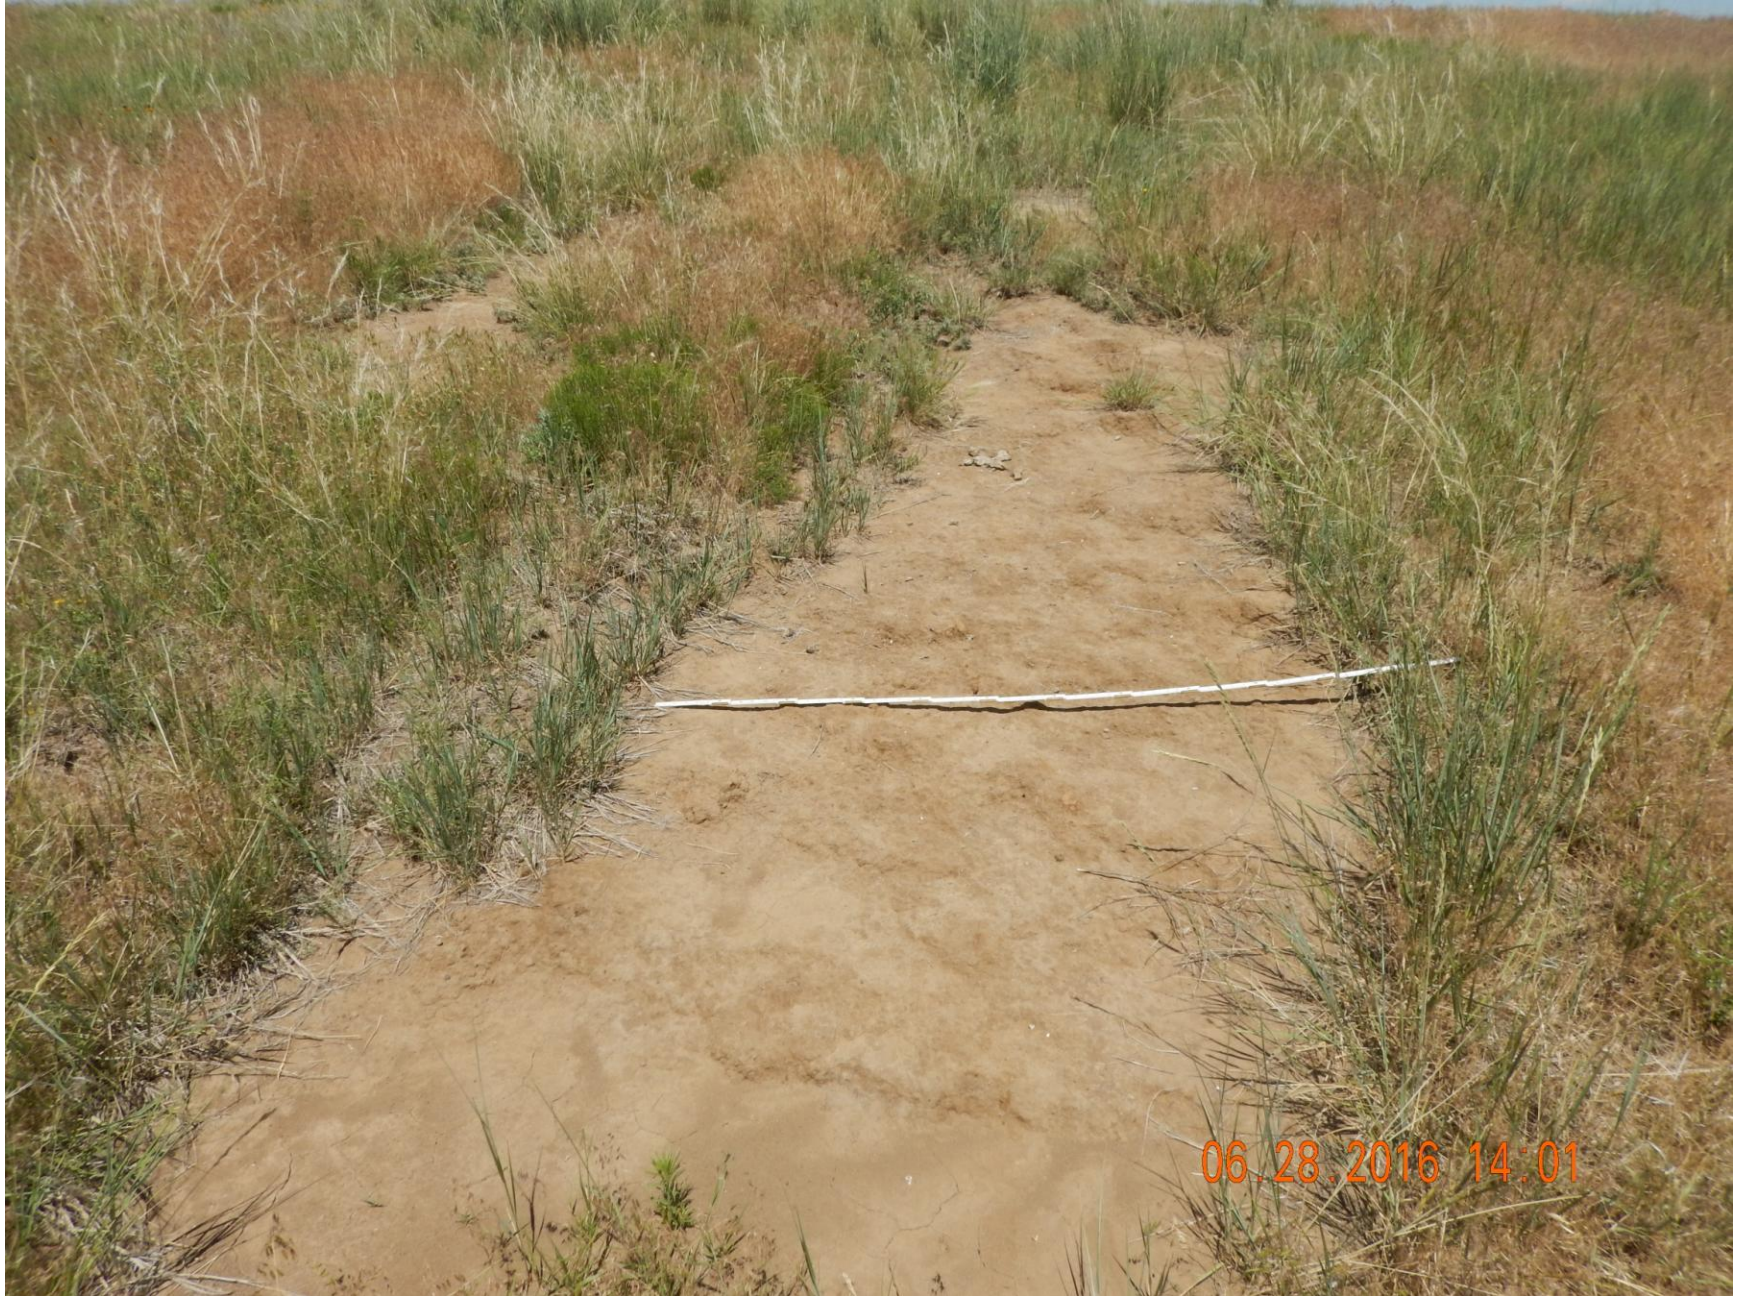
**Figure 12:** Photo taken from within the fenced remediation area. Photo shows remediation has not achieved uniform vegetative cover per reclamation regulations. 6' measuring stick for reference.
