Complaint #200440029
Rissler State Location ID: #306150

Complaint #200440029

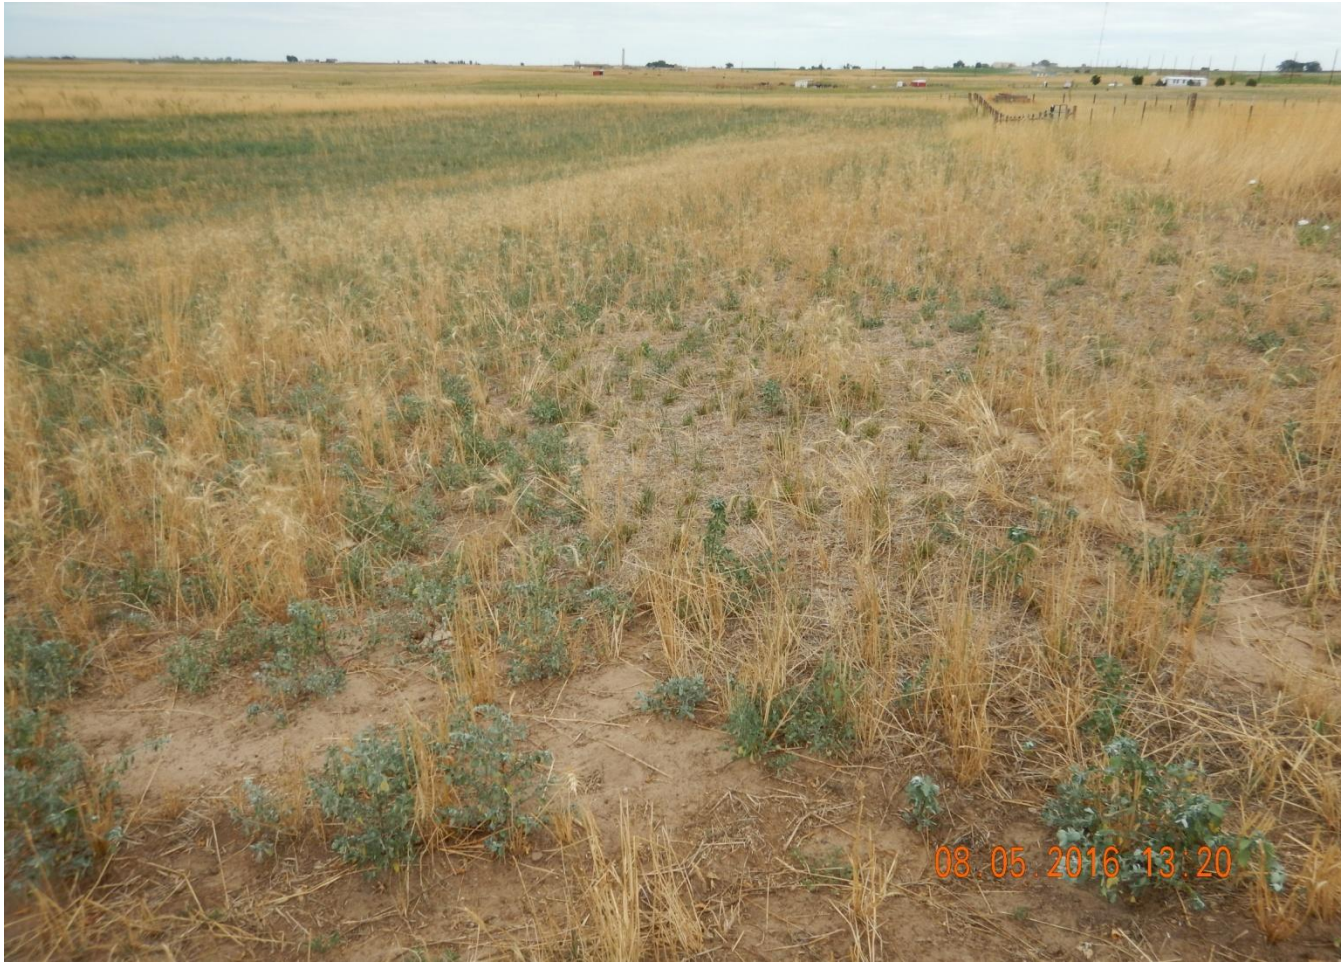
Photo 1. Photo taken from the south central location, facing East. Wildrye (*Elymus* sp.) and Kochia (*Kochia scoparia*) dominate interim area.

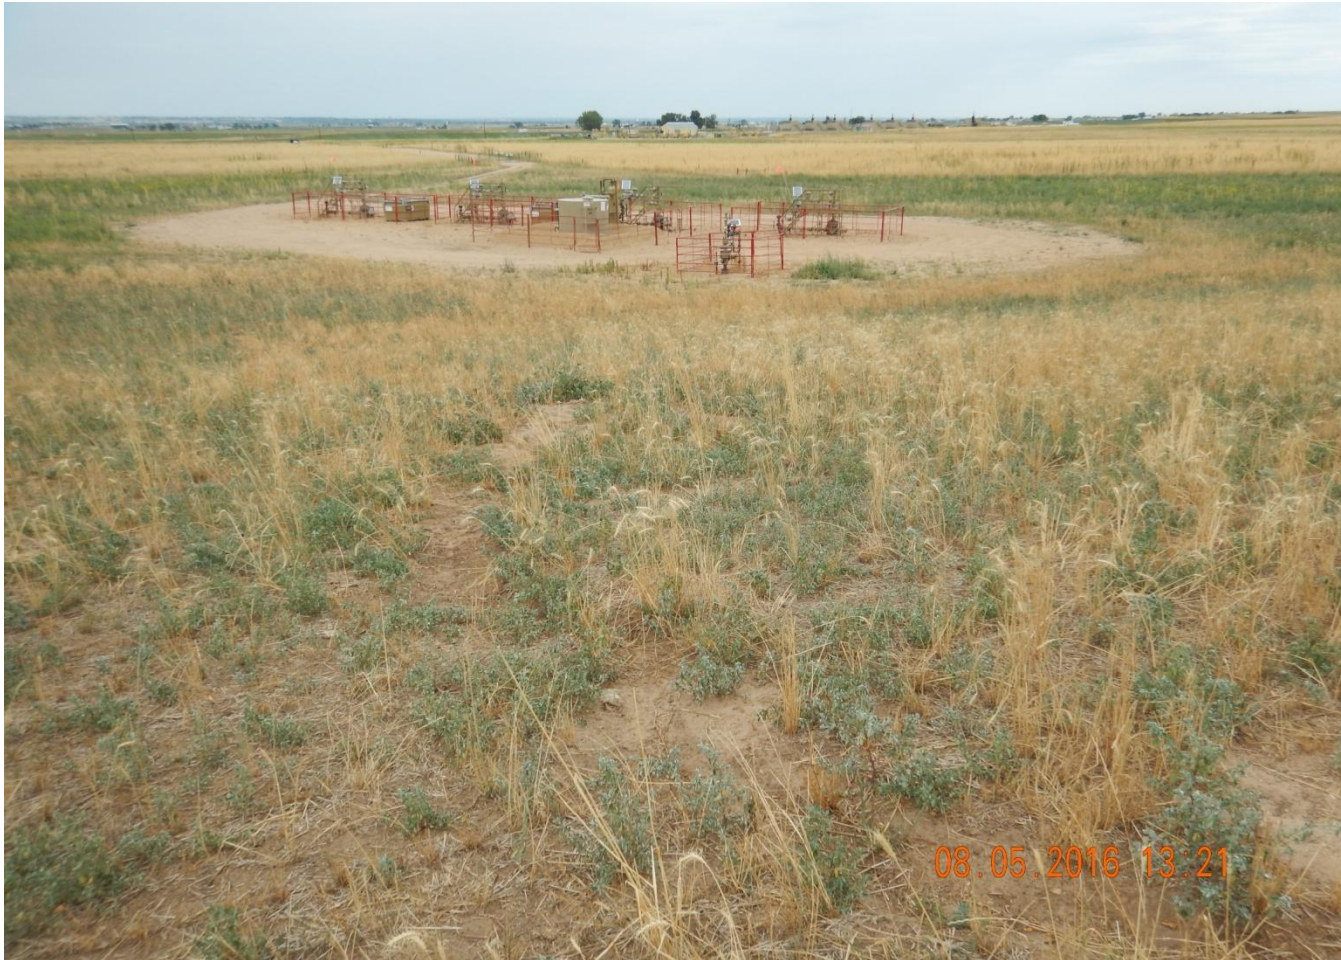
Photo 2. Photo taken from the south central location, facing North. Wildrye (*Elymus* sp.) and Kochia (*Kochia scoparia*) dominate interim area.

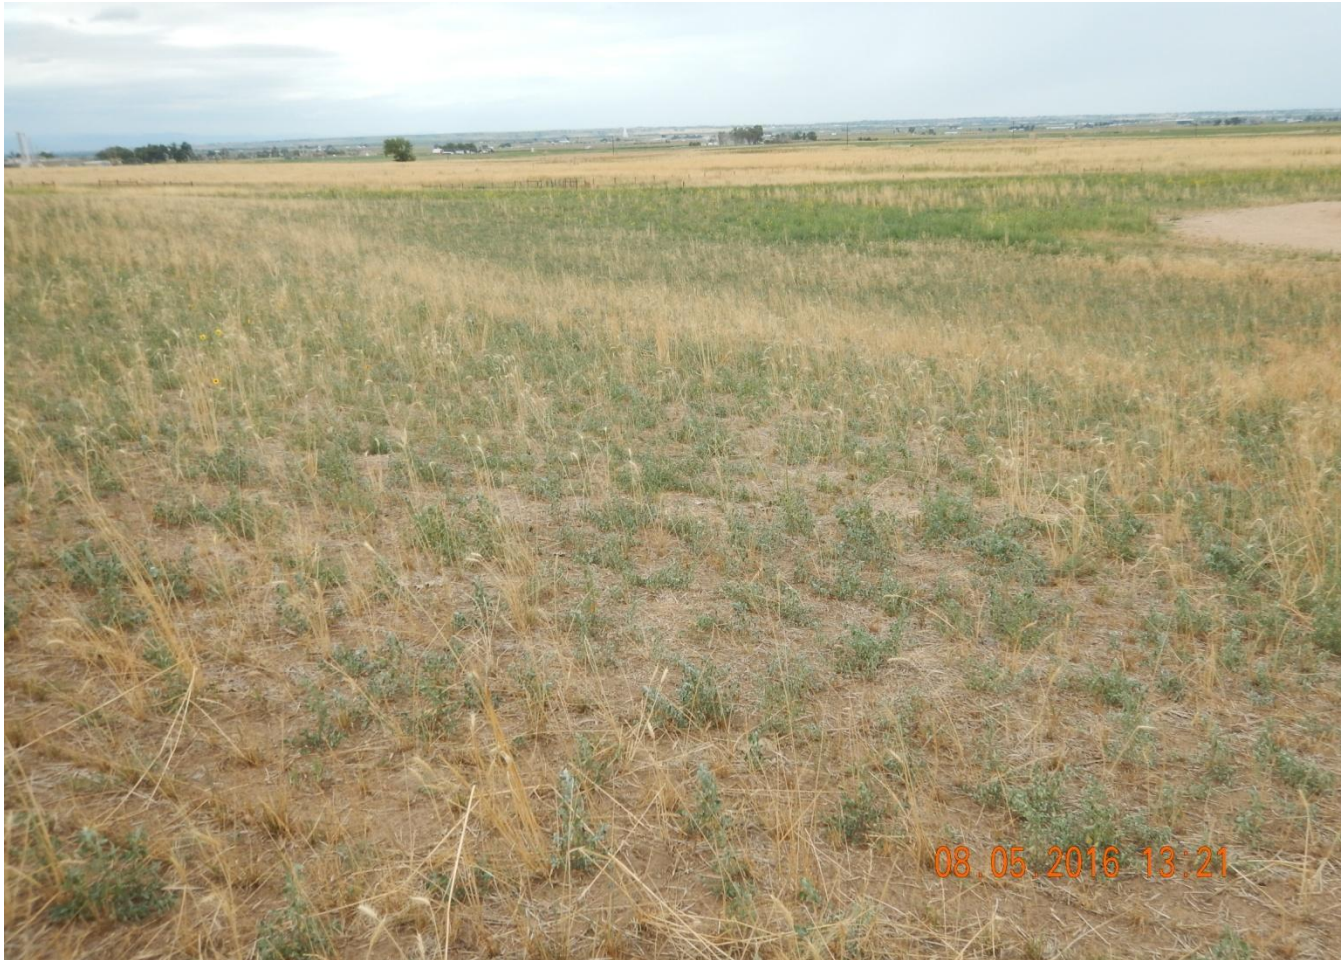
Photo 3. Photo taken from the south central location, facing West. Wildrye (*Elymus* sp.) and Kochia (*Kochia scoparia*) dominate interim area.

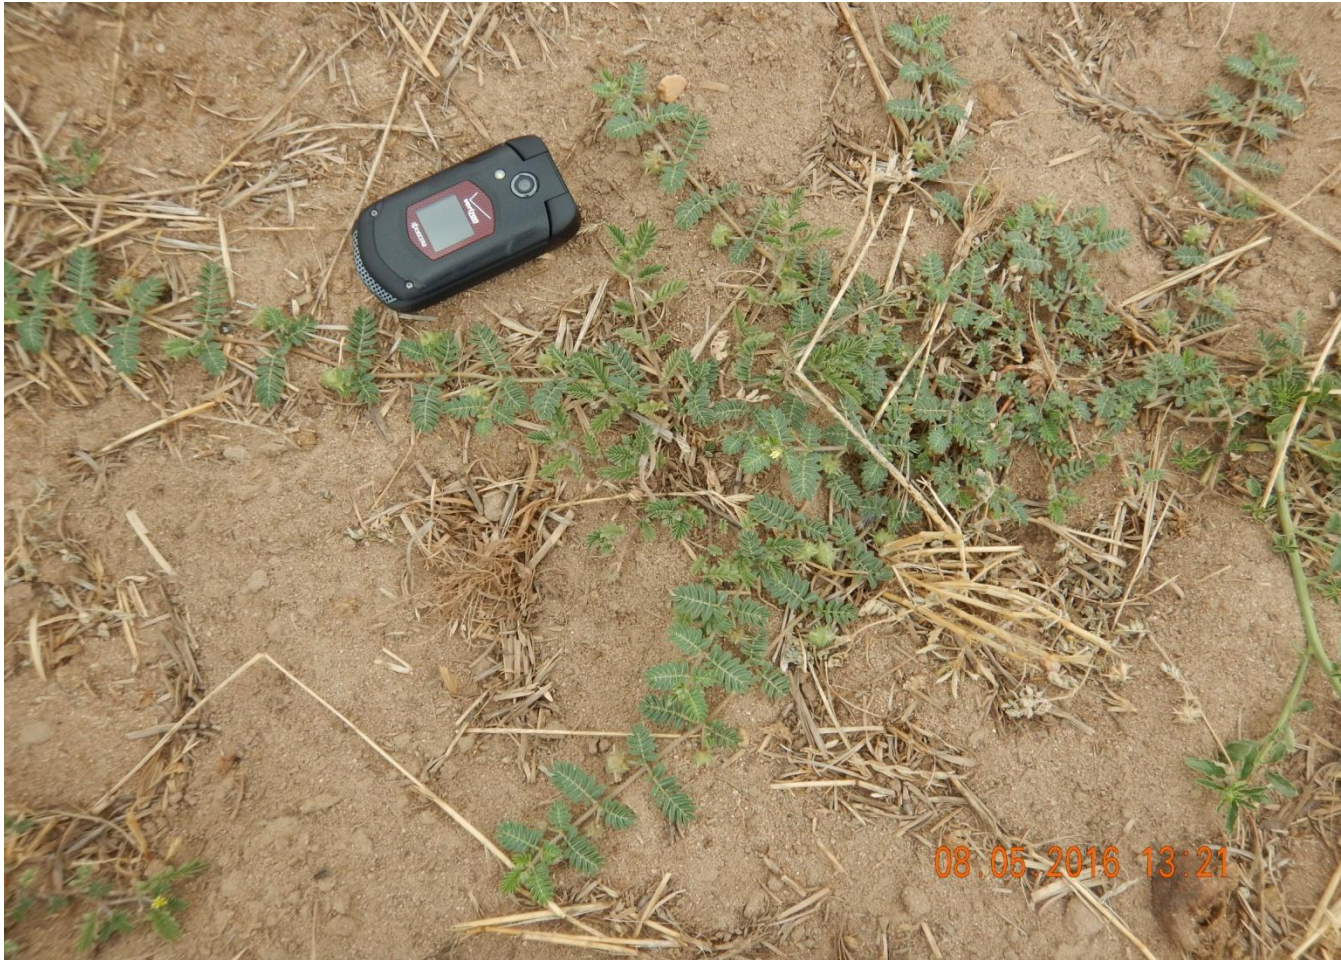
Photo 4. Close-up photo of puncturevine (*Tribulus terrestris*) that has established in many areas throughout the interim area.

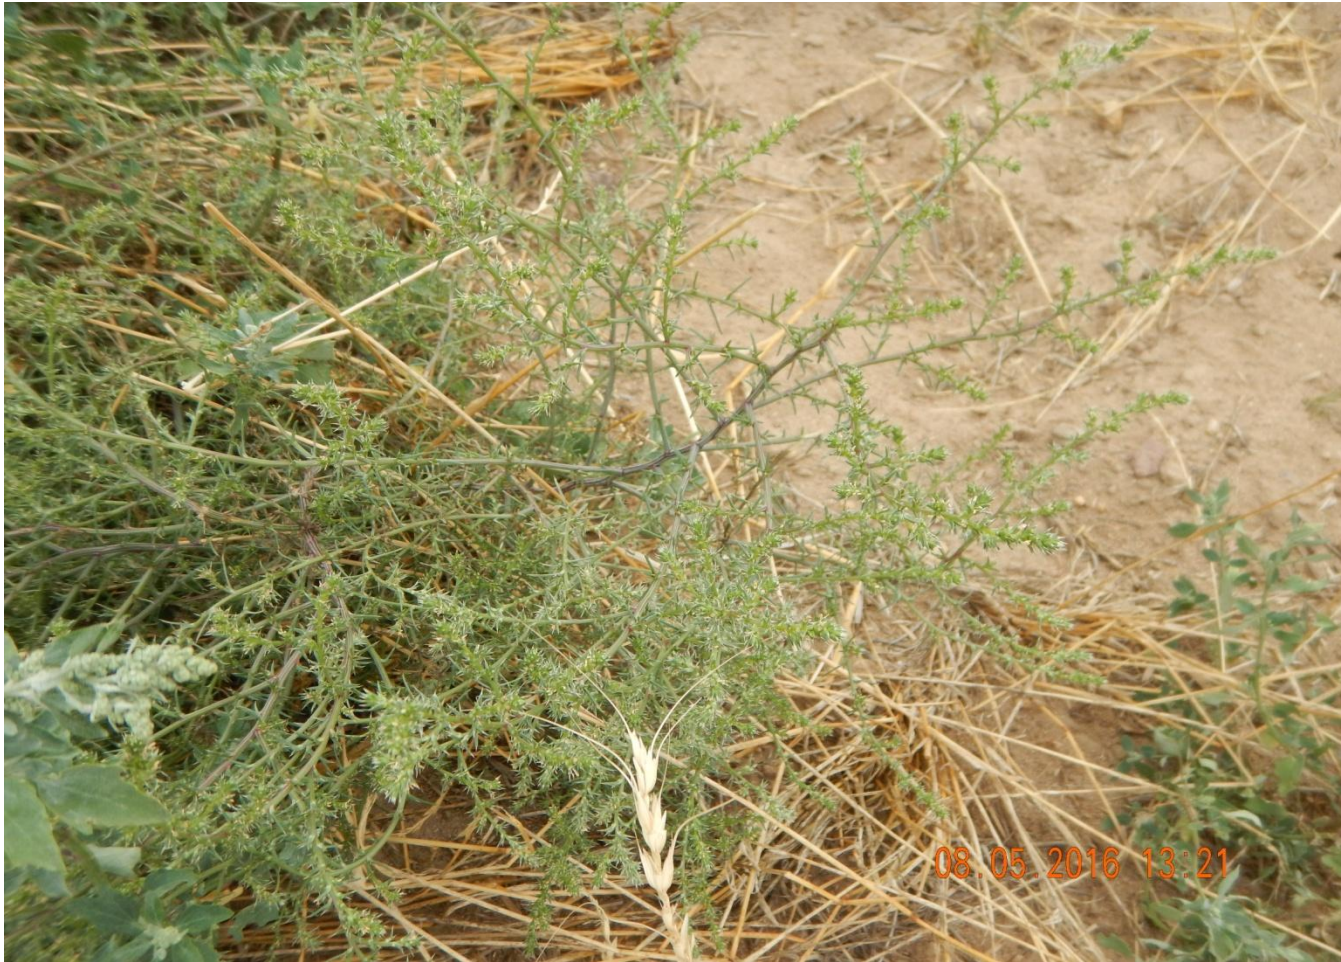
Photo 5. Close-up photo of Russian thistle (*Salsola sp.*).

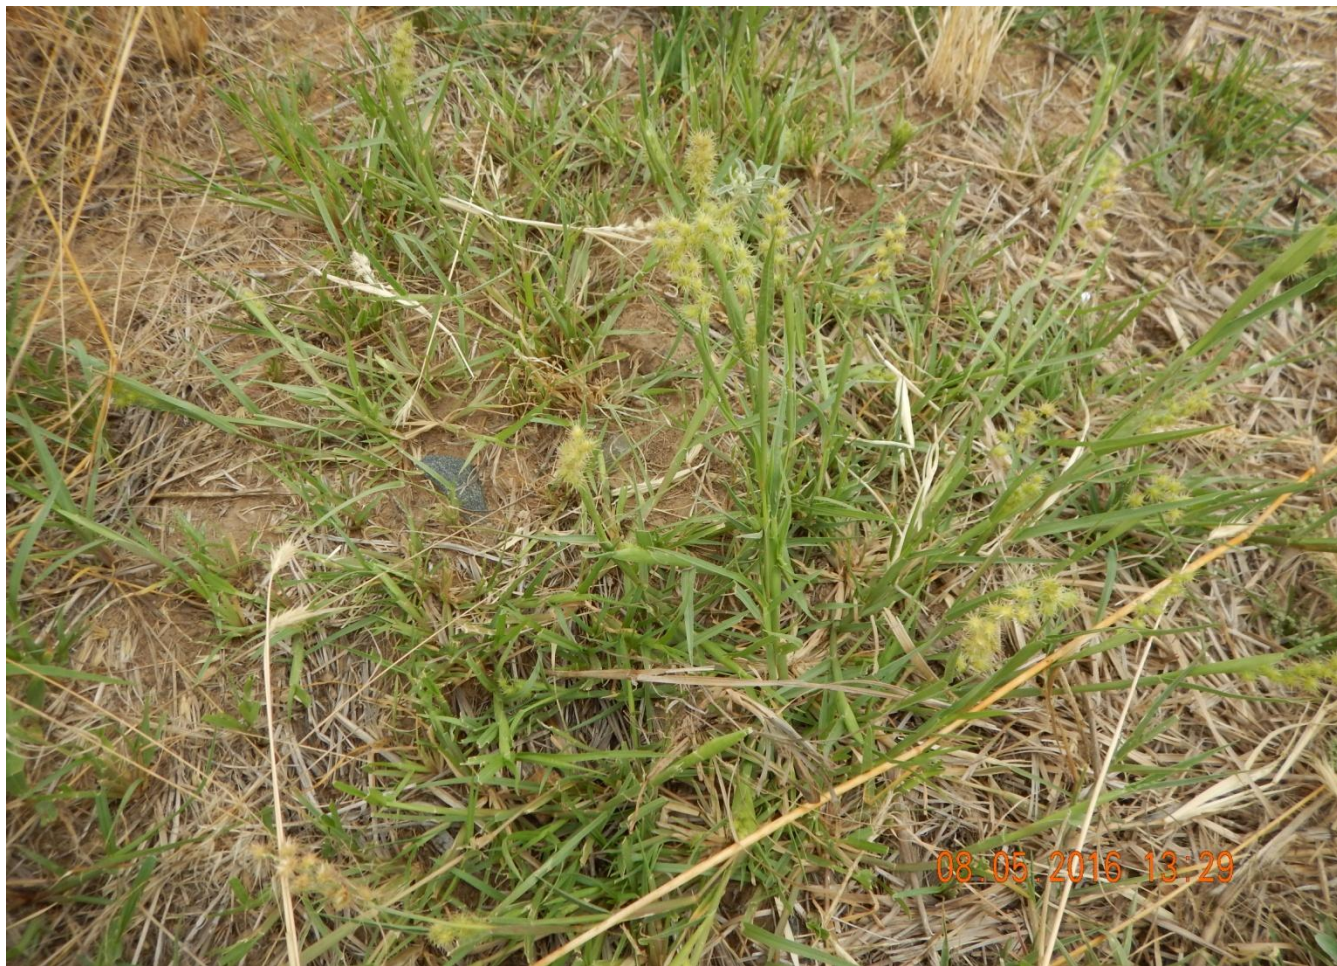
Photo 6. Close-up photo of longspine sandbur (*Cenchrus longispinus*).

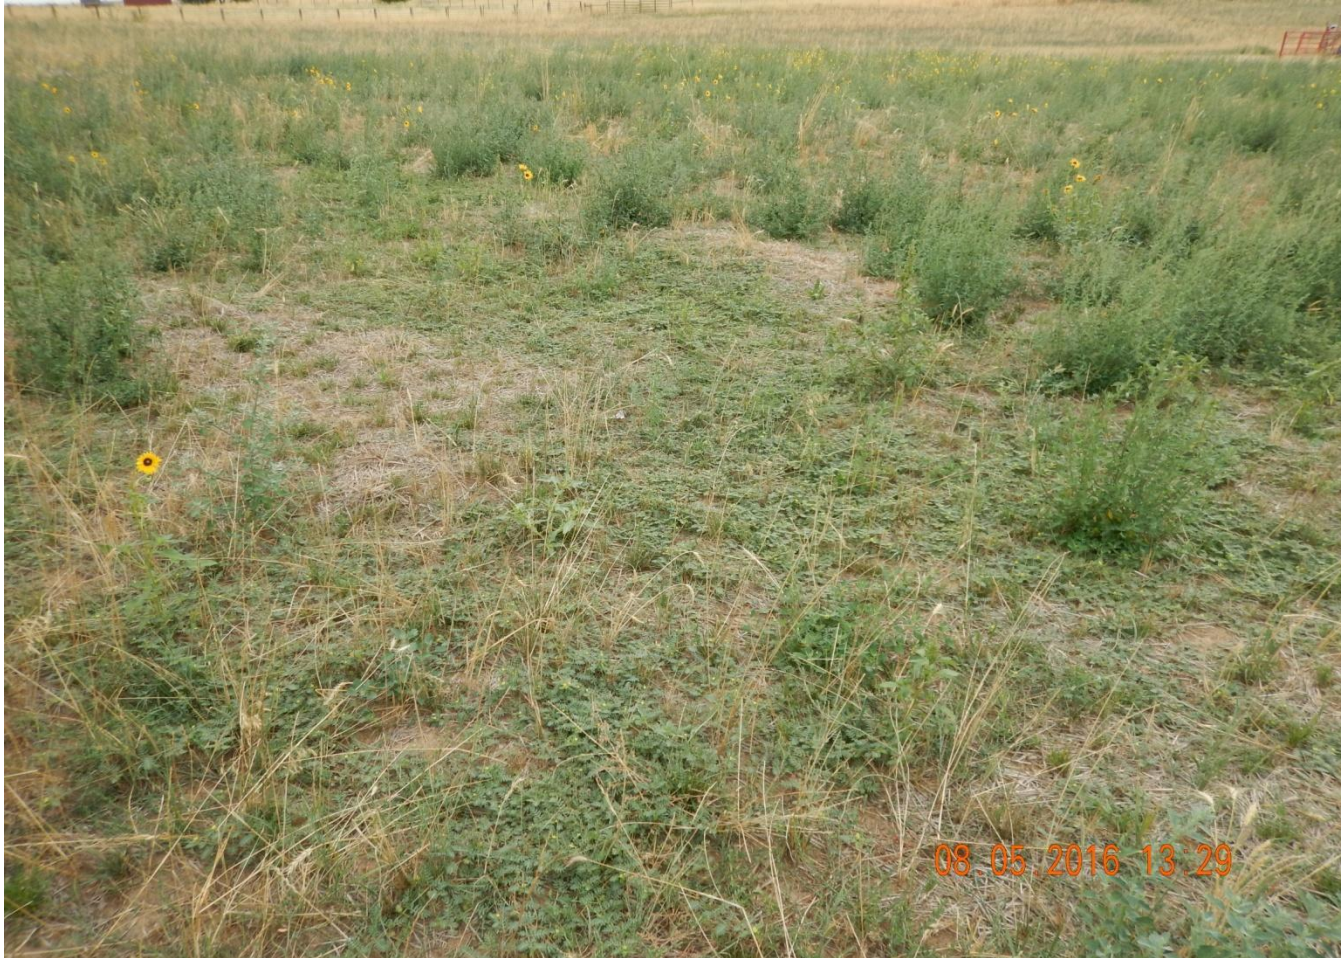
Photo 7. Photo taken from the eastern location, facing West. Notice the puncturevine and Kochia dominating the interim area.
