Construction Inspection

08/01/2016

Operator: Grand Mesa

Location ID: 445661

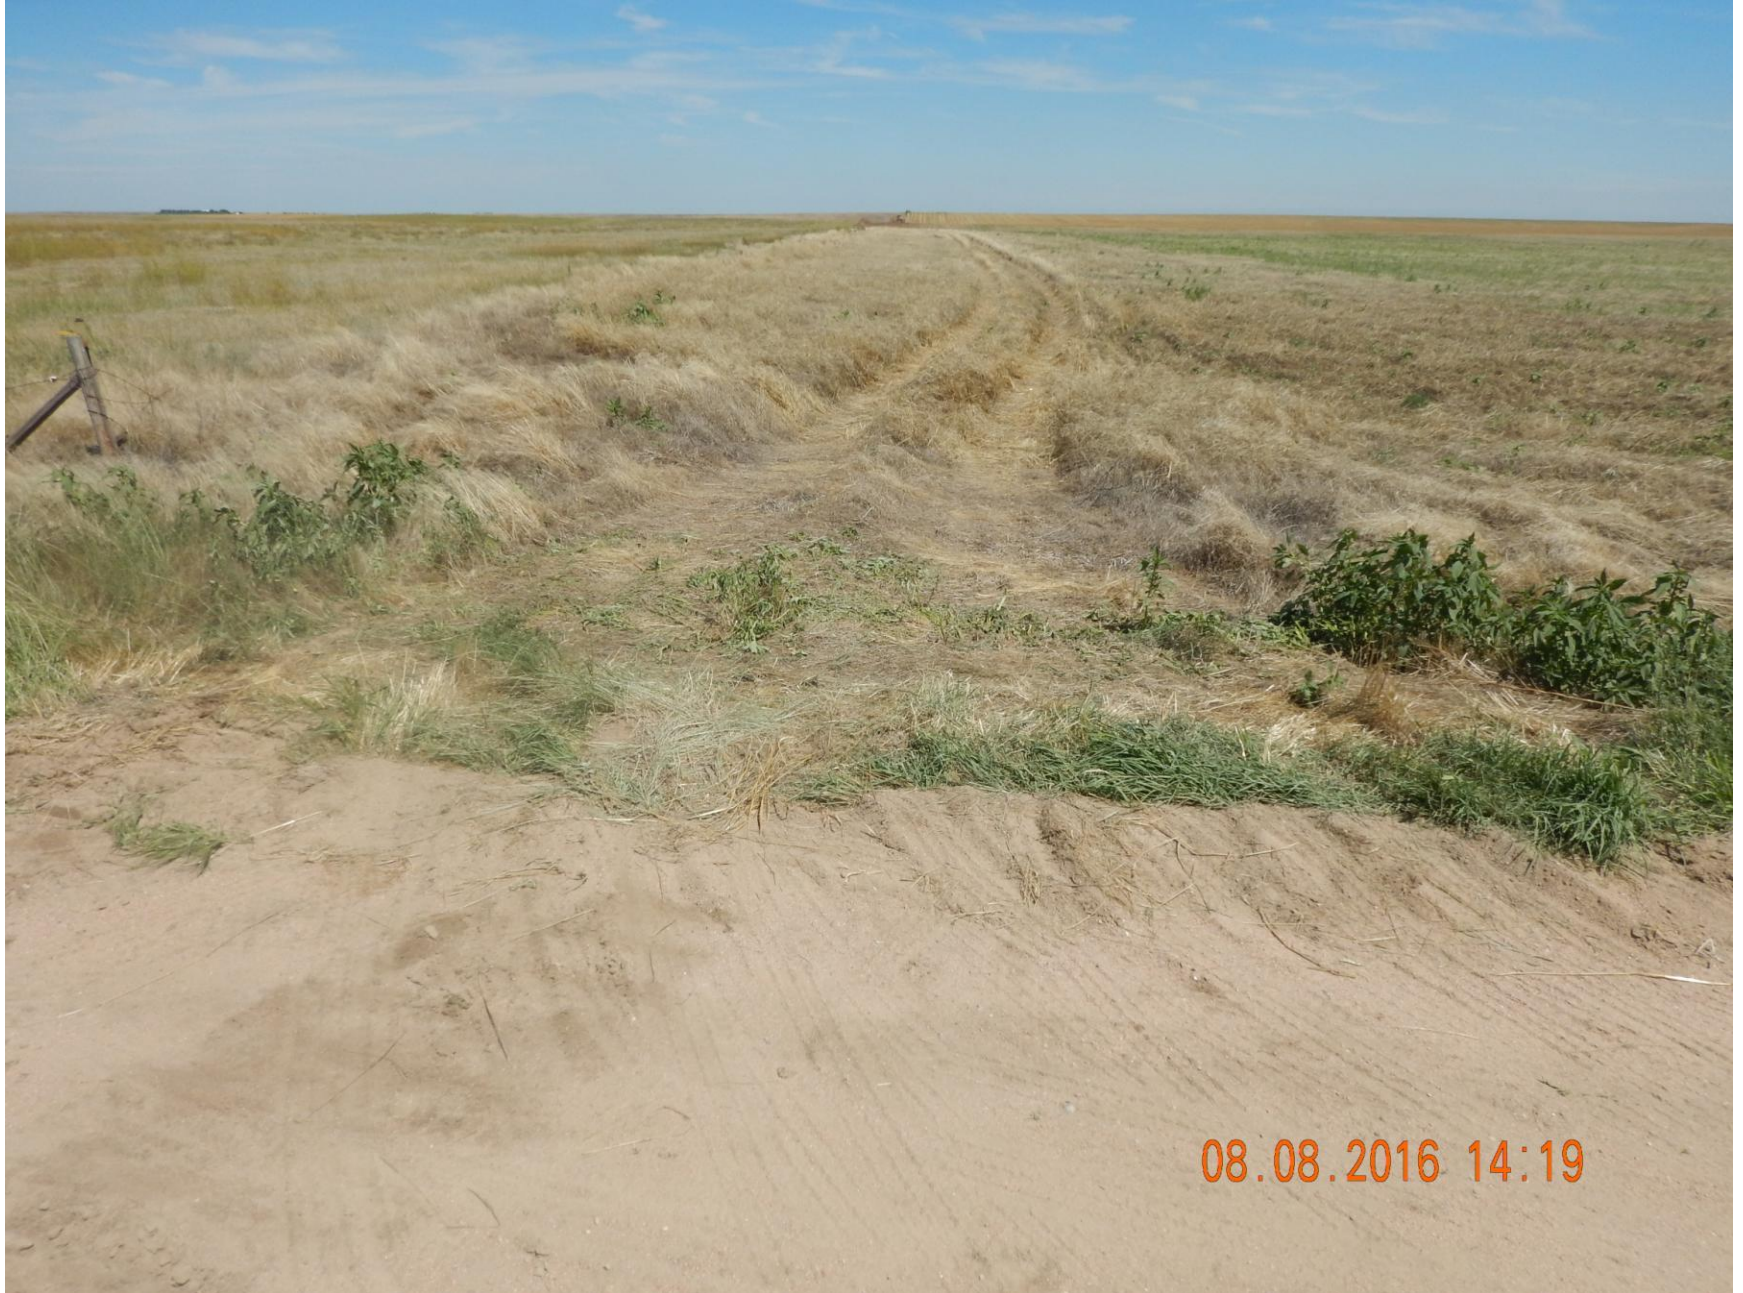
Figure 1: Photo taken from CR U, west of the location, facing east. Photo shows area vehicles have used to access location. Likely to be where access road will be constructed.

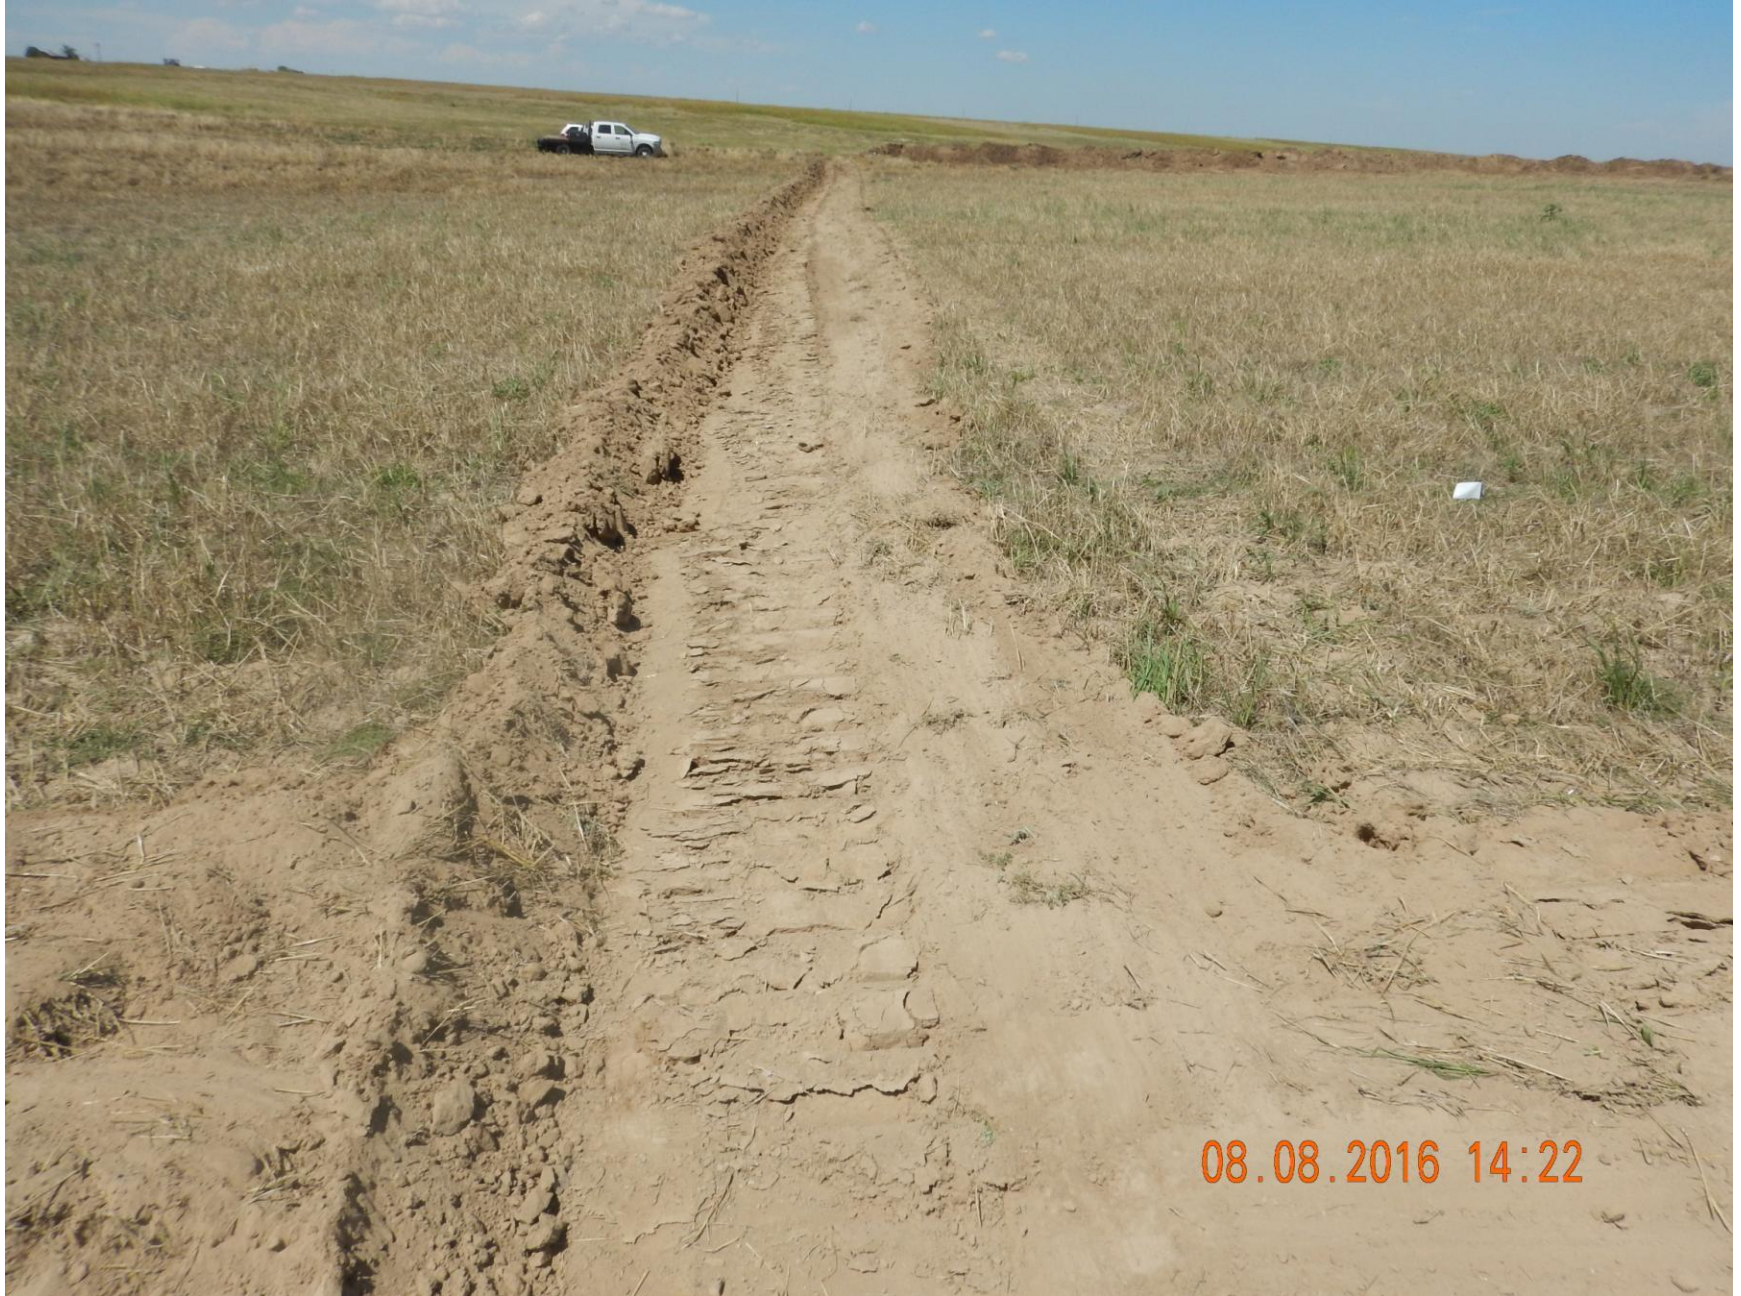
Figure 2: Photo taken from the southwest corner of the location, facing north. Photo shows stormwater and sediment control ditch on the western perimeter.

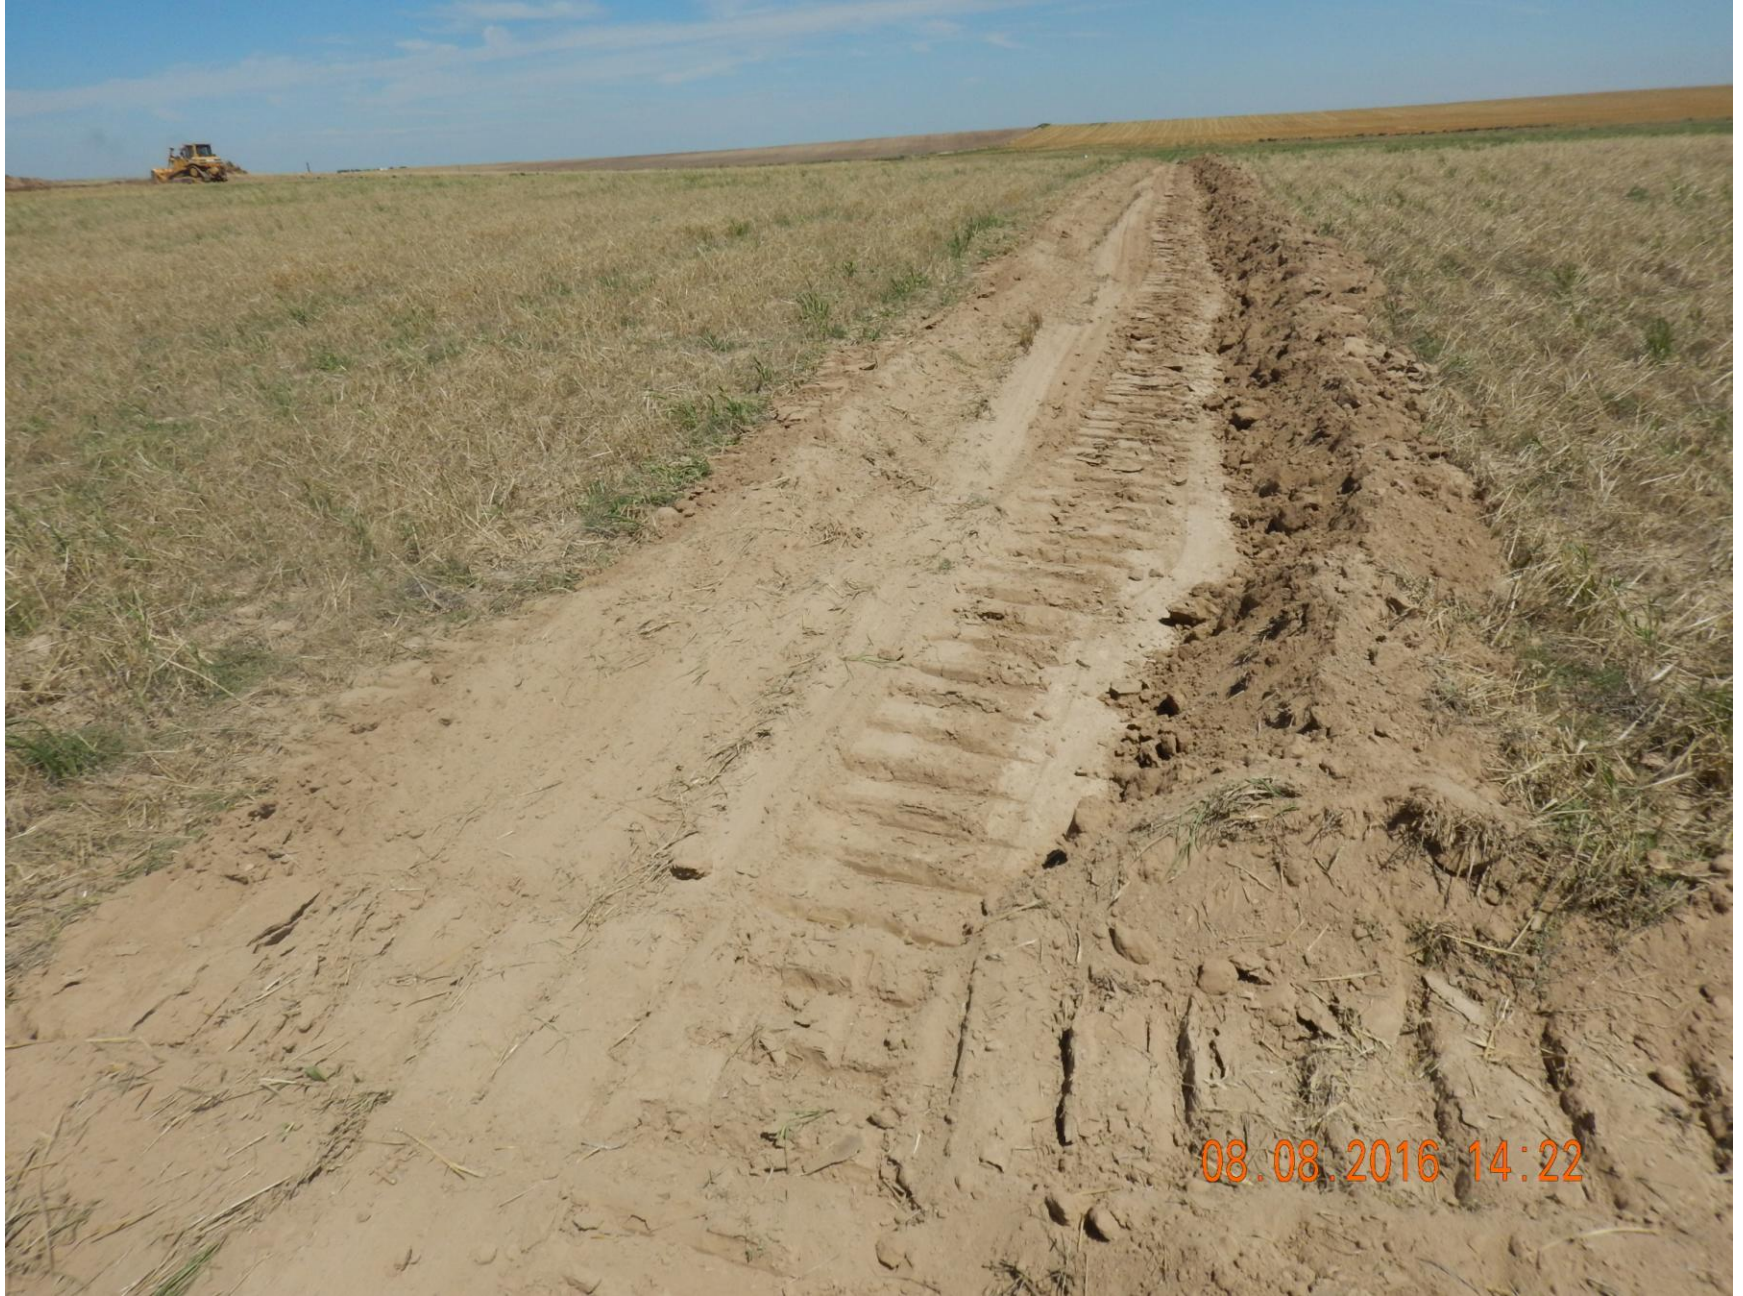
Figure 3: Photo taken from the southwest corner of the location, facing east. Photo shows stormwater and sediment control ditch on the eastern perimeter.

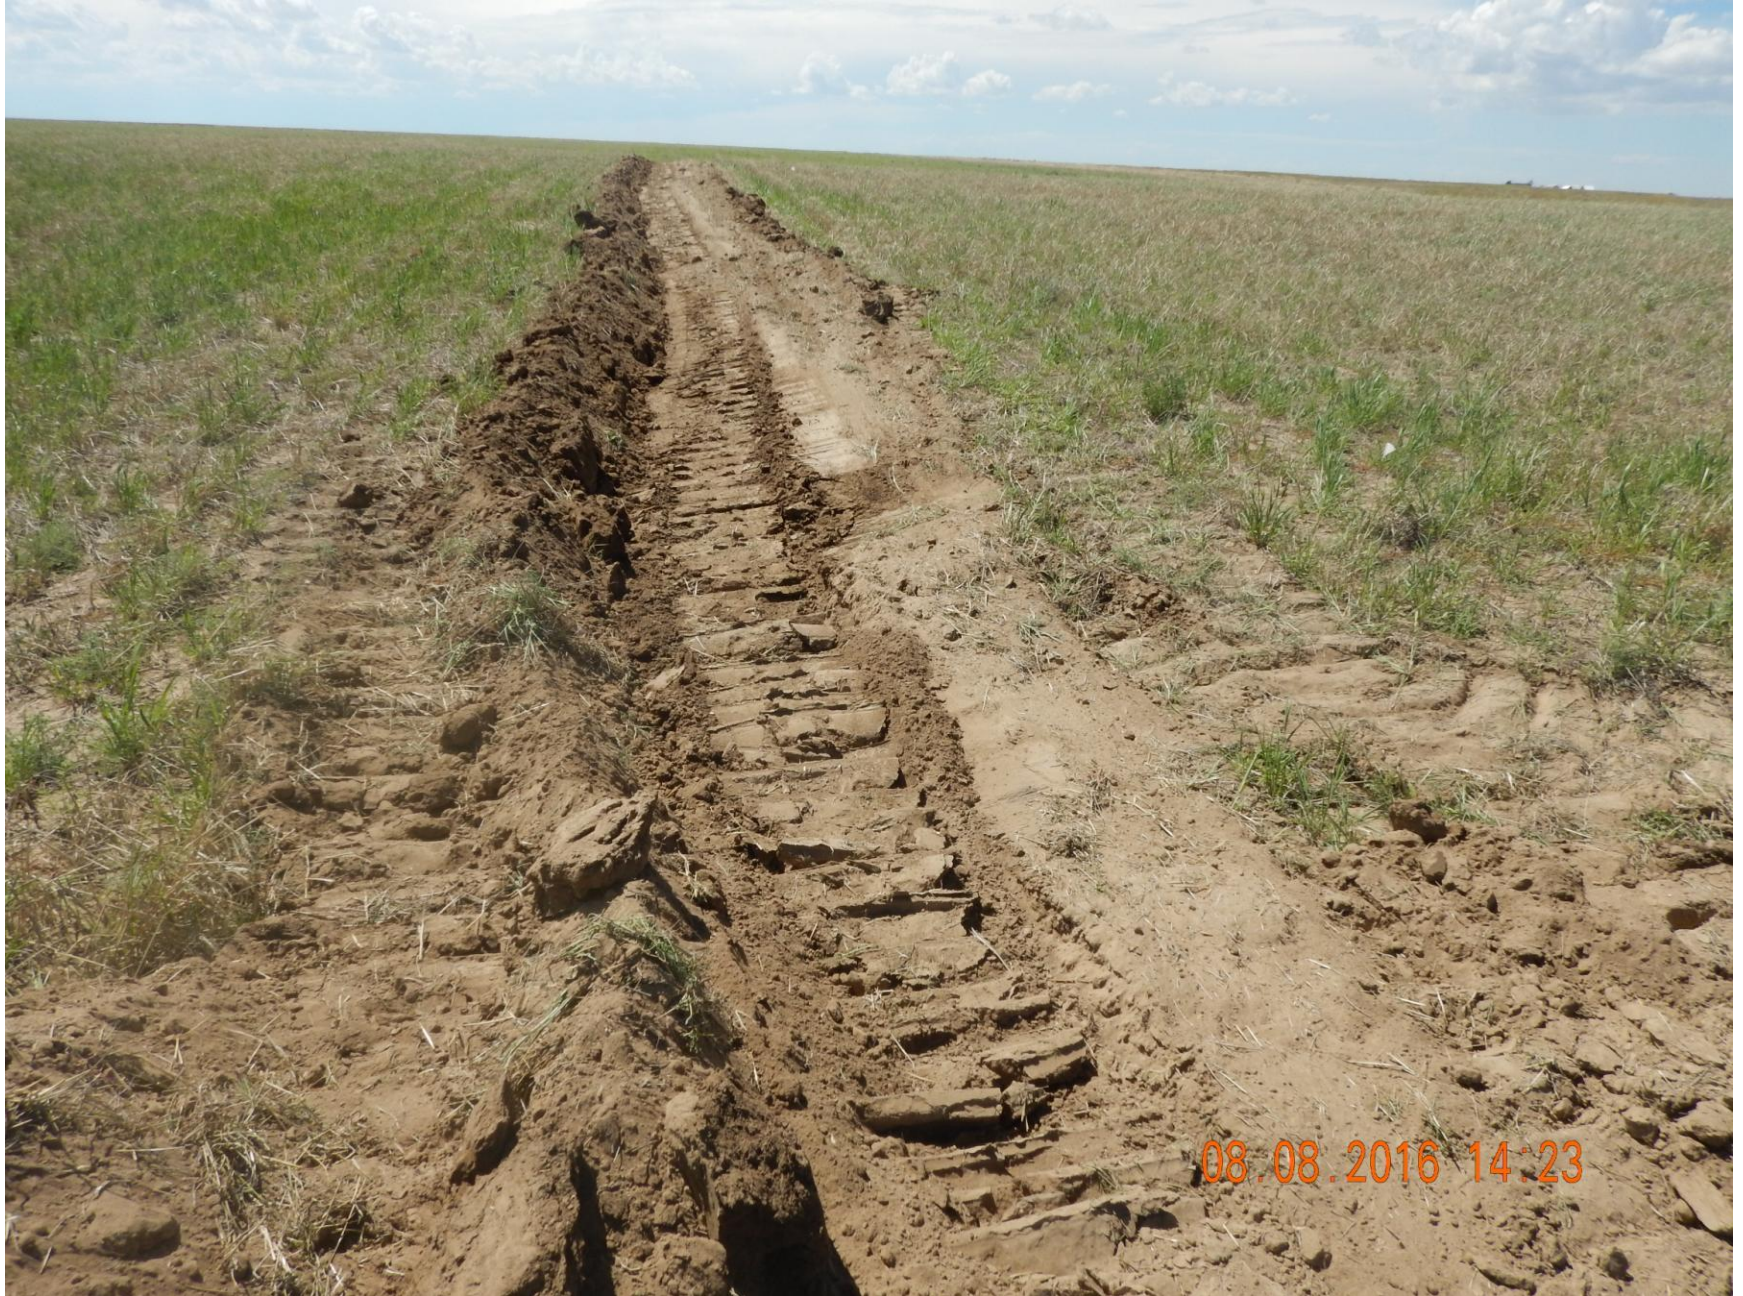
Figure 4: Photo taken from the southeast corner of the location, facing west. Photo shows stormwater and sediment control ditch on the southern perimeter.

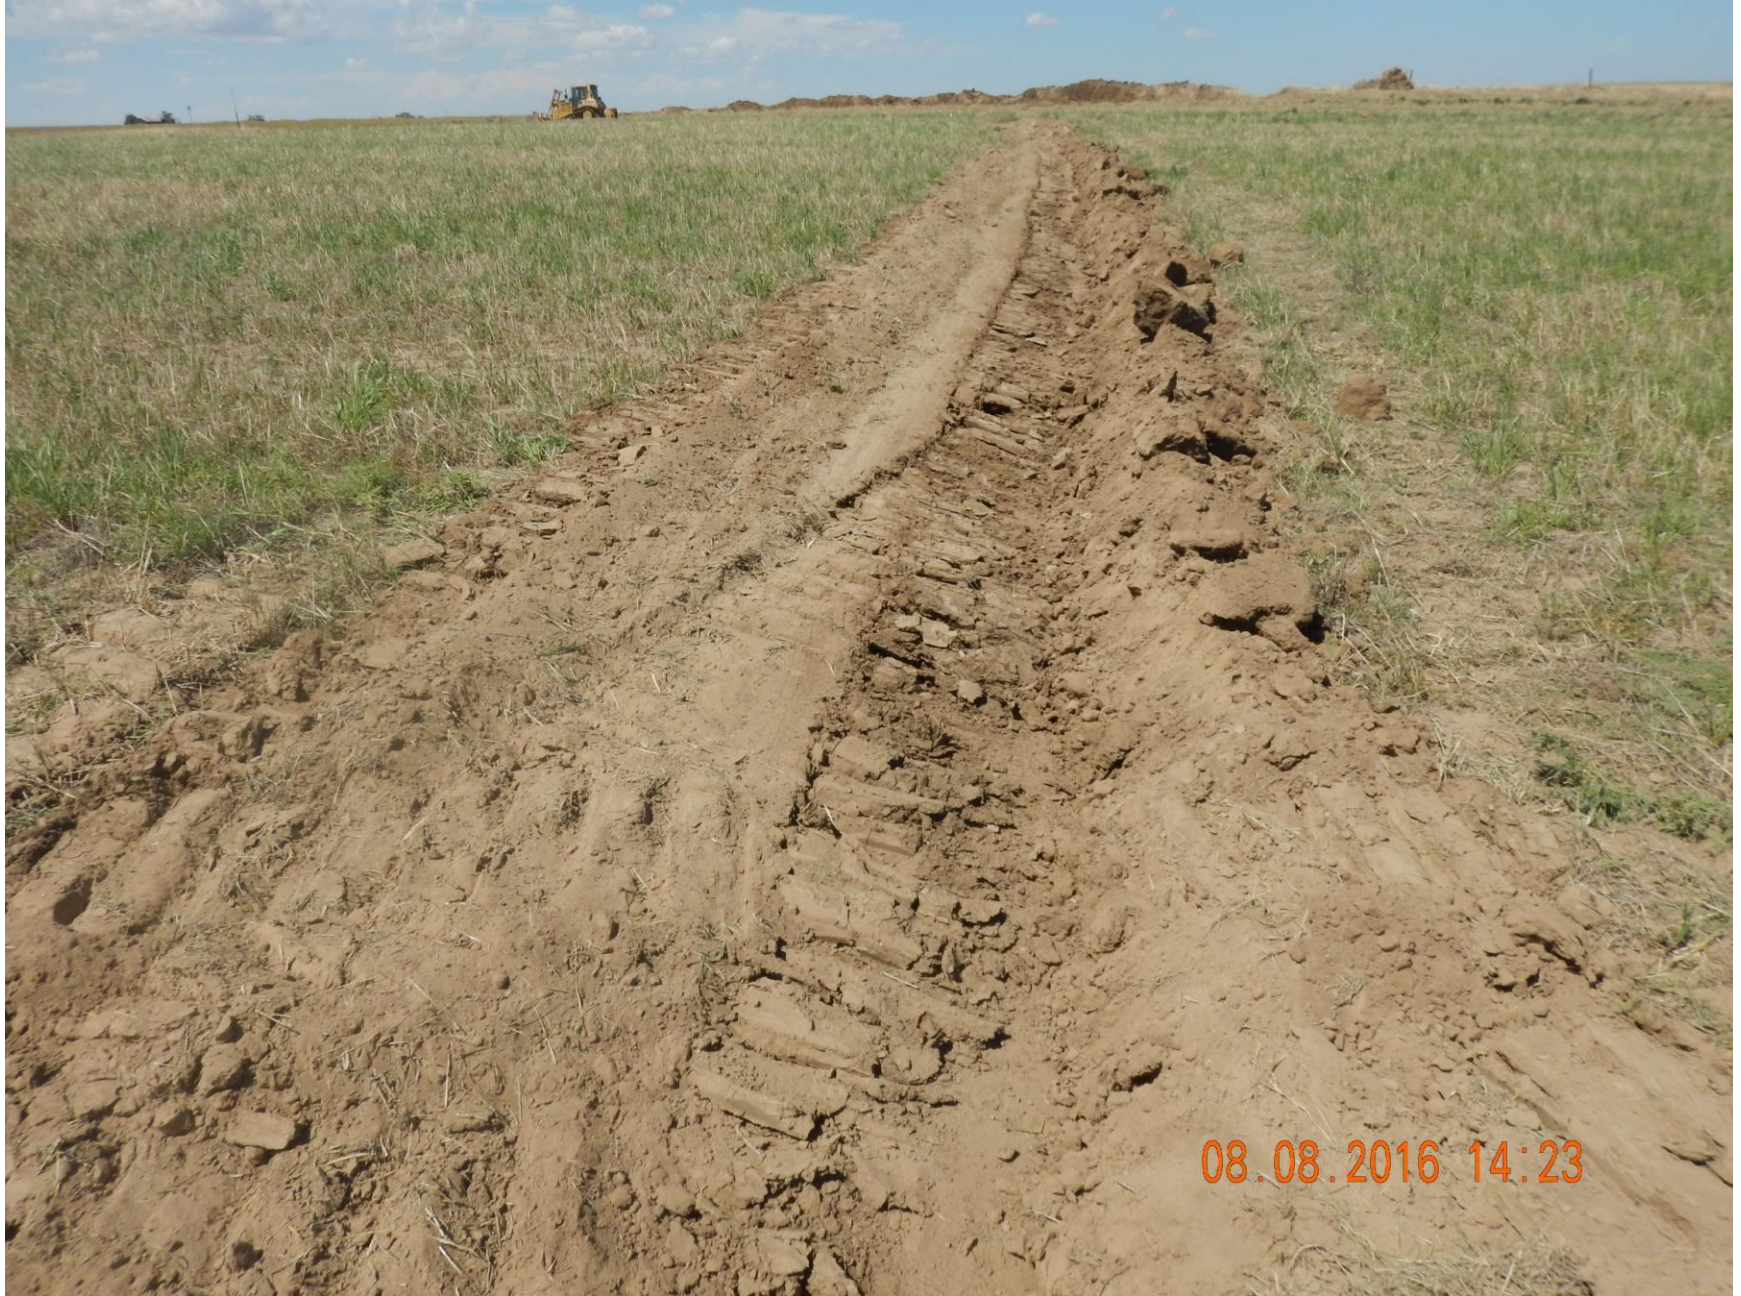
Figure 5: Photo taken from the southeast corner of the location, facing north. Photo shows stormwater and sediment control ditch on the eastern perimeter..

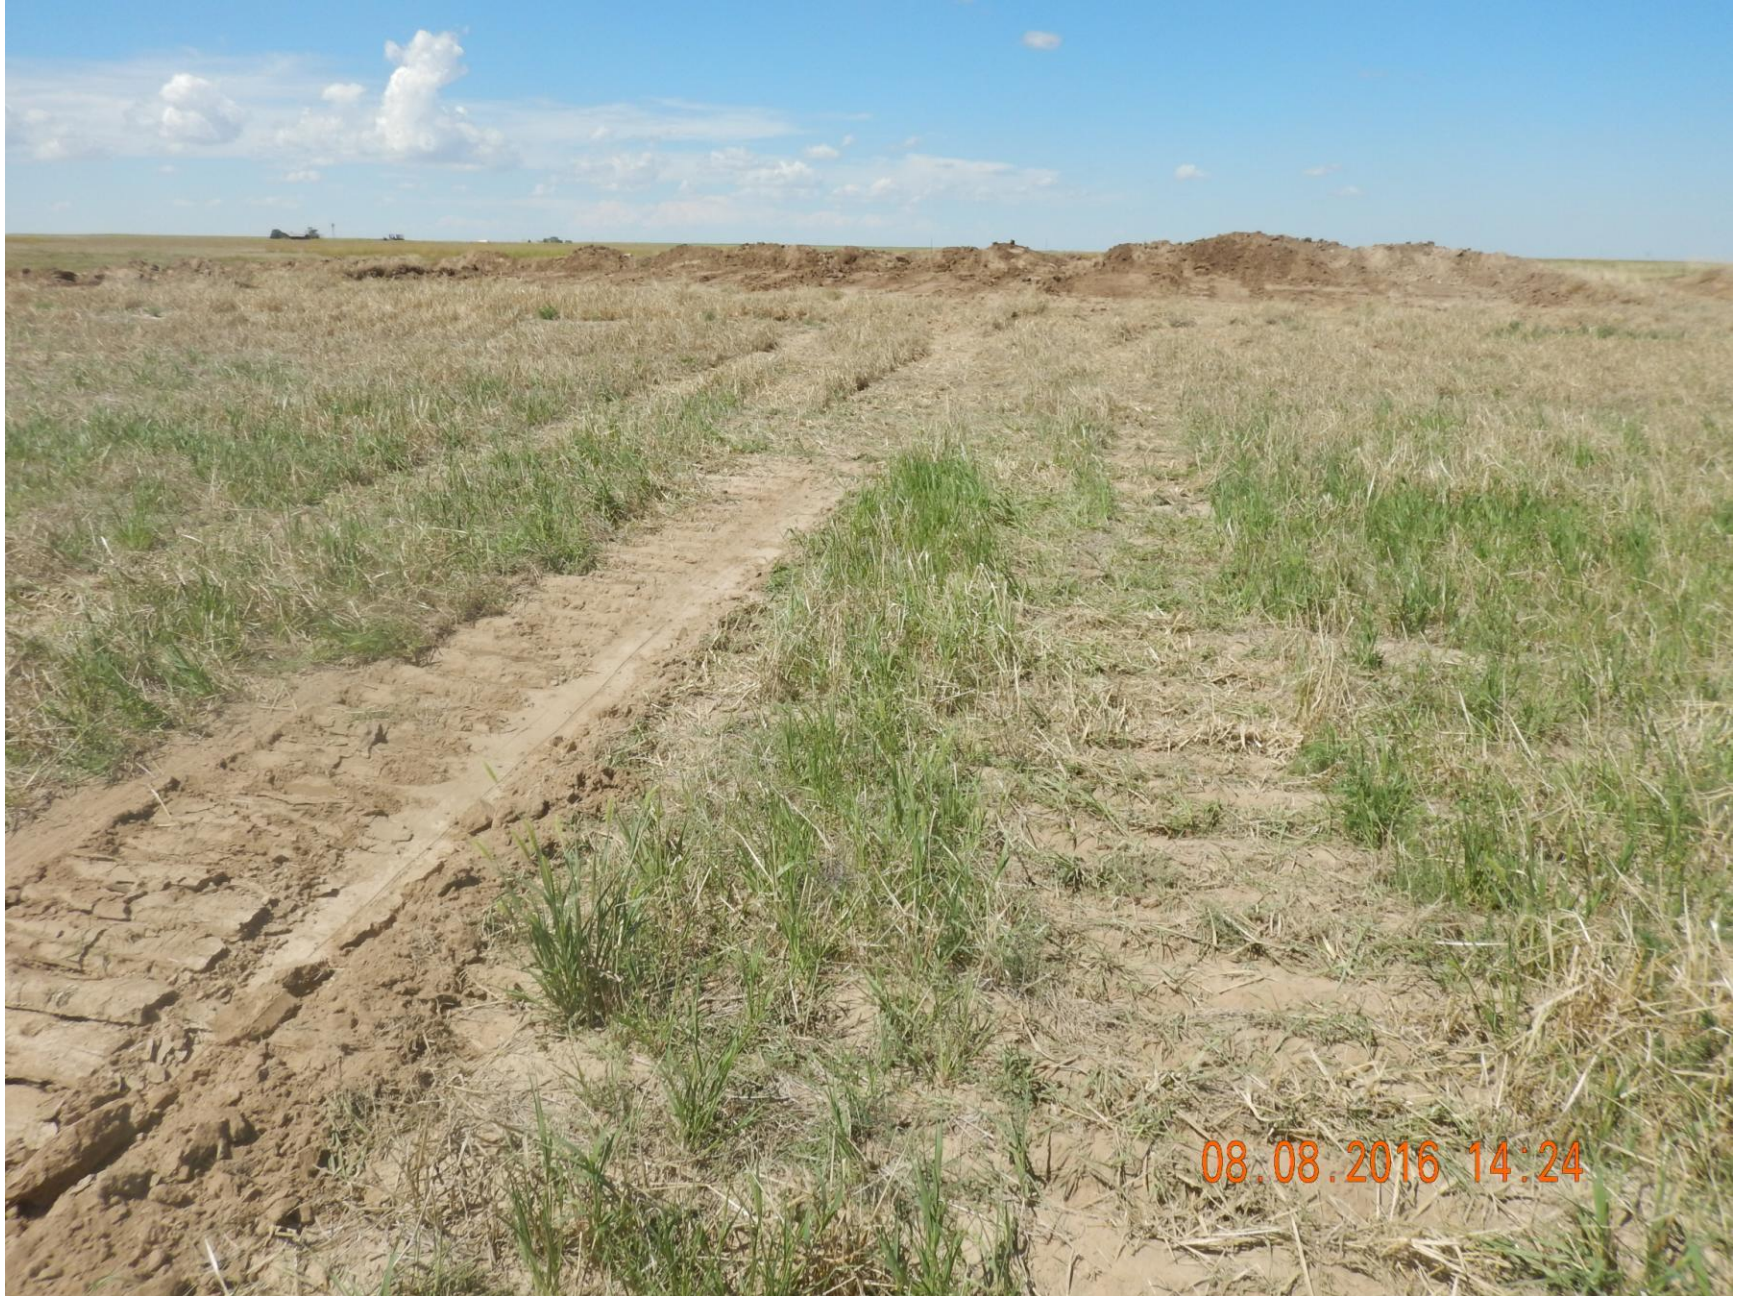
Figure 6: Photo taken from the east end of the location, facing north. Photo shows stormwater and sediment control BMP incomplete on the eastern perimeter.

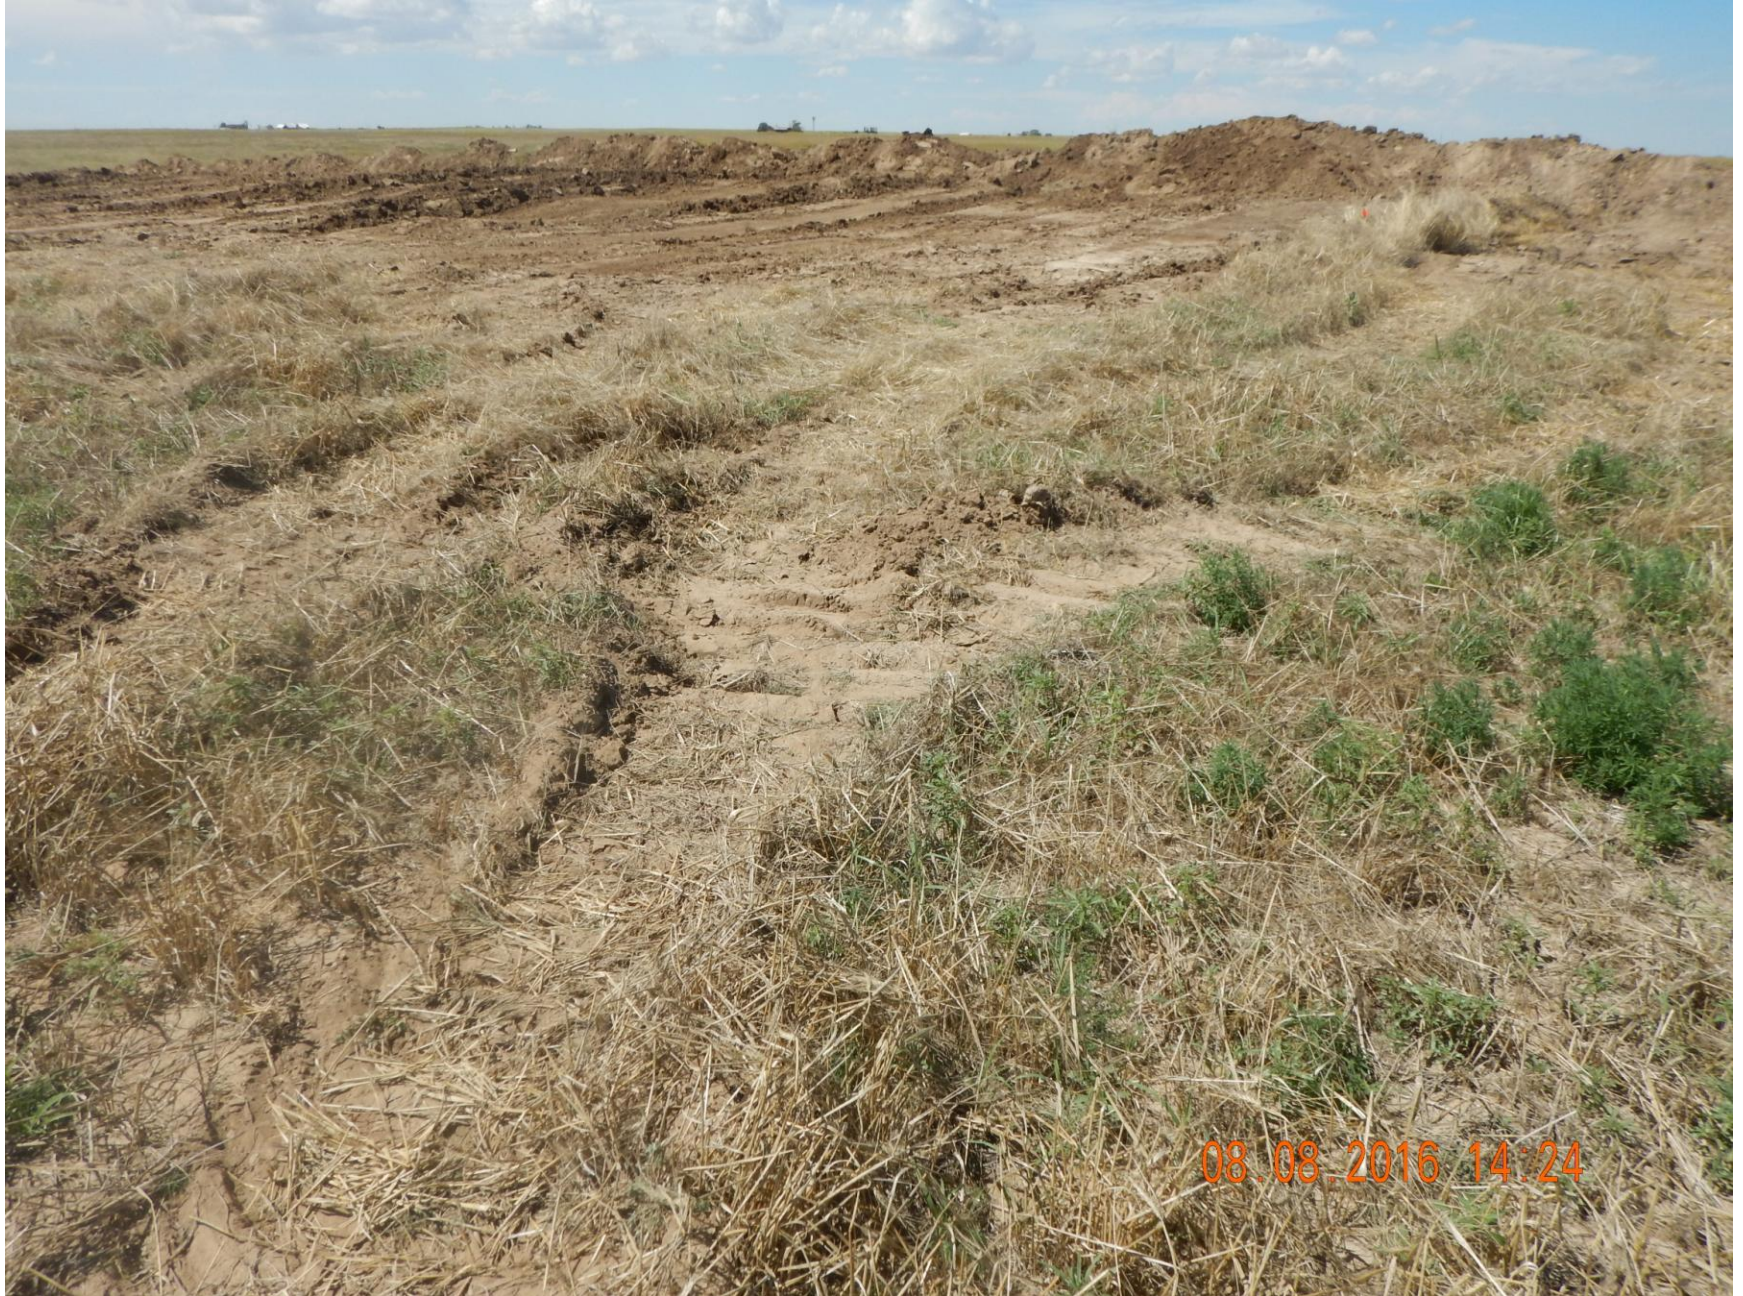
Figure 7: Photo taken from the east end of the location, facing northwest. Photo shows stormwater and sediment control BMPs absent from the northeast end of the location.

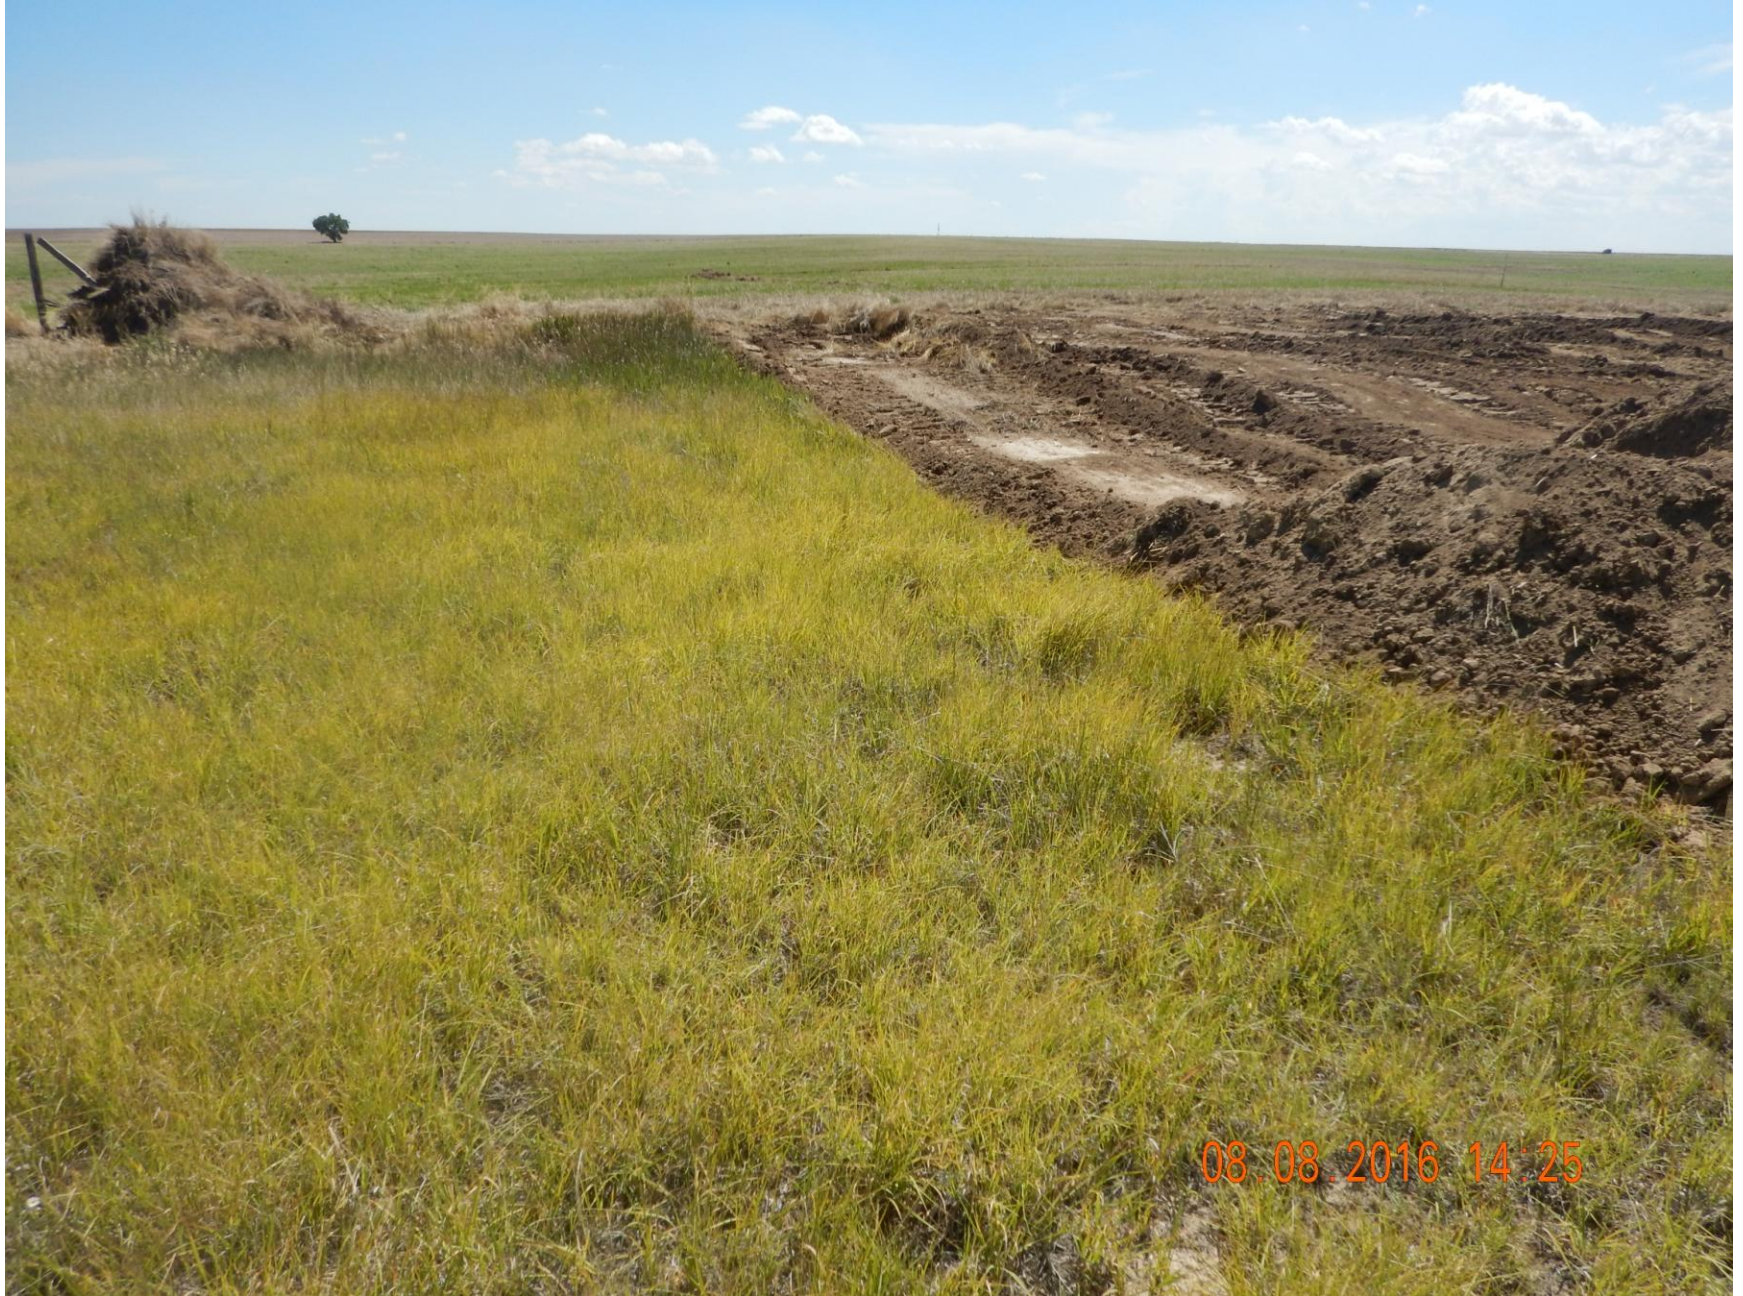
Figure 8: Photo taken from the northeast corner of the location, facing south. Photo shows stormwater and sediment control BMPs absent.

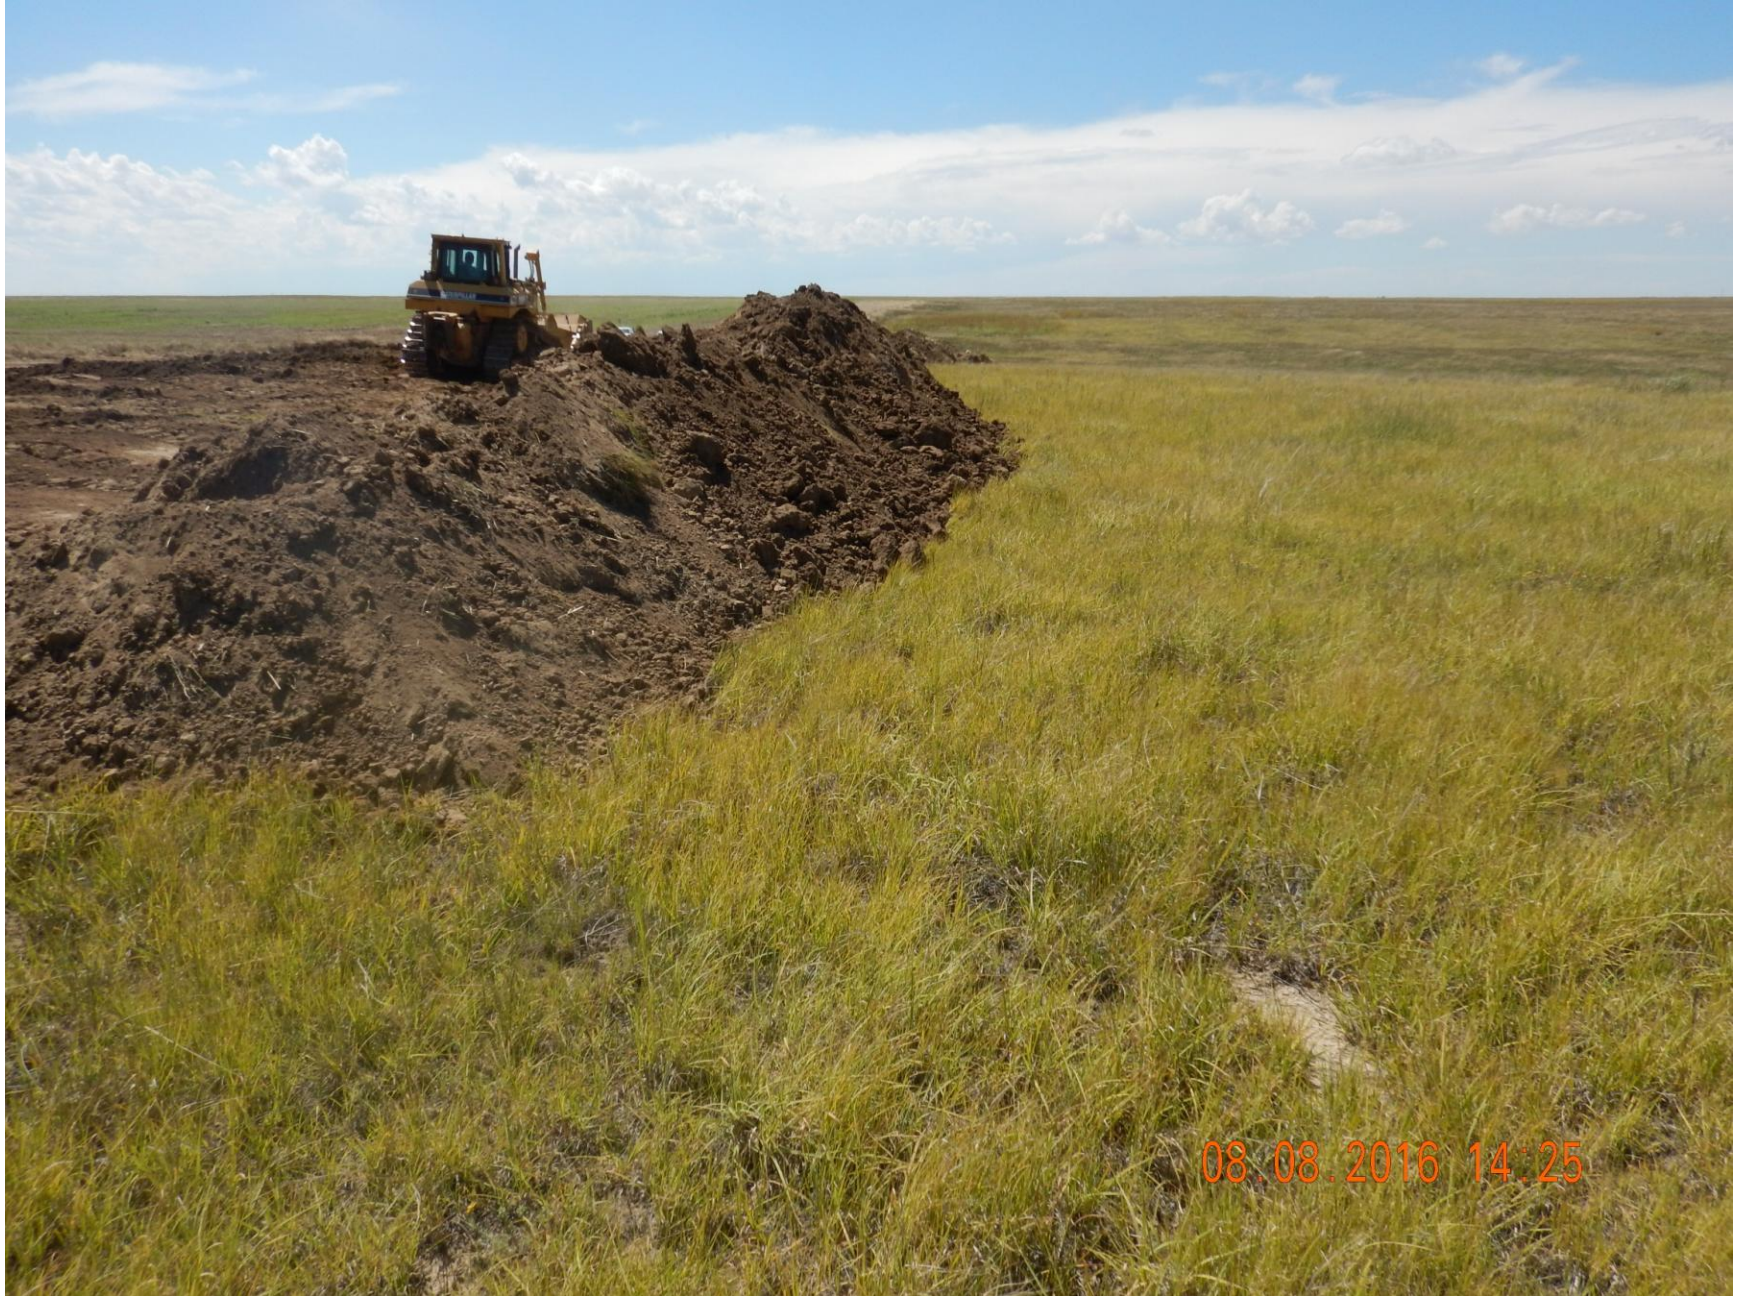
Figure 9: Photo taken from the northeast corner of the location, facing west. Photo shows stormwater and sediment control BMPs absent from north end of the location.

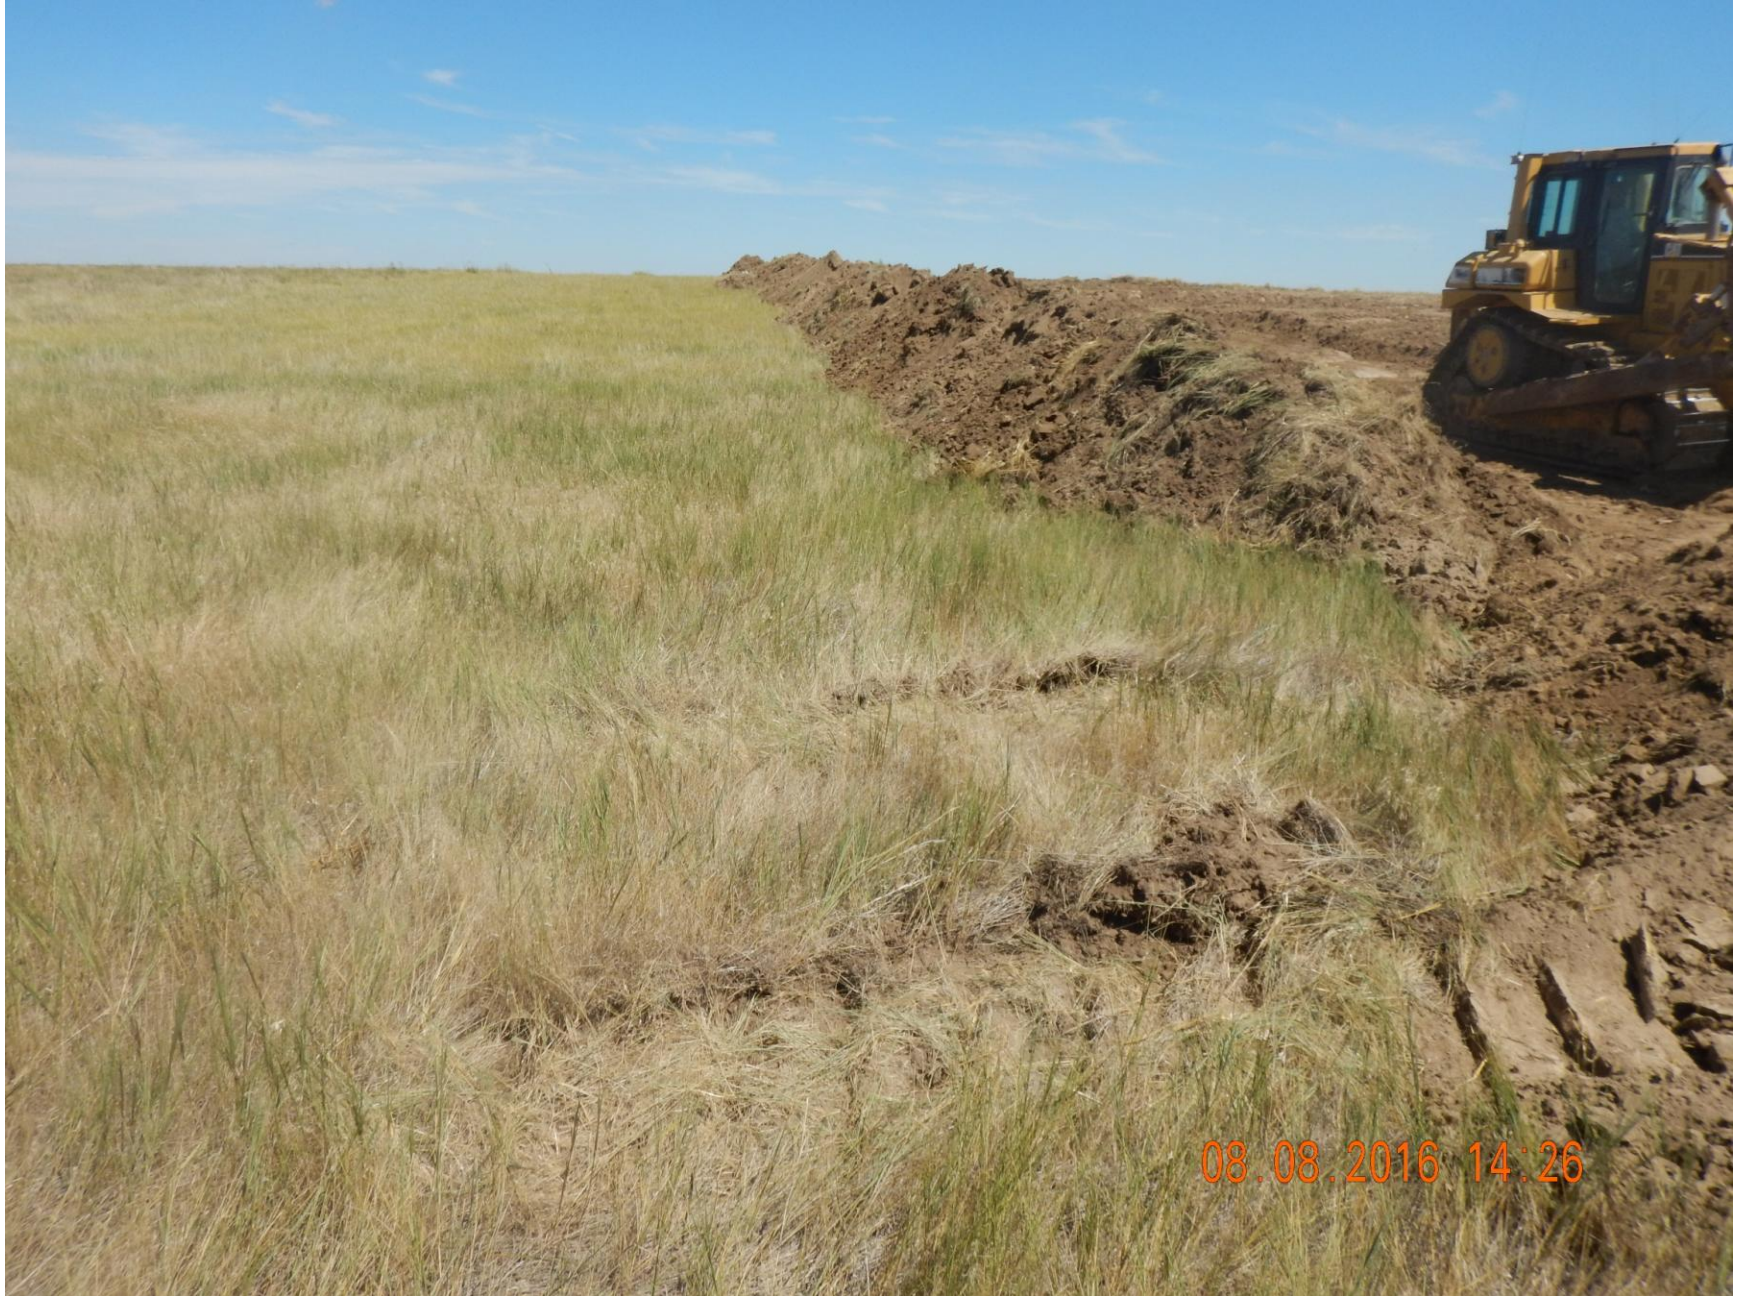
Figure 10: Photo taken from the northwest corner of the location, facing east. Photo shows stormwater and sediment control BMPs absent from north end of the location.
