Construction Inspection

08/01/2016

Operator: Grand Mesa

Location ID: 445661

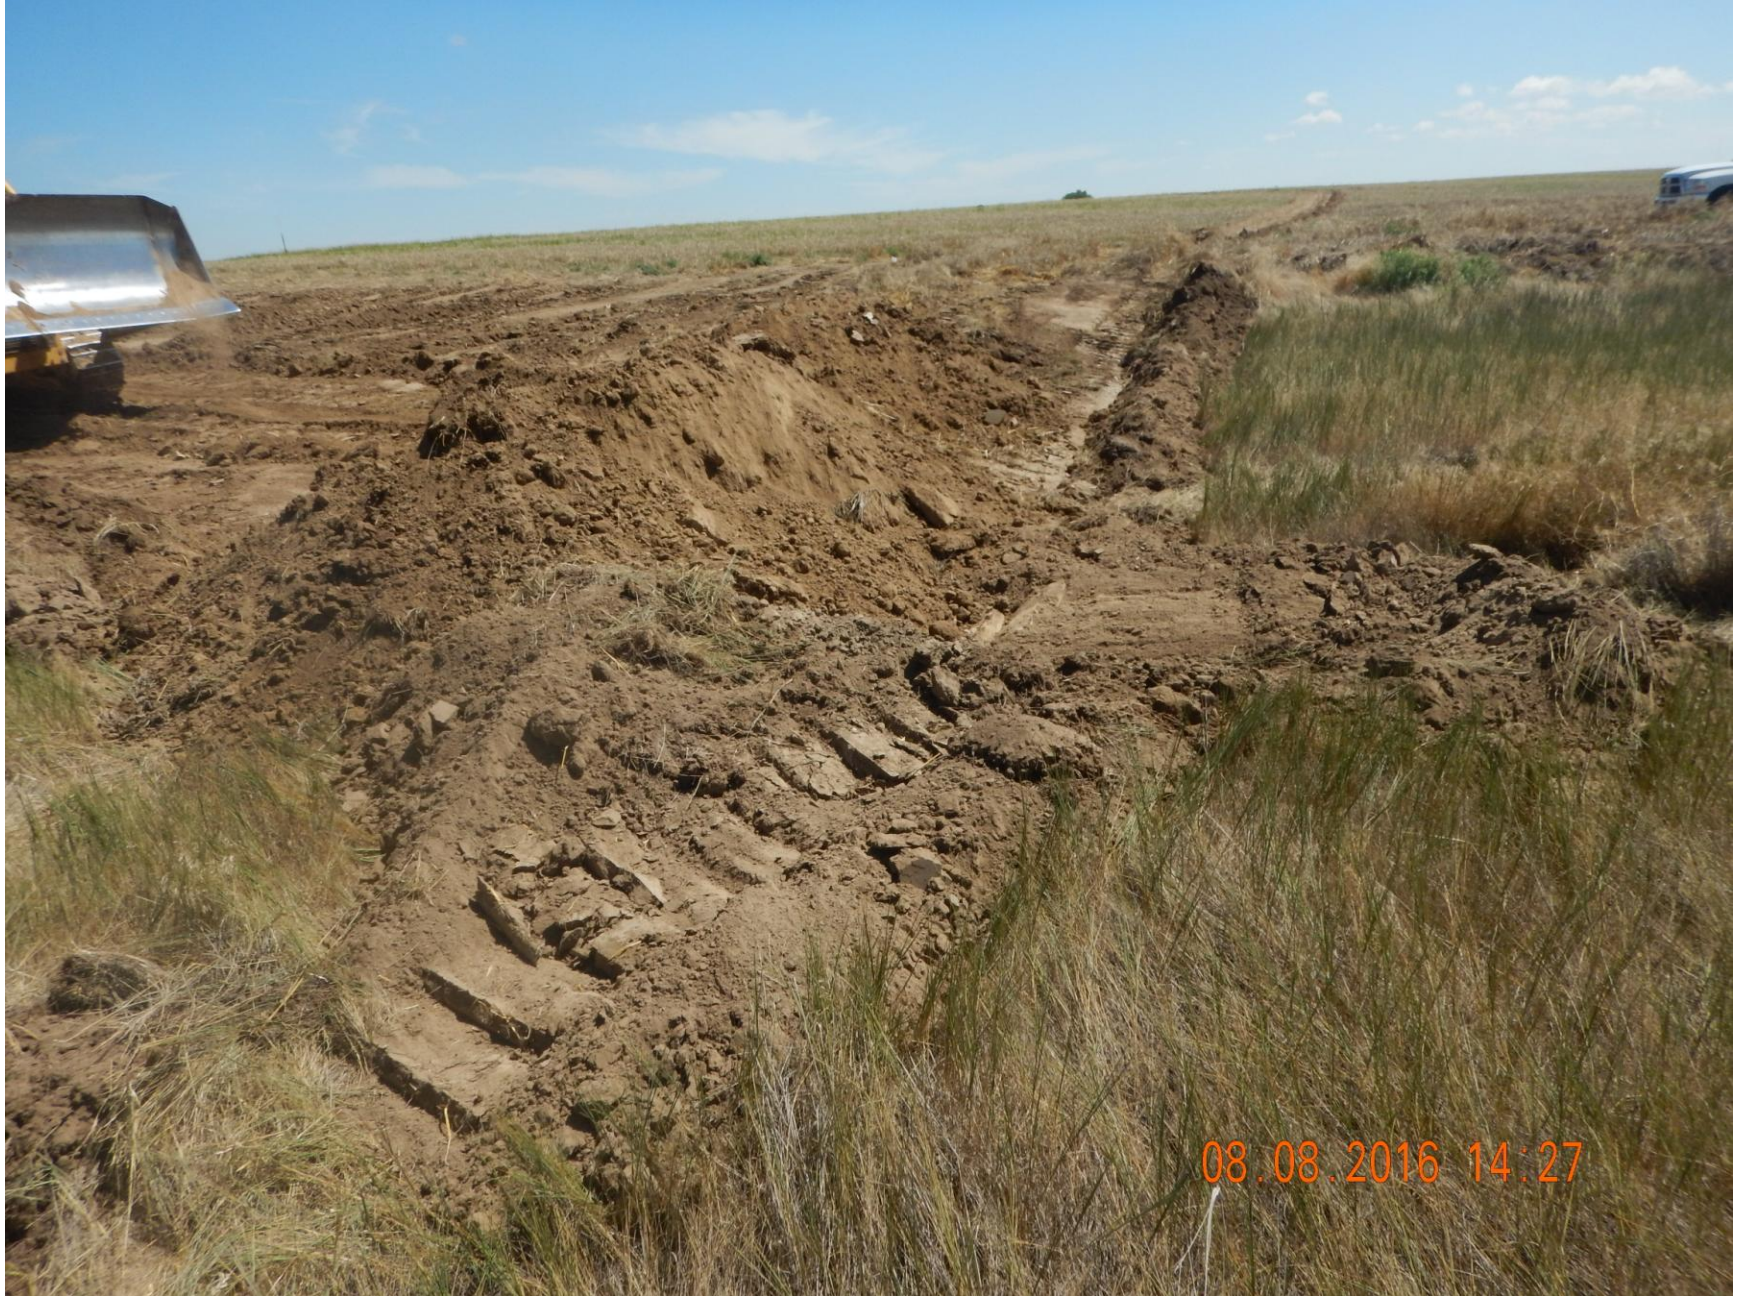
Figure 11: Photo taken from the northwest corner of the location, facing south. Photo shows stormwater and sediment control BMP incomplete on the western perimeter.
