## Follow-up Interim Reclamation Inspection: Overview

## Follow-up Interim Reclamation Inspection

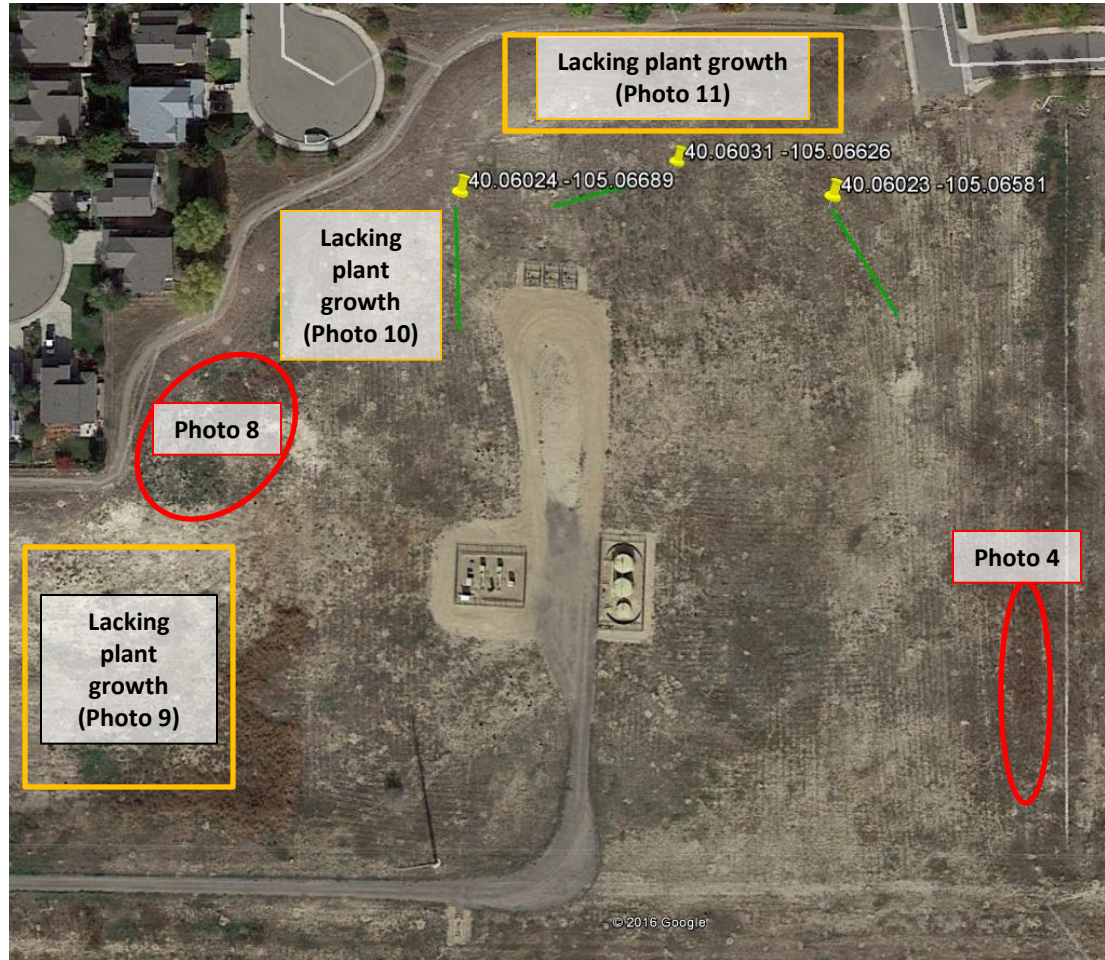
**Photo 1.** Google Earth aerial imagery illustrating locations of three (3) 100-foot transect lines used to measure seedling germination density (green lines), red circles indicate approximate size and location of Canada thistle (*Cirsium arvense*) patches, and orange boxes indicate approximate locations with little to no plant growth. Field bindweed (*Convolvulus arvensis*) dominated throughout interim area.

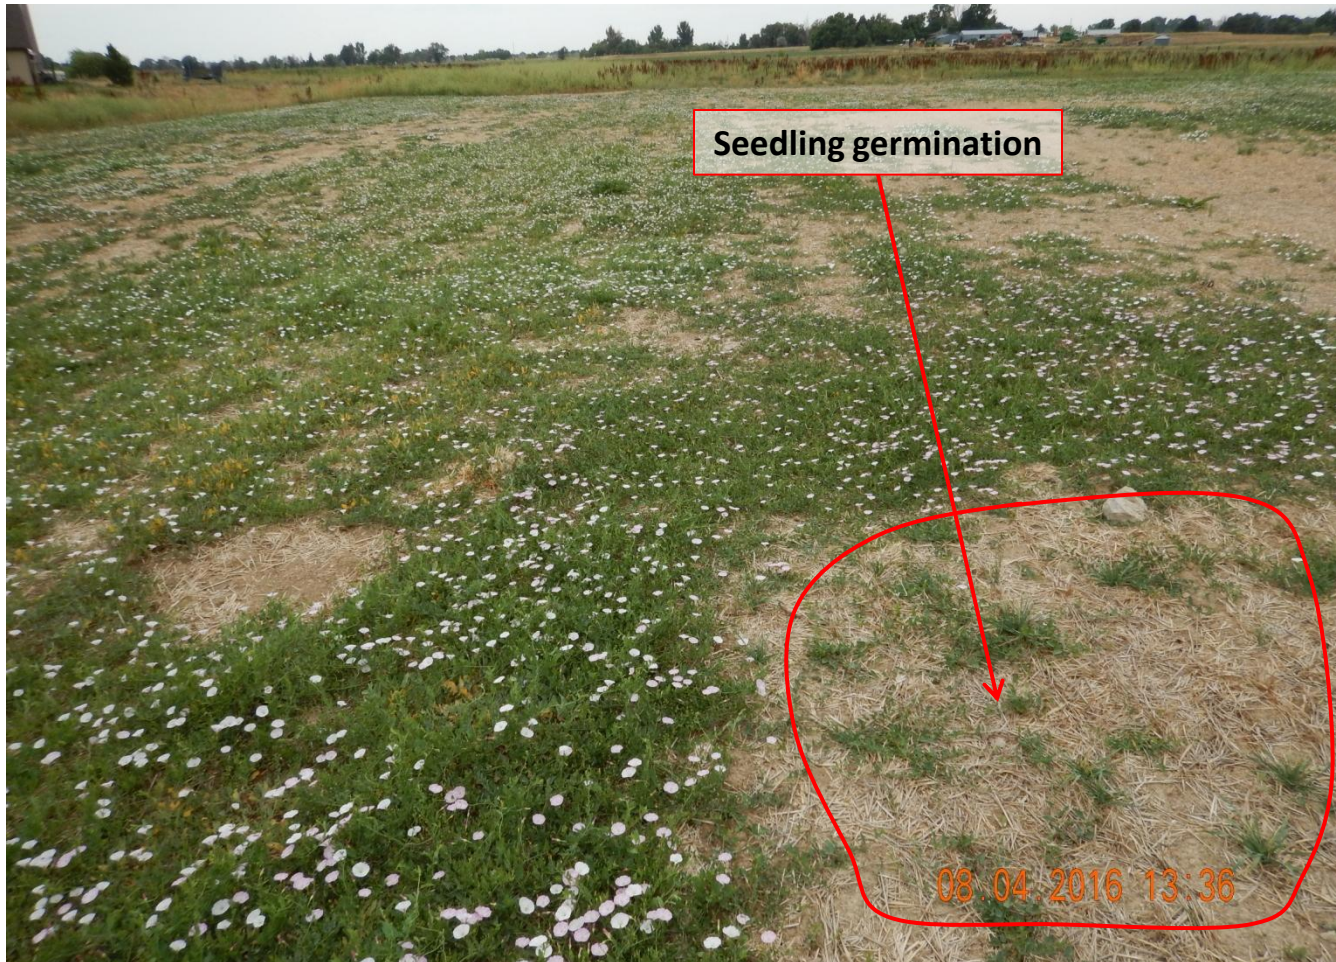
**Photo 2.** Photo taken from the eastern location, facing South. Field bindweed (white blooming flower) dominates vegetative plant cover throughout interim area, affecting desirable seedling germination. Sparse desirable seedling germination was observed throughout interim area.

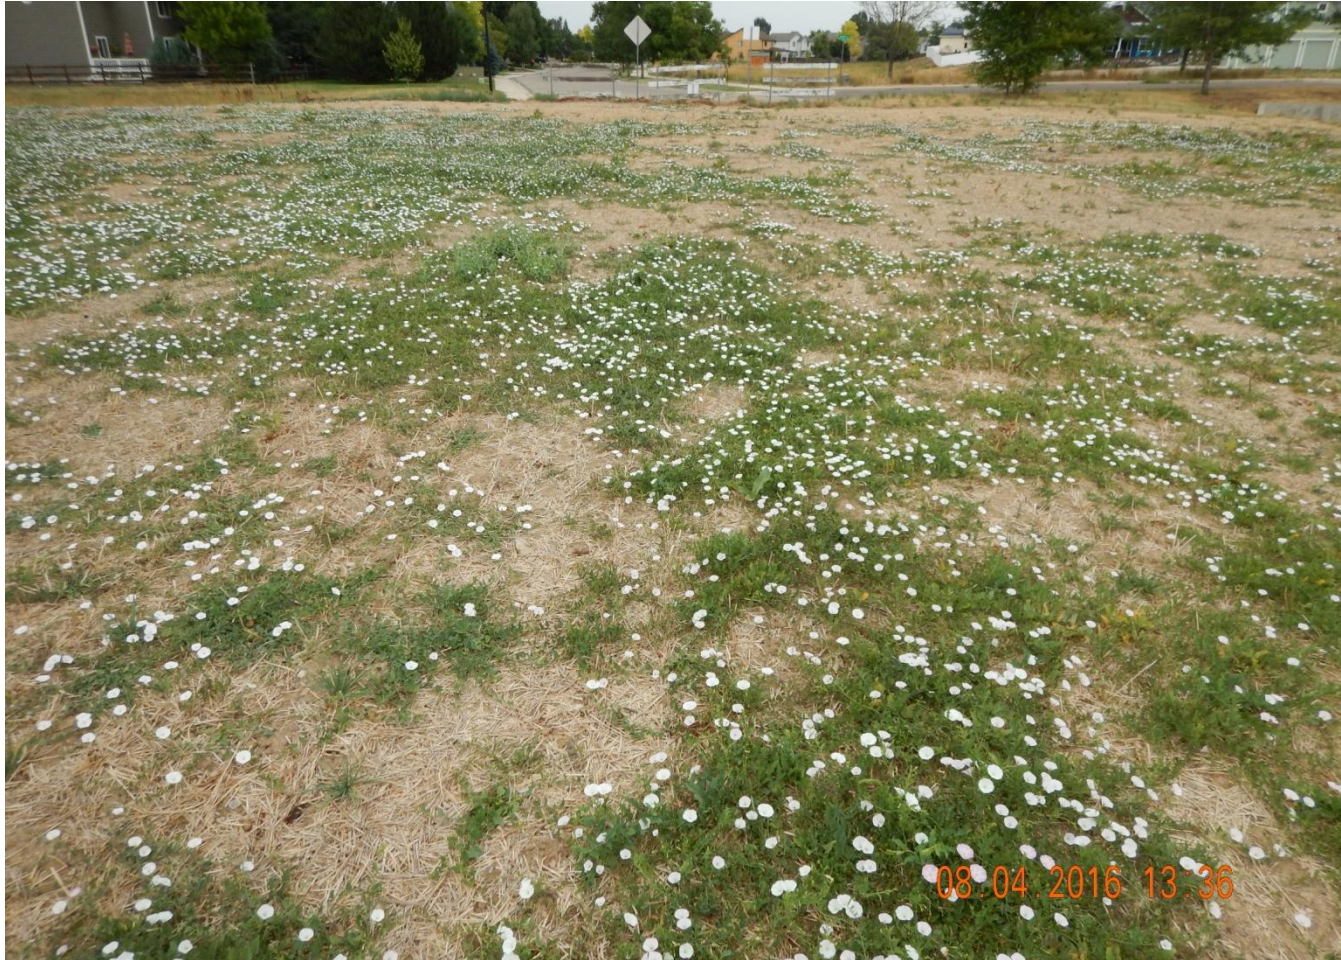
**Photo 3.** Photo taken from the eastern location, facing North. Field bindweed (white blooming flower) dominates vegetative plant cover throughout interim area. Sparse desirable seedling germination was observed throughout interim area.

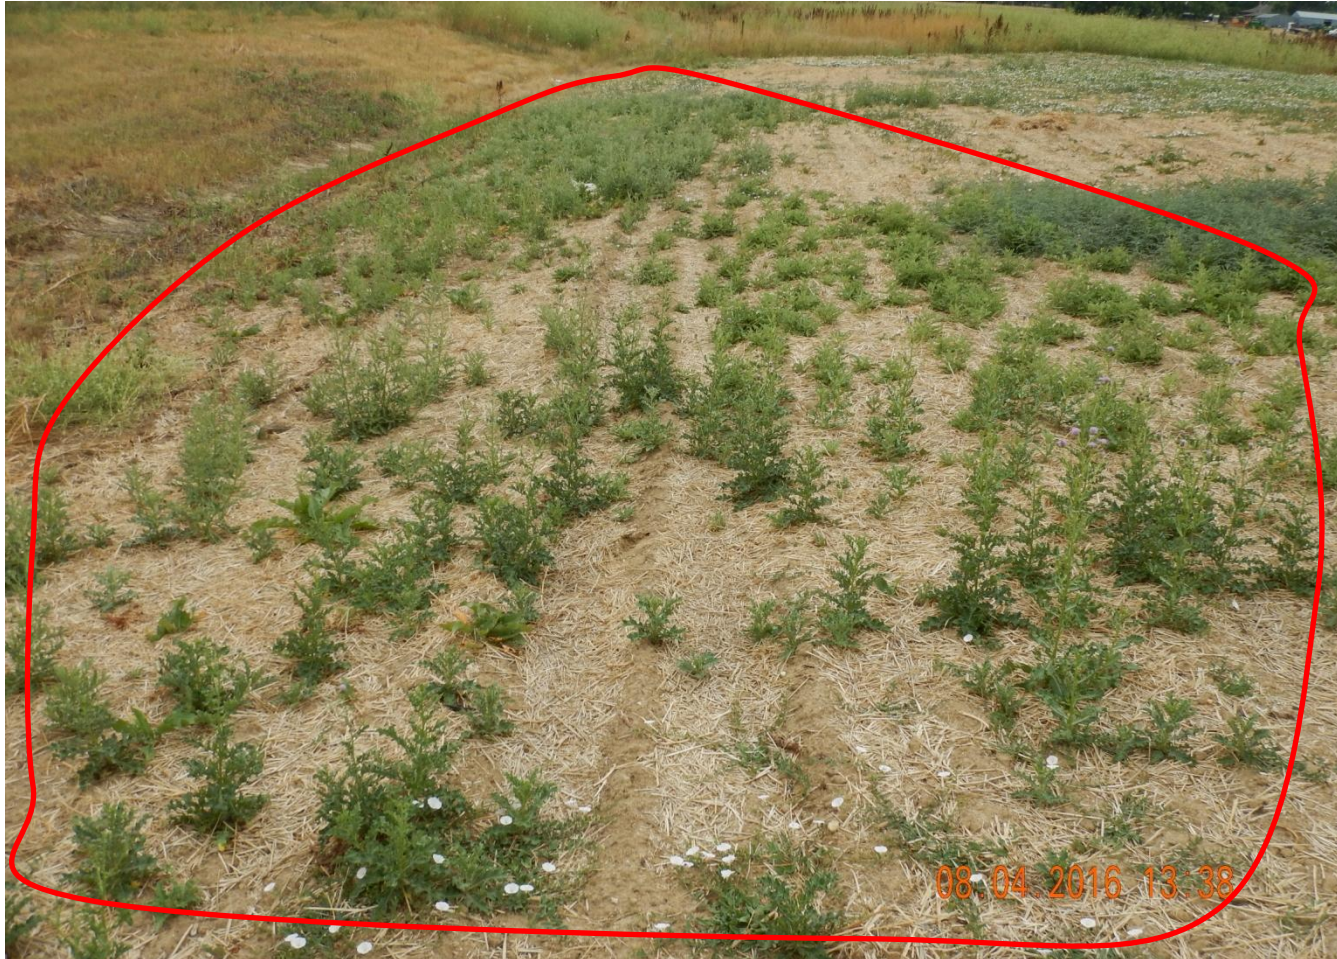
**Photo 4.** Photo taken from the southeastern location, facing South. Canada thistle (*Cirsium arvense*), List B Colorado perennial noxious weed species, outlined in the red circle needs to be controlled.

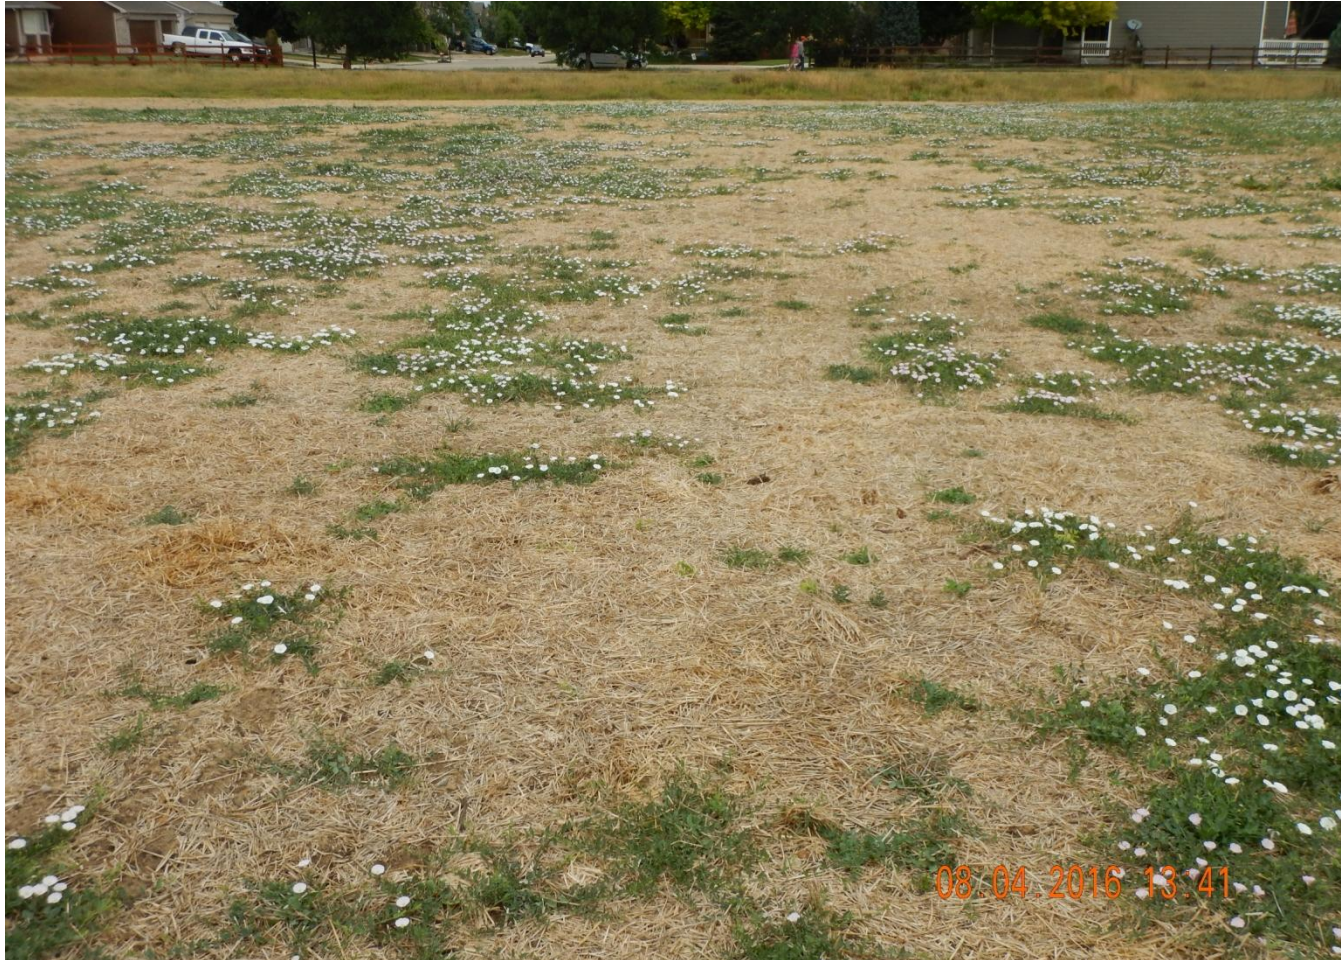
**Photo 5.** Photo taken from the north central location, facing North. Field bindweed (white blooming flower) dominates vegetative plant cover throughout interim area. Little to no germination of desirable plant species.

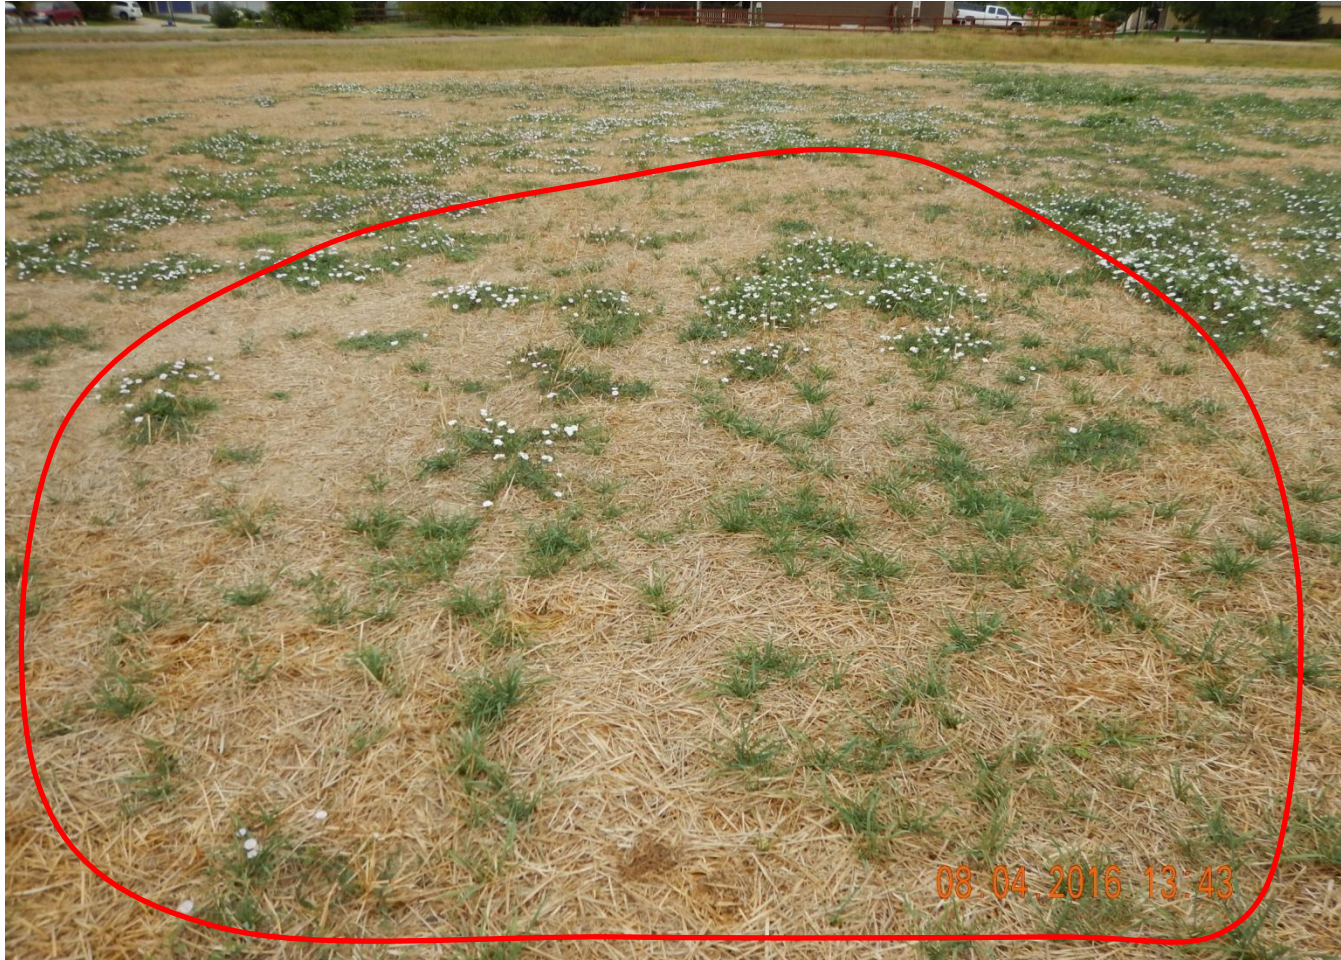
**Photo 6.** Photo taken from the northwestern location, facing North. Patch size of 12'x12' of desirable seedling germination but still lacks a sufficient seedling density.

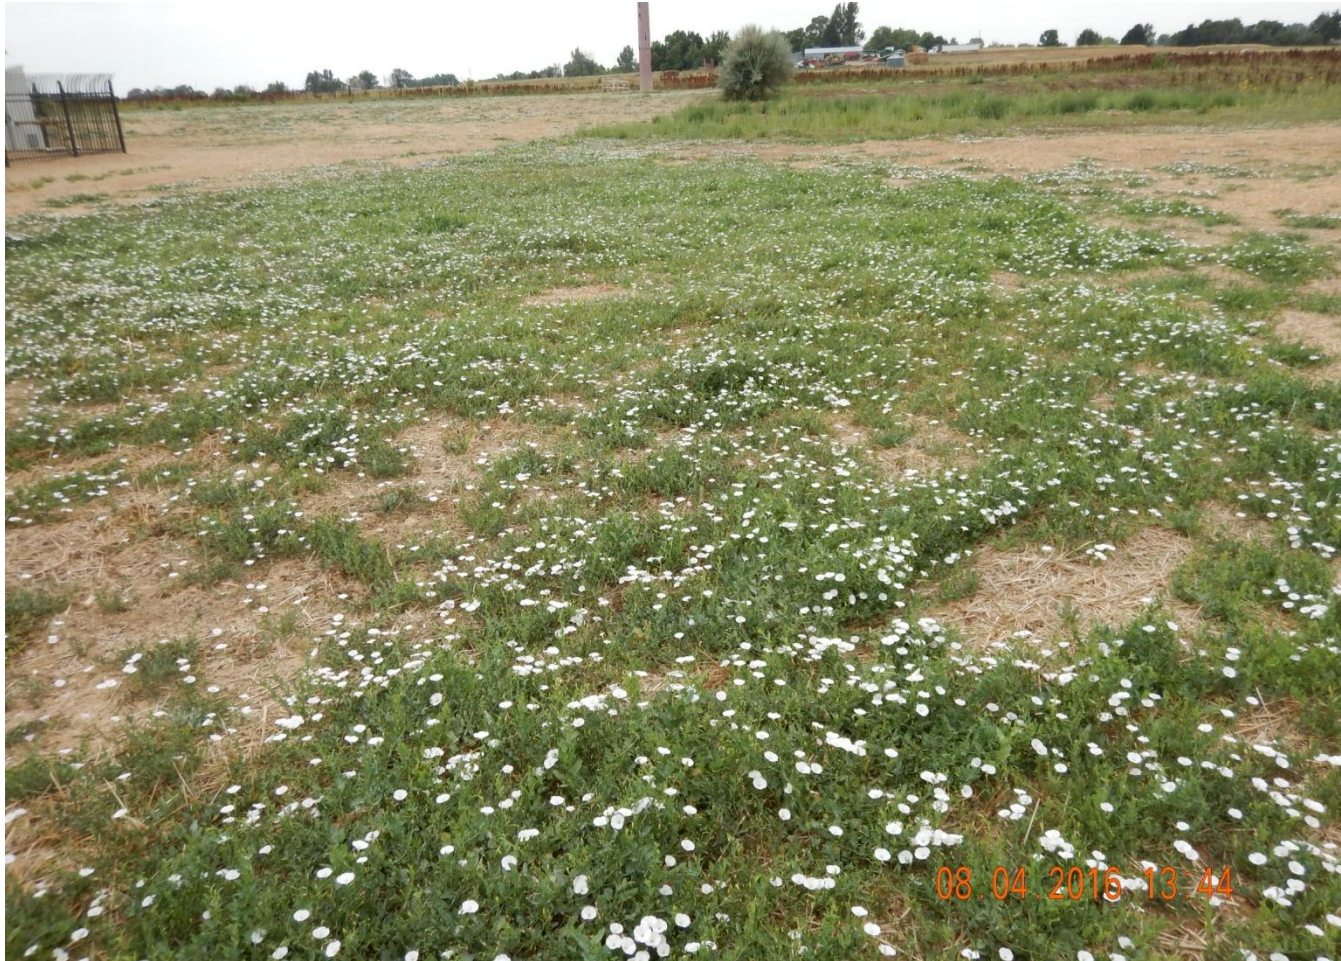
**Photo 7.** Photo taken from the western location, facing South. Field bindweed (white blooming flower) dominates vegetative plant cover, affecting desirable seedling germination.

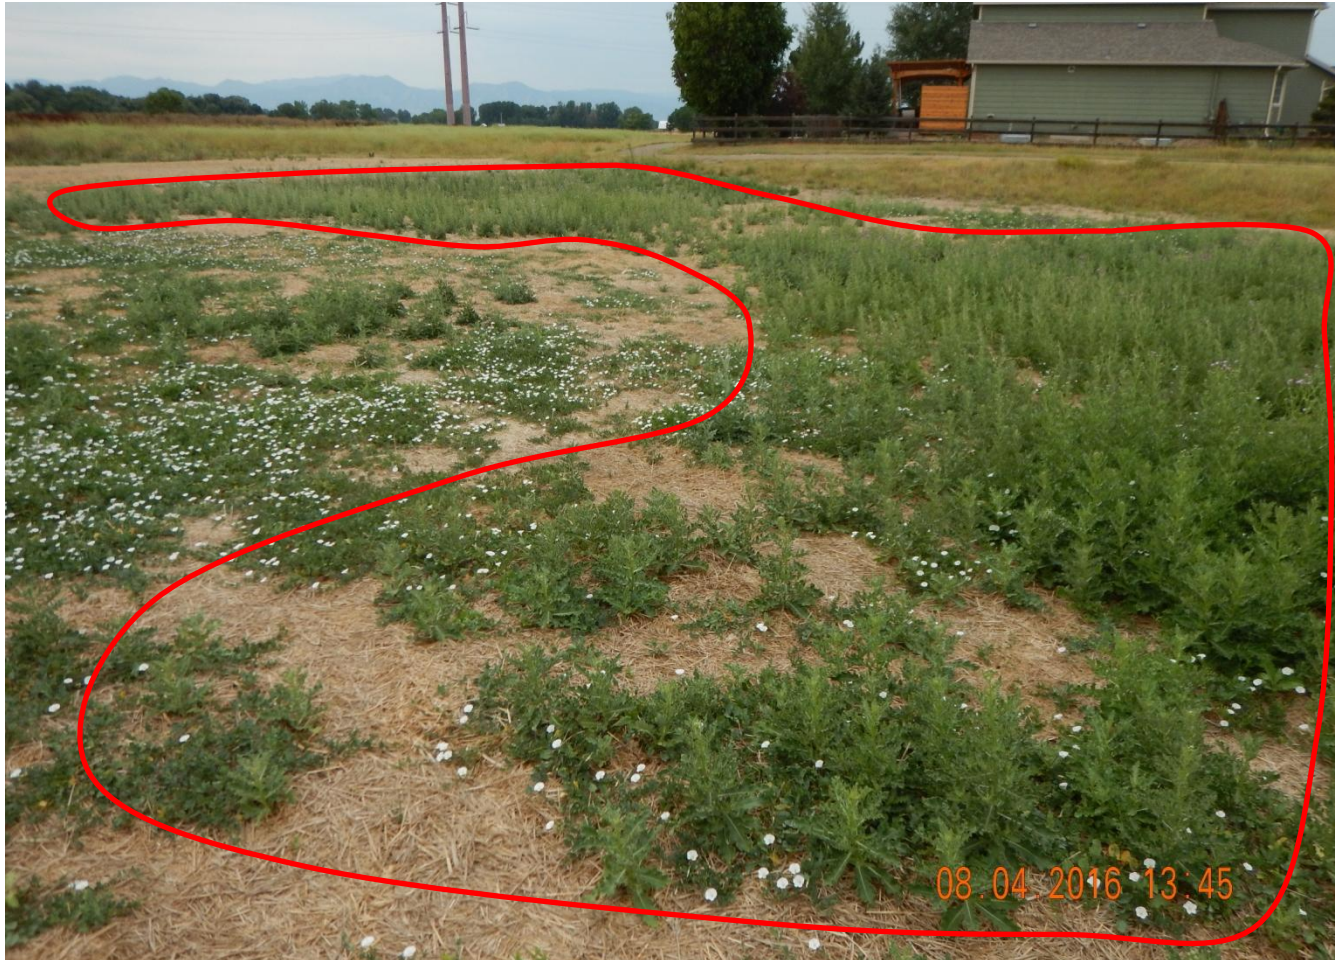
**Photo 8.** Photo taken from the northwestern location, facing West. Canada thistle (*Cirsium arvense*), List B Colorado perennial noxious weed species, outlined in the red circle needs to be controlled.

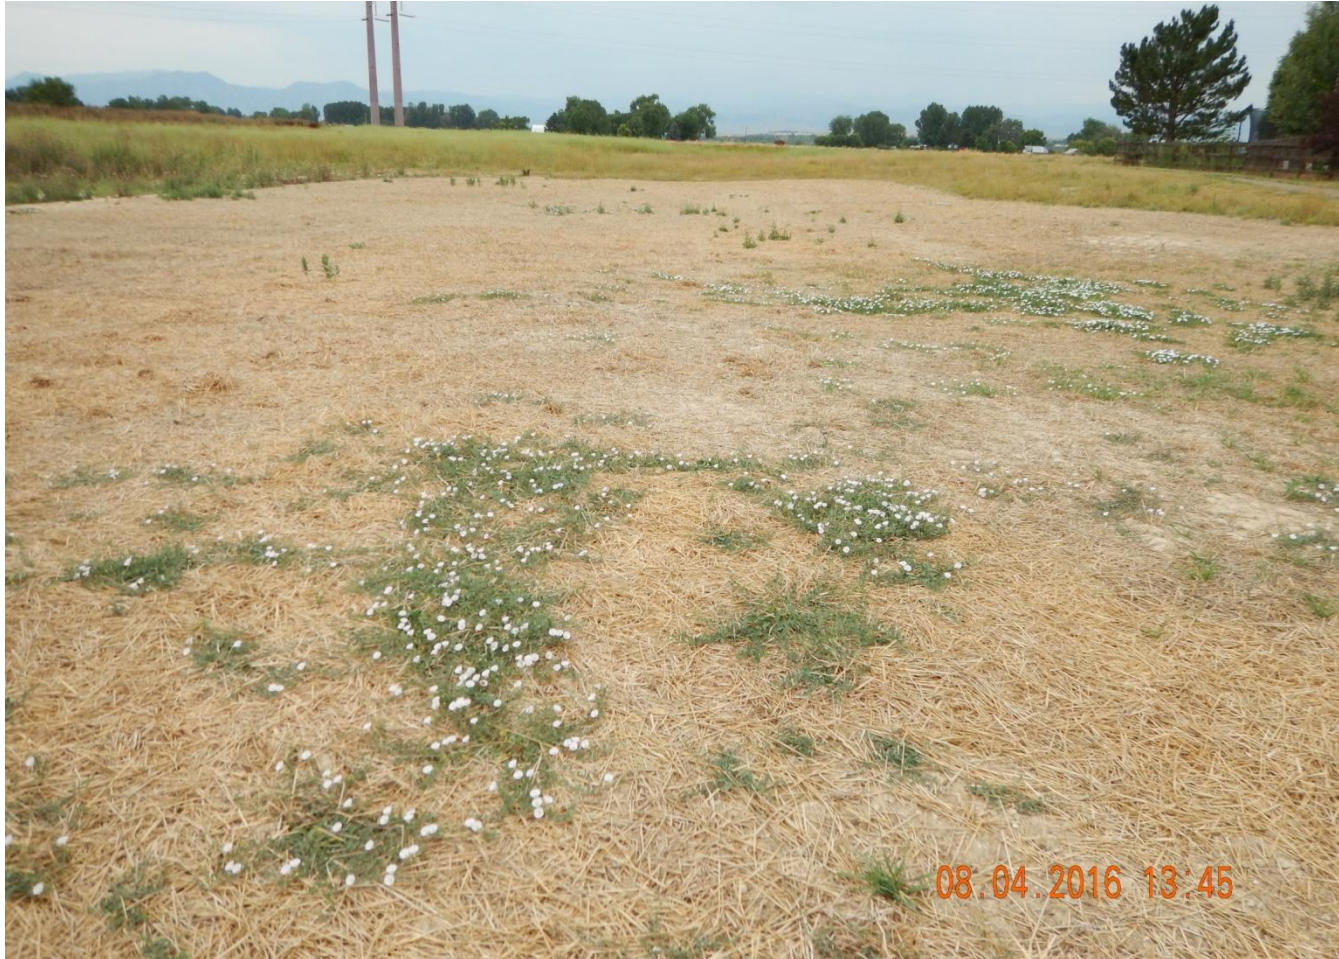
**Photo 9.** Photo taken from the western location, facing West. Little to no germination of desirable plant species of any kind.

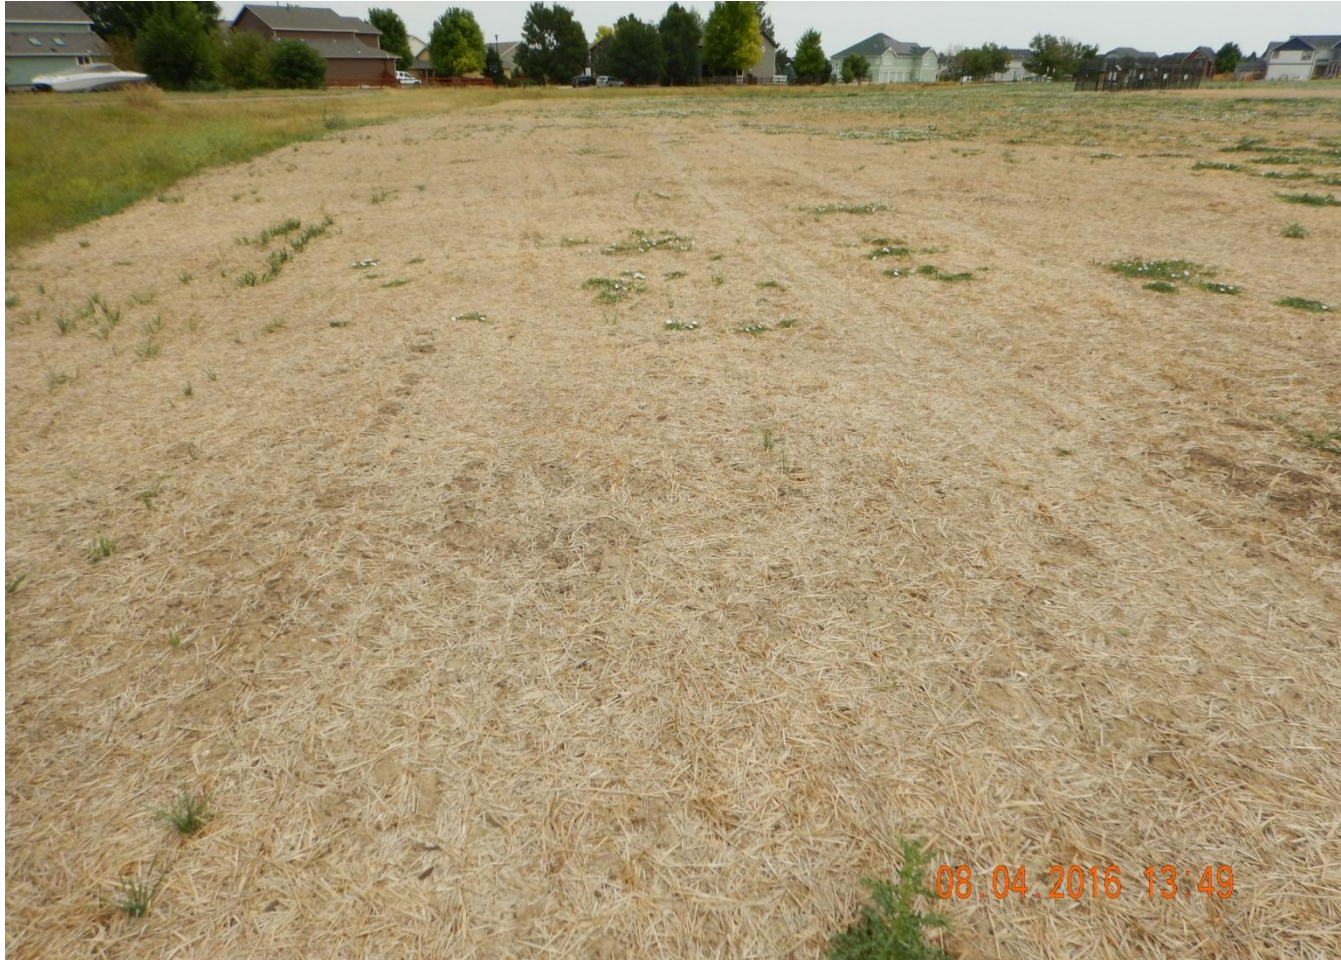
**Photo 10.** Photo taken from the northwestern location, facing North. Little to no germination of desirable plant species of any kind.

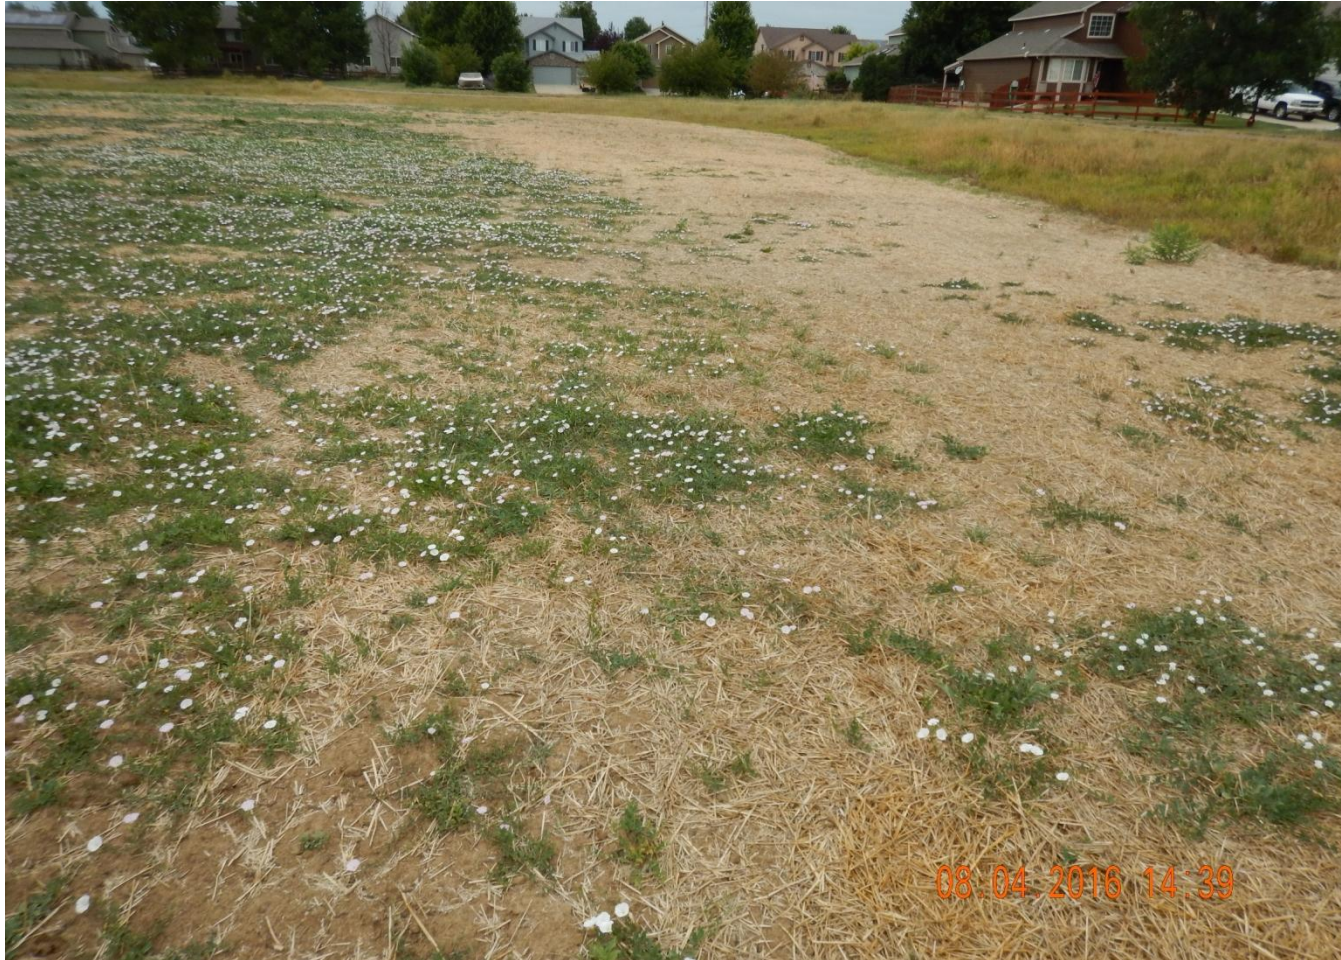
**Photo 11.** Photo taken from the northern location, facing West. Field bindweed (white blooming flower) dominates vegetative plant cover throughout interim area. Little to no germination of desirable plant species along the northern boundary.

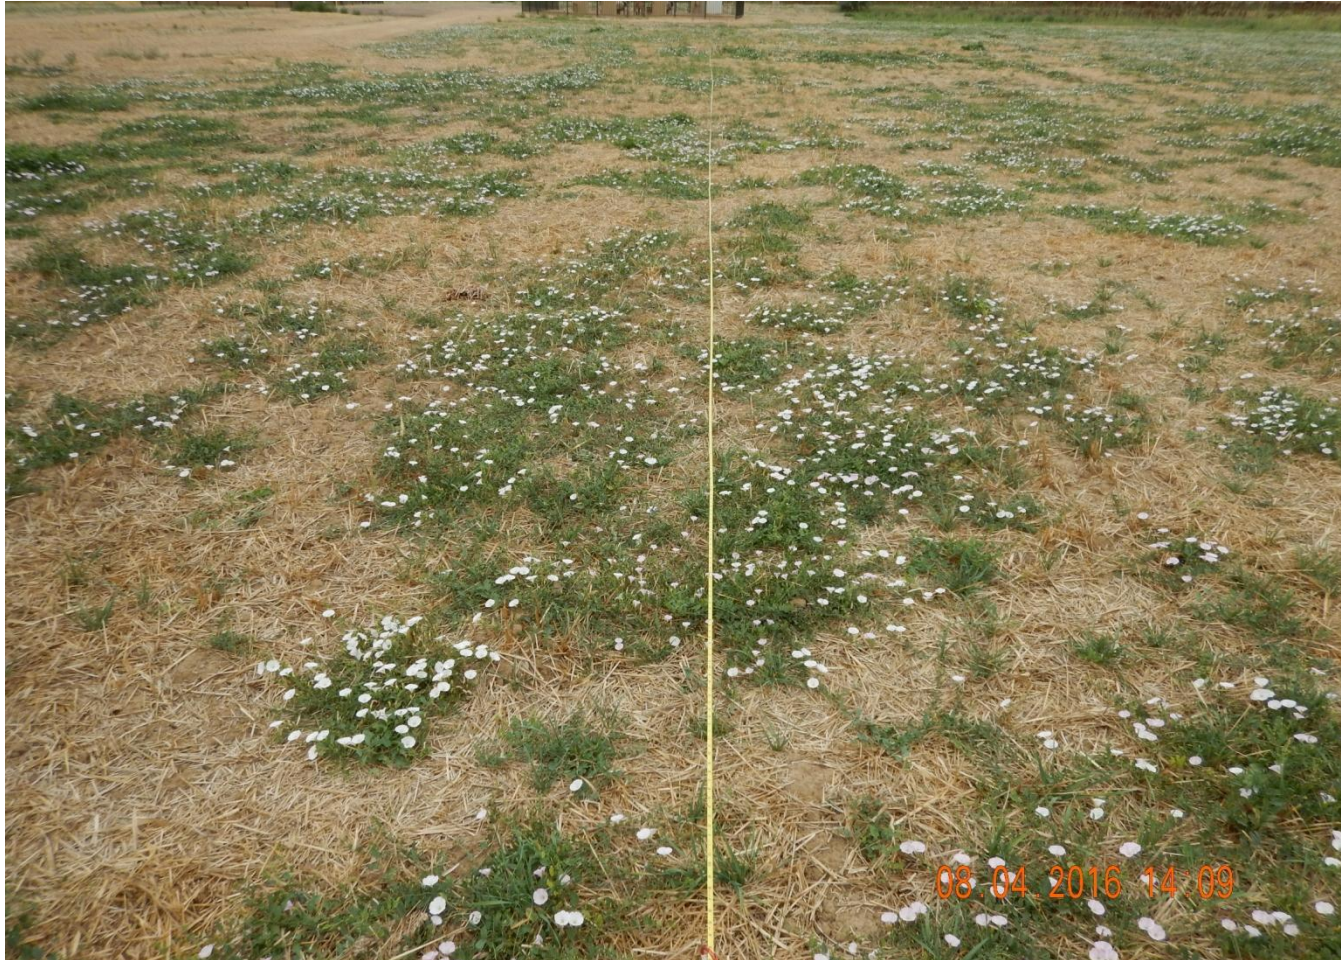
**Photo 12.** Photo taken from start of Transect #1, facing South. Field bindweed (white blooming flower) dominated vegetative plant cover throughout quadrat measurements.

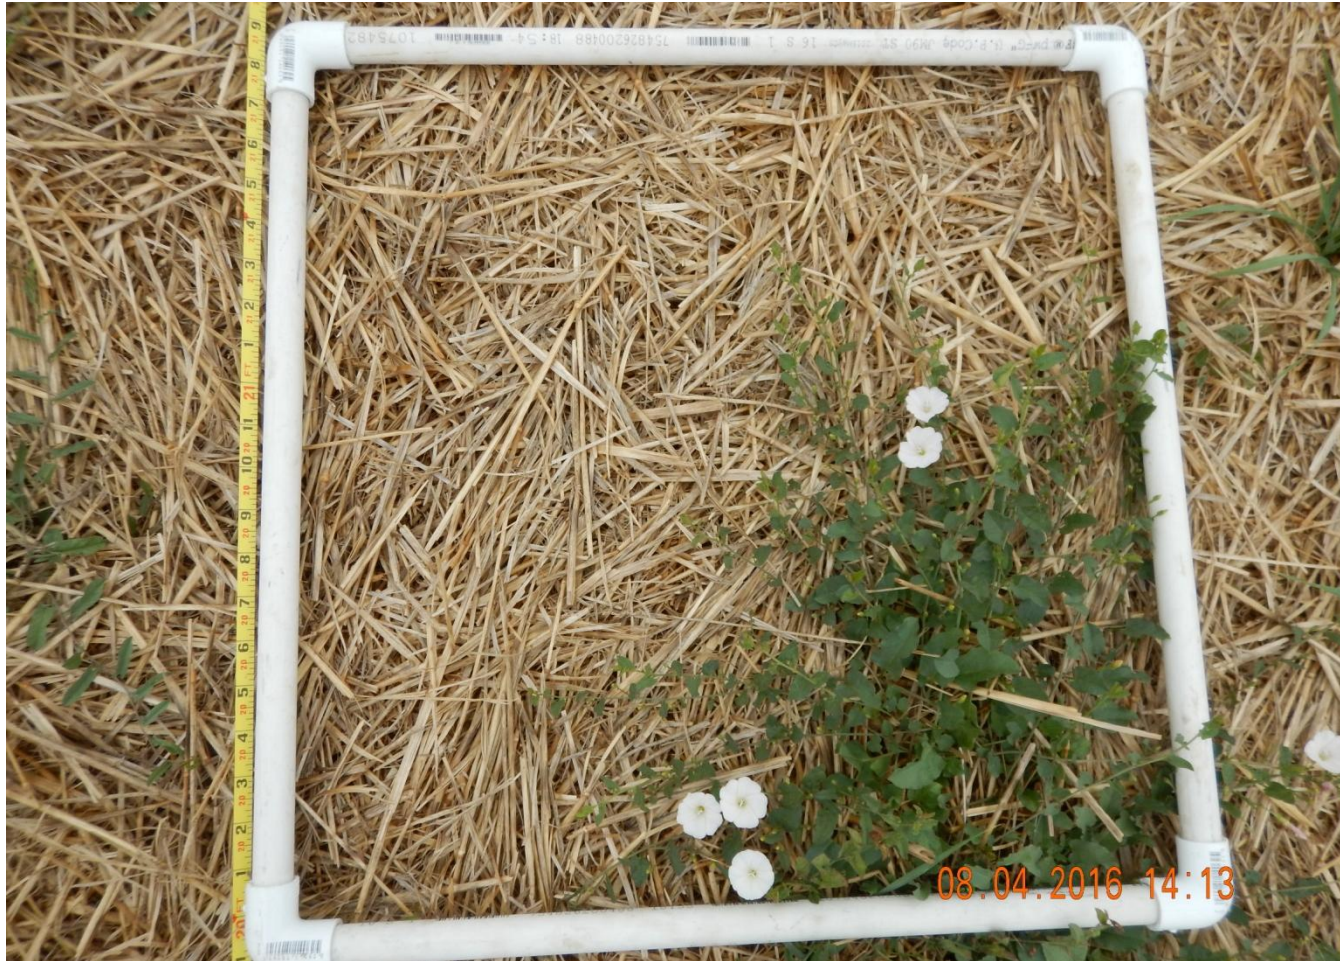
**Photo 13.** Photo taken from the 20-foot mark, right side of Transect #1, with no seedling germination observed. Field bindweed (white blooming flower) only observed plant inside quadrat.

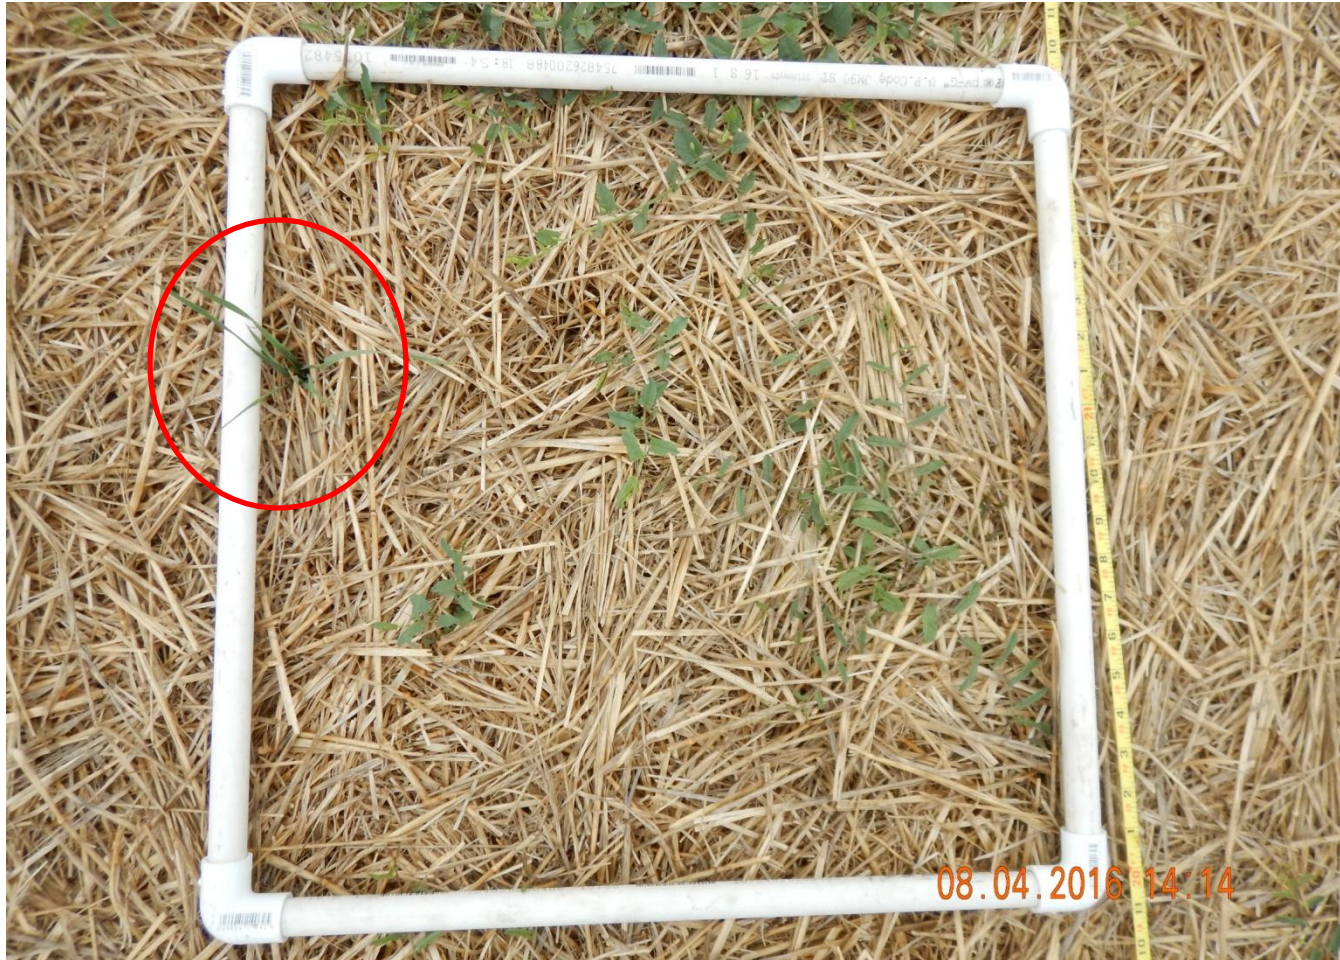
**Photo 14.** Photo taken from the 20-foot mark, left side of Transect #1, with one (1) seedling germination observed with field bindweed inside the quadrat.

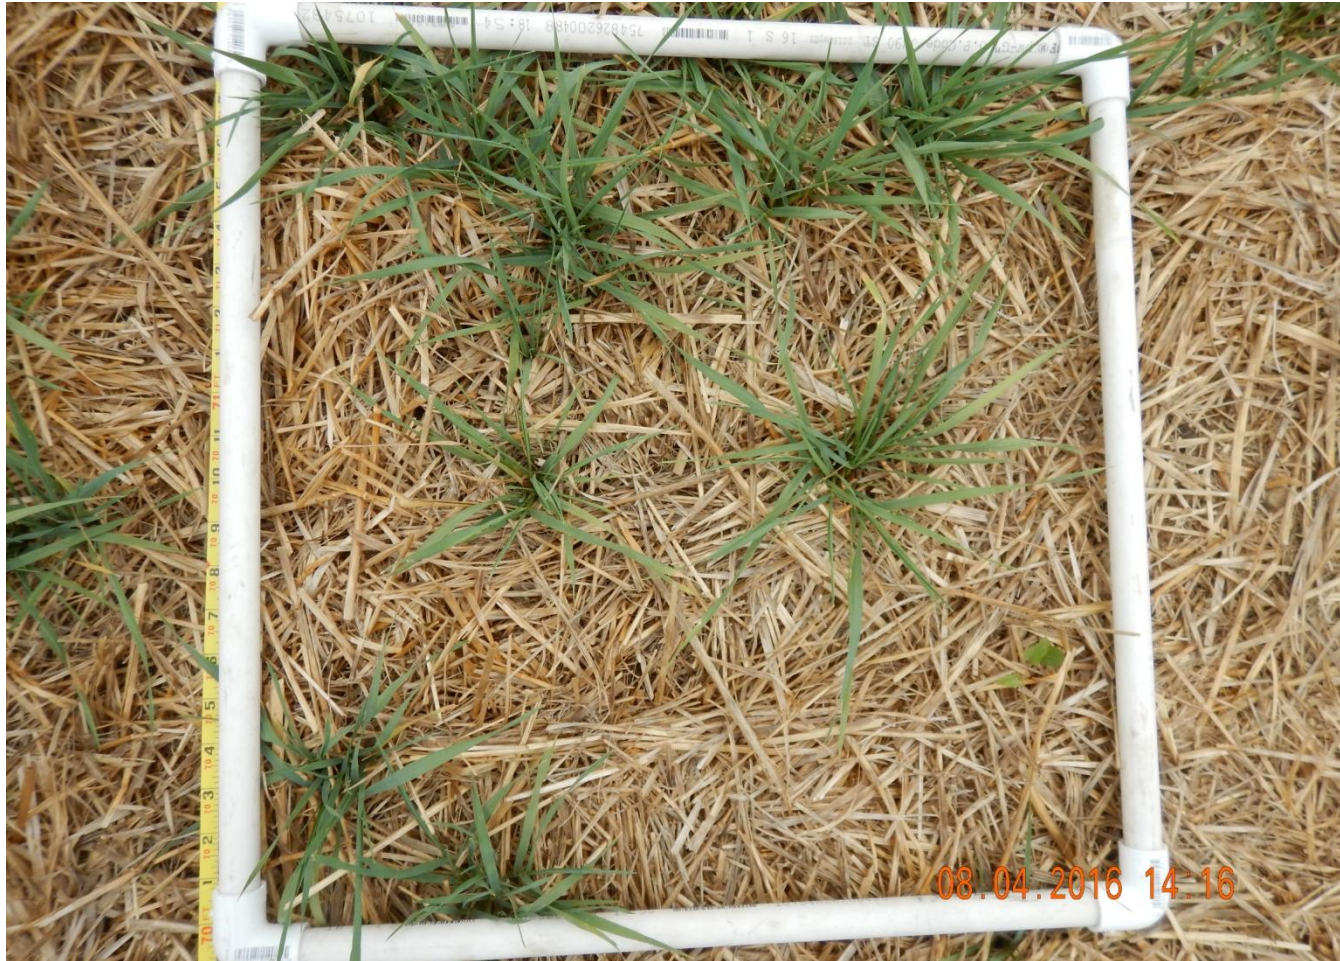
**Photo 15.** Photo taken from the 70-foot mark, right side of Transect #1, with ten (10) seedling germinations observed inside quadrat.

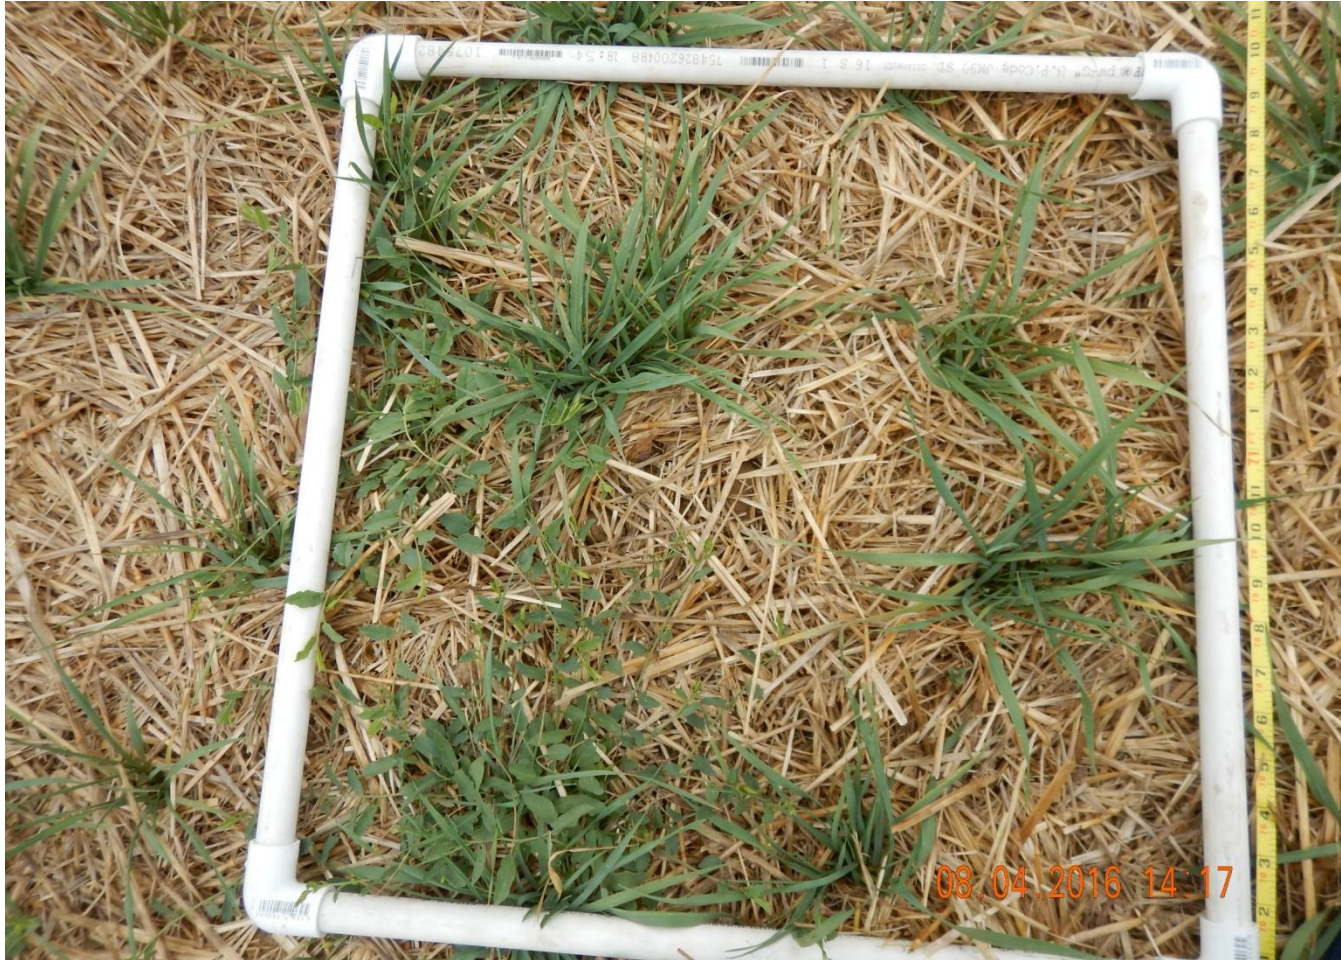
**Photo 16.** Photo taken from the 70-foot mark, left side of Transect #1, with nine (9) seedling germinations observed and field bindweed inside quadrat.

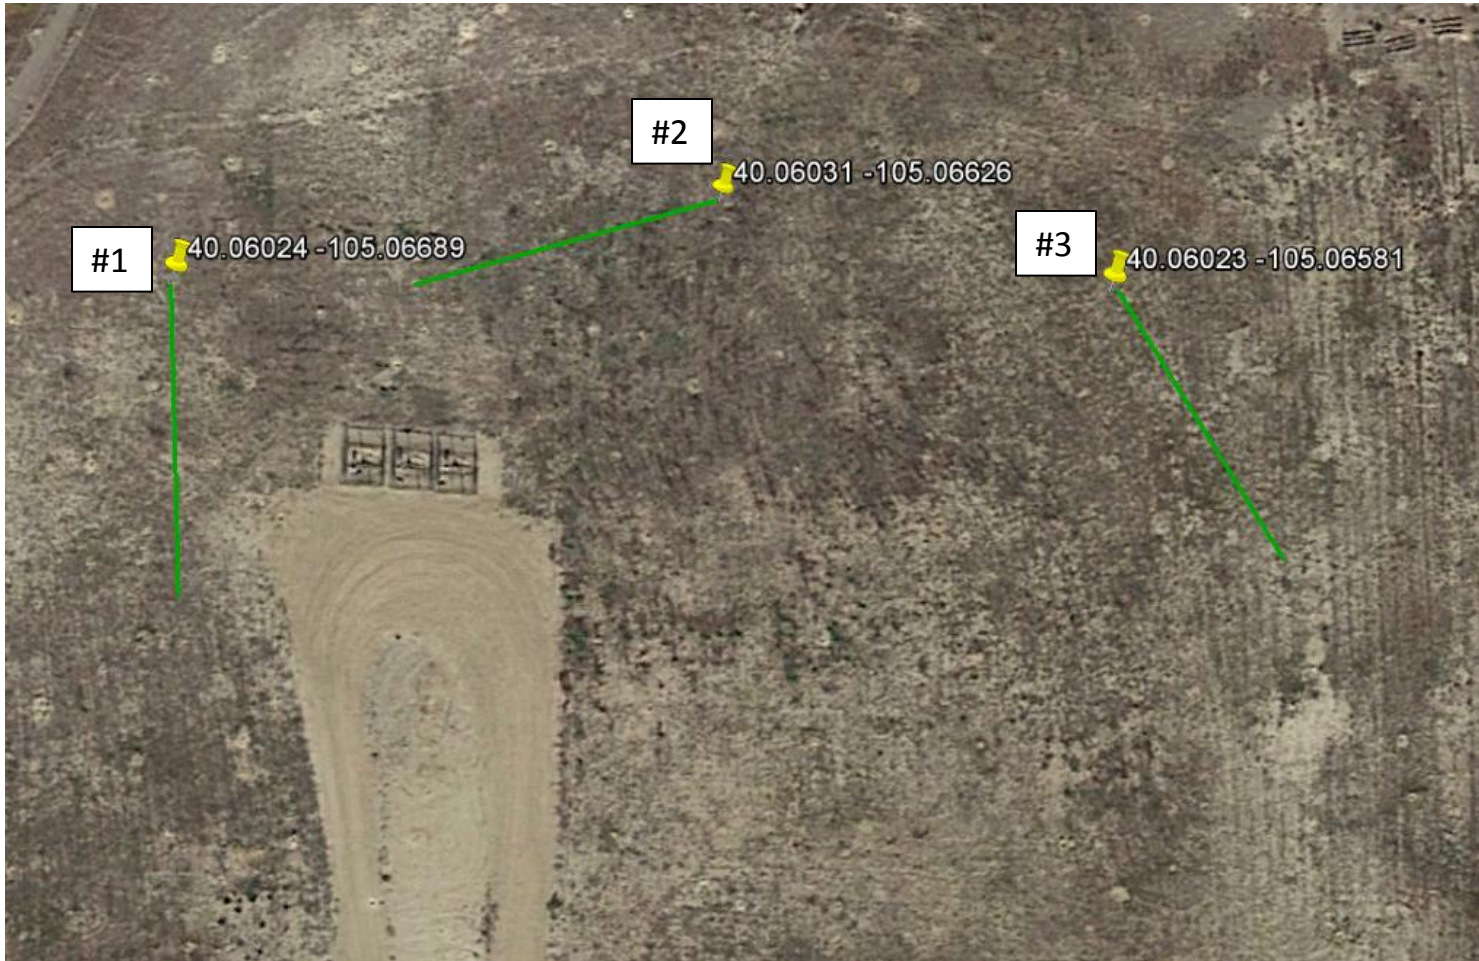
**Photo 17.** Aerial overview of monitoring transect locations with compass bearing information, and total desirable seedling counts for each 100-foot transect.

#1: 40.06024, -105.06689 @ 180°= 56 seedlings

#2: 40.06031, -105.06626 @ 250°= 4 seedlings

#3: 40.06023, -105.06581 @ 145°= 7 seedlings
