## Follow-up Interim Reclamation Inspection: Overview

## Follow-up Interim Reclamation Inspection

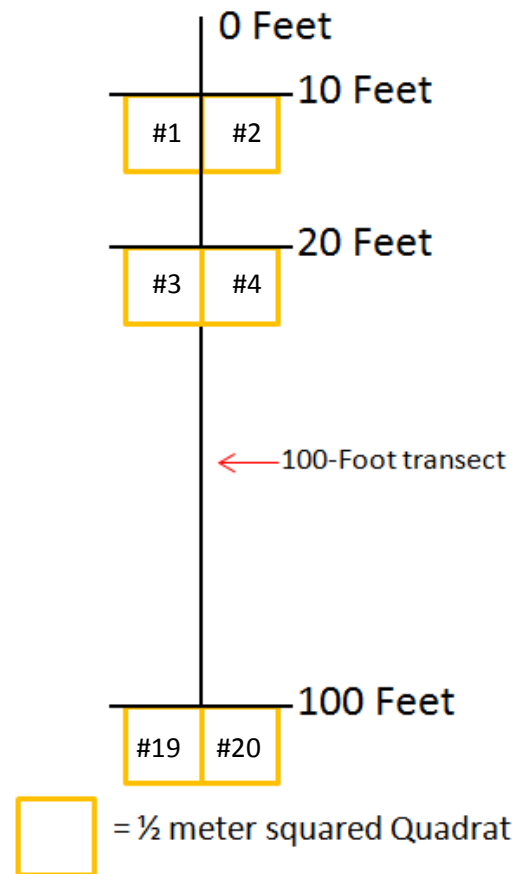
**Photo 18.** Note- this is not to scale. Stretch 100-foot transect to the desired compass bearing. Lay 1/2 meter squared quadrat at the first 10-foot mark, either on the left or right side of the transect line (need to count seedling germination on both sides of the transect line). Conduct this measurement every 10 feet to the end of the 100-foot transect line, totaling 20 quadrat measurements. Refer to Photo 17 regarding the three transect locations and compass bearings.
