Final Reclamation Inspection

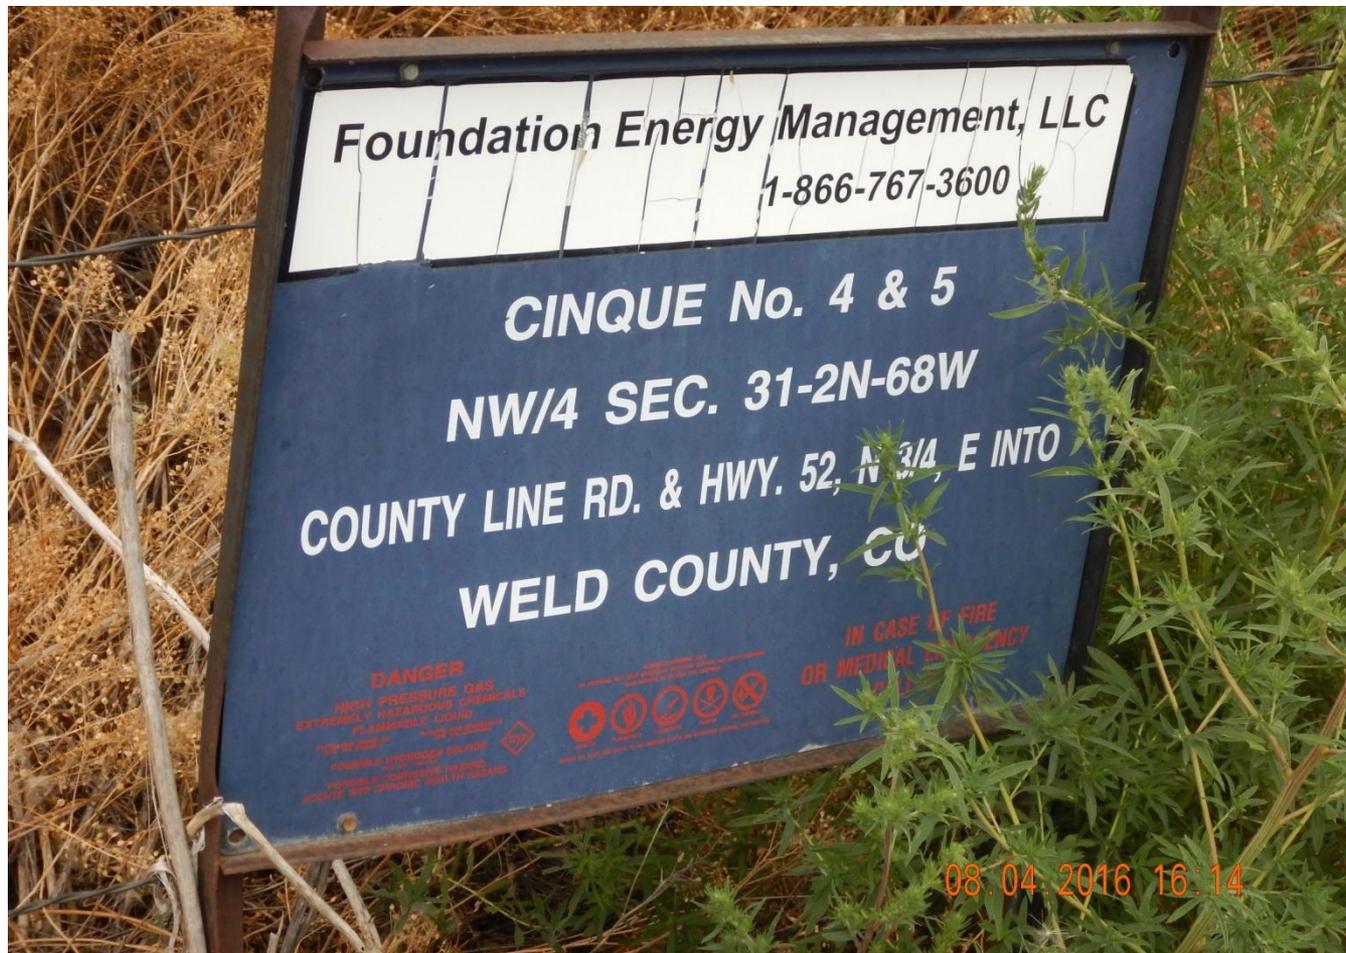
Photo 1. Photo taken from entrance of location off County Line Road. Need to remove sign.

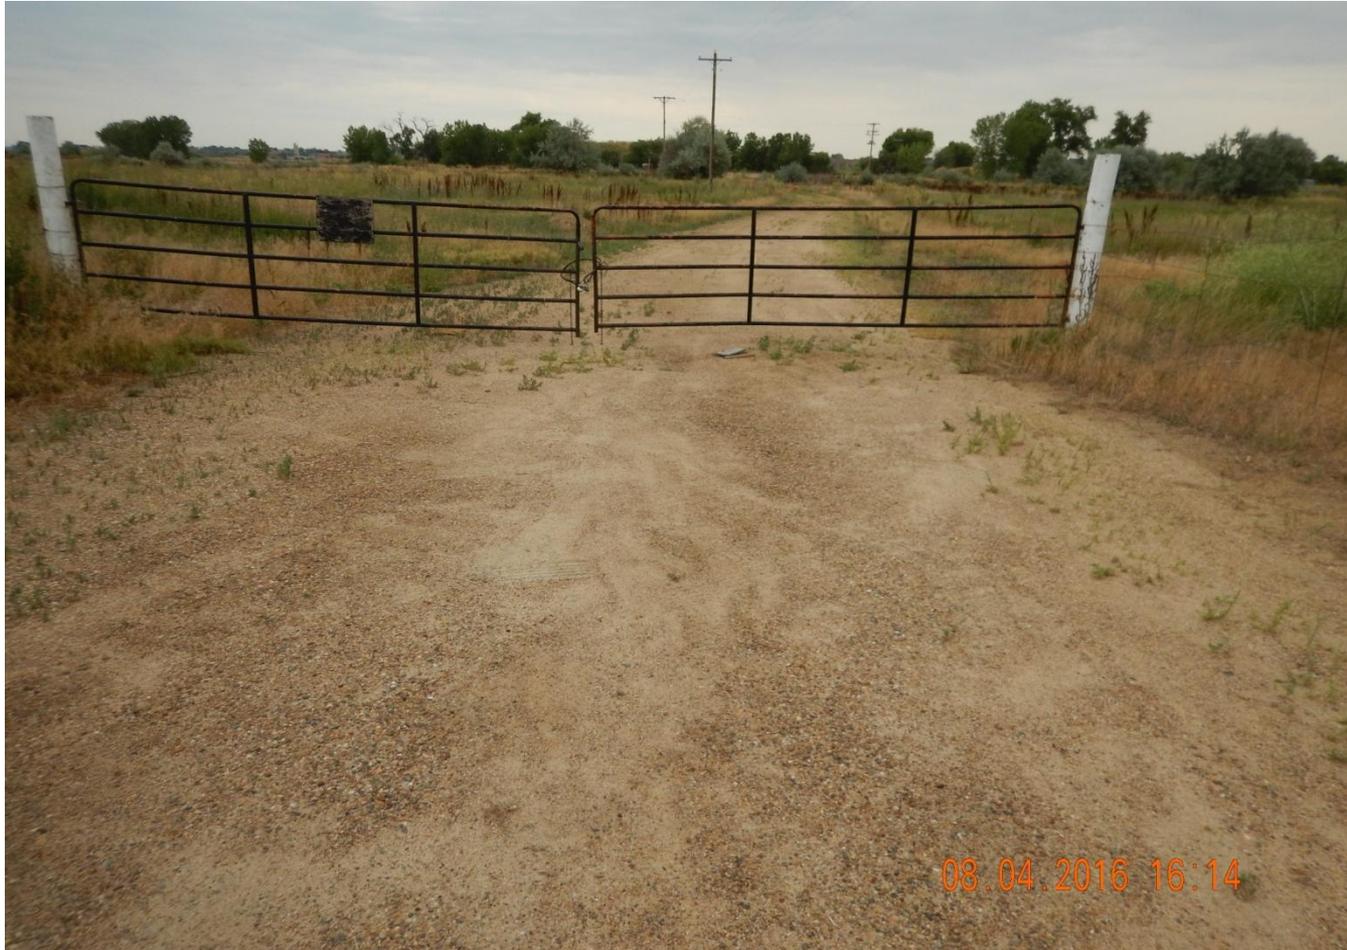
Photo 2. Photo taken from entrance of location, facing East. Access road has not been reclaimed per Rule 1004. Also, List B Noxious weeds exist throughout access road and location which need to be removed per Rule 1004.

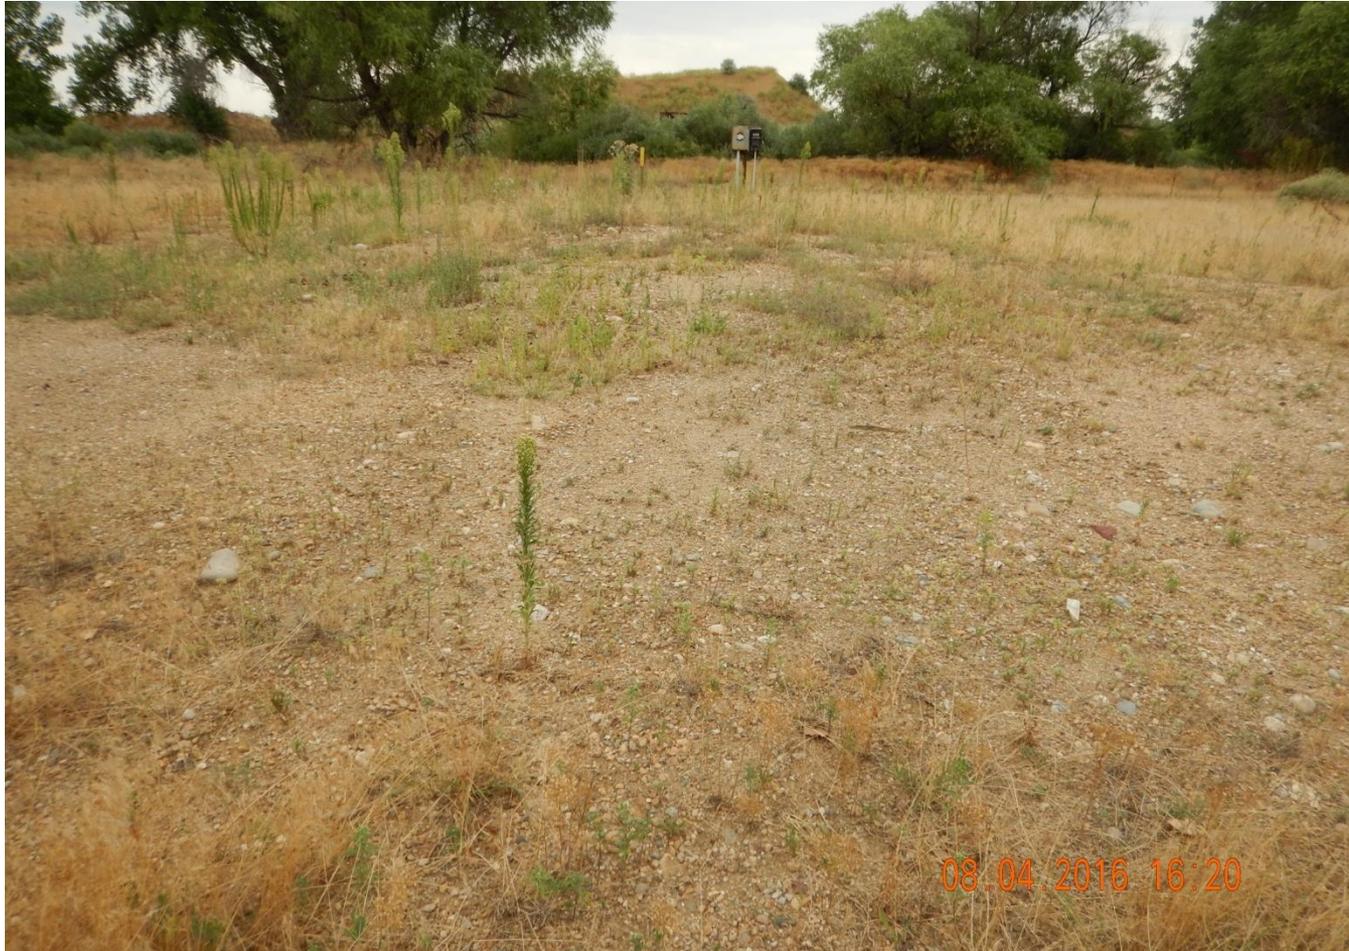
Photo 3. Photo taken from approximate center of location, facing East. Location has not been reclaimed per Rule 1004.

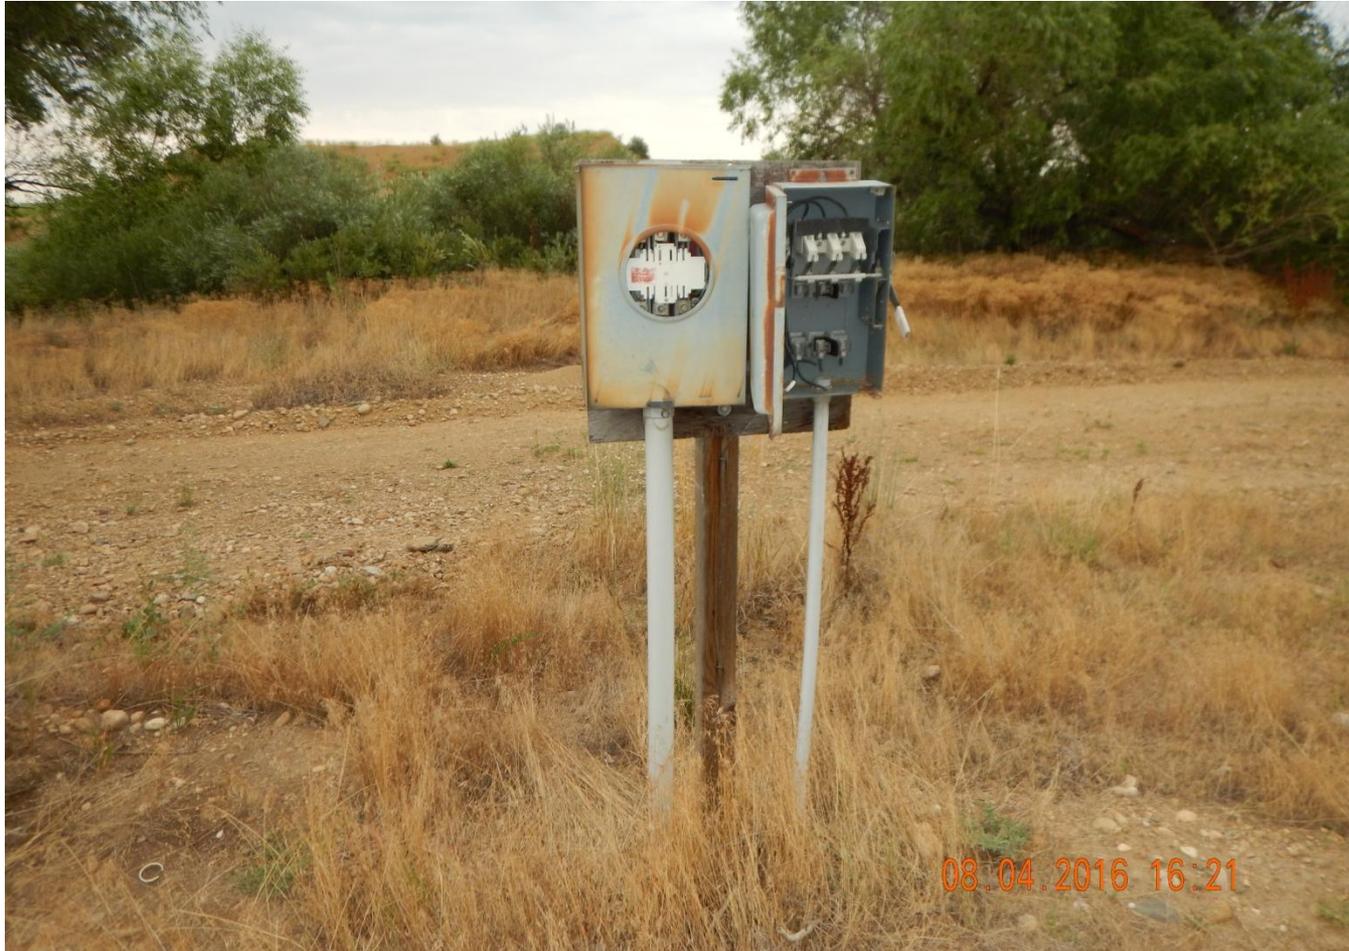
Photo 4. Electrical service panel needs to be removed from location.

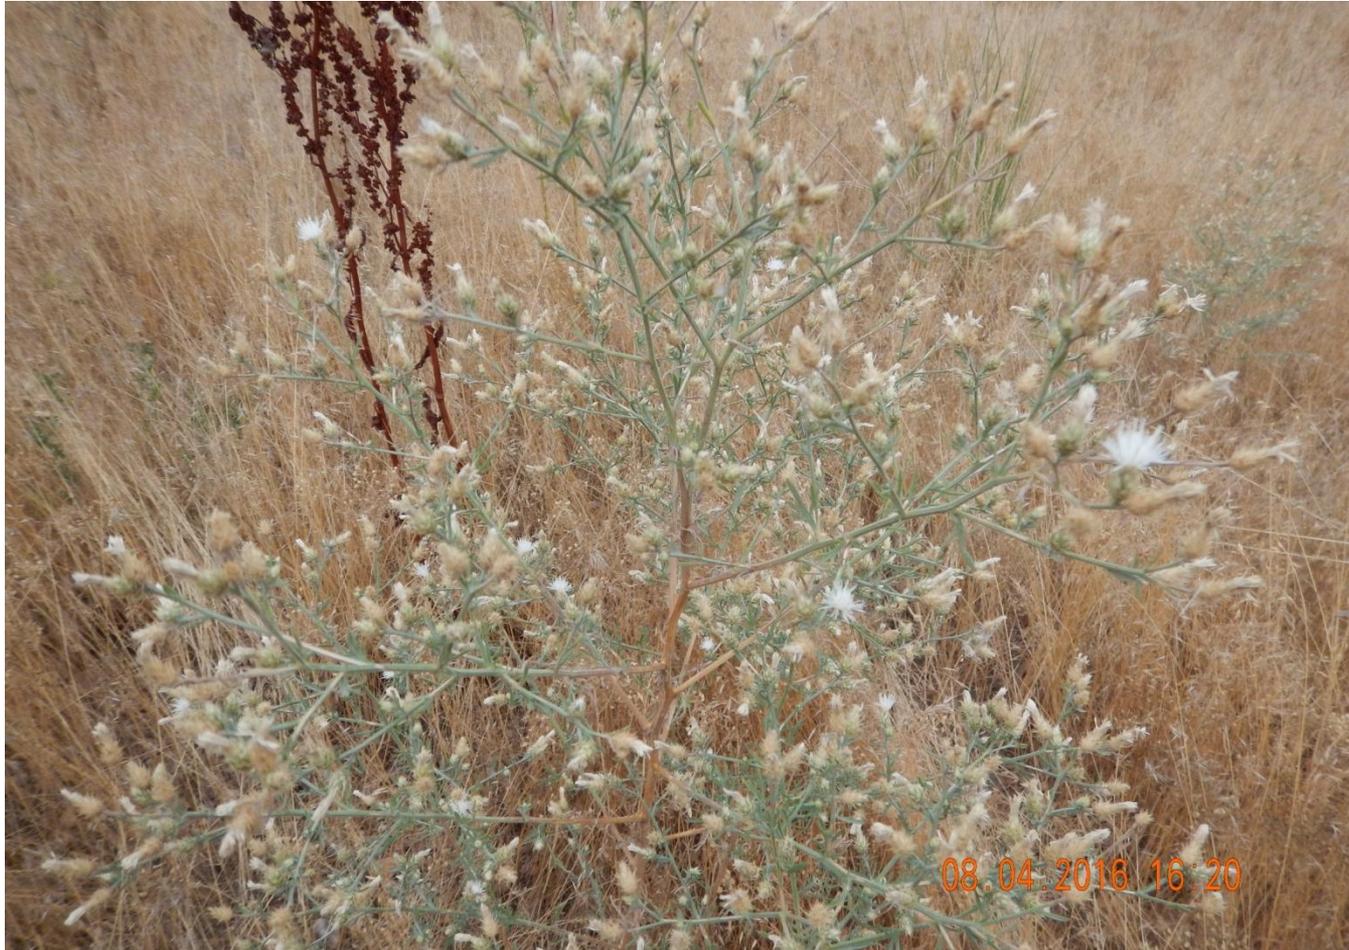
Photo 5. Photo taken of a List B noxious weed species, Diffuse knapweed (*Centaurea diffusa*), which is found along the access road and location, and needs to be removed per Rule 1004.

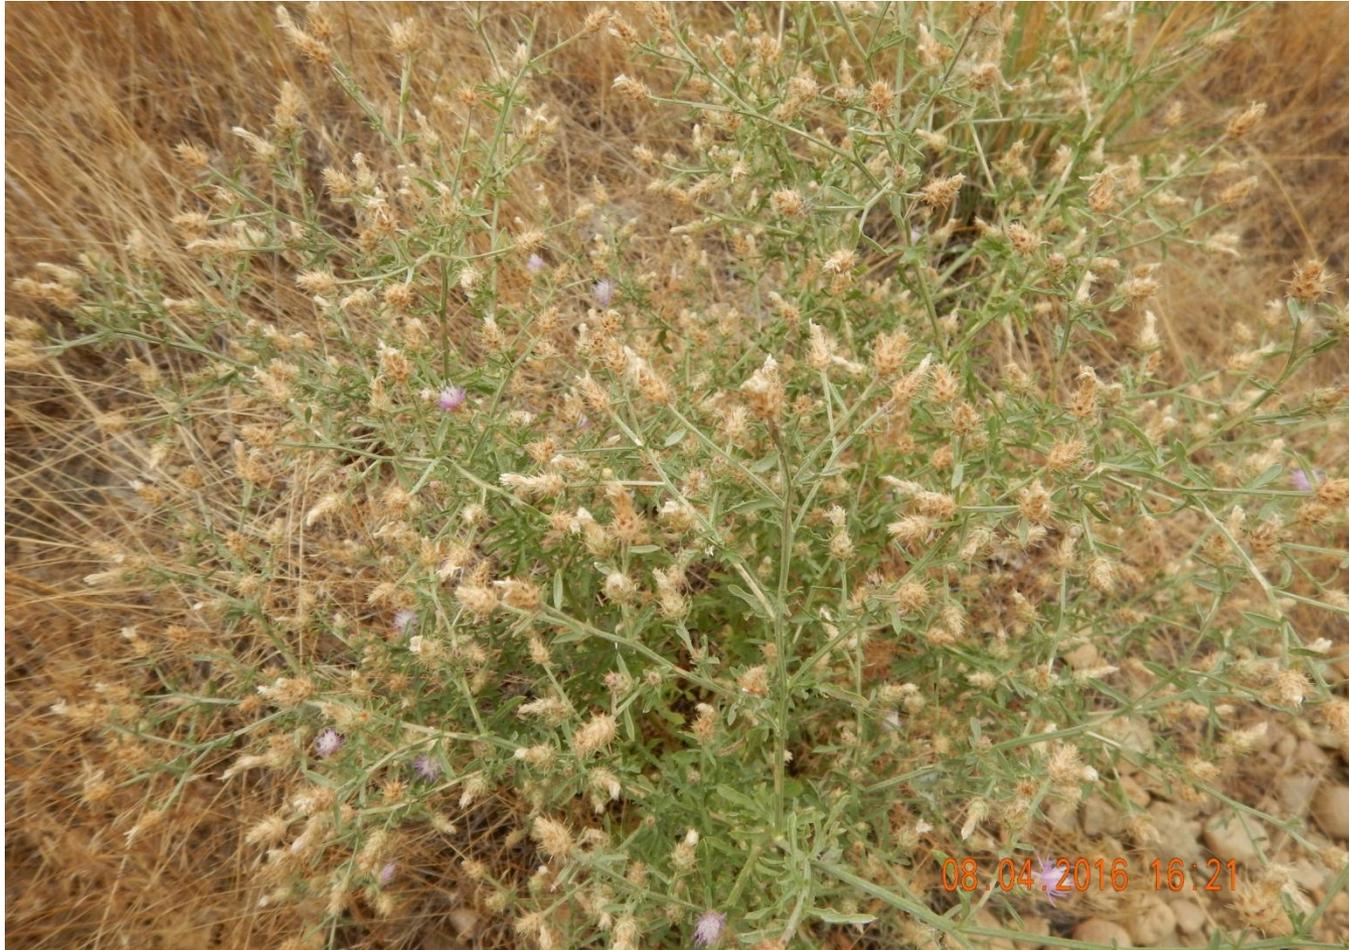
Photo 6. Photo taken of a List B noxious weed species, Spotted knapweed (*Centaurea stoebe*), which is found along the access road and location, and needs to be removed per Rule 1004.

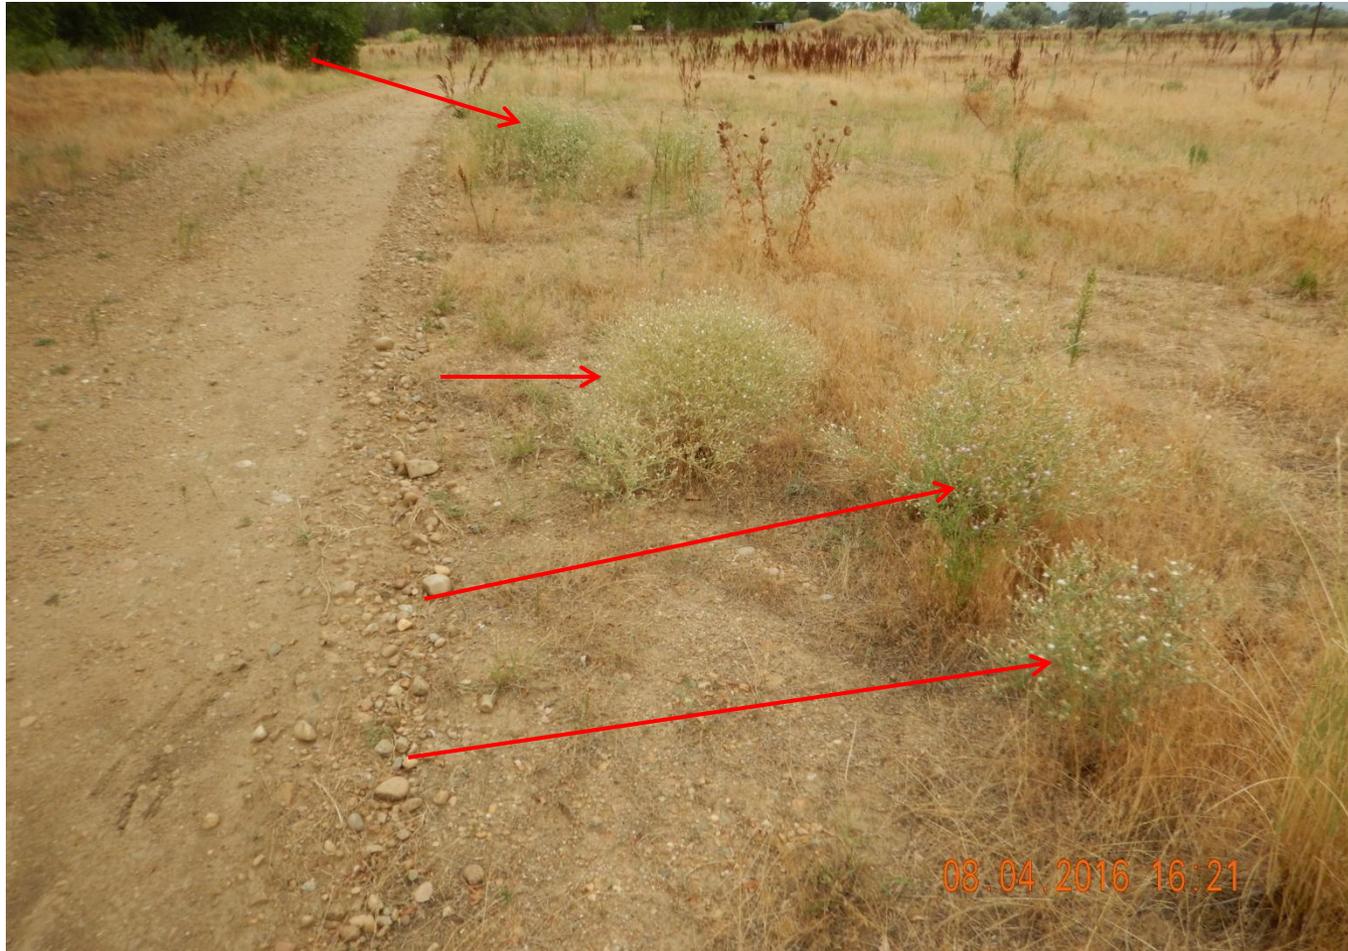
Photo 7. Photo taken of Diffuse and Spotted knapweed along the access road.

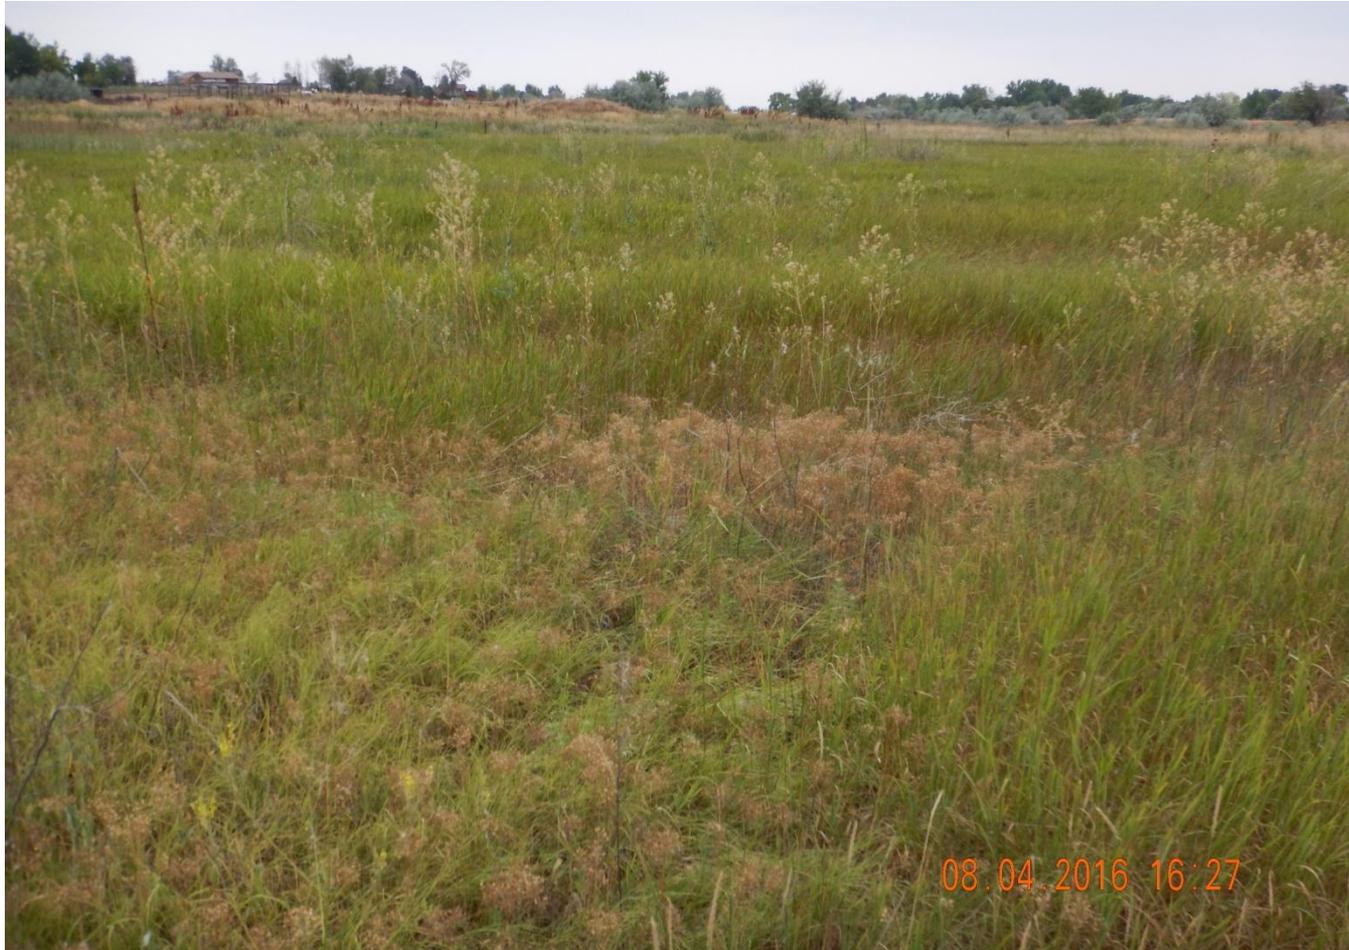
Photo 8. Reference photo taken from west of location, facing North. Location is not reflective of reference areas and noxious weeds are present throughout access road and location.
