Construction Inspection

08/15/2016

Operator: Whiting

Location ID: 445049

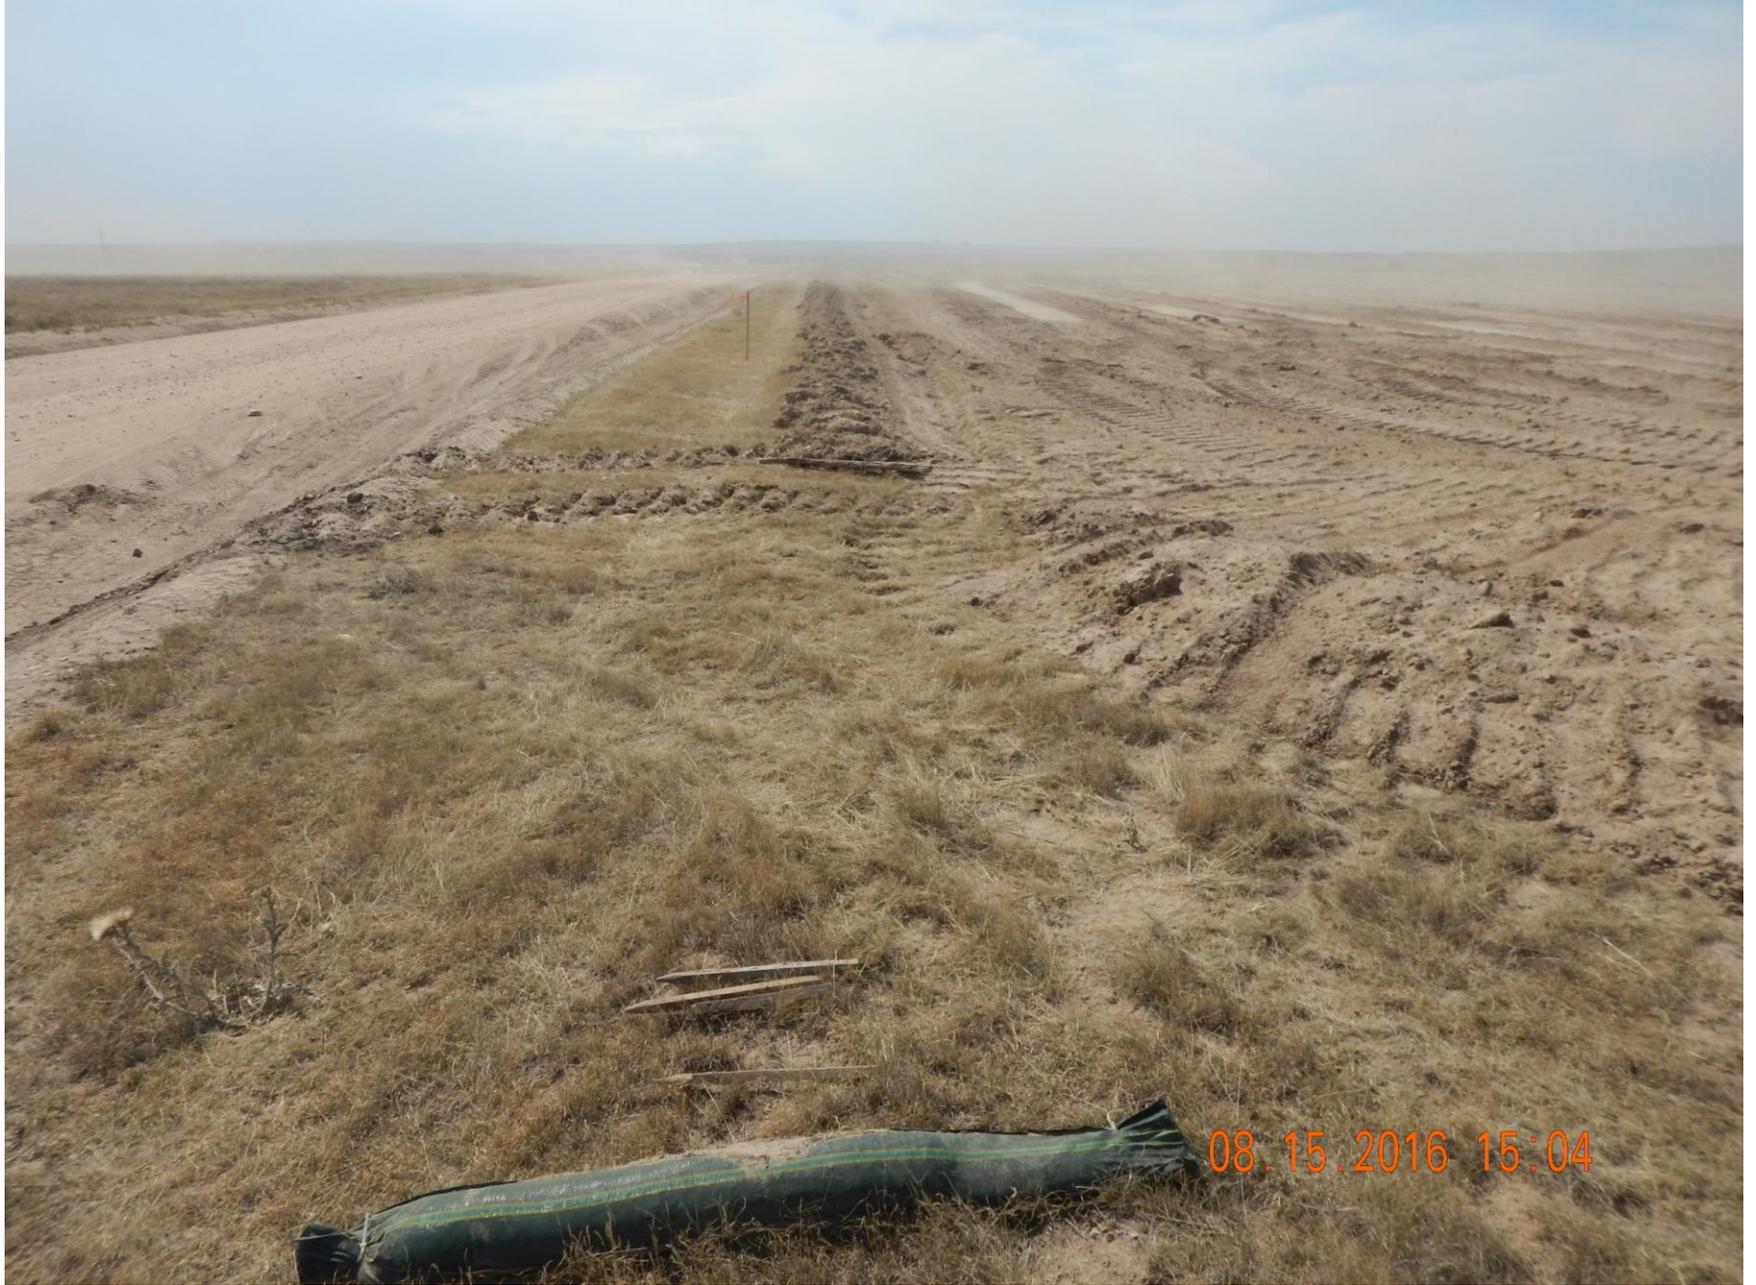
Figure 1: Photo taken from the southeast corner of the location, facing west. Photo shows stormwater and sediment control ditch BMP on the southern perimeter of the location.

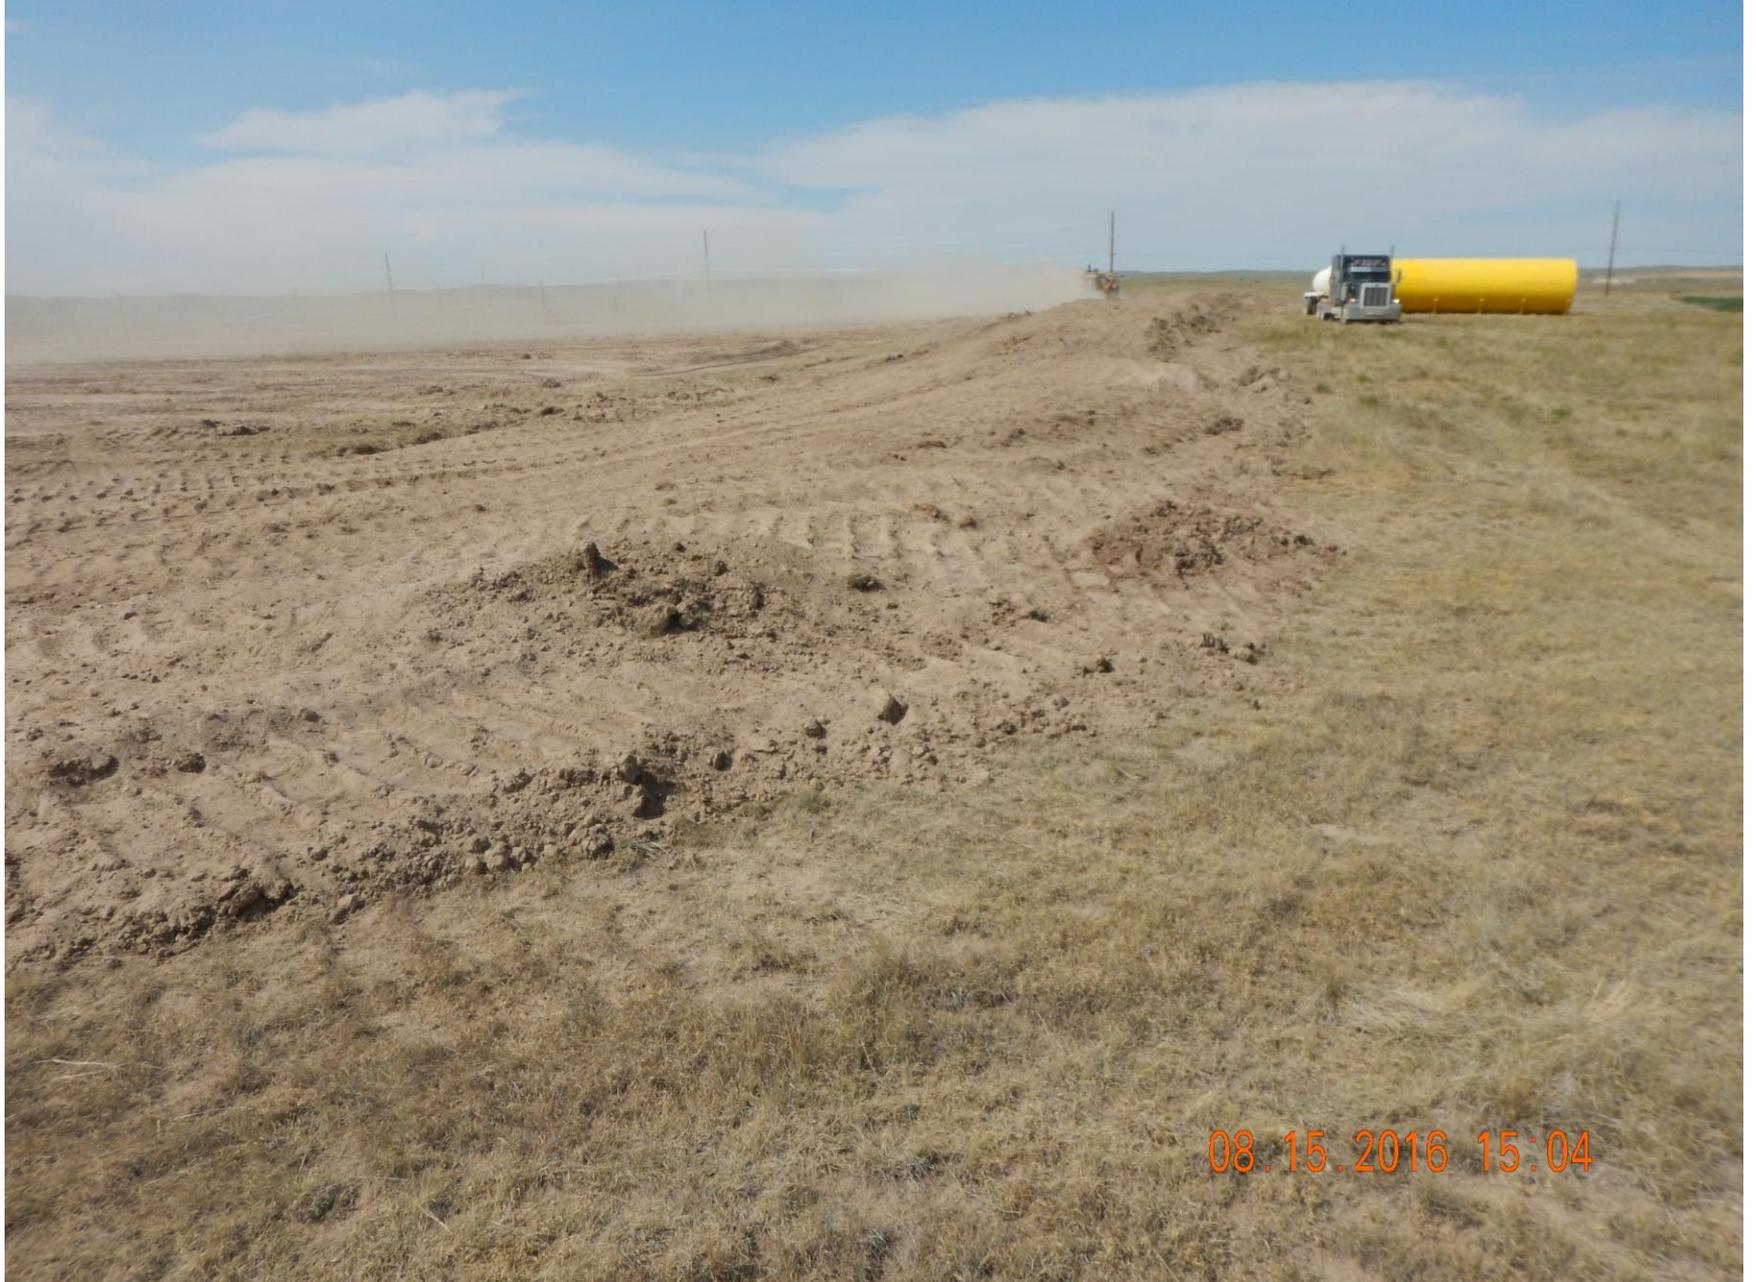
Figure 2: Photo taken from the southeast corner of the location, facing north. Photo shows stormwater and sediment control BMPs missing partially on the eastern perimeter of the location and topsoil stockpile.

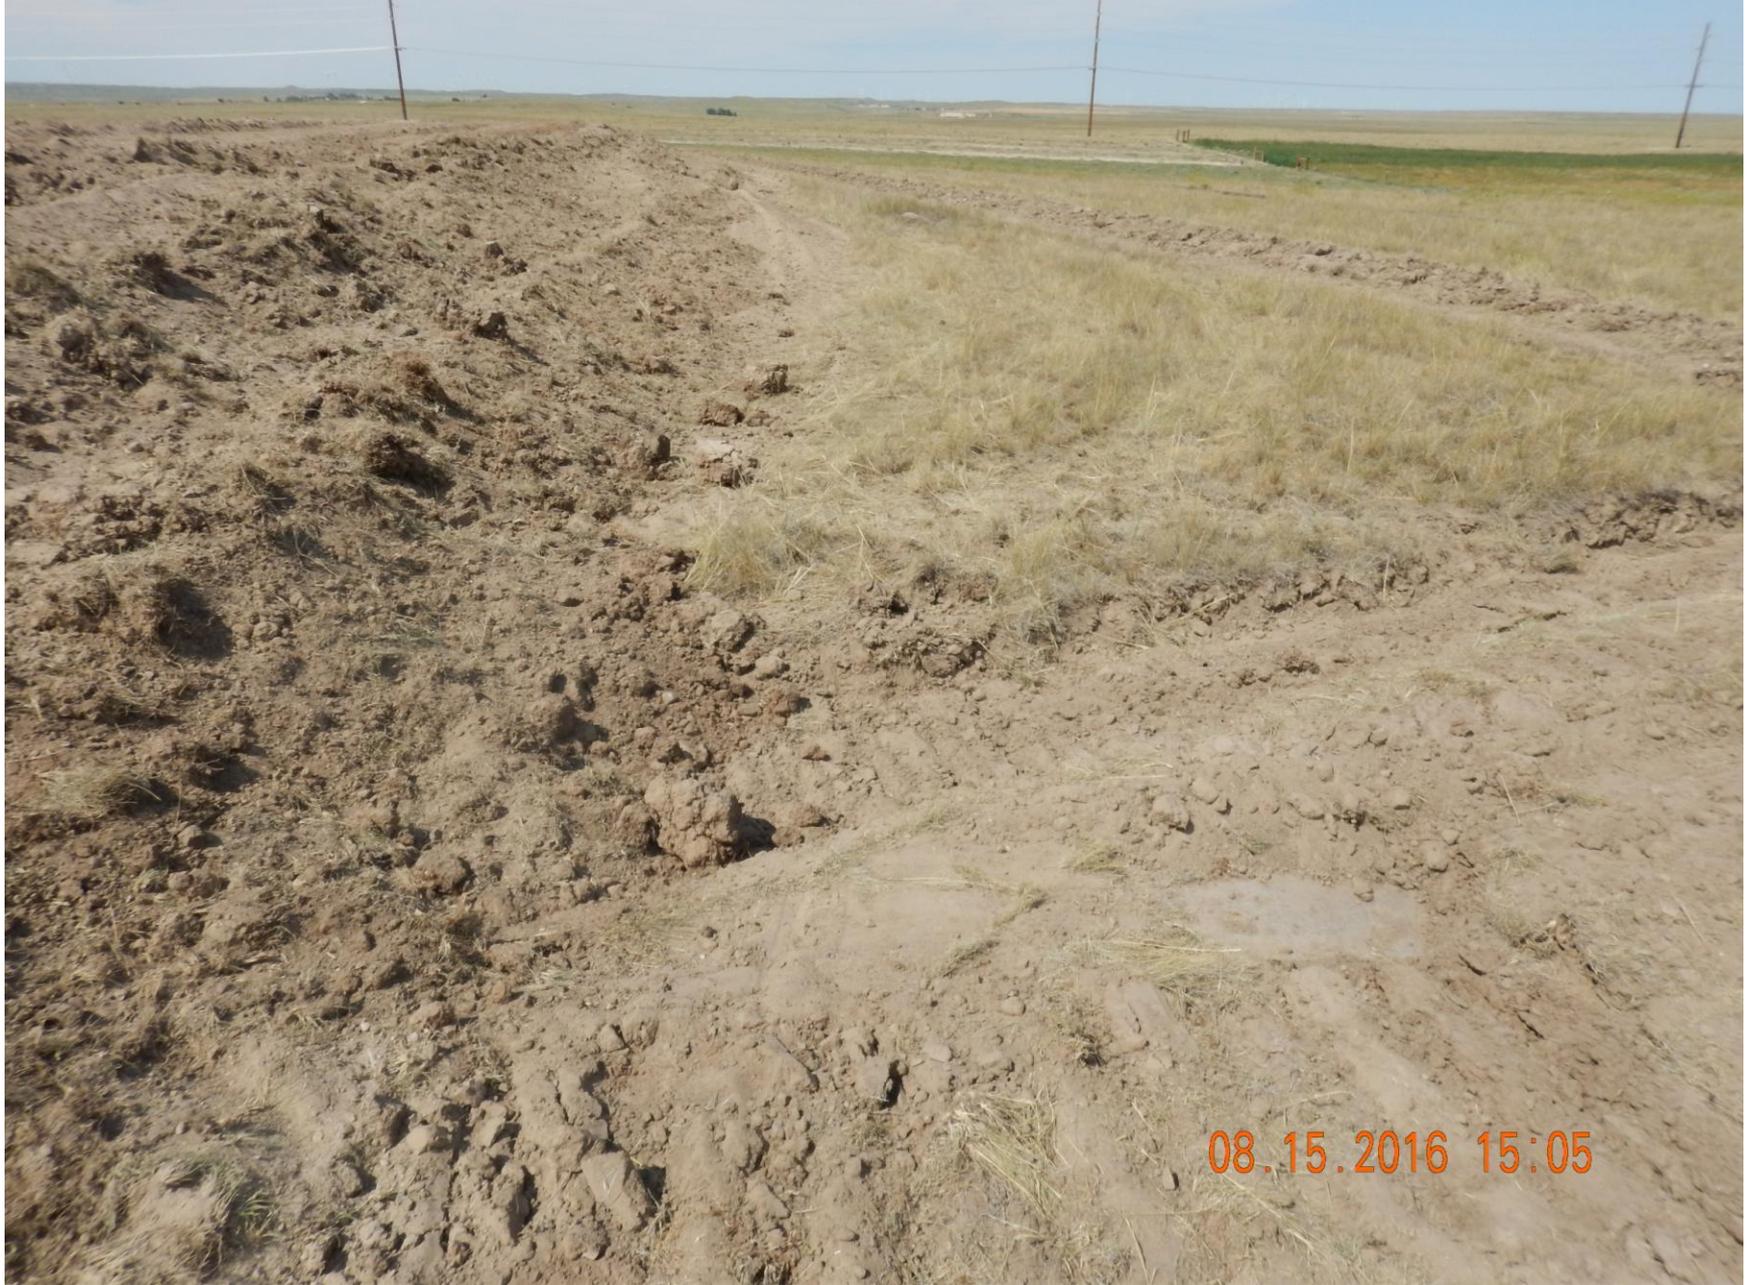
Figure 3: Photo taken from the east end of the location, facing north. Photo shows stormwater and sediment control ditch BMP only partially on the eastern perimeter of the location.

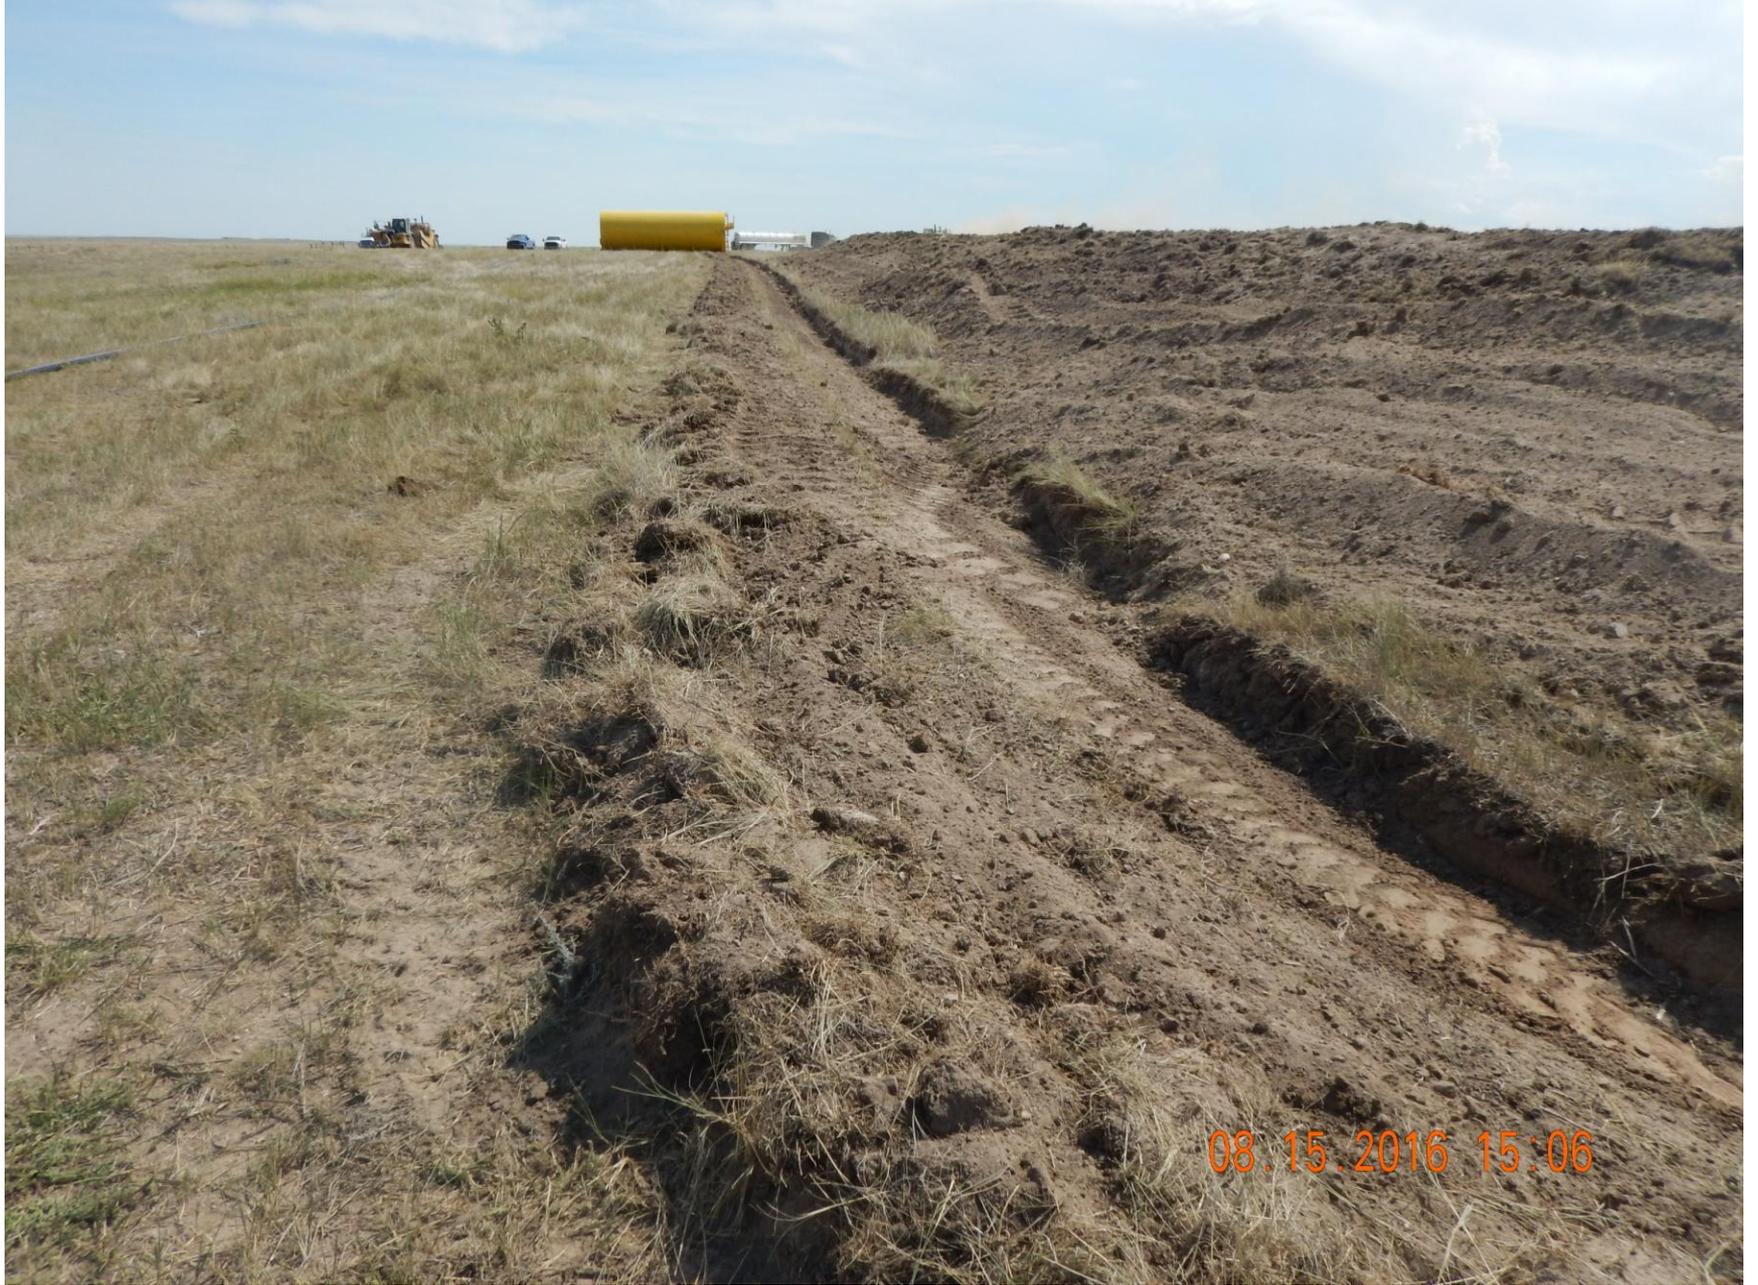
Figure 4: Photo taken from the northeast corner of the location, facing south. Photo shows stormwater and sediment control ditch BMP on the (partial) eastern perimeter of the location.

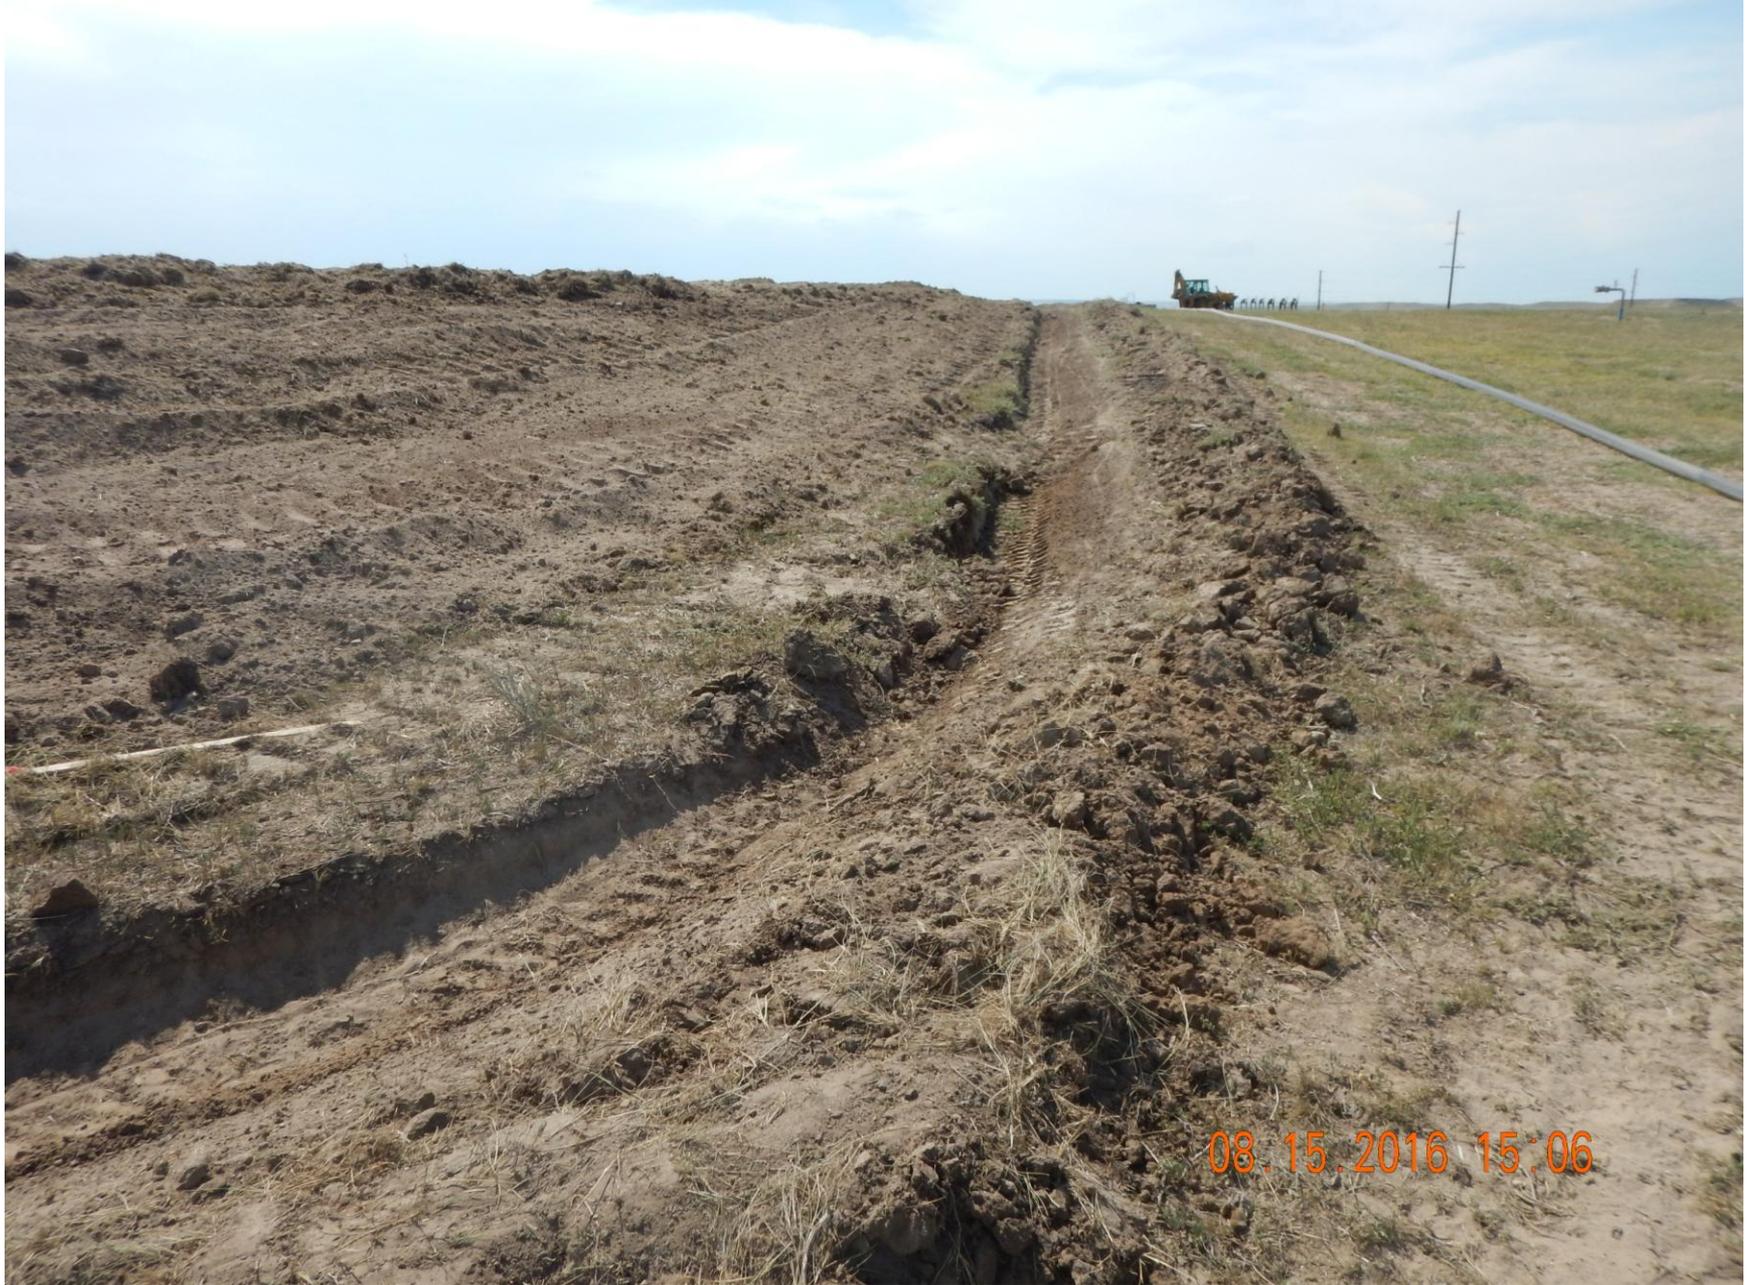
Figure 5: Photo taken from the northeast corner of the location, facing west. Photo shows stormwater and sediment control ditch BMP on the northern perimeter of the location.

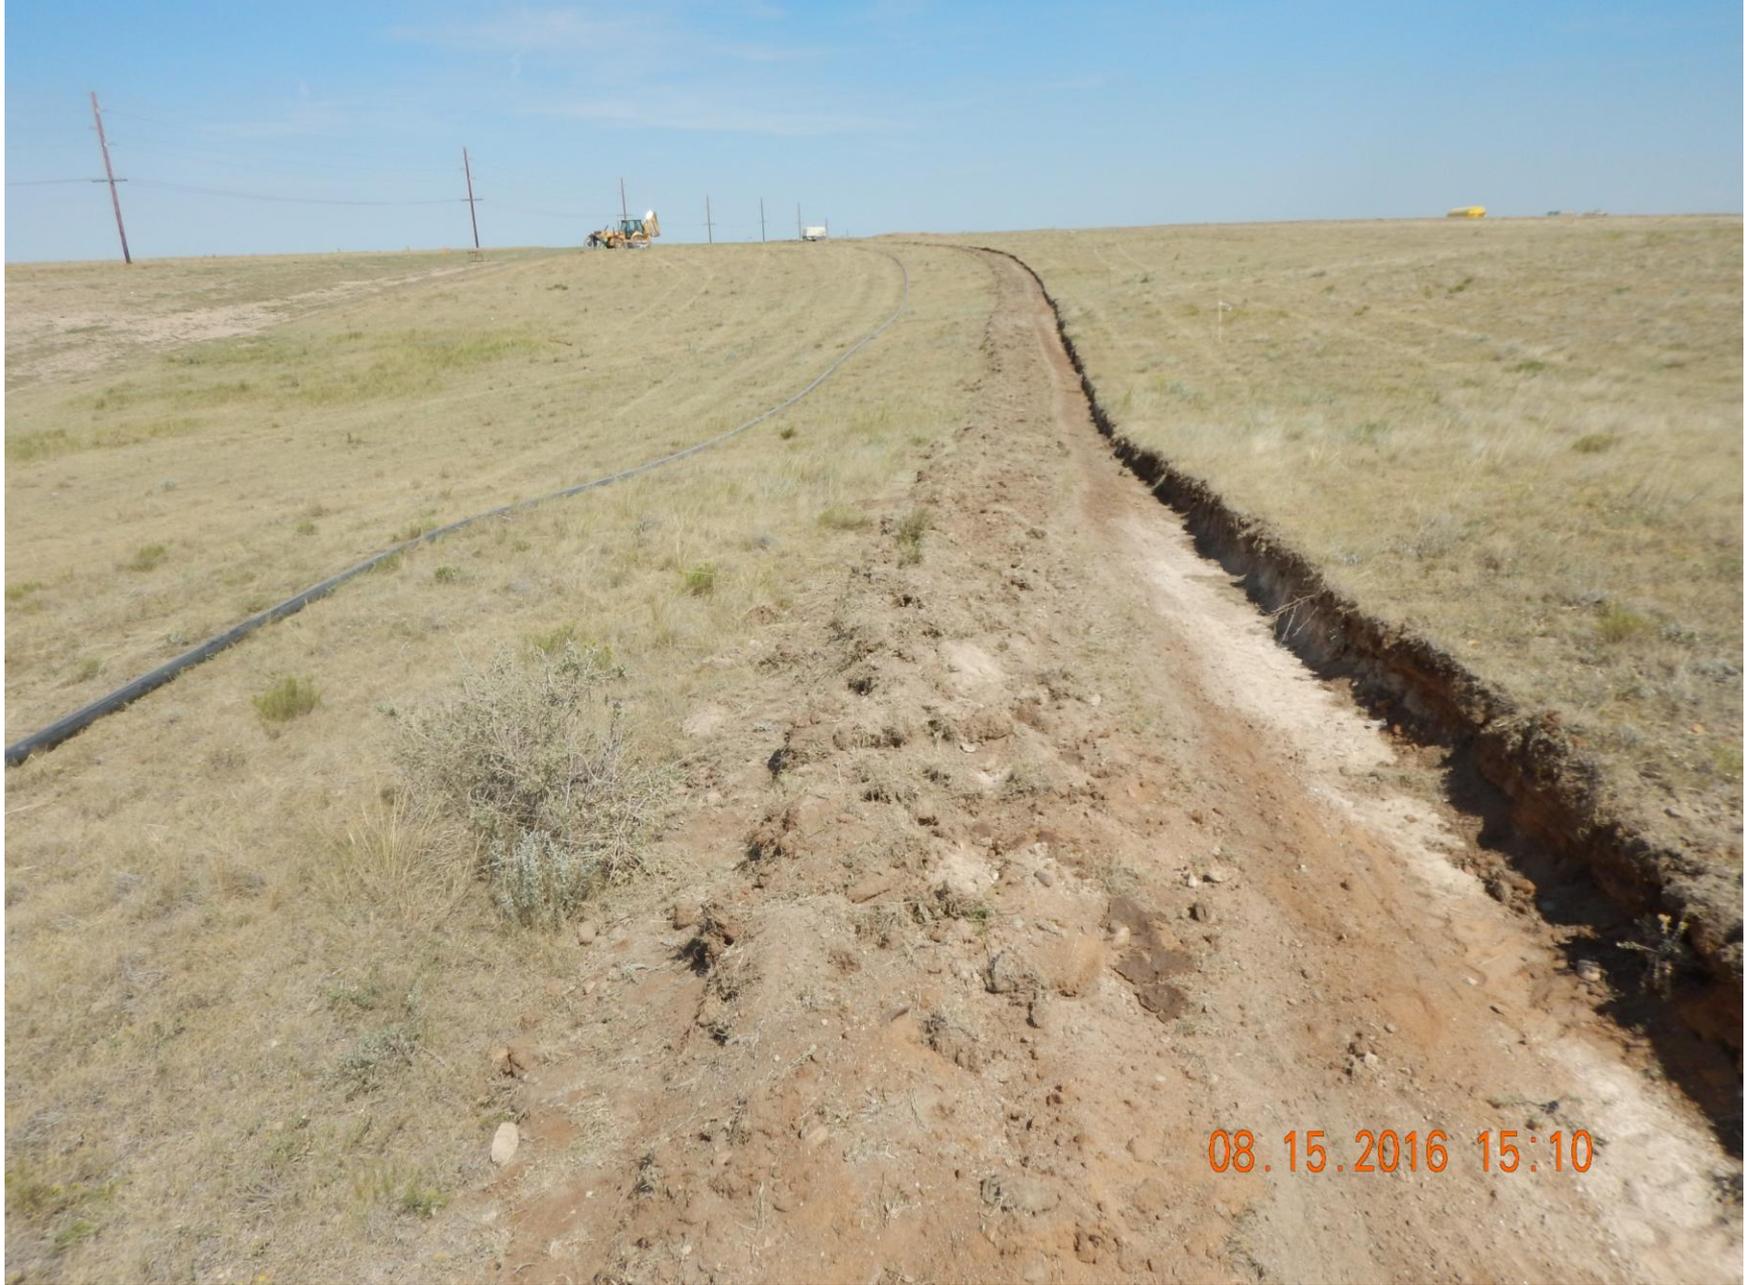
Figure 6: Photo taken from the northwest corner of the location, facing east. Photo shows stormwater and sediment control ditch BMP on the northern perimeter of the location.

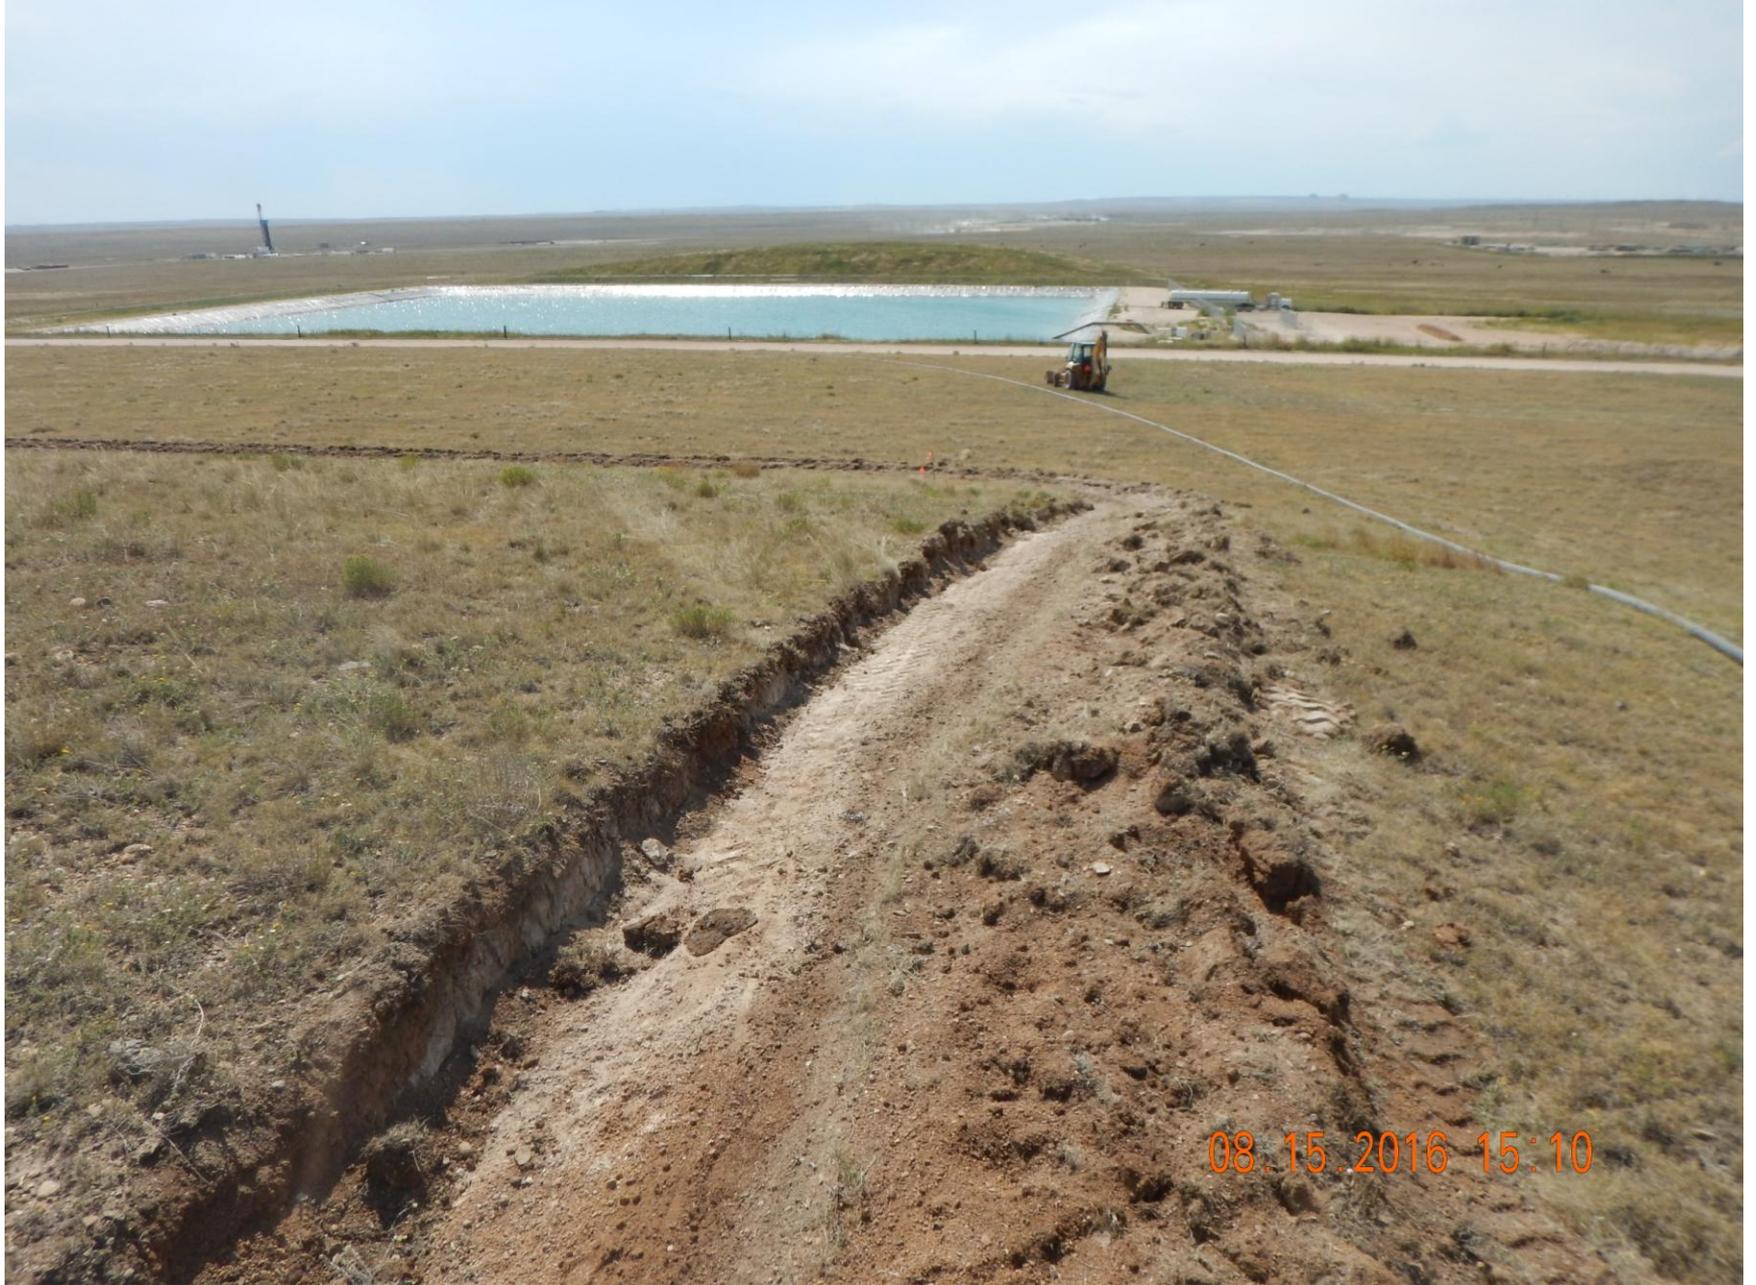
Figure 7: Photo taken from the northwest corner of the location, facing west. Photo shows stormwater and sediment control ditch BMP on the northern perimeter of the location.

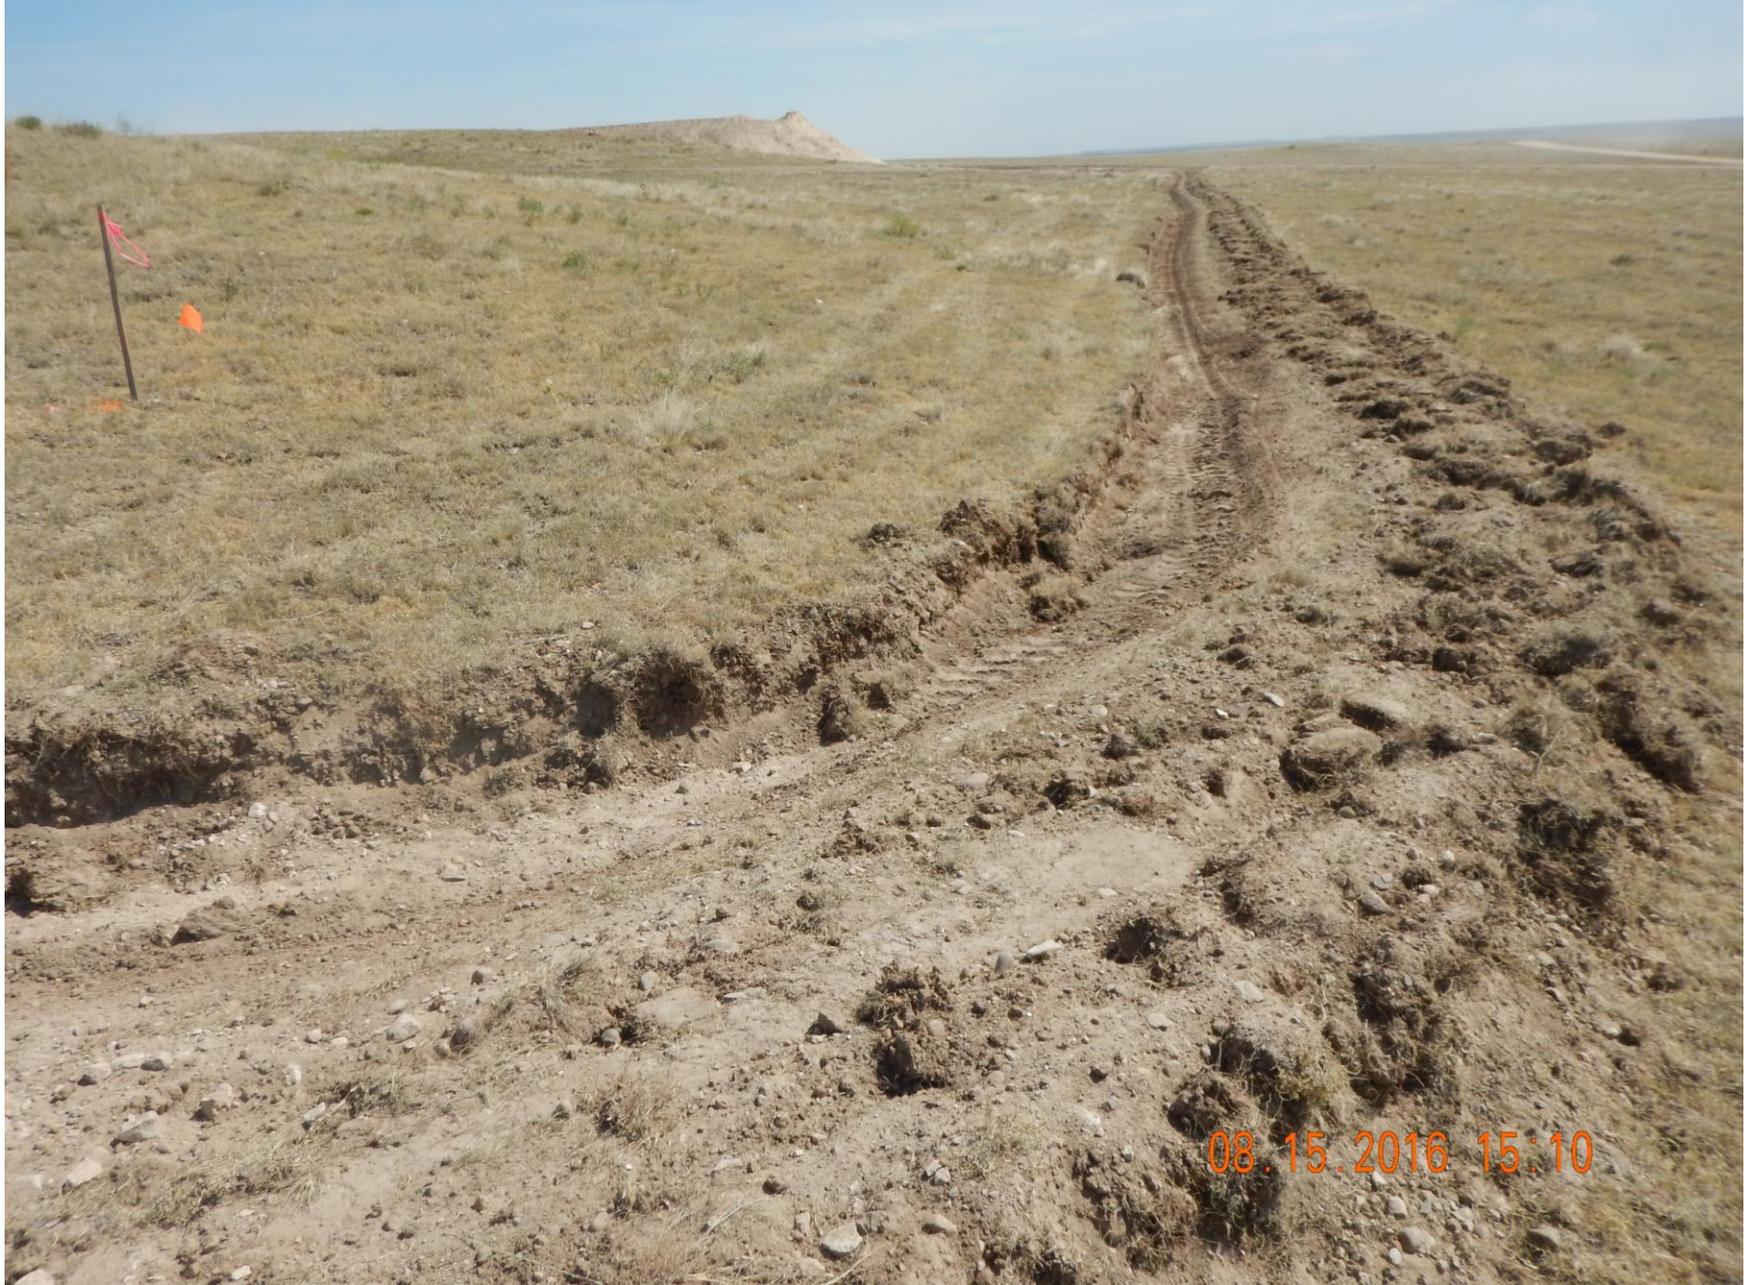
Figure 8: Photo taken from the northwest corner of the location, facing south. Photo shows stormwater and sediment control ditch BMP on the western perimeter of the location.

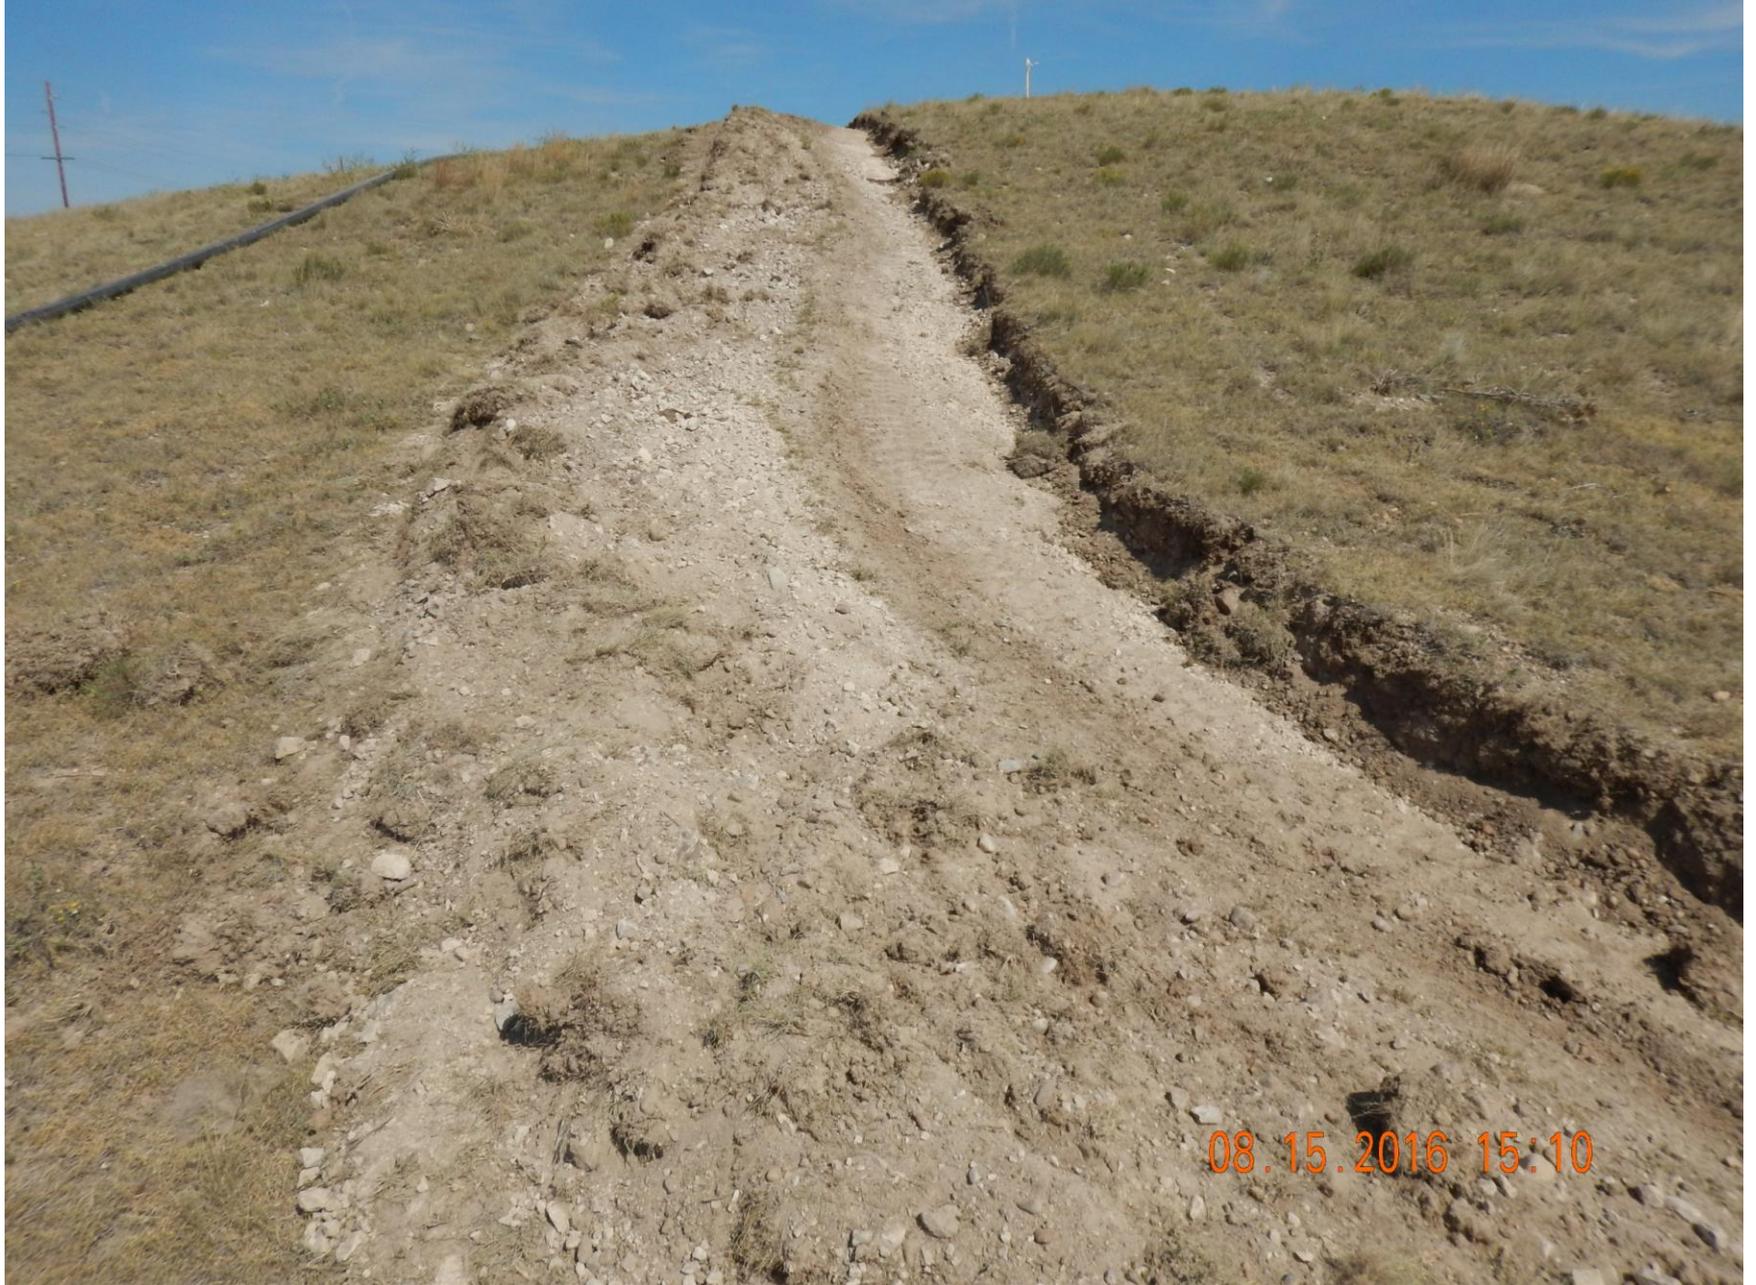
Figure 9: Photo taken from the northwest corner of the location, facing east. Photo shows stormwater and sediment control ditch BMP on the northern perimeter of the location.

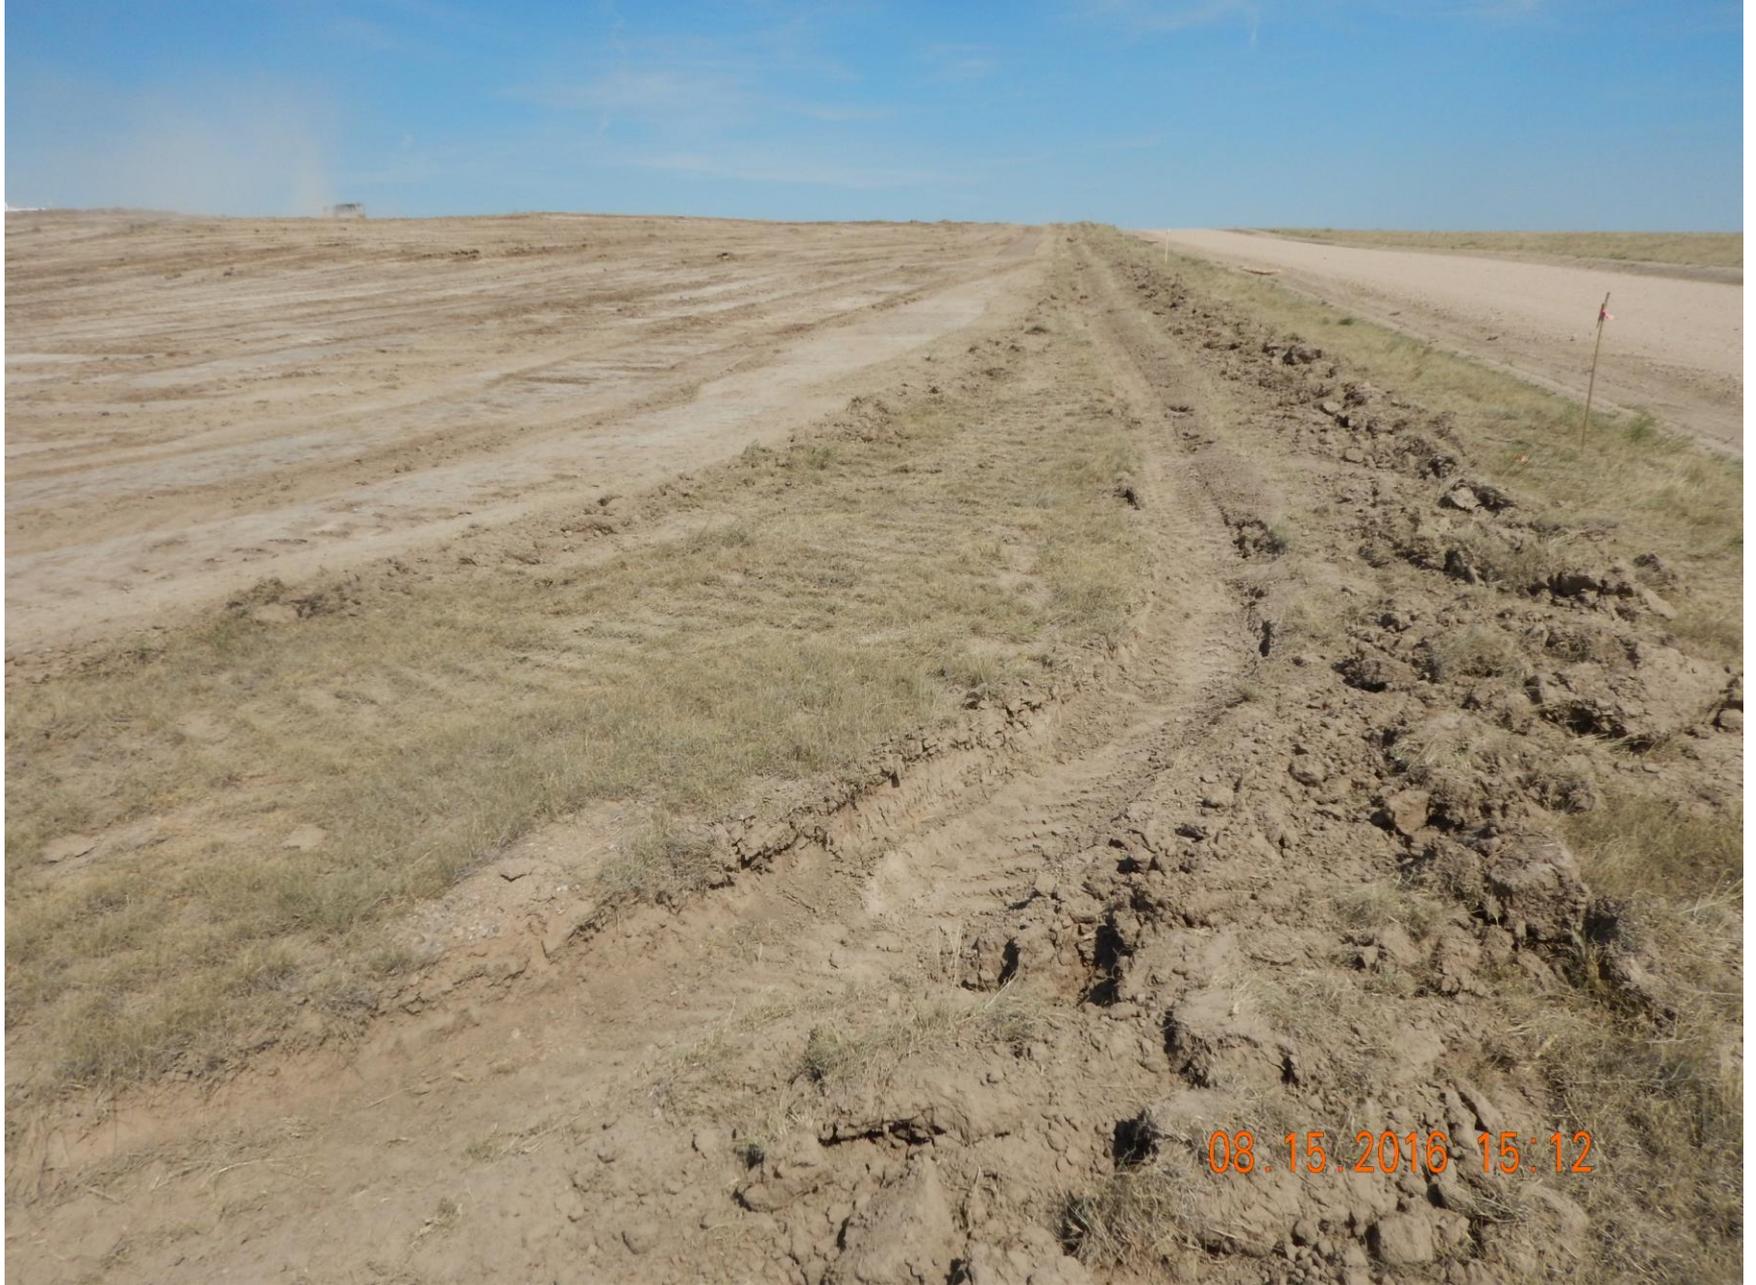
Figure 10: Photo taken from the southwest corner of the location, facing east. Photo shows stormwater and sediment control ditch BMP on the southern perimeter of the location.
