Construction Inspection

08/15/2016

Operator: Whiting

Location ID: 445049

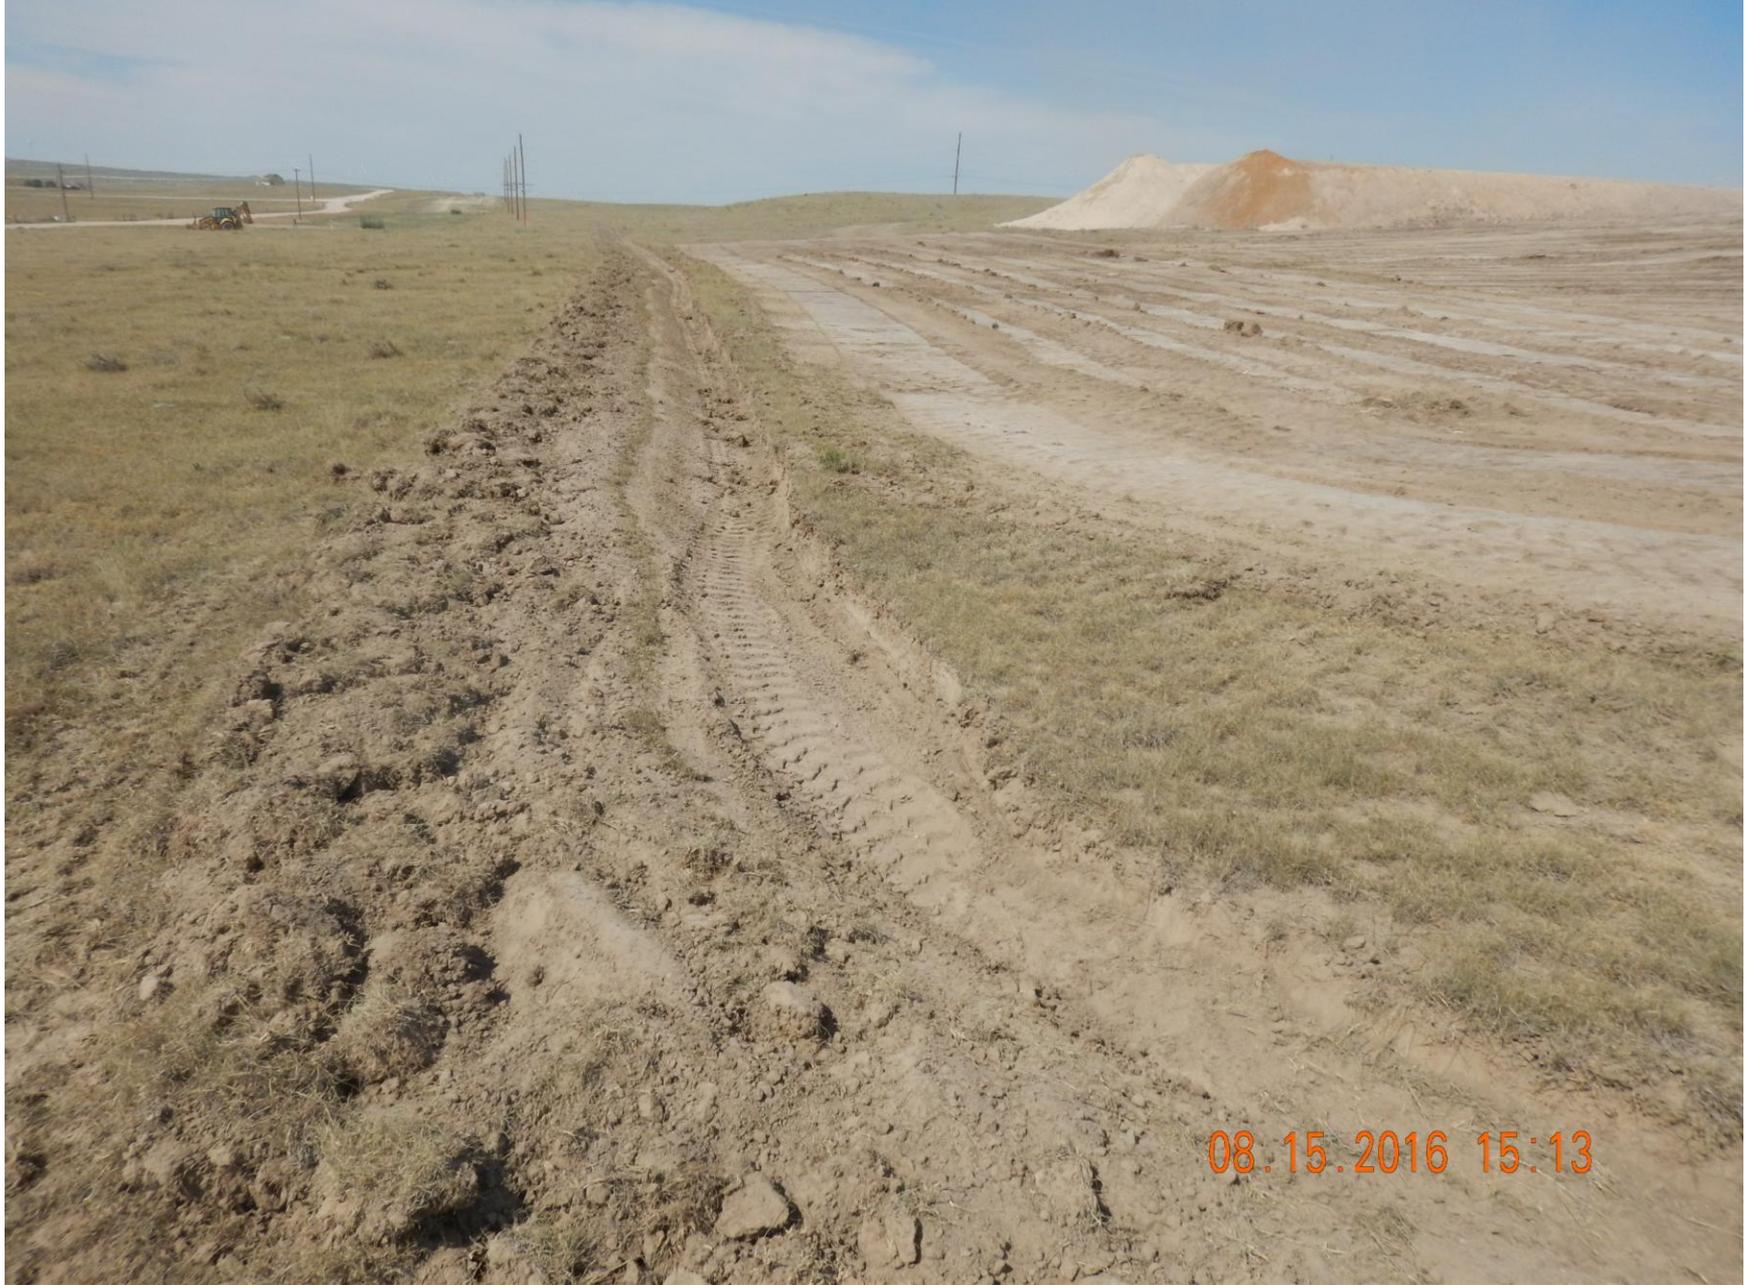
Figure 11: Photo taken from the southwest corner of the location, facing north. Photo shows stormwater and sediment control ditch BMP on the western perimeter of the location.
