# Final Reclamation Inspection

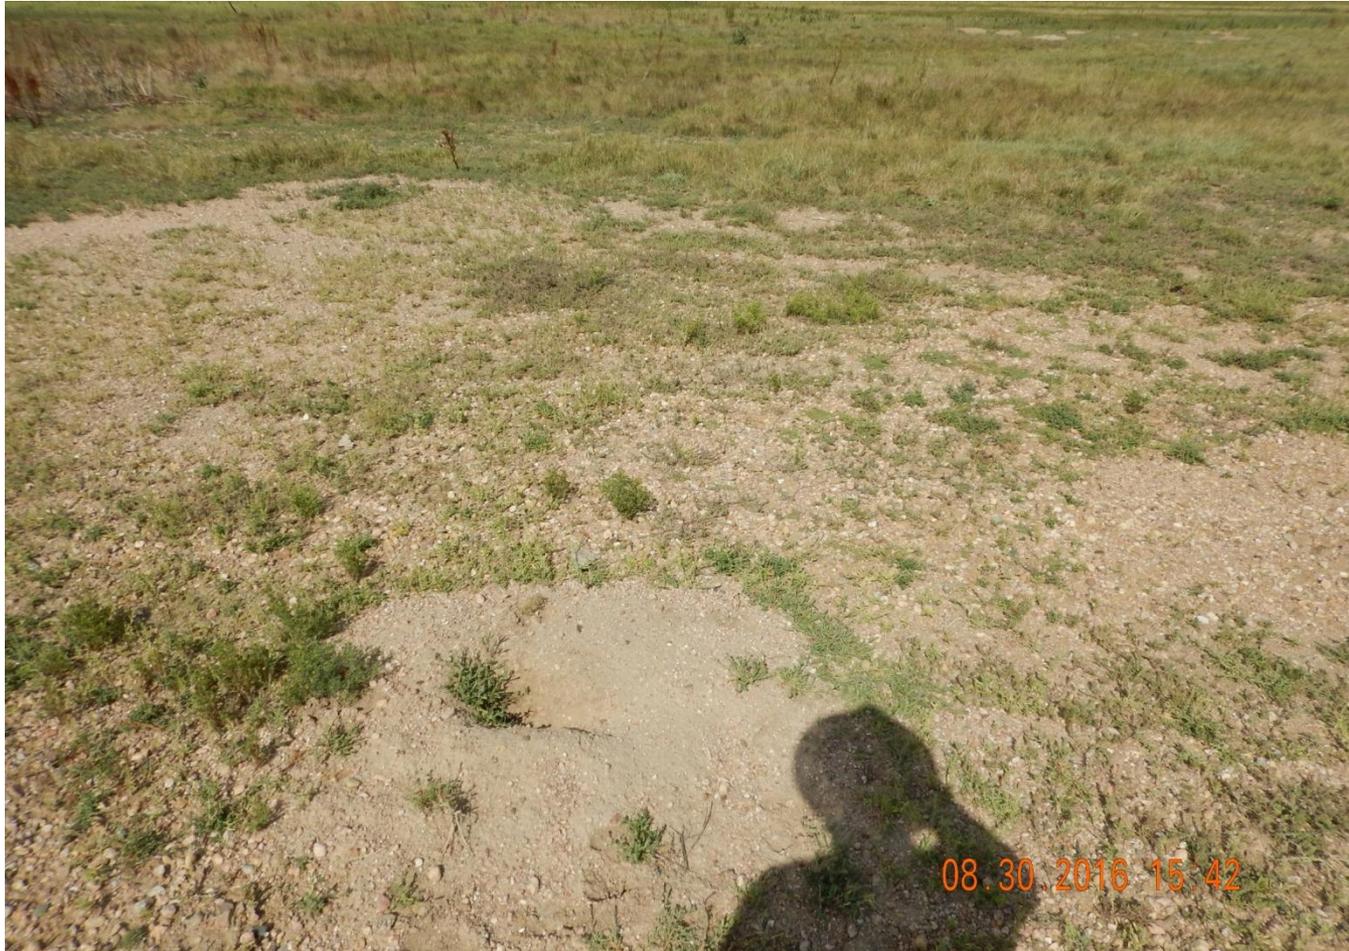
**Photo 2.** Photo taken from center of location, facing East. Location has not been reclaimed per Rule 1004. Little to no perennial vegetative growth has established at location. Does not appear all of the gravel was removed.

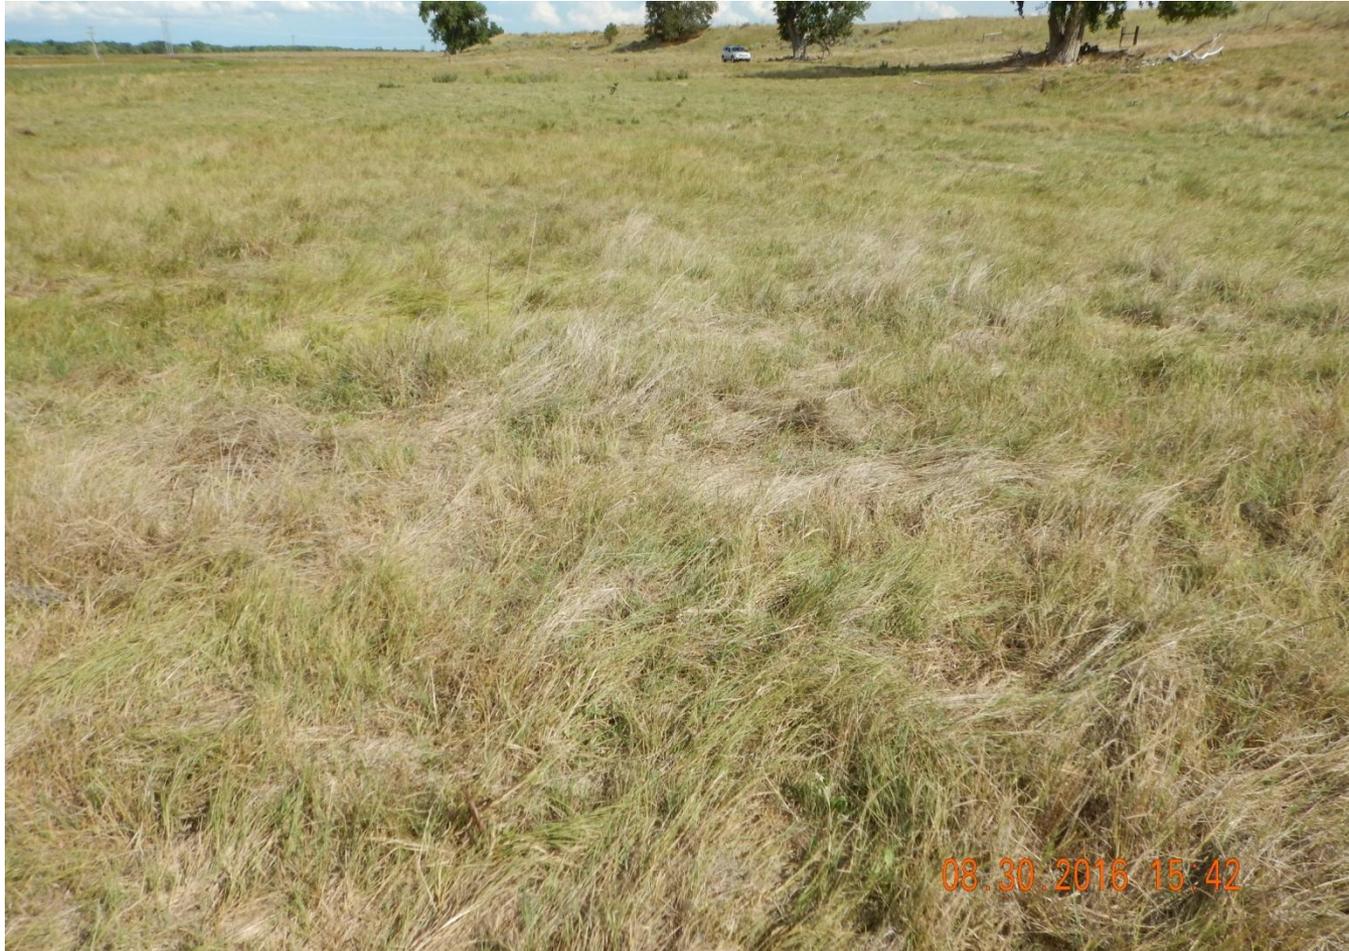
**Photo 4.** Reference photo taken south of location, facing South. Vegetative growth does not appear to be reflective of reference areas.
