# Construction Inspection

09/20/2016

Operator: Grynberg

Location ID: 386901

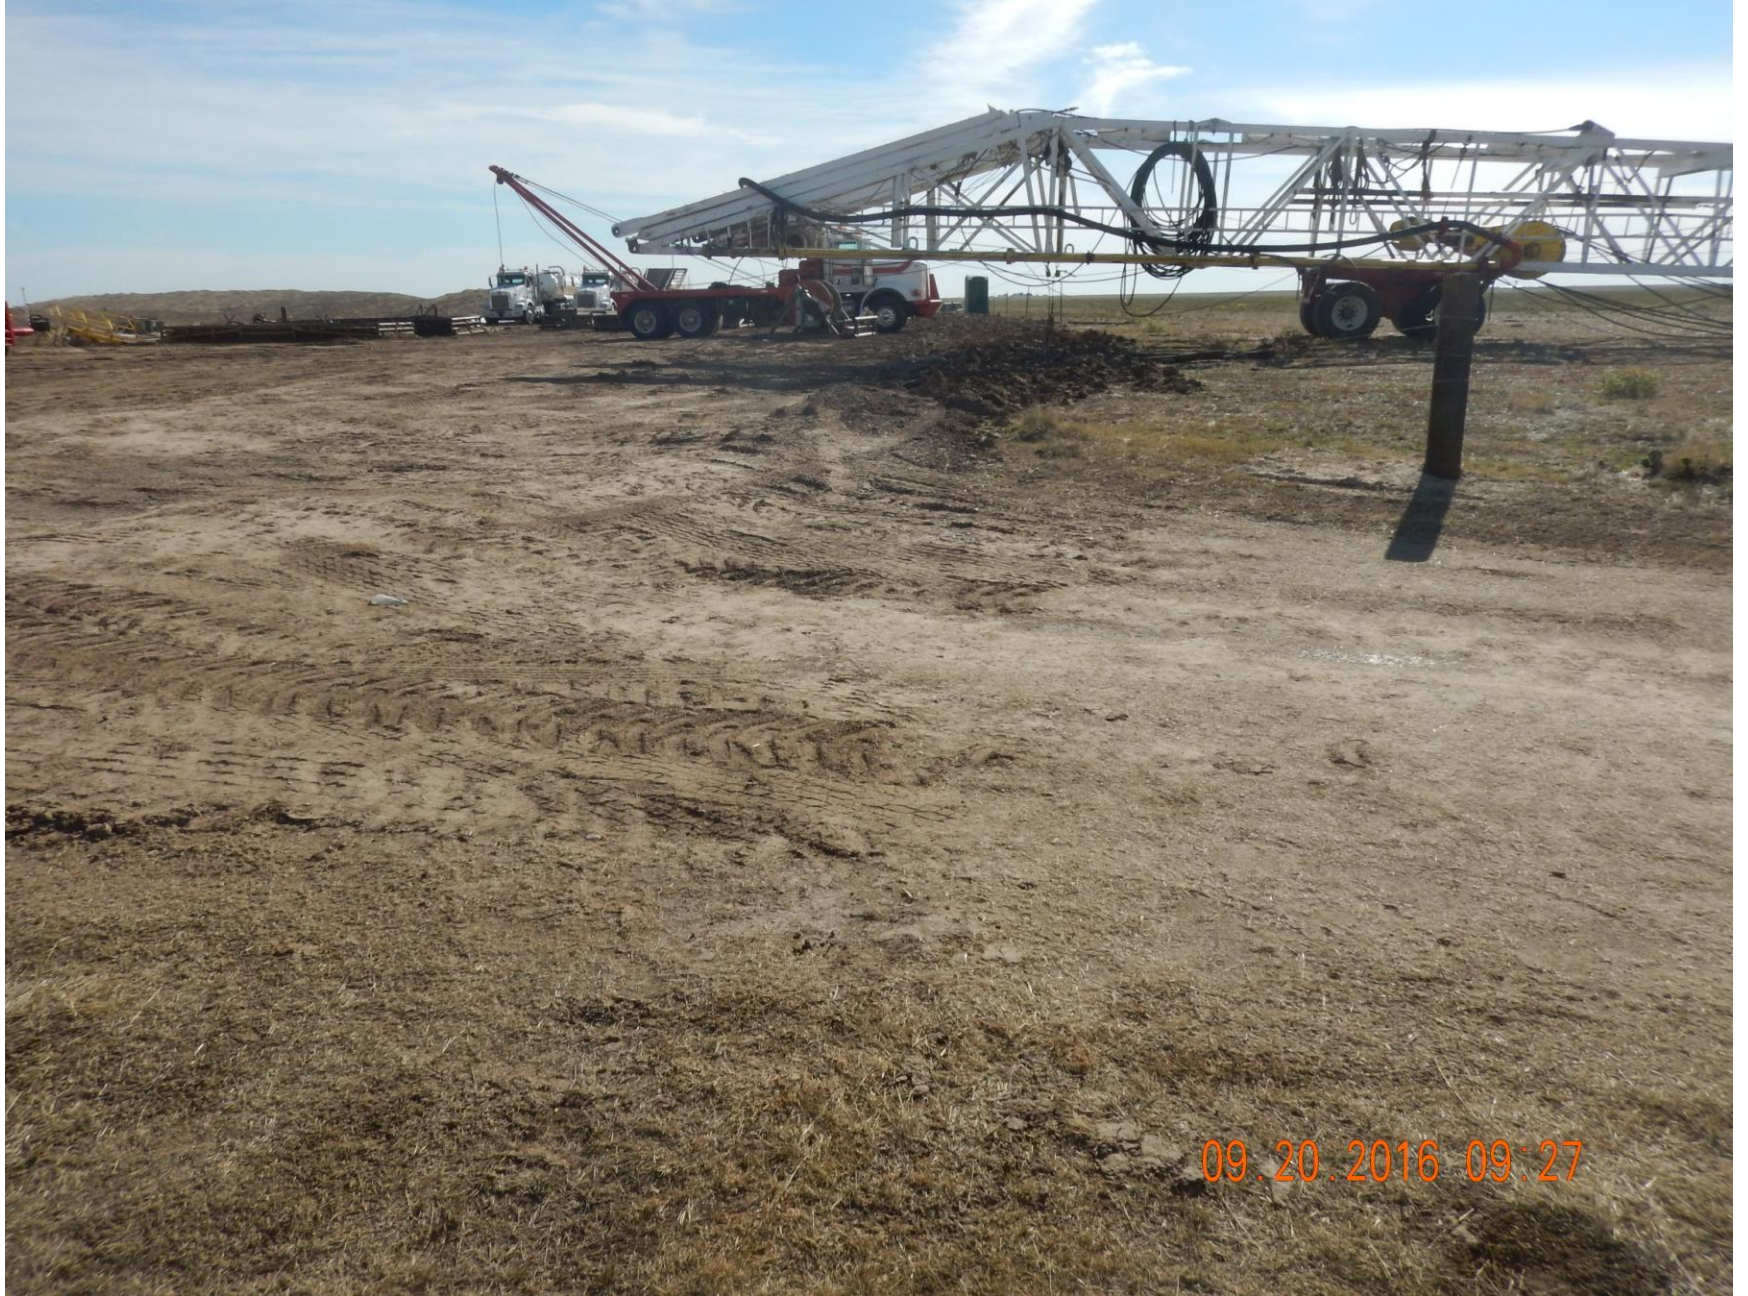
**Figure 1:** Photo taken from the south end of the location, facing east. Location had been expanded ~50 to the south.

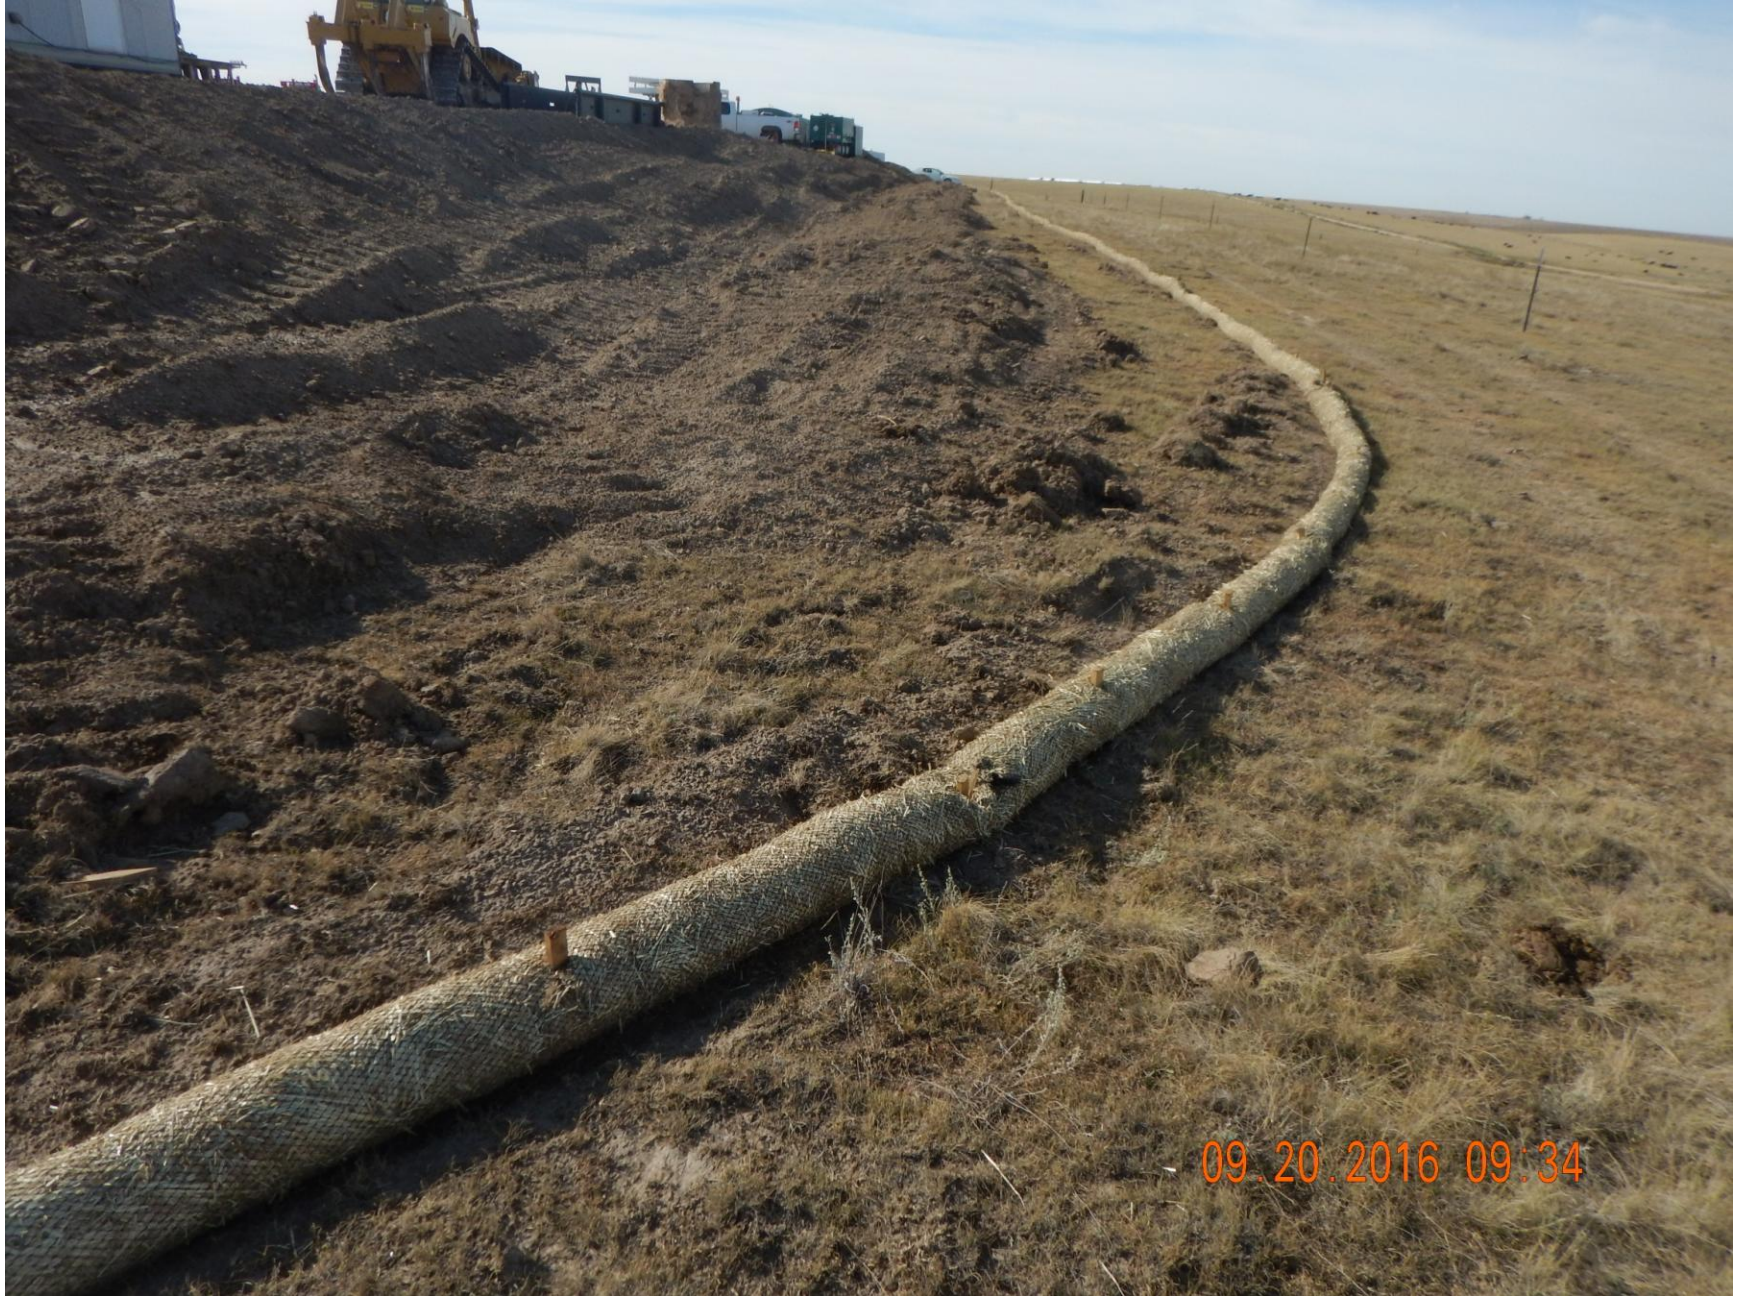
**Figure 2:** Photo taken from the northwest corner of the location, facing south. Photo shows straw wattles used as stormwater and sediment control BMPs have been properly entrenched.

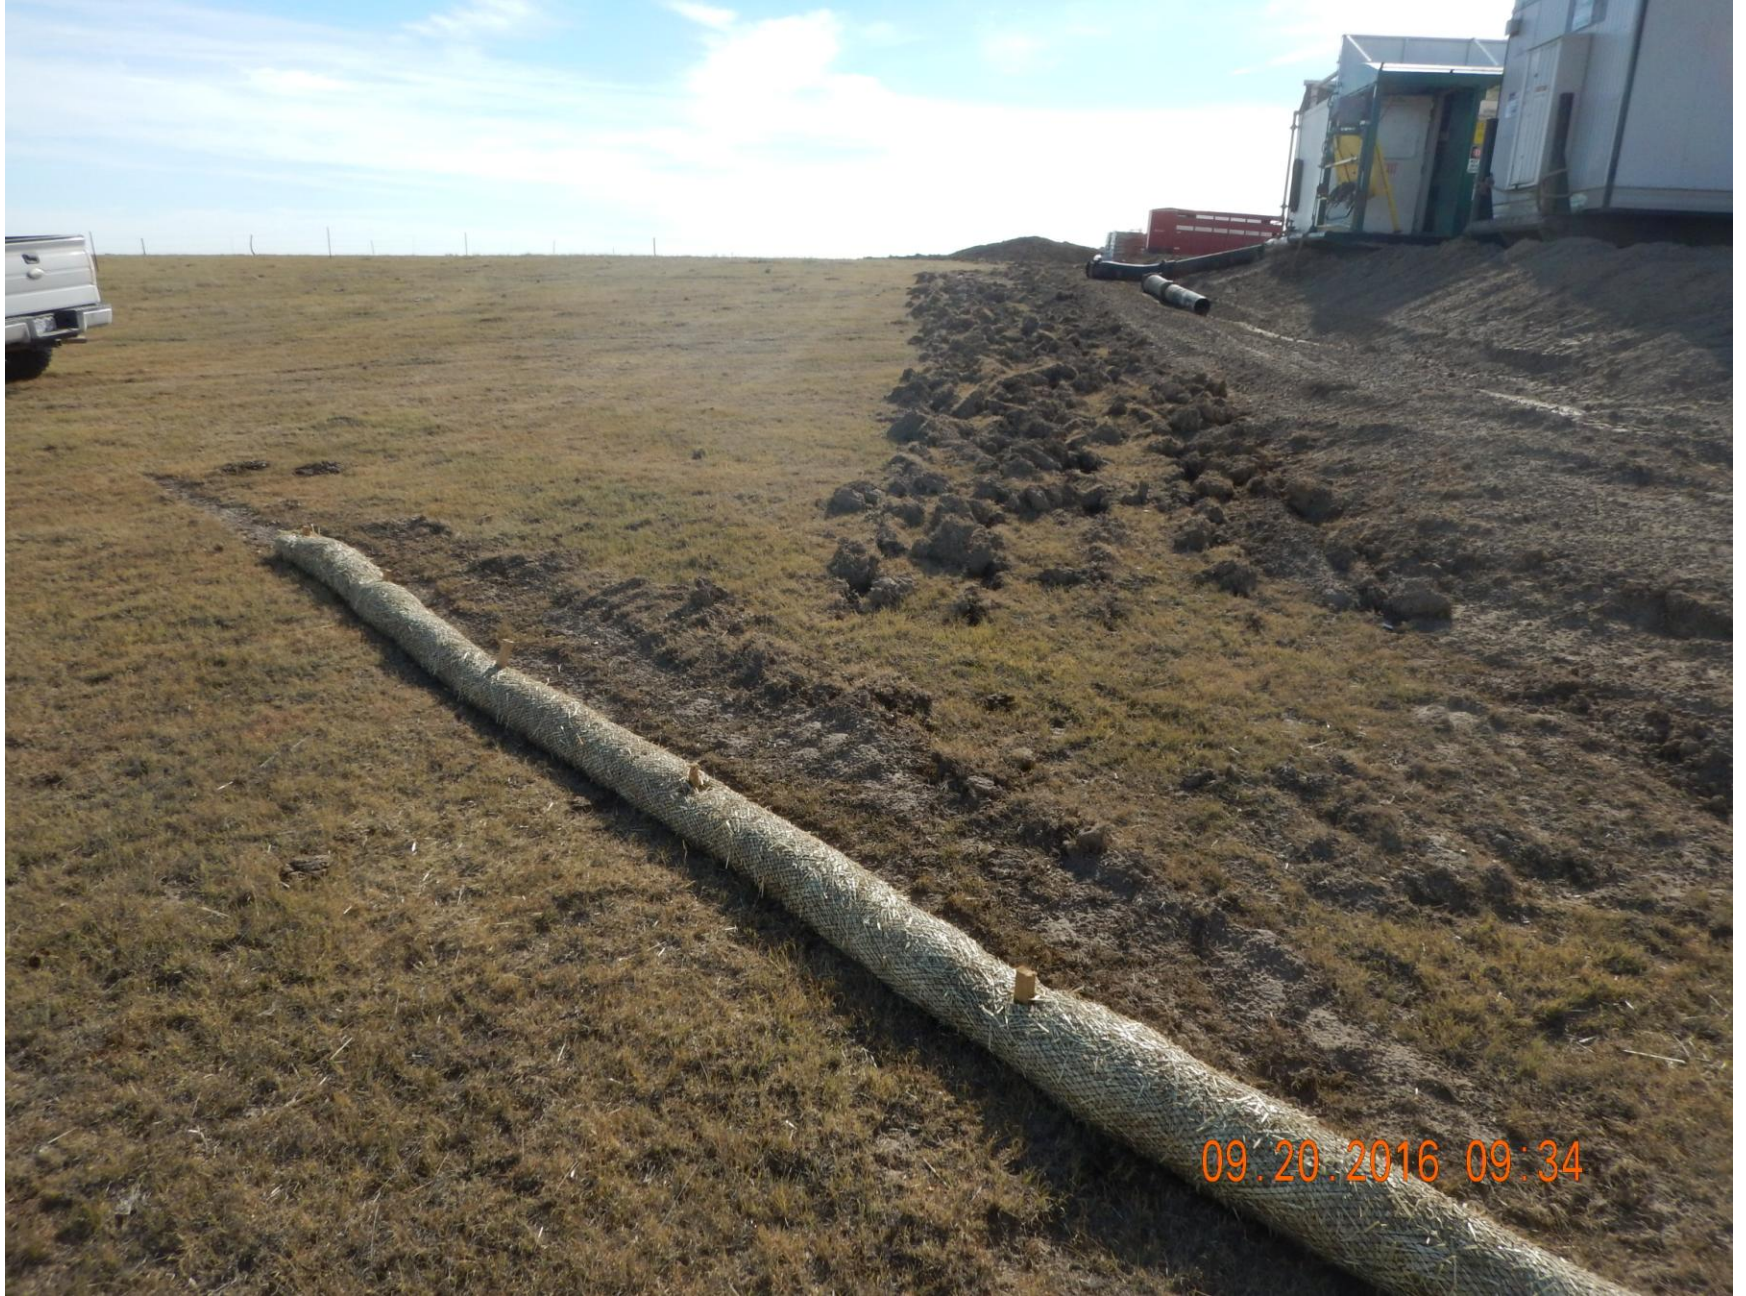
**Figure 3:** Photo taken from the northwest corner of the location, facing east. Photo shows straw wattle “j-hook” had been extended and additional surface roughening had been incorporated.

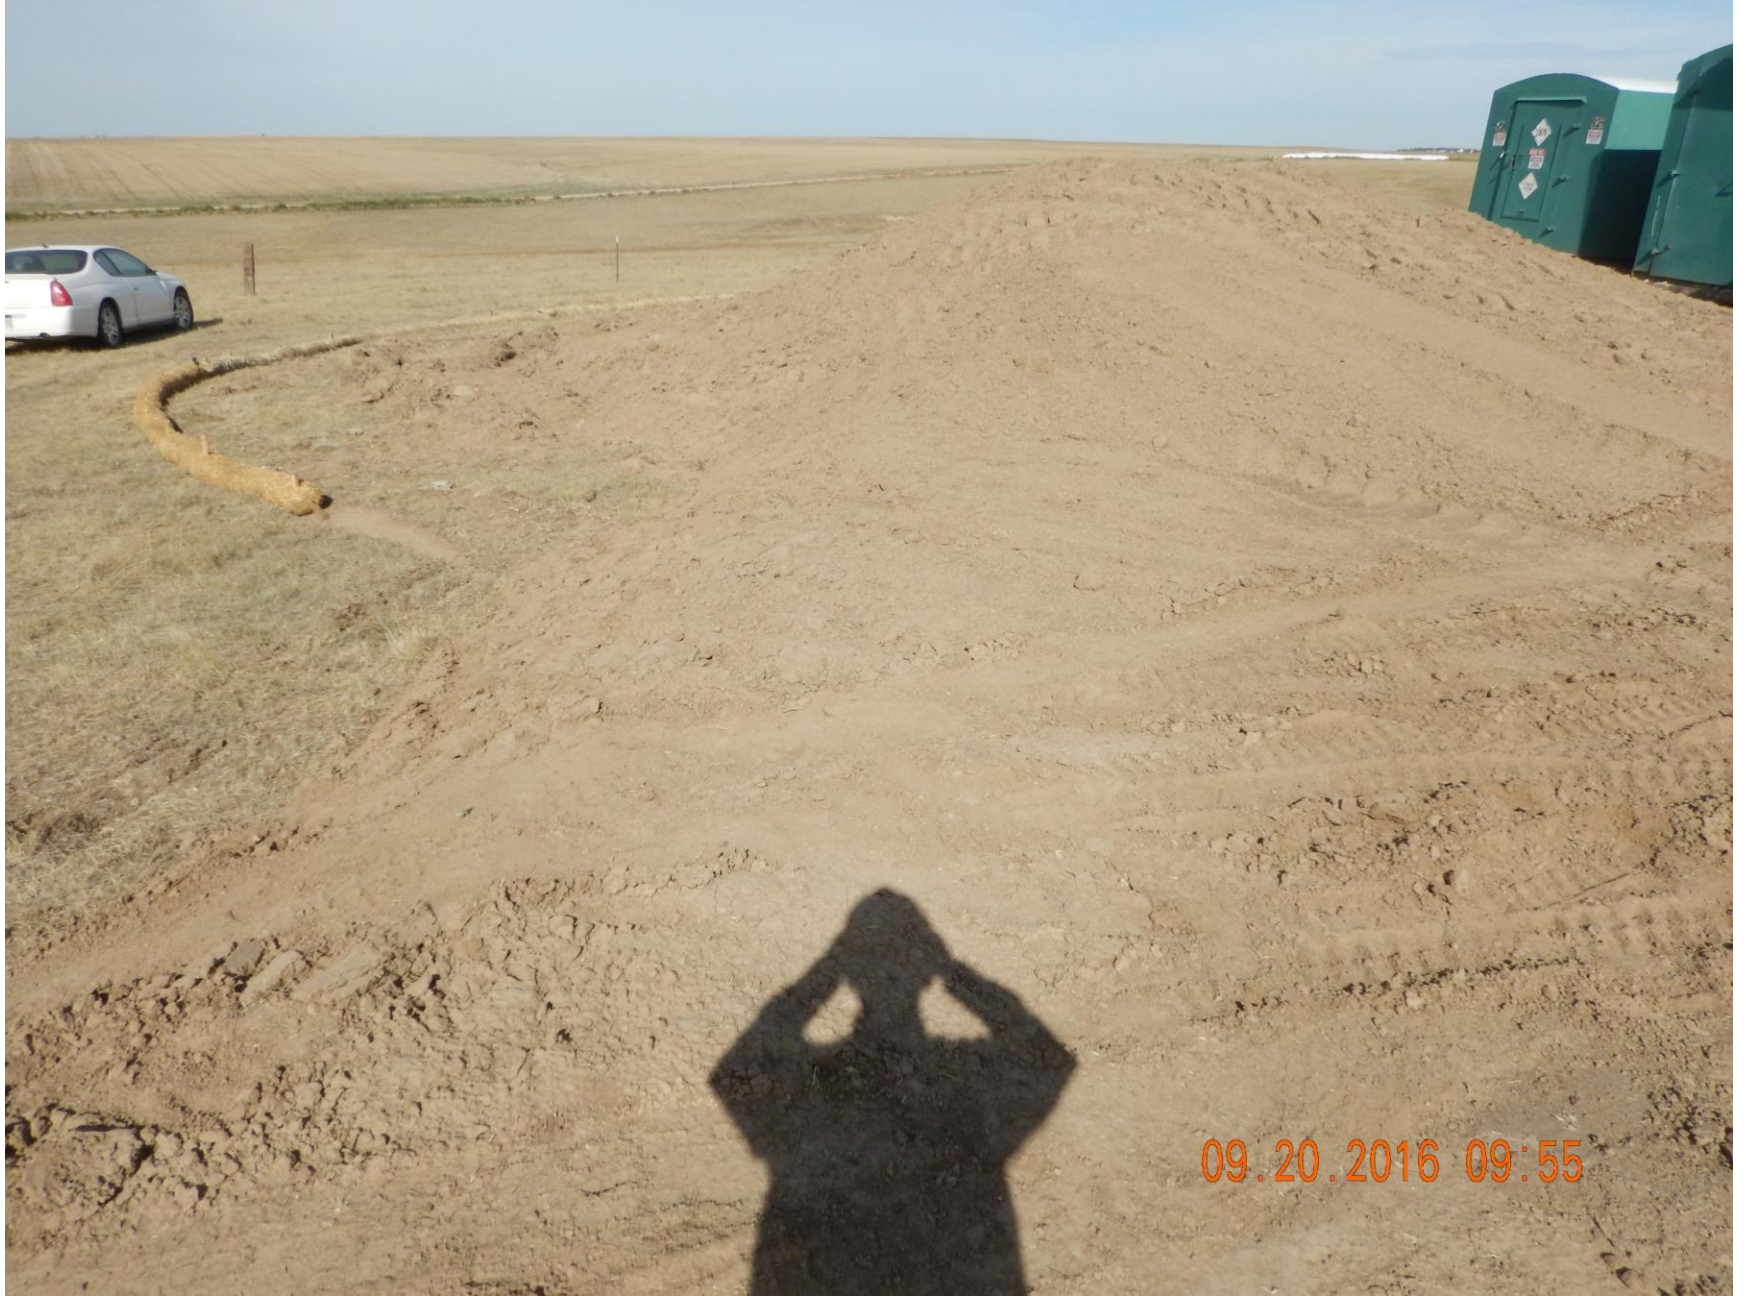
**Figure 4:** Photo taken from the southwest corner of the location. Photo shows topsoil pile. Construction foremen had mentioned they placed additional topsoil at this, and one other location to the southeast when they expanded the location.
