October 14, 2016

**RE: McCulloch #4 Soil Gas Survey Results
La Plata County, Colorado**

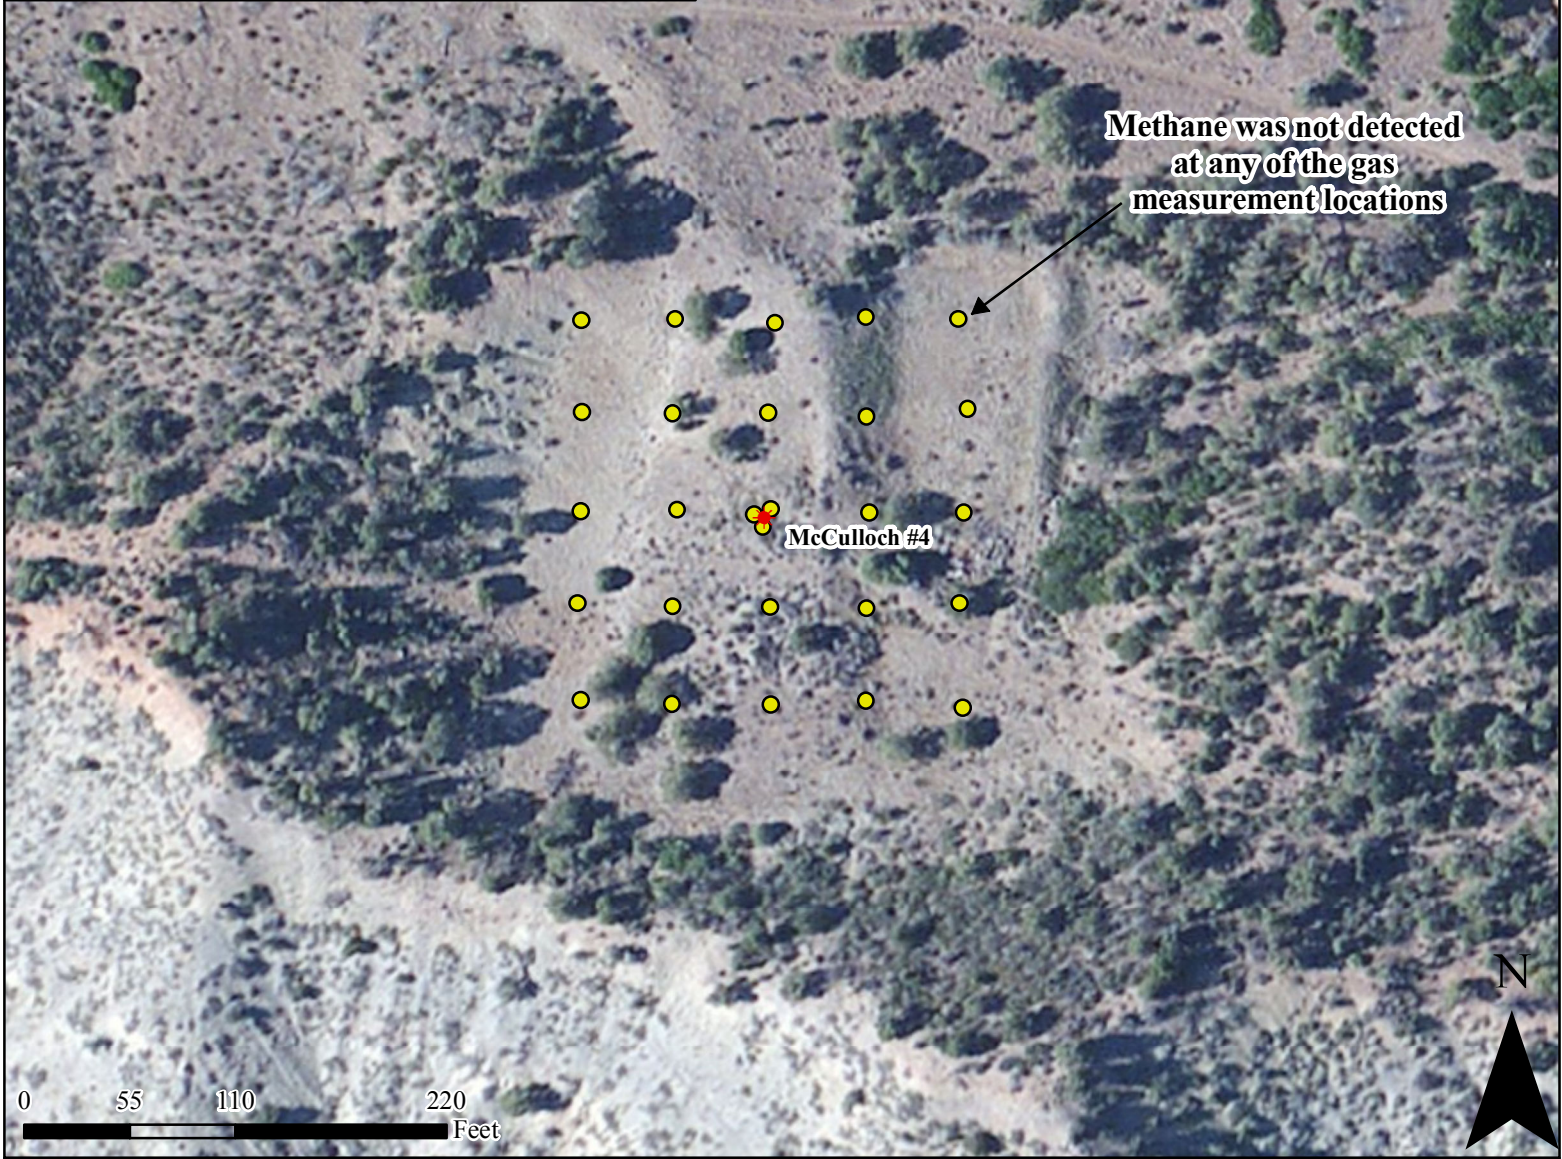
</p> <p>Mapping: J. Harter, 10/10/16 Coordinate System: NAD 1983 UTM Z13</p>	<p>SOIL GAS SURVEY MAP McCULLOCH #4 COGCC</p>
---	--	--

The soil gas survey was conducted using a grid-mapping system to systematically cover the area. Soil gas measurements were collected at 50-foot intervals across the gridded areas including the McCulloch #4 temporarily-abandoned well. Cottonwood used a slide-hammer to advance a borehole to a total depth of approximately two feet (bgs) at each measurement location. Tubing

Results indicate that methane was not detected at any of the 27 measurement locations during the soil gas survey. Additionally, oxygen, carbon dioxide, carbon monoxide, and hydrogen sulfide levels were generally consistent with background levels. Vegetation appeared to be healthy in the vicinity of the survey area and no visual evidence that would suggest the presence of methane seepage was observed. The attached Figure and Table present the results of the soil gas survey. Photographic documentation of site conditions during the survey are included as Attachment 1.

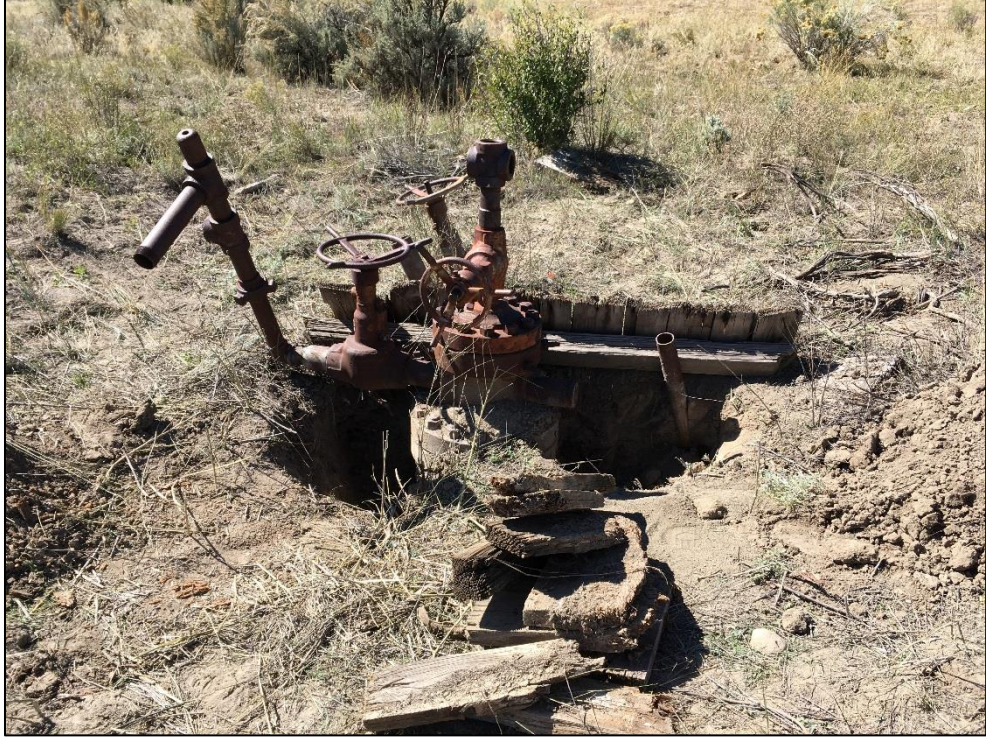
Photo 1: McCulloch #4 Well Head

Cottonwood anticipated collecting a gas sample from the well for analysis of gas composition and stable isotopes of methane. Due to well head conditions, including valves and piping, Cottonwood was unable to collect a gas sample at the time of the soil gas survey. Cottonwood found the tubing master valve open and one of the production casing master valves missing. Methane was recorded venting from the production casing valve port. Additional well head equipment including valves and plugs are needed to stop the current venting and for gas sample collection.

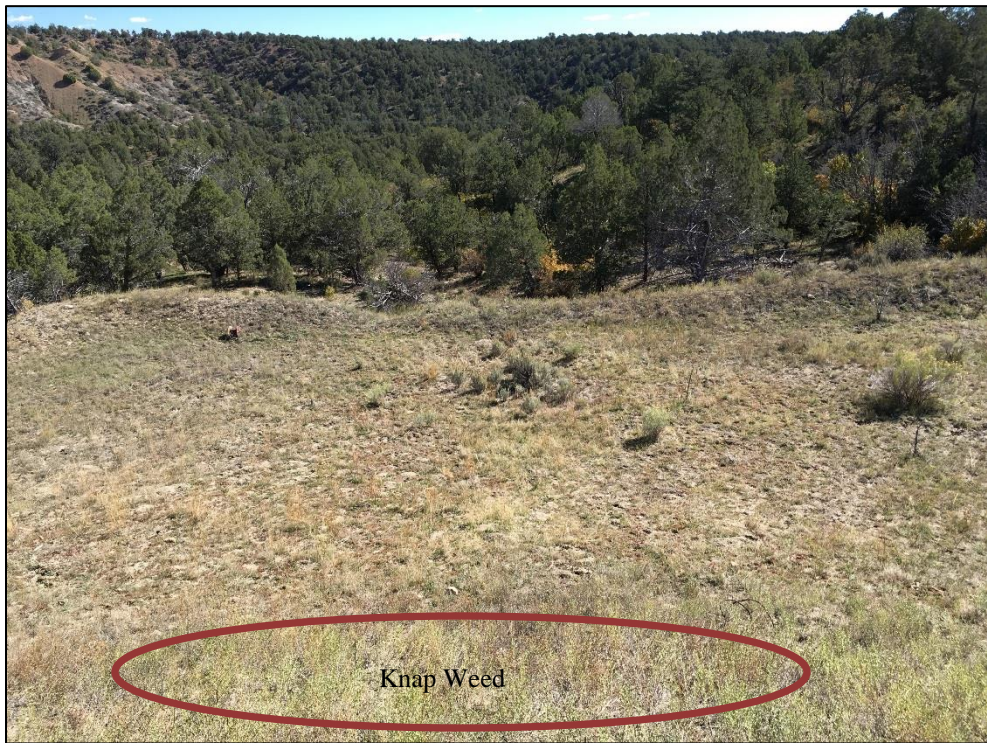
Photo 4: Location of former reserve pit, view east. Knap weed noted on fill slope to reserve pit.
