# Final Reclamation Inspection

Operator: Petroleum Energy Corp

Location ID: 395744

API: 087-07994

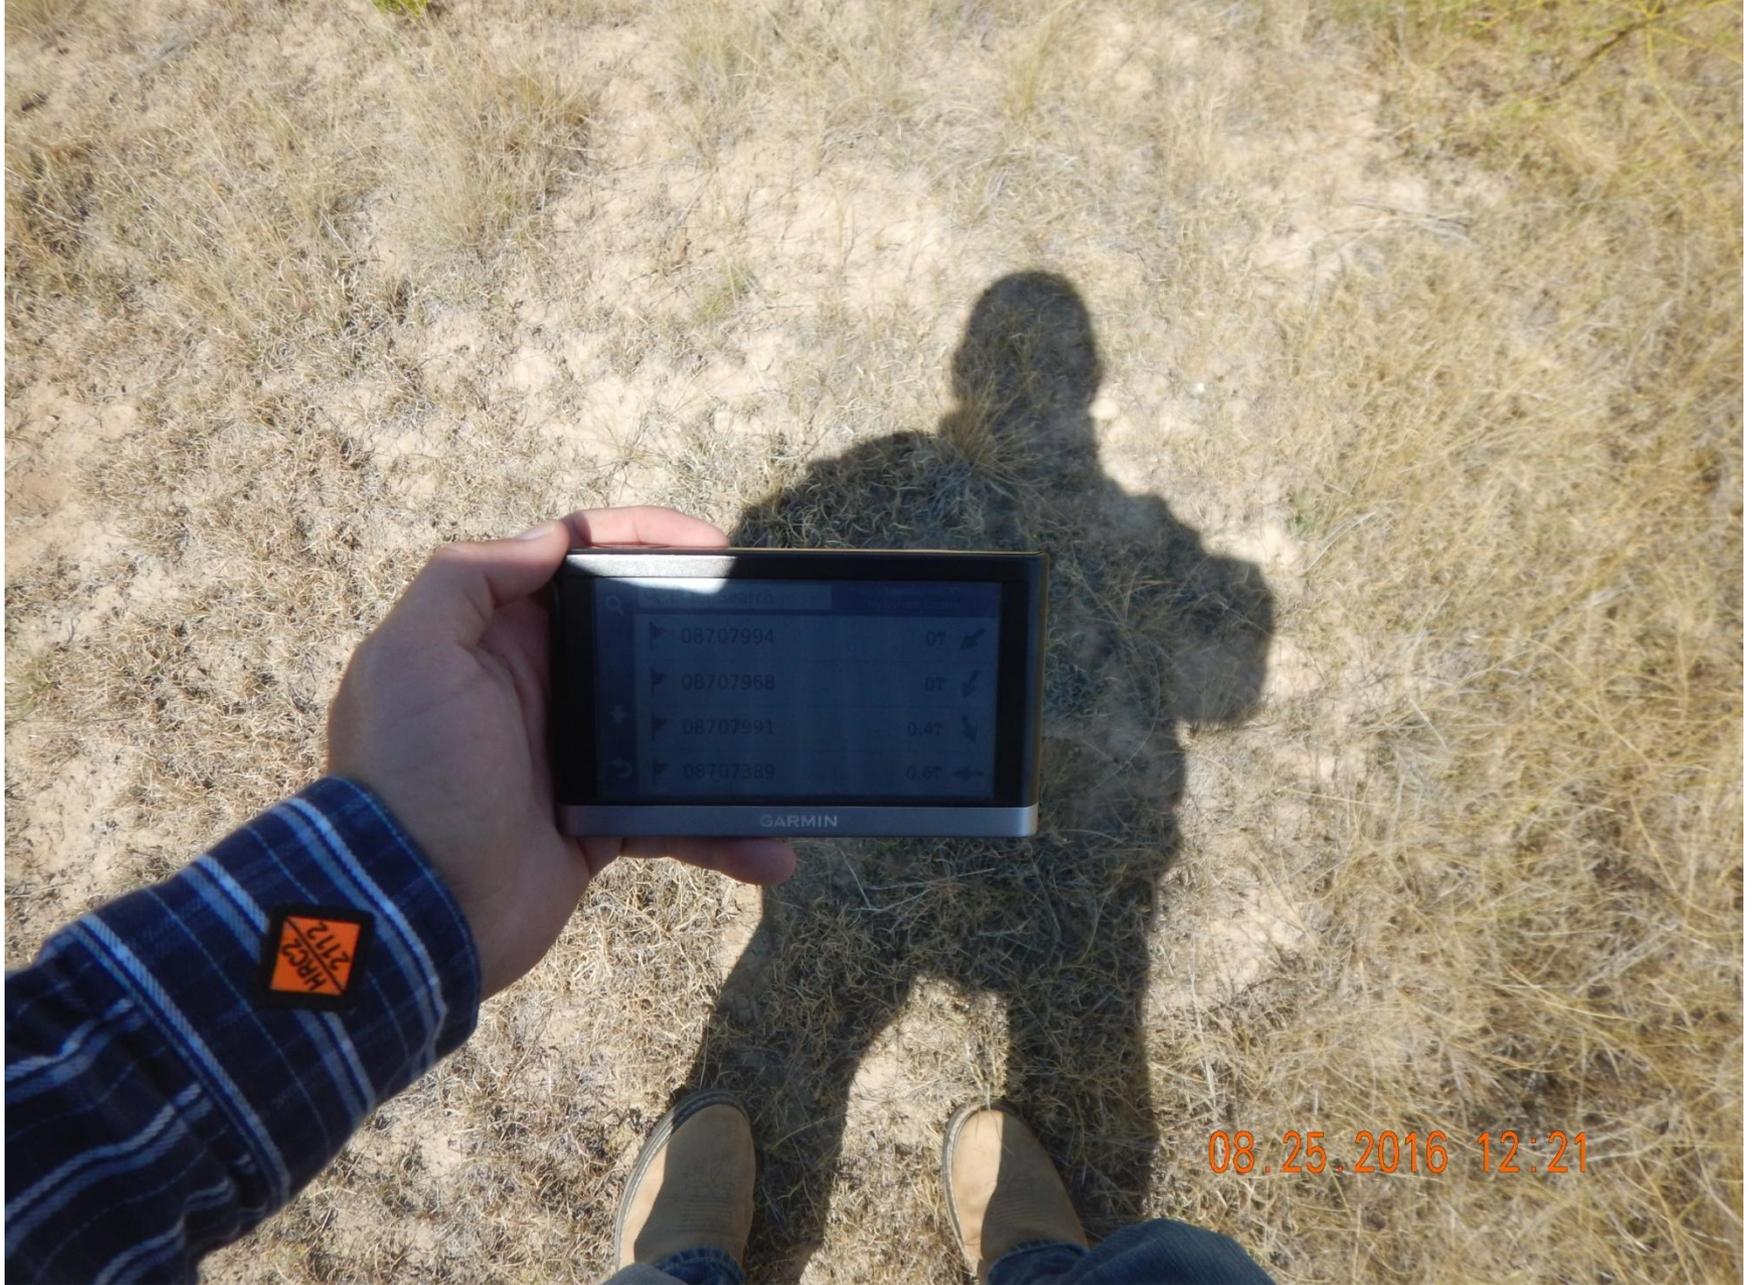
**Figure 1:** Photo of GPS confirming location.

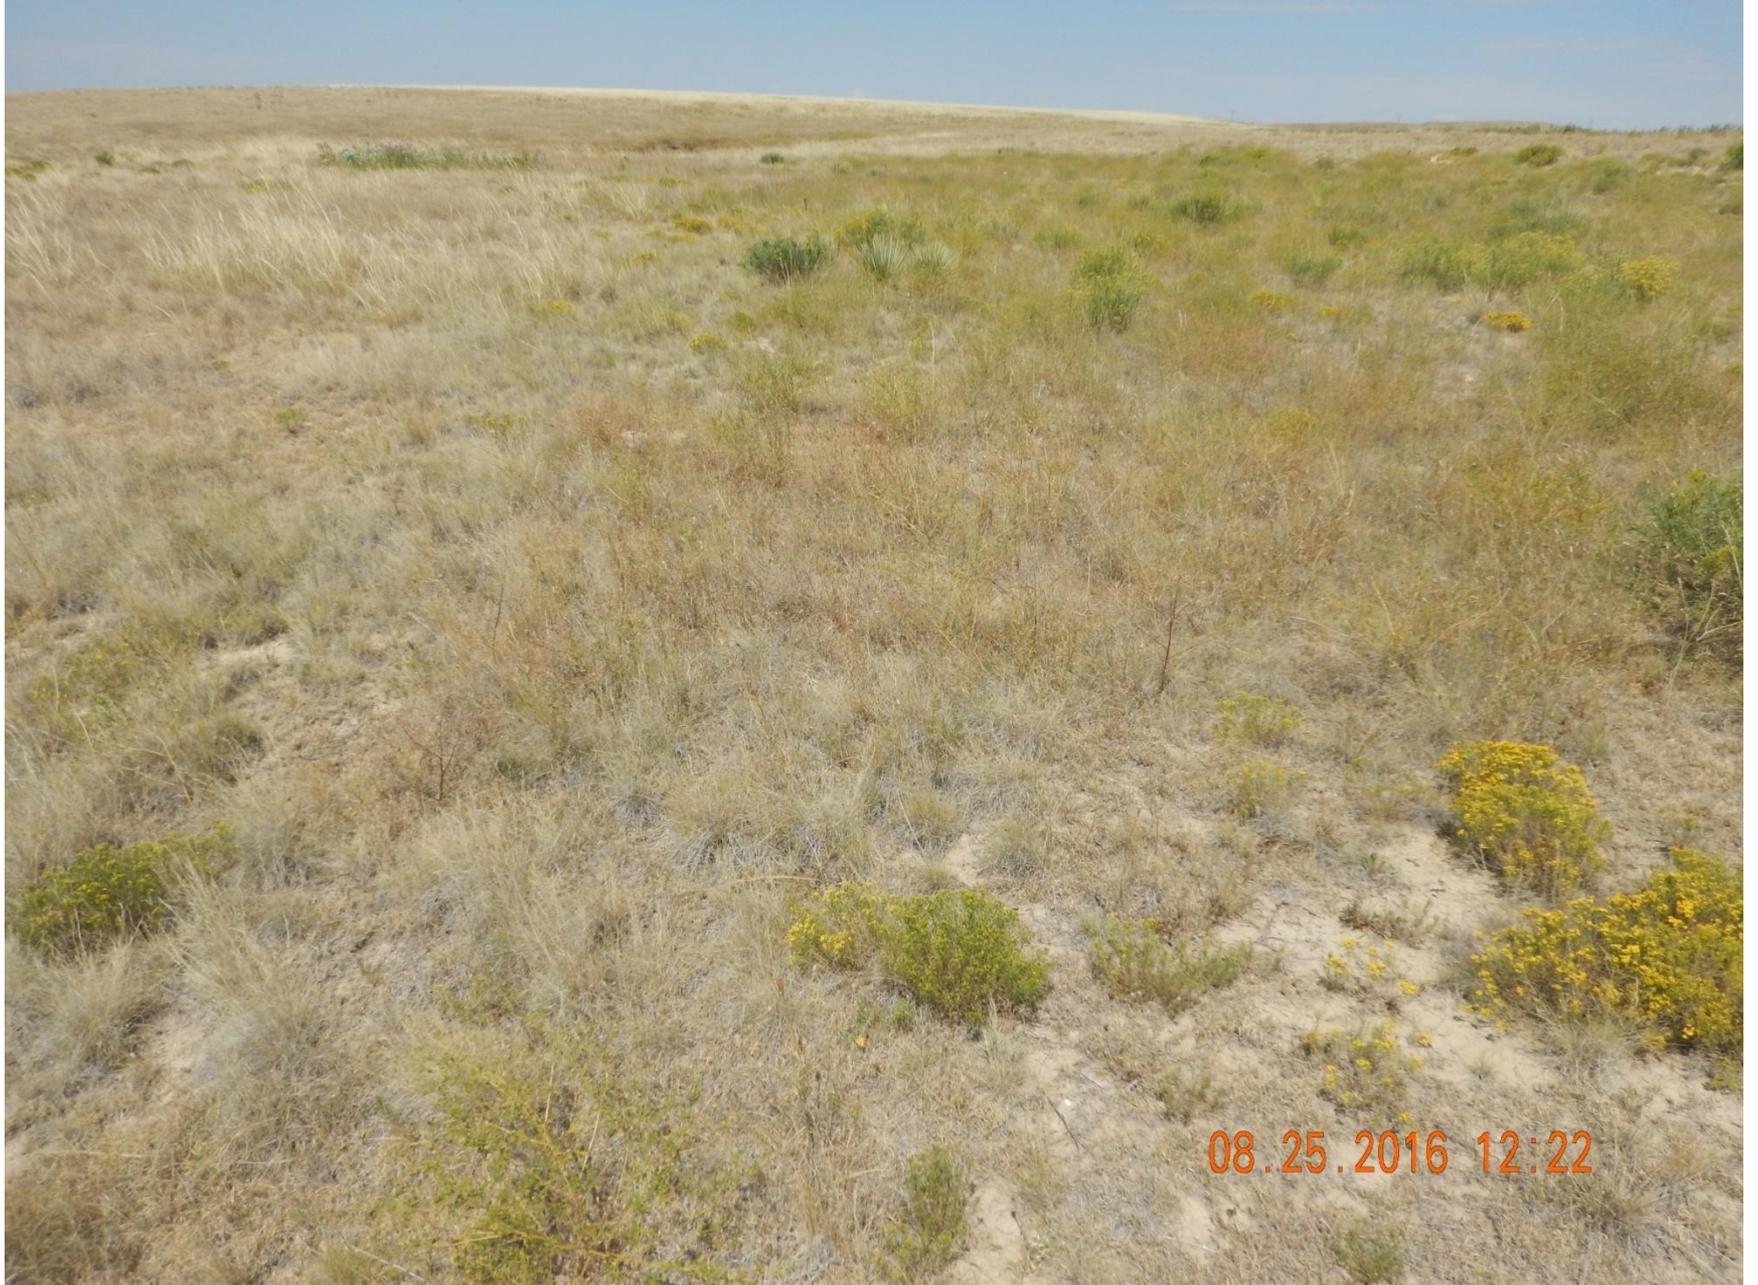
**Figure 5:** Photo taken from the southwest corner of the location, facing north. Photo shows vegetation over the reclamation area.

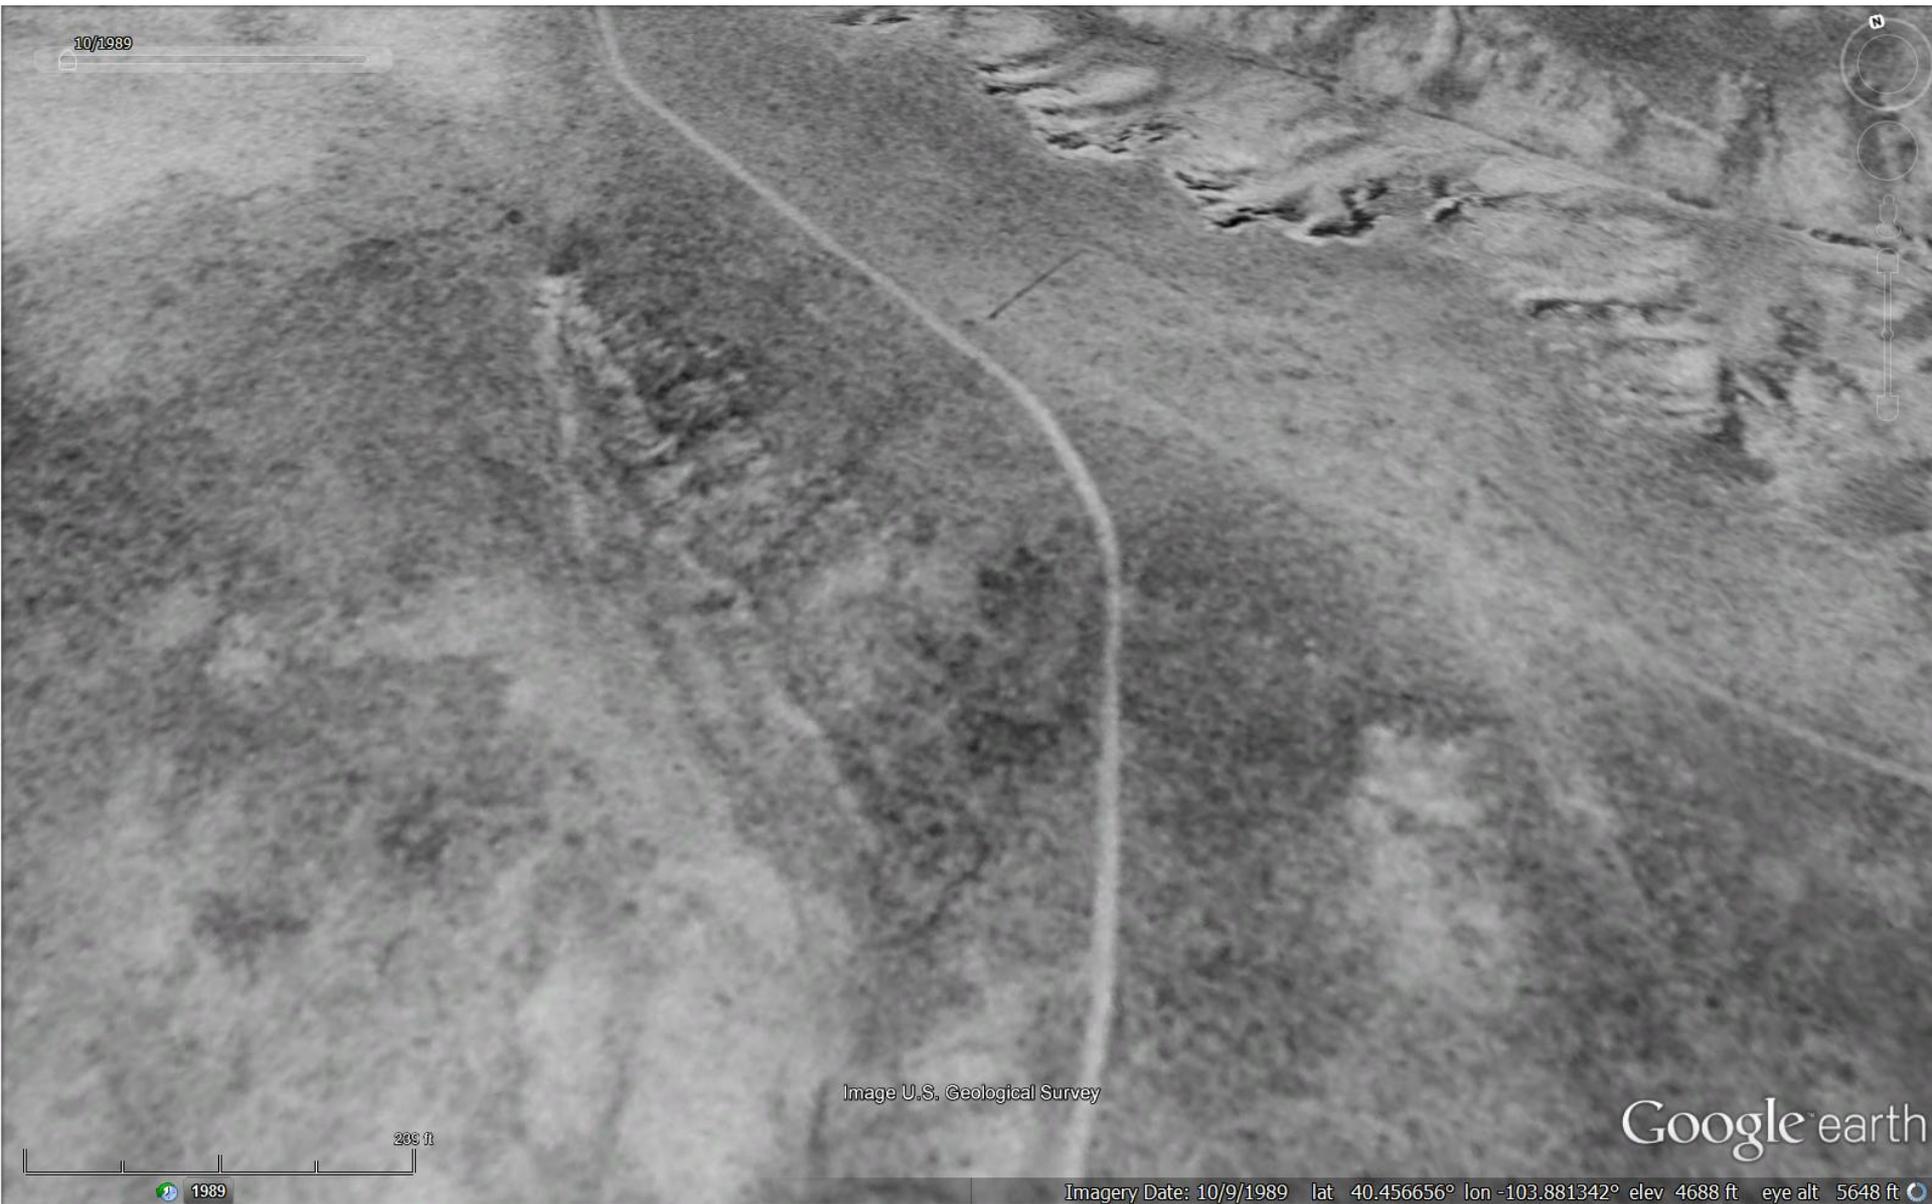
**Figure 11:** Aerial imagery (1989) of location pre-disturbance.

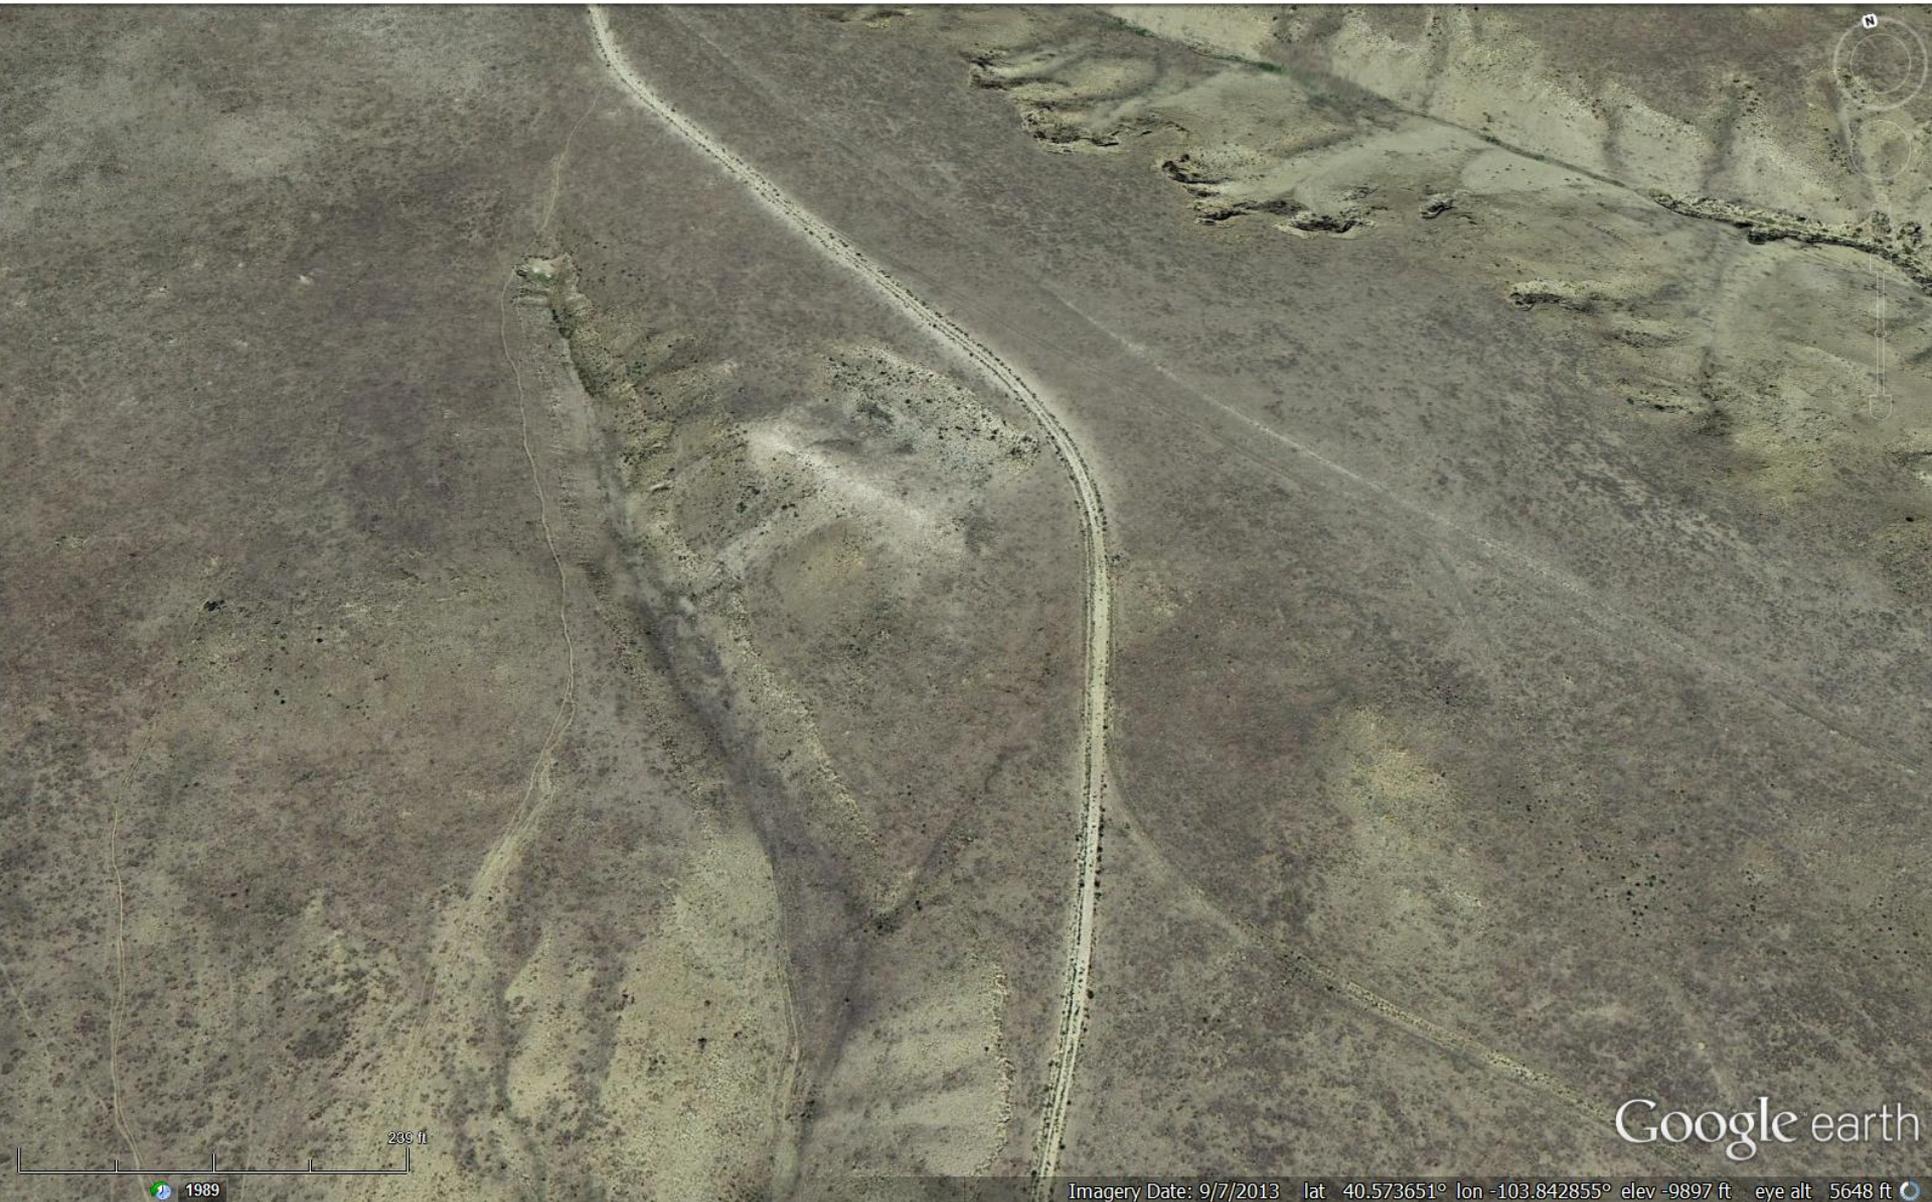
**Figure 12:** Most current aerial image (2013) of location. Approximate area of disturbance is 1 ac.
