Elk Springs Unit #4, API No. 05-081-06837

Date: 11/7/2016

Photographer: Dave Andrews

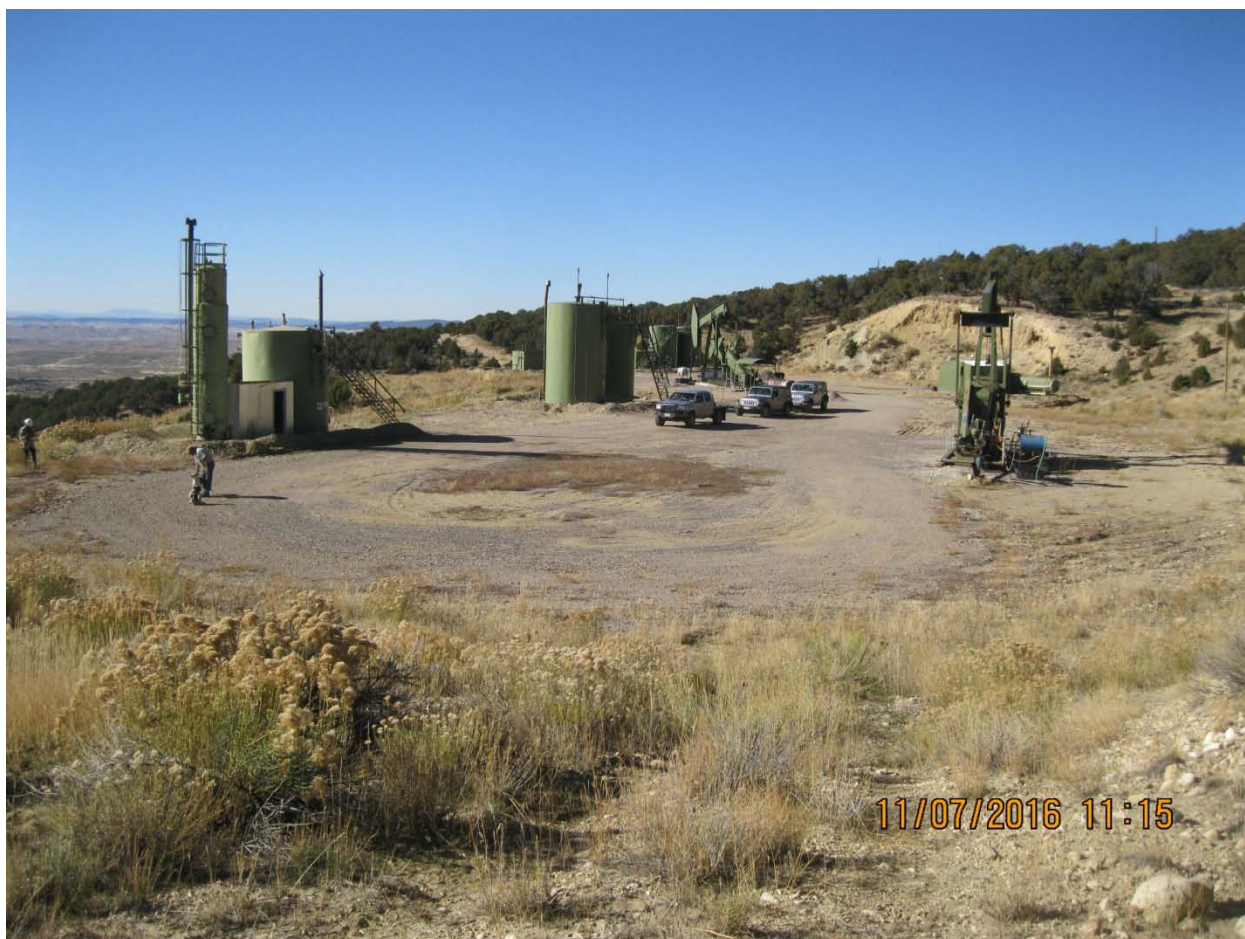
Description: Pad overview, with Heater Treater, shed, and Produced Water Tank on left, Crude Oil Production Tanks, Elk Springs Unit #3 (081-06472) Pump Jack and other production equipment in middle background, and Elk Springs Unit #4 Pump Jack on right.

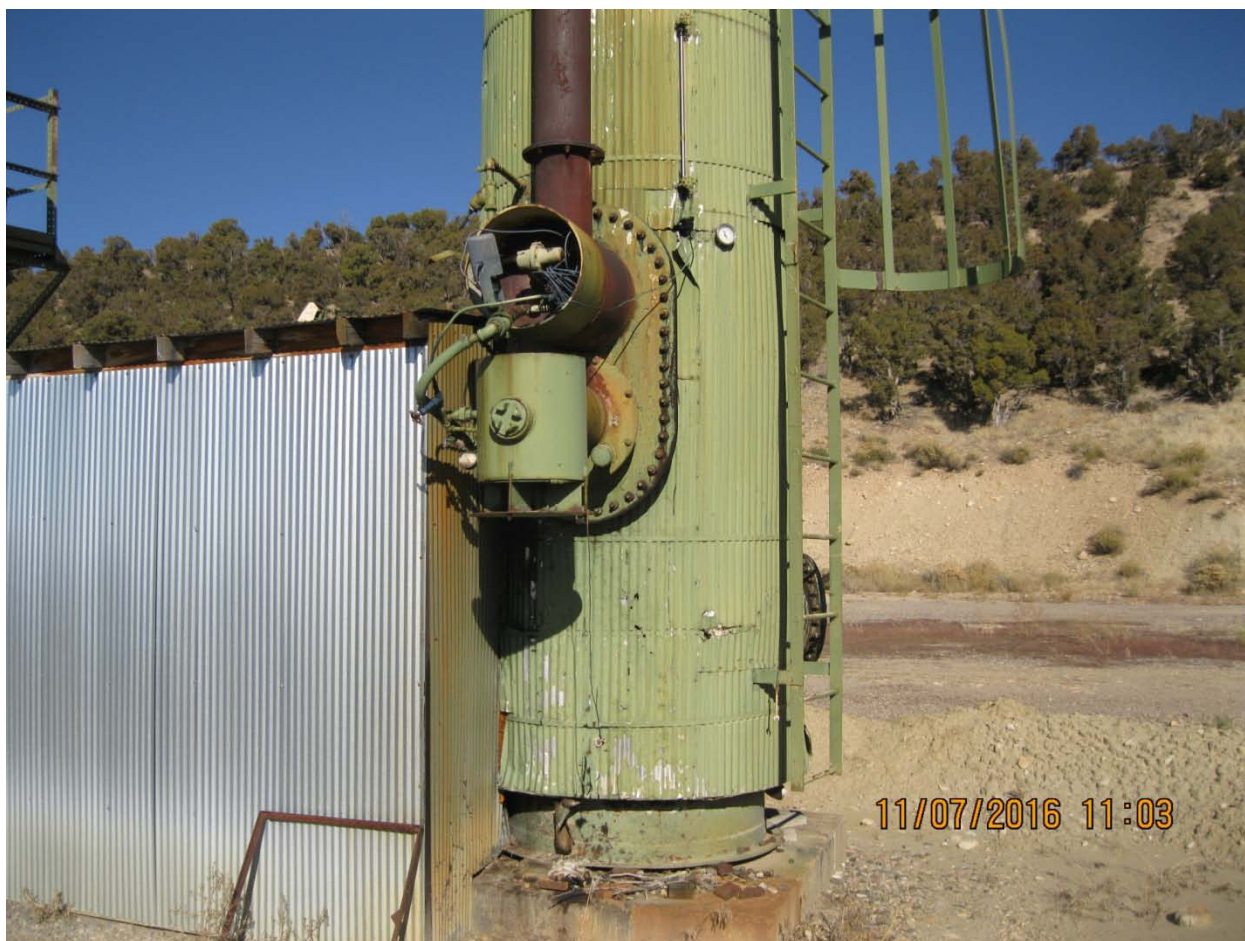
Description: Back side of Heater Treater showing location of ignition source outside of the shed, fire tube, and bottom of exhaust stack.

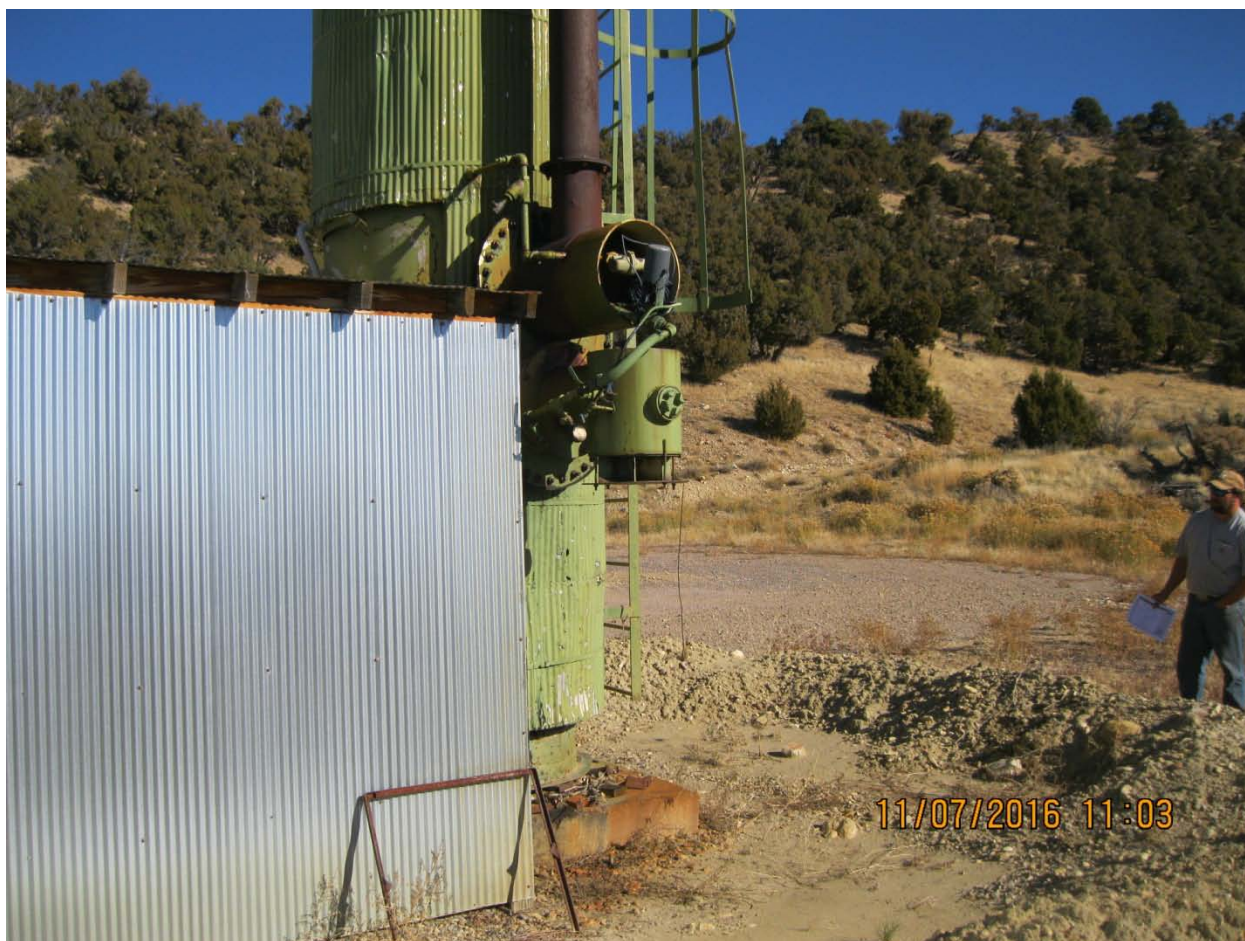
Description: Back side of Heater Treater showing location of ignition source outside of the shed, fire tube, and bottom of exhaust stack.

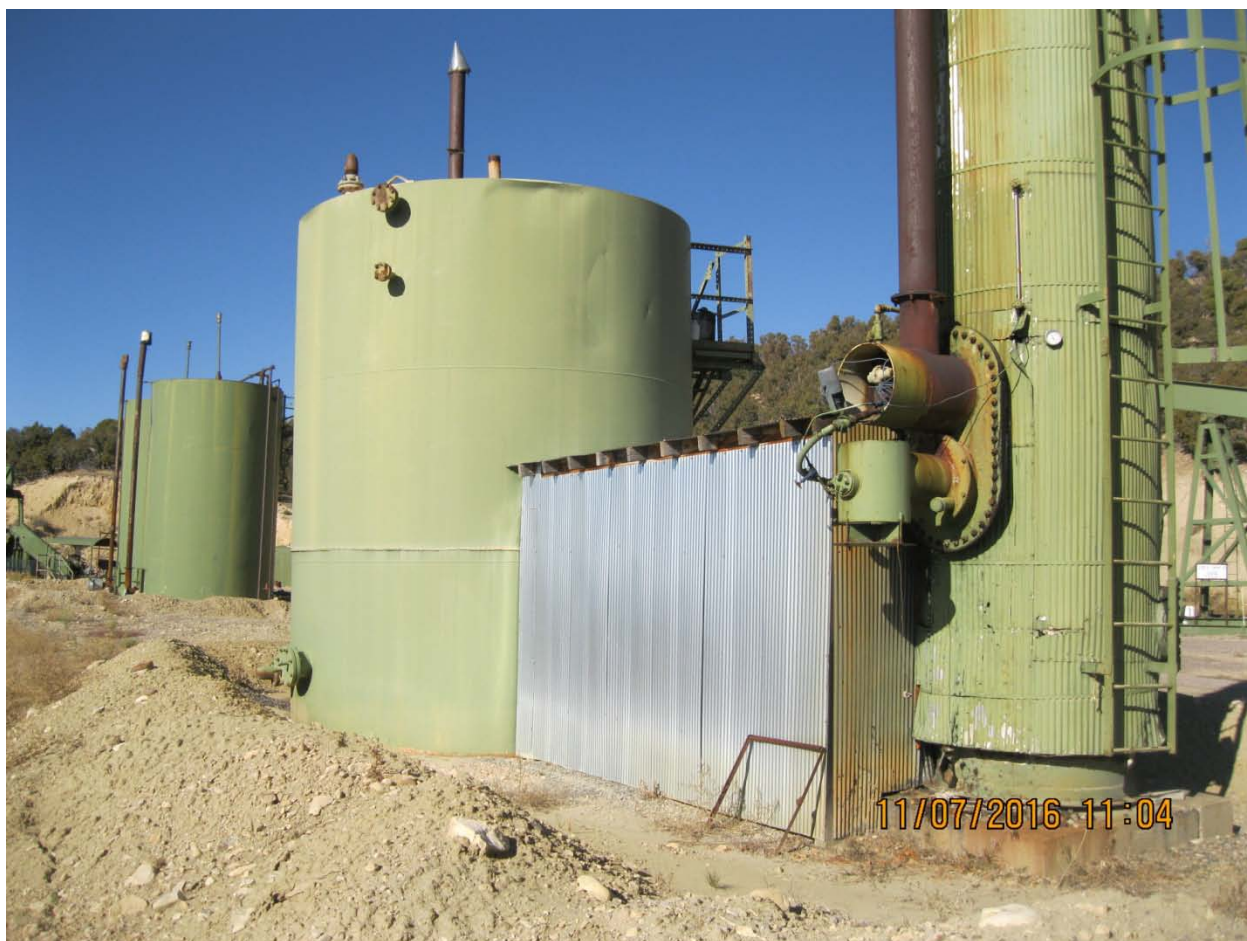
Description: Back side of Heater Treater and produced water tank, with Pump Jack for Elk Springs Unit #4 in the background to the right of the Heater Treater. Crude Oil Production tanks and the Pump Jack for a different well (Elk Springs Unit #3, 081-06472) are in the background to the left of the Produced Water Tank on the same pad.

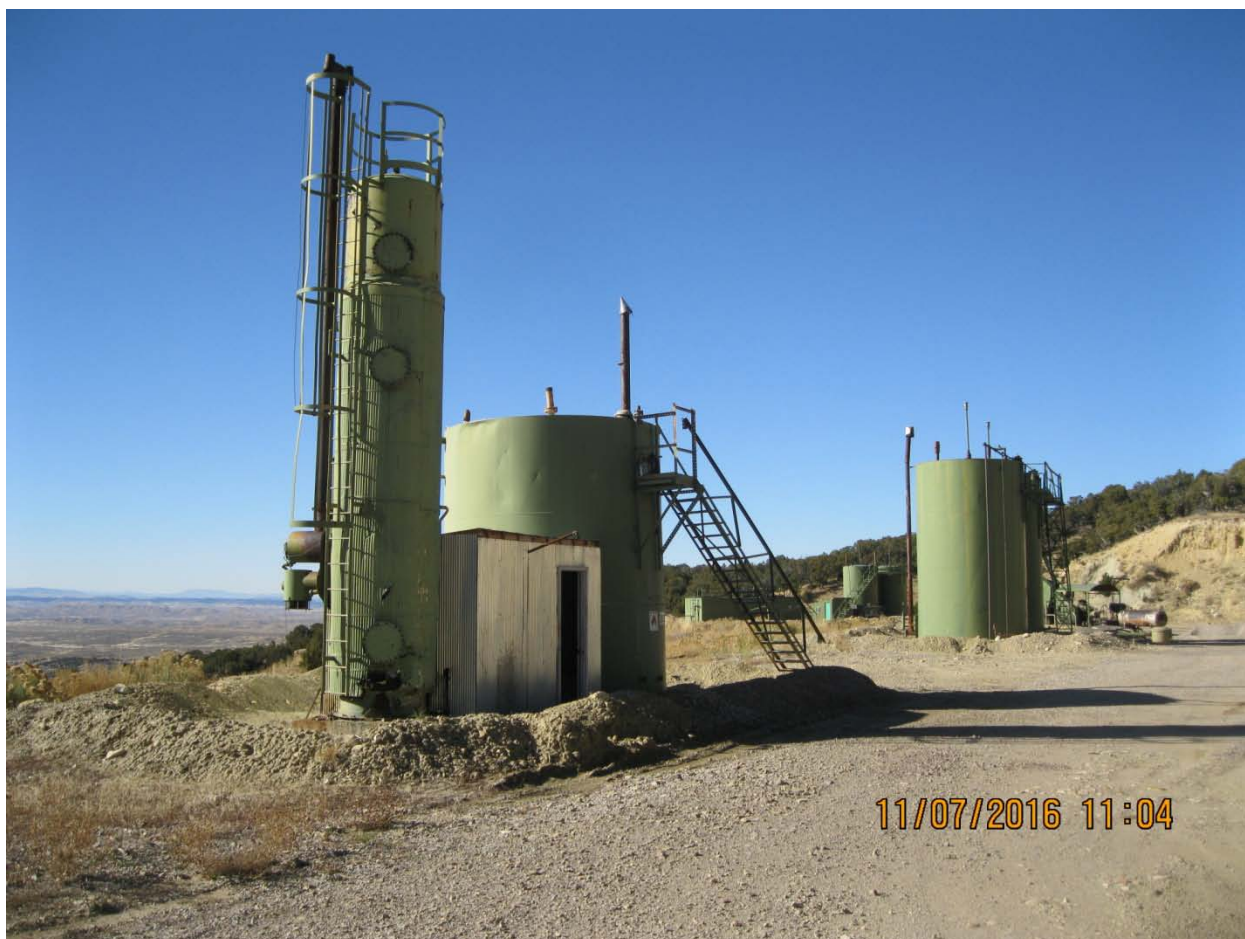
Description: Front side of Heater Treater, shed, and Produced Water Tank in a common containment berm. Other production equipment, including two crude oil production tanks, are in the background to the right of the Produced Water Tank. The Heater Treater gas outlet is directed to a pipe run through the shed, discharging to atmosphere, shown in this photo to the left and above the door, near the roofline of the shed.

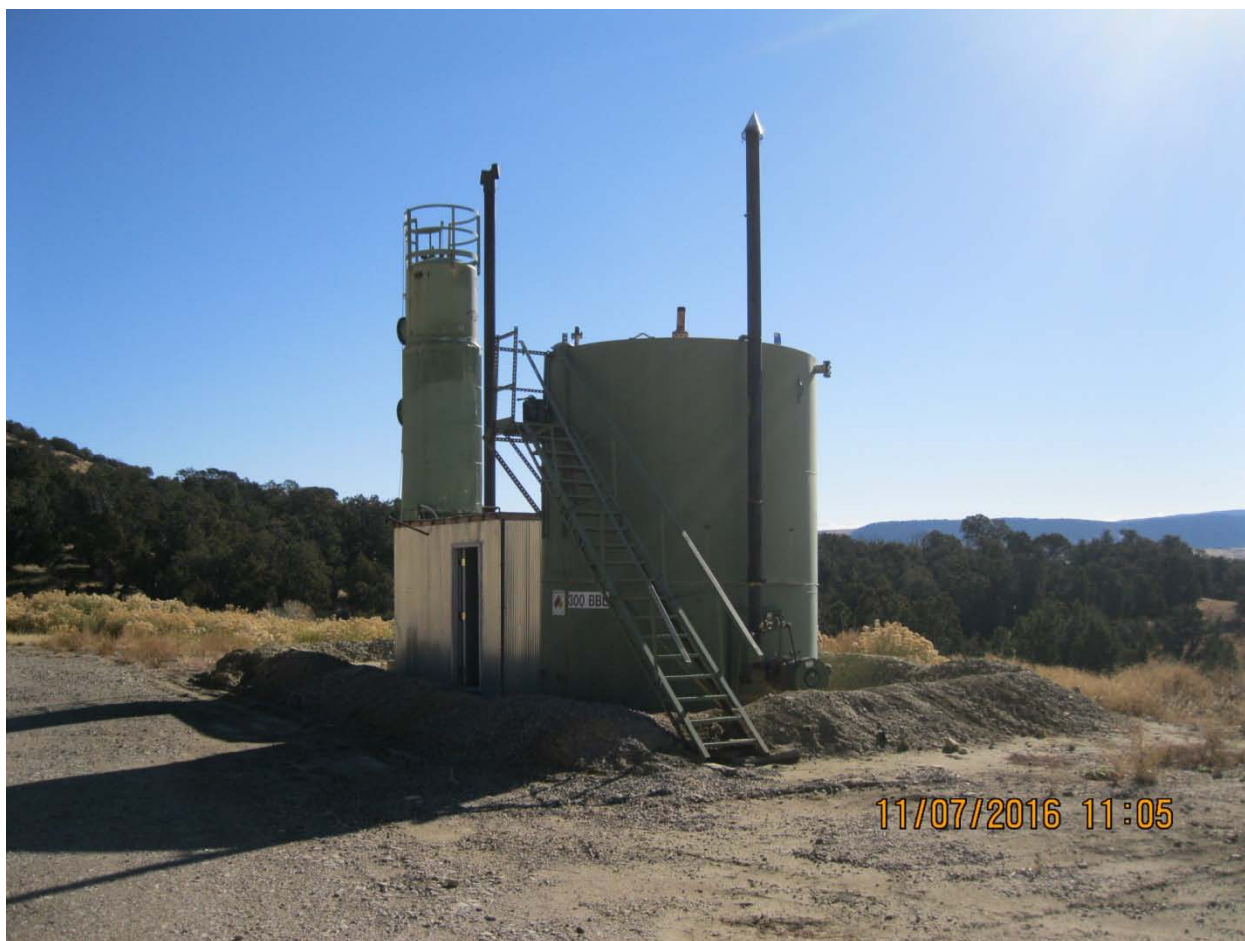
Description: Front side of Heater Treater, shed, and Produced Water Tank in a common containment berm. The Heater Treater gas outlet is directed to a pipe run through the shed, discharging to atmosphere, shown in this photo to the left and above the door, near the roofline of the shed.

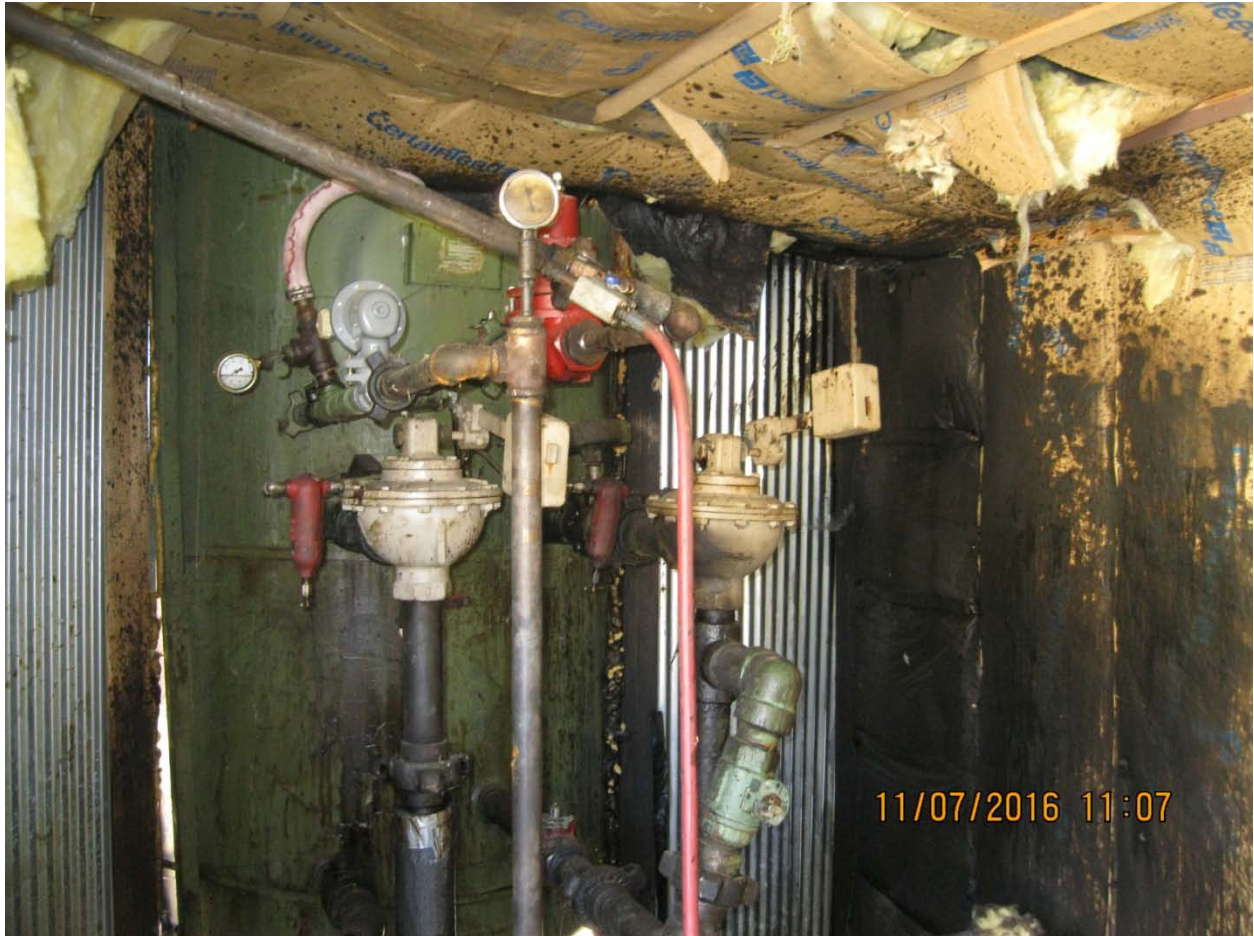
Description: Upper view of Heater Treater valves and piping inside shed. Clockwise from upper-left: 1) emulsion inlet with pressure gauges; 2) piping from gas outlet through red regulator valve into discharge pipe directed to the upper, left corner of the photo; 3) Diatroller oil dump valve piped to Crude Oil Production Tank; and 4) Diatroller water dump valve piped to Produced Water Tank.

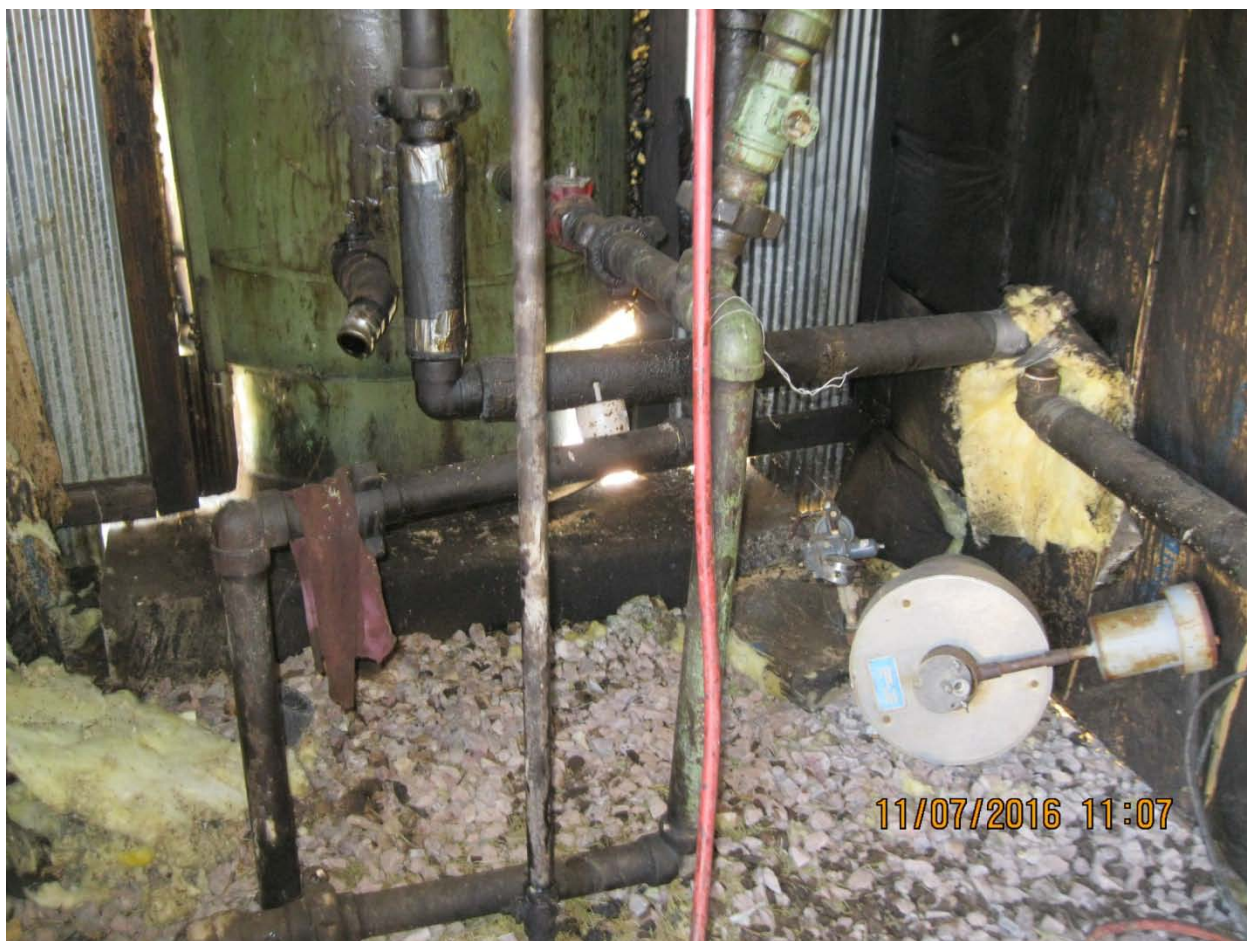
Description: Lower view of Heater Treater valves and piping inside shed.

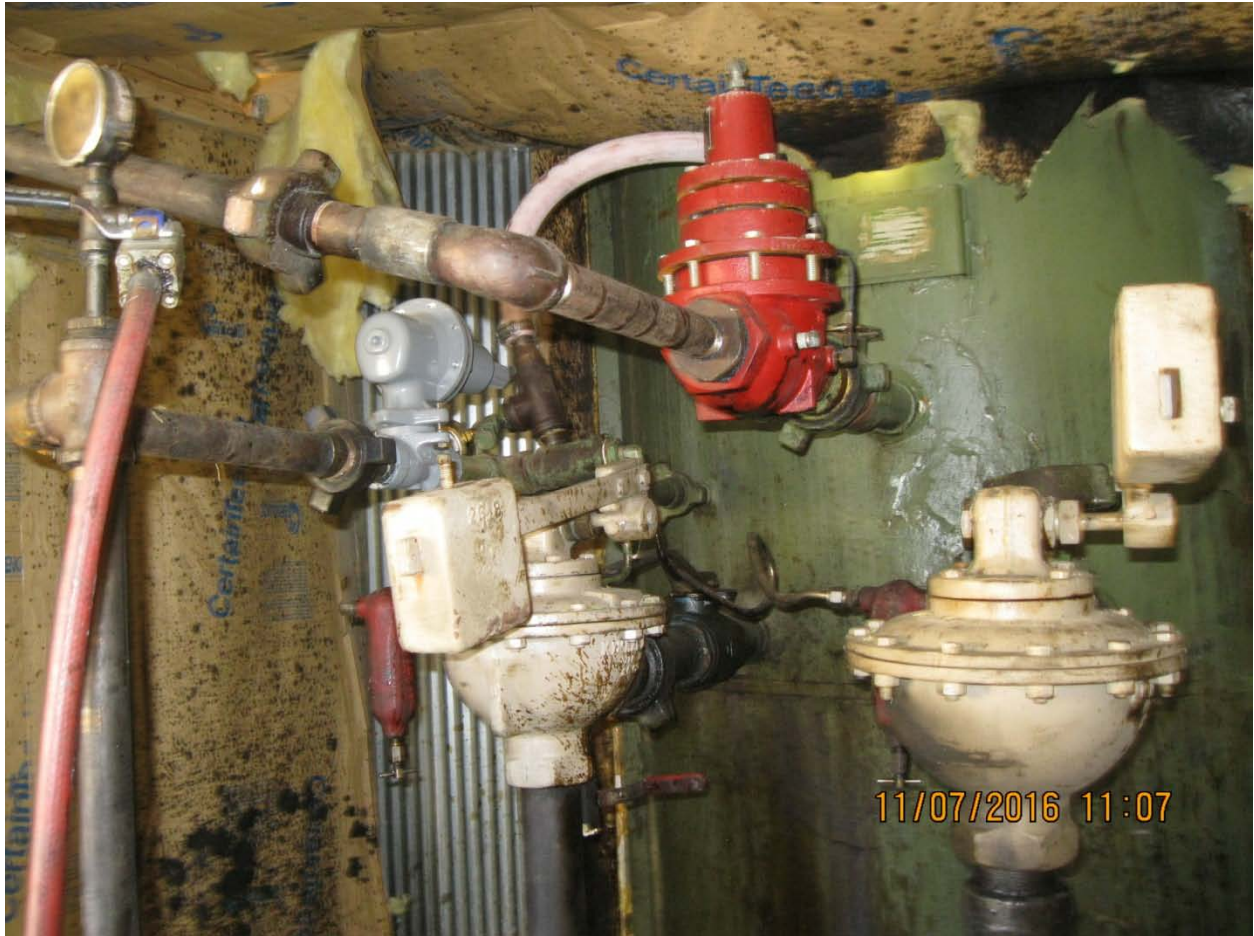
Description: Heater Treater valves and piping inside shed. Red gas regulator to discharge outside of shed in upper part of photo.

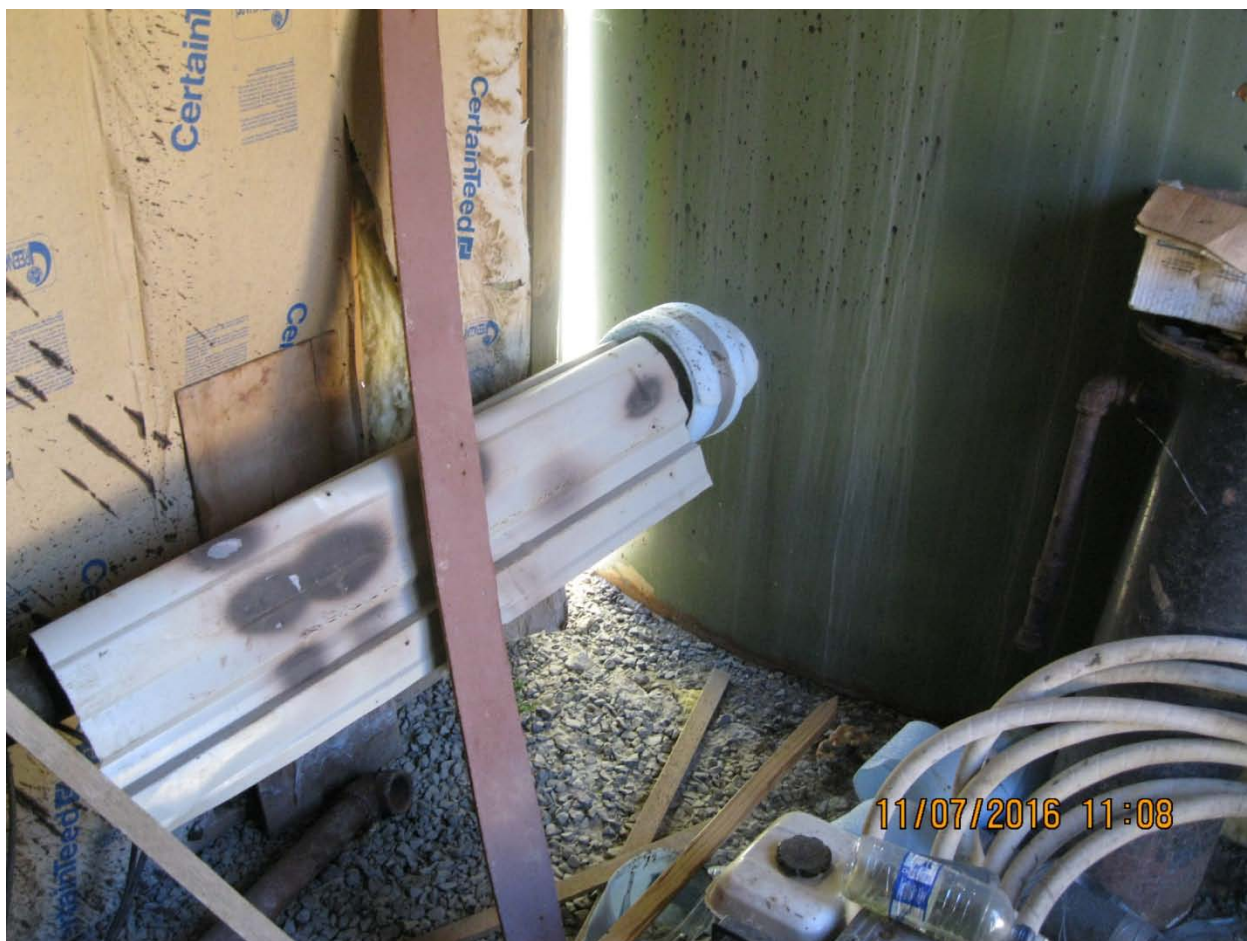
Description: Side of Produced Water Tank inside shed showing produced water inlet.

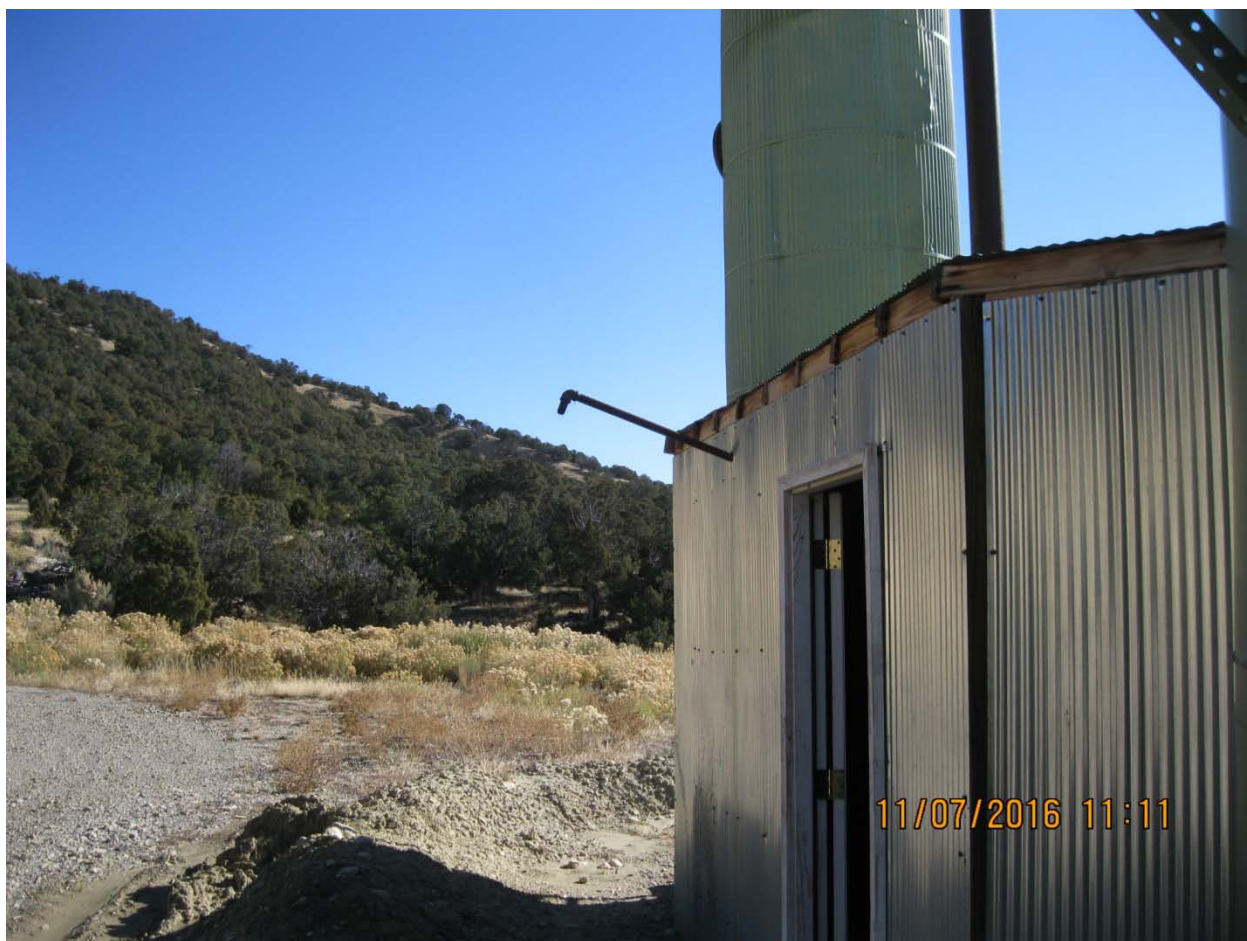
Description: Heater Treater gas discharge pipe directed outside of shed.
