Reclamation Inspection- Overview

Google Earth aerial photo taken 9/7/16 illustrating total disturbance of the Lazy D ZN #03-09 well location. Total area of 4.0 acres (Position dilution of precision (PDOP)= 2.8) was mapped using a Trimble Juno 3B handheld device indicates the location was overbuilt by approximately 0.6 acres.

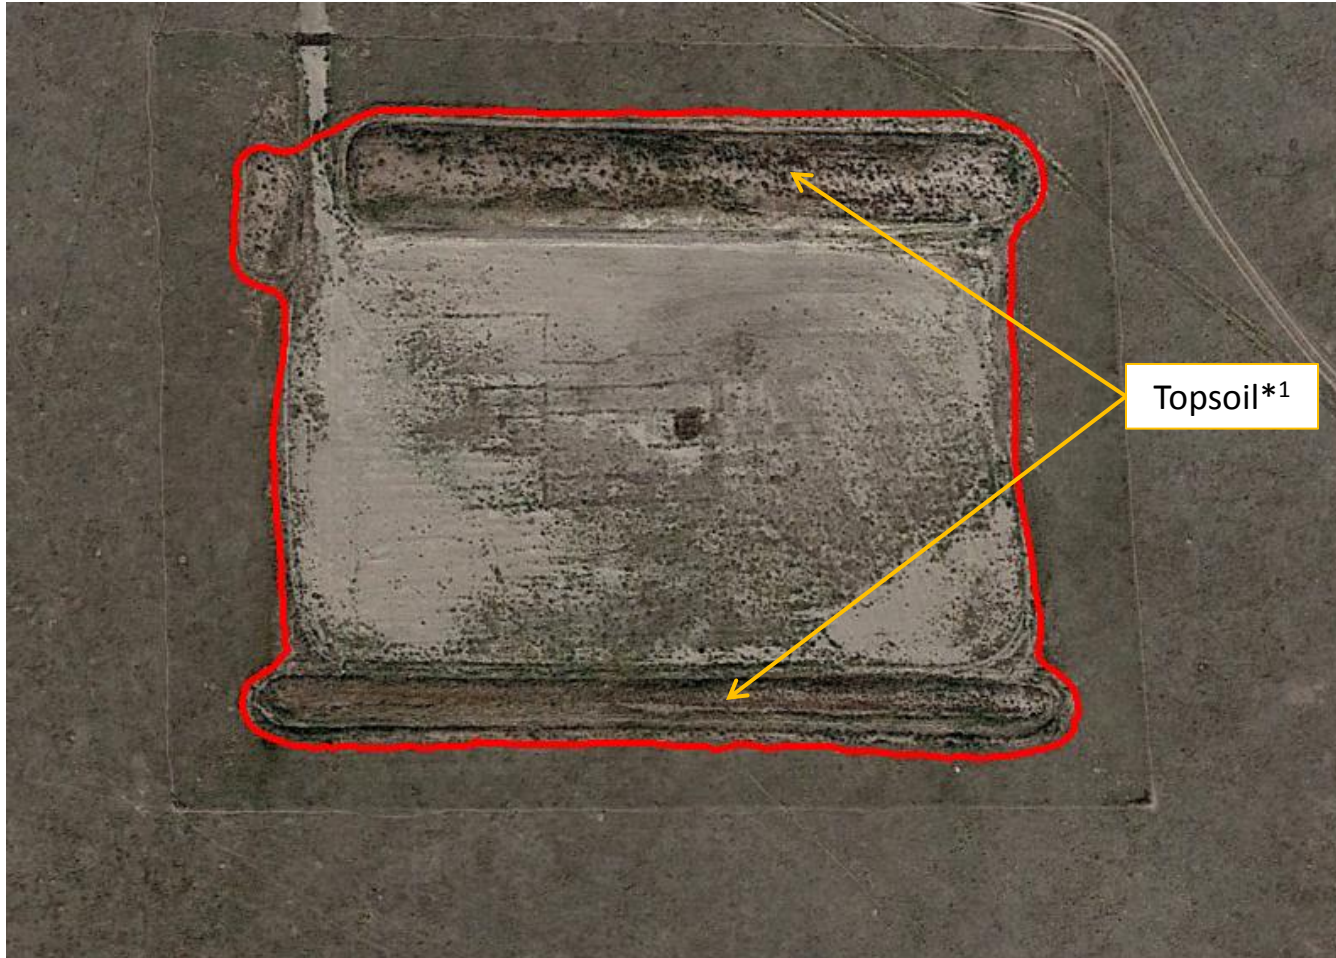
*1 = Possible topsoil stockpile. Stockpile not marked or documented.

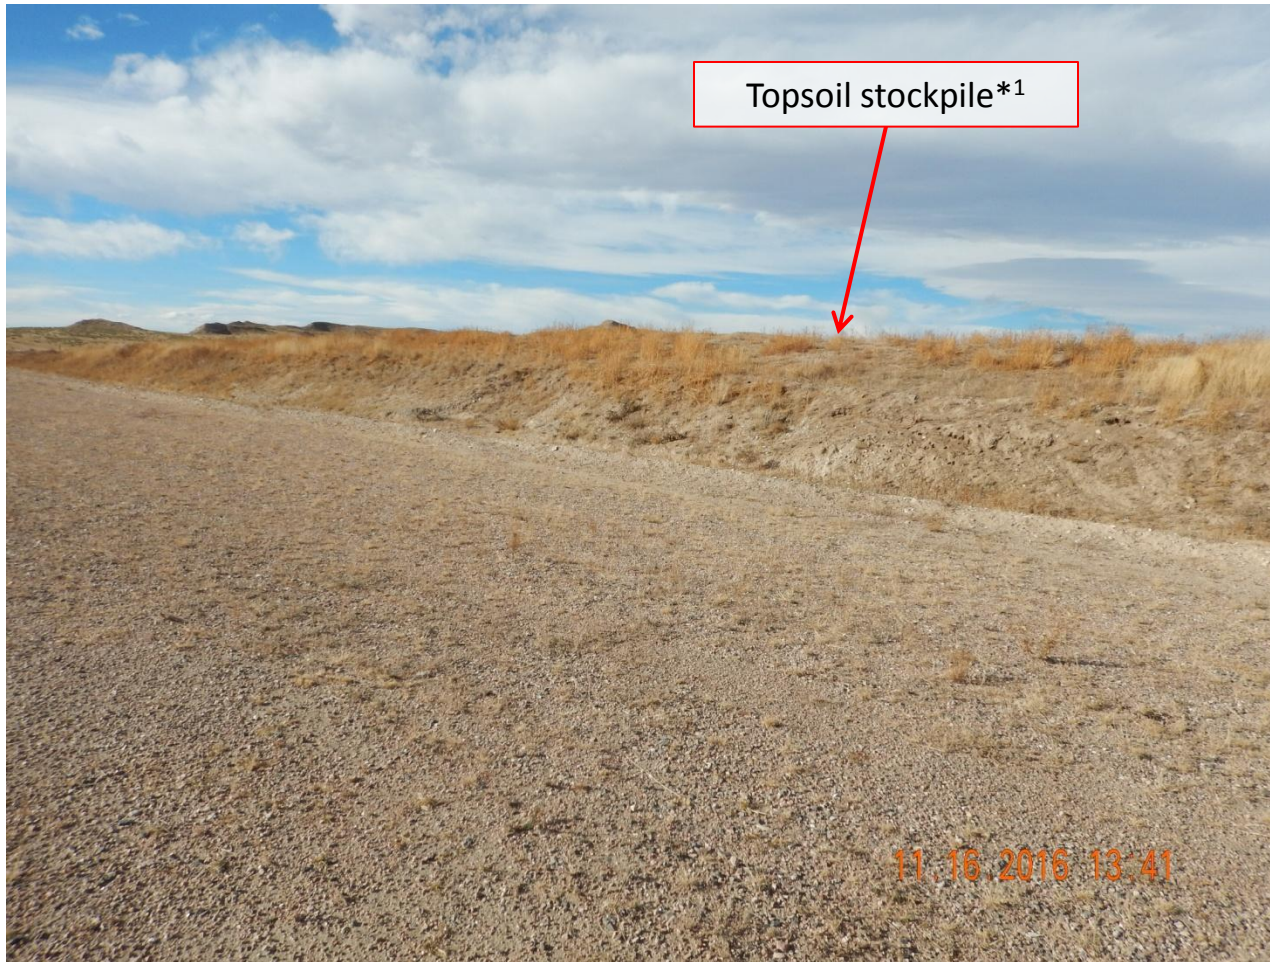
Photo 1. Photo taken from the northern location, facing Northwest, towards the northern topsoil stockpile.

*1 = Possible topsoil stockpile. Stockpile not marked or documented.

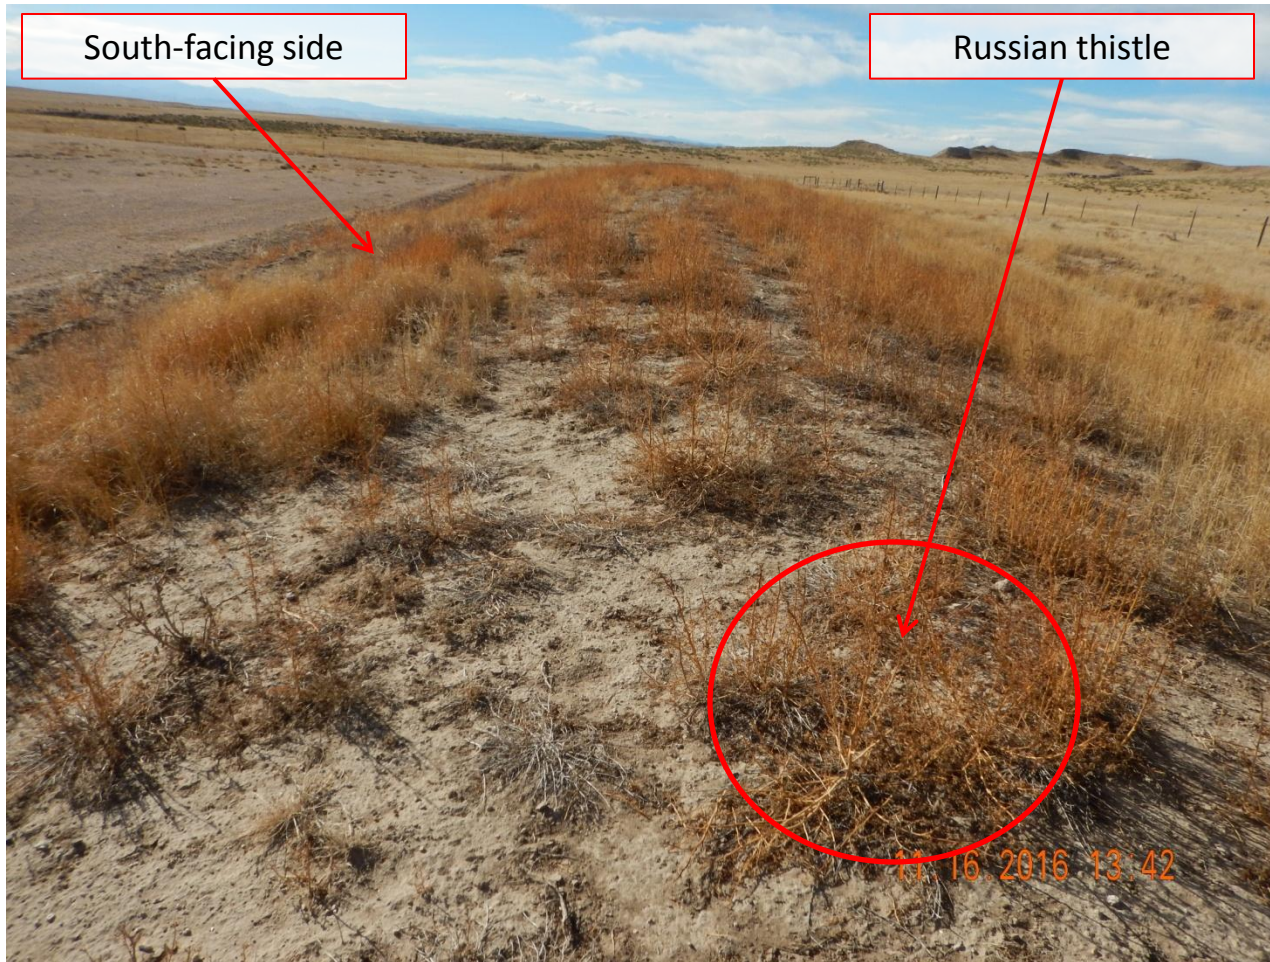
Photo 2. Photo taken from the northern topsoil stockpile, facing West. Along the center (i.e., top) and south-facing side, vegetation either lacks or an undesirable, weedy annual plant species has established on the stockpile (e.g., Russian thistle) which is not protective of soils to prevent weed establishment under Rule 1002.c.

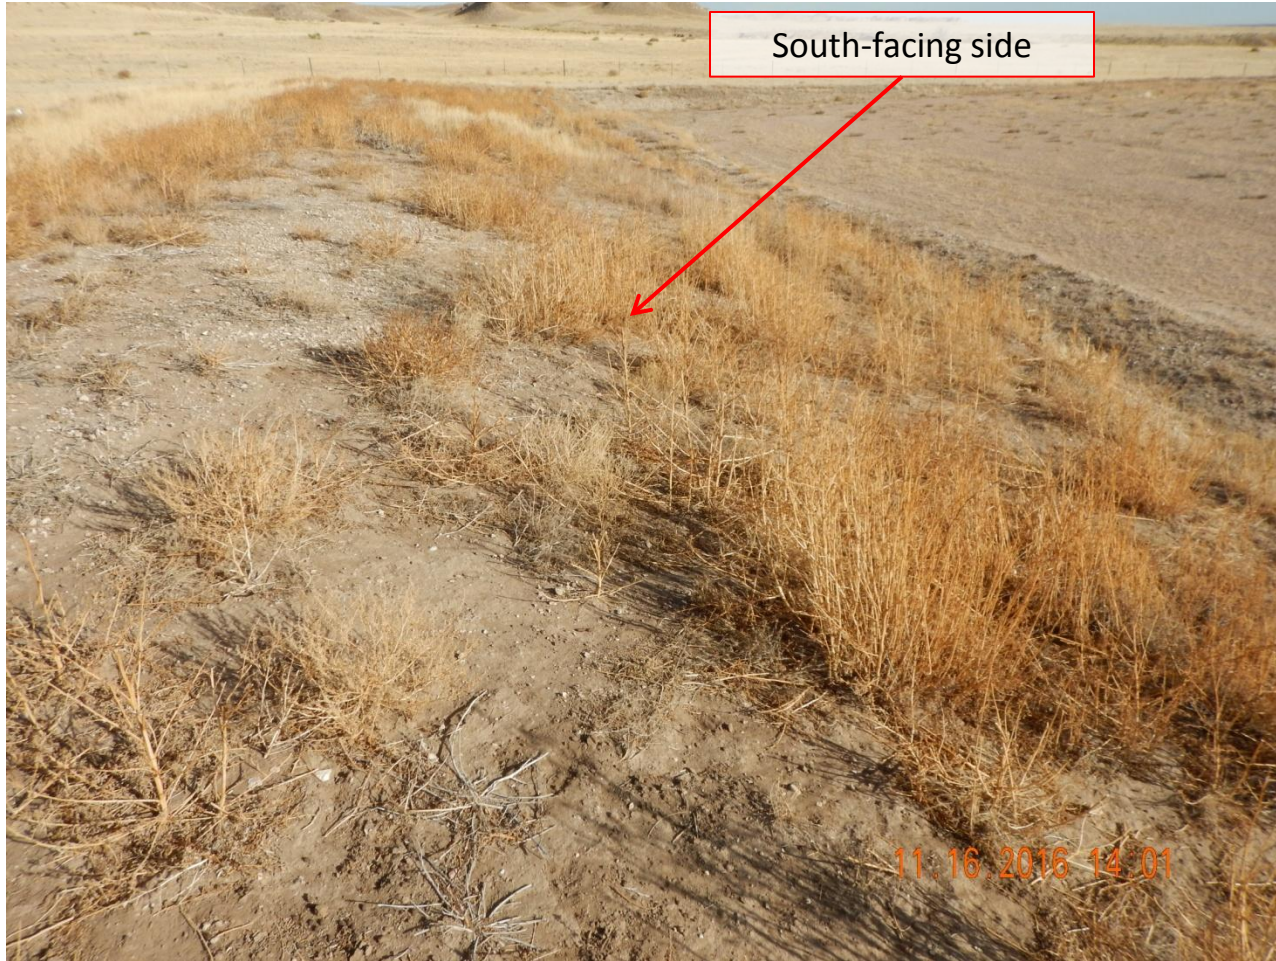
Photo 3. Photo taken from the northern topsoil stockpile, facing East. Along the center (i.e., top) and south-facing side, vegetation either lacks or an undesirable, weedy annual plant species has established on the stockpile (e.g., Russian thistle) which is not protective of soils to prevent weed establishment under Rule 1002.c.

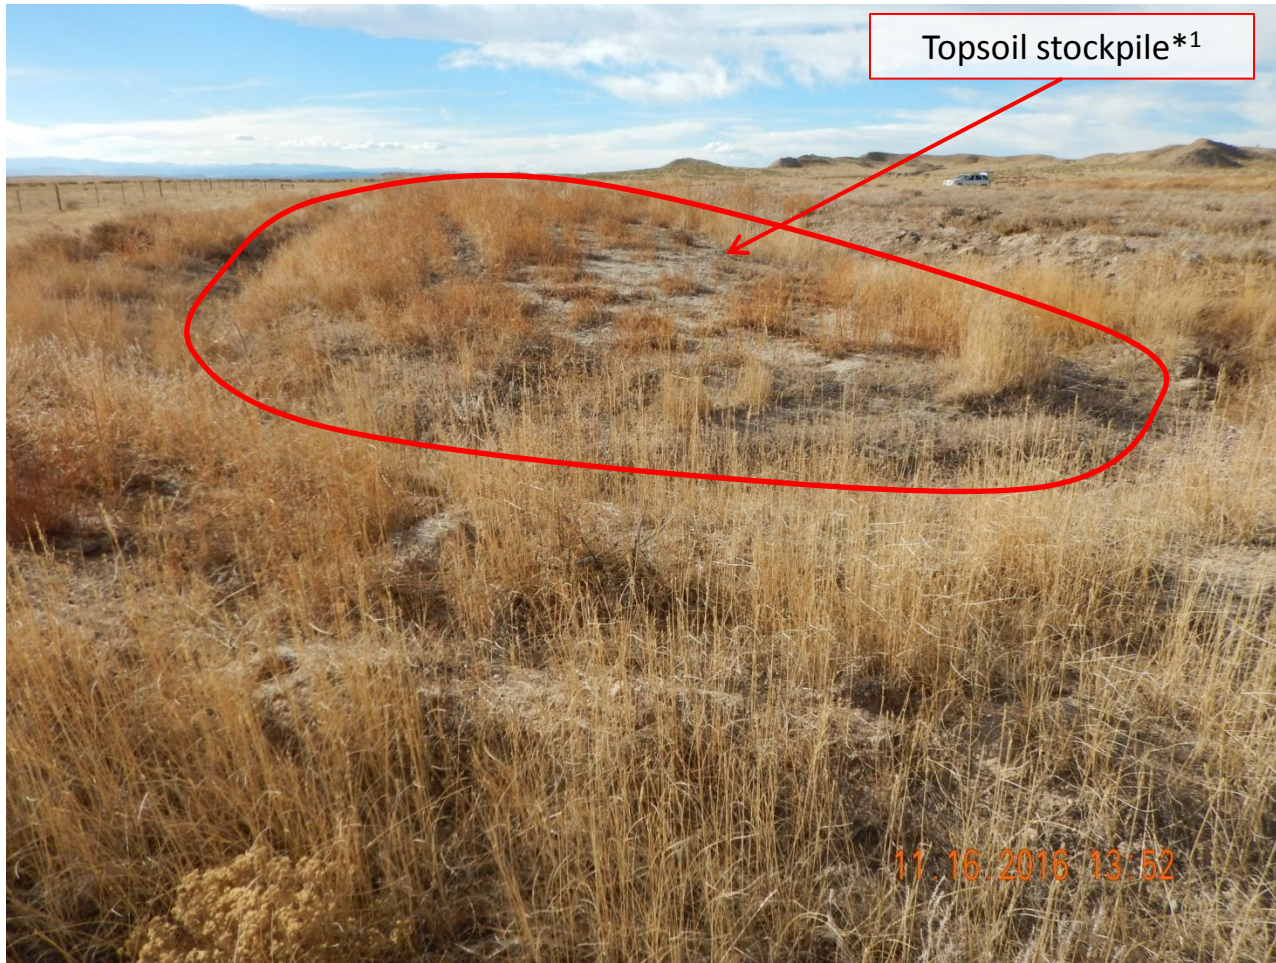
Photo 4. Photo taken from the southern topsoil stockpile, facing West. Portions along the stockpile either lack vegetative growth or an undesirable, weedy annual plant species has established on the stockpile (e.g., Russian thistle) which is not protective of soils to prevent weed establishment under Rule 1002.c.

*1 = Possible topsoil stockpile. Stockpile not marked or documented.

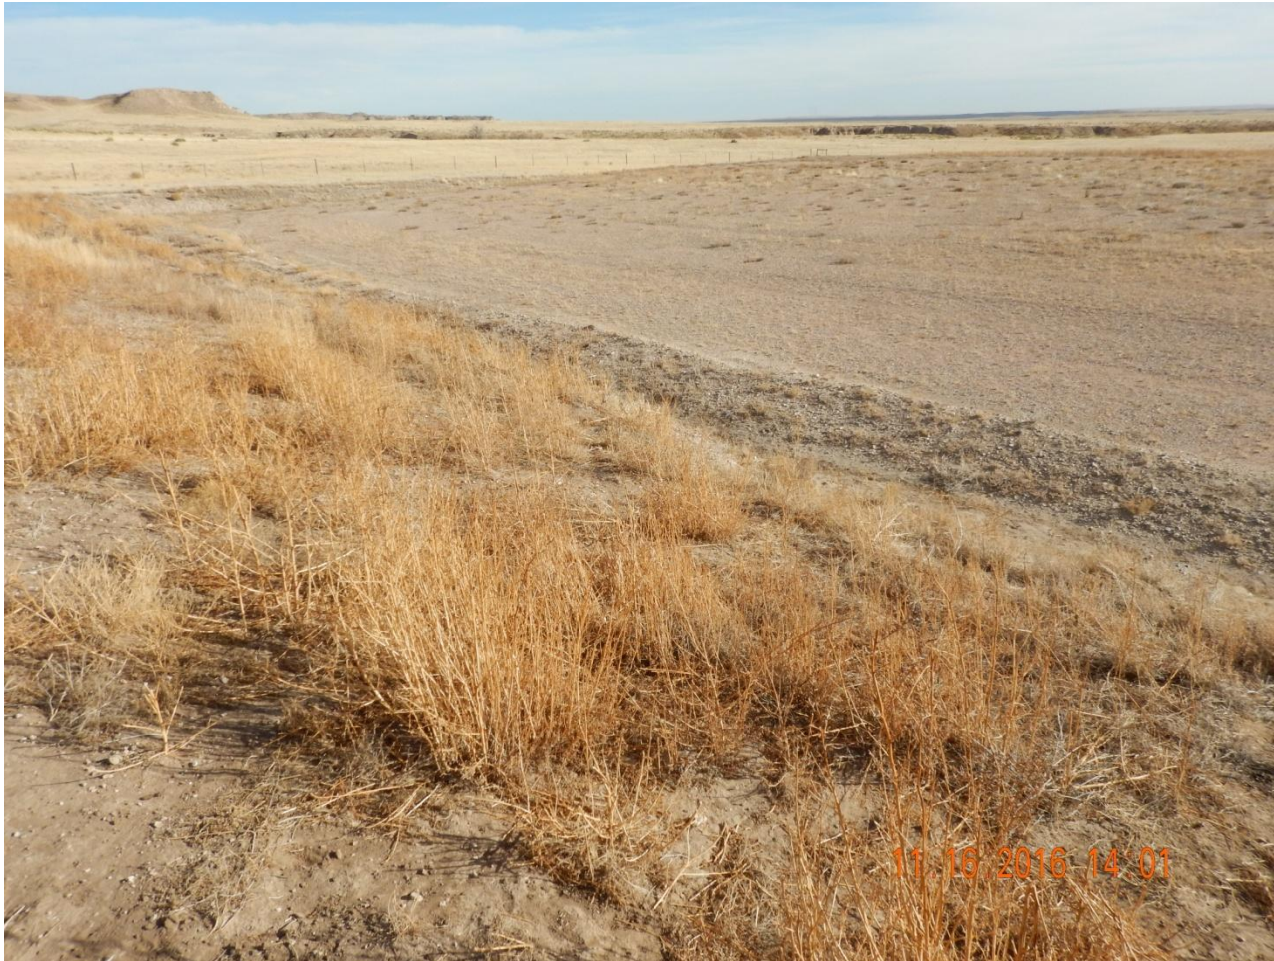
Photo 5. Photo taken from the northern topsoil stockpile, facing Southeast, illustrating total extent of well location, including areas that have not been reclaimed per Rule 1003.

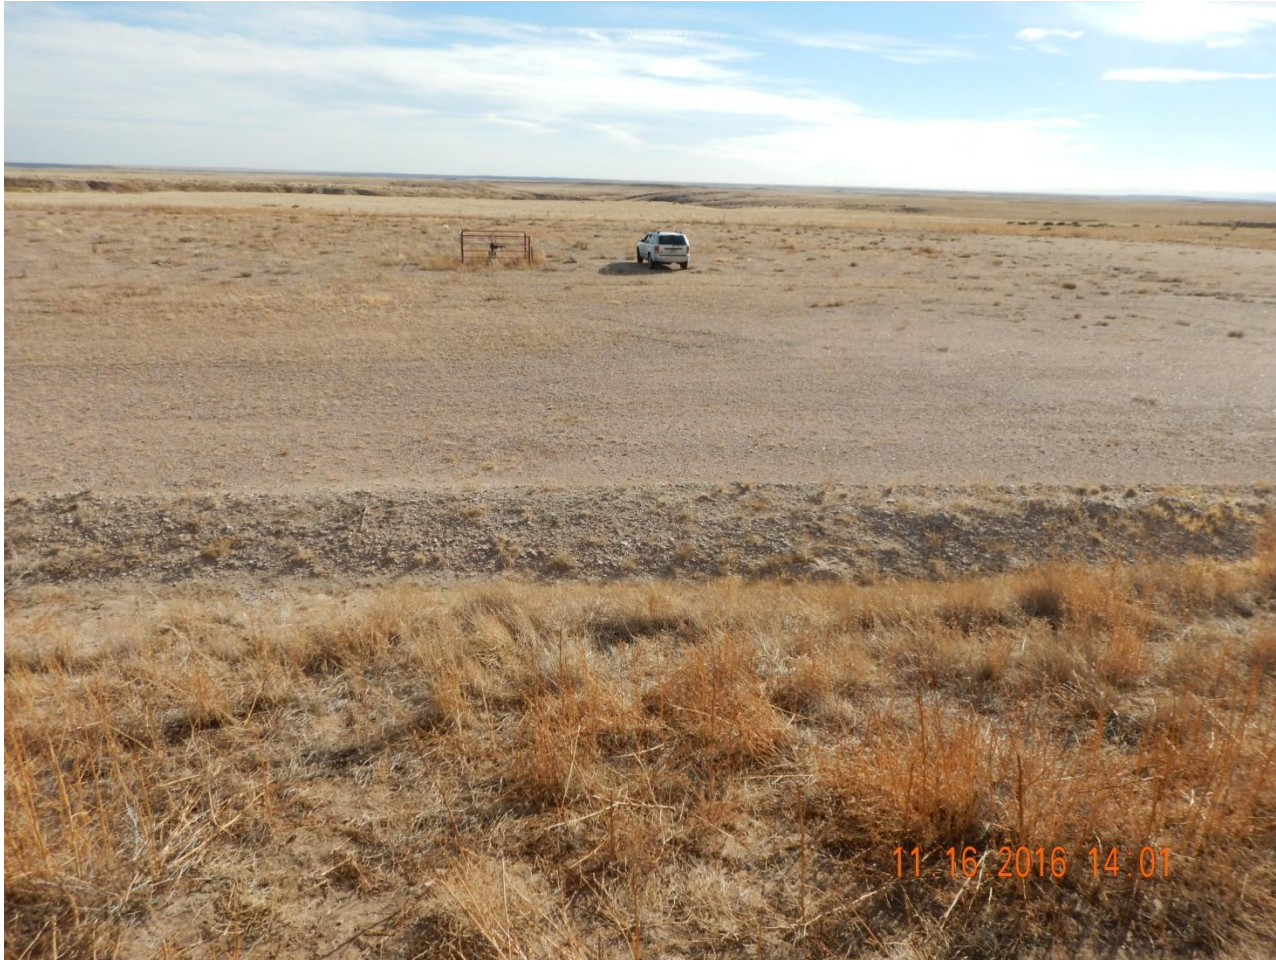
Photo 6. Photo taken from the northern topsoil stockpile, facing South, illustrating total extent of well location, including areas that have not been reclaimed per Rule 1003.

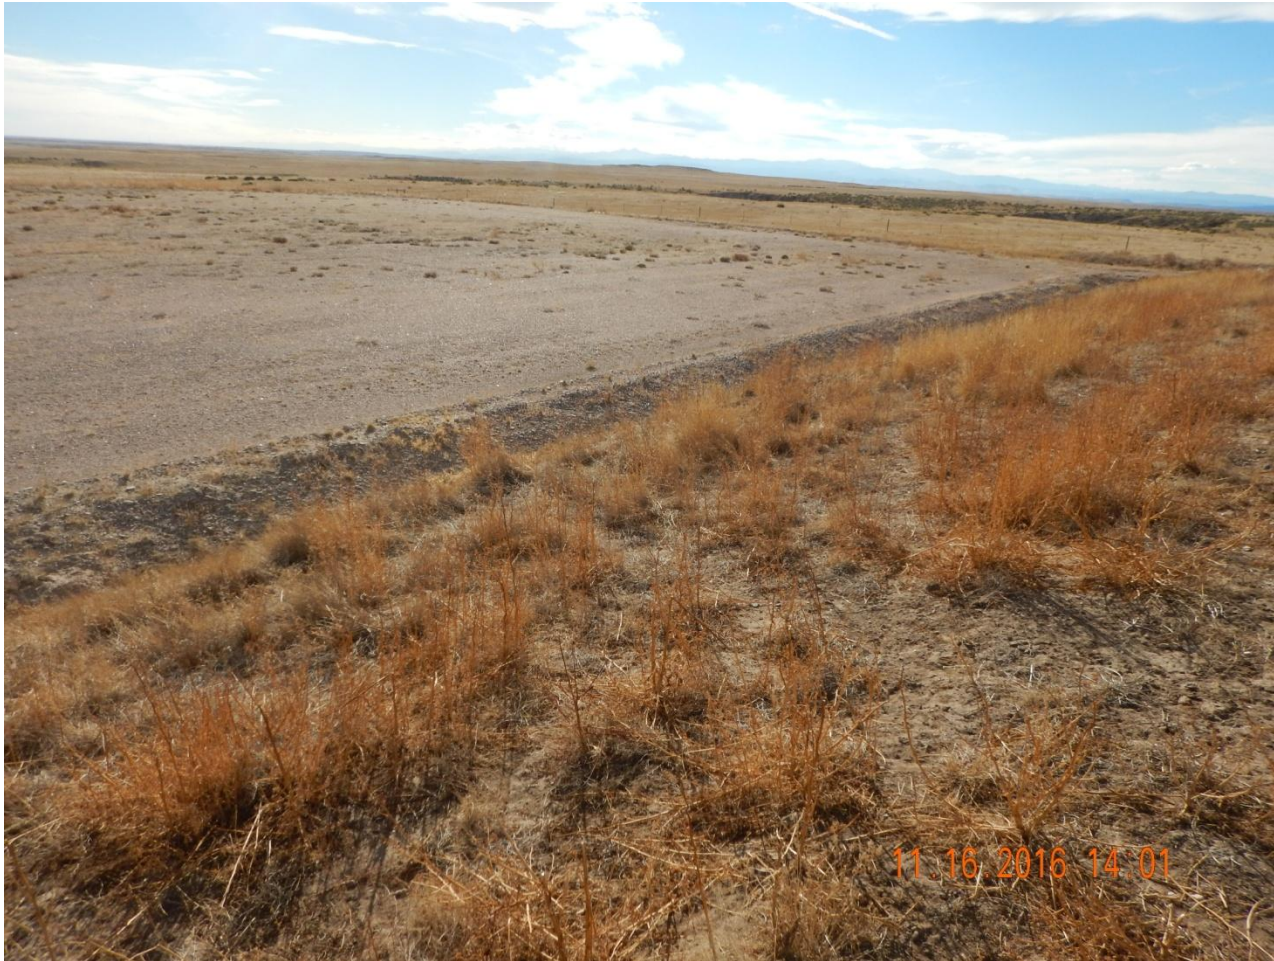
Photo 7. Photo taken from the northern topsoil stockpile, facing Southwest, illustrating total extent of well location, including areas that have not been reclaimed per Rule 1003. .
