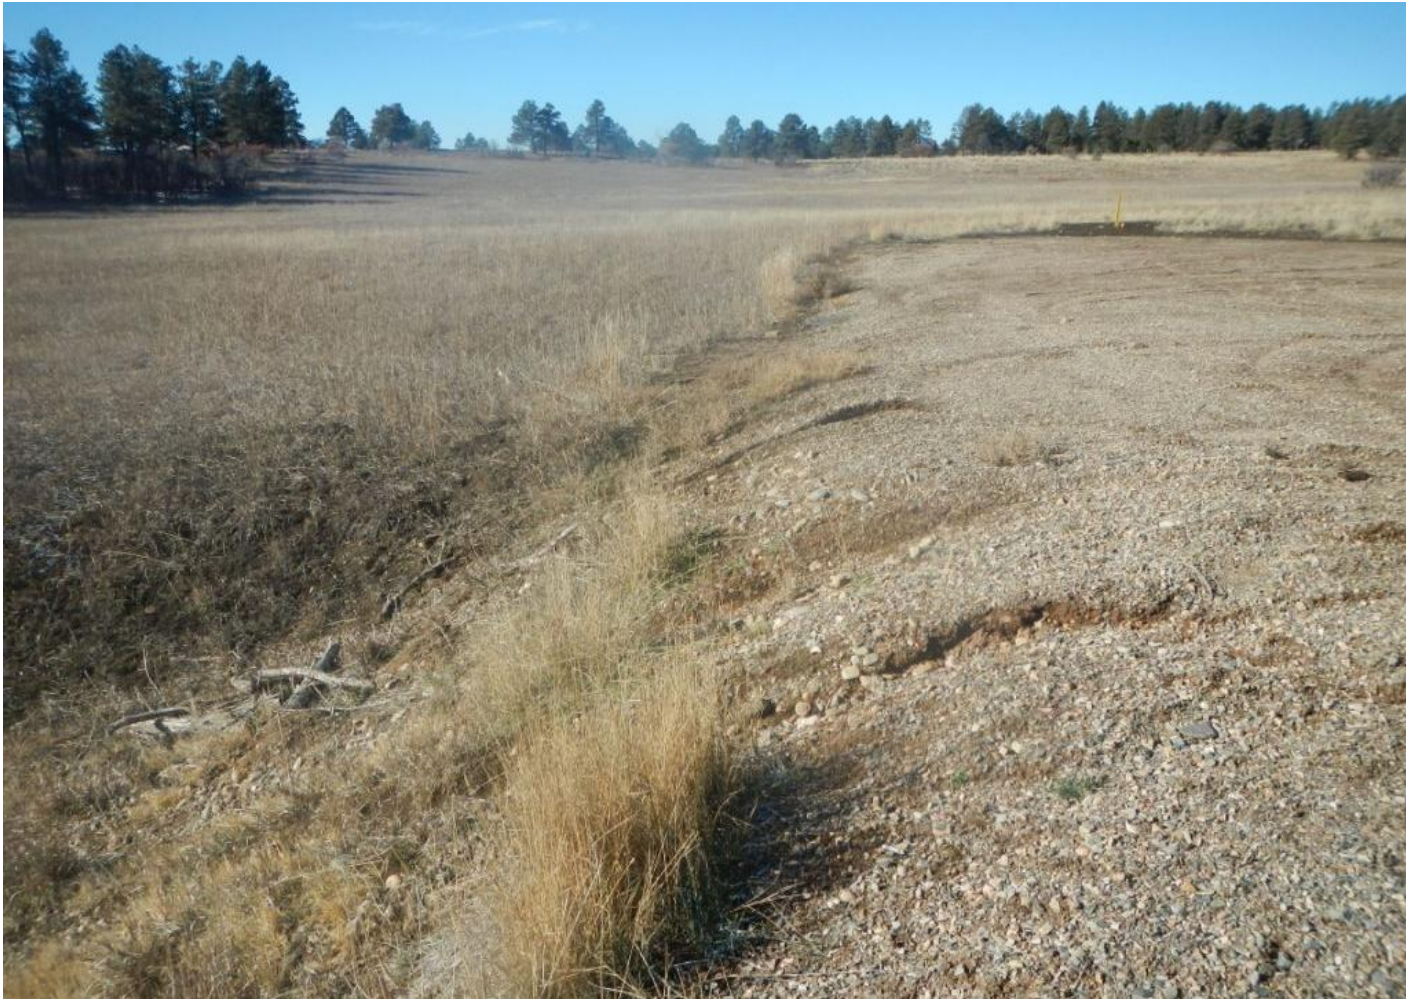
Photo 3. View of the southern portion of the project area from the southeastern corner facing westward. Rills on the edge need to be monitored and stormwater controls installed if it worsens.

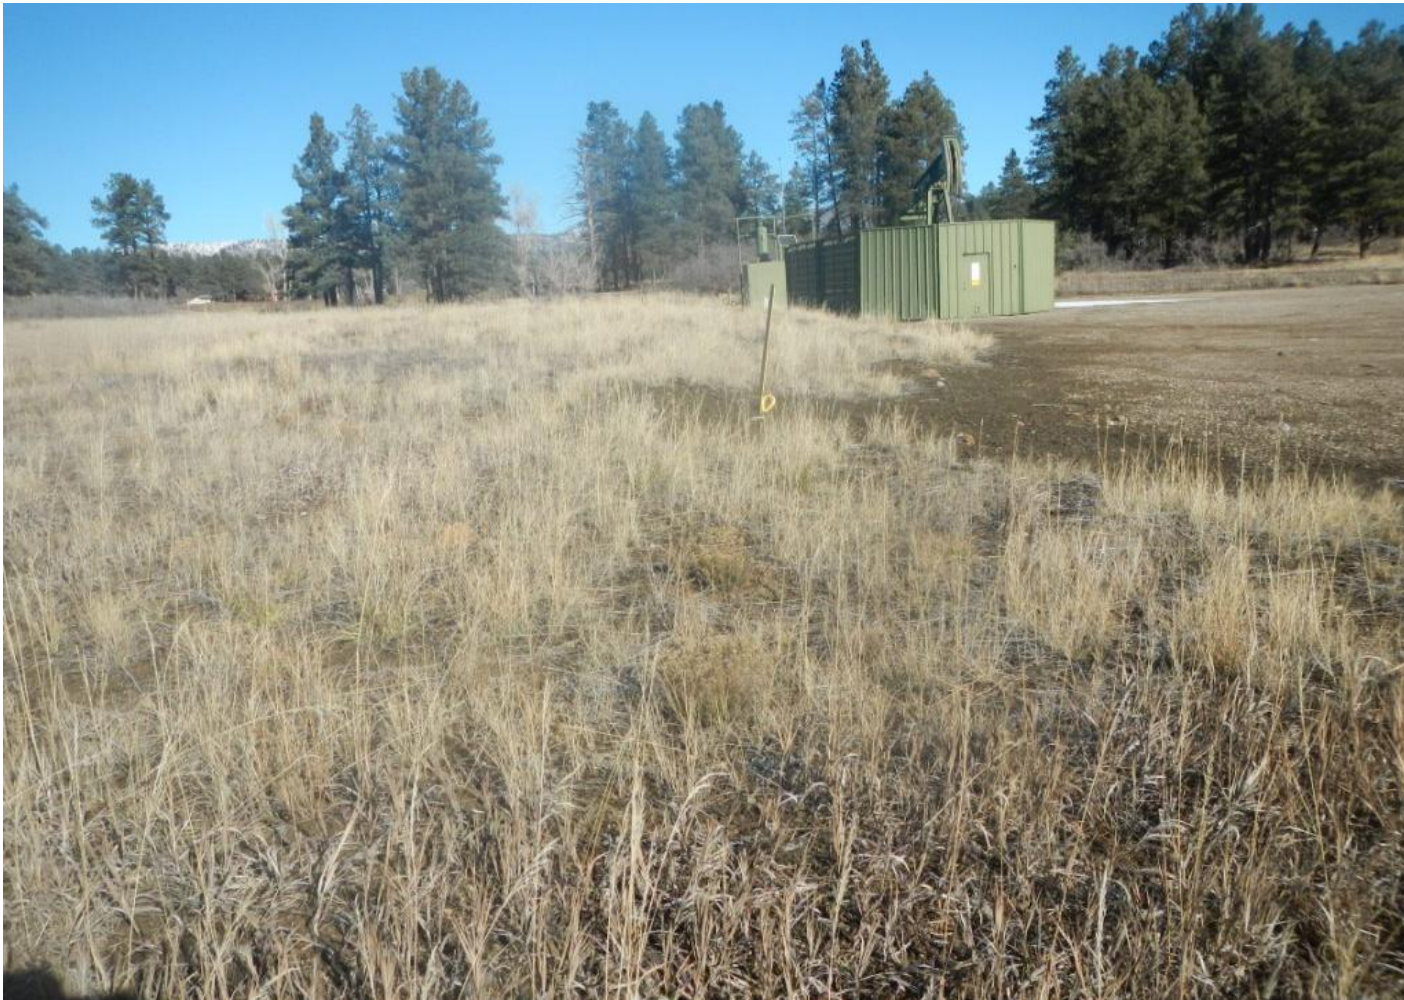
Photo 4. View of the western portion of the project area from the southwestern corner facing northward. Revegetation is comprised of grasses such as smooth brome (*Bromus inermis*) and western wheatgrass (*Pascopyrum smithii*).
