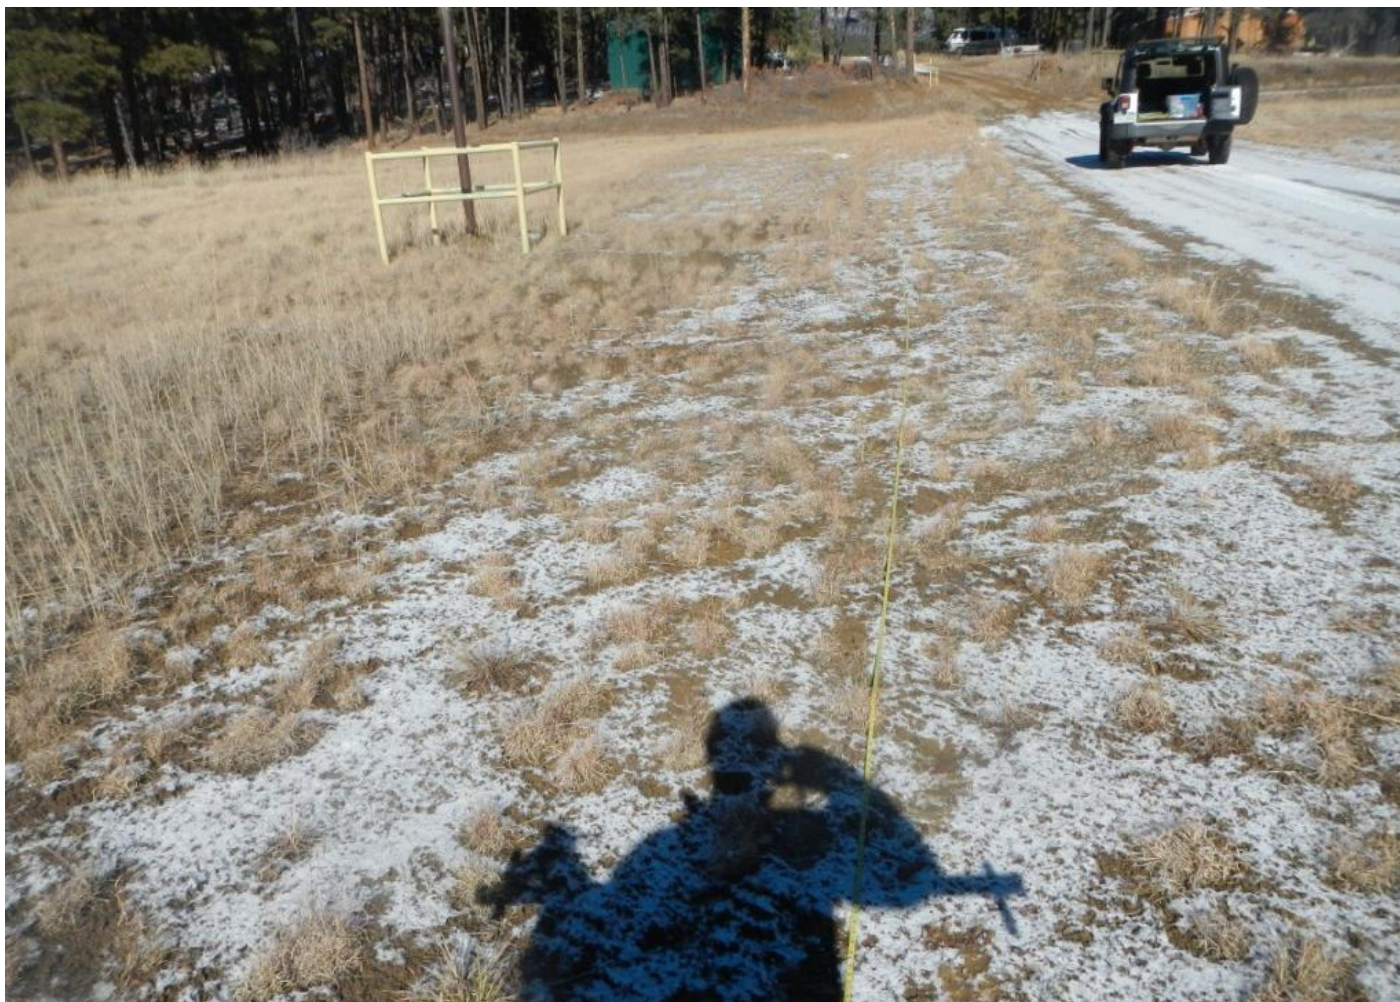
Photo 1. View of Transect 1, within the project disturbance, from the end of the transect facing northward. Revegetation is largely comprised of blue grama (*Bouteloua gracilis*).

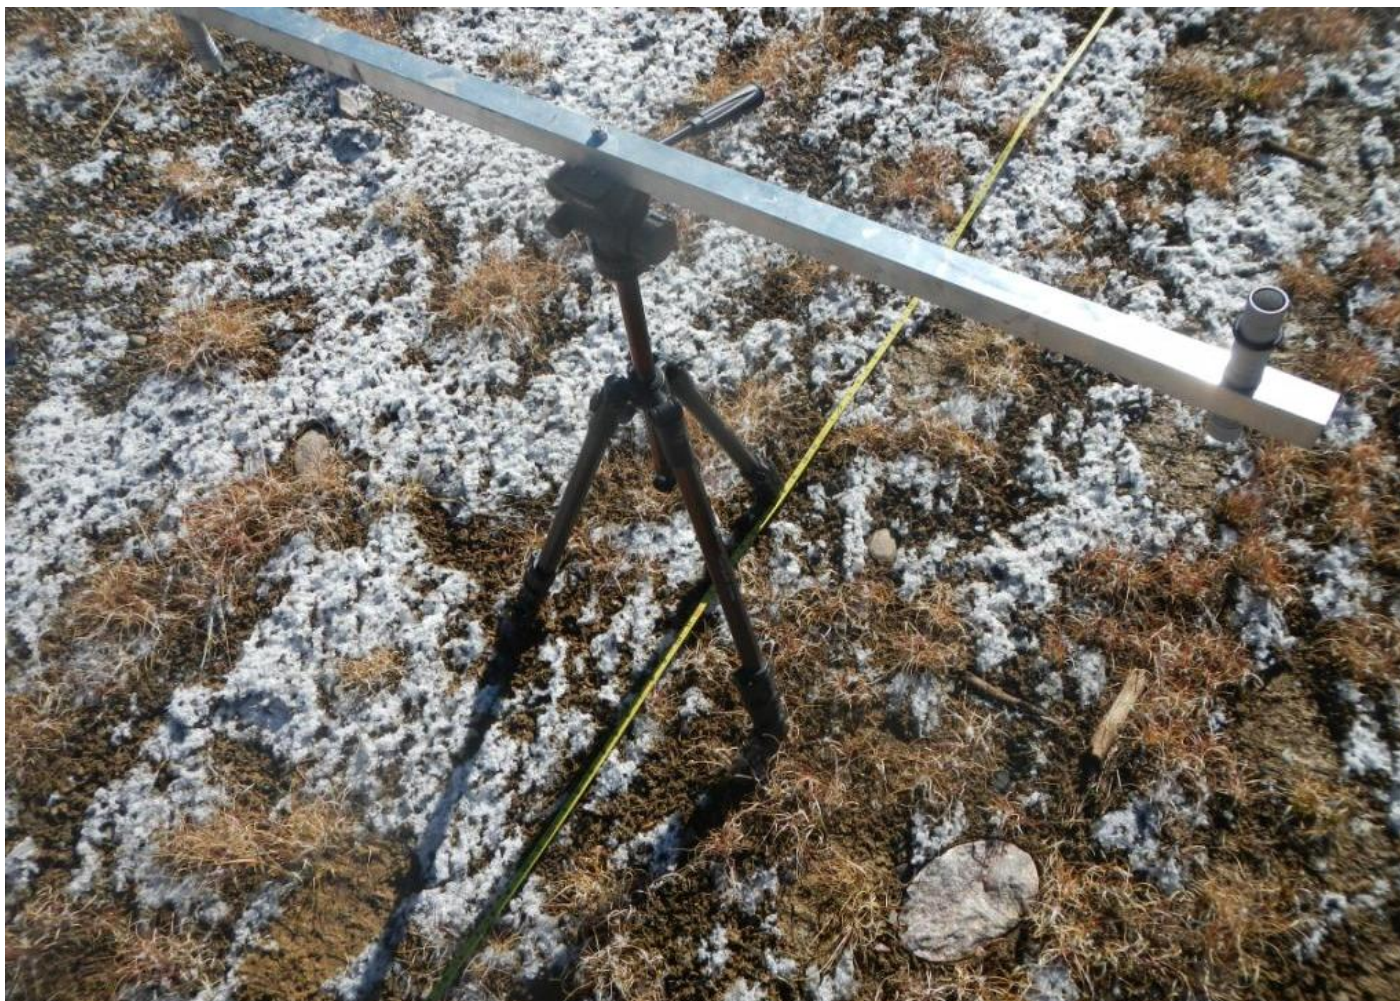
Photo 2. Birdseye view of vegetation at the midpoint along Transect 1, within the project disturbance.

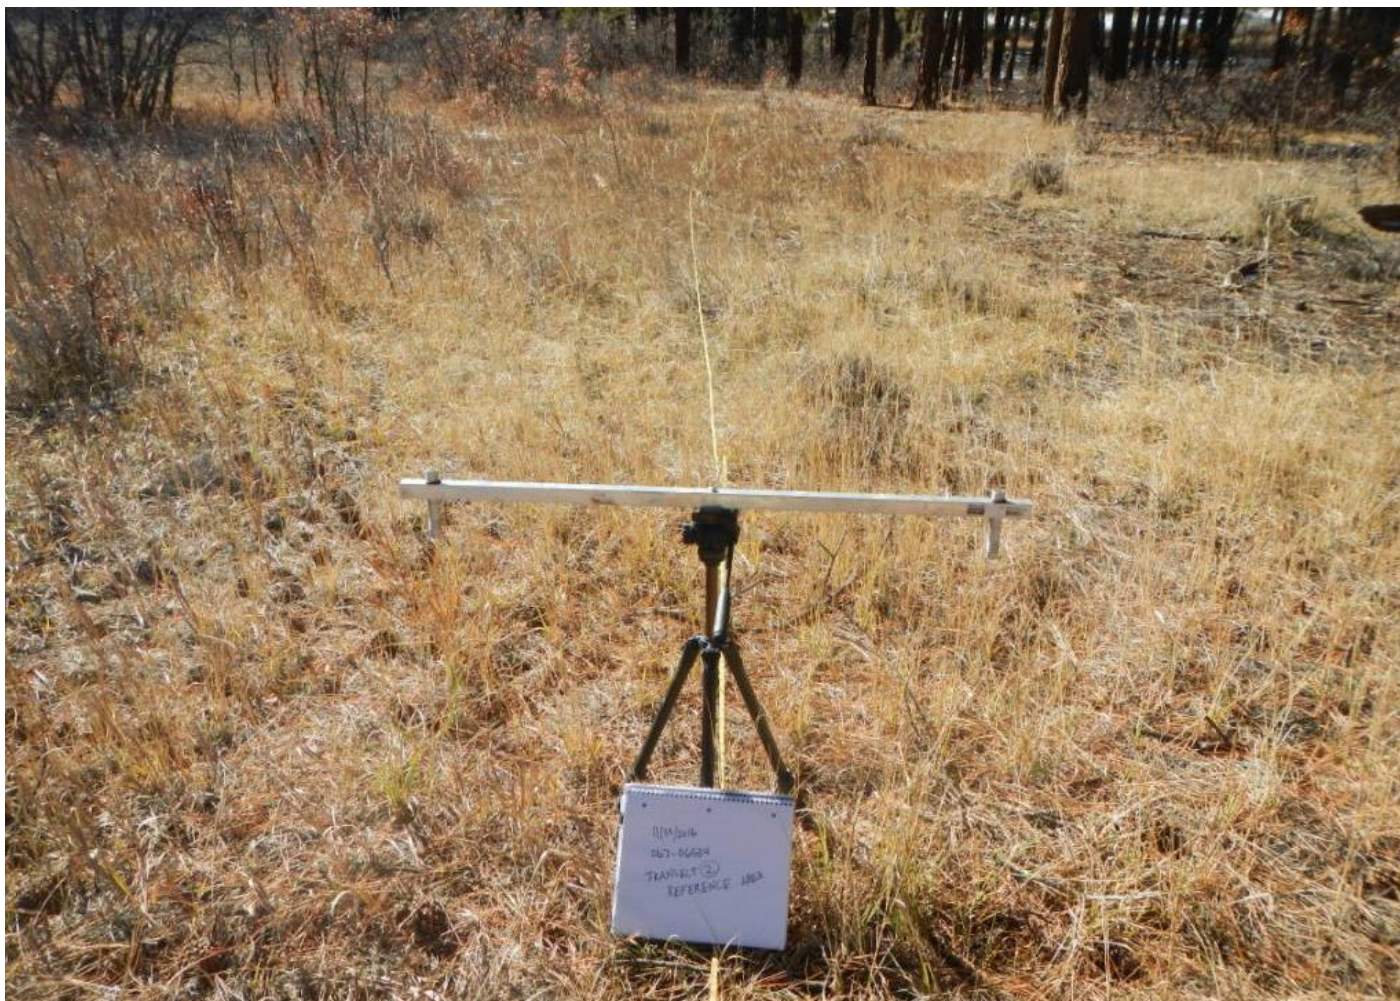
Photo 3. View of the beginning of Transect 2, in the reference area facing southwestward. Vegetation in this area is dominated by smooth brome (*Bromus inermis*), western wheatgrass (*Pascopyrum smithii*), and Gambel's oak (*Quercus gambelii*).

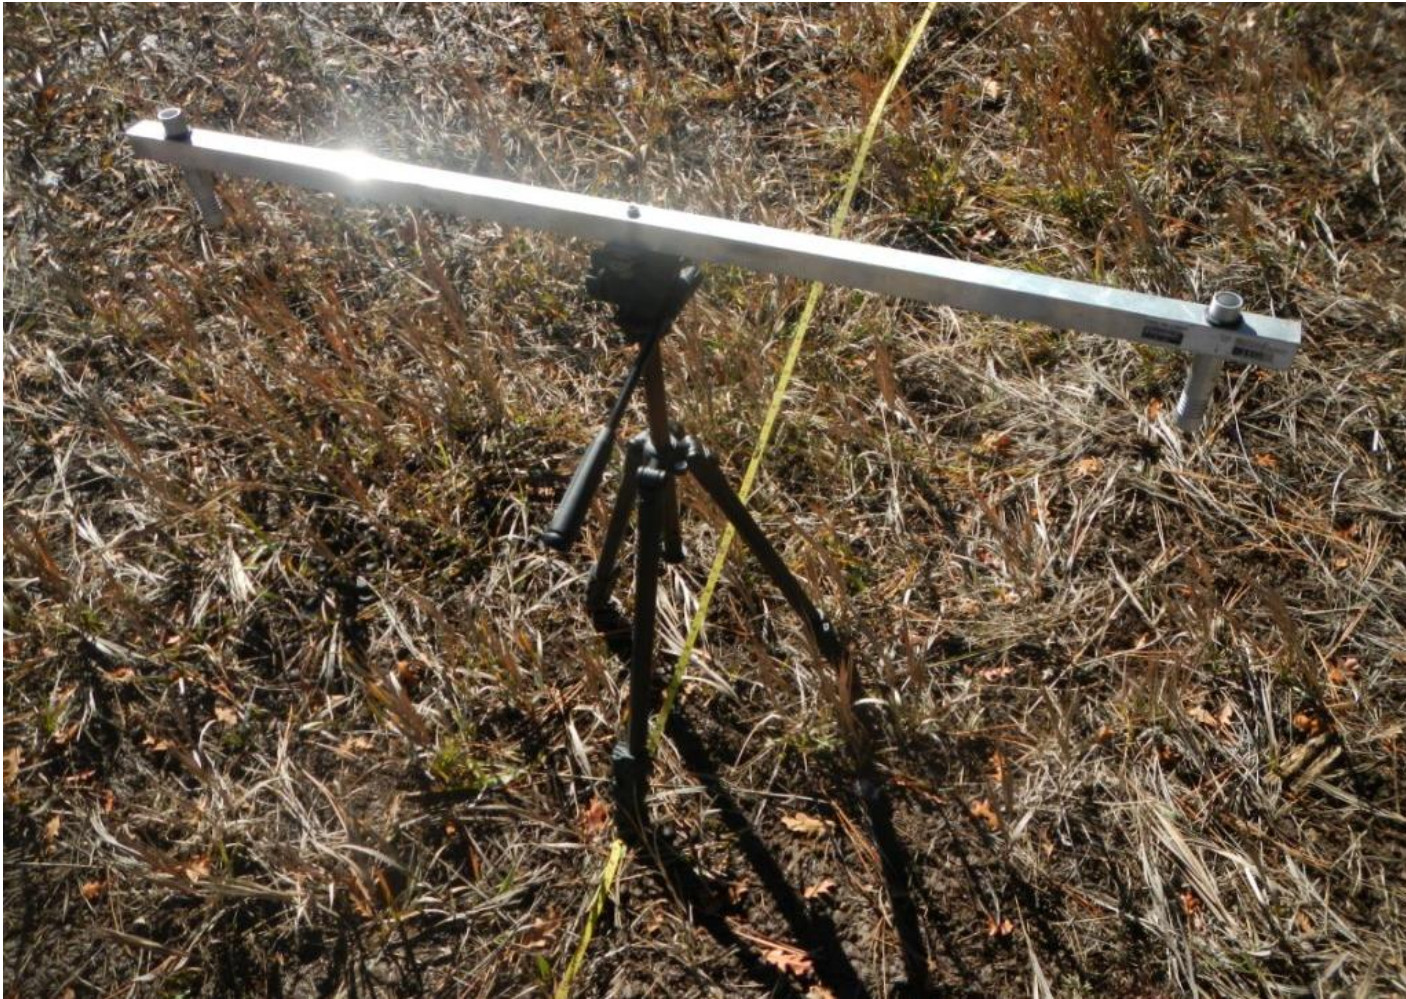
Photo 4. Birdseye view of vegetation at the midpoint of Transect 2, within the reference area. This area is dominated with smooth brome with a significant cover of ponderosa pine (*Pinus ponderosa*) needles.

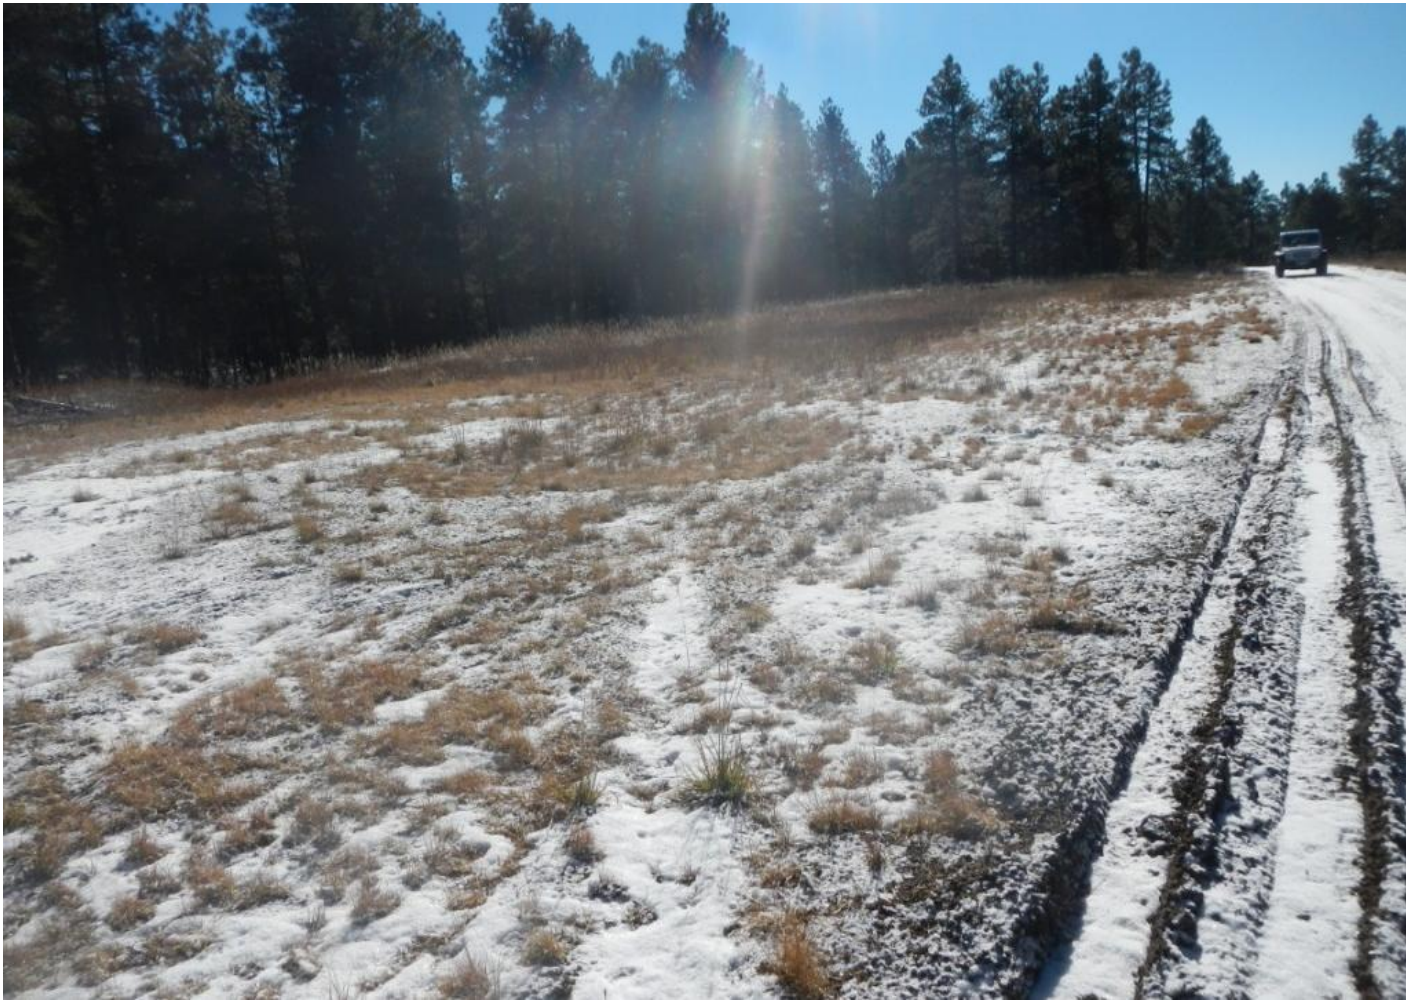
Photo 5. View of the eastern portion of the well pad facing southward.

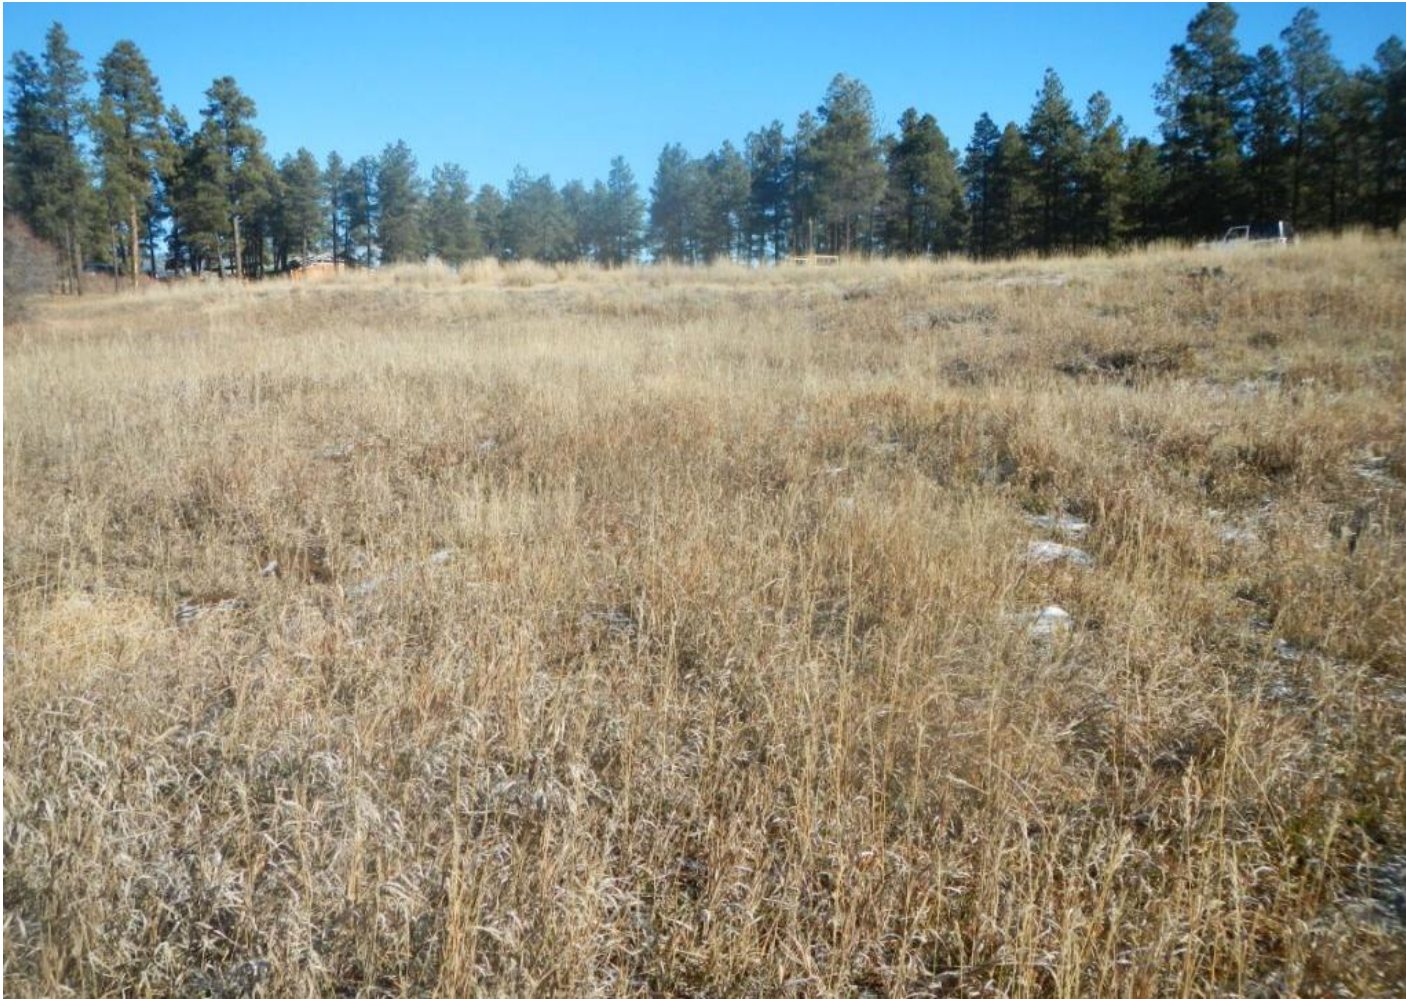
Photo 6. View from the southwestern corner of the project area showing well established vegetation within the interim reclamation area facing center.
