# Construction and Stormwater Inspection

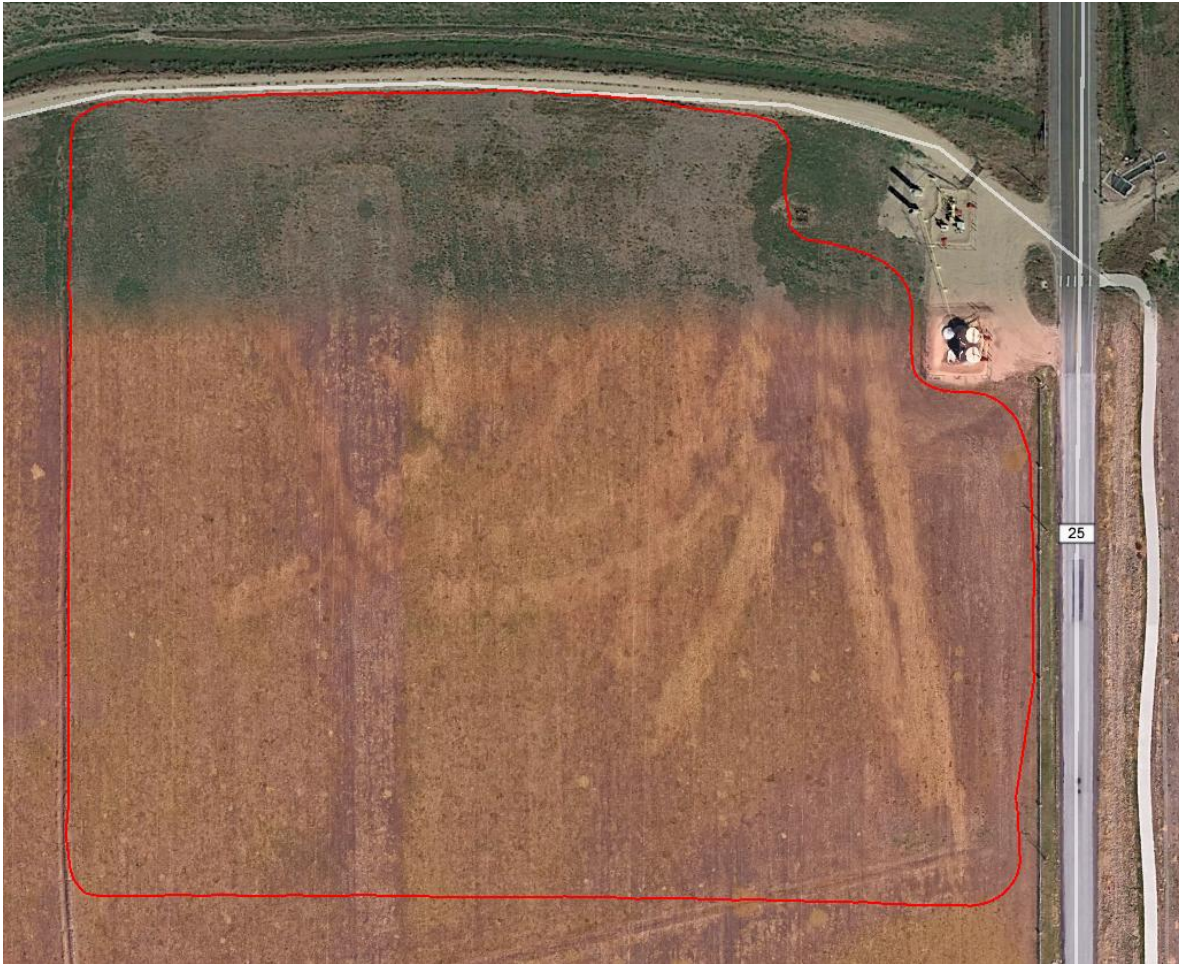
Google Earth aerial photo taken 9/7/2016 illustrating total extent of the Orr State /40-36 Pad location. Total area of 9.37 acres was mapped on 11/29/16 using a Trimble Juno 3B handheld device. Perimeter of location was mapped and highlighted in red.

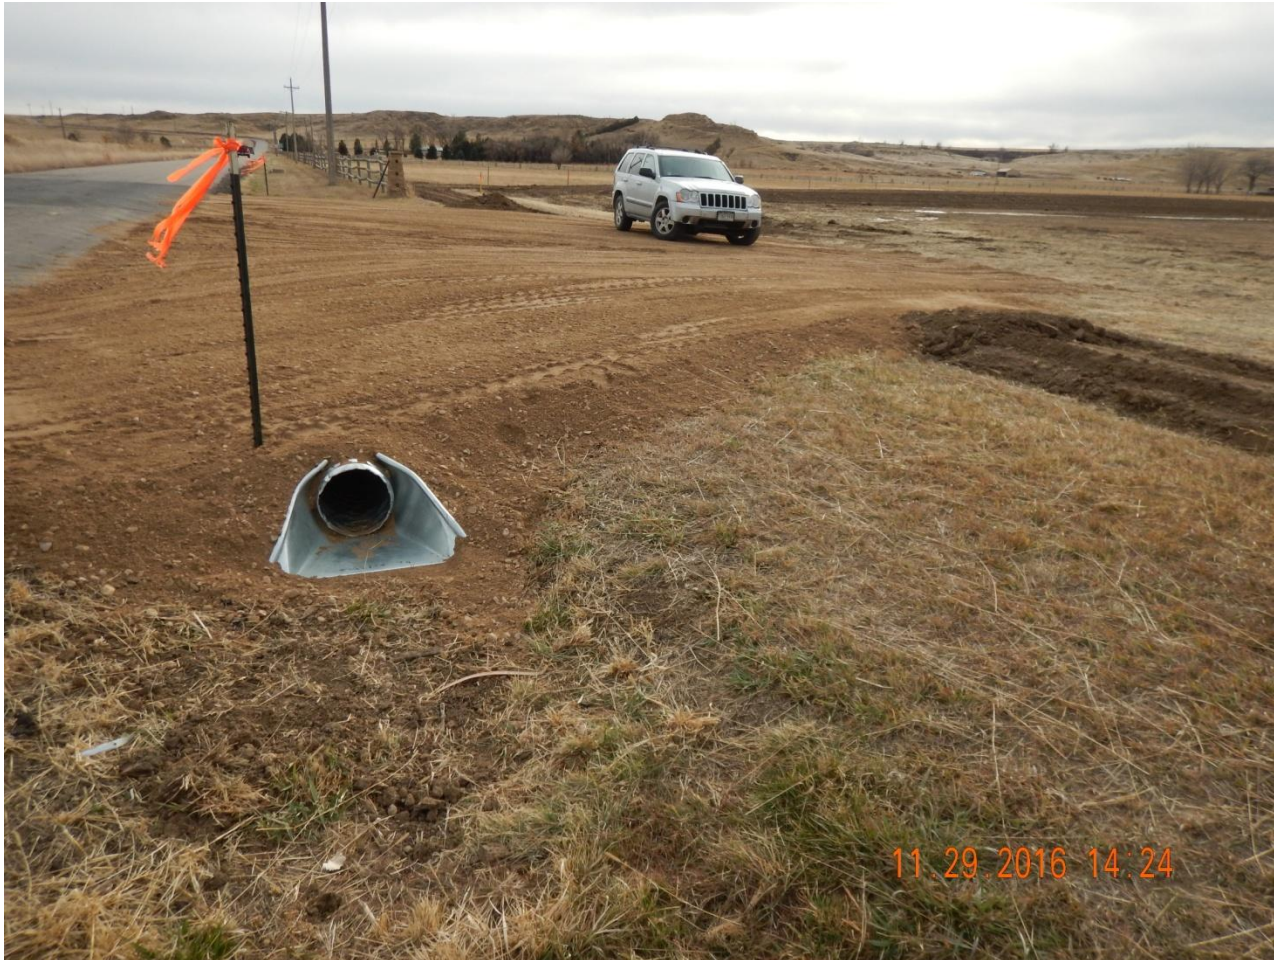
**Photo 1.** Photo taken from location entrance, facing South. Culvert installed in-line with borrow ditch.

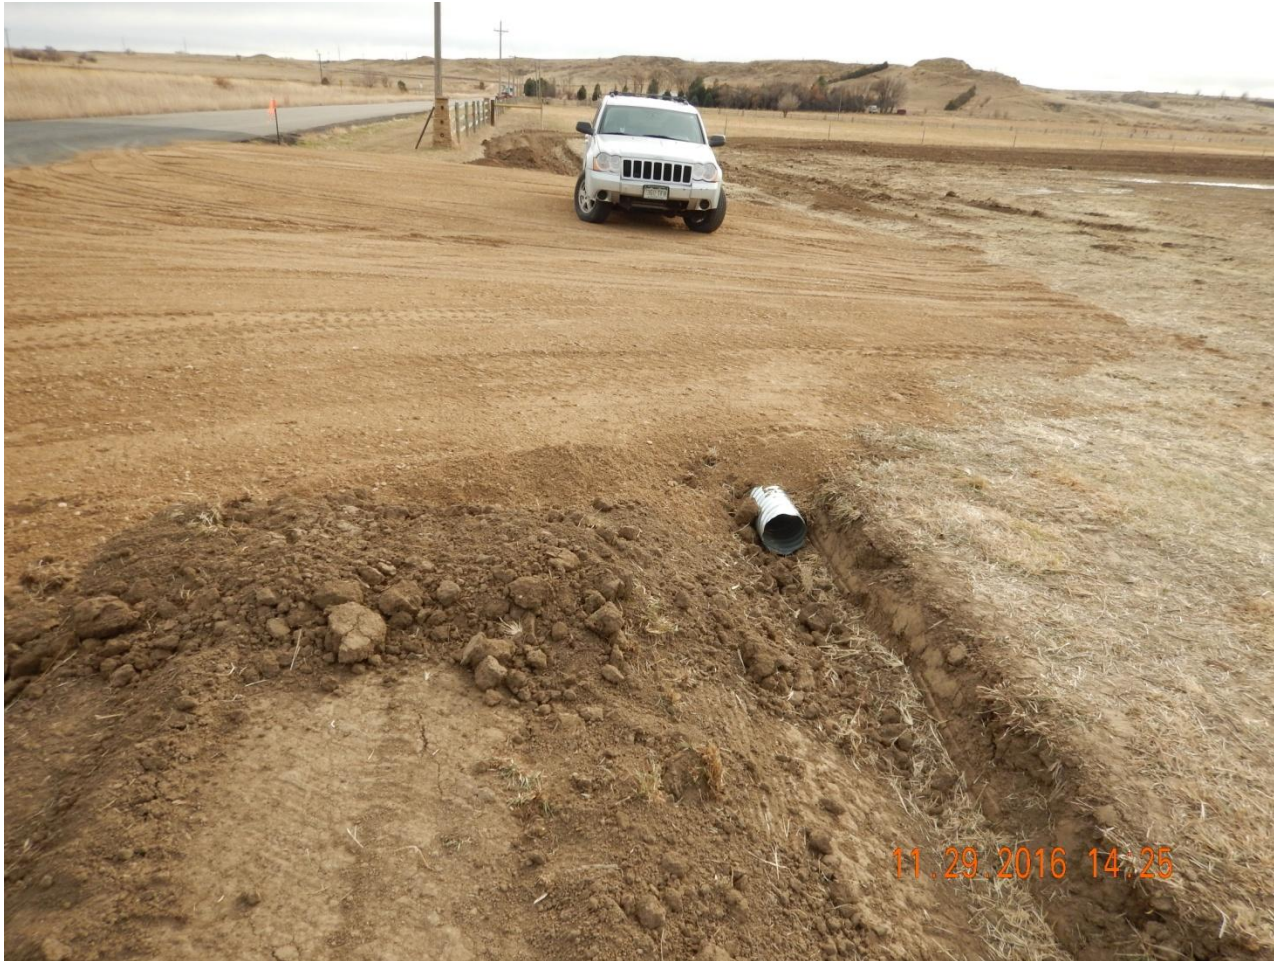
**Photo 2.** Photo taken from location entrance, facing South. Culvert installed in-line with ditch and berm BMP.

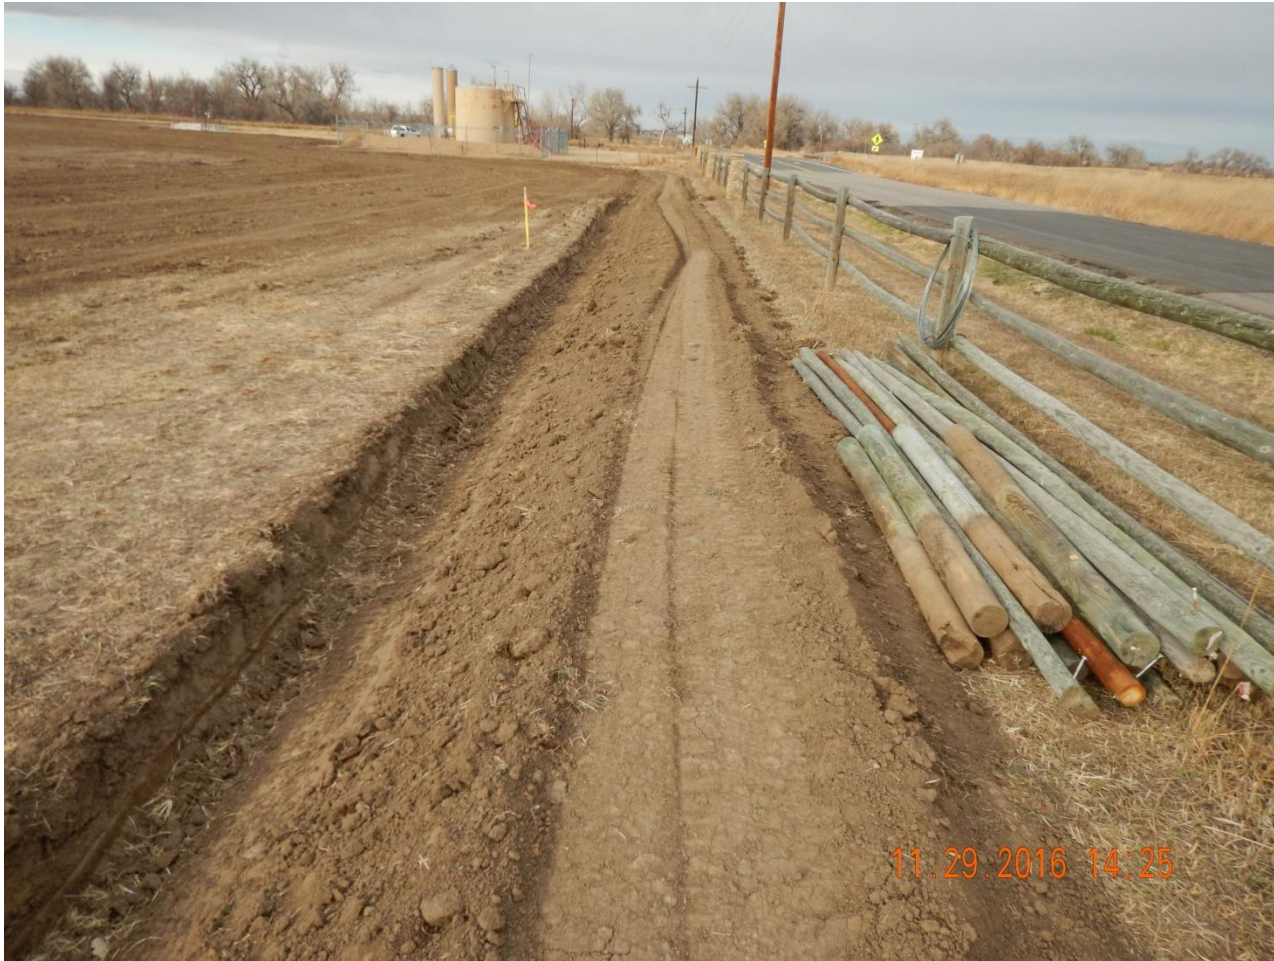
**Photo 3.** Photo taken from location entrance, facing North. Ditch and berm BMP installed around perimeter of location.

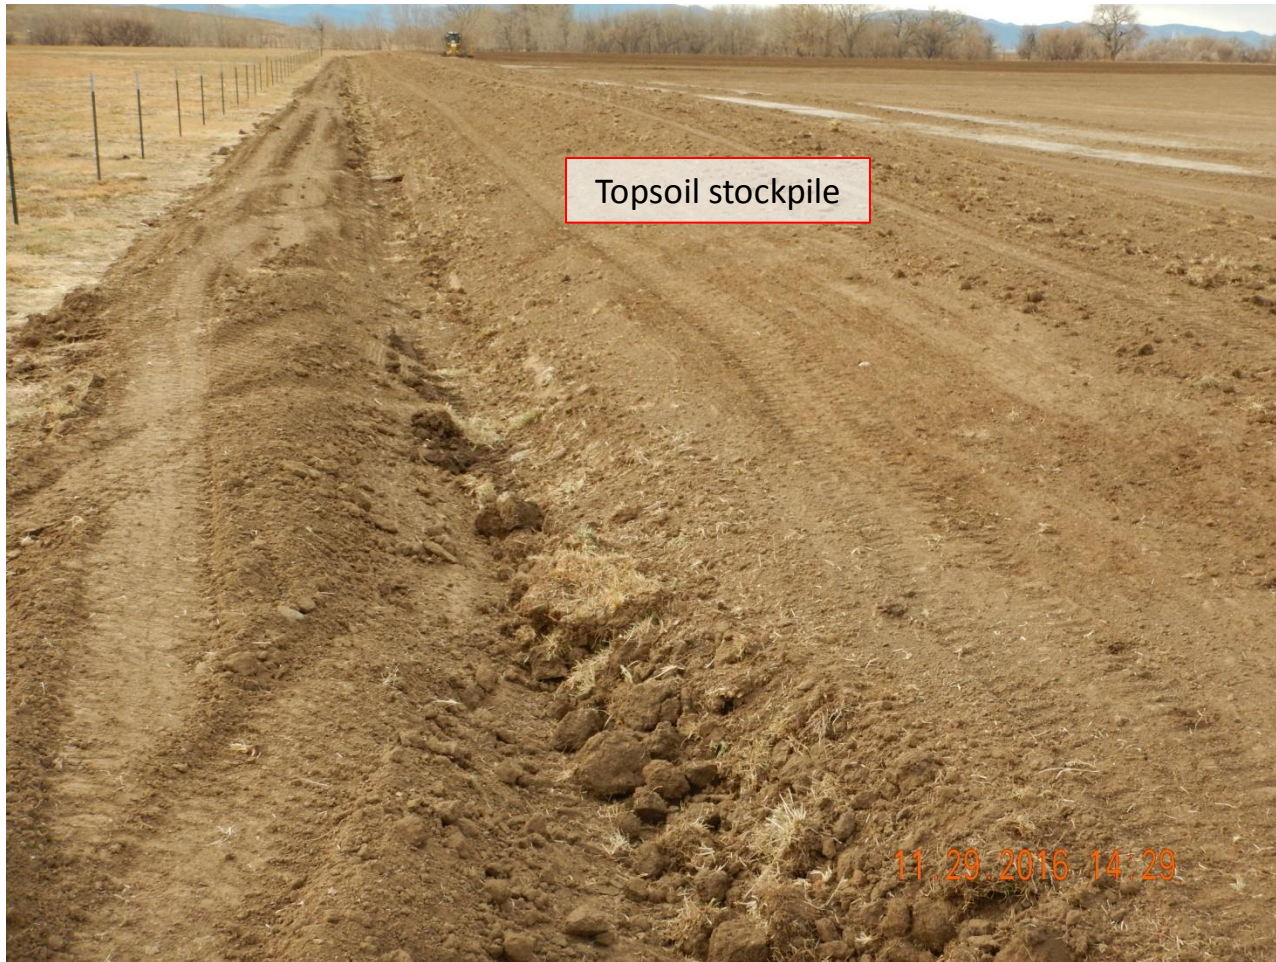
**Photo 4.** Photo taken from the southern location, facing West. Ditch and berm BMP installed around perimeter of location. Topsoil stockpile stored along southern and western perimeter of location.

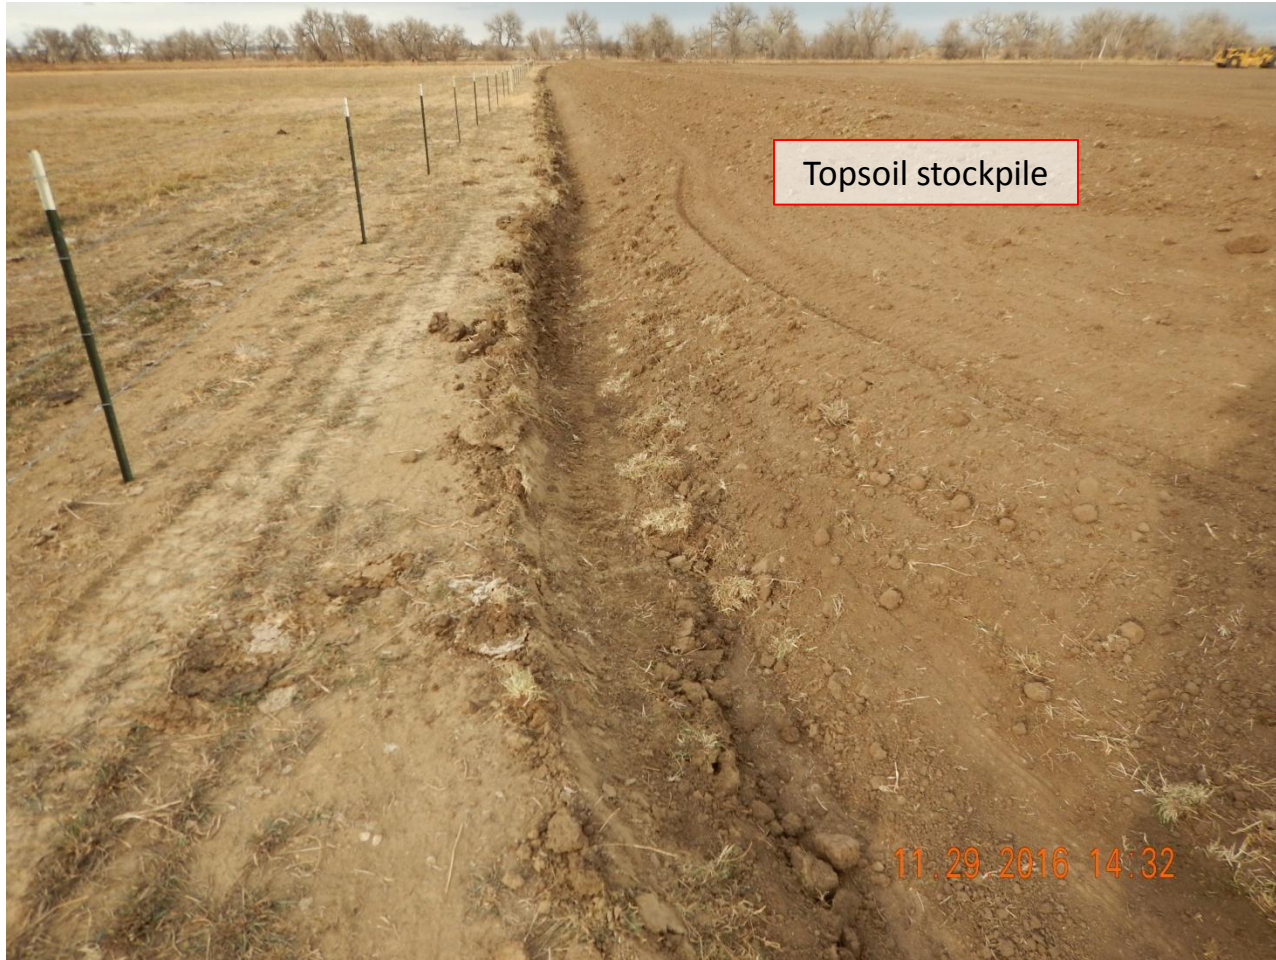
**Photo 5.** Photo taken from the southwest location, facing North. Ditch and berm BMP installed around perimeter of location. Topsoil stockpile stored along southern and western perimeter of location.

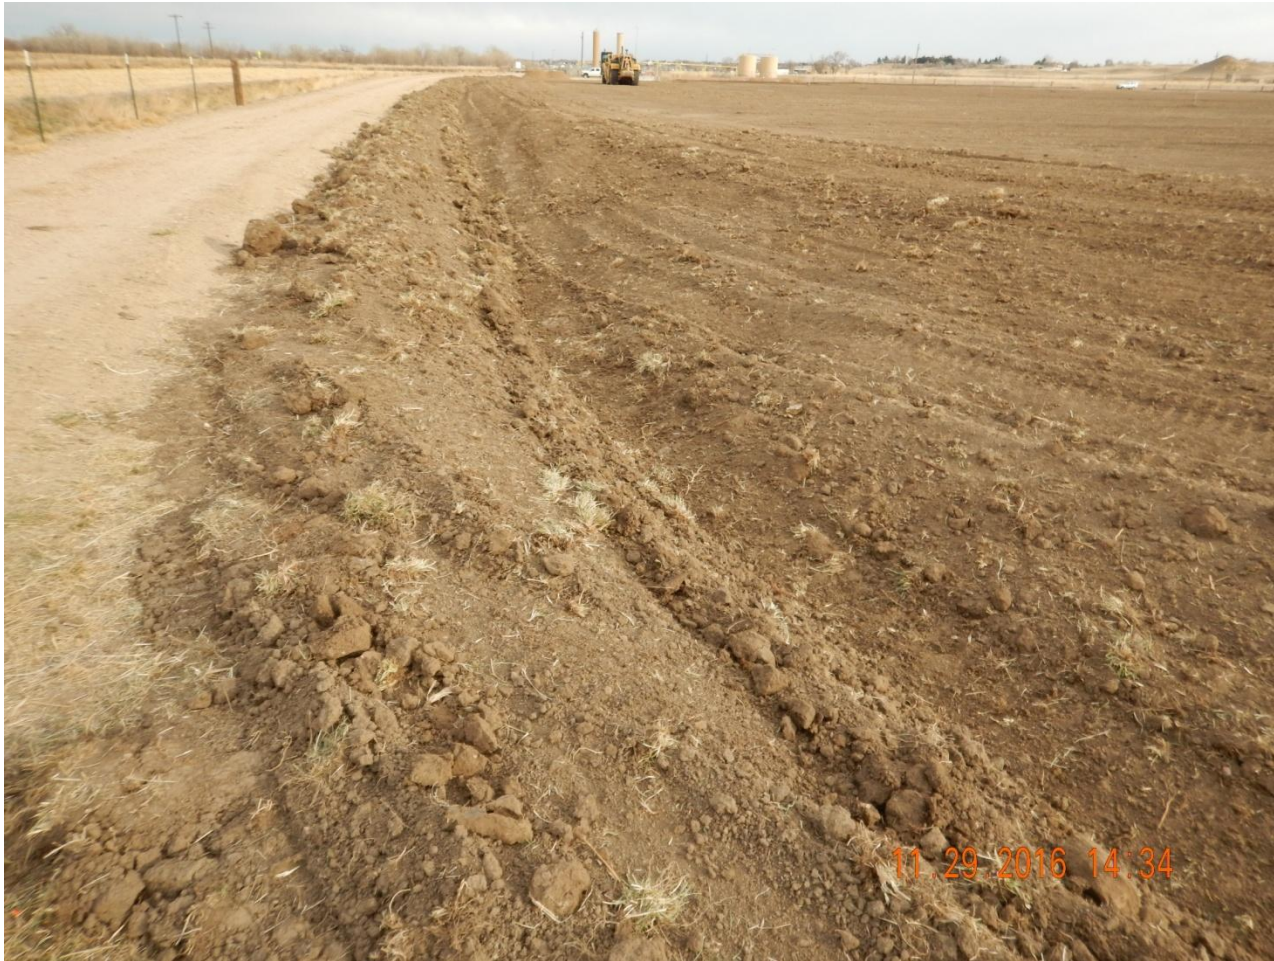
**Photo 6.** Photo taken from the northwest location, facing East. Ditch and berm BMP installed around perimeter of location.
