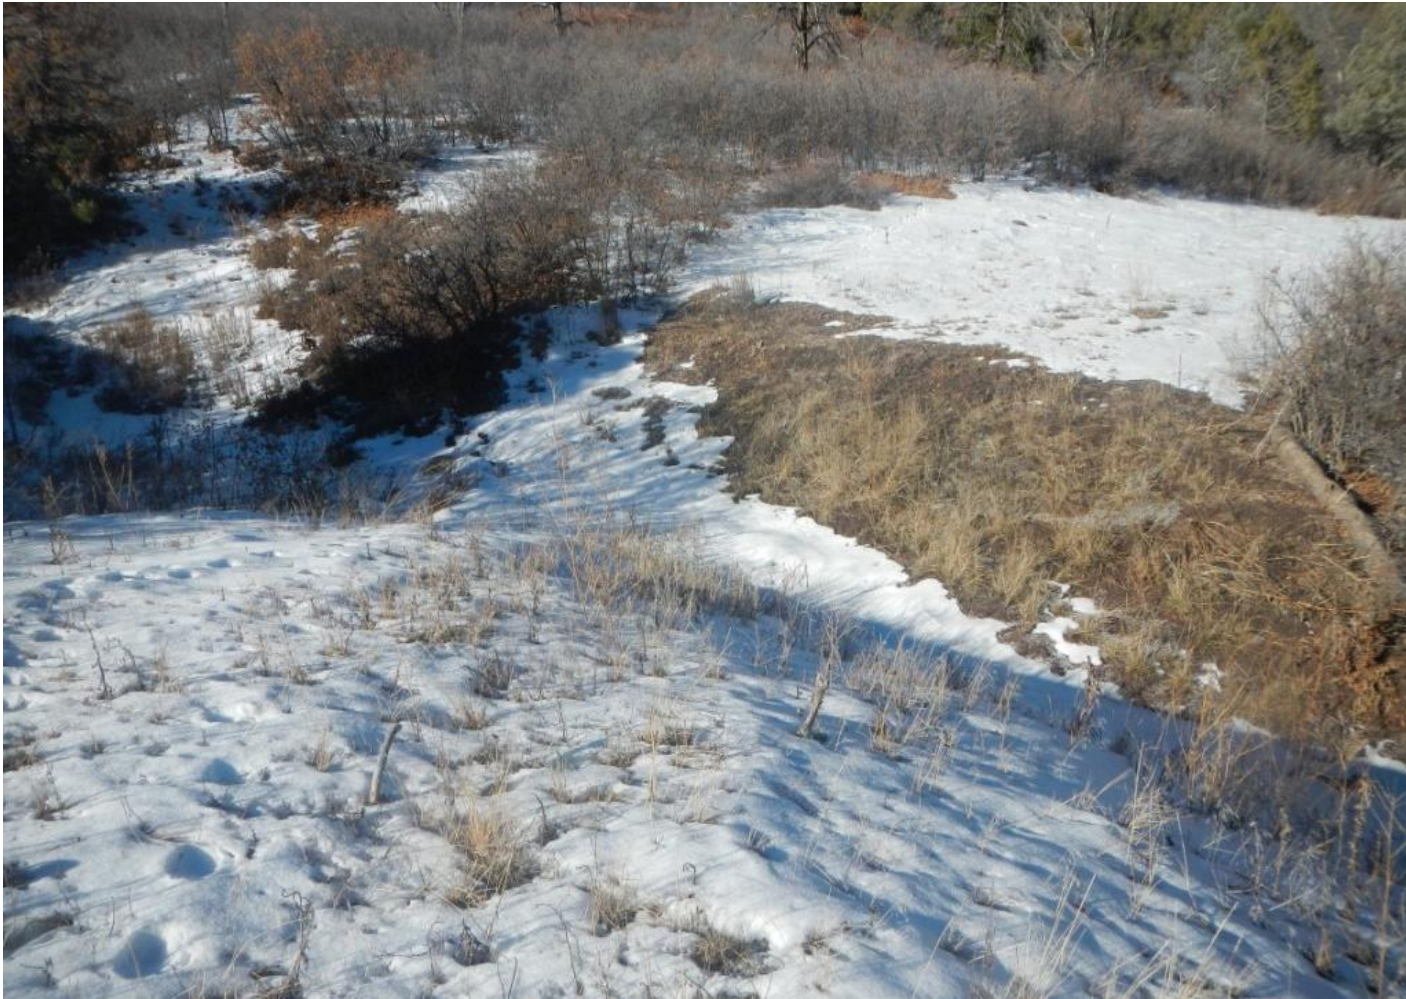
Photo 1. View of recontoured drainage near beginning of access road appears to be functioning and revegetation progressing.

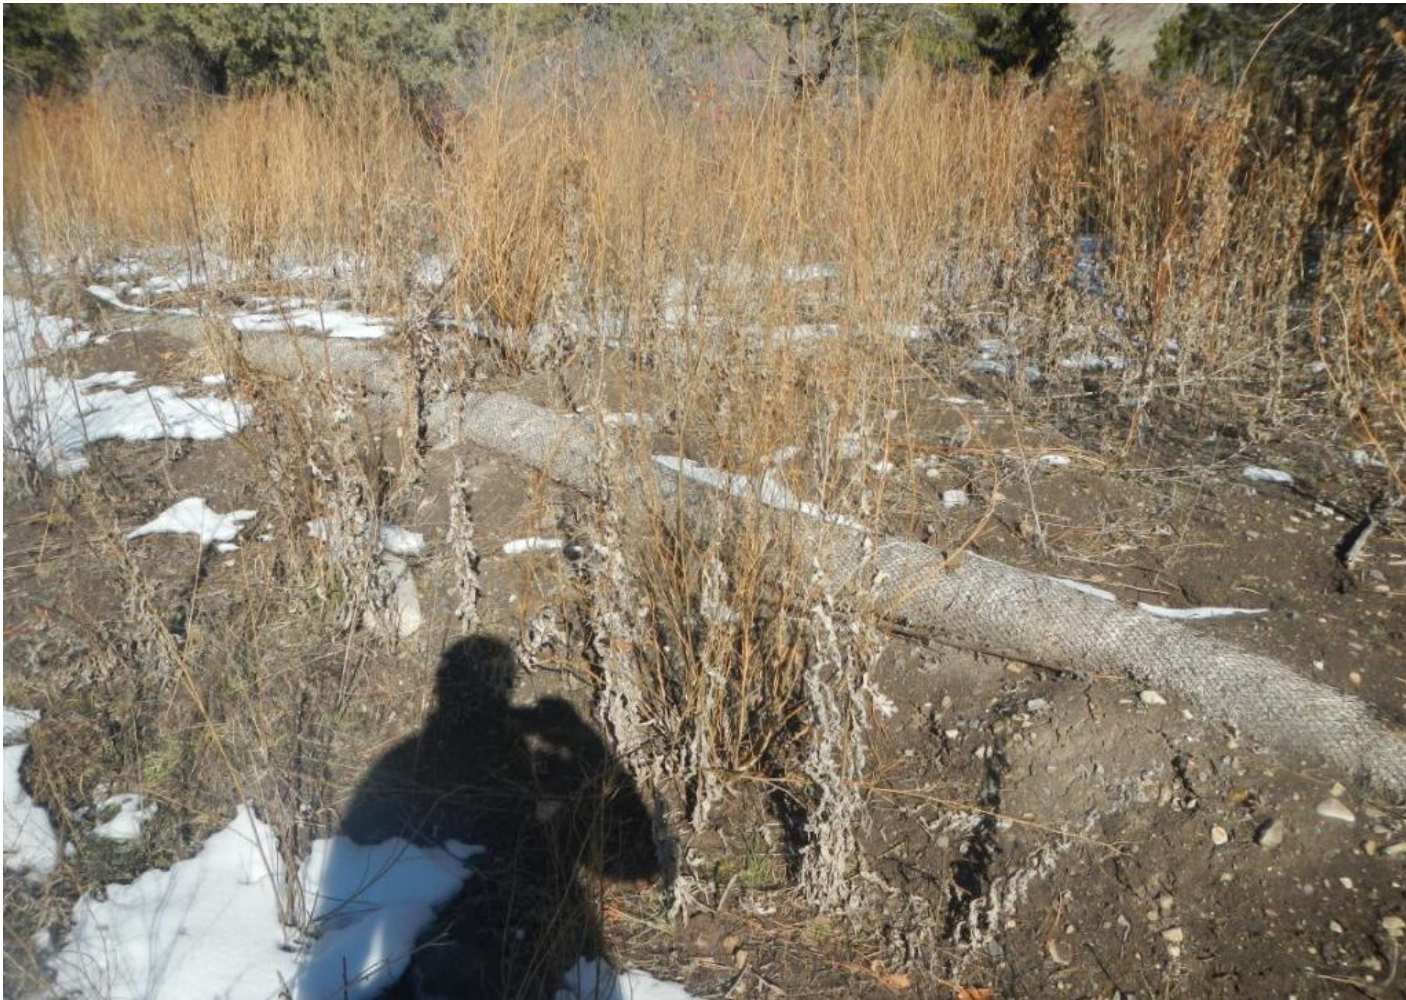
Photo 2. View of Canada thistle (*Cirsium arvense*) infestation (approx. 500 individuals) along the access road. Canada thistles are dormant at this point in the year, but will recover during the following growing season.

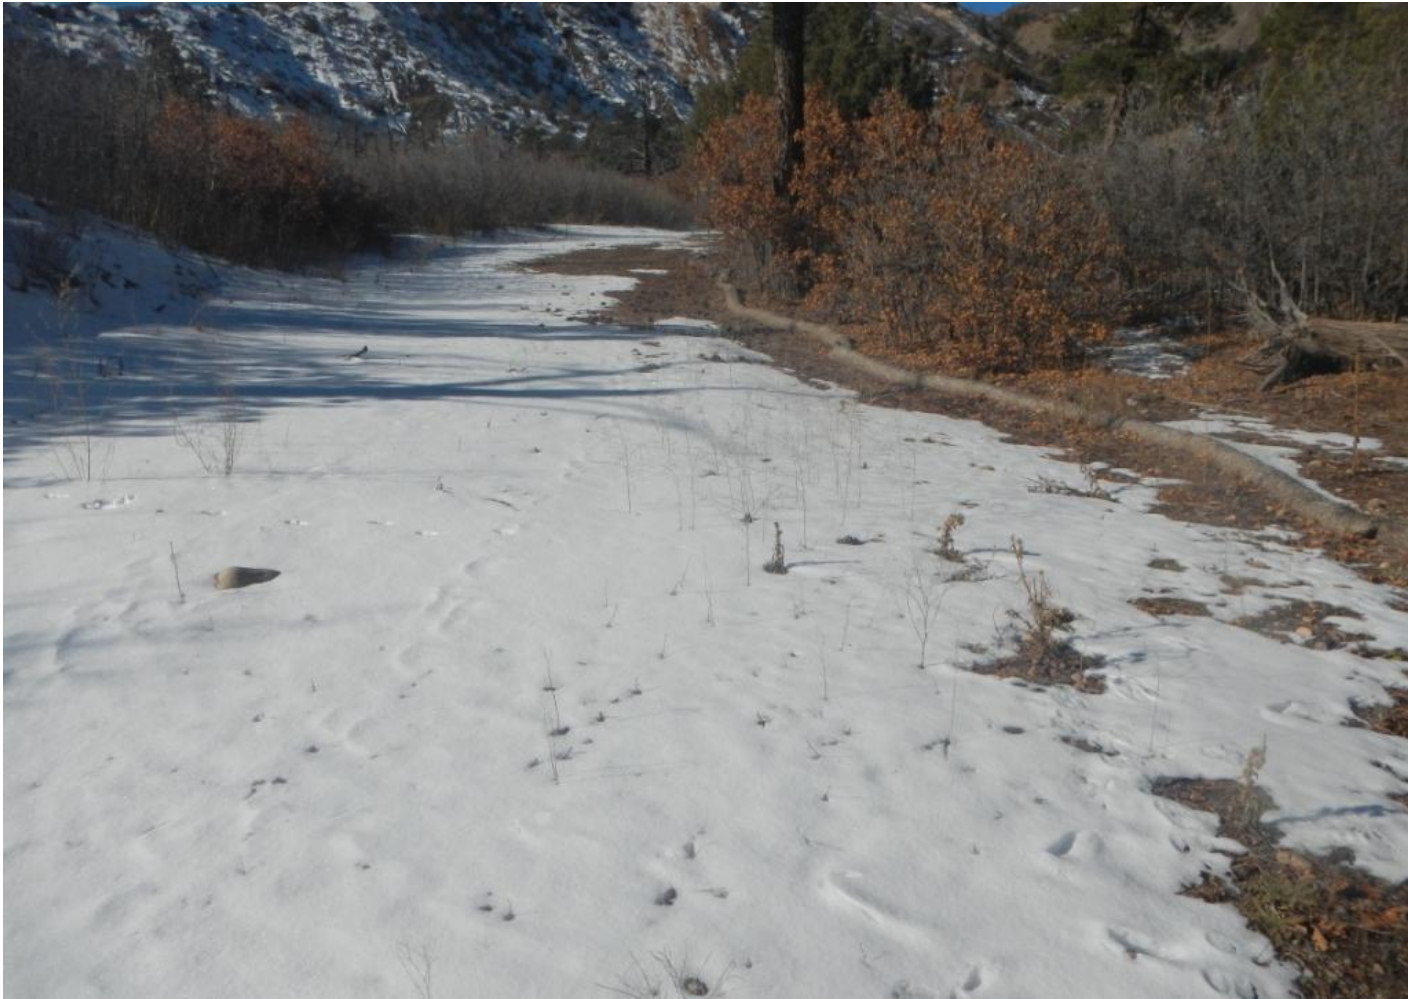
Photo 3. View of the northern portion of the access road from northeastern bend in road facing northwestward.

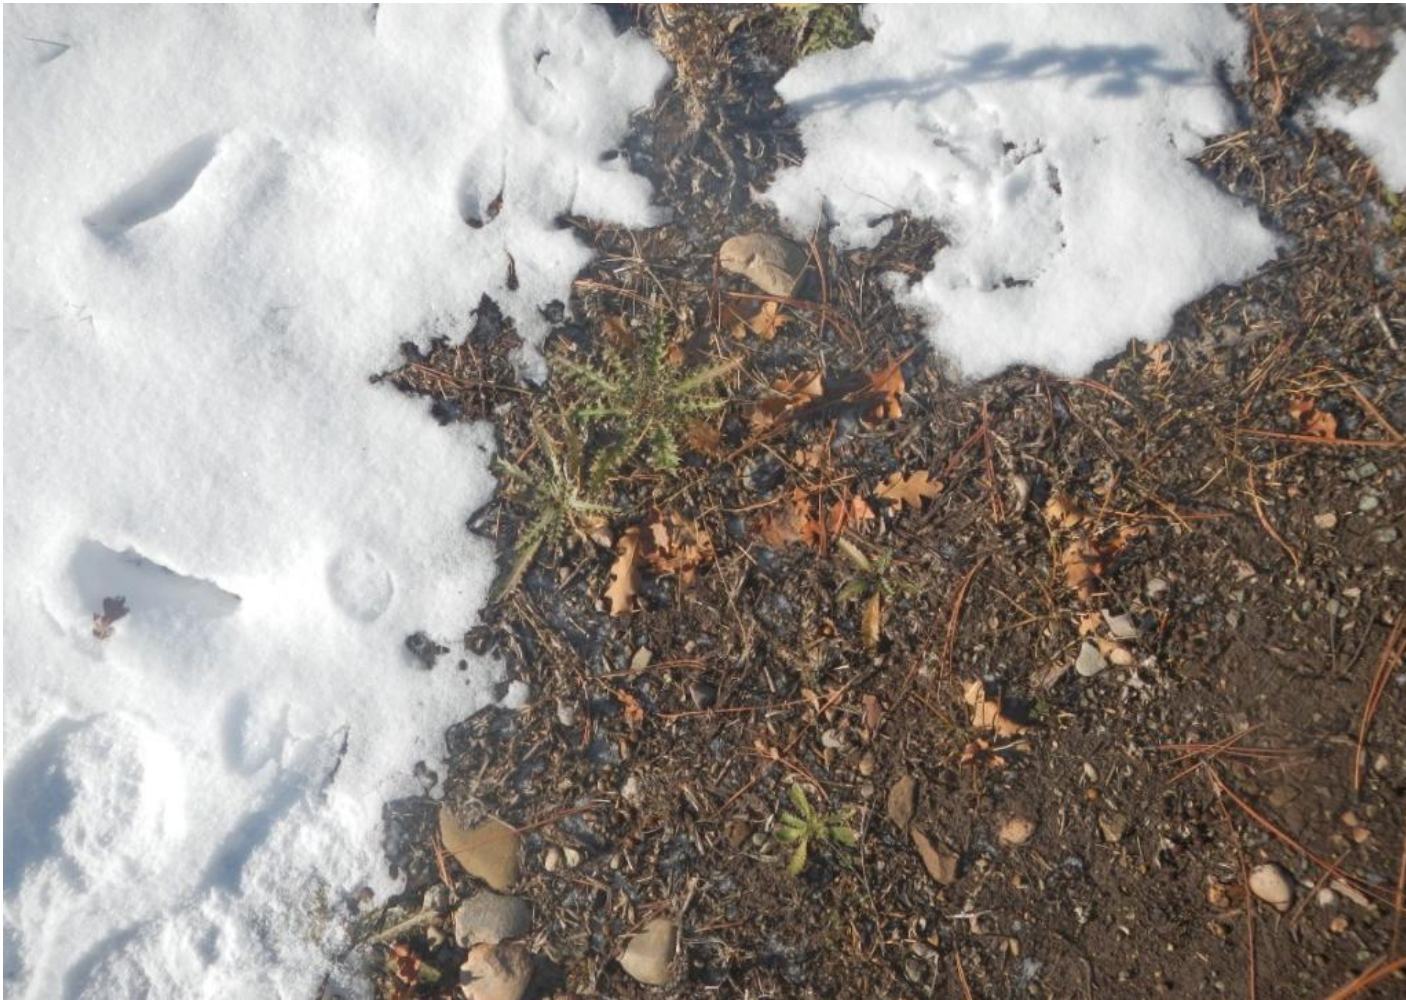
Photo 4. View of musk thistles (*Carduus nutans*) growing within then northwestern portion of the access road.

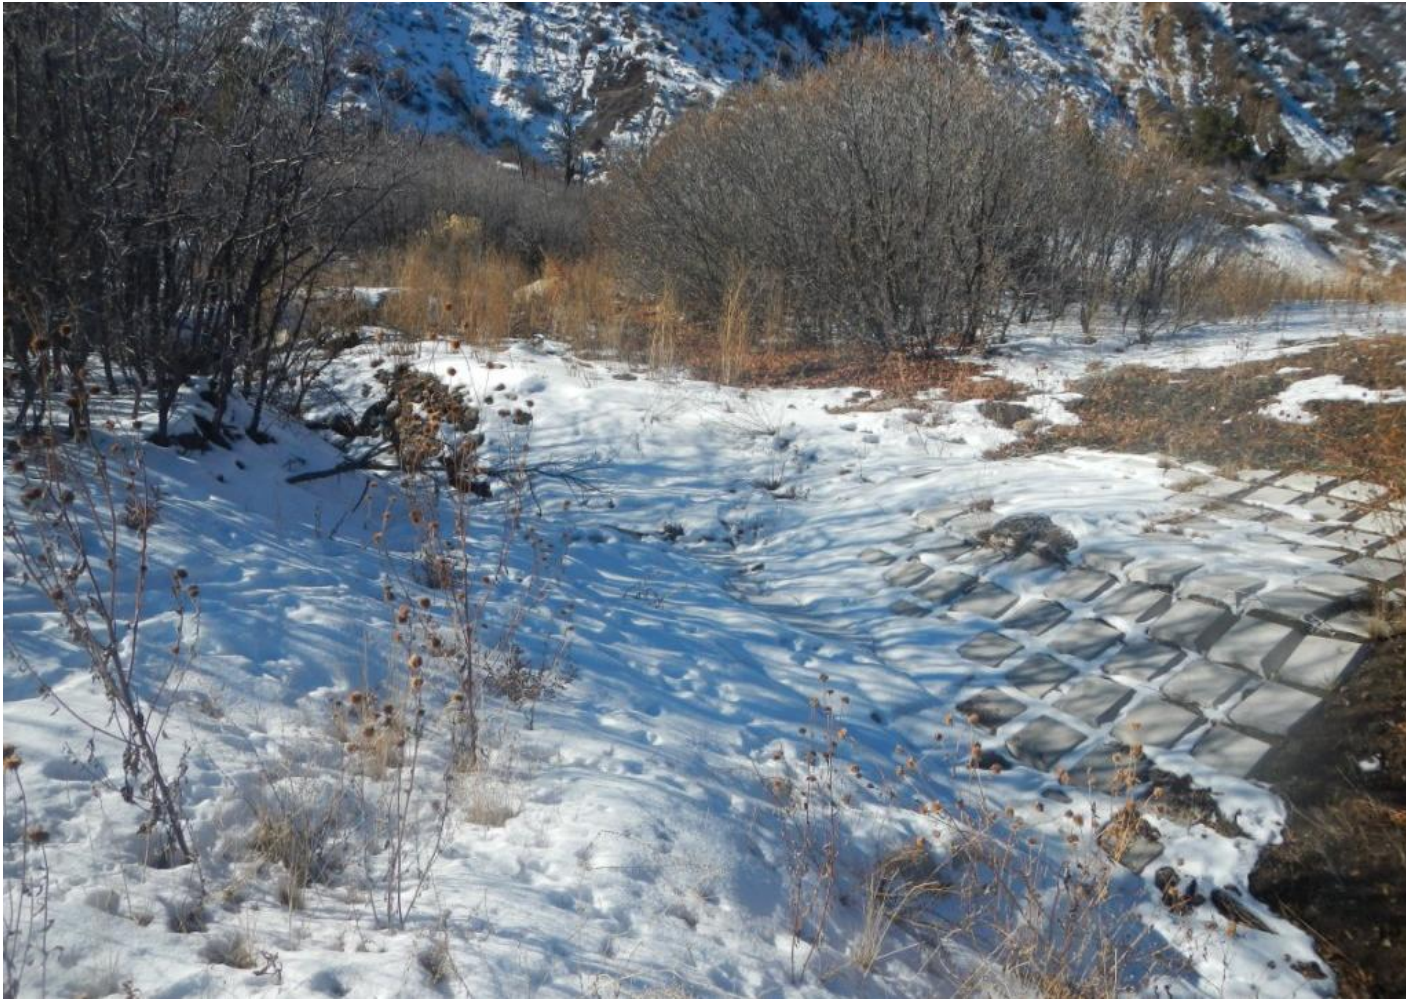
Photo 5. View of channel that was reclaimed and stormwater controls installed near the entrance to the well pad.

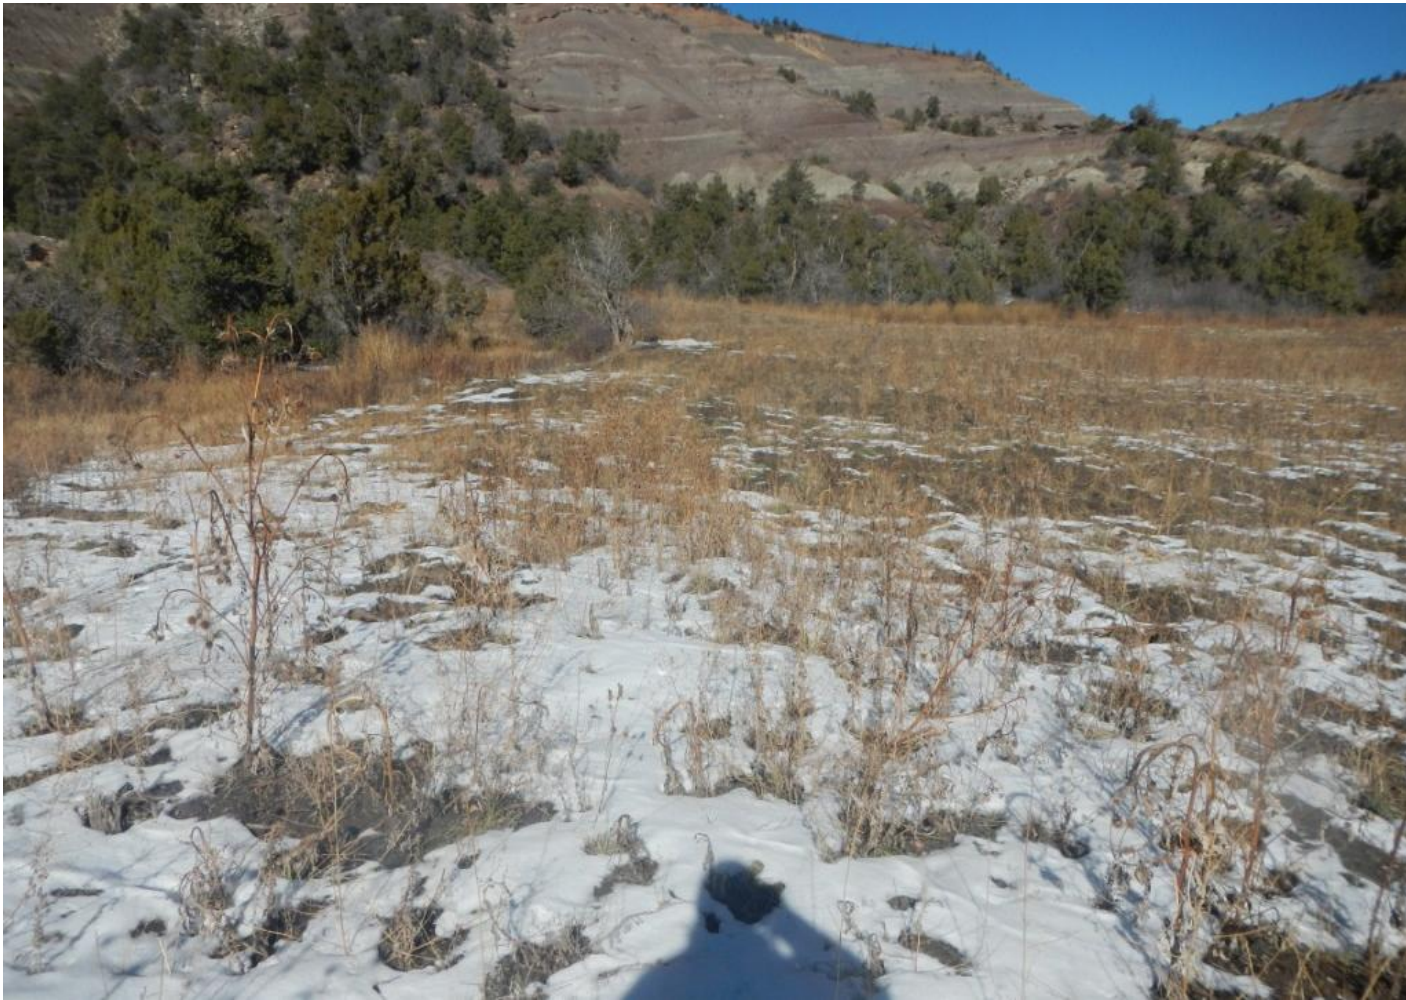
Photo 6. View of the western portion of the reclaimed well pad from the southwestern corner facing northward.

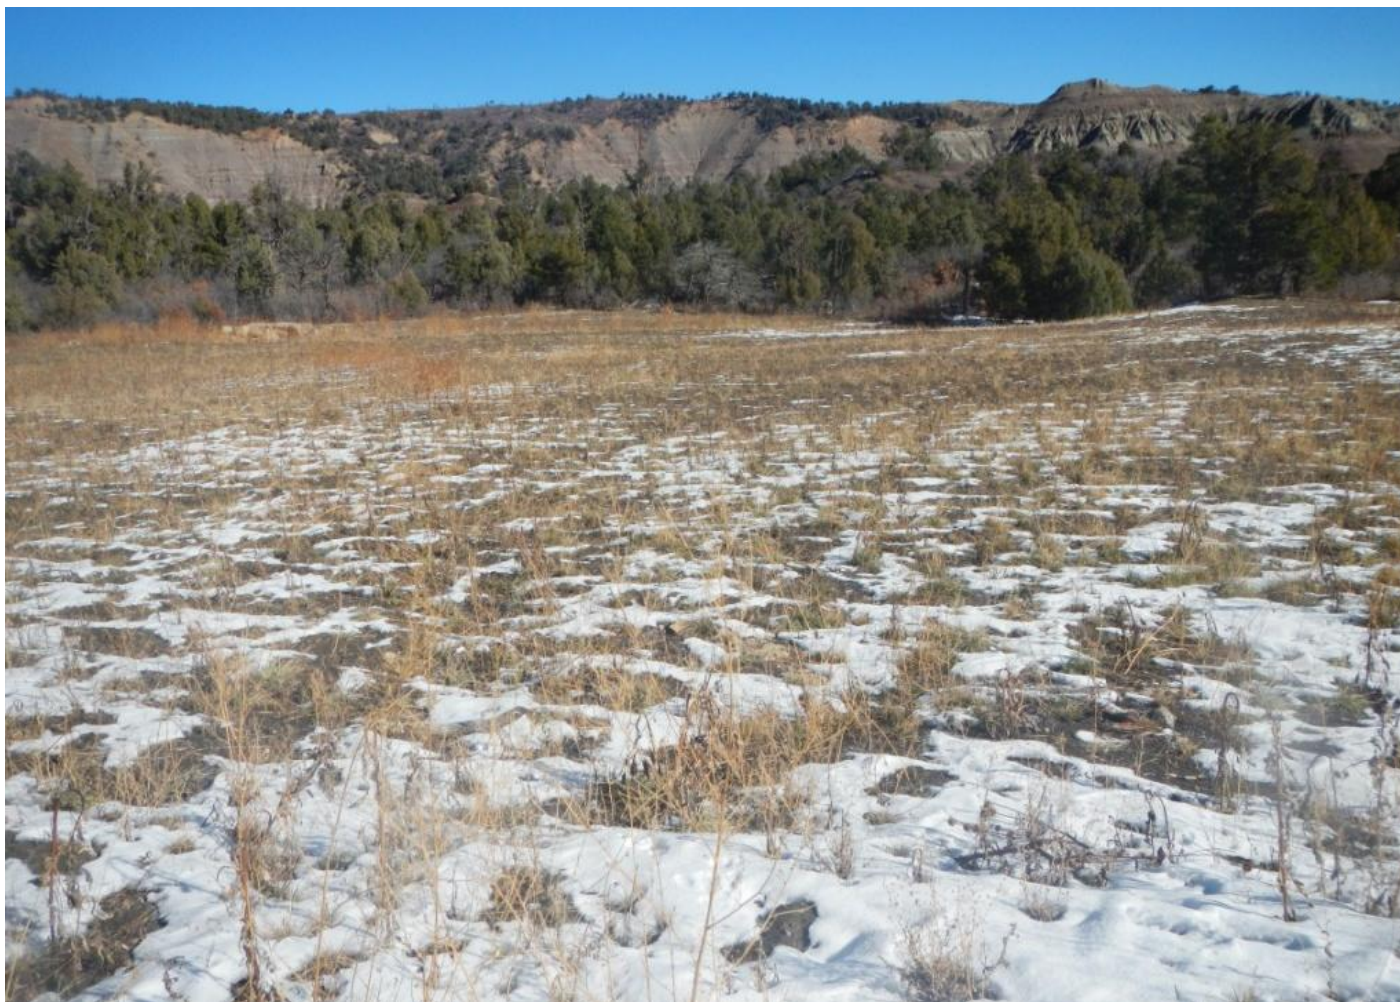
Photo 7. View of the project area from the southwestern corner of the well pad facing center. Revegetation is progressing but appears to be threatened by aggressive weeds such as musk thistle, Canada thistle, yellow tumblemustard (*Sysimbrium altissimum*), and yellow sweetclover (*Melilotus officinalis*).

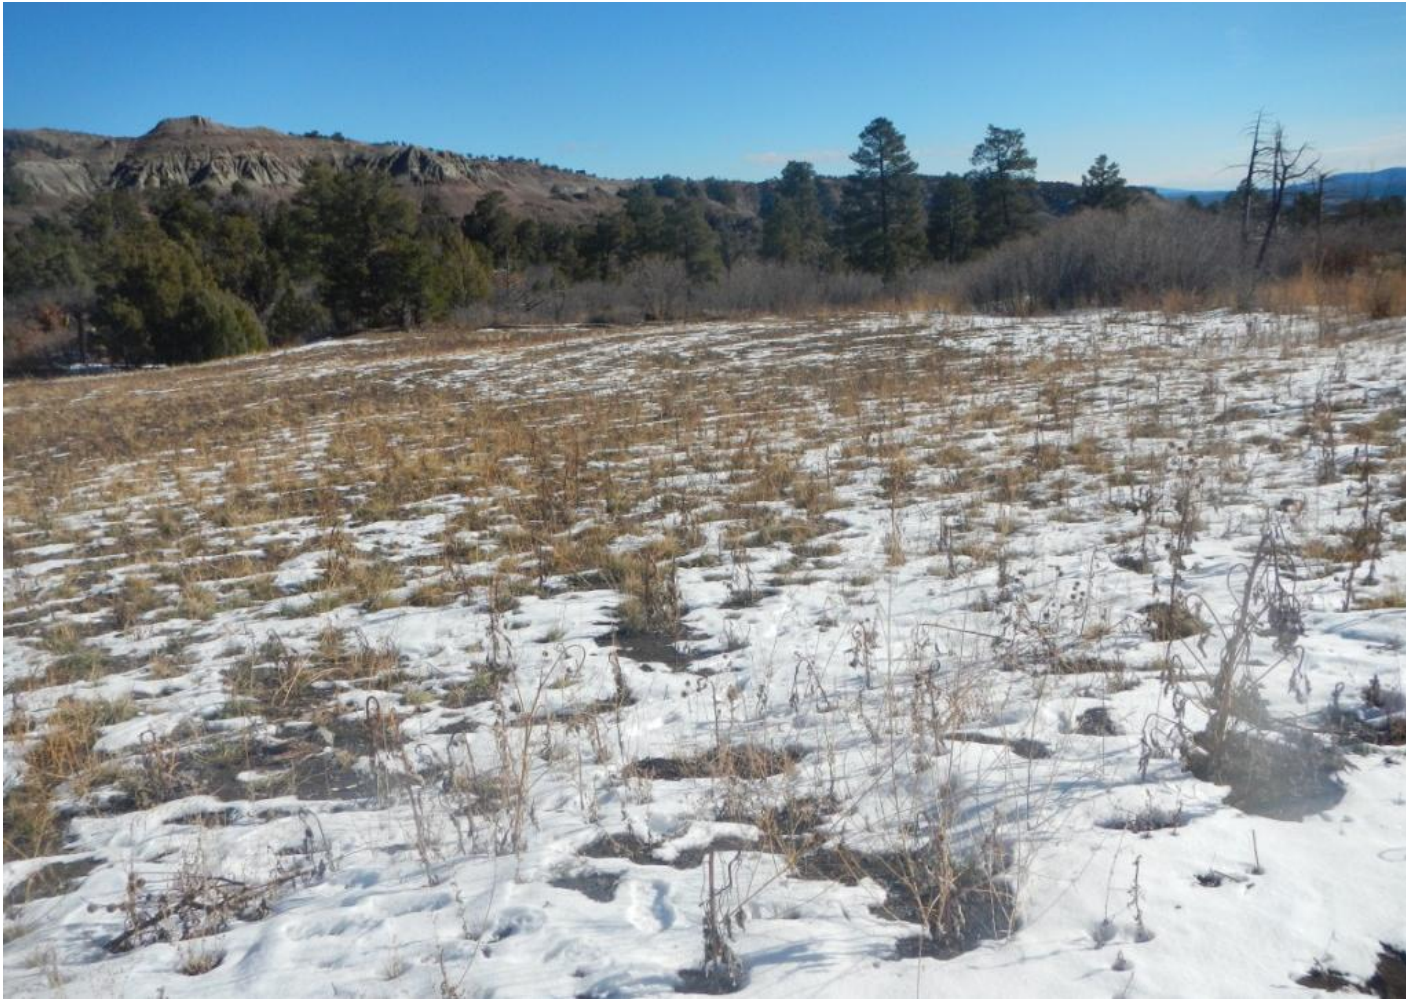
Photo 8. View of the southern portion of the project area from the southwestern corner facing eastward.

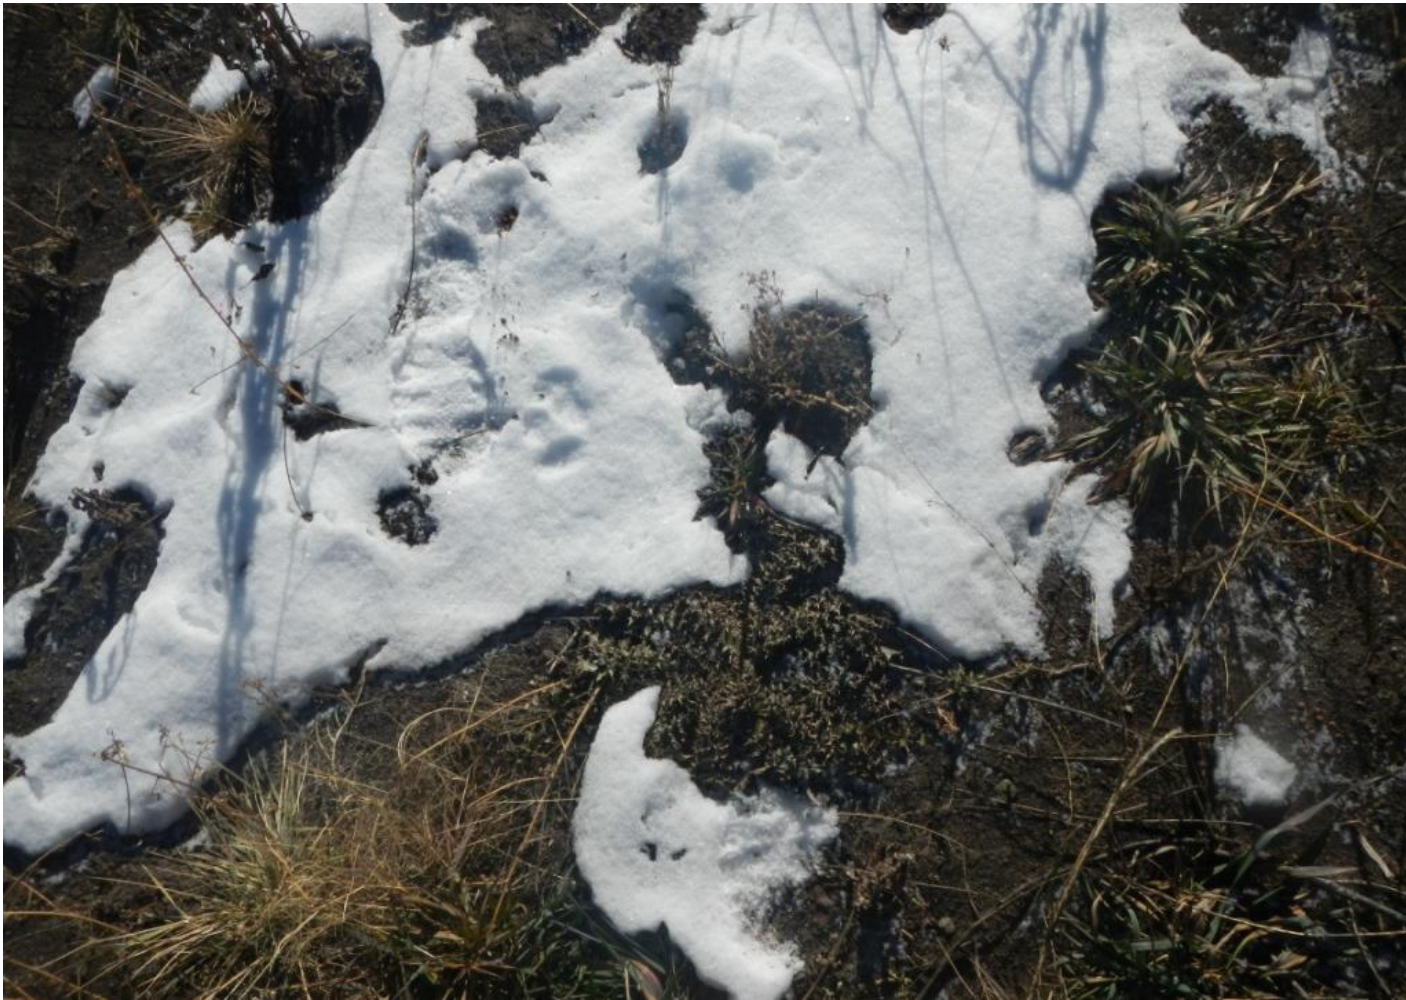
Photo 9. View of musk thistles (*Carduus nutans*) growing in the well pad area.

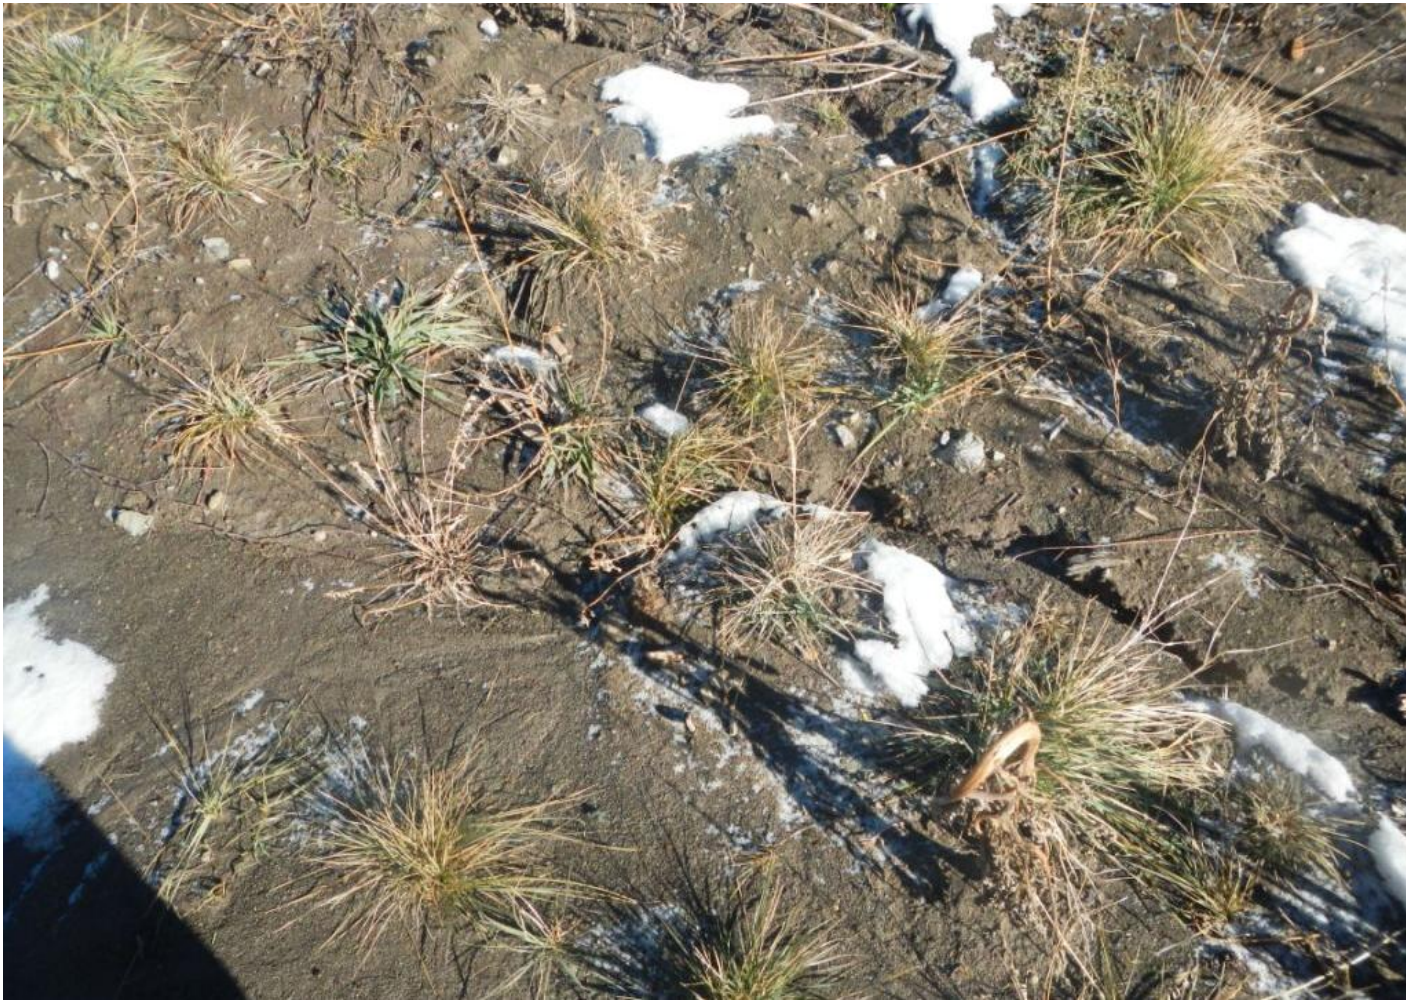
Photo 10. Typical birdseye view of vegetation on the well pad. Some of the desirable species identifiable are western wheatgrass (*Pascopyrum smithii*), squirreltail (*Elymus elymoides*), and sideoats grama (*Bouteloua curtipendula*).

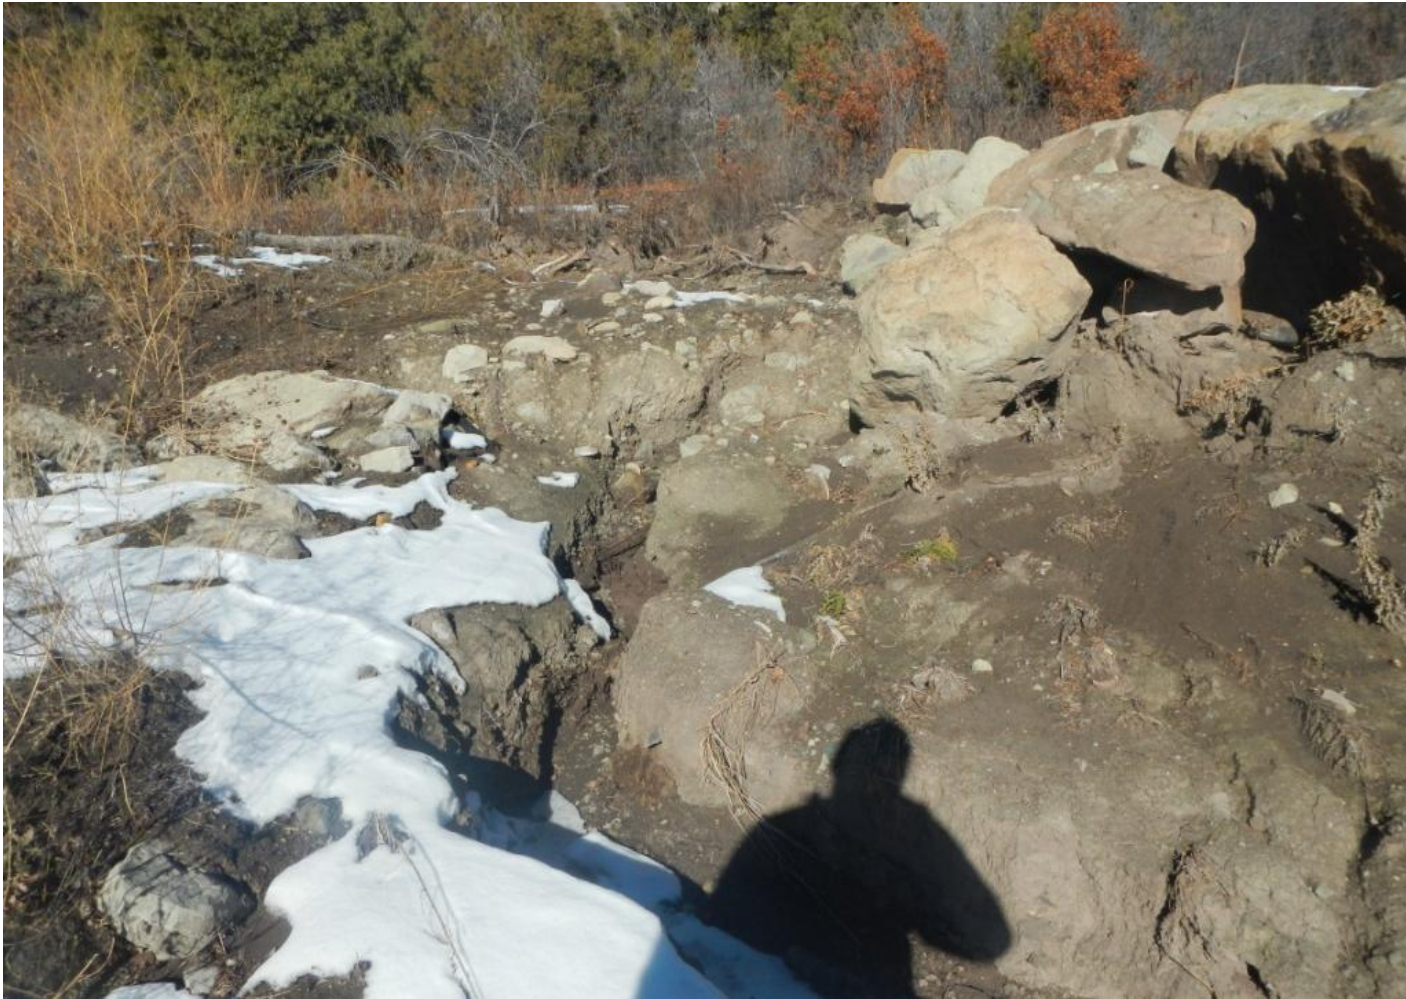
Photo 11. View of area on re-routed drainage within the northeastern portion of the well pad that is not sufficiently armored and erosion is occurring.

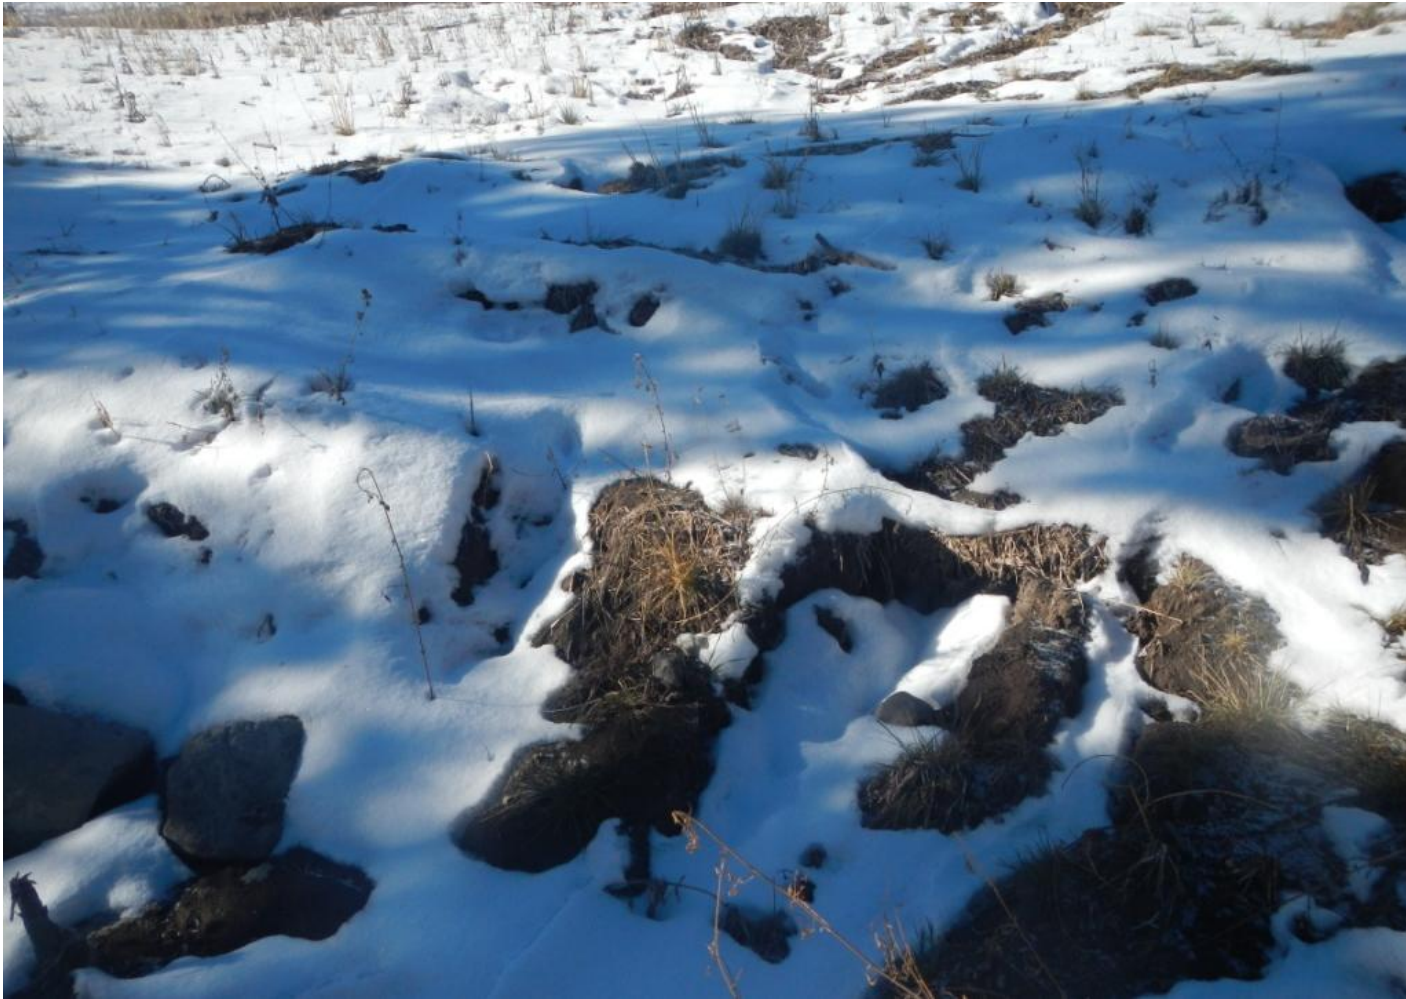
Photo 12. View of area that is contoured down toward the re-routed drainage in the northeastern well pad where erosion is also occurring near the banks.

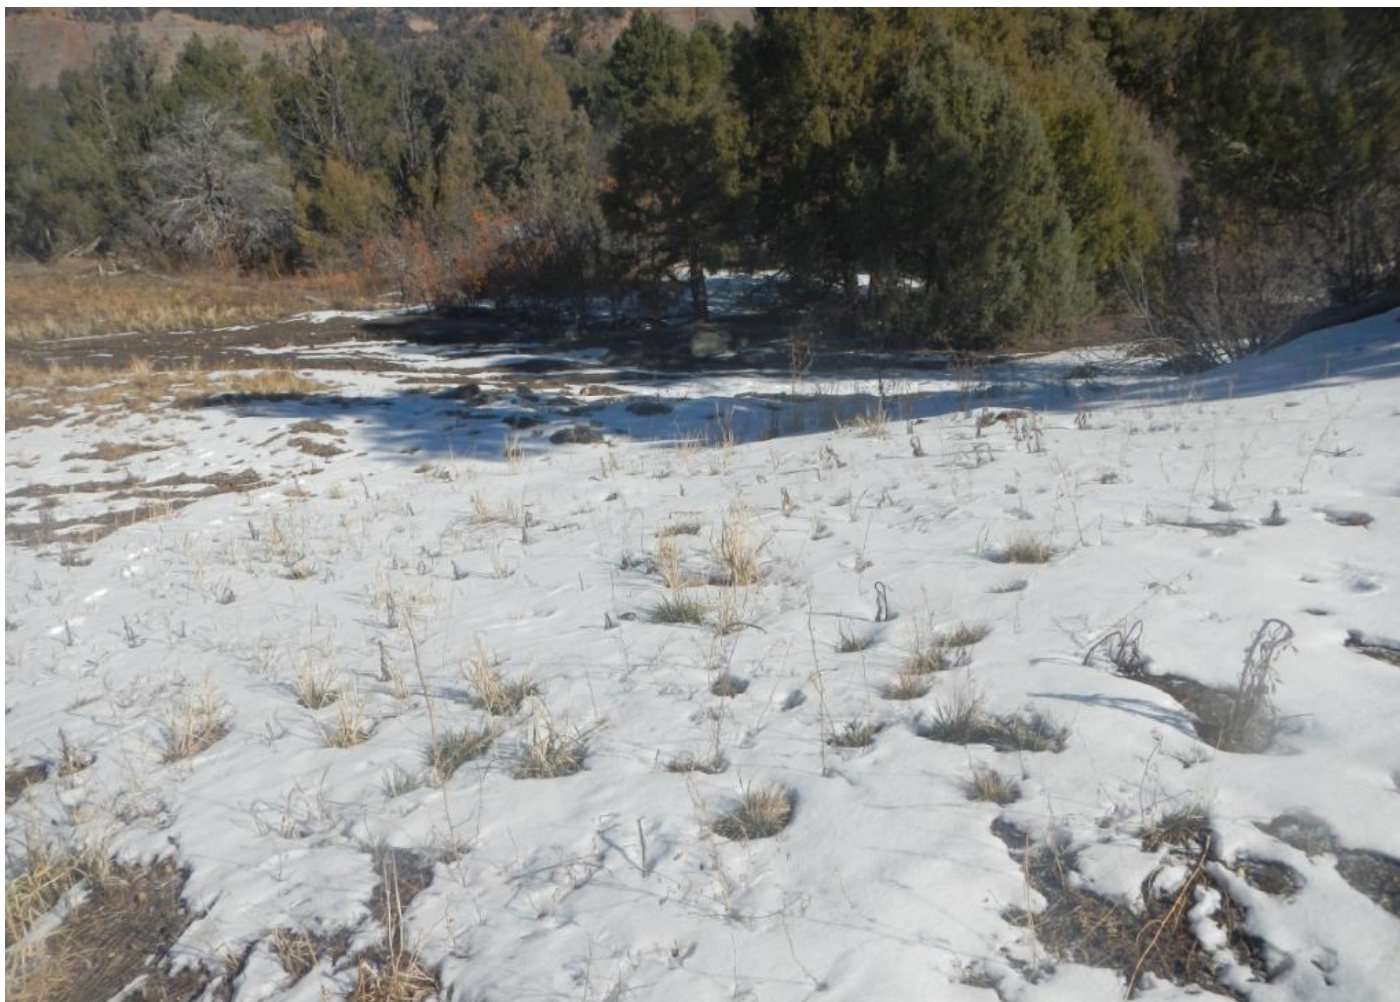
Photo 13. Overview of area shown in Photo 12 that slopes toward the contoured drainage. It appears that surface flows are causing erosion near the banks of the re-routed drainage.
