Final Reclamation & Stormwater Inspection

Operator: Petro-Canada #72085

Location ID: 375675

Adams County, CO

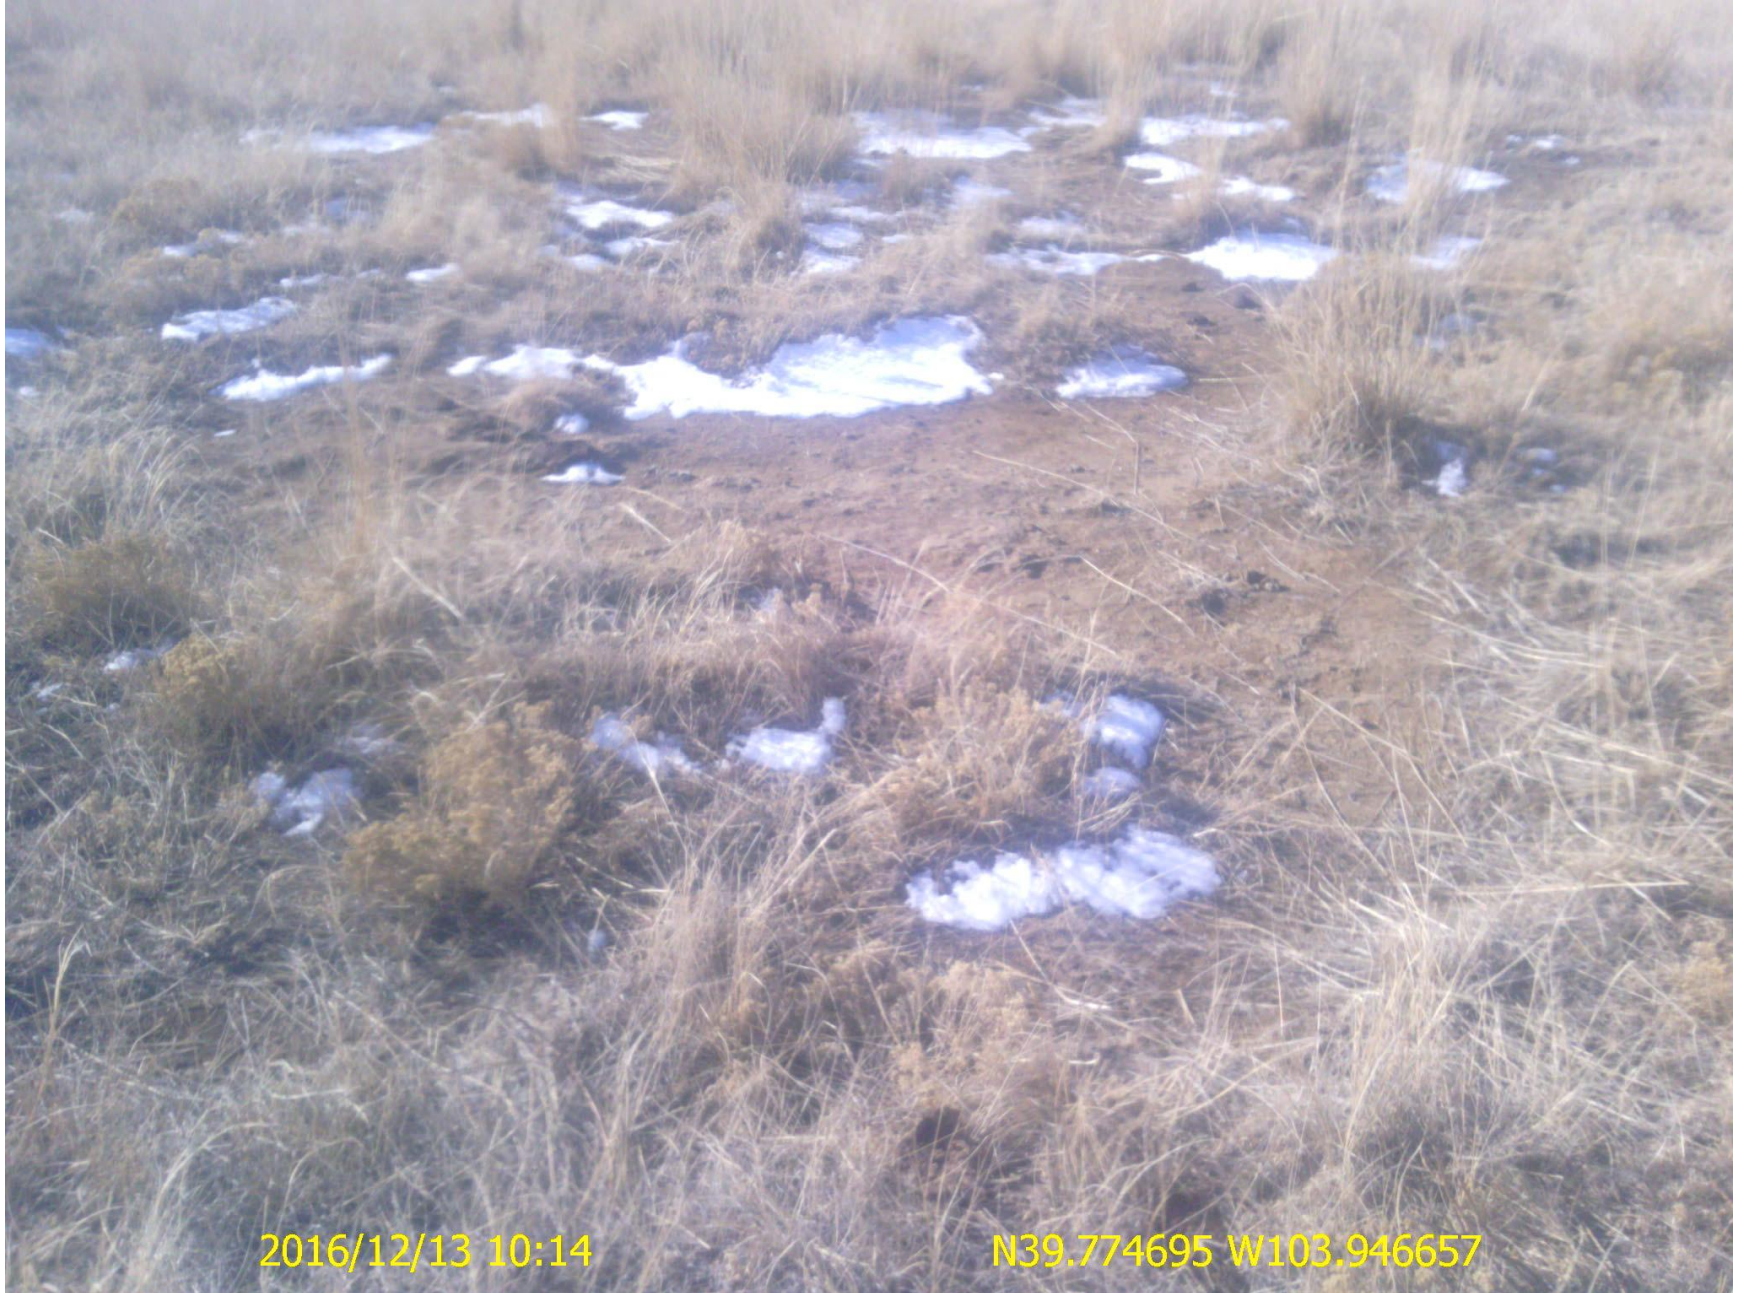
Figure 2: Photo taken from the well location, facing south. Photo shows well location has not achieved uniform vegetative cover, or that reclamation work has not been conducted as required by inspection doc. #682500940

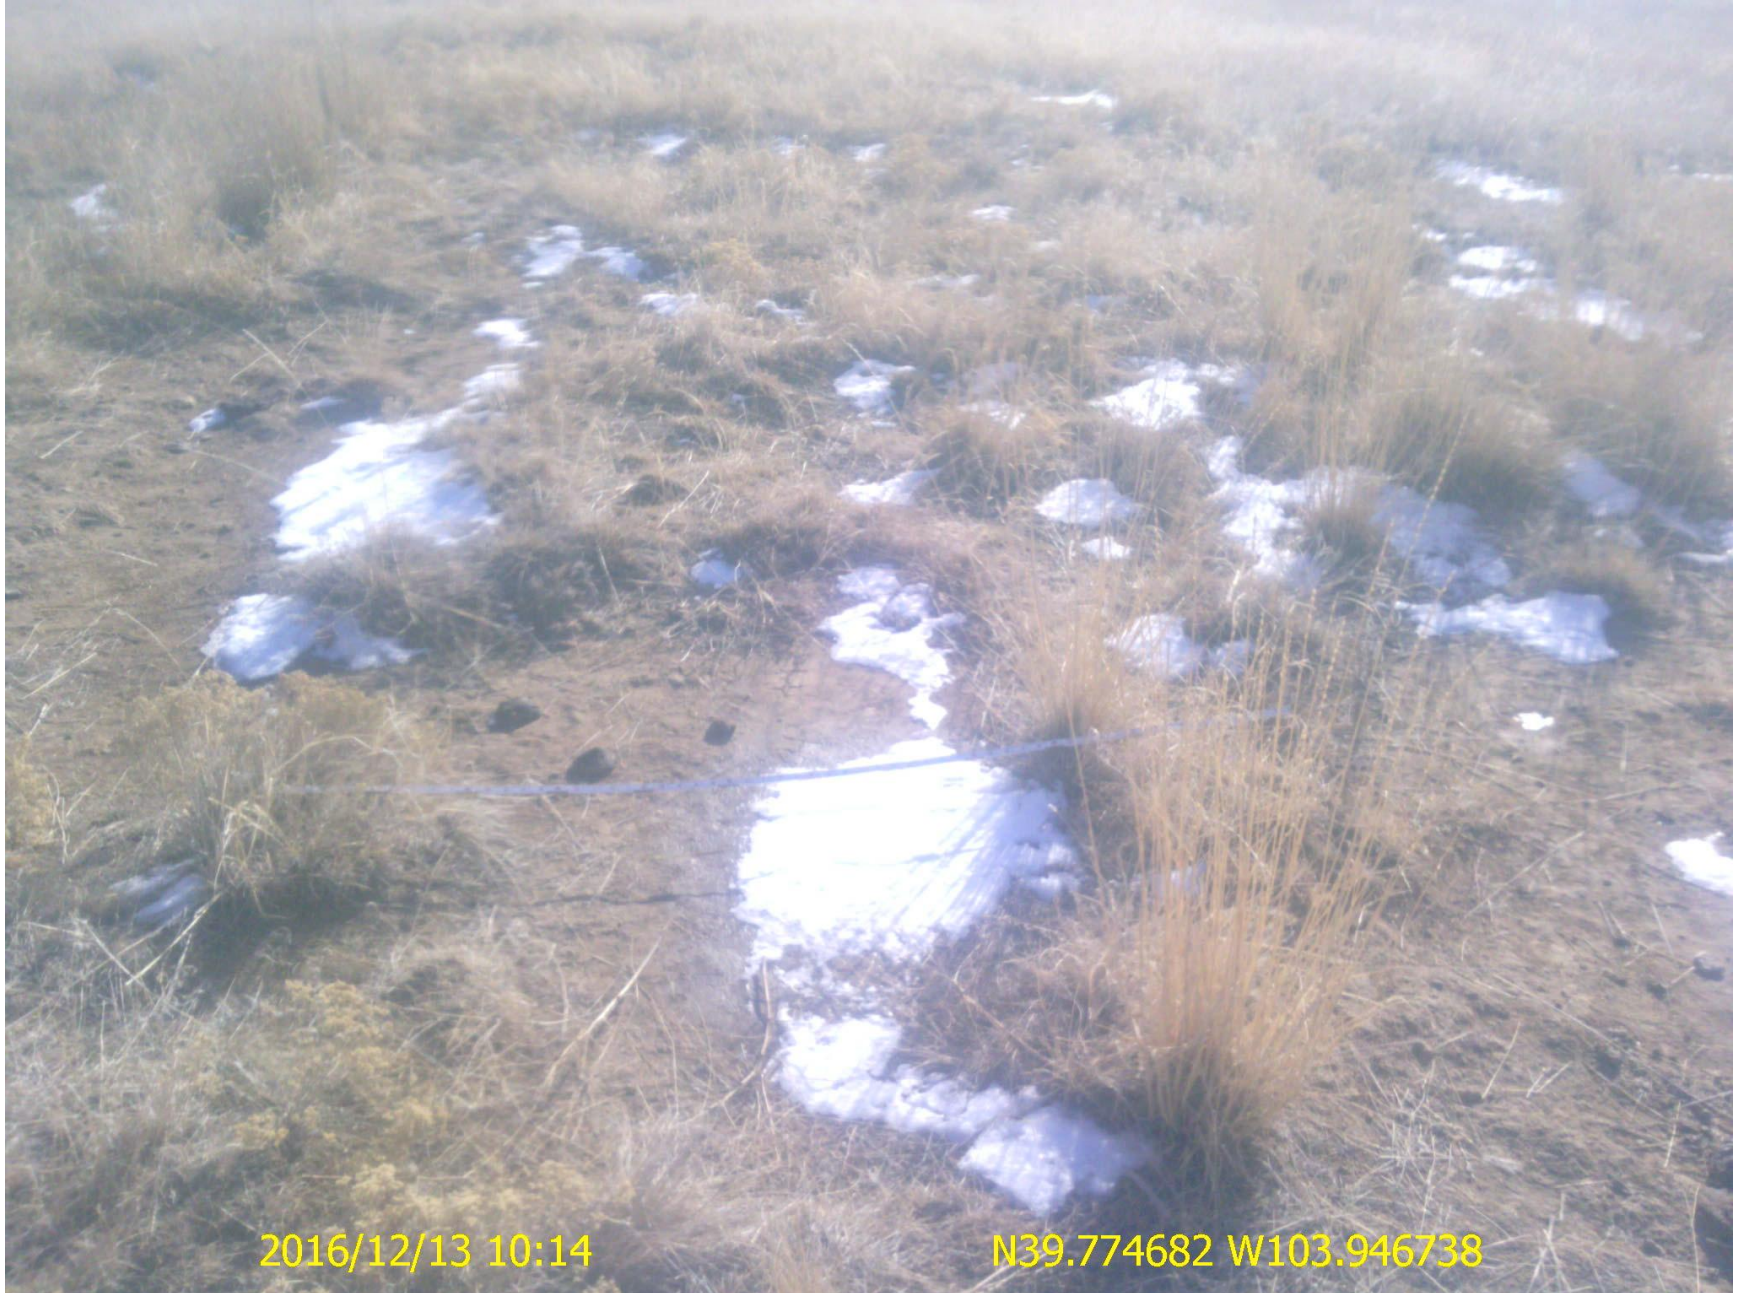
Figure 3: Photo taken from the well location, facing east. Photo shows well location has not achieved uniform vegetative cover, or that reclamation work has not been conducted as required by inspection doc. #682500940

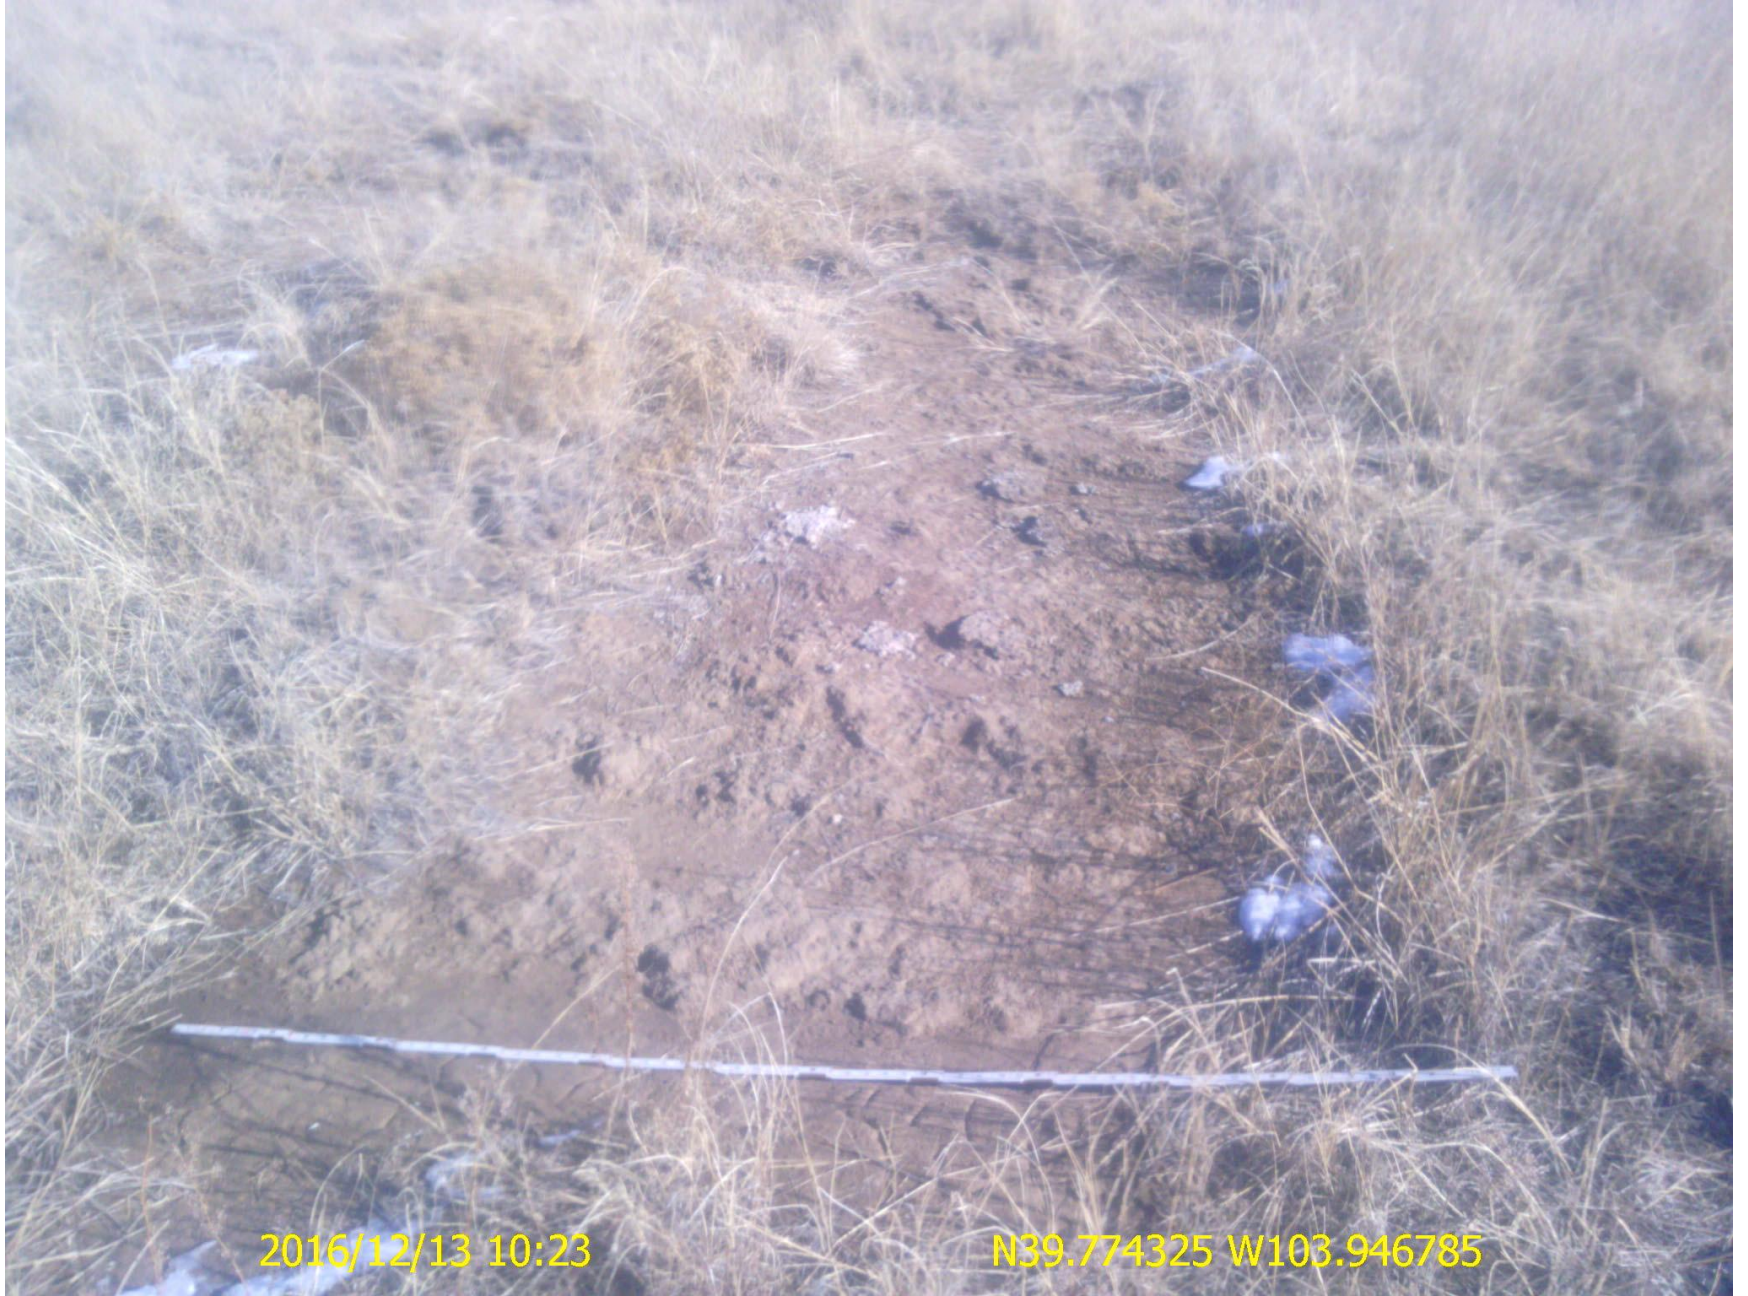
Figure 4: Photo taken down slope, south of the well location. Photo shows unvegetated areas experiencing degradation due to stormwater.

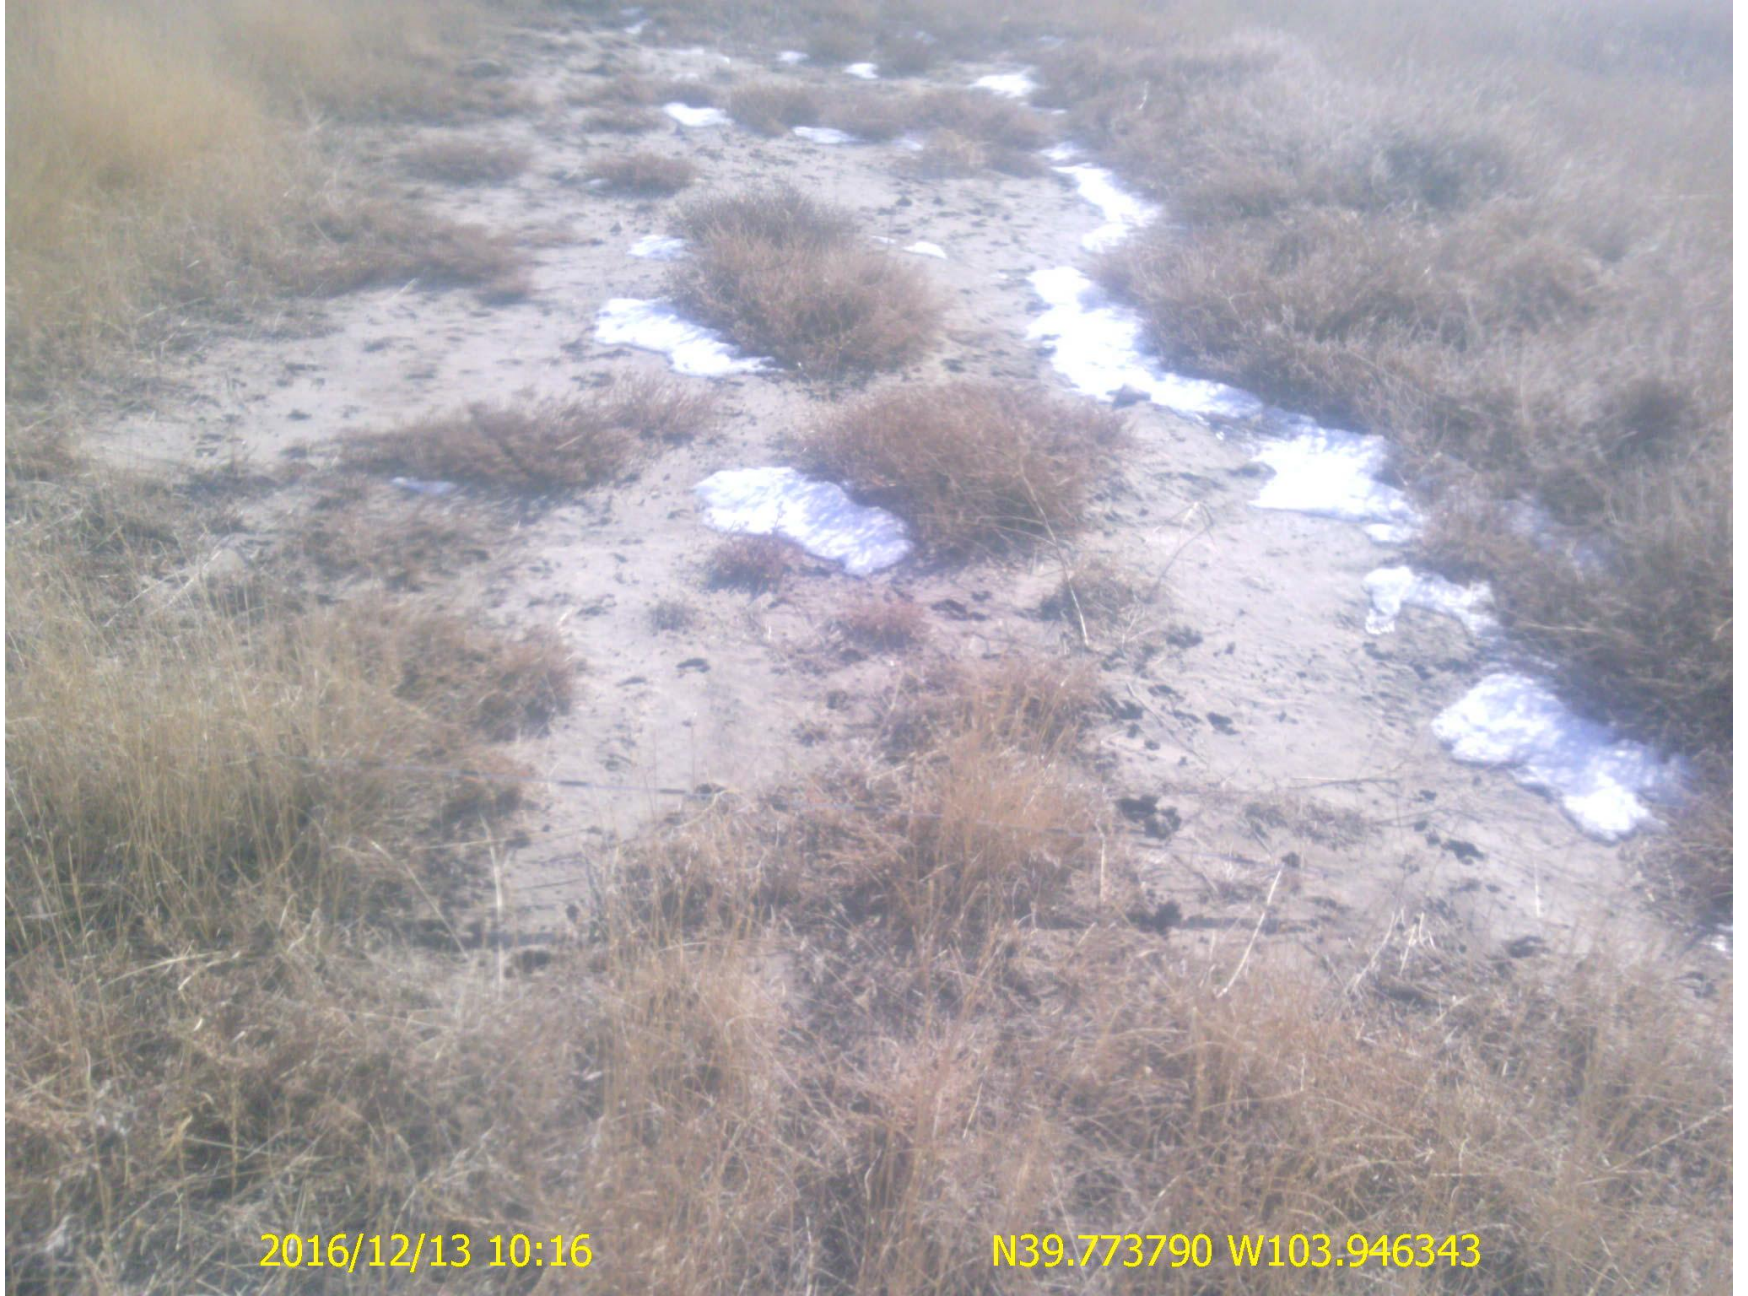
Figure 5: Photo taken from within the fenced remediation area. Photo shows reclamation work has not been conducted as required by inspection doc. #682500940
