Final Reclamation & Stormwater Inspection

12/13/2016

Operator: Petro-Canada #72085

Location ID: 376781

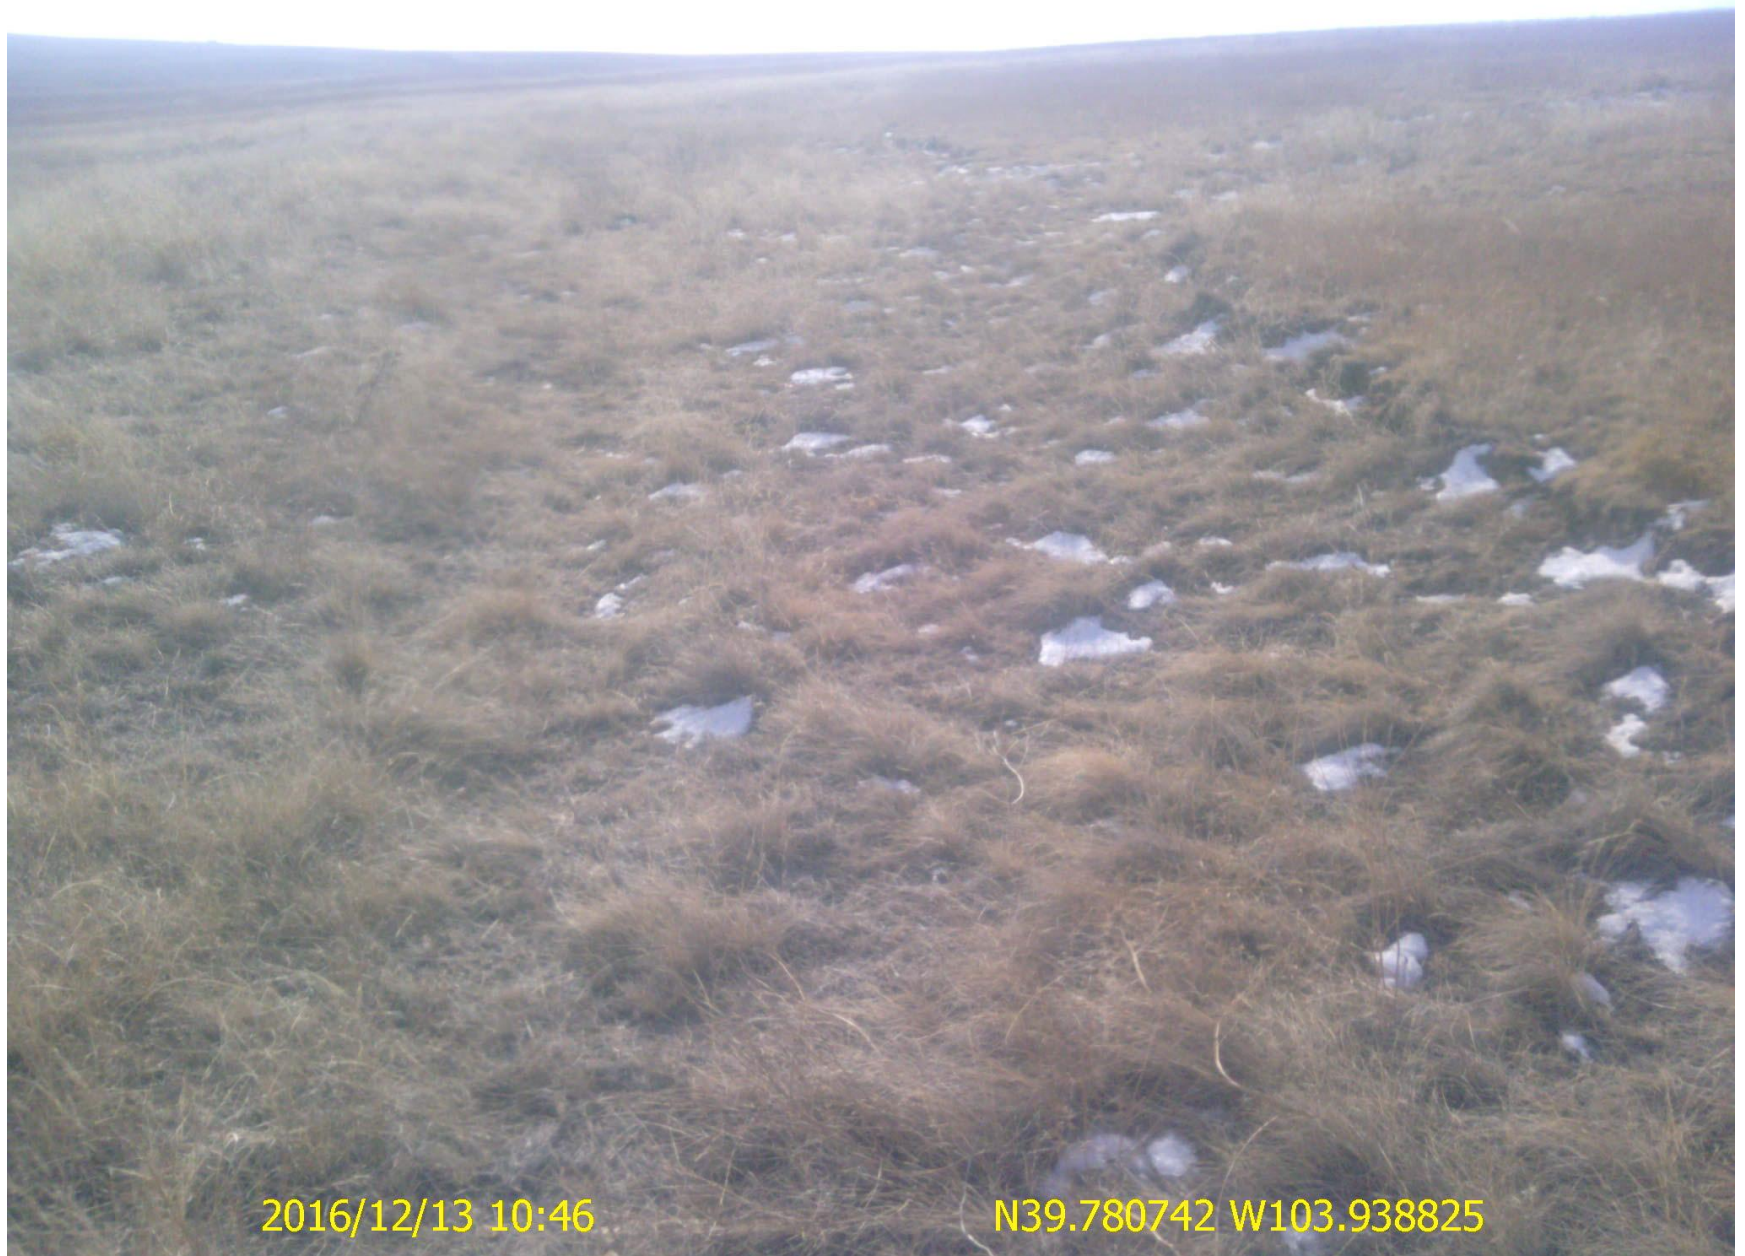
Figure 1: Photo taken from the west end of the location, facing south. Photo shows road has not been re-contoured. Refer to inspection doc. 682500936 for more details

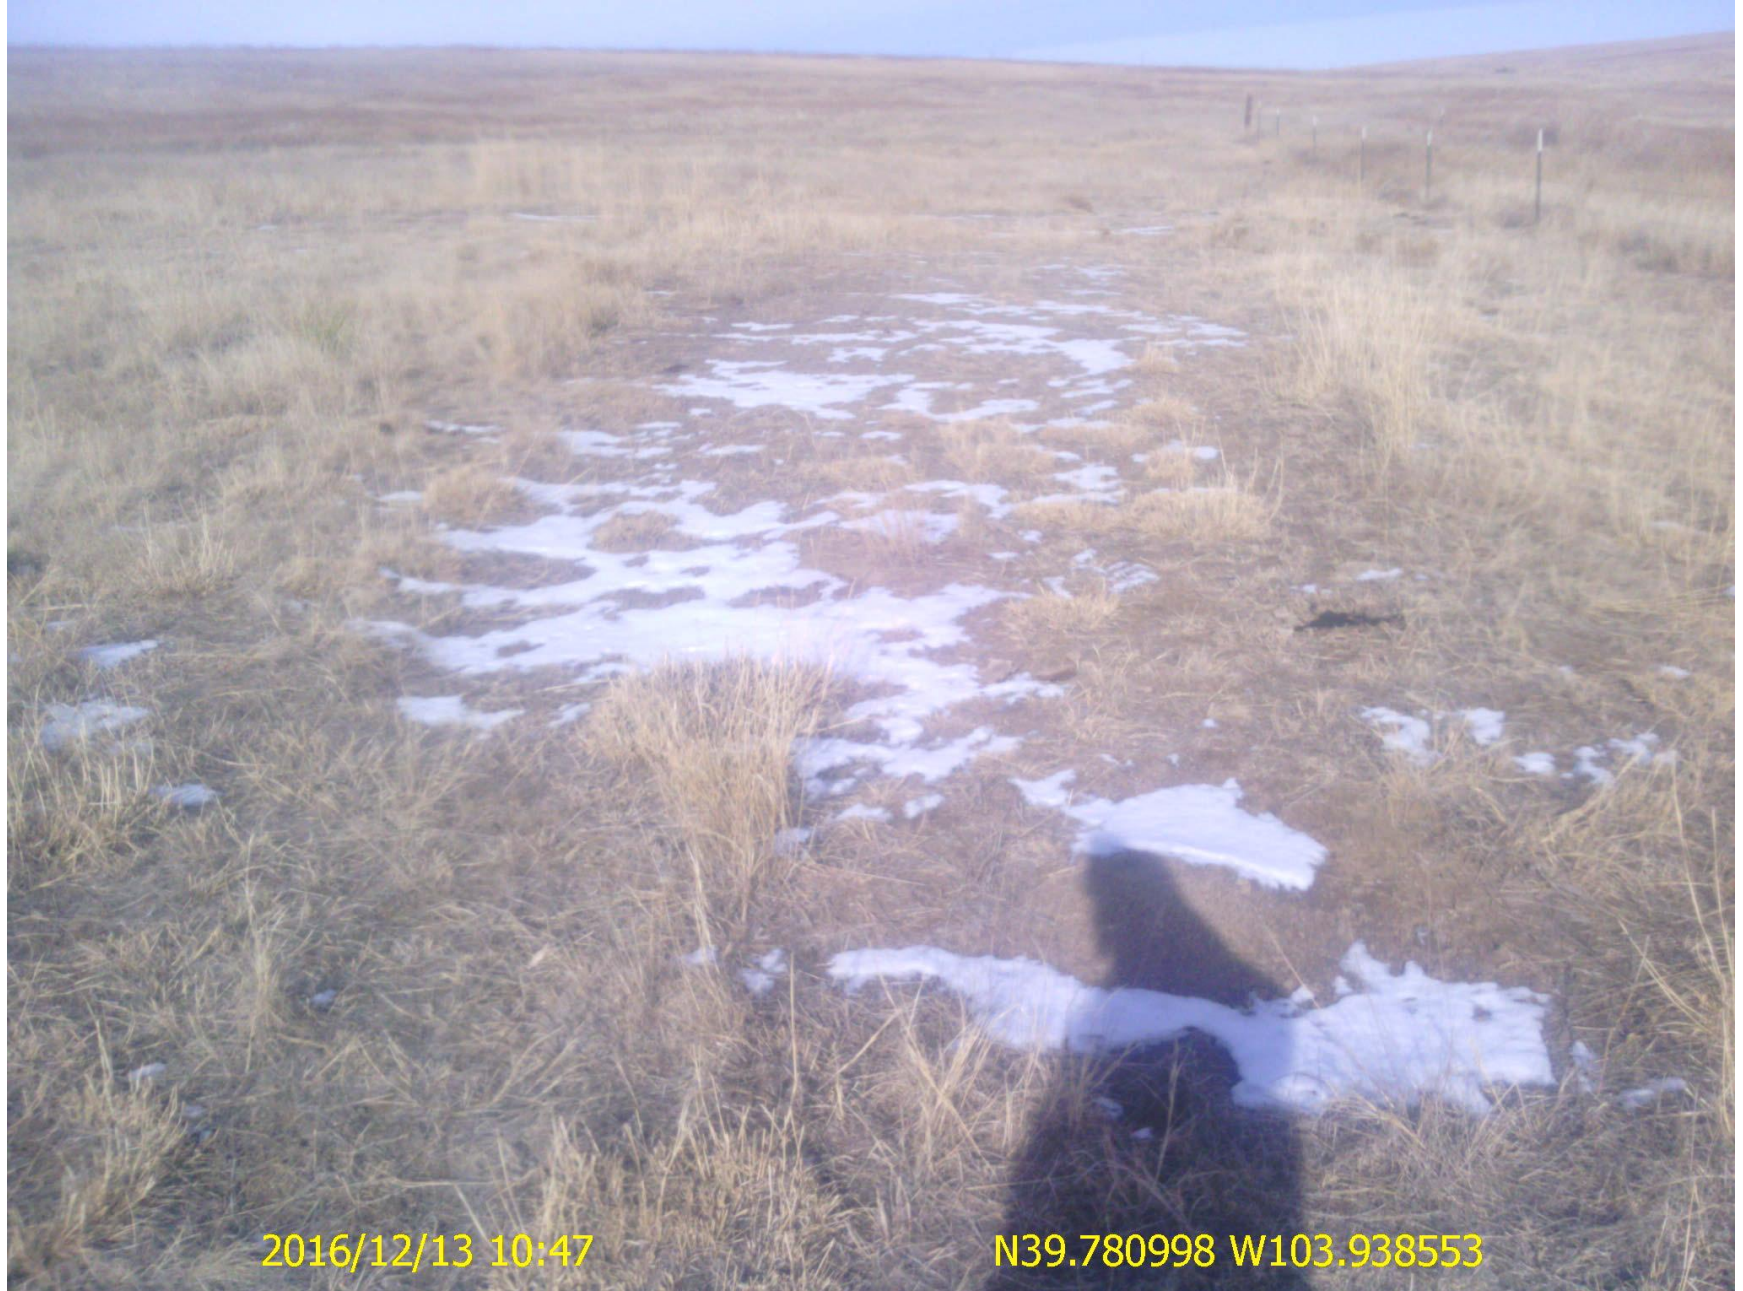
Figure 2: Photo taken from the west end near the battery/pit facility of the location, facing north. Photo shows road has not been re-contoured, and portions of battery/pit remain unvegetated. Refer to inspection doc. 682500936 for more details

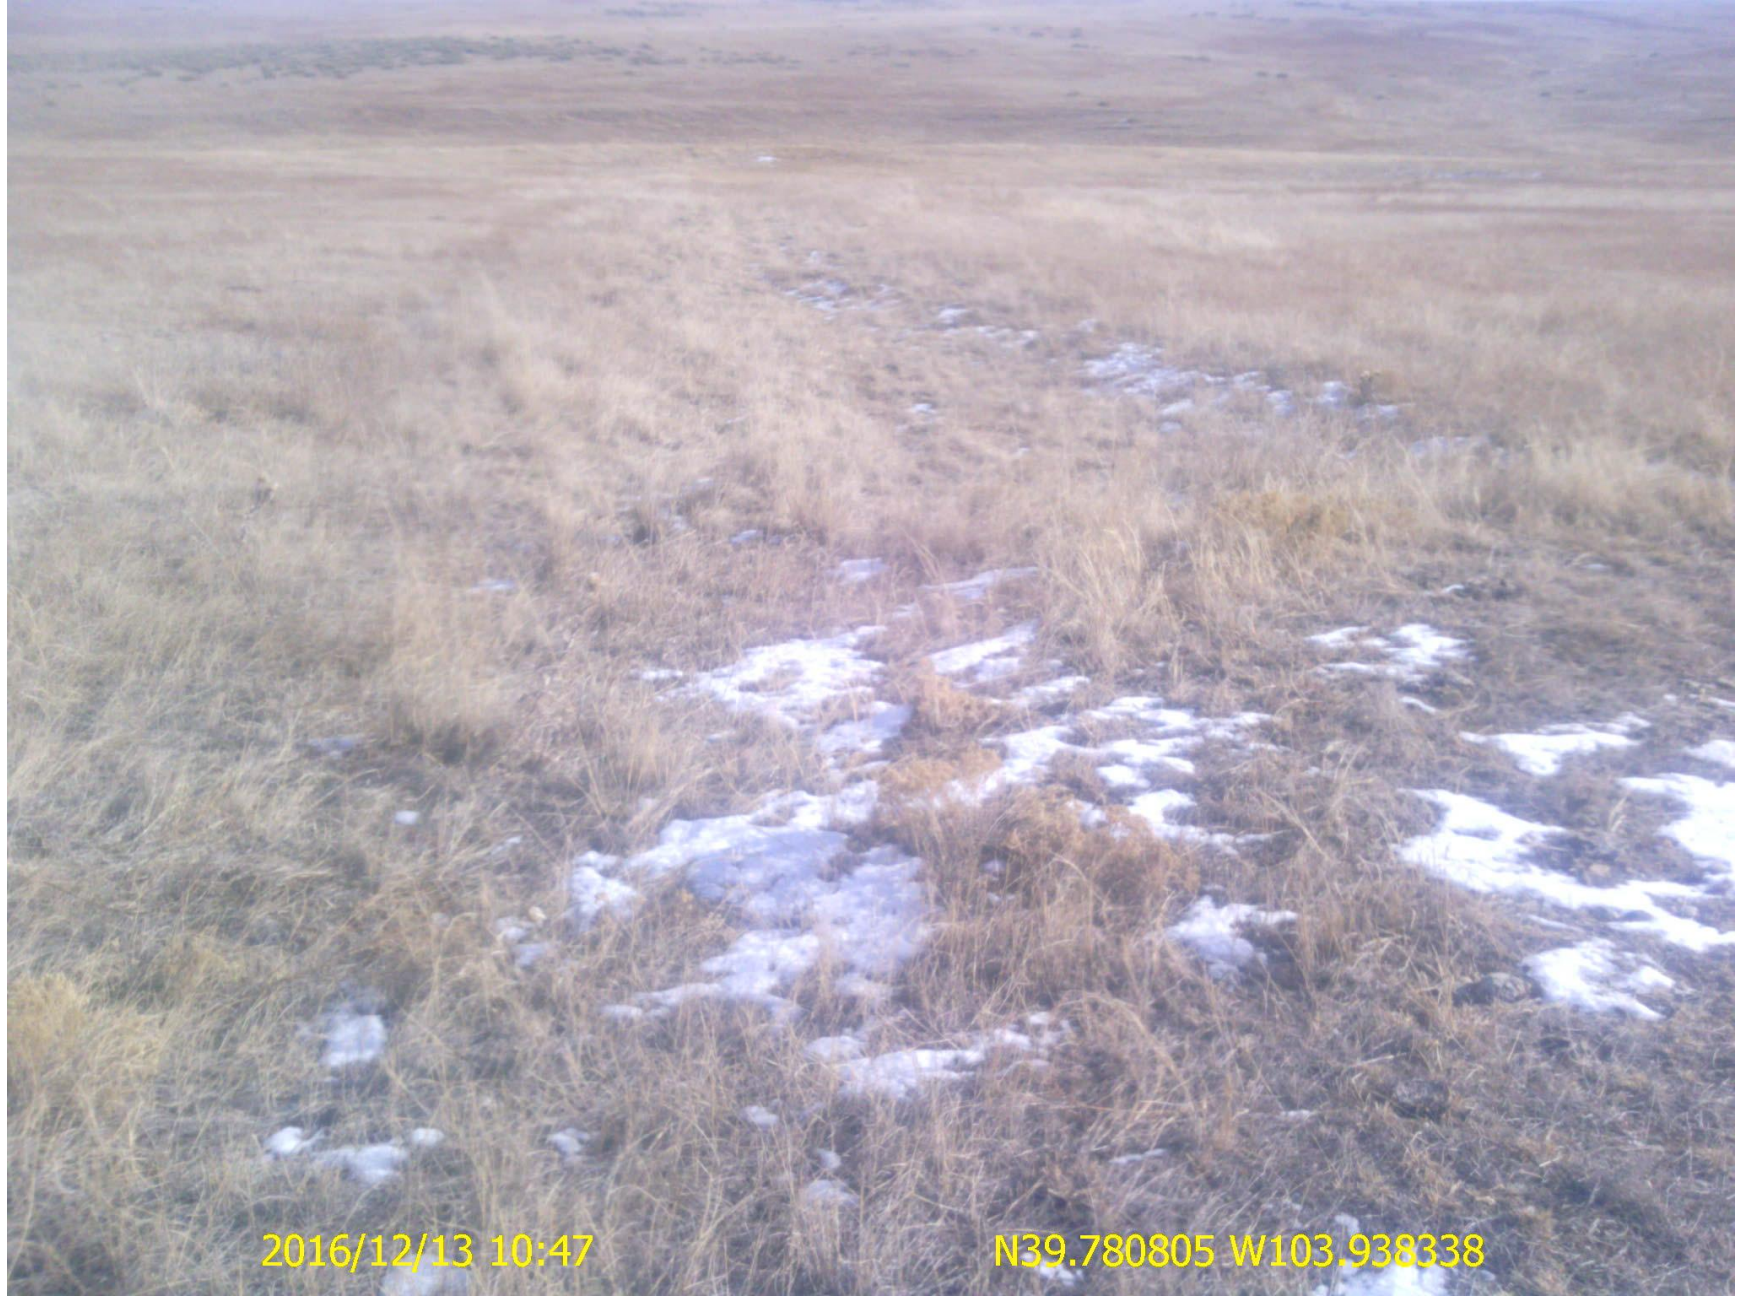
Figure 3: Photo taken from the west end of the location, facing east. Photo shows road has not been re-contoured. Refer to inspection doc. 682500936 for more details

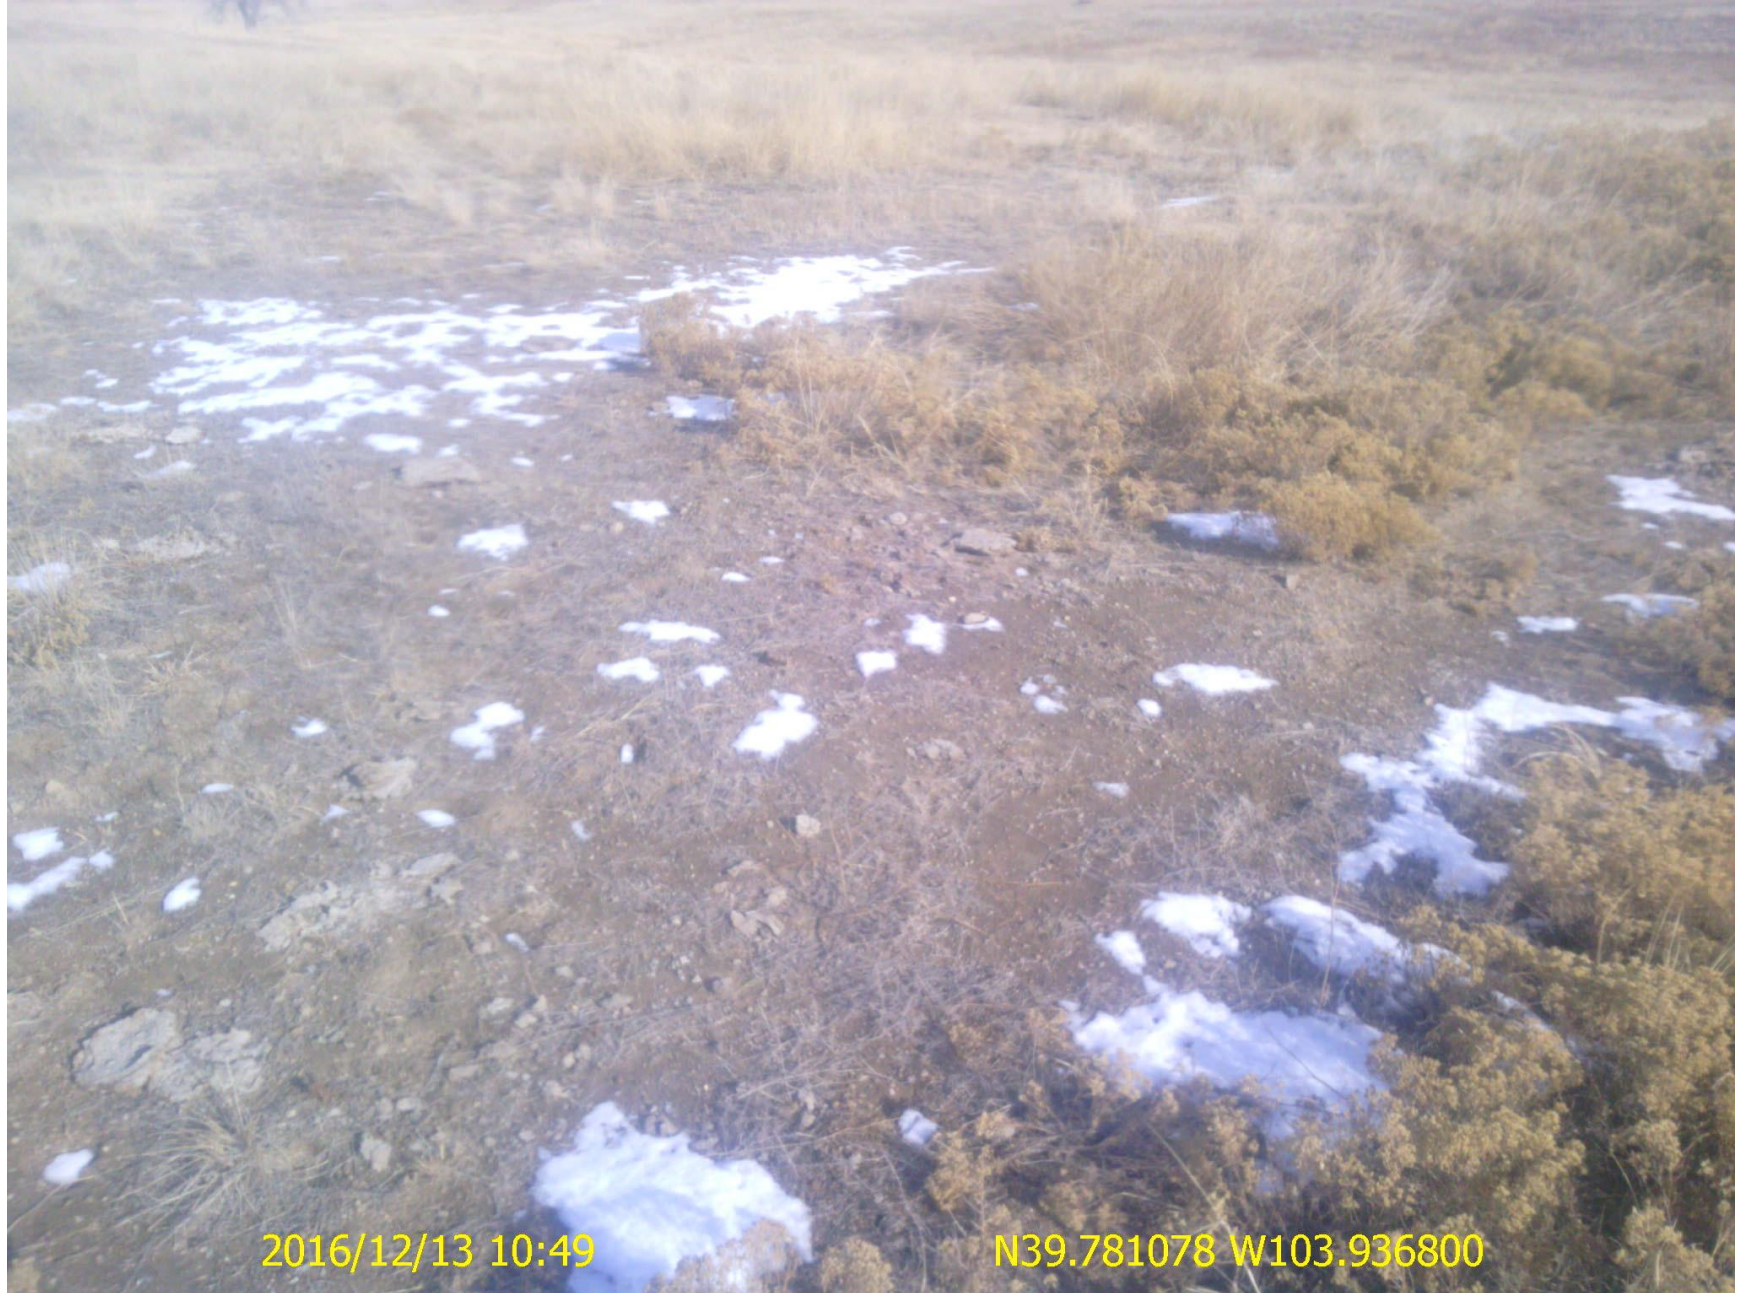
Figure 4: Photo taken from the well. Photo shows well location has not achieved uniform, desirable perennial vegetative cover. Refer to inspection doc. 682500936 for more details

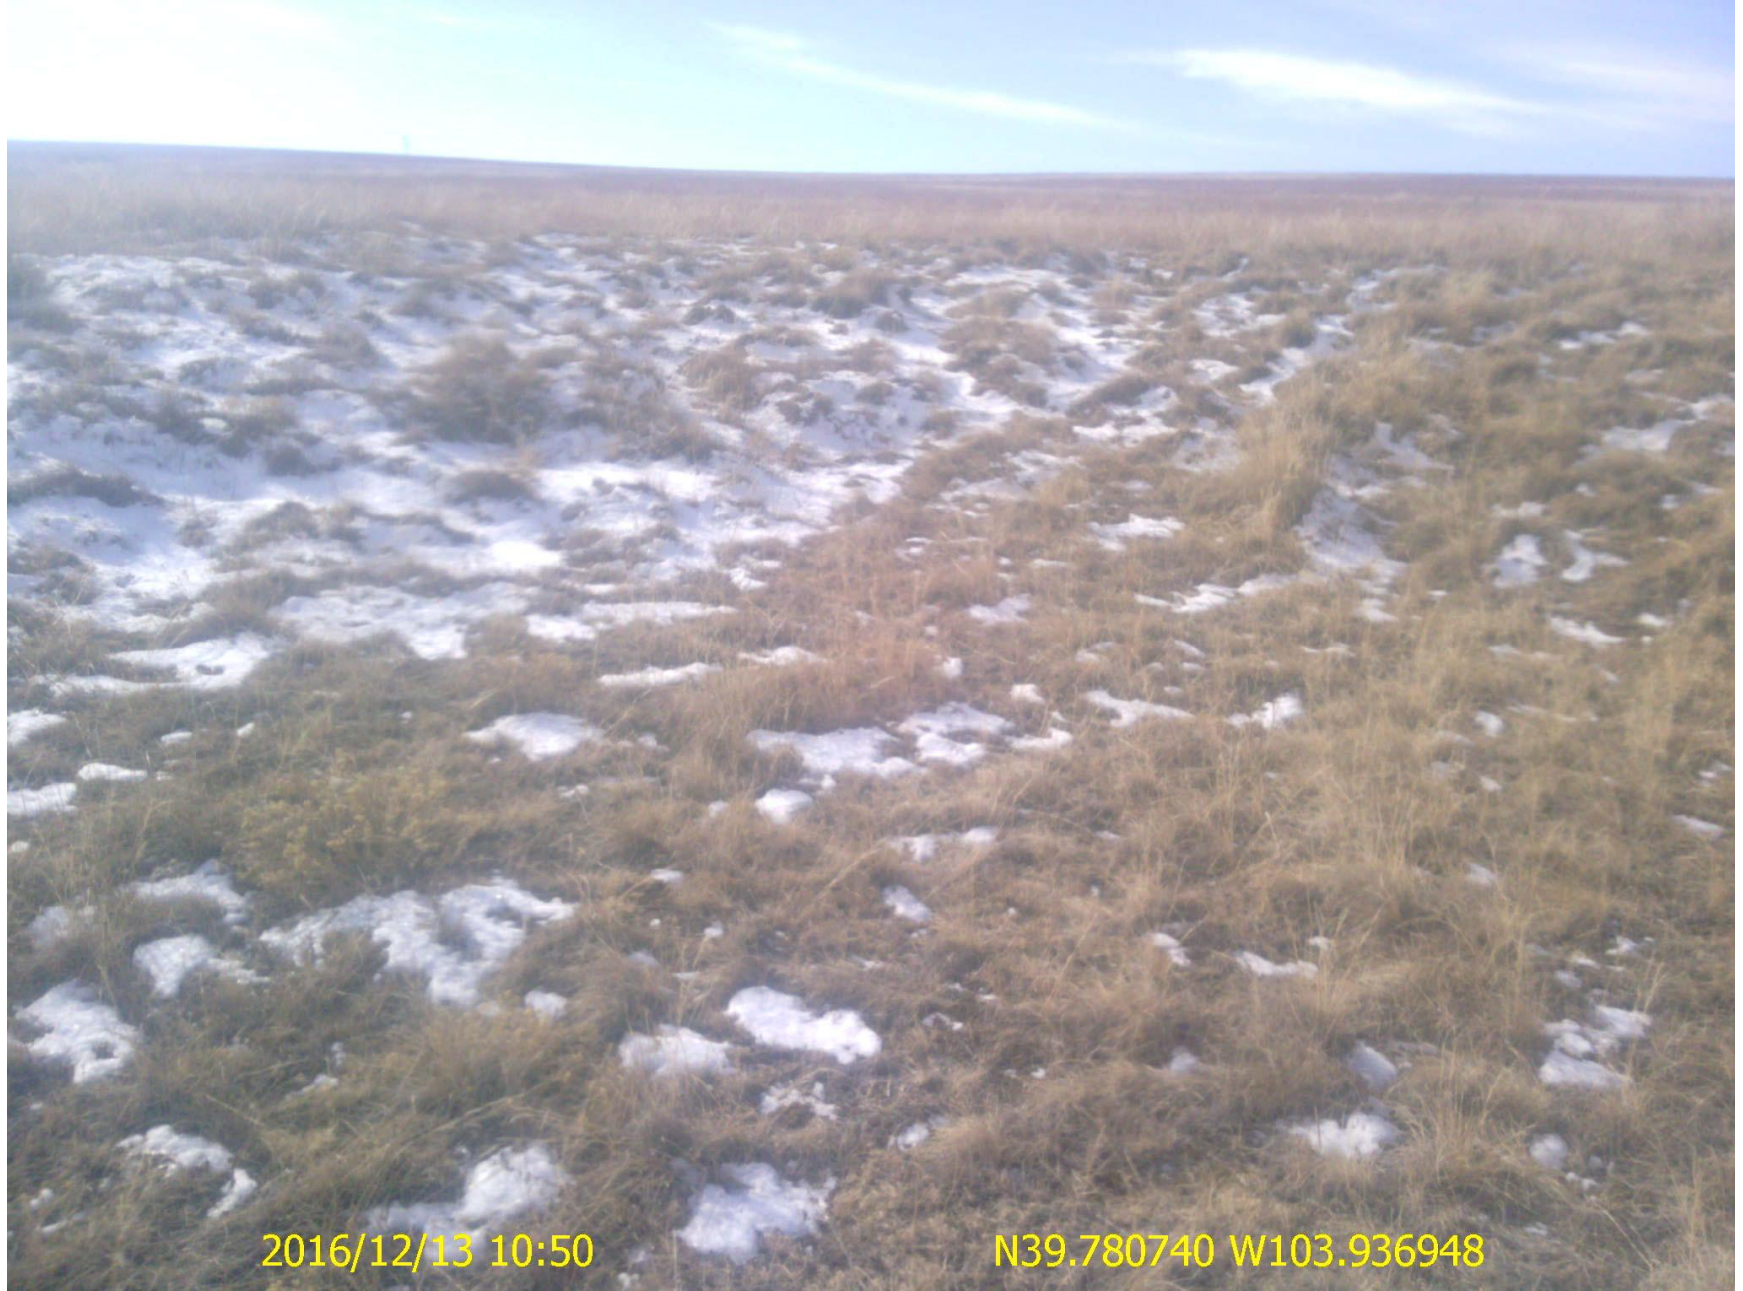
Figure 5: Photo taken from the well location, facing northwest. Photo shows well location has not been re-contoured, and slopes are experiencing erosion. Refer to inspection doc. 682500936 for more details
