Location Overview

Construction and Stormwater Inspection

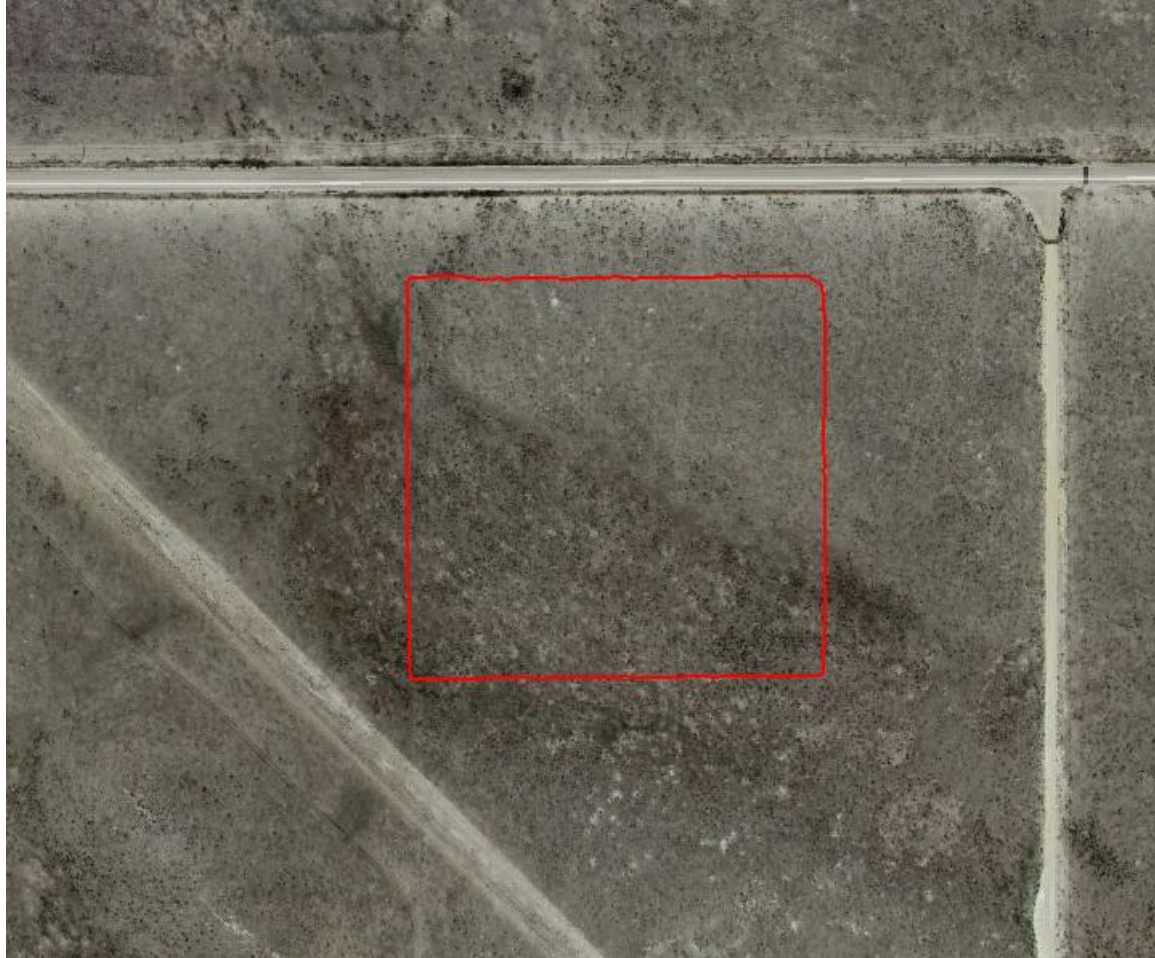
Google Earth aerial photo taken 9/7/2013 of the LC22-02 pad location. Total area of 8.6 acres was mapped using a Trimble Juno 3B handheld device. Perimeter of location was mapped and highlighted in red.

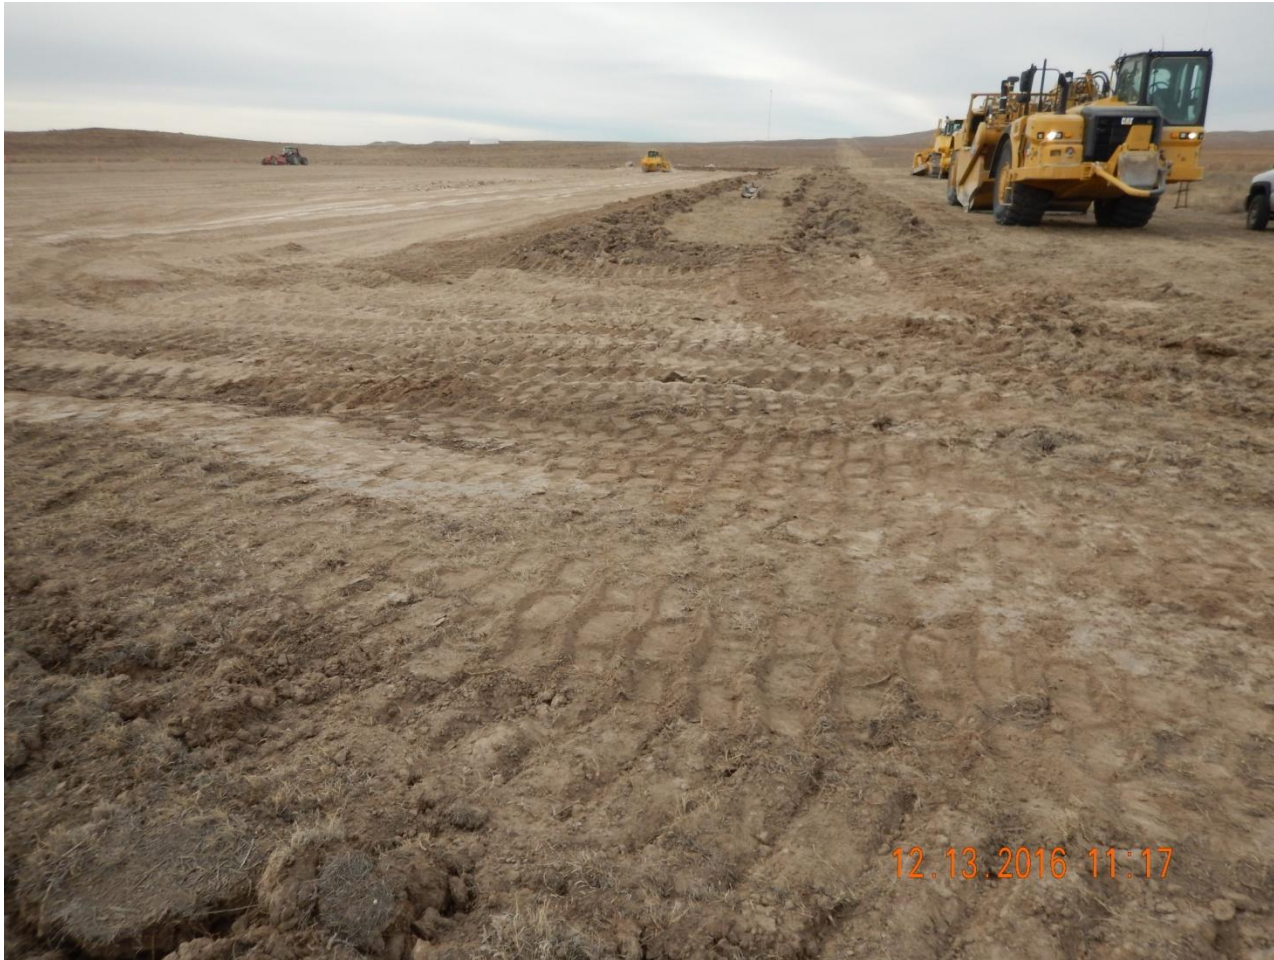
Photo 1. Photo taken from the northeast location, facing West. Temporary BMP, surface roughening, installed around perimeter of location.

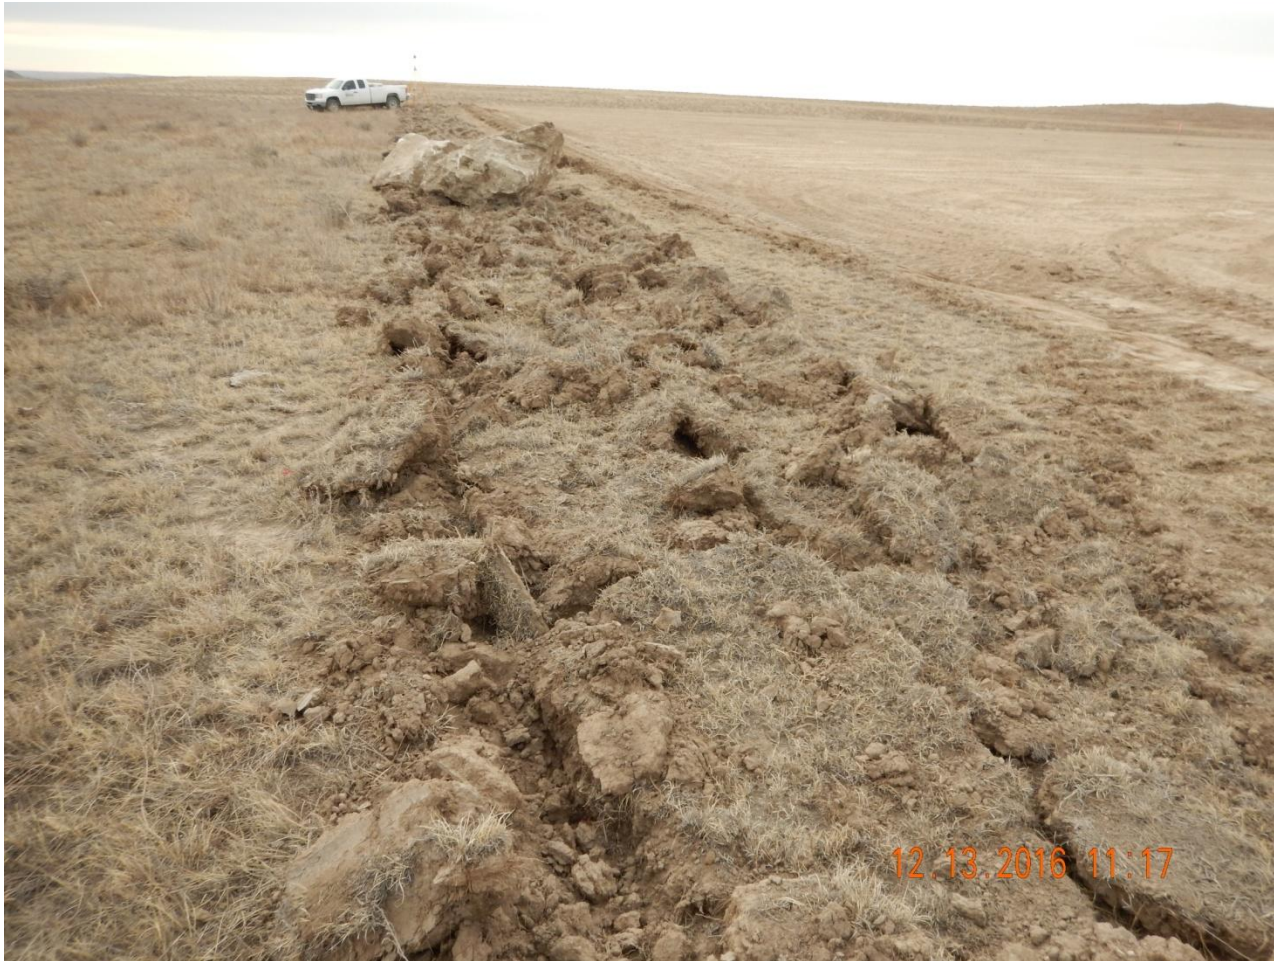
Photo 2. Photo taken from the northeast location, facing South. Temporary BMP, surface roughening, installed around perimeter of location.

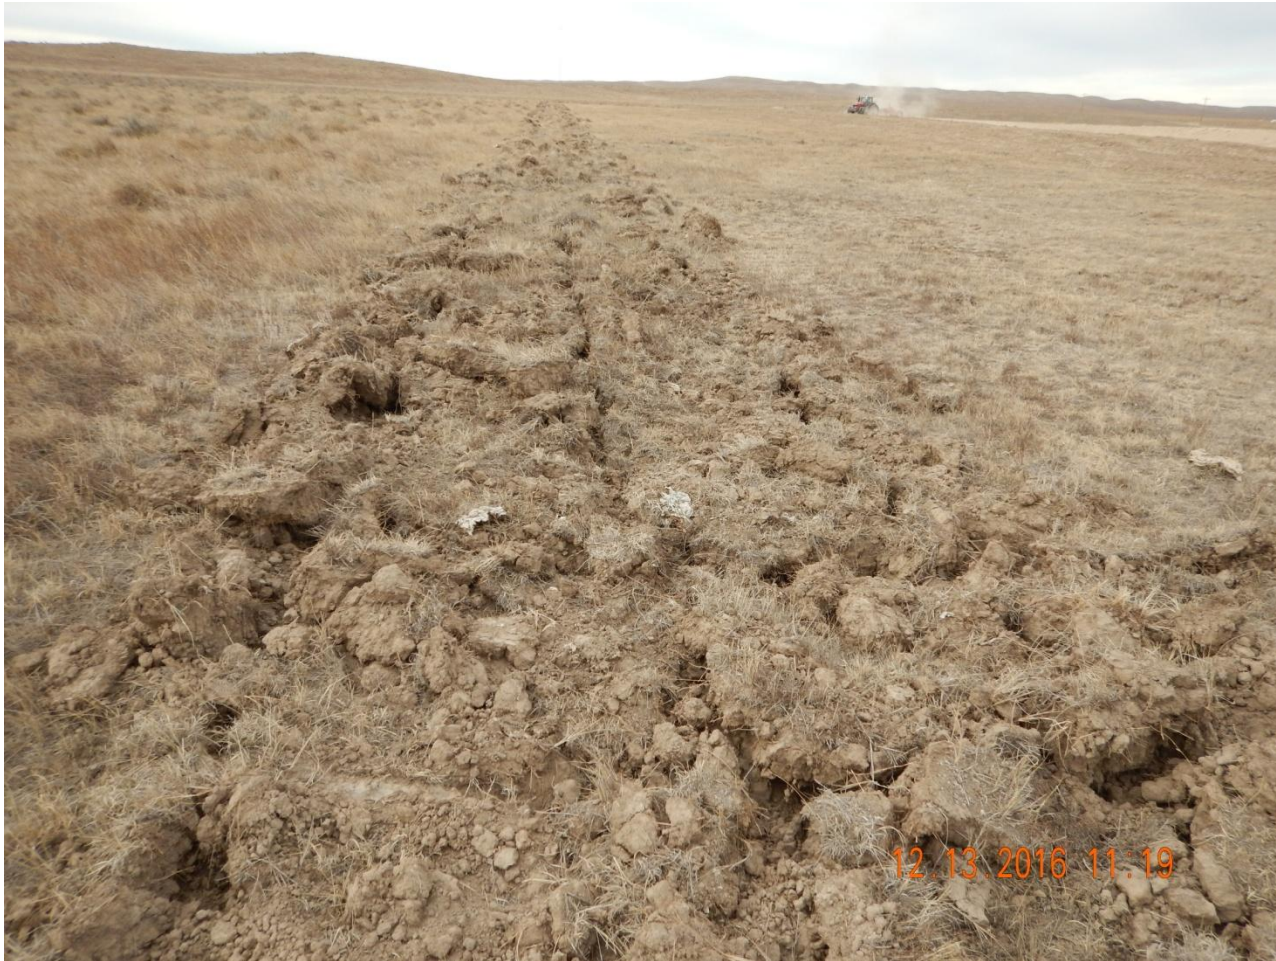
Photo 3. Photo taken from the southeast location, facing West. Temporary BMP, surface roughening, installed around perimeter of location.

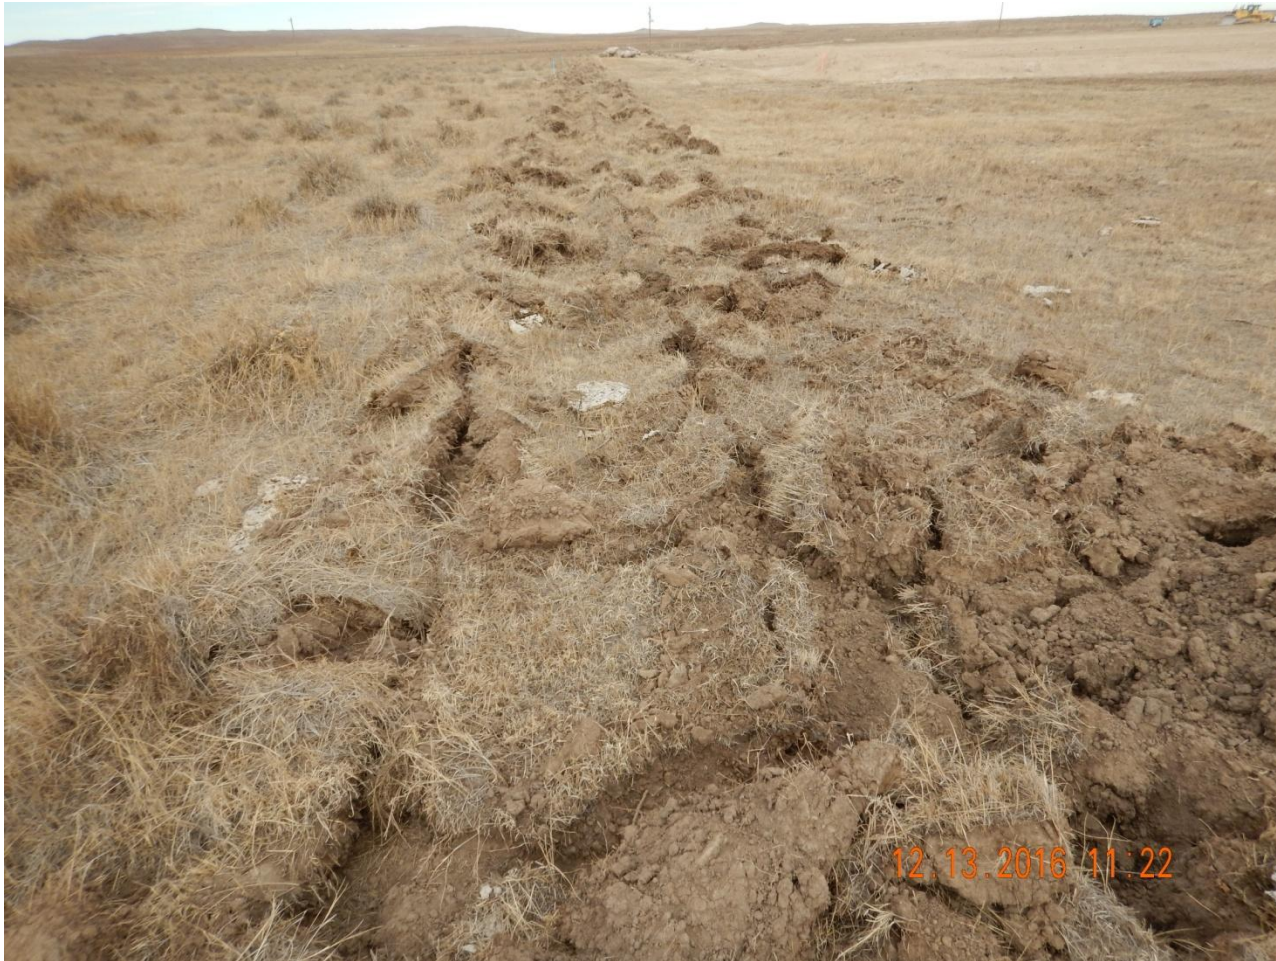
Photo 4. Photo taken from the southwest location, facing North. Temporary BMP, surface roughening, installed around perimeter of location.

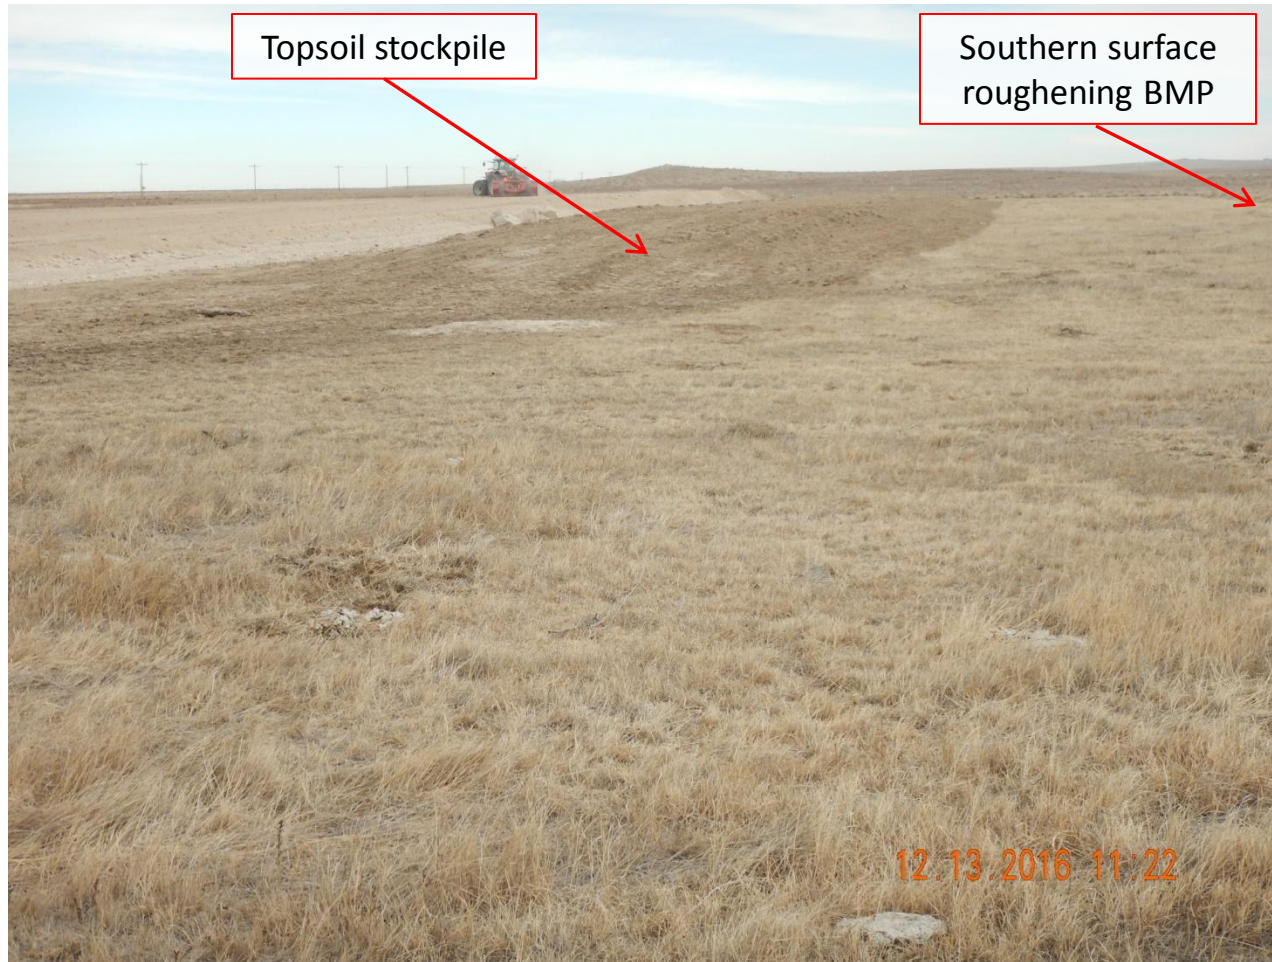
Photo 5. Photo taken from the southwest location, facing East, towards to topsoil stockpile.
