Construction and Stormwater Inspection

Google Earth aerial photo taken 9/7/2013 of the Will Trust 6-62-10 11 CW2 location overview. An area of 7.43 acres was mapped on 1/20/2017 using a Trimble Juno 3B handheld device. Perimeter of the area mapped and highlighted in red.

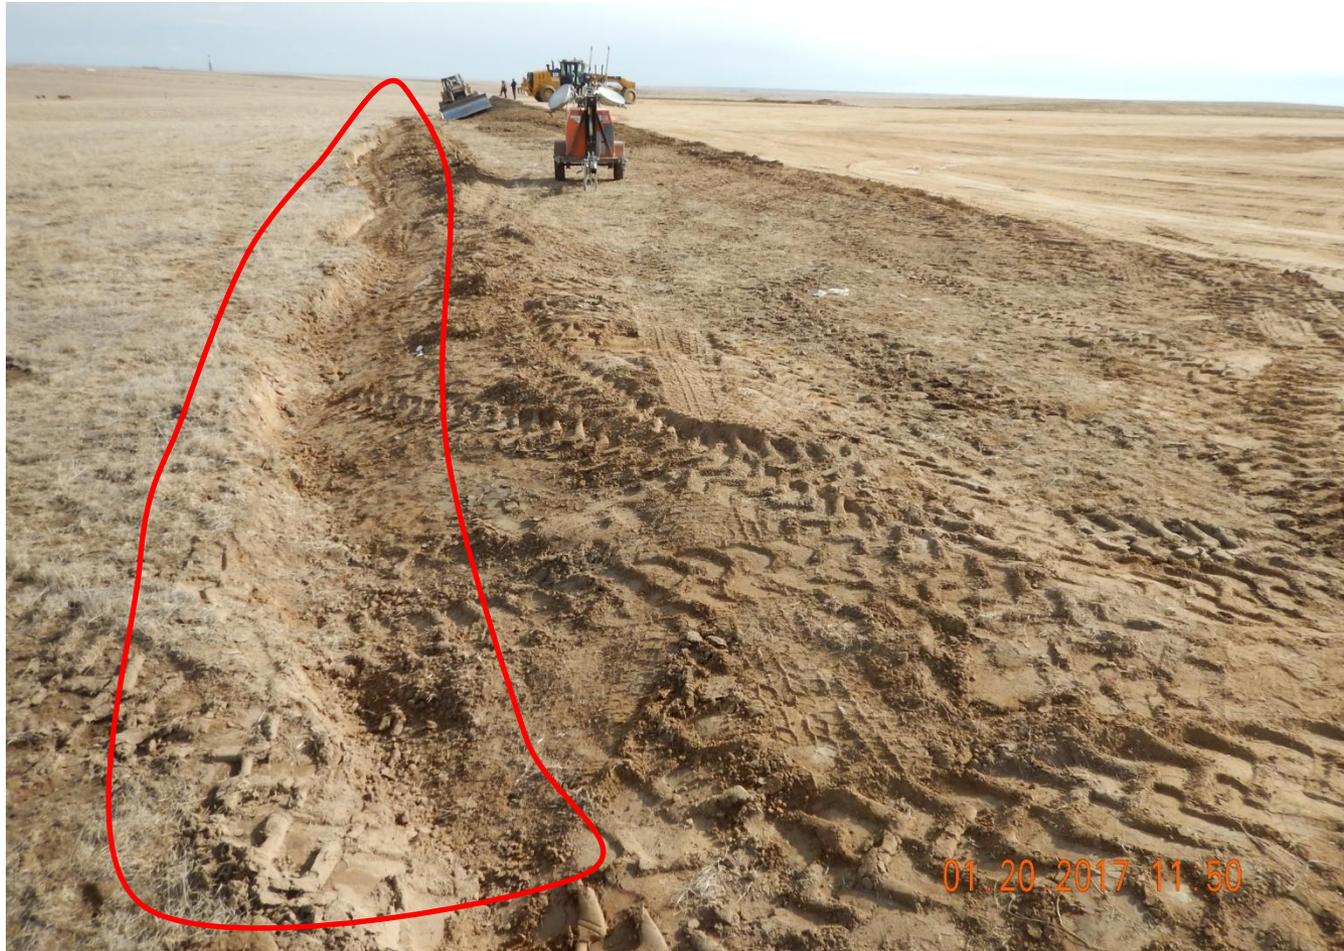
Photo 1. Photo taken from the northwest location, facing East. Insufficient BMP installed around perimeter of location (i.e., swallow ditch) and equipment traffic should be kept off BMPs to ensure they function properly.

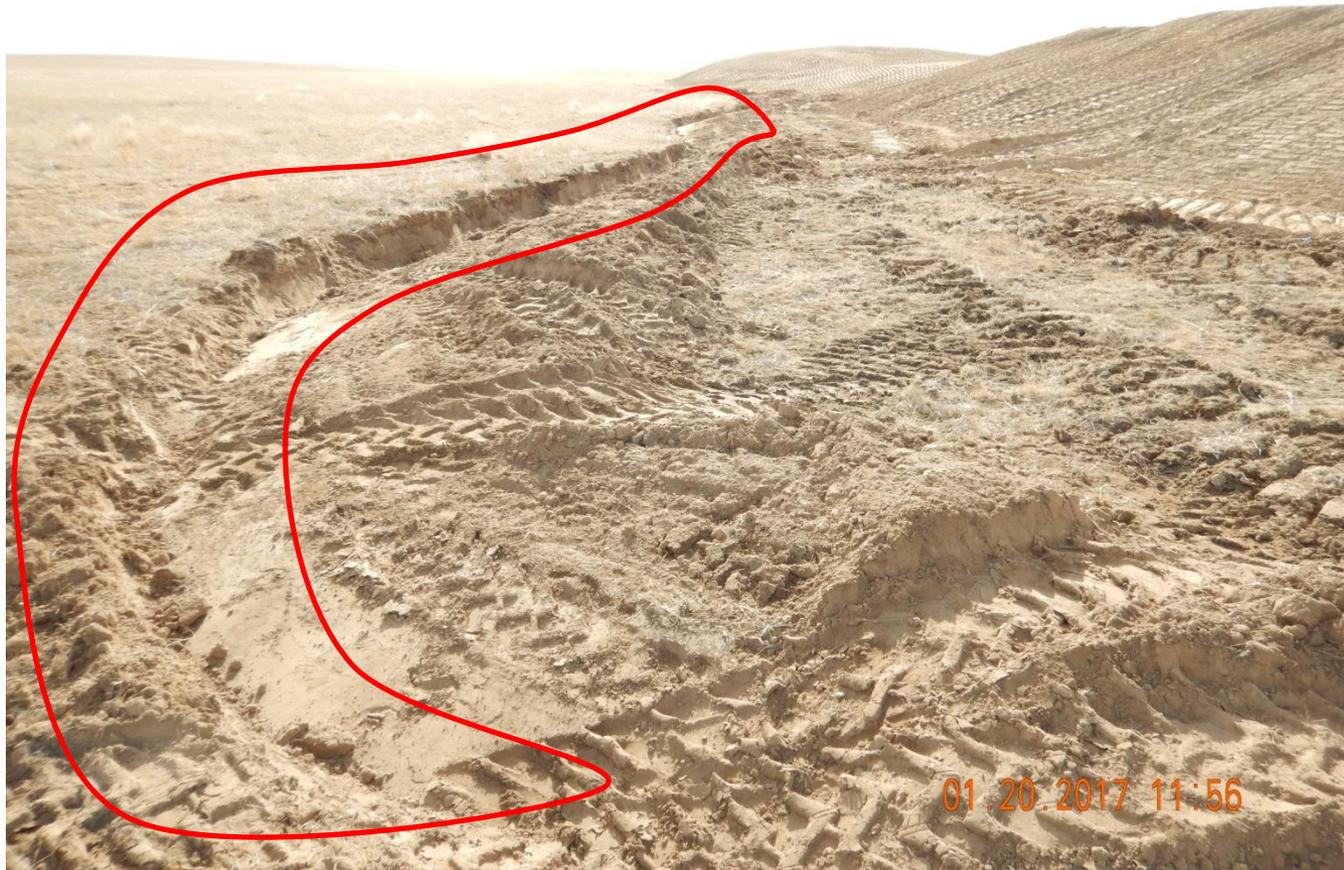
Photo 2. Photo taken from the northeast location, facing South. Insufficient BMP installed around perimeter of location (i.e., swallow ditch). Equipment traffic should be kept off BMPs to ensure they function properly.

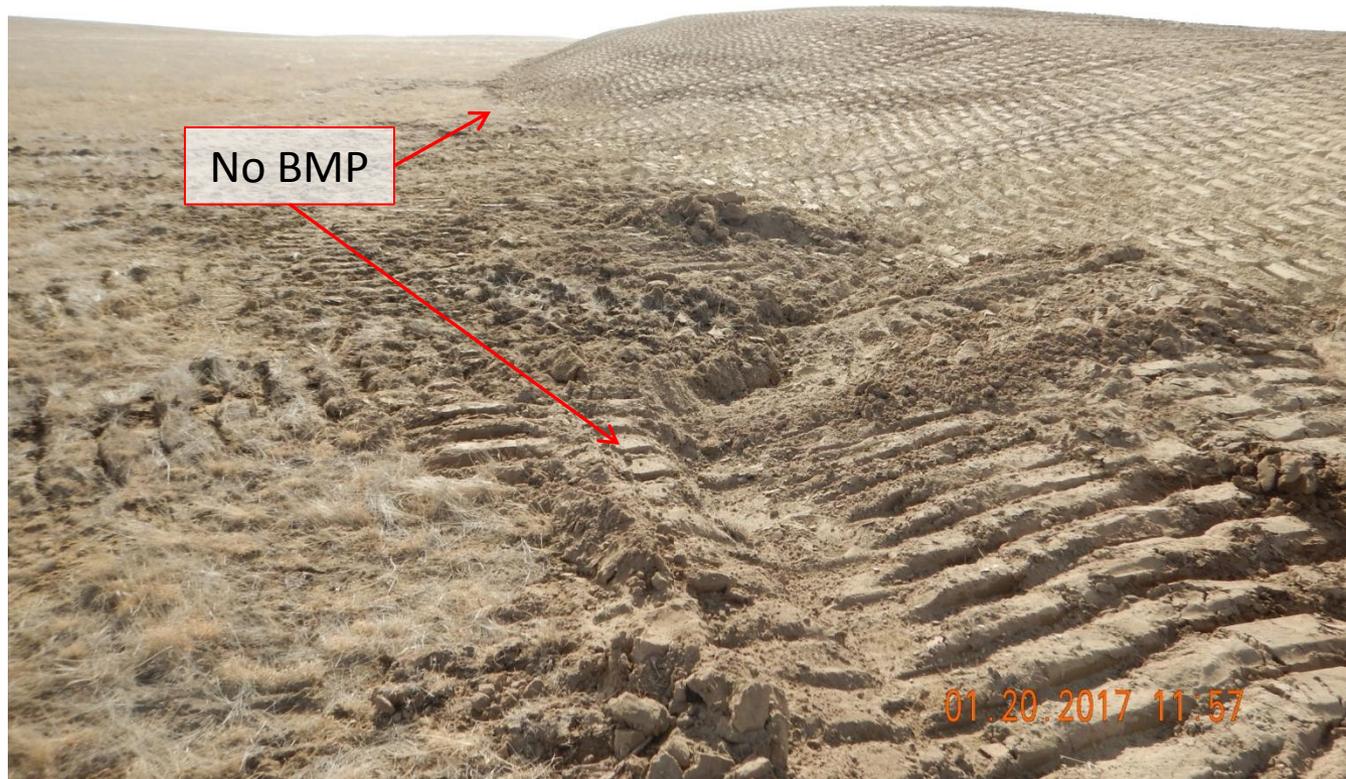
Photo 3. Photo taken from the eastern location, facing South. Does not appear a BMP was installed around the eastern spoil stockpile. Spoil stockpile has been tracked and stabilized but that alone is not sufficient to control potential erosion. May suggest marking spoil and topsoil stockpiles to aid in identifying stockpiles for future reference.

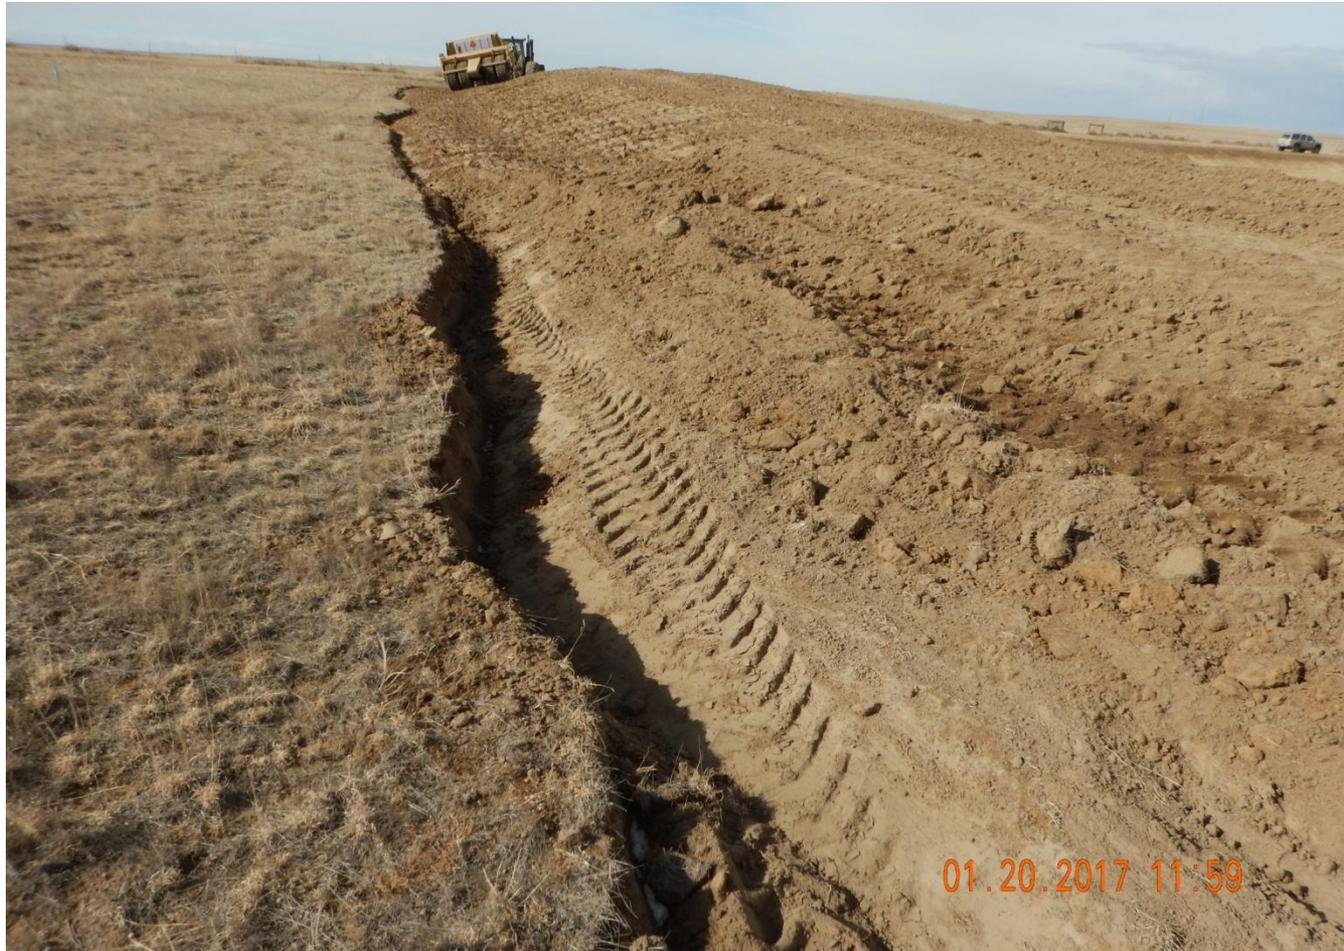
Photo 4. Photo taken from the northern location, facing West. Insufficient BMP installed around perimeter of location. Topsoil stockpile has been tracked and stabilized but that alone is not sufficient to control potential erosion.

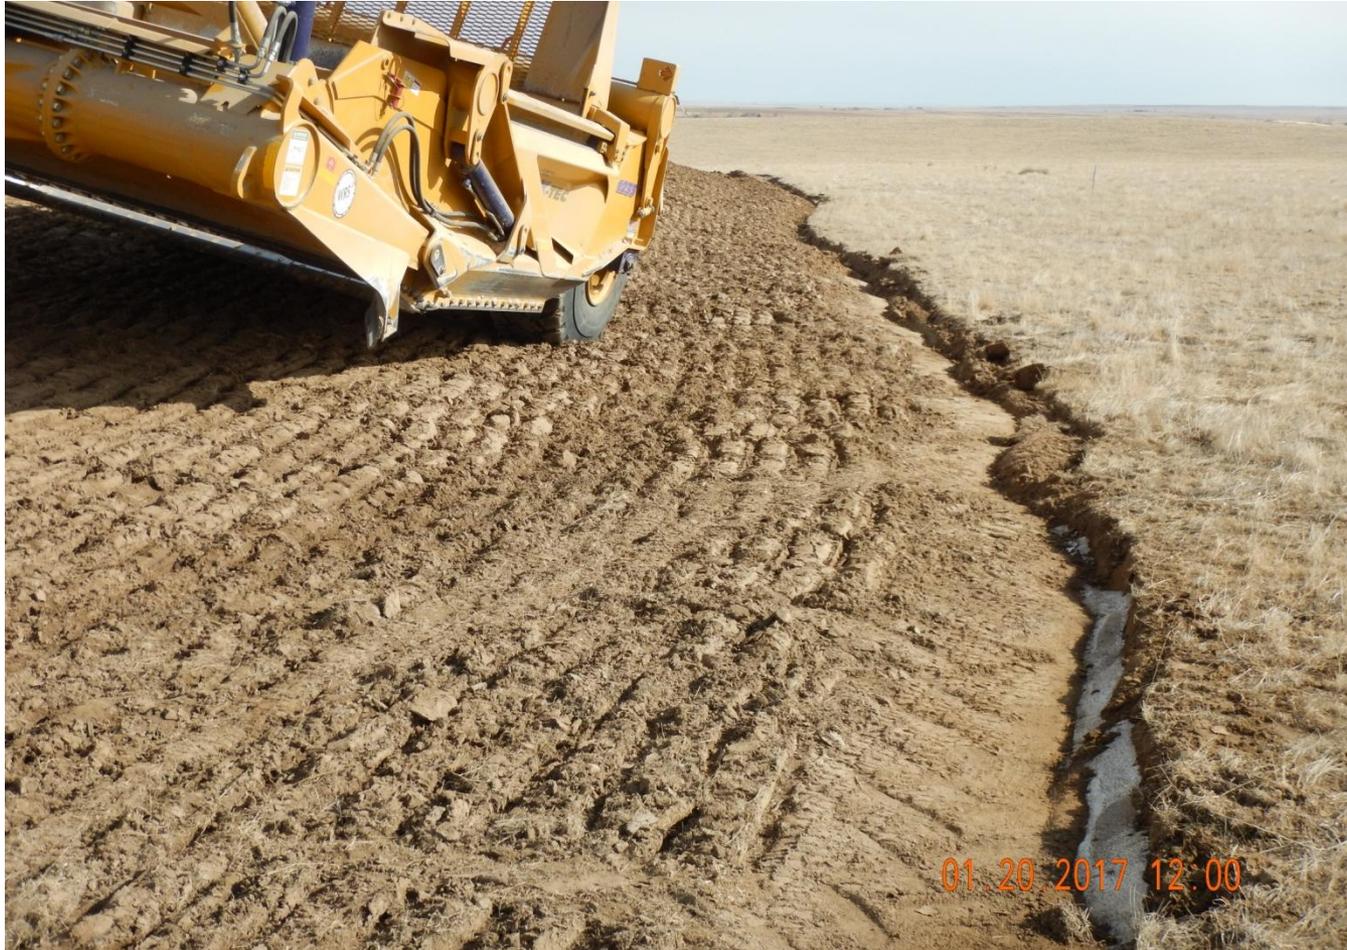
Photo 5. Photo taken from the southwest location, facing East. Insufficient BMP installed around perimeter of location. Topsoil stockpile has been tracked and stabilized but that alone is not sufficient to control potential erosion.

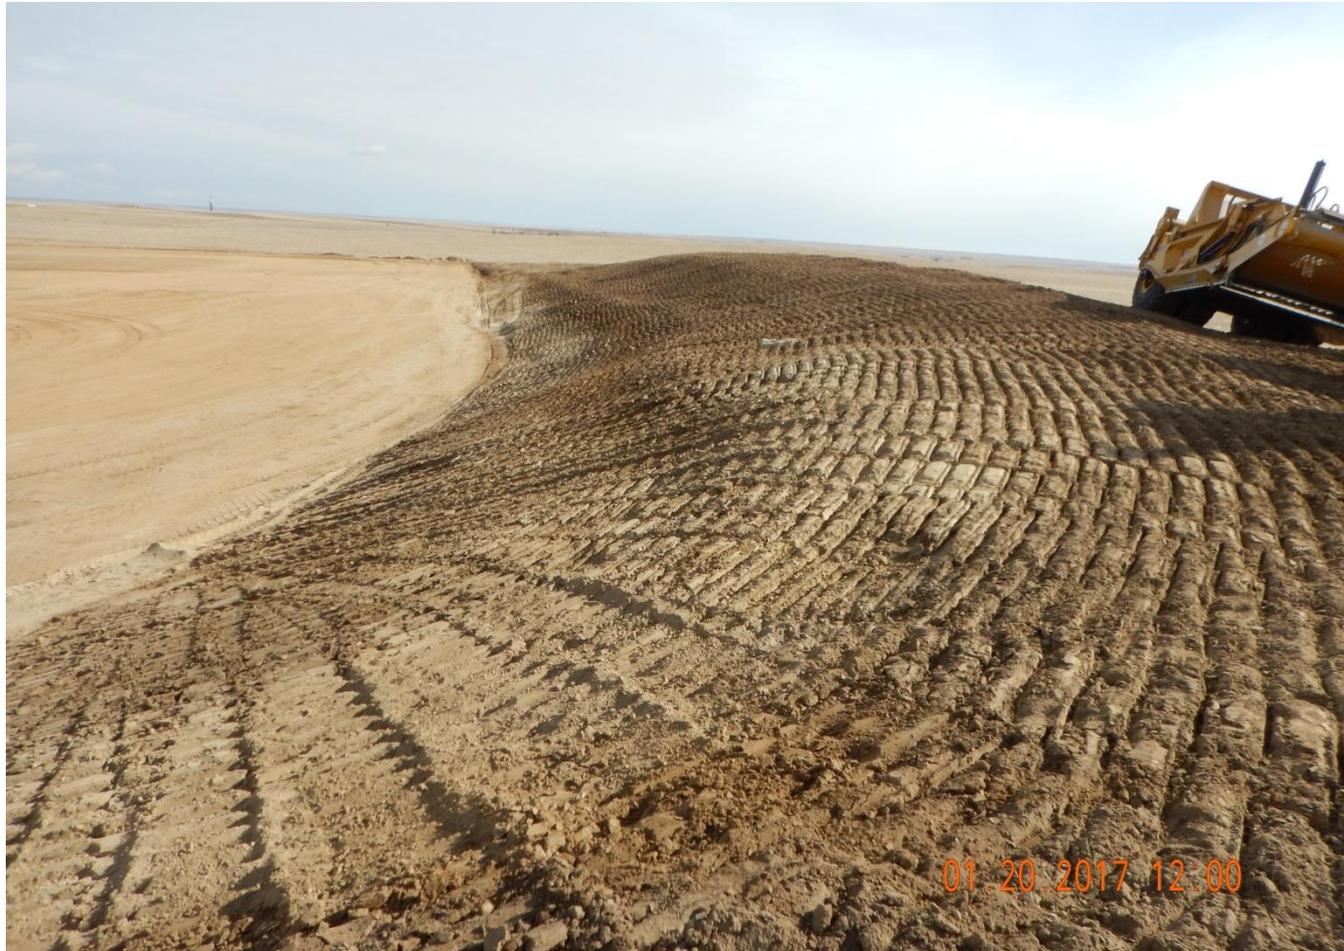
Photo 6. Photo taken from the southwest location, facing East. Topsoil stockpile has been salvaged and stored along the southern perimeter of location. May suggest marking spoil and topsoil stockpiles to aid in identifying stockpiles for future reference.
