**INFORMATION REQUIRED BY COGCC OPERATOR GUIDANCE REGARDING
RULE 1001.c: RECLAMATION VARIANCES AND WAIVERS (DECEMBER 17, 2015)**

Pond E

A. Site History and Description

B. Final Reclamation and Requested Variances

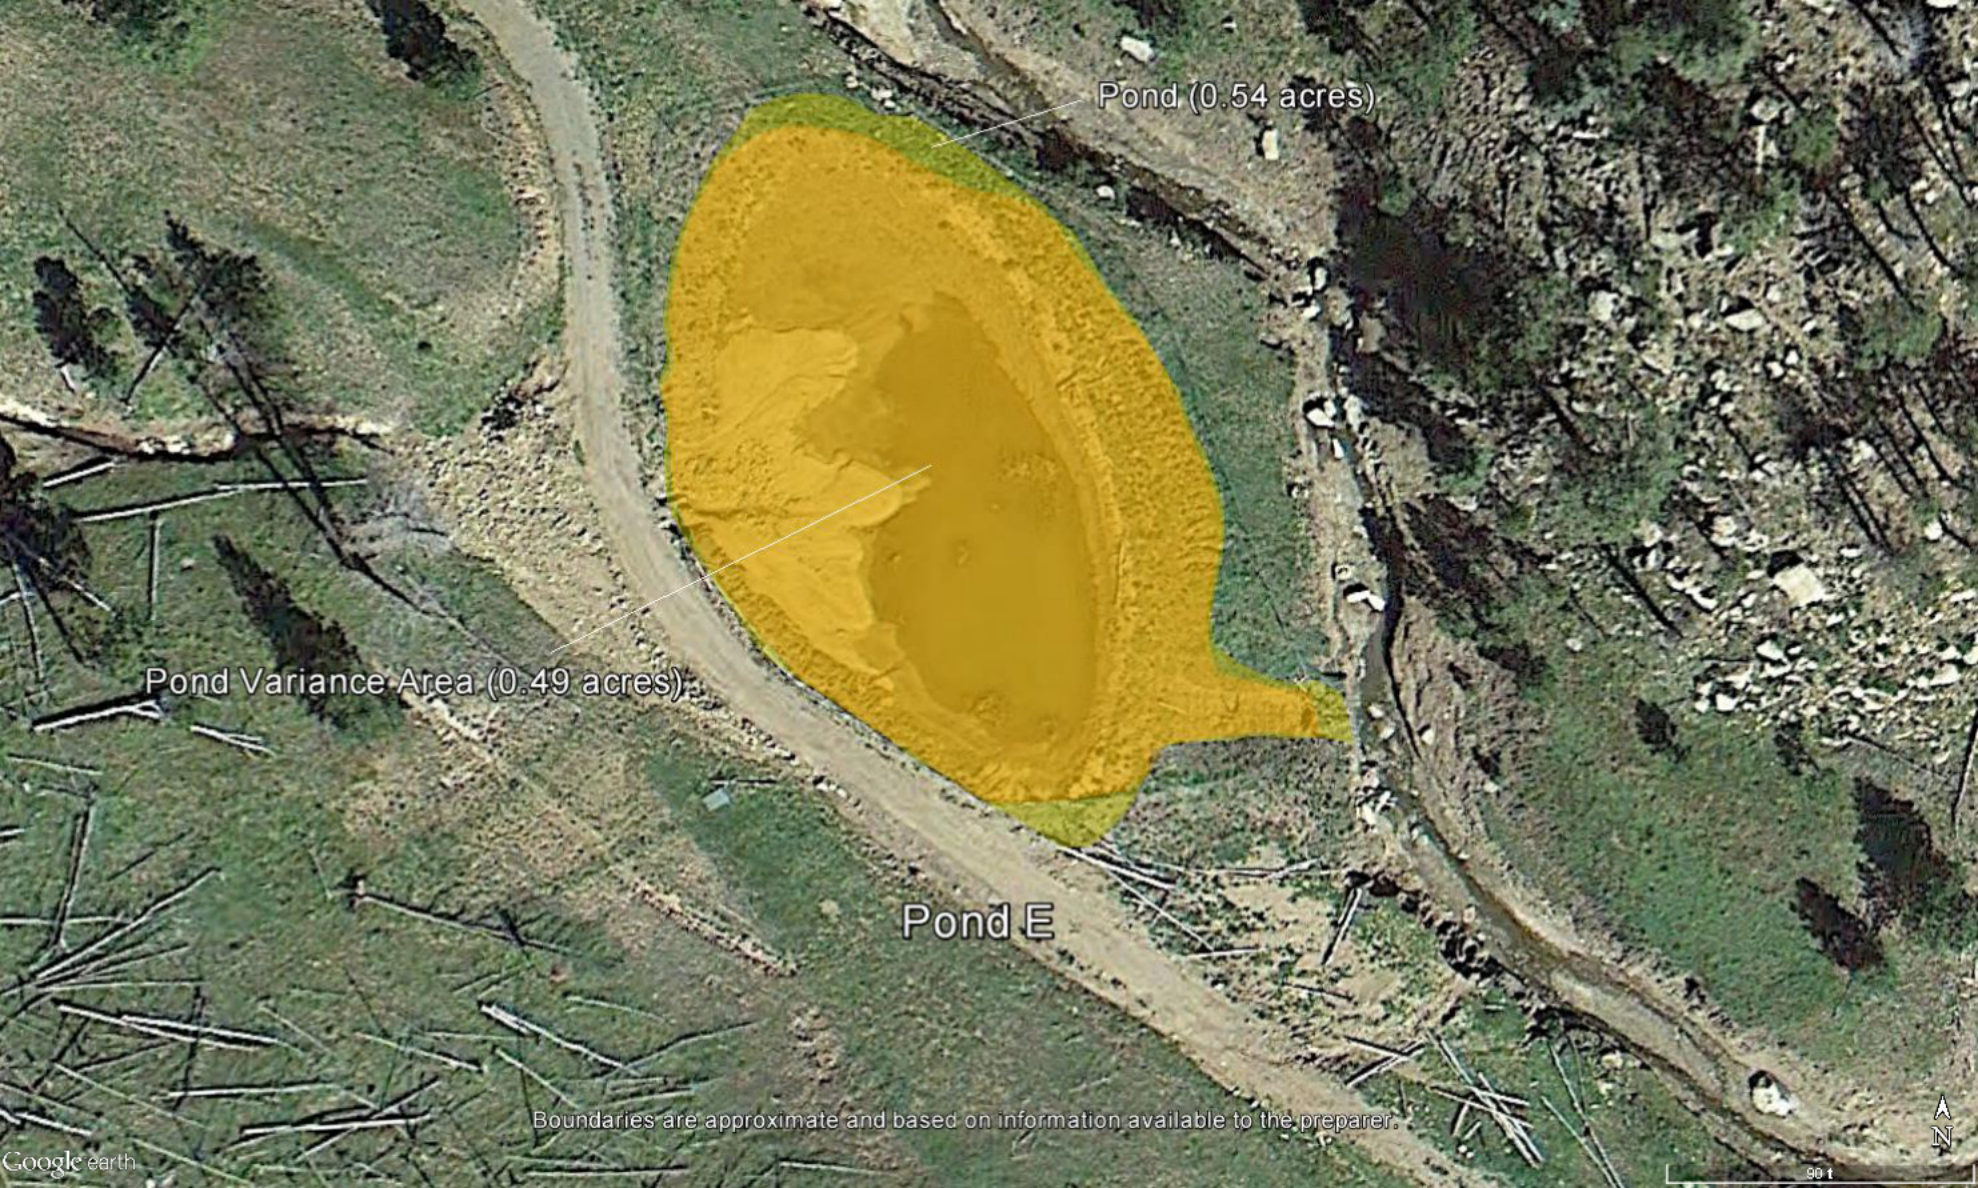
Pond E

Pond (0.54 acres)

Pond Variance Area (0.49 acres)

- The pond will not be backfilled or graded back to its original topographic contours so that the site can continue to function as a pond. The outlet structure will be retained so that RRRH can regulate water levels in the pond if needed.
- The synthetic liner will be left in place.
- The vegetative cover that has been established around the pond and on the access road may not reflect pre-disturbance forbs, shrubs, and grasses and may be less than 80 percent of pre-disturbance levels in some parts of the location.

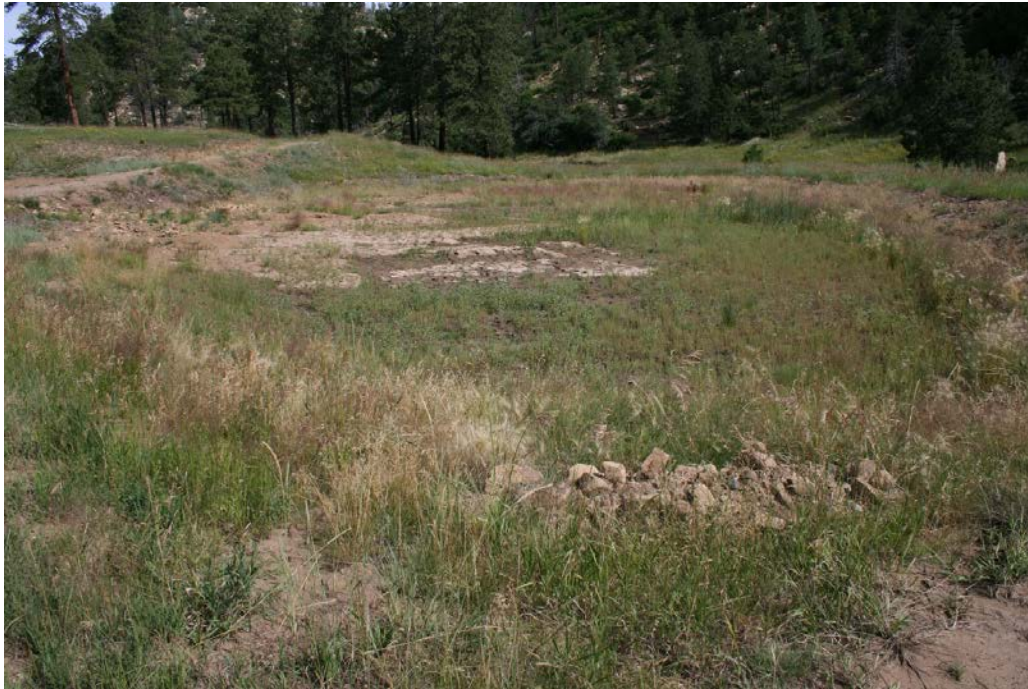
Photograph 1. Pond E, facing northwest from southeast end of pond.

Because no wells were drilled at the Pond E location, there was no oil and gas equipment to be removed as evidenced by the three photographs that are submitted along with this document as a COGCC Form 4 attachment.

All trash and debris belonging to RRRH and its agents have been removed from this location. This is evidenced by the two photographs that are submitted along with this document as a COGCC Form 4 attachment.

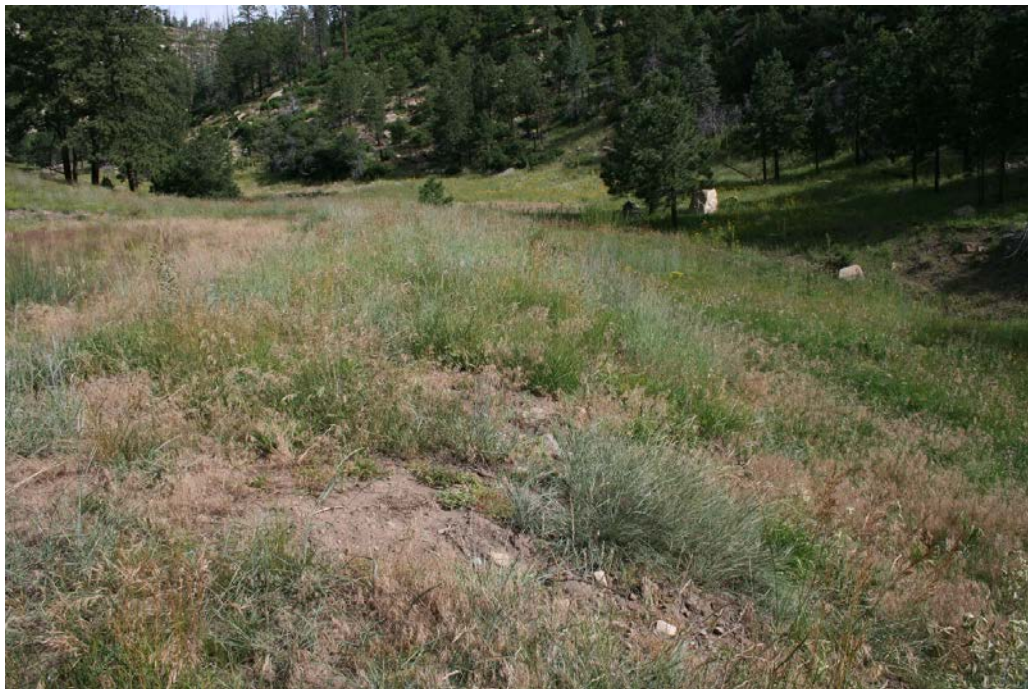
Photograph 2. Pond E, facing northwest across dam face from southeast end of dam.

The site is currently well-stabilized with vegetation, and the dam faces are free of gullies. No structural controls are required to prevent erosion and sedimentation.

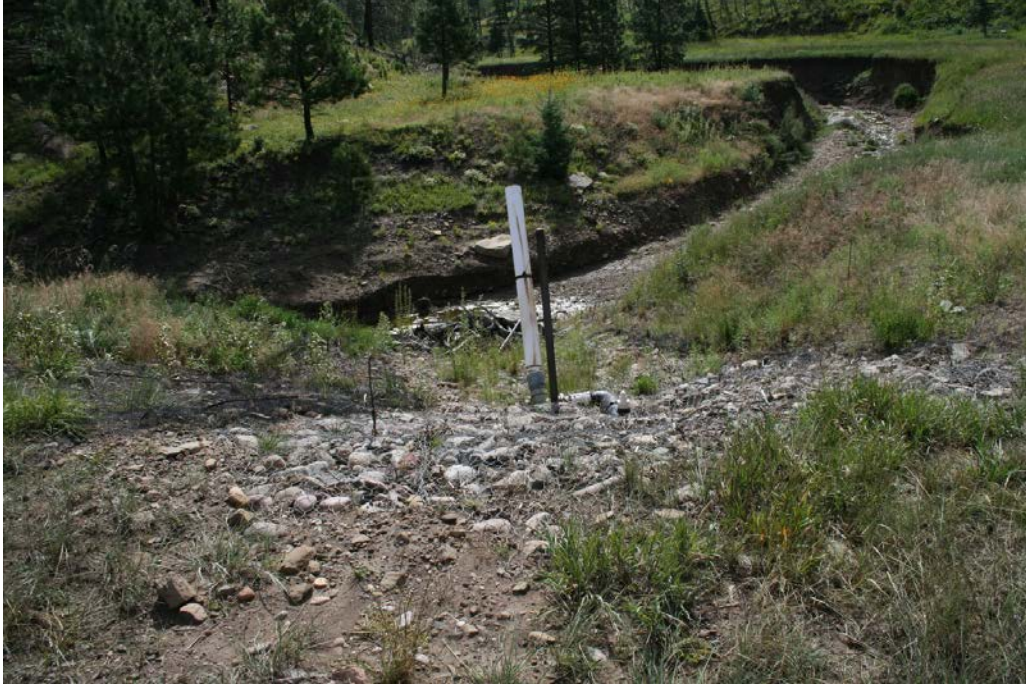
Photograph 3. Pond E, facing east from south end of dam.
