# Final Reclamation and Stormwater Inspection

Operator: Kerr McGee Oil & Gas- #47120

API: 001-09338

Location Name: HSR-PICCADILLY #8-25

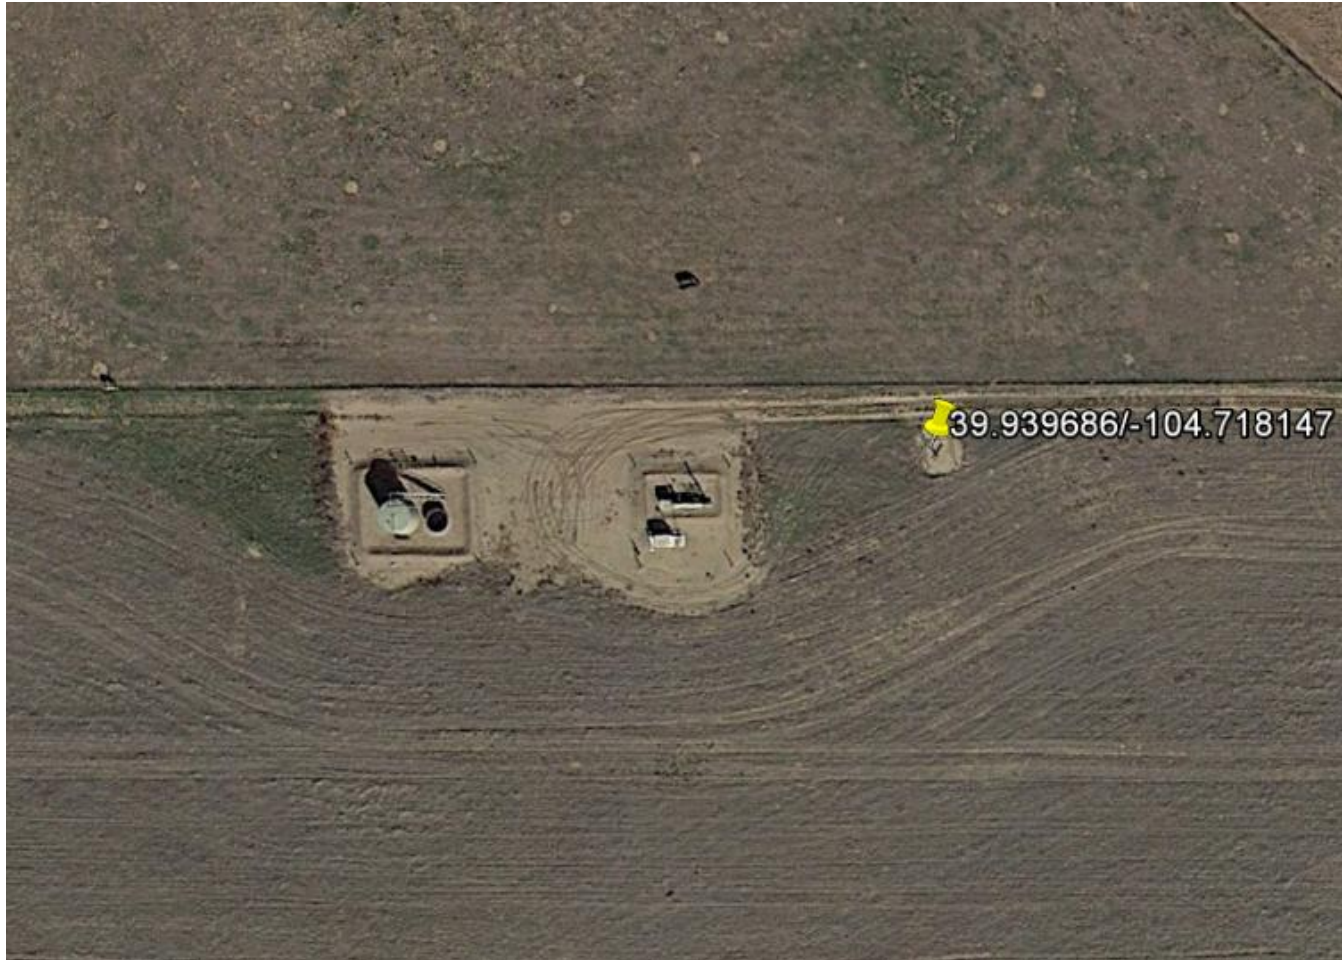
Google Earth aerial imagery taken October 7, 2012 of the well and tank battery location while it was active.

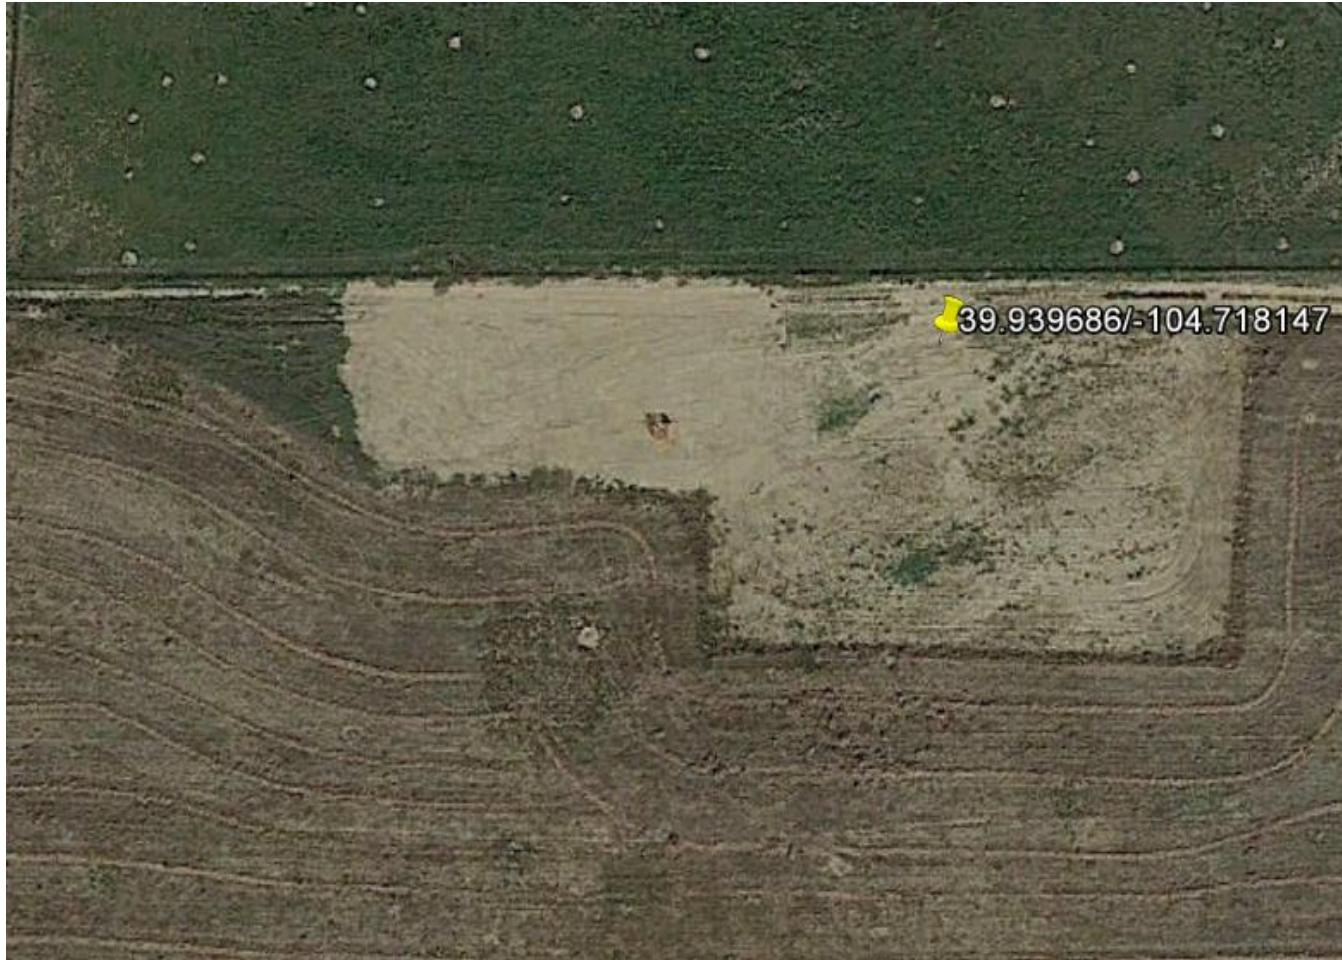
Google Earth aerial imagery taken October 6, 2013 of the well and tank battery location approximately two months after plugging operations.

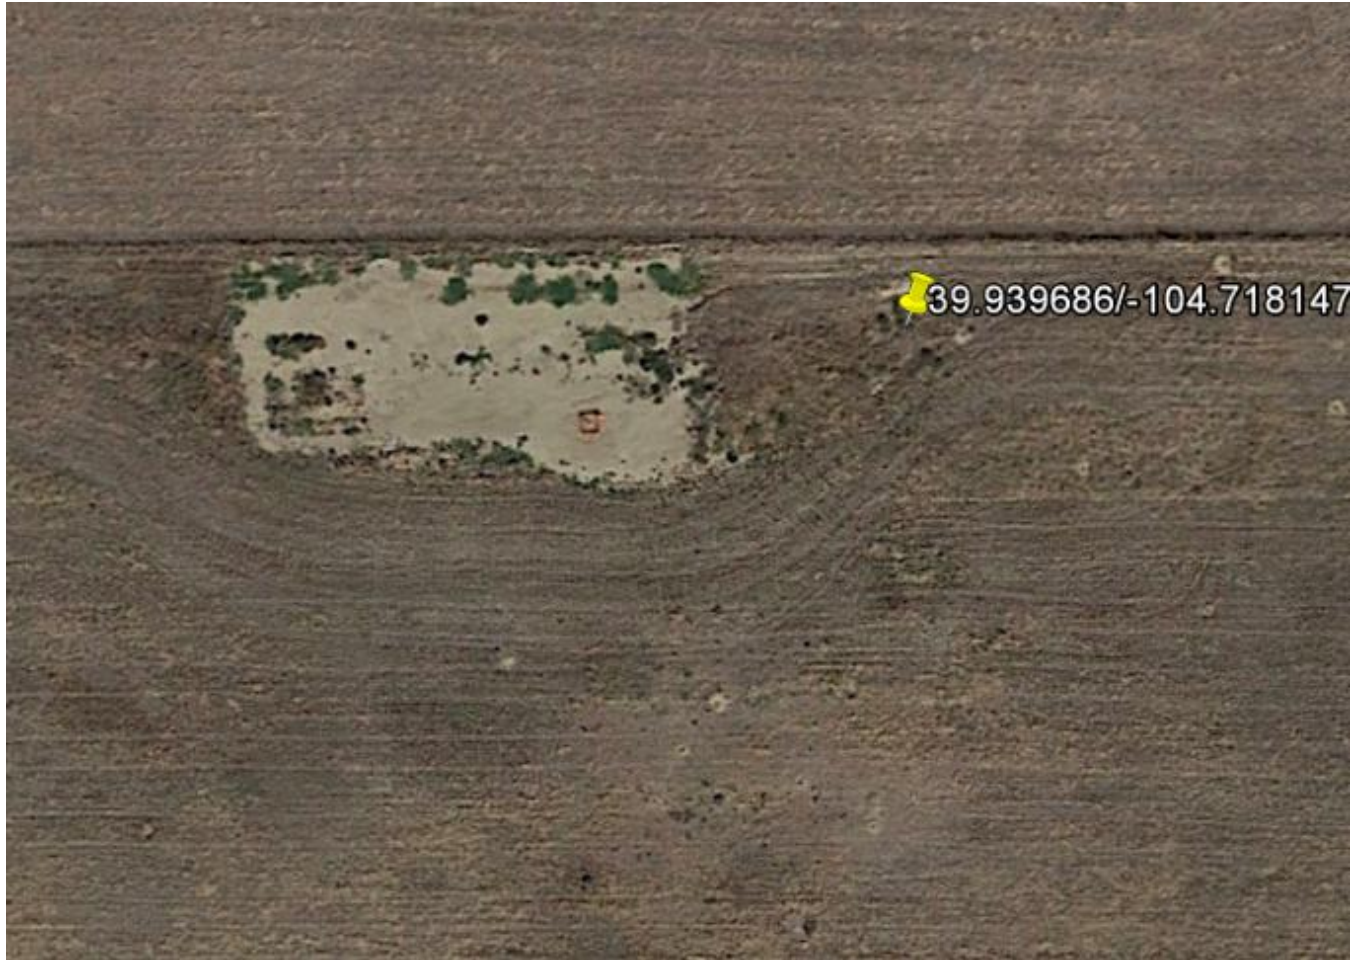
Google Earth aerial imagery taken October 9, 2015 of the well and tank battery location approximately two years and two months after plugging operations. Does not appear final reclamation activities have been performed.

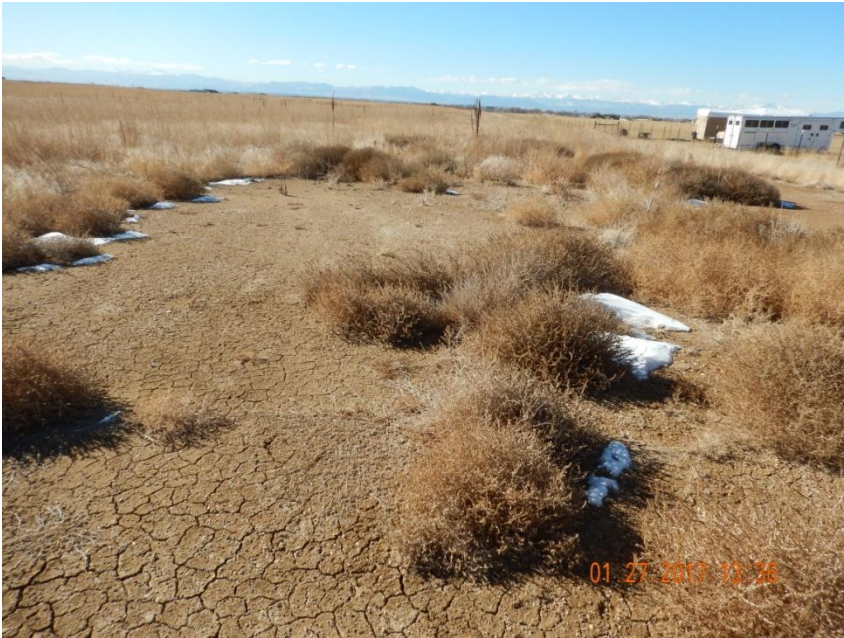
**Photo 1.** Photo taken from the approximate center of the tank battery location, facing West. Does not appear final reclamation activities have been performed per Rule 1004.

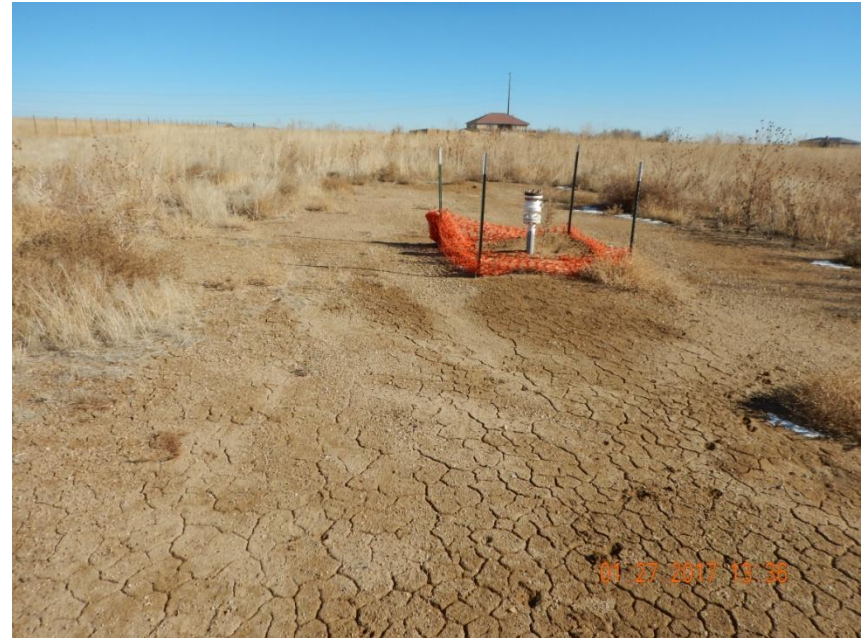
**Photo 2.** Photo taken from the approximate center of the tank battery location, facing East. Equipment (i.e., riser) remains at location.

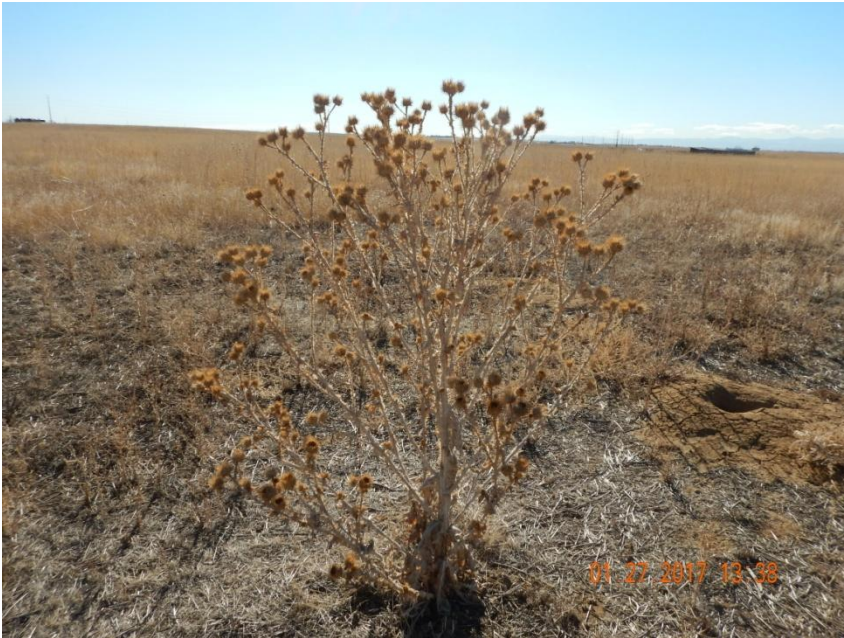
**Photo 3.** Photo taken from the southern tank battery location, facing South. List B Colorado Noxious weed species observed at location- Scotch thistle.

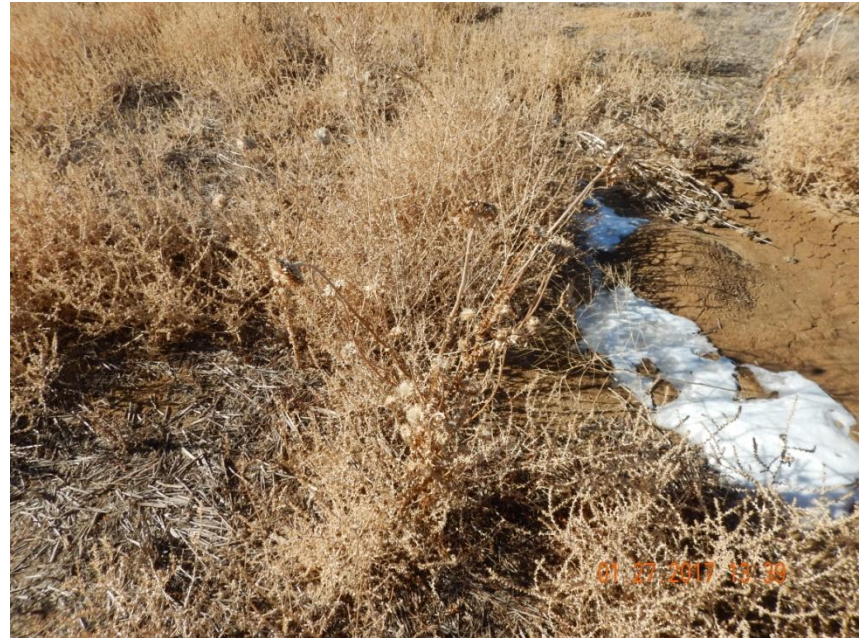
**Photo 4.** Photo taken from the southern tank battery location. List B Colorado Noxious weed species observed at location- Musk thistle.
