Construction and Stormwater Inspection

February 13, 2017

Operator: KERR MCGEE OIL & GAS ONSHORE LP
#47120

Location ID: 449025

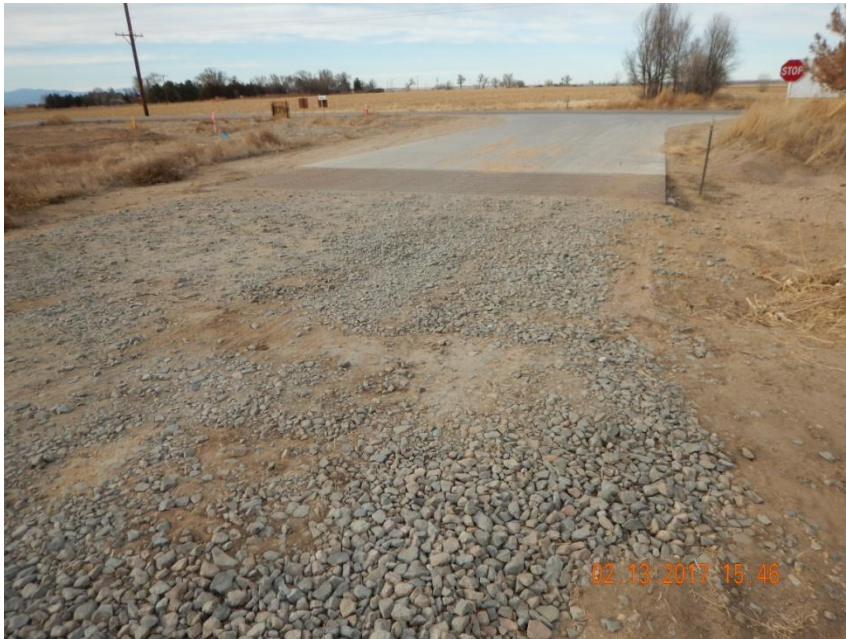
Photo 1. Photo taken from the entrance of location, facing North. Vehicle tracking pad installed with cattle guard. BMP appears to be properly functioning.

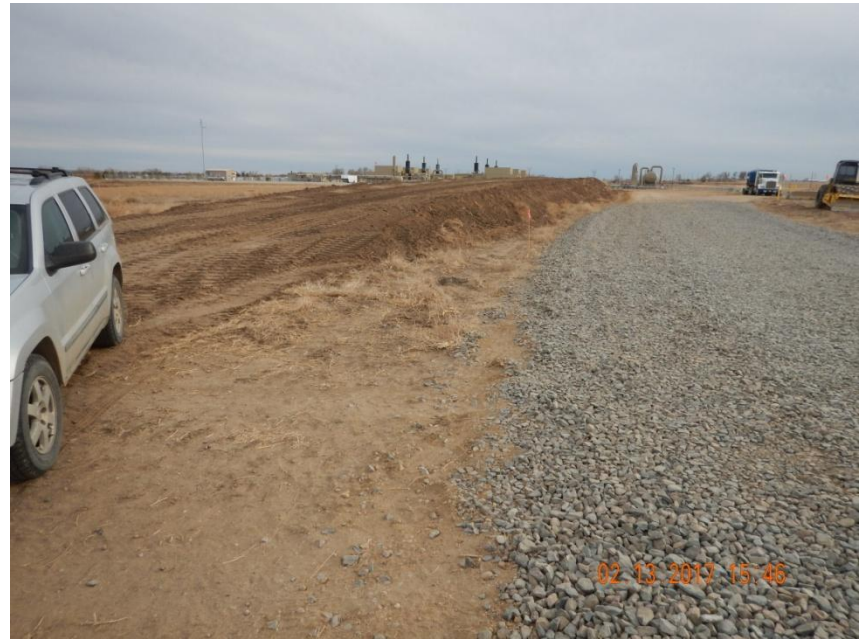
Photo 2. Photo taken from the northern location, facing South. Topsoil salvaged and stored along the eastern perimeter.

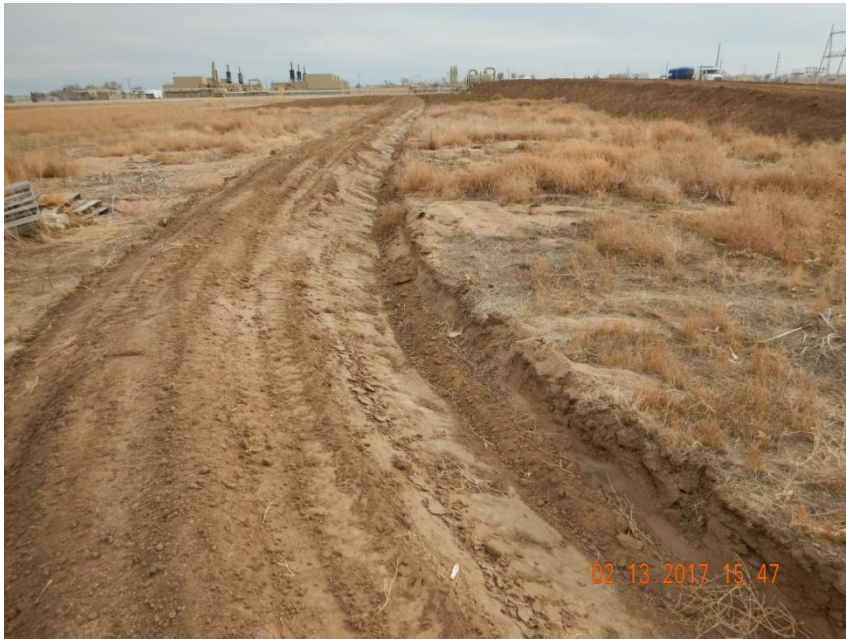
Photo 3. Photo taken from the northeast location, facing South. Ditch and berm BMP installed around perimeter of location.

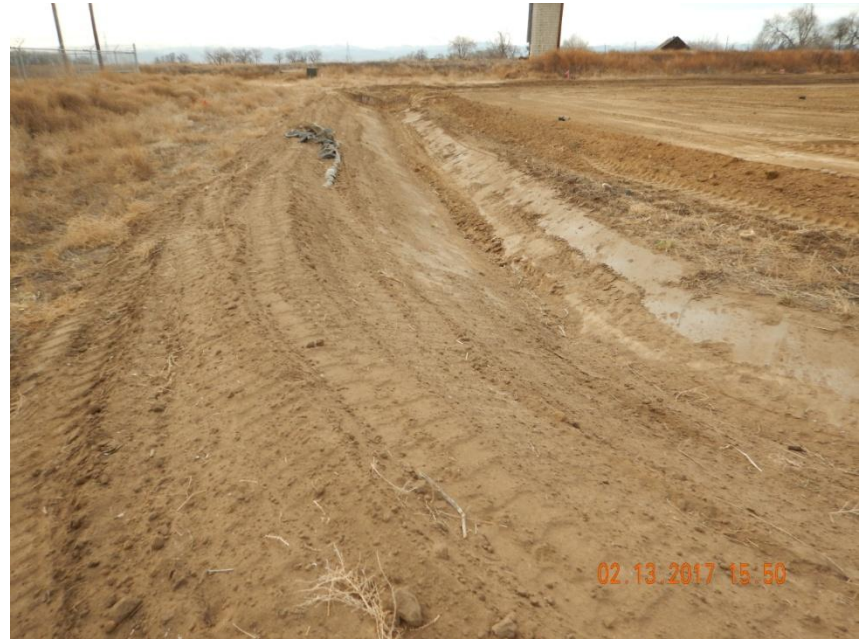
Photo 4. Photo taken from the southern location, facing West. Ditch and berm BMP installed around perimeter of location.

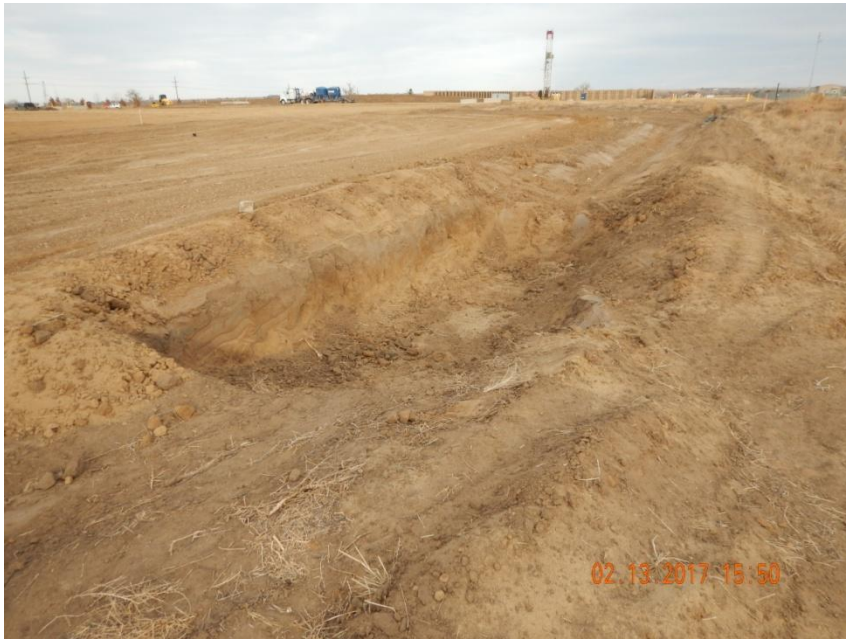
Photo 5. Photo taken from the southwest location, facing East. Sediment trap is IN-PROCESS of being constructed.

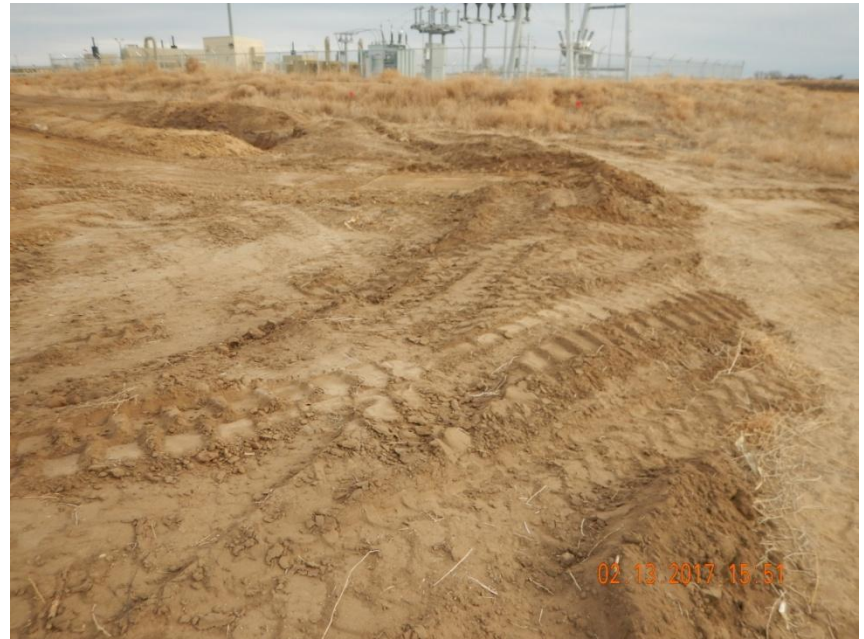
Photo 6. Photo taken from the southwest location, facing South. Ditch and berm BMPs appears to be damaged from equipment traffic. Need to repair BMP per Rule 1002.f.

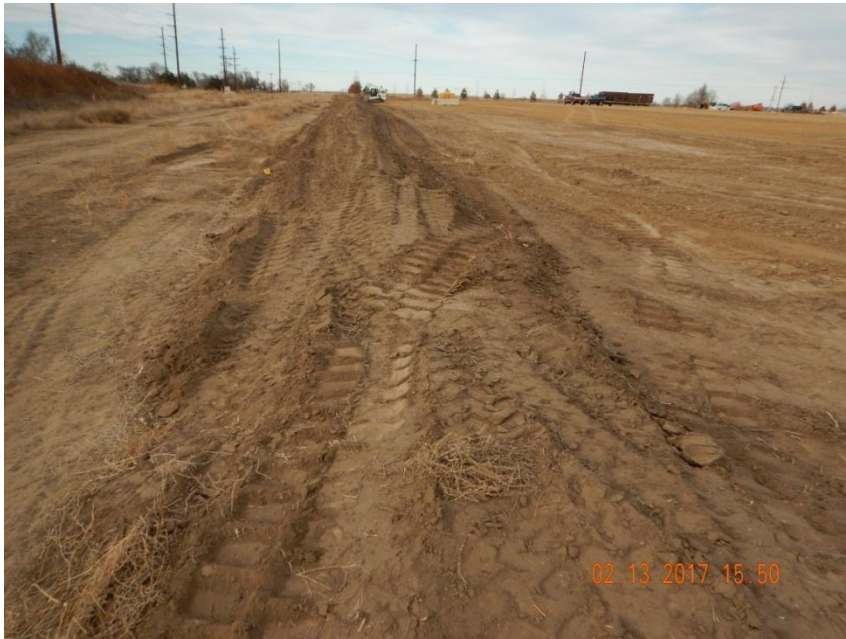
Photo 7. Photo taken from the southwest location, facing North. Ditch and berm BMP installed along perimeter of location. Ensure all portions of the berm are properly compacted to manage pollutant contributions to stormwater runoff from unconsolidated soil material.

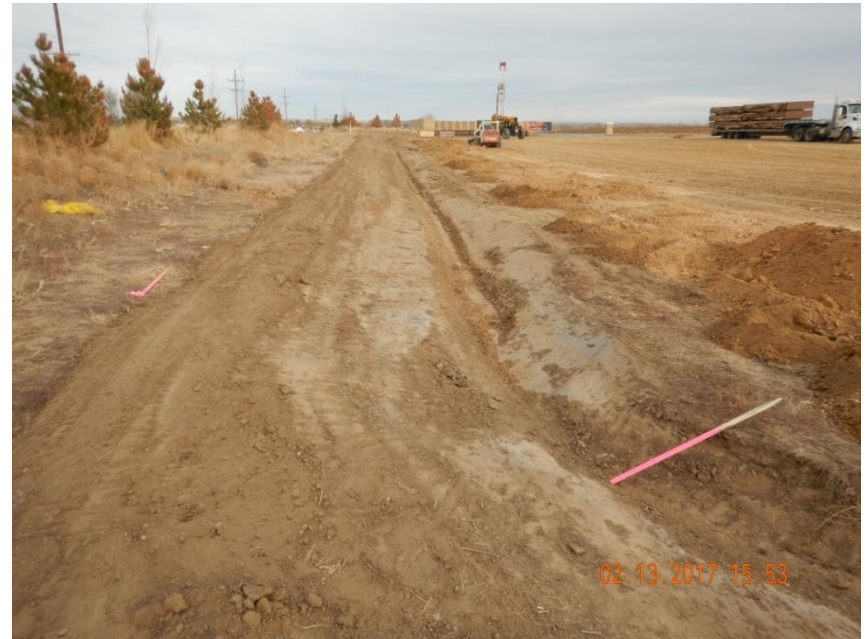
Photo 8. Photo taken from the northwest location, facing East. Ditch and berm BMP installed along perimeter of location.

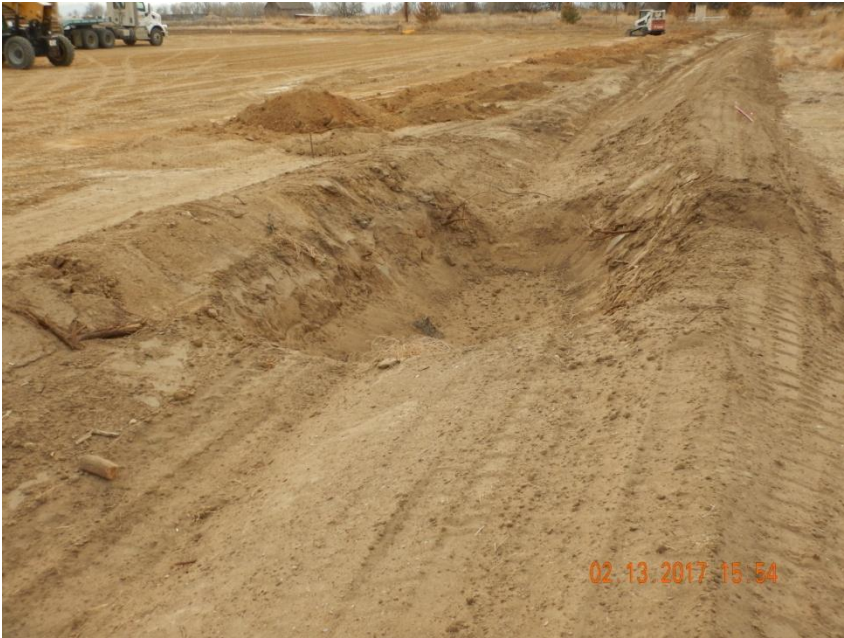
Photo 9. Photo taken from the northern location, facing West. Sediment trap is IN-PROCESS of being constructed.
