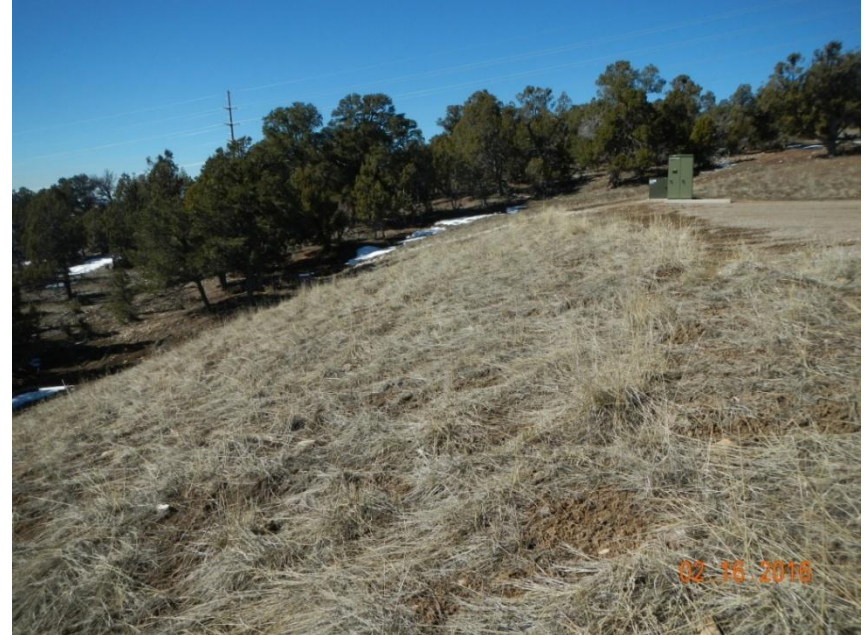
Photo 2: View of the southern portion of the project area from the southeastern corner facing westward. Revegetation is largely comprised of grasses such as western wheatgrass (*Pascopyrum smithii*) and Intermediate wheatgrass (*Thinopyron intermedium*), and smooth brome (*Bromus inermis*).

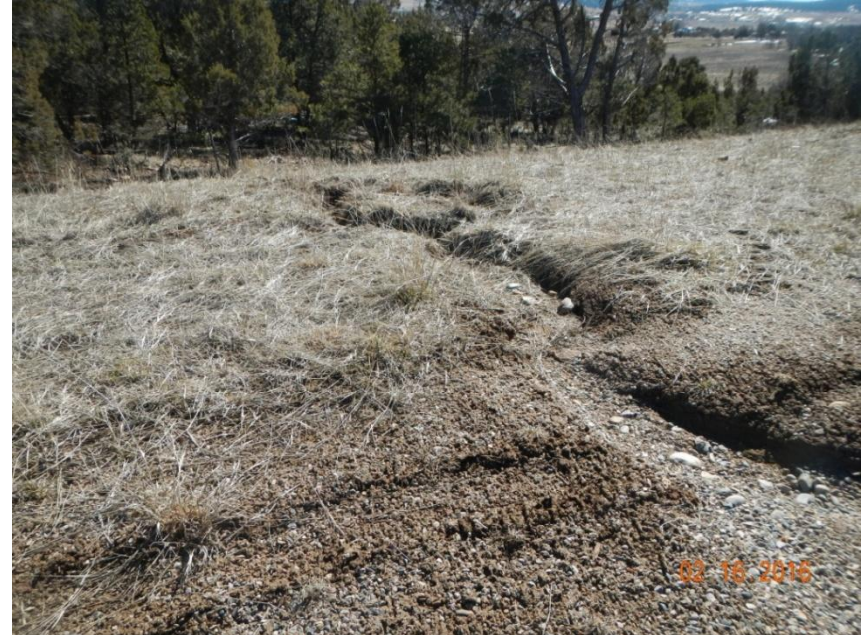
Photo 4: View of an erosional channel approximately 1.5 feet wide and up to 2 feet deep in the eastern portion of the project area.

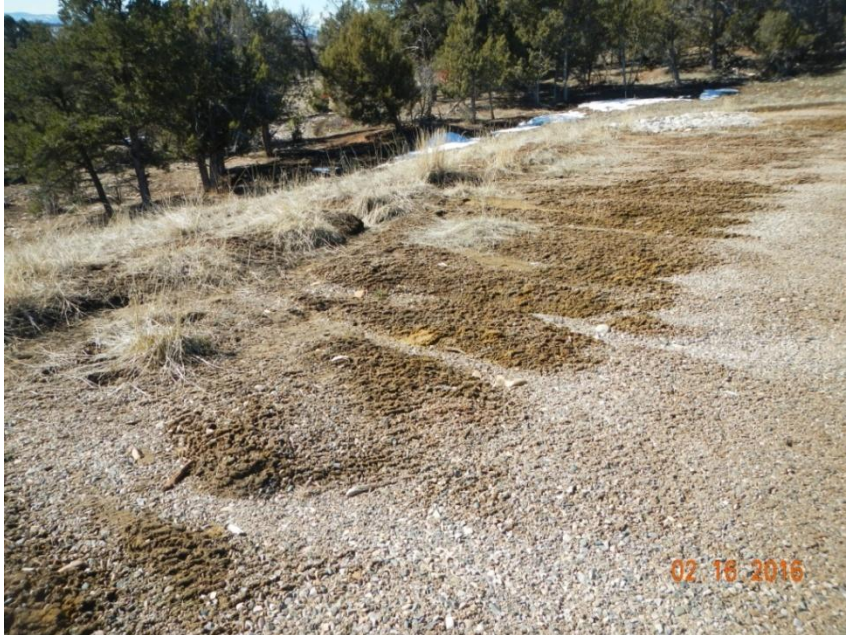
Photo 5: View of rills along the southern edge of the working area where concentrated stormwater flows into the interim reclamation area.

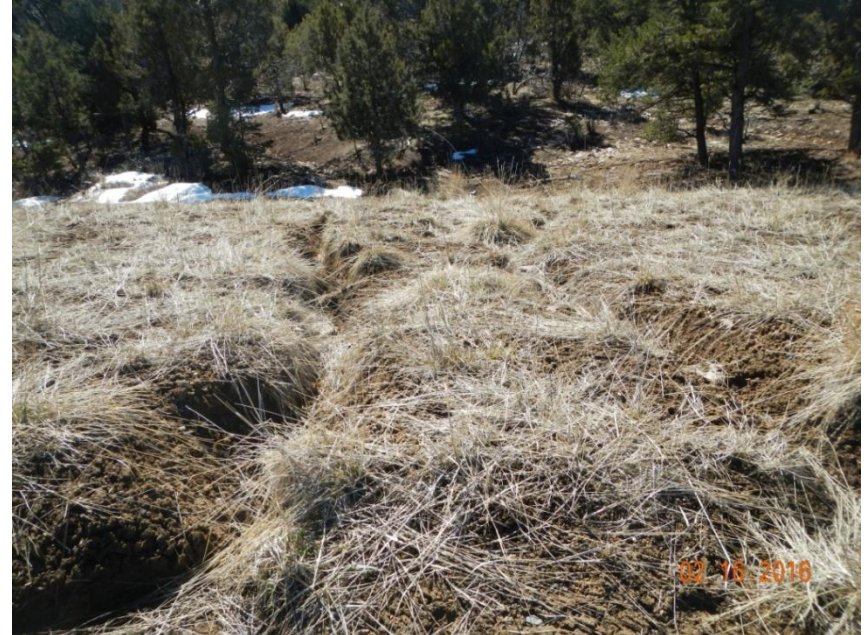
Photo 6: View erosional channels in the southern portion of the project area.

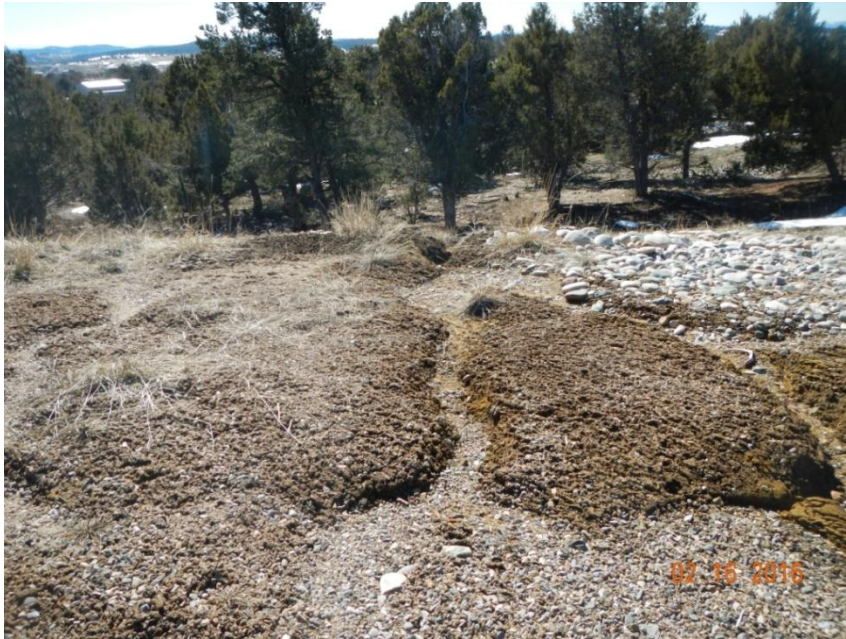
Photo 7: View of erosional controls eroding the southwestern portion of the interim reclamation area.

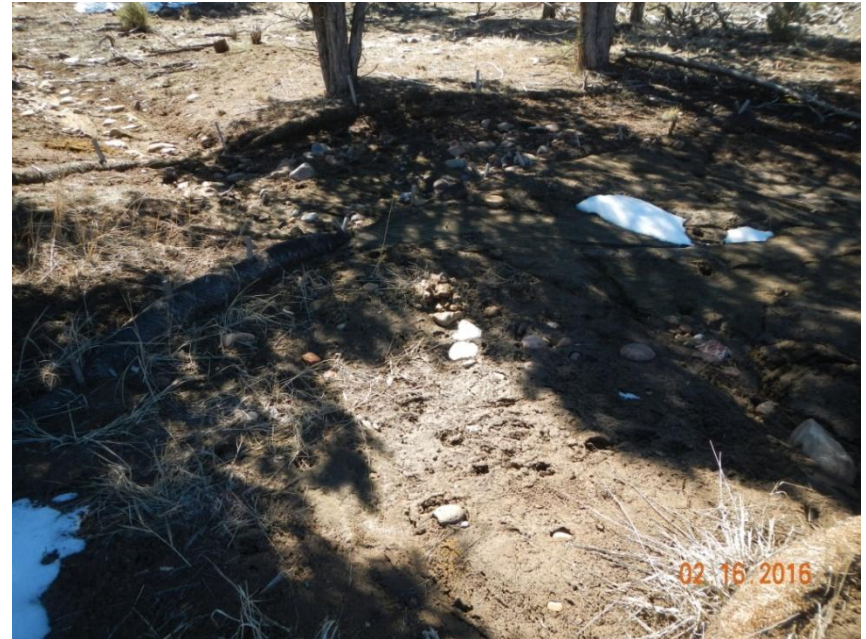
Photo 8: View of wattles along the southern edge of the project area that are full of sediment and no longer functioning.
