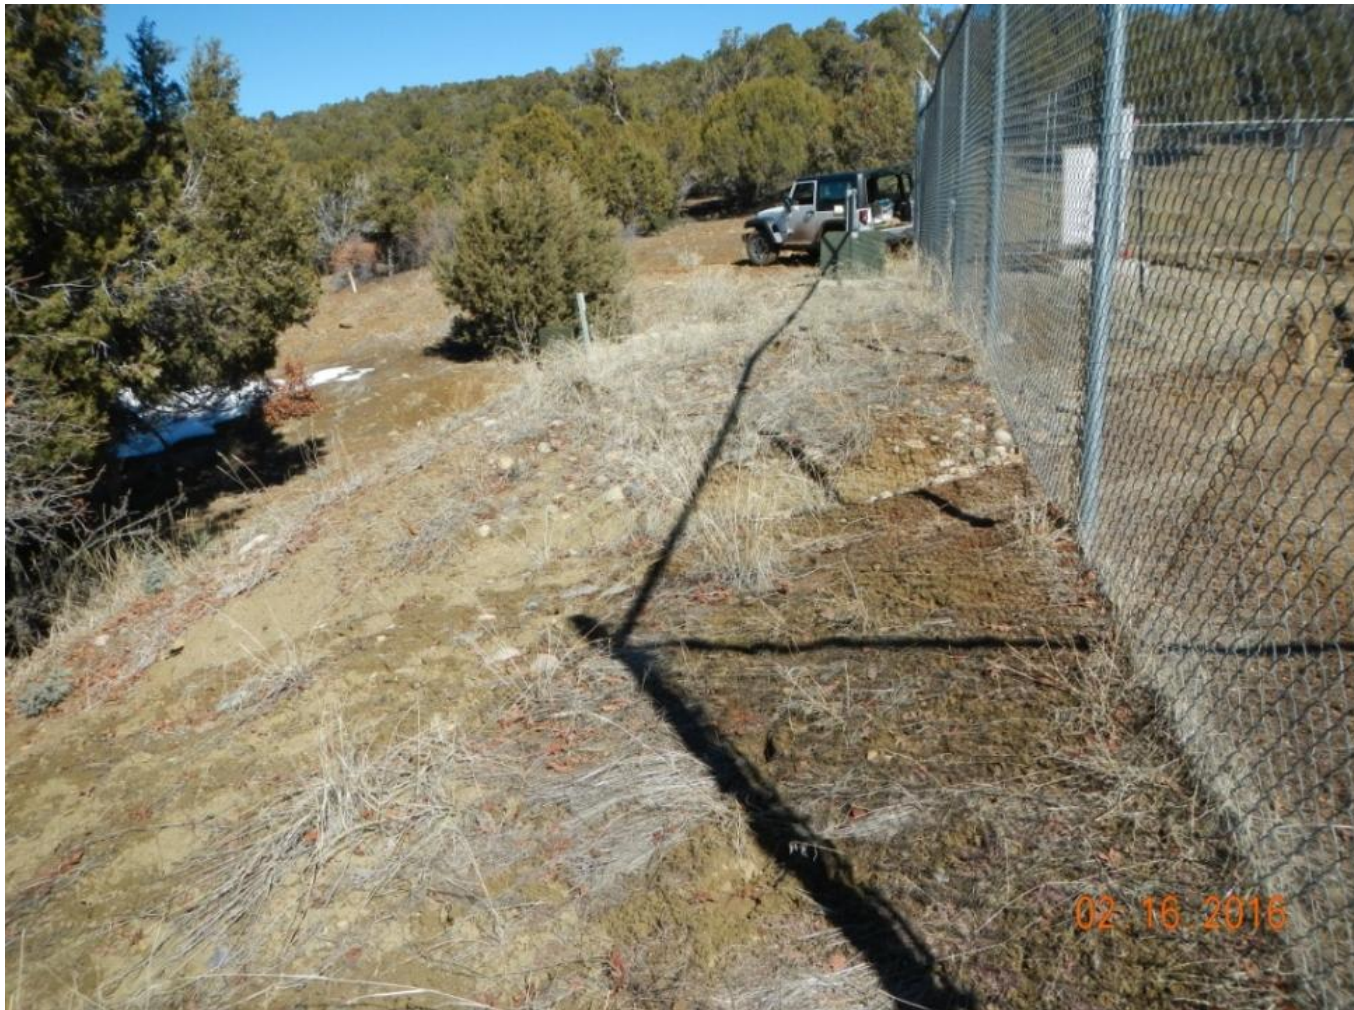
**Photo 1: View of the western portion of the project area from the southwestern corner facing northward. Erosional channels are forming along this border. Revegetation is progressing and largely comprised of grasses such as Indian ricegrass (*Achnatherum hymenoides*), dropseed (*Sporobolus* sp.), and weeds such as cheatgrass (*Bromus tectorum*).**

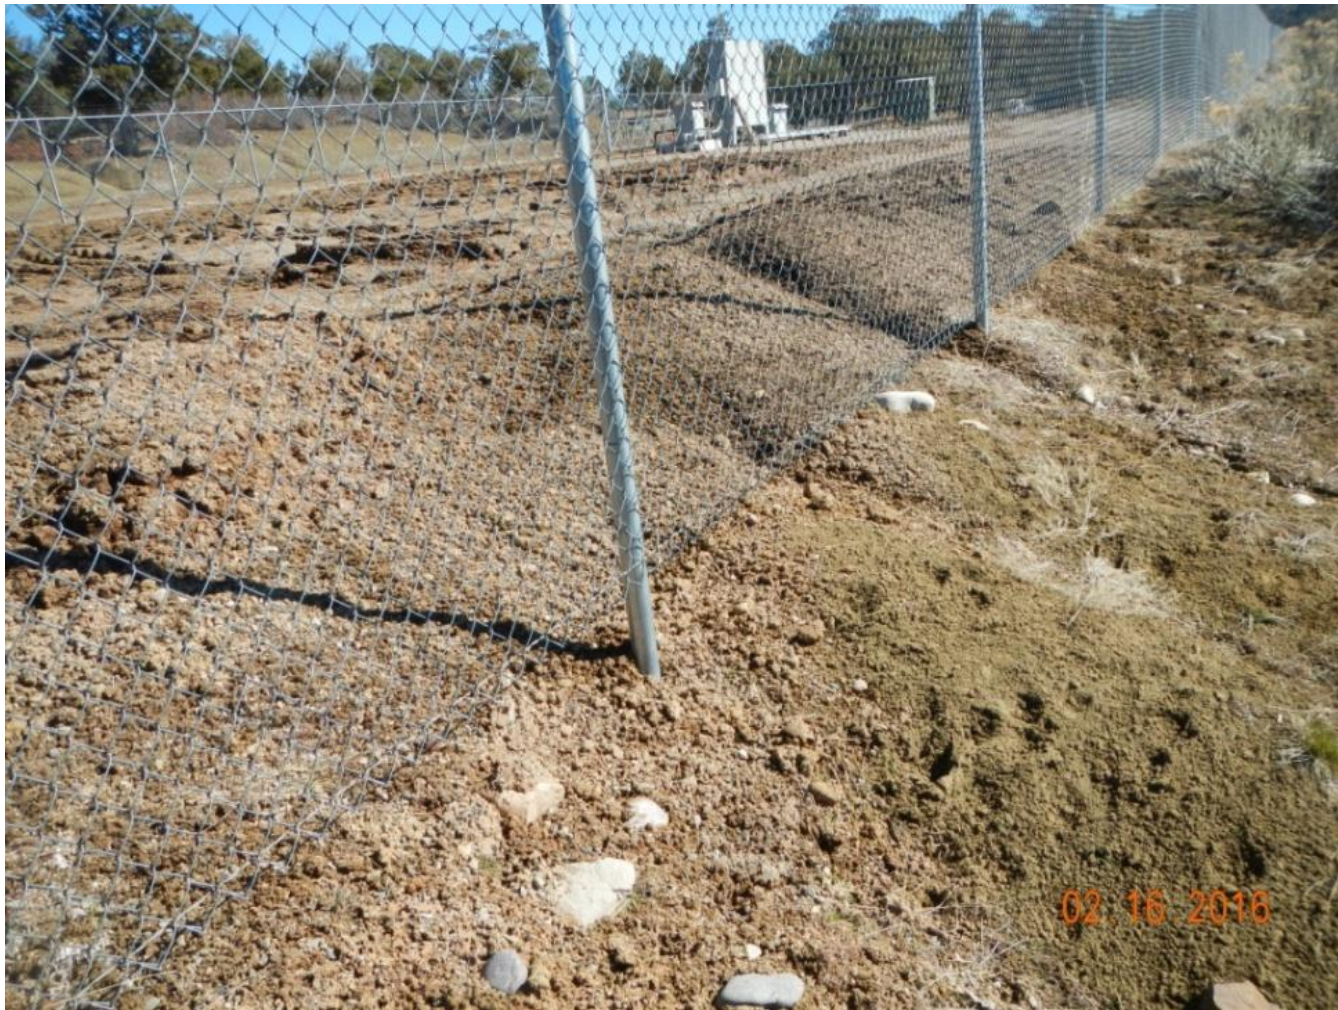
**Photo 2: View of erosional channels forming in the southwestern portion of the project area from the southwestern corner facing northeastward.**

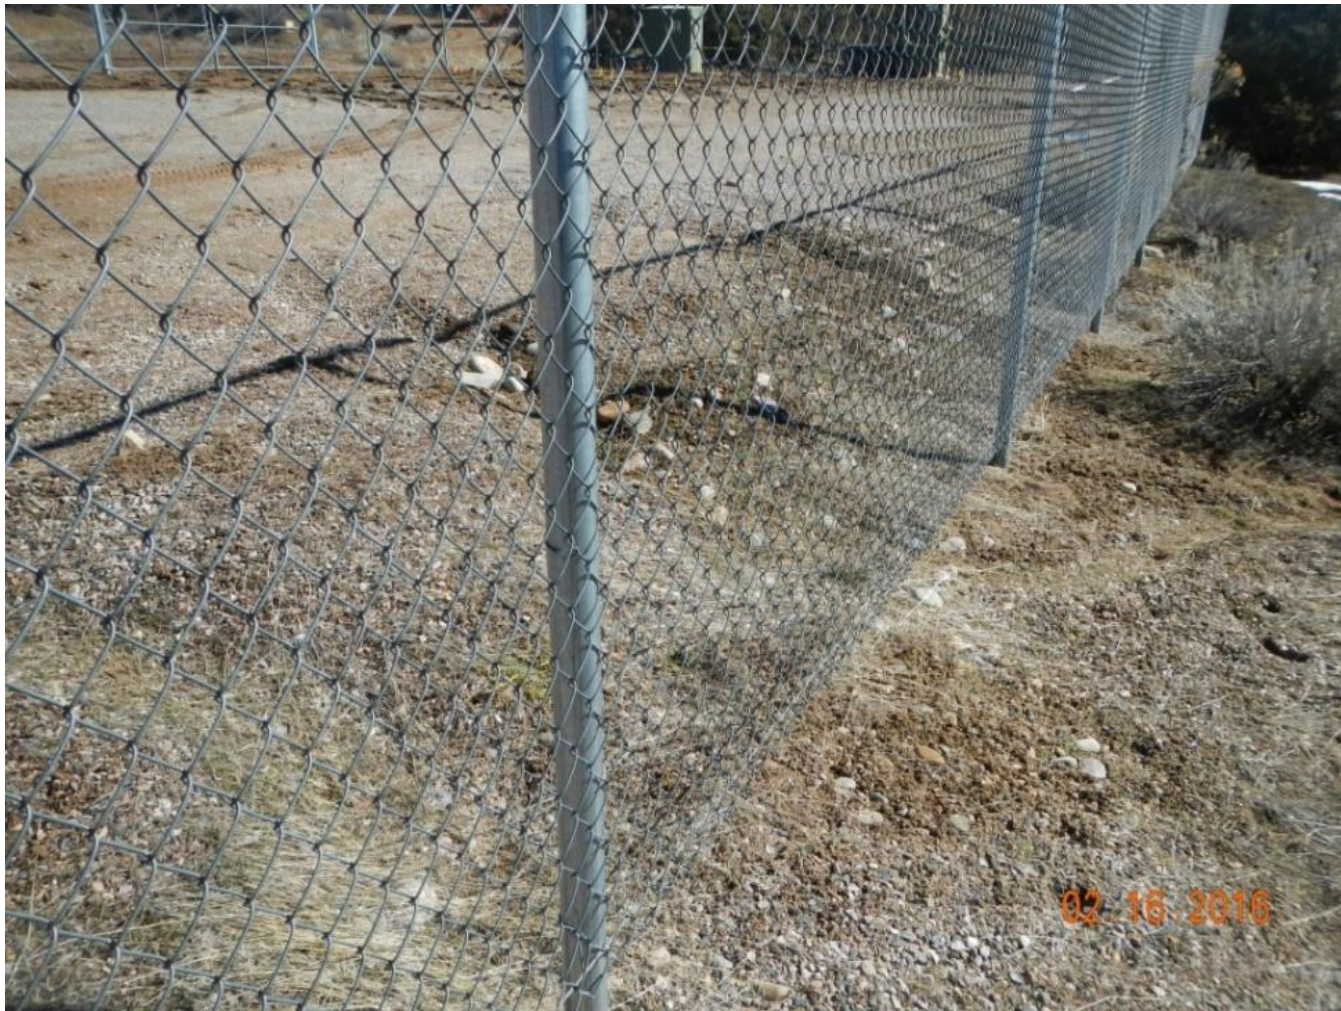
**Photo 3: View of erosional channels forming in the southeastern portion of the project area.**

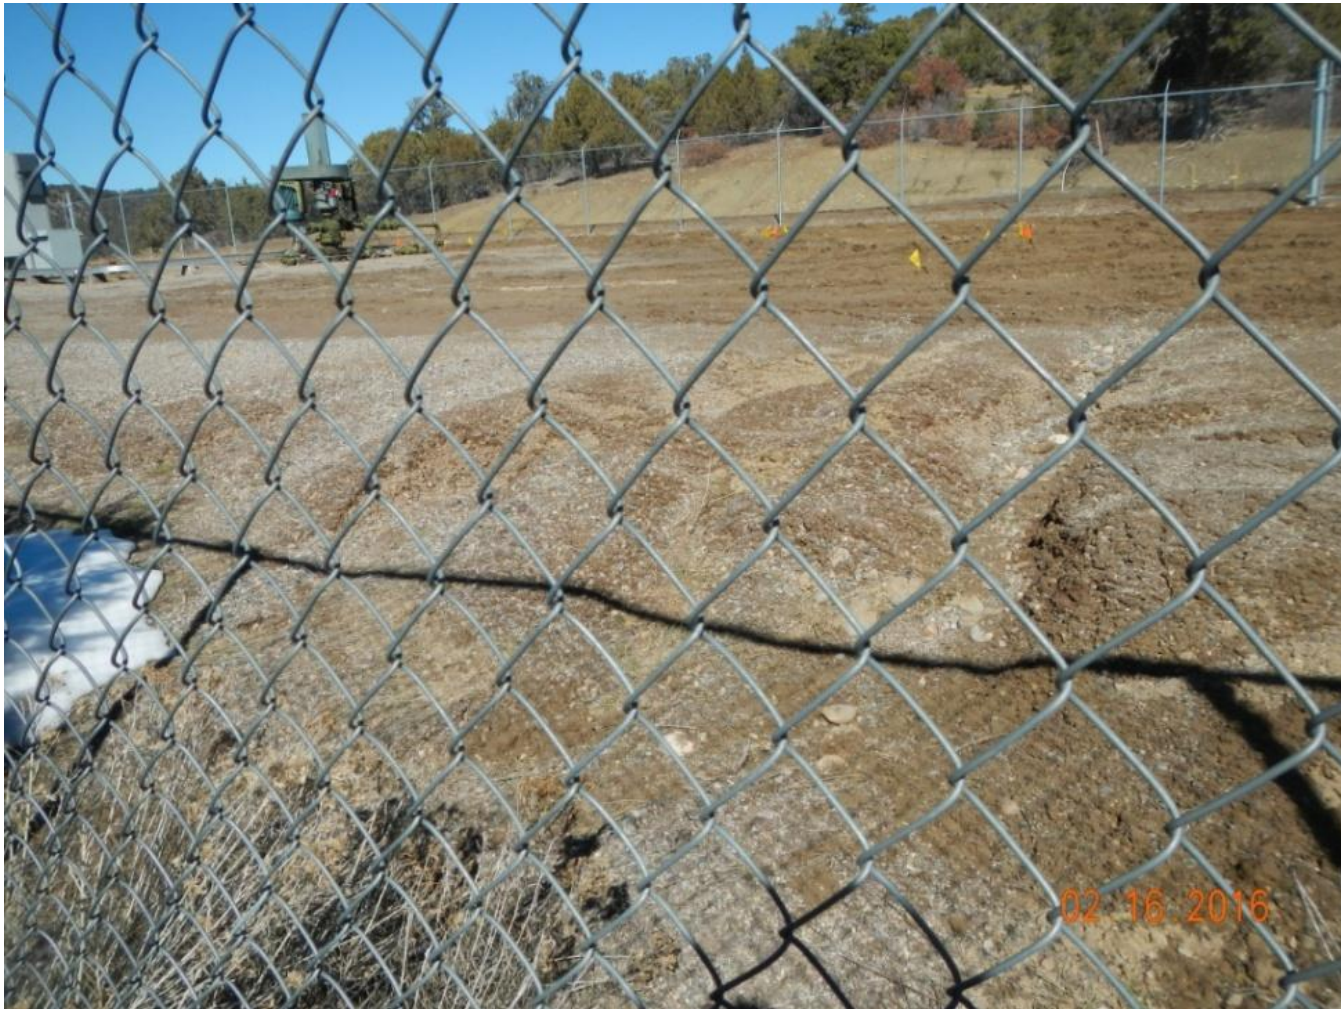
**Photo 4: View of area in the southern portion of the working area where concentrated stormwater flows off of the well pad.**
