SUNDRY NOTICES AND REPORTS ON WELLS

8. Well Name and No. **West Salt Creek - Federal 4-17**

Final Reclamation Inspection/Monitoring - Environmental

Chevron's West Salt Creek Fed 4-17 Well Inspections

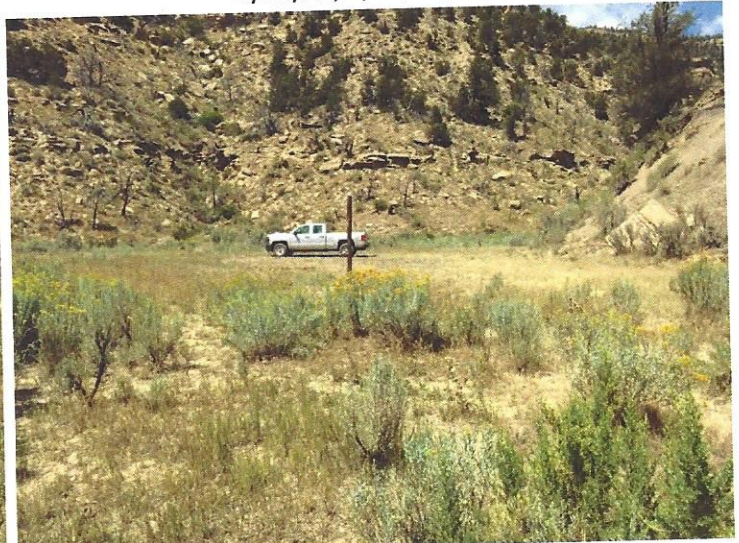
8/19/16 – Views of site from east edge with established veg – sagebrush, rabbitbrush & broom snakeweed, desirable grasses with some cheatgrass.

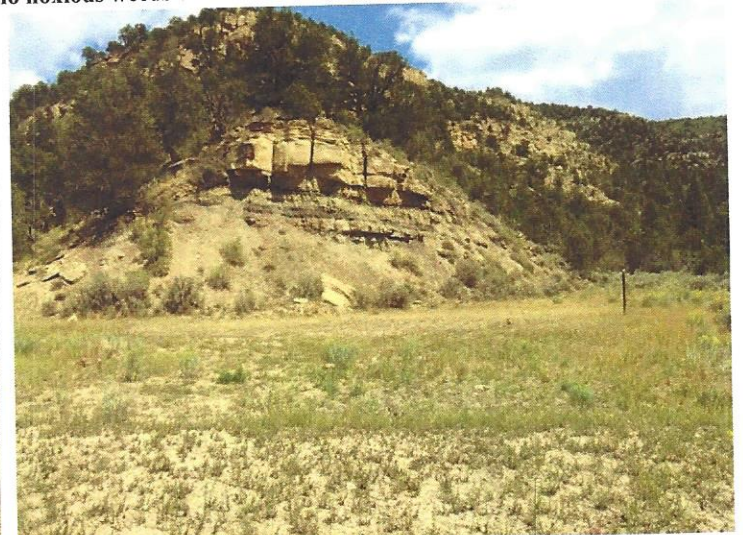
8/19/16 - Exposed cut matches the natural landscape. Berm in foreground at right directs surface flows away from road entrance.

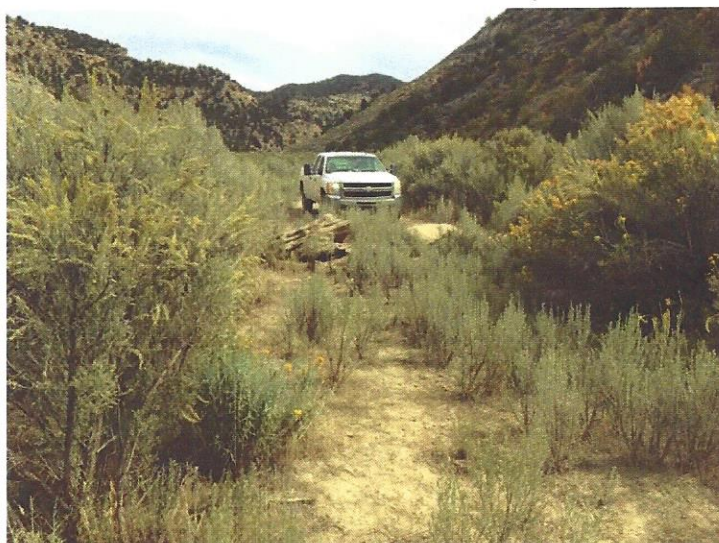
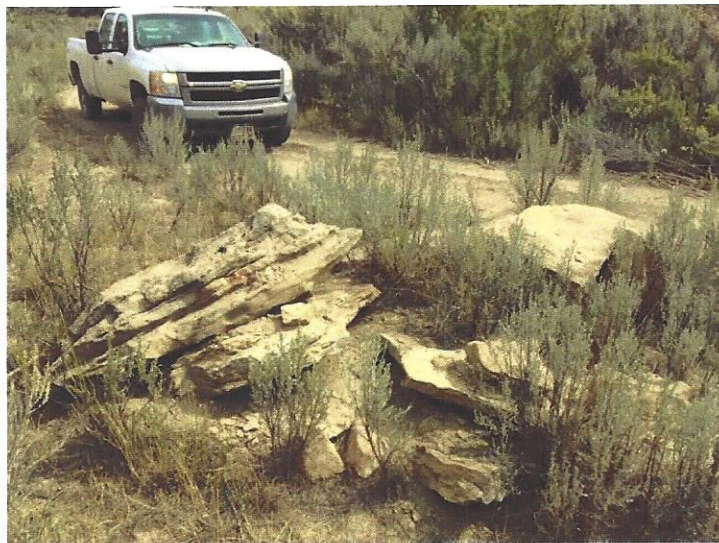
9/21/16 – Access road near Baxter Pass Road was blocked with rocks; public has developed road around the boulders. Checking the GJFO Travel Plan, the access road to well site is designated to remain open for public use. Operator used backhoe to remove boulders & install water bars along entire route to the pad site. Big storm hit the area after road work was completed, creating deep channeling in short sections of road.

I asked operator to complete some road maintenance work on the access road to provide water bars for drainage and restore the road to a primitive route. This was accomplished in acceptable manner by Dave Lefever. It should be noted that during the road work, a strong localized thunderstorm struck the area and created deeper channels in the road from the debris flows.

These channels now contribute to some of the primitive nature of the road. The water bars are functioning and over time, the ditching and channeling (filled with rocks and boulders) will hopefully retard some of the natural erosion that occurs with the summer thunderstorms.

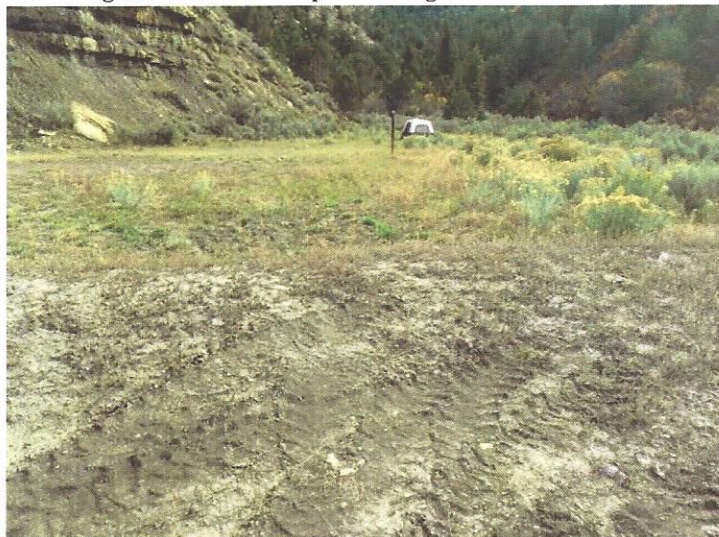
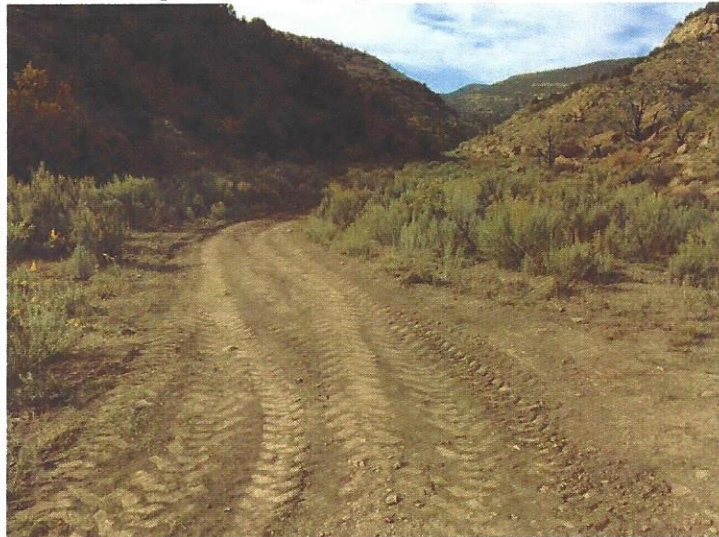
10/11/16 – Example of road maintenance work completed by D. Lefever with backhoe including berm reinforcement at left.

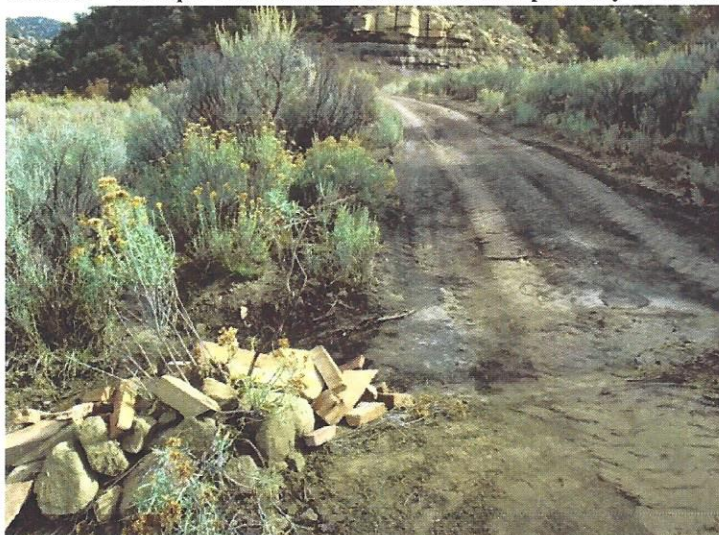
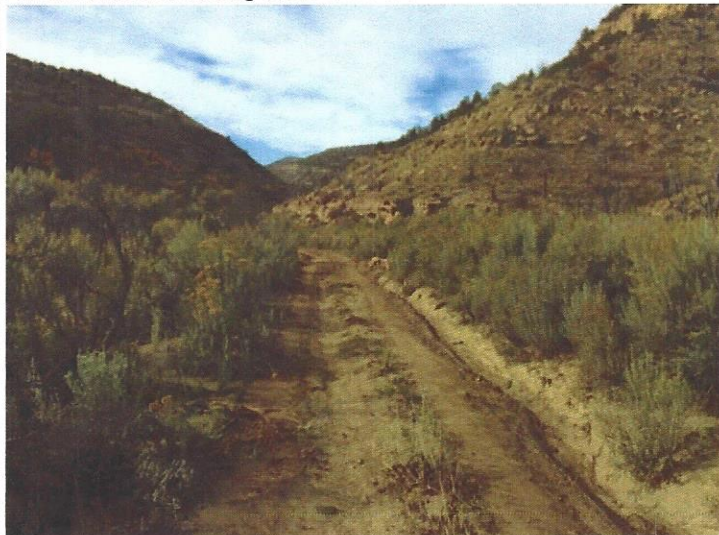
10/11/16 – Water bar established directly west of well site with rocked outlet. Use of erosion as a storm water ditch w/ water bar in background.
