Complaint #200440901

Interim Reclamation Inspection

January 13 & 20, 2017

Operator: Kerr McGee Oil & Gas ONSHORE LP - #47120

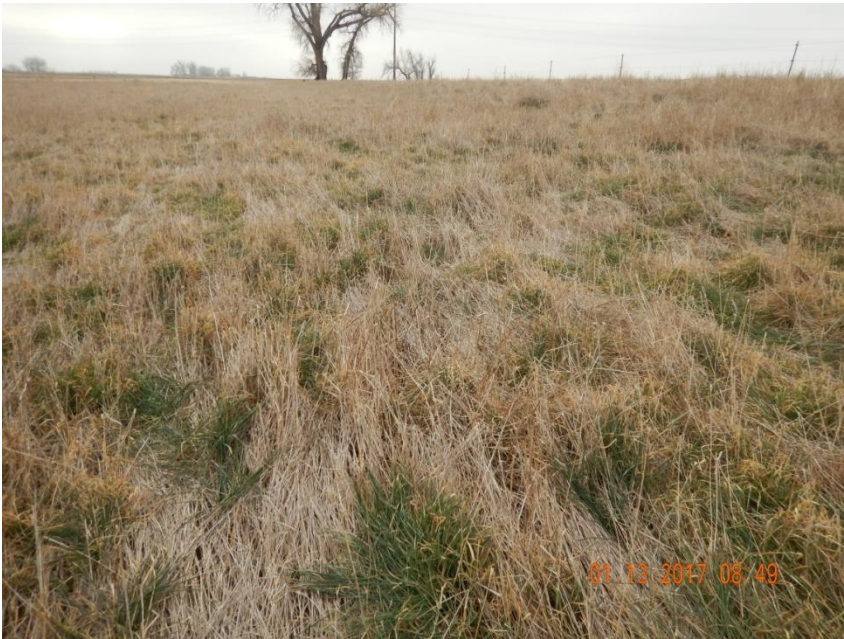
Photo 1. Photo taken from the northwest release area, facing South. Wheat grass mix observed with little, to no, smooth brome.

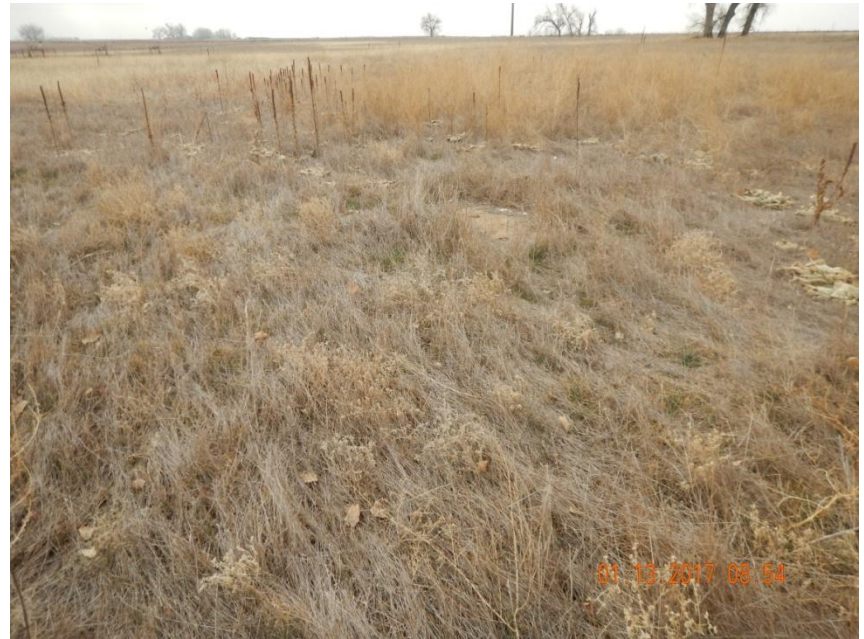
Photo 2. Photo taken from the northern release area, facing South. Wheat grass mix observed with little, to no, smooth brome.

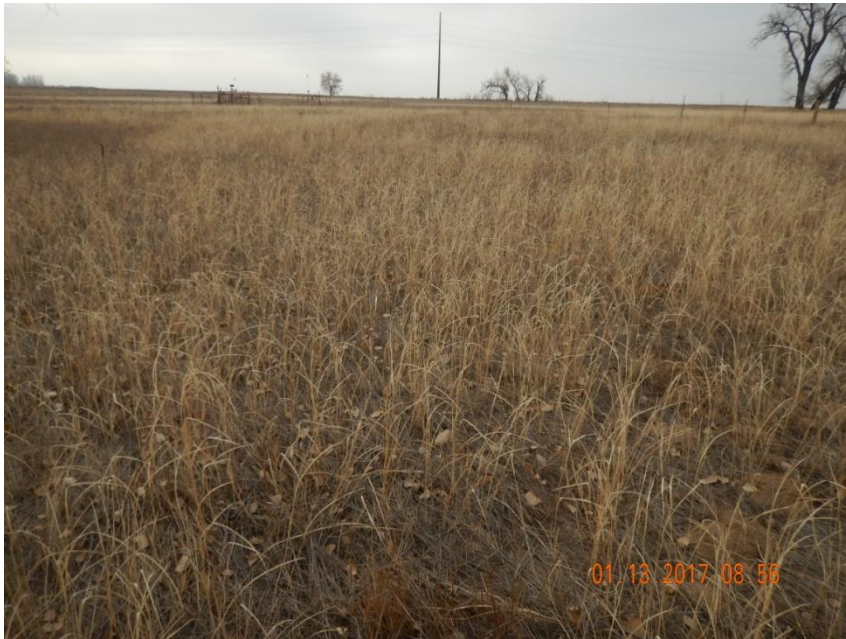
Photo 3. Photo taken from the northeastern release area, facing South. Predominantly Sand dropseed, with little, to no, smooth brome.

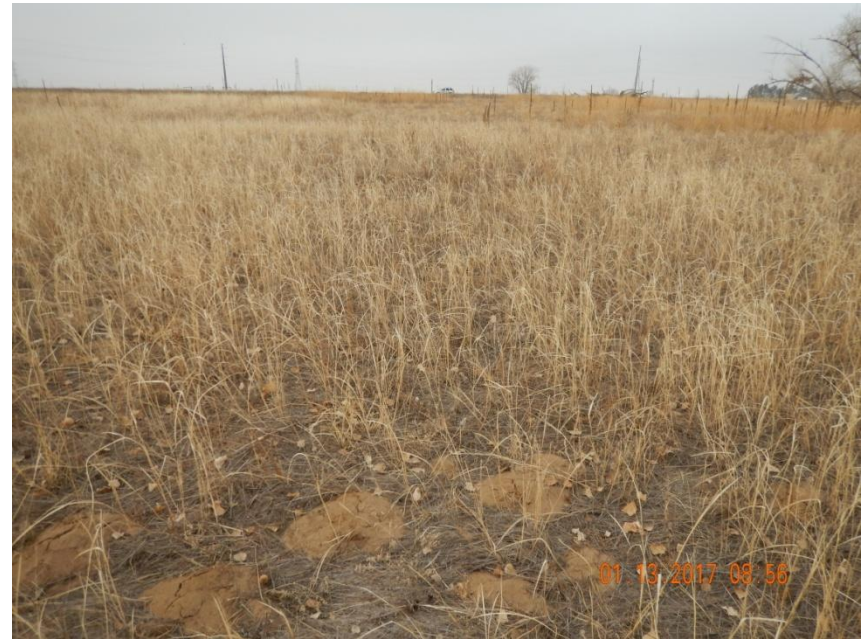
Photo 4. Photo taken from the northeastern release area, facing West. Predominantly Sand dropseed, with little, to no, smooth brome.

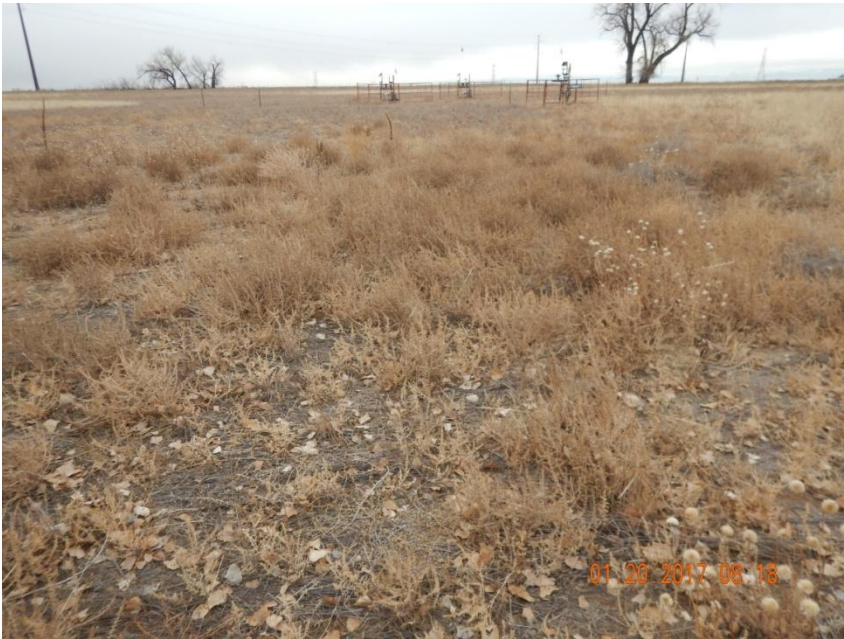
Photo 5. Photo taken northeast of the Turner well, facing Southwest. Kochia and Russian thistle are the dominant vegetative plant cover in this area.

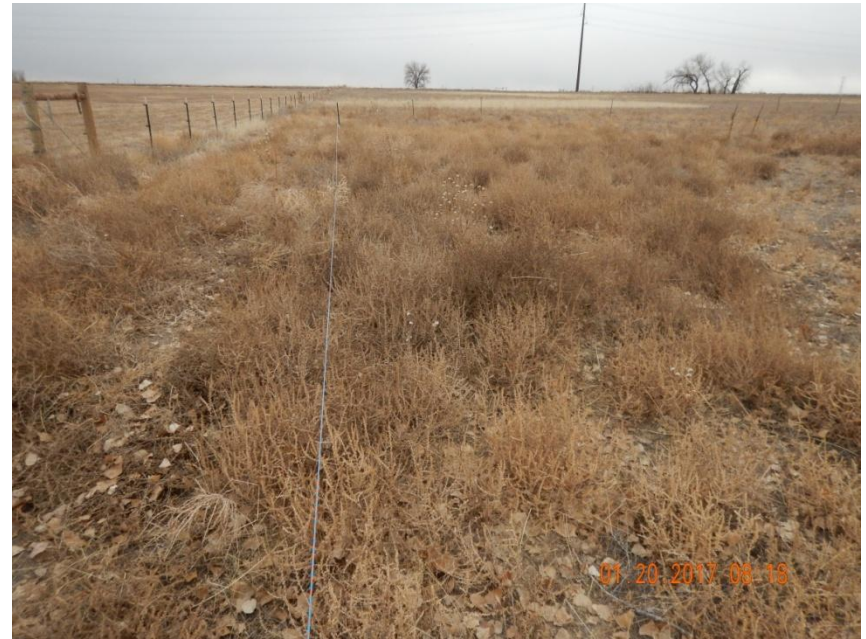
Photo 6. Photo taken northeast of the Turner well, facing South. Kochia and Russian thistle are the dominant vegetative plant cover in this area.

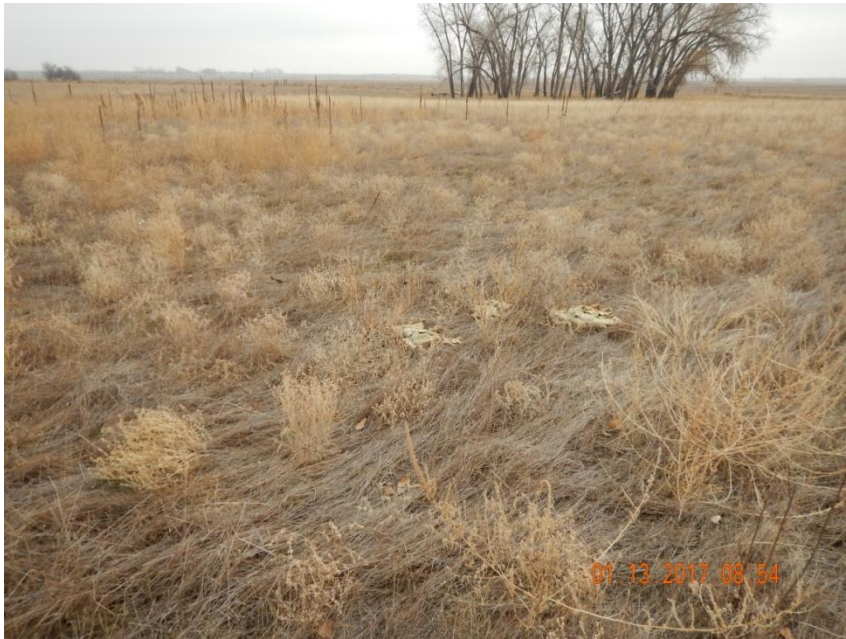
Photo 7. Photo taken north of the Turner well, facing North. Wheat grass mix observed with little, to no, smooth brome.

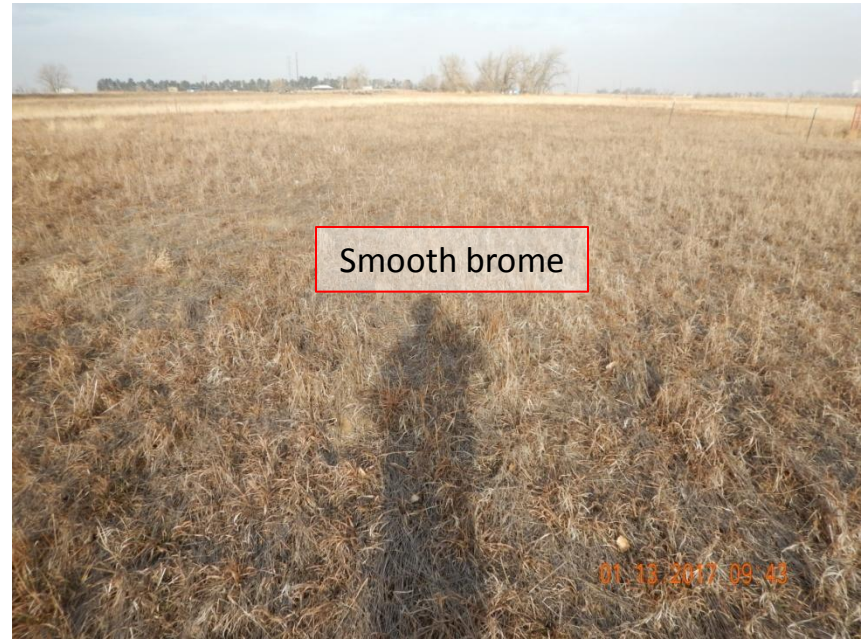
Photo 8. Photo taken southwest of the Turner well, facing North. Smooth brome is the primary vegetative species throughout this area.

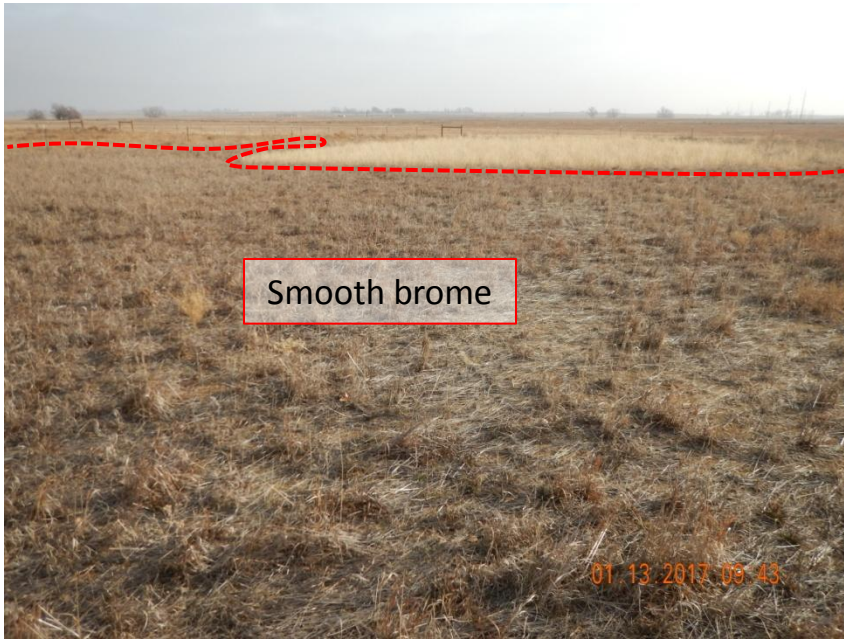
Photo 9. Photo taken south of the Turner well, facing East. Smooth brome is the primary vegetative species throughout this area. However, there is a distinct line where Sand dropseed and a wheat grass mix is growing along the eastern property boundary.

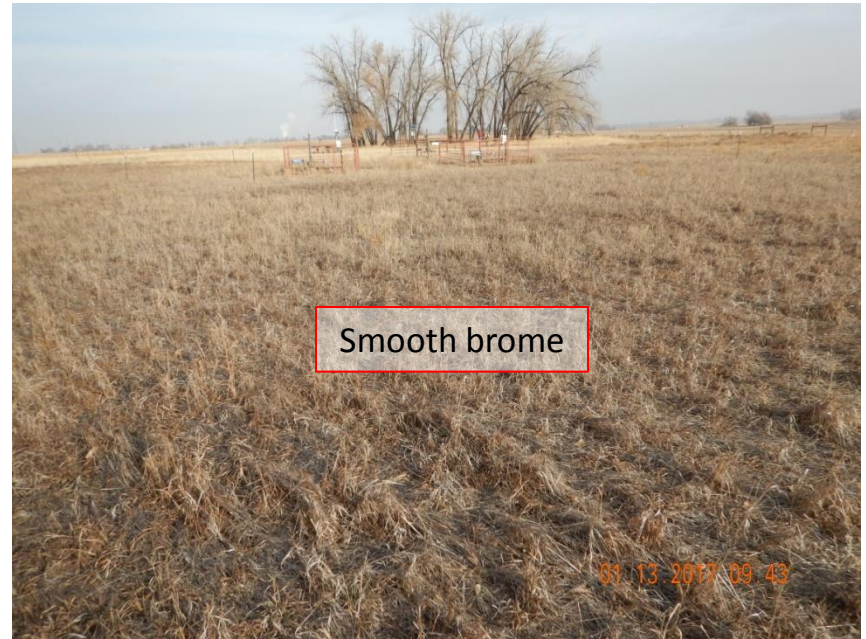
Photo 10. Photo taken south of the Turner well, facing North. Smooth brome is the primary vegetative species throughout this area.

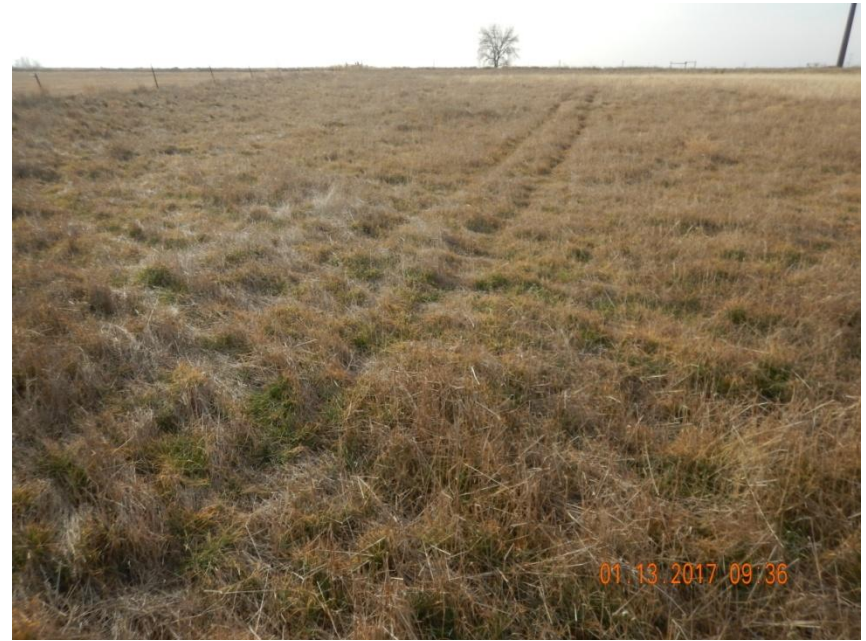
Photo 12. Photo taken from the eastern release area, facing South. Wheat grass mix observed that continues along the eastern property boundary until the southern property boundary with little, to no, smooth brome.

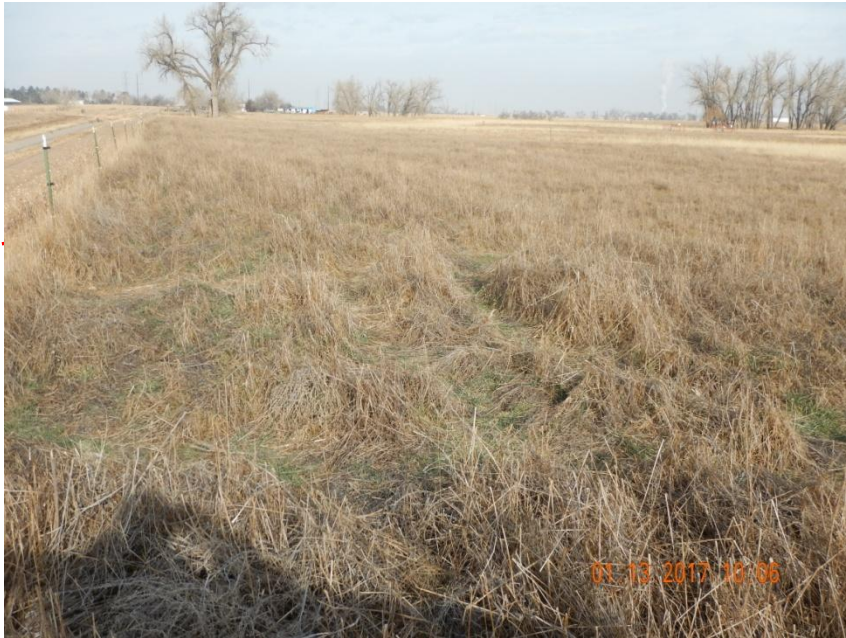
Photo 13. Photo taken from the southwest release area along the property boundary, facing North. Wheat grass mix observed with little, to no, smooth brome.

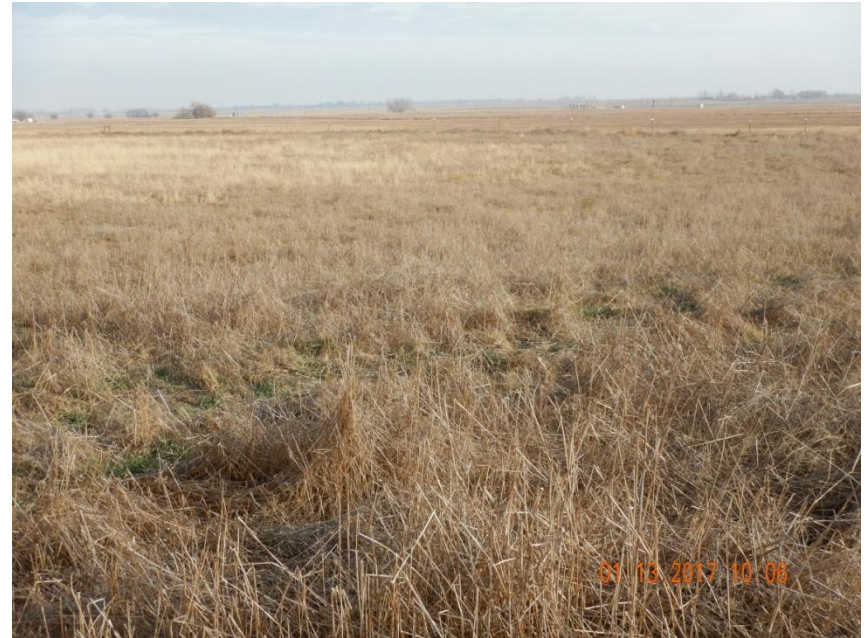
Photo 14. Photo taken from the southwest release area along the property boundary, facing Northeast. Wheat grass mix observed with little, to no, smooth brome.
