# Interim Reclamation and Stormwater Inspection

February 27, 2017

Operator: CONOCO PHILLIPS COMPANY - # 19160

API: 005-07179

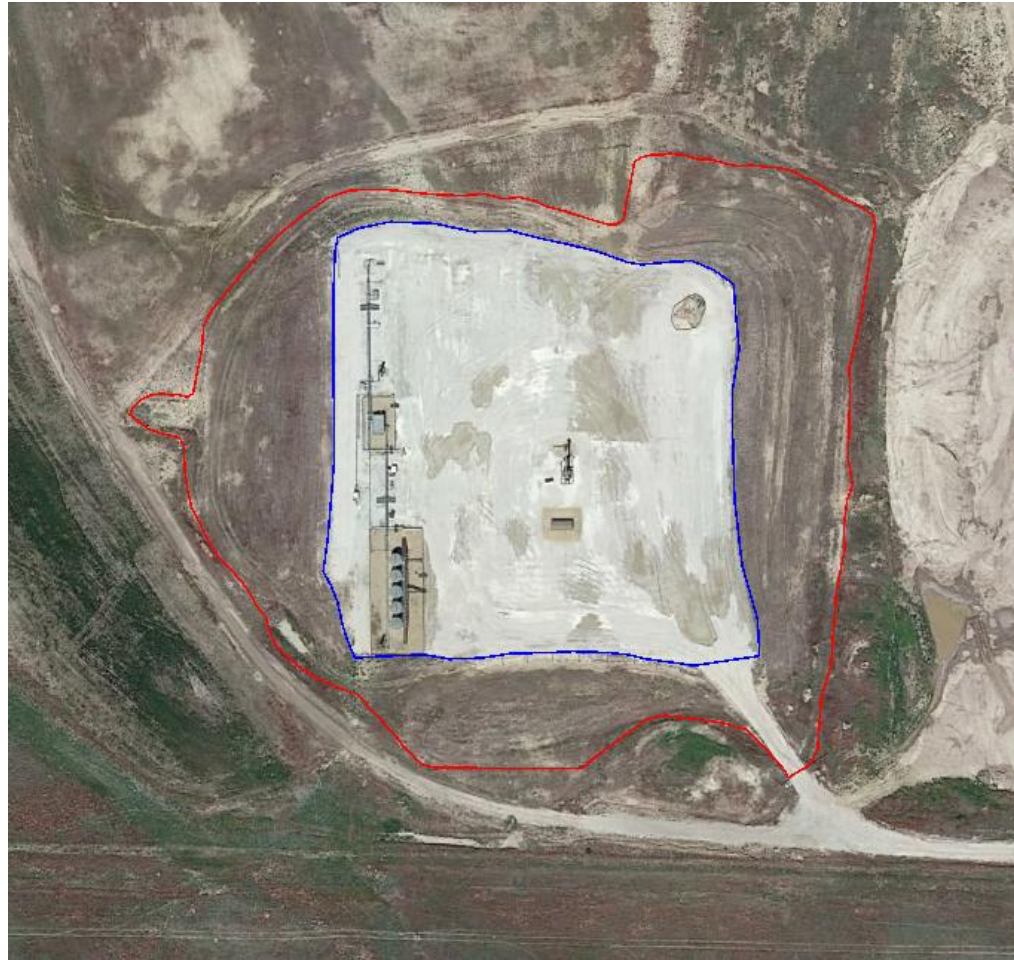
Google Earth aerial imagery taken June 14, 2016, and overlaid with field collected data on February 27, 2017 using a Trimble handheld GPS. Construction disturbance in red (6.87 acres) and current production area in blue (3.40 acres). The approved 2A was permitted for 5.10 acres of disturbance during construction.

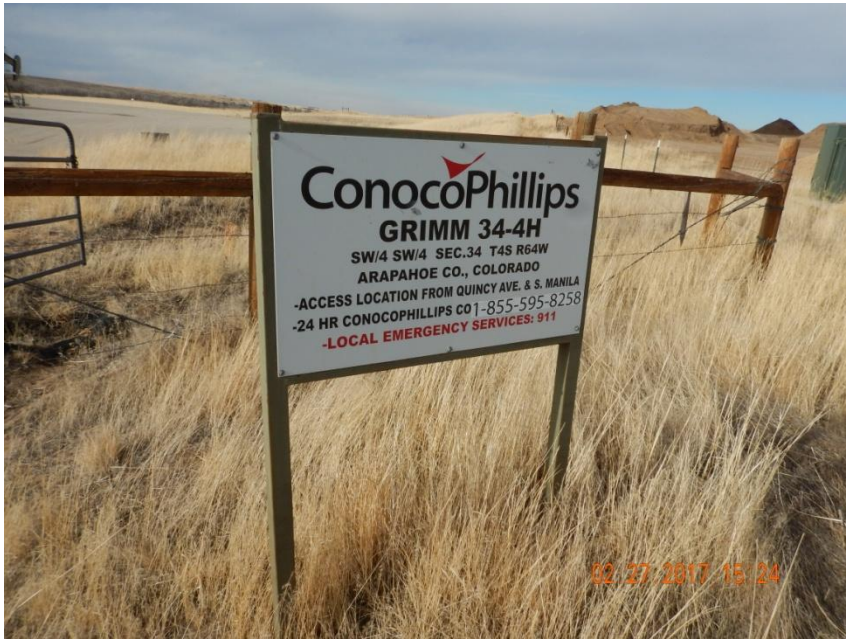
**Photo 1.** Photo of well sign at entrance of location.

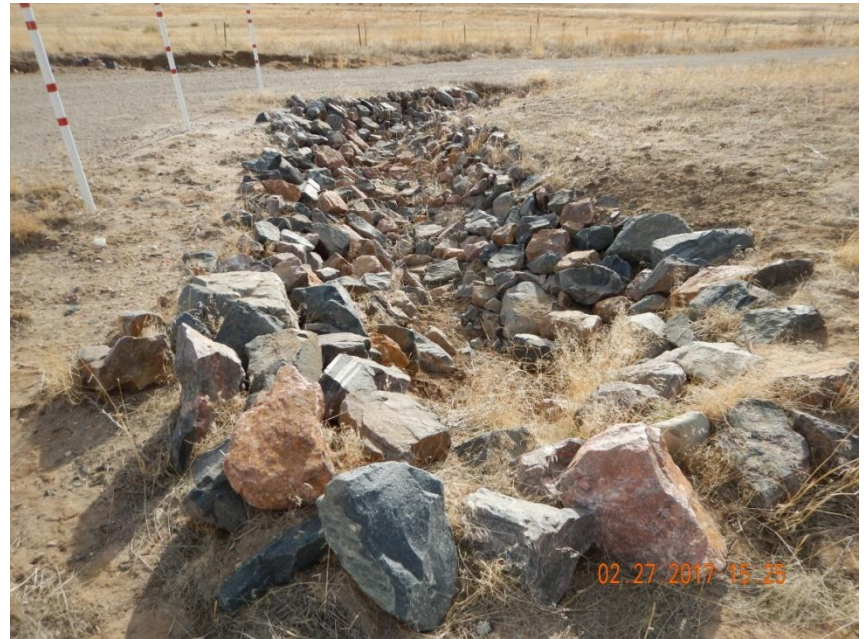
**Photo 2.** Photo taken from entrance of location, facing Southwest. Culvert installed with rip rap as outlet protection.

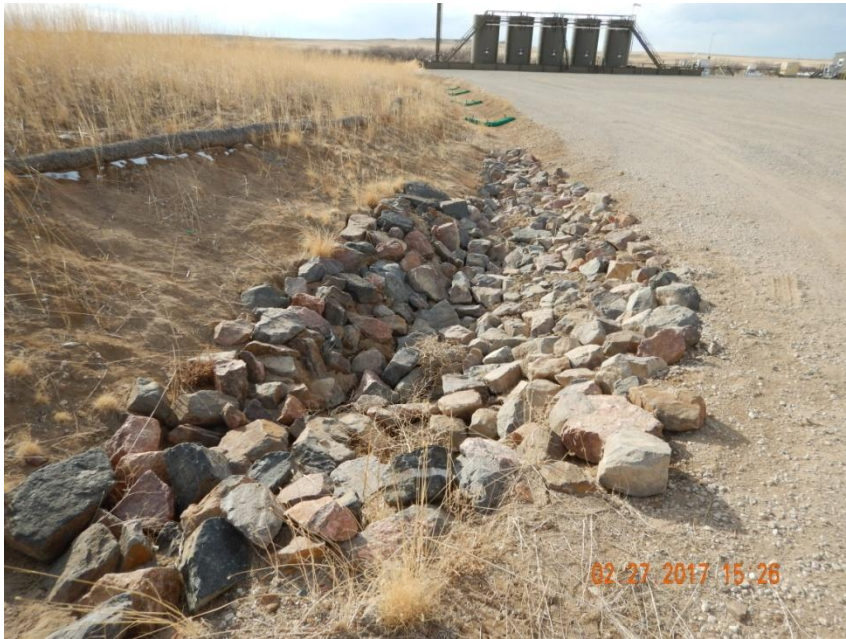
**Photo 3.** Photo taken from entrance of location along the current interim area, facing Northwest, towards the production area. Rip rap and wattles installed along the interim area and ditch BMP area.

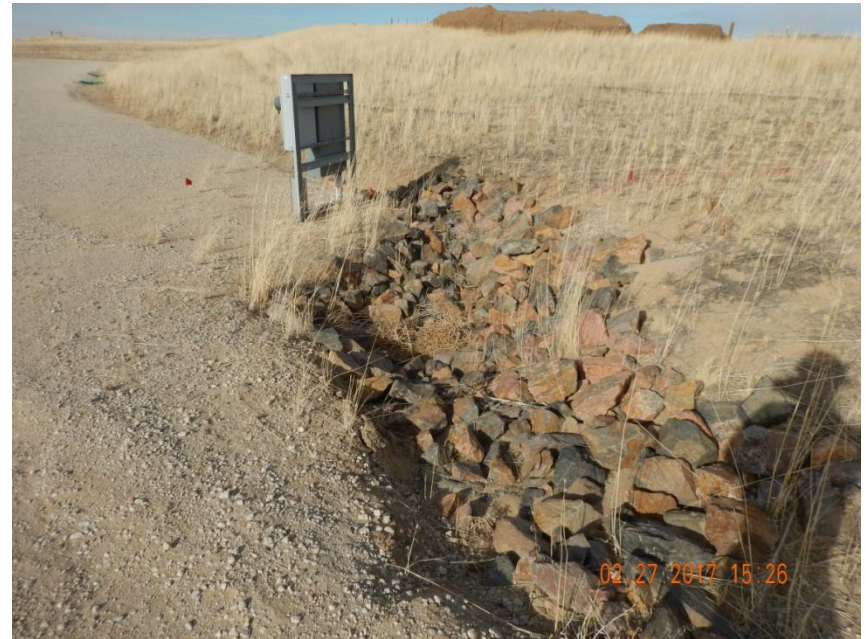
**Photo 4.** Photo taken from entrance of location along the current interim area, facing North. Culvert installed with rip rap as inlet protection.

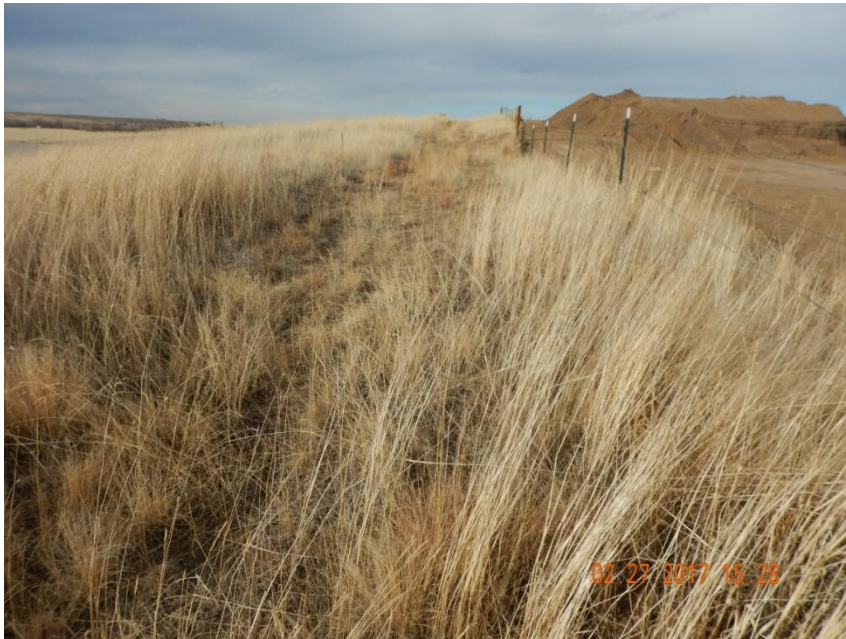
**Photo 5.** Photo taken from the southeast location along the current interim area, facing North. Wattles installed throughout the interim, west-facing slope area.

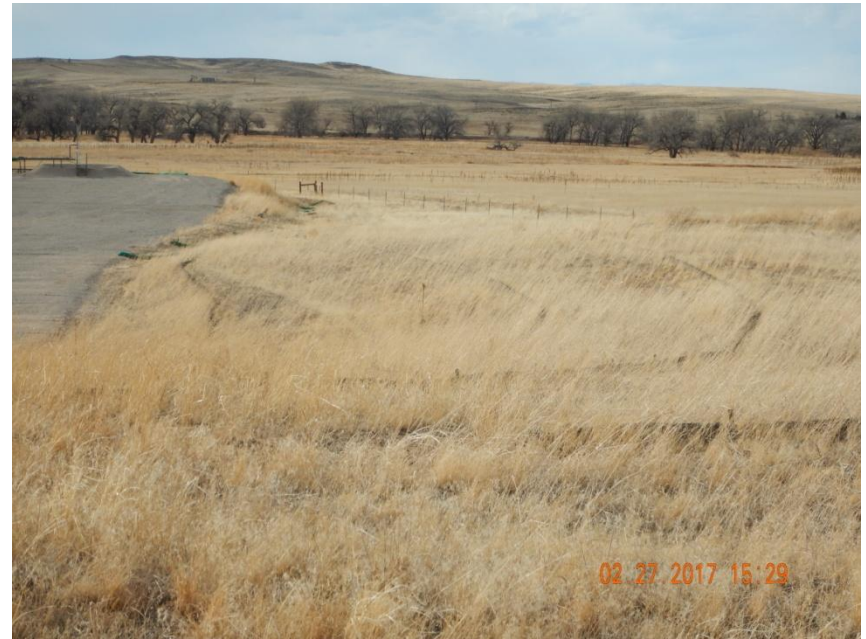
**Photo 6.** Photo taken from the northeast location along the current interim area, facing West. Wattles installed throughout the interim, south-facing slope area.

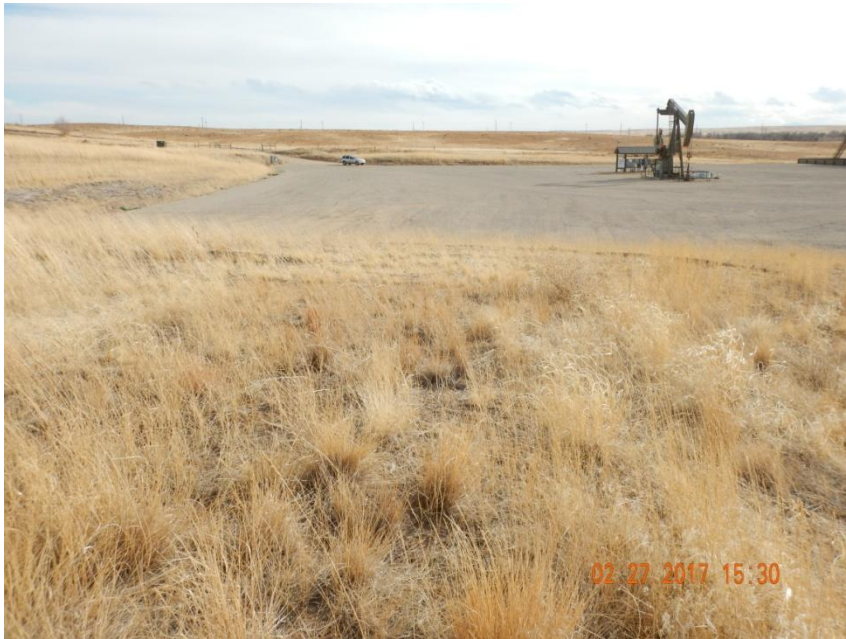
**Photo 7.** Overview photo taken from the northern location, facing South.

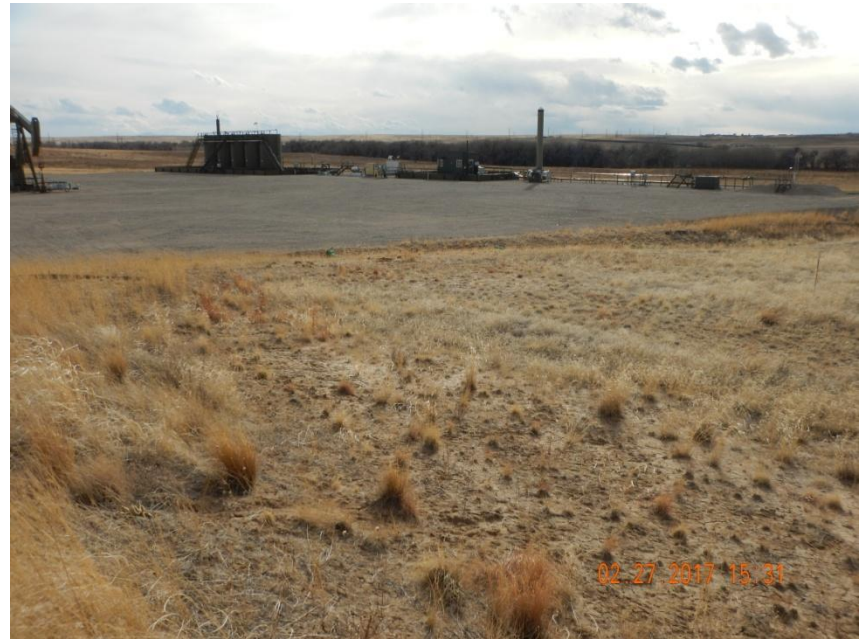
**Photo 8.** Overview photo taken from the northern location, facing Southwest.

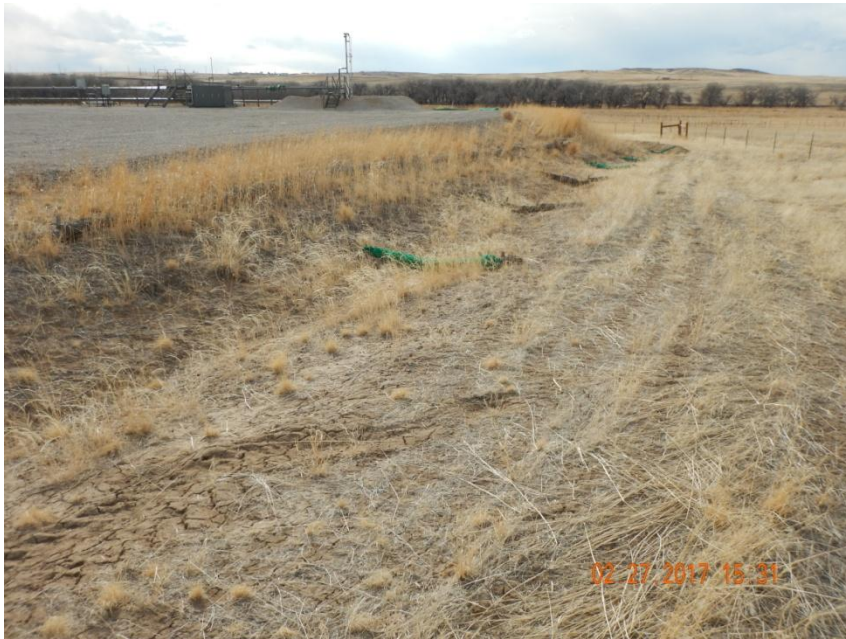
**Photo 9.** Photo taken from the northern location along the current interim area, facing West. Wattles installed throughout the ditch BMP area.

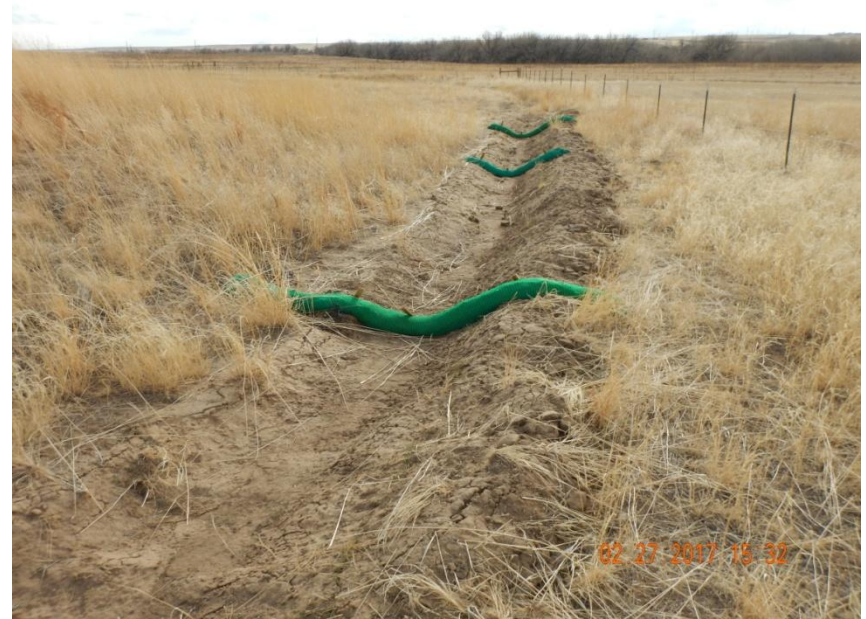
**Photo 10.** Photo taken from the northwest location along the current interim area, facing South. Wattles installed throughout the ditch BMP area.

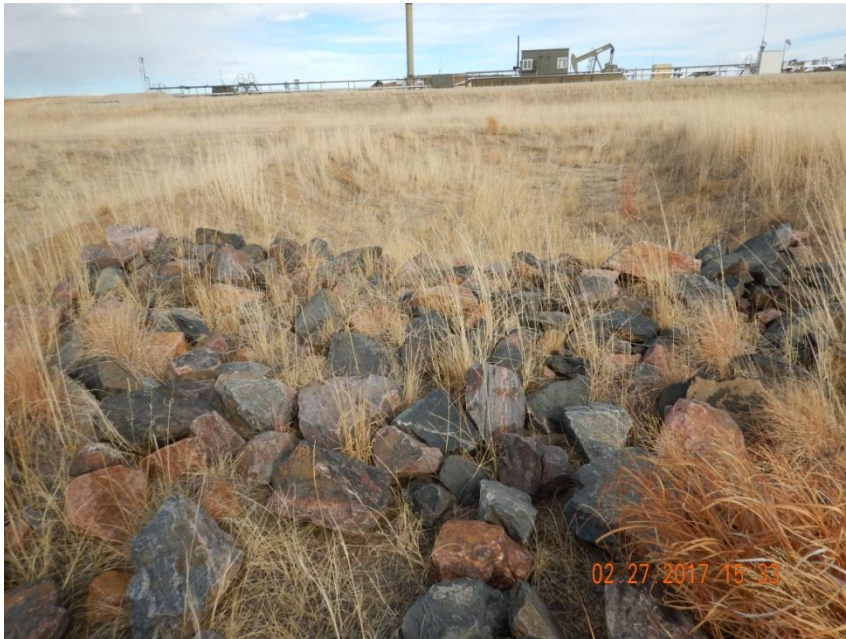
**Photo 11.** Photo taken from the western location along the current interim area, facing East. Sediment trap installed with armored outlet protection. Did not observe any sediment discharge at the sediment trap location.

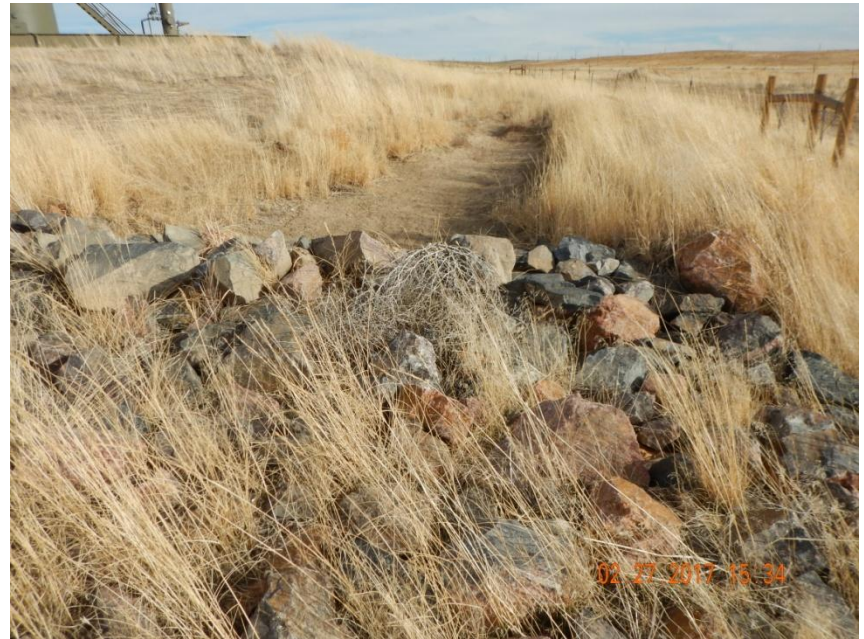
**Photo 12.** Photo taken from the southwest location along the current interim area, facing Southeast. Sediment trap installed with armored outlet protection. Did not observe any sediment discharge at the sediment trap location.
