Inspection Photos

Operator: Klabzuba O&G #10148

Location ID: 393690

Inspection Doc. Number: 682501783

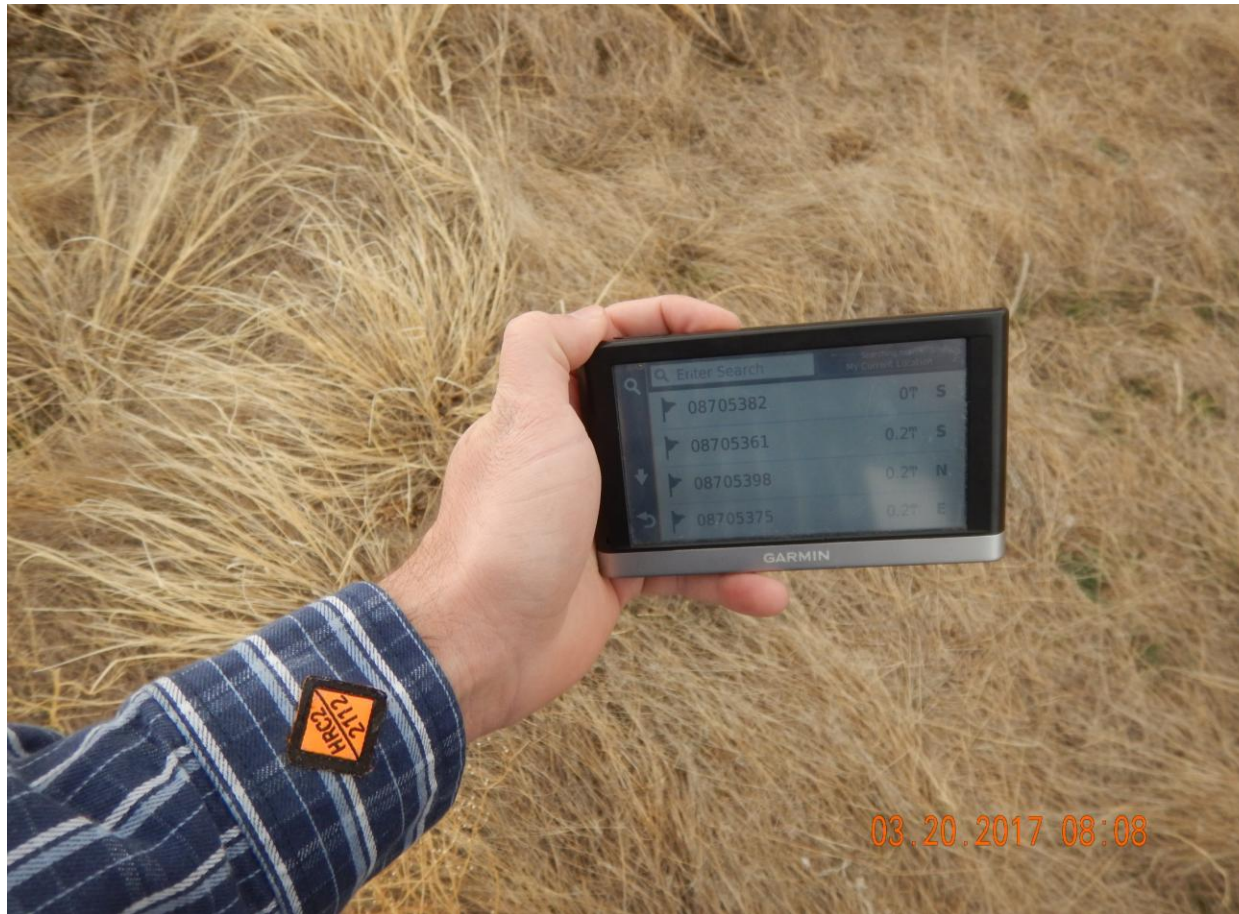
Photo 1: Photo of GPS verifying location.

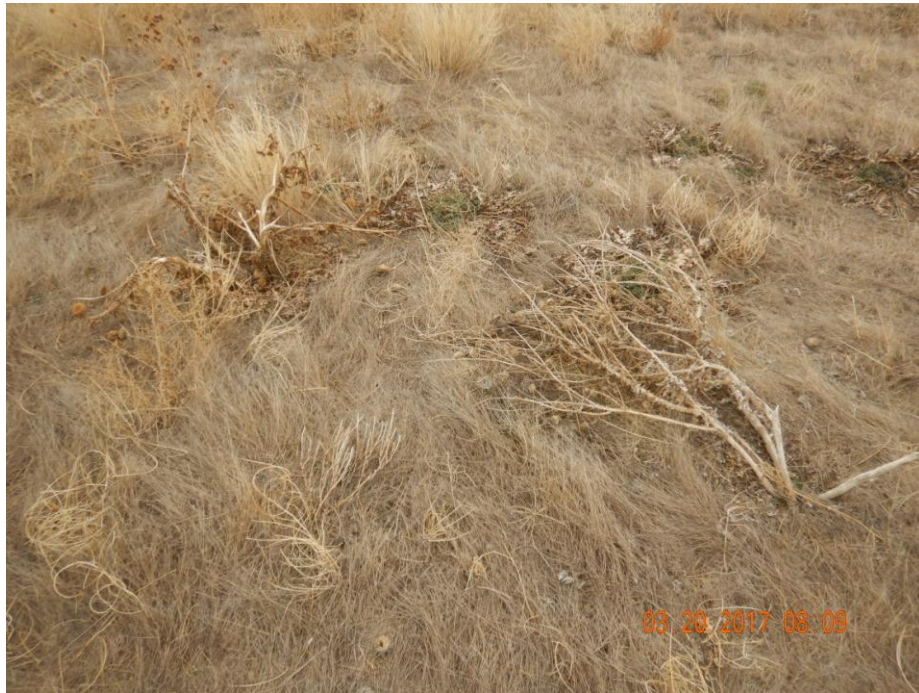
Photo 2: Photo taken from the location. Photo shows remnant Musk thistle stalks from 2016 growing season. Musk thistle is a Colorado State listed Noxious Weed and needs to be managed. Photo also shows vegetation in the disturbance area predominantly undesirable weedy cheat grass.

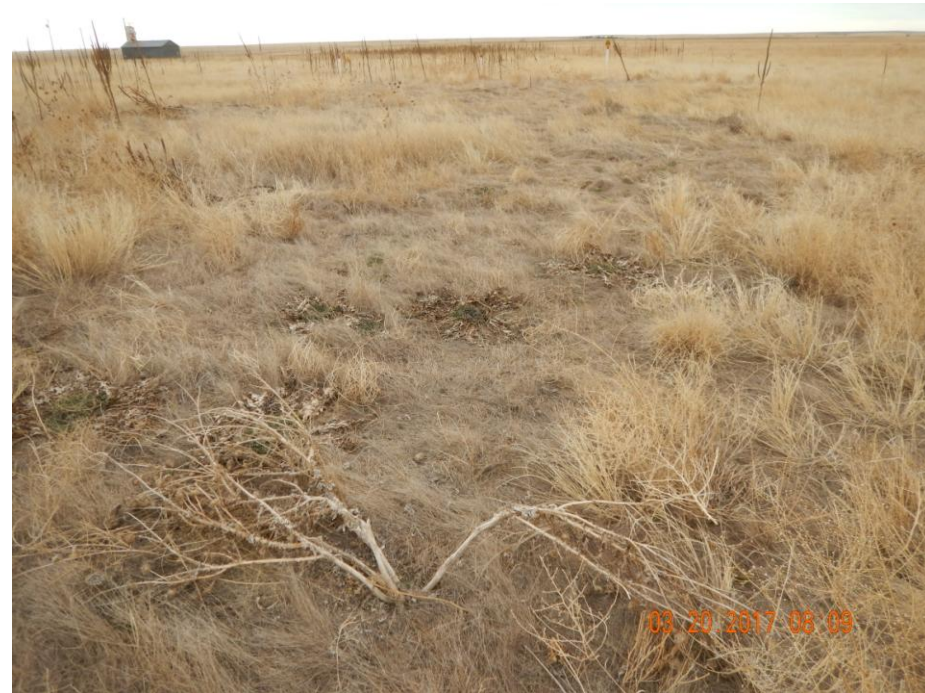
Photo 3: Photo taken from the location. Photo shows remnant Musk thistle stalks from 2016 growing season. Musk thistle is a Colorado State listed Noxious Weed and needs to be managed. Photo also shows vegetation in the disturbance area predominantly undesirable weedy cheat grass.

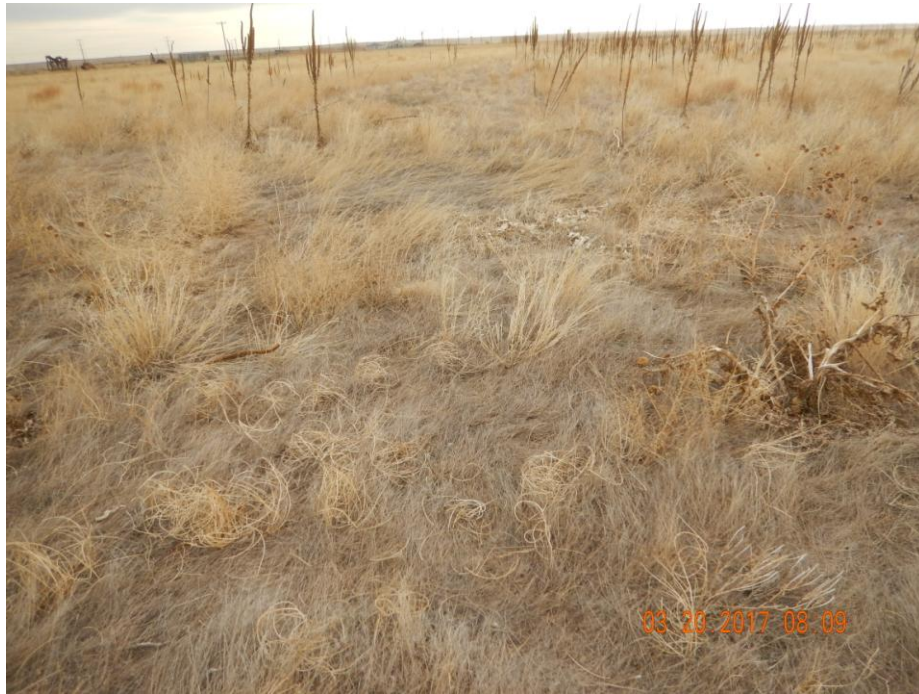
Photo 4: Photo taken from the north end of the location, facing south. Photo shows vegetation in the disturbance area has not achieved uniform desirable perennial vegetative cover. Location is vegetated predominantly undesirable weedy cheat grass.

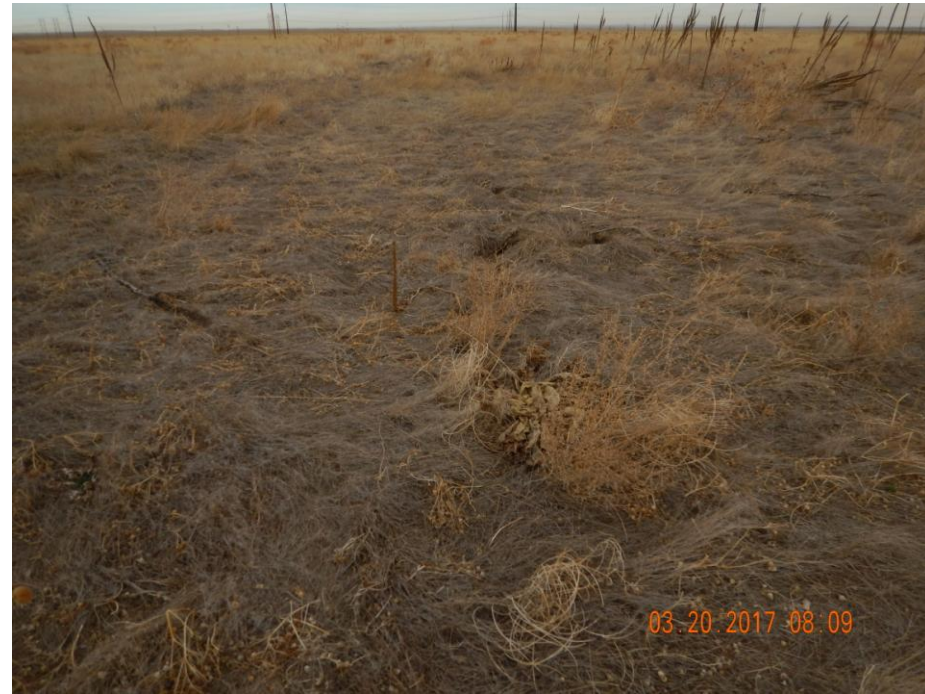
Photo 5: Photo taken from the south end of the location, facing north. Photo shows vegetation in the disturbance area has not achieved uniform desirable perennial vegetative cover. Location is vegetated predominantly undesirable weedy cheat grass.

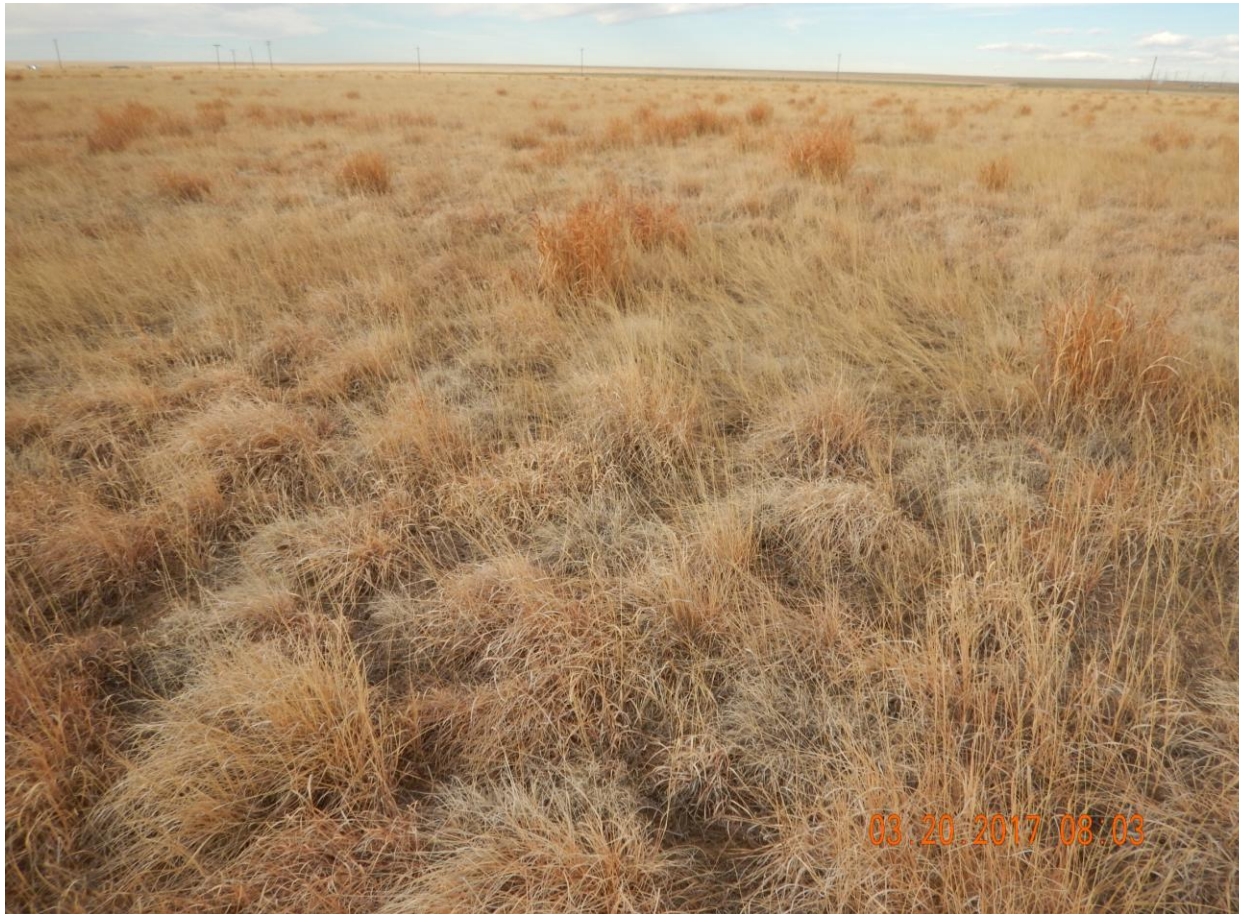
Photo 6: Photo of vegetation in the reference area. Vegetation seen here predominantly a mix of sideoats grama, western wheat, switch grass and little bluestem.
