# Inspection Photos

Operator: Foundation Energy #10112

Location ID: 330865

Inspection Doc. Number: 682501790

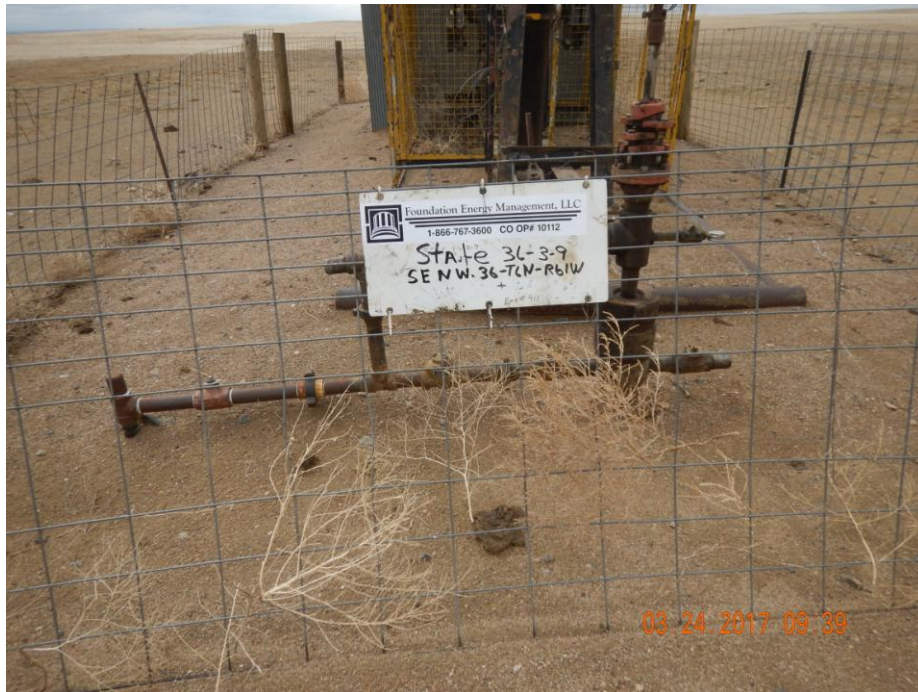
**Photo 1:** Photo taken from the well head. Inspection doc. #682501708 documented an audible leak occurring from well. Inspector can no longer detect leak. Sign has been placed at well.

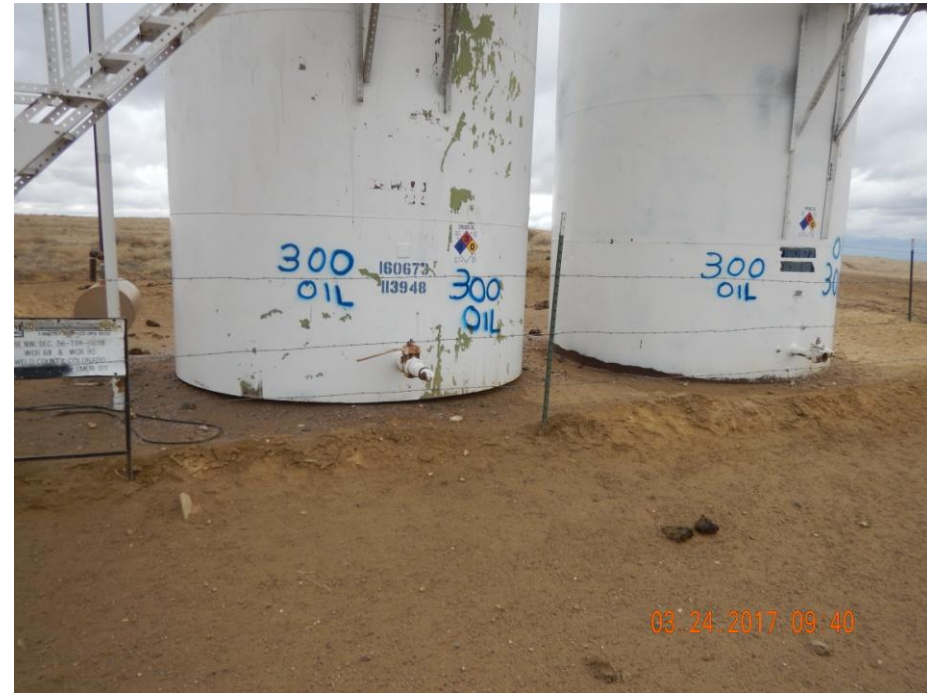
**Photo 2:** Photo taken from the tank battery. Appropriate labeling has been place. Berm along tank battery still remains in improper function condition.

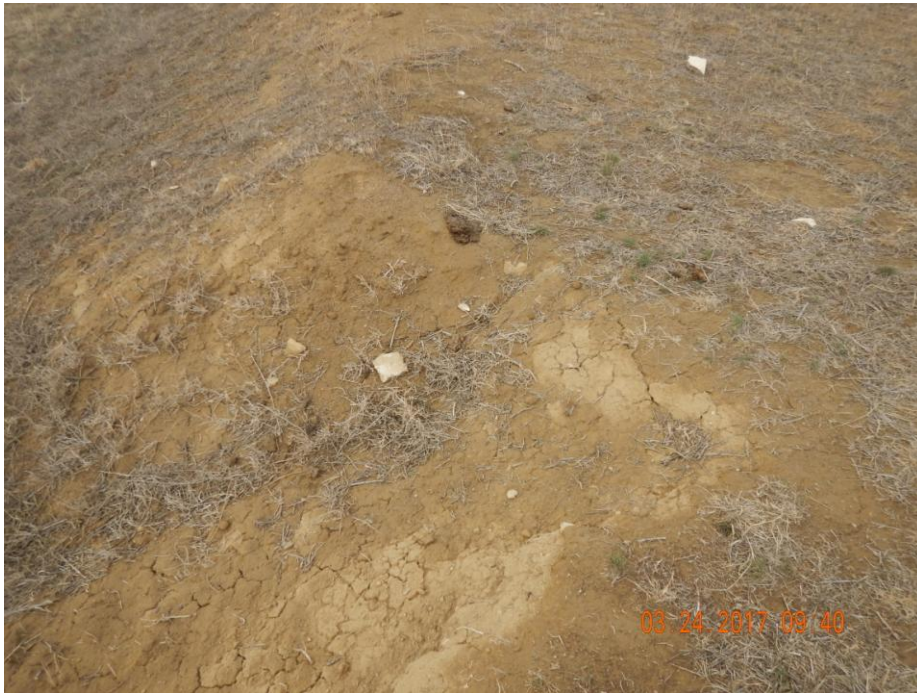
**Photo 3:** Photo taken from the south end of the location. Photo shows temporary stormwater and sediment control BMPs have not been installed to mitigate stormwater erosion.

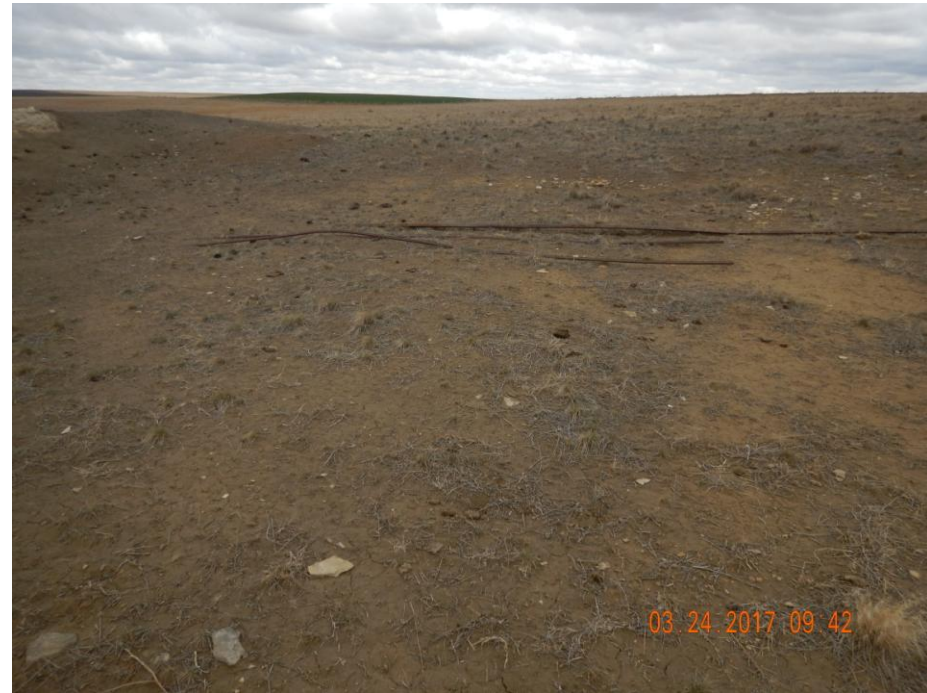
**Photo 5:** Photo taken from the north end of the location. Photo shows iron square tubing still stored on the interim area.
