Inspection Photos

Operator: Klabzuba Oil and Gas Inc #10148

Location ID: 393686

Inspection Doc. Number: 682501792

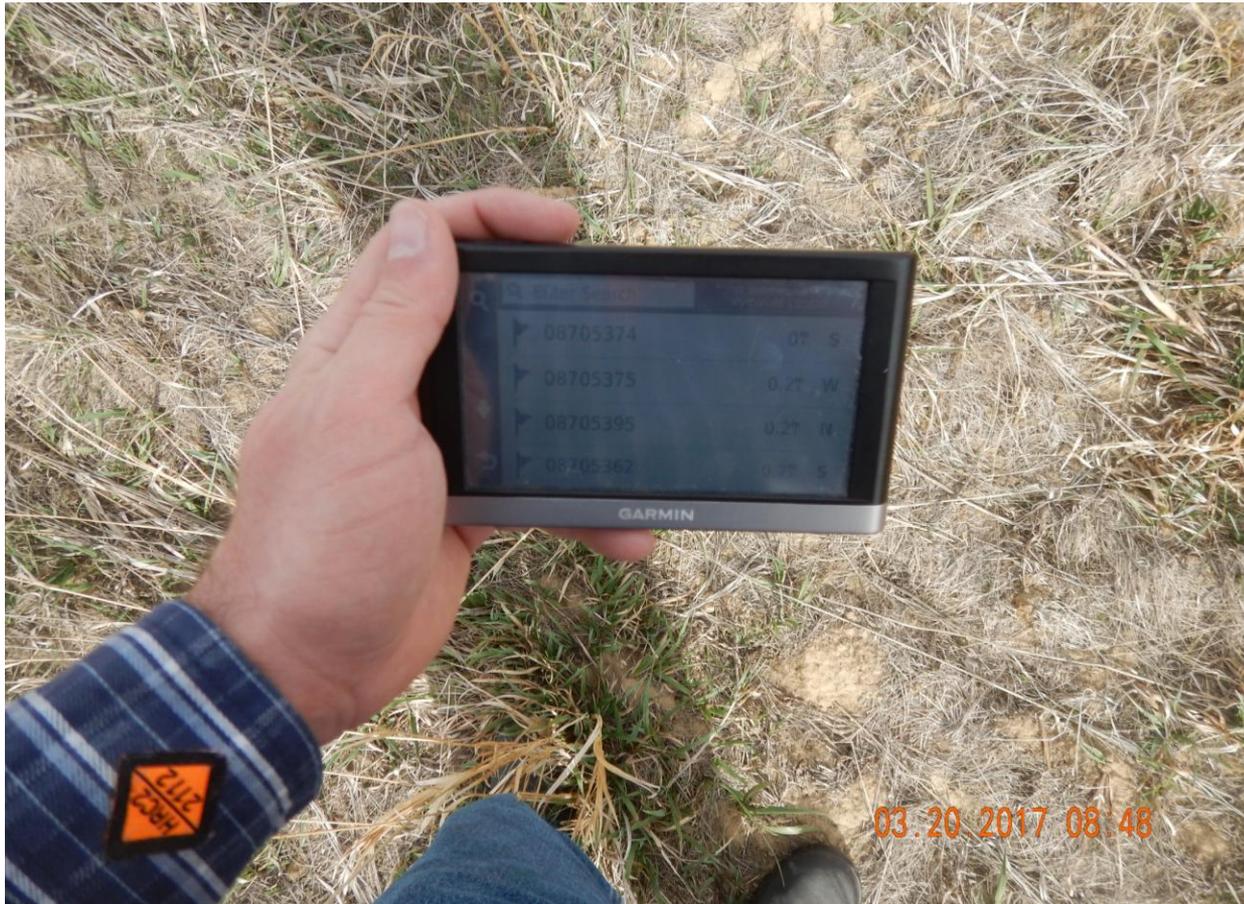
Photo 1: Photo of GPS verifying the location.

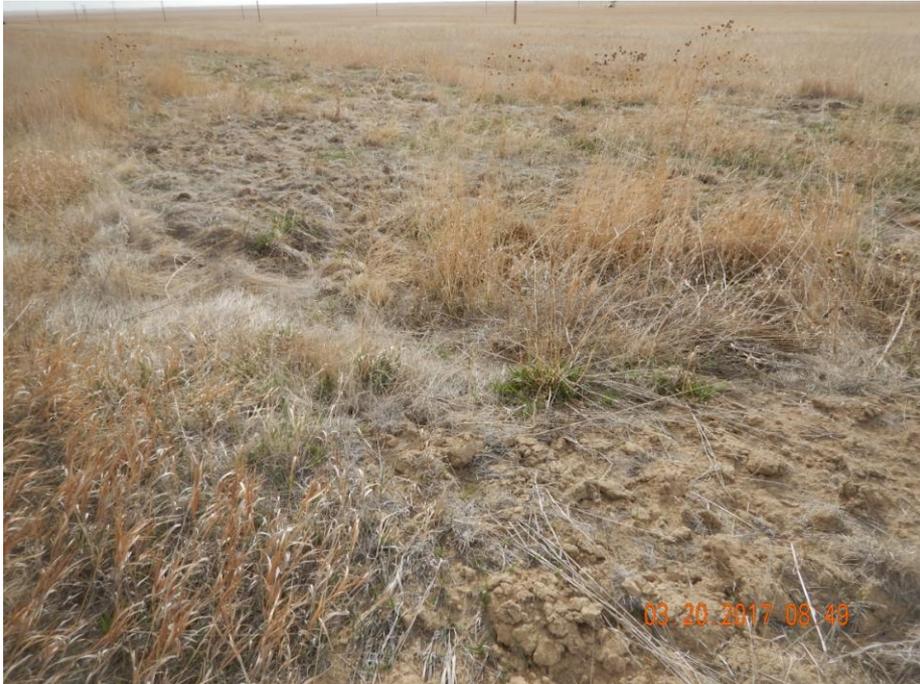
Photo 2: Photo taken from the north end of the location, facing southeast. Location appears to have been recently disked, likely per mid contract management requirements for CRP. Note: location seen here is predominantly exposed soil and undesirable grass species such as *Bromus tectorum* (Cheat Grass). Even with the disturbance, this location is not representative to reference areas that have also been disked (see photo 5)

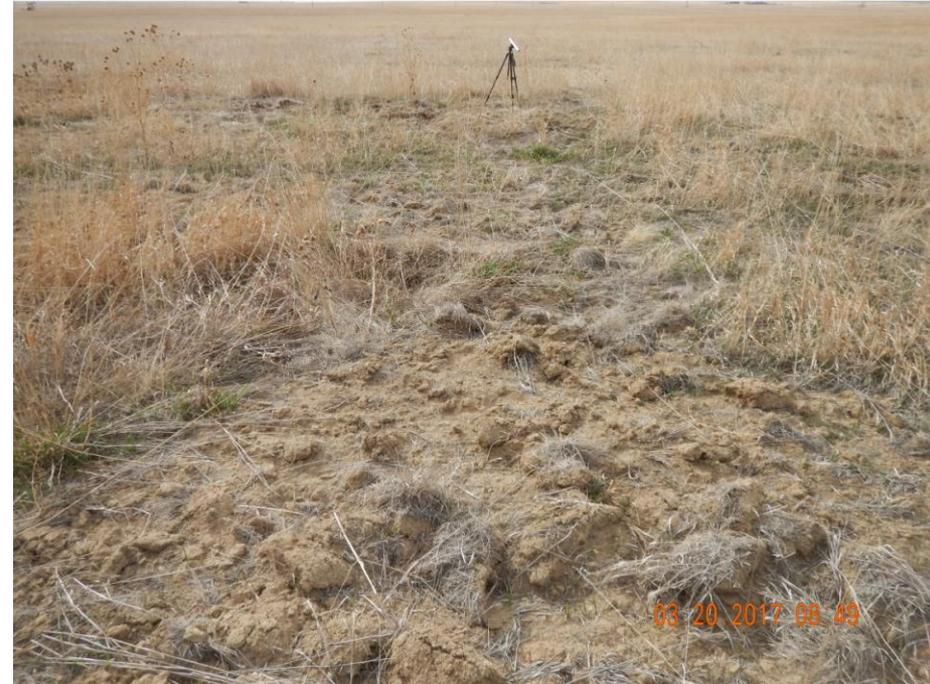
Photo 3: Photo taken from the north end of the location, facing south. Location appears to have been recently disked, likely per mid contract management requirements for CRP. Note: location seen here is predominantly exposed soil and undesirable grass species such as *Bromus tectorum* (Cheat Grass). Even with the disturbance, this location is not representative to reference areas that have also been disked (see photo 5)

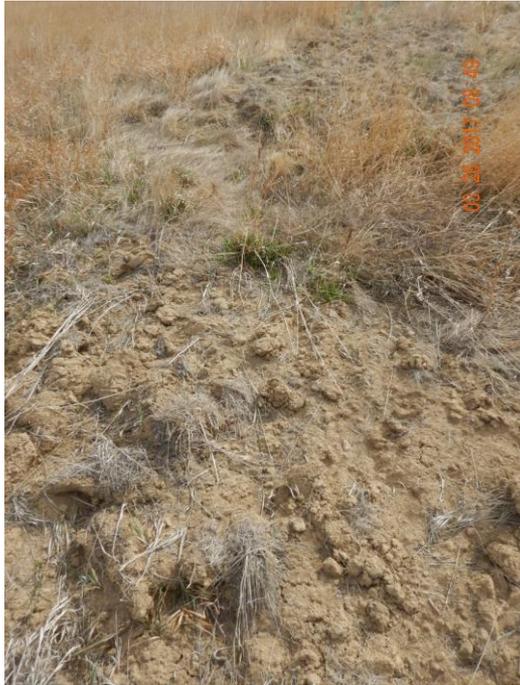
Photo 4: Photo taken from the north end of the location. Location appears to have been recently disked, likely per mid contract management requirements for CRP. Note: location seen here is predominantly exposed soil and undesirable grass species such as *Bromus tectorum* (Cheat Grass). Even with the disturbance, this location is not representative to reference areas that have also been disked (see photo 5)

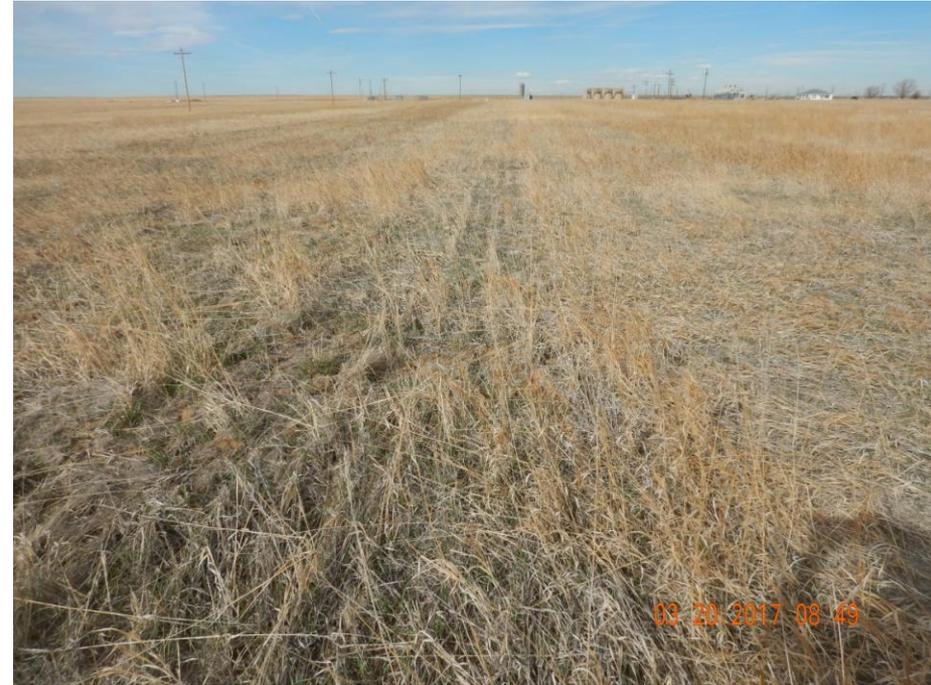
Photo 5: Photo taken from the adjacent reference area. Photo shows that the reference area has also been disturbed, however exposed soil is minimal and *Bromus tectorum* is at very low densities when compared to the well location.
