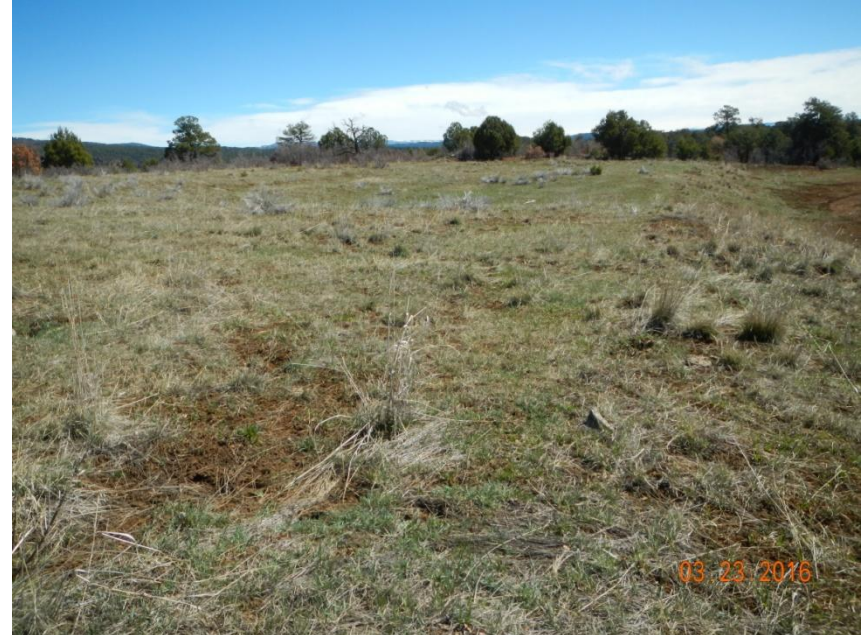
Photo 2: View of the northern portion of the project area from the northwestern corner facing eastward. Revegetation is largely comprised of grasses such as western wheatgrass (*Pascopyrum smithii*) and intermediate wheatgrass (*Thinopyron intermedium*), and smooth brome (*Bromus inermis*).

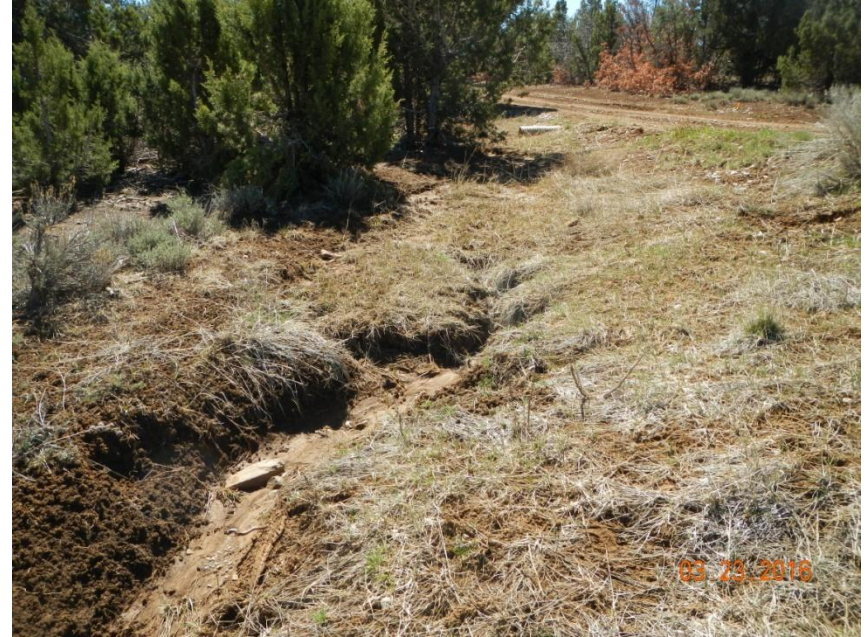
Photo 4: View of area downstream from culvert near the entrance to the well pad where a head-cut is forming. This area needs to be stabilized.
