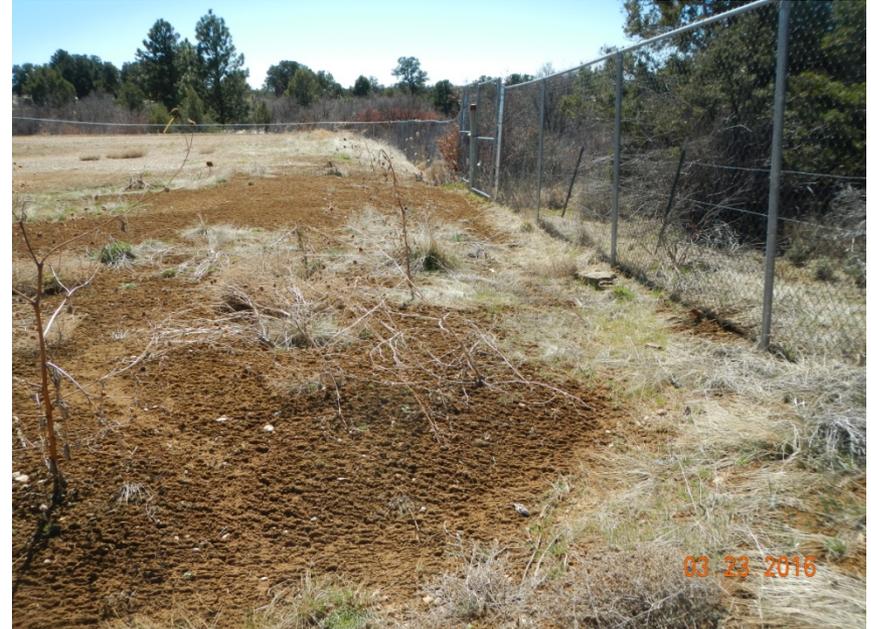
Photo 2: View of the western portion of the project area from the northwestern corner facing southward. Revegetation is progressing but weedy, and largely comprised of smooth brome (*Bromus inermis*) and sand dropseed (*Sporobolus* sp.).

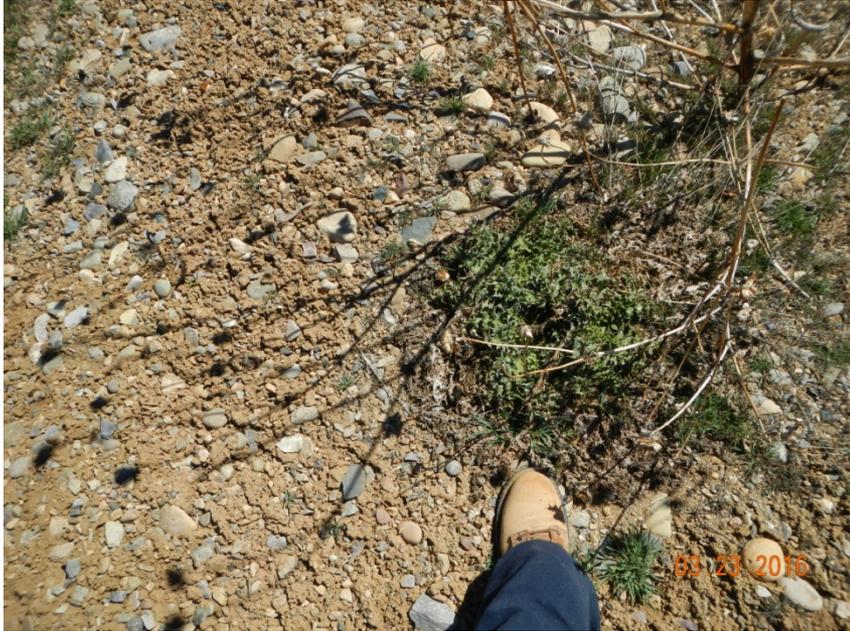
Photo 5: View of musk thistles (*Carduus nutans*) within the western portion of the project area.

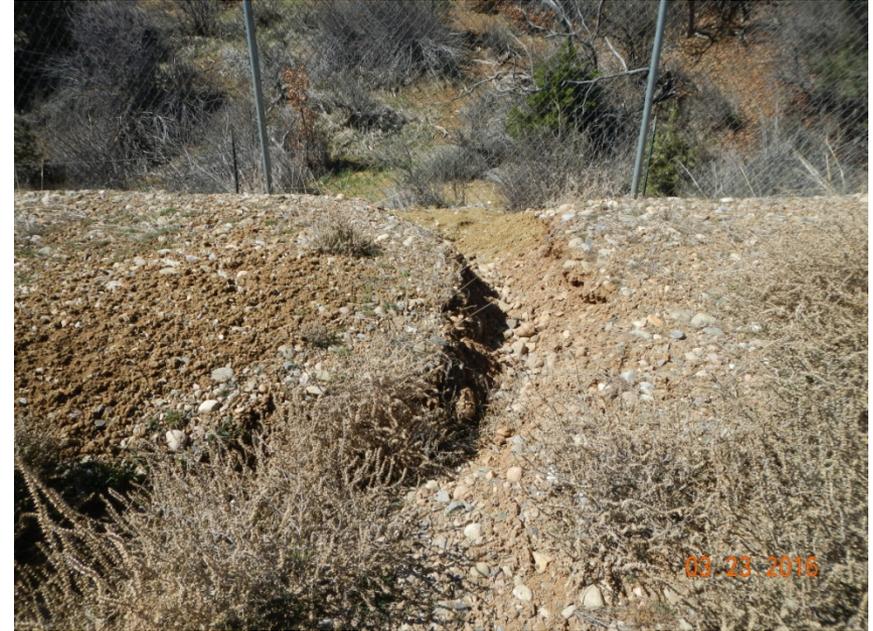
Photo 6: View of erosional channel (approximately 2 feet wide and deep) forming within the western portion of the project area.
